**CONSERVATION AIMED EVALUATION OF THE
BATH RUIN IN GÜLBAHÇE, URLA, İZMİR**

**A Thesis Submitted to
The Graduate School of Engineering and Sciences of
İzmir Institute of Technology
In Partial Fulfillment of the Requirements for the Degree of**

in Architectural Restoration

**by
Aslı ÇAĞLIYURT**

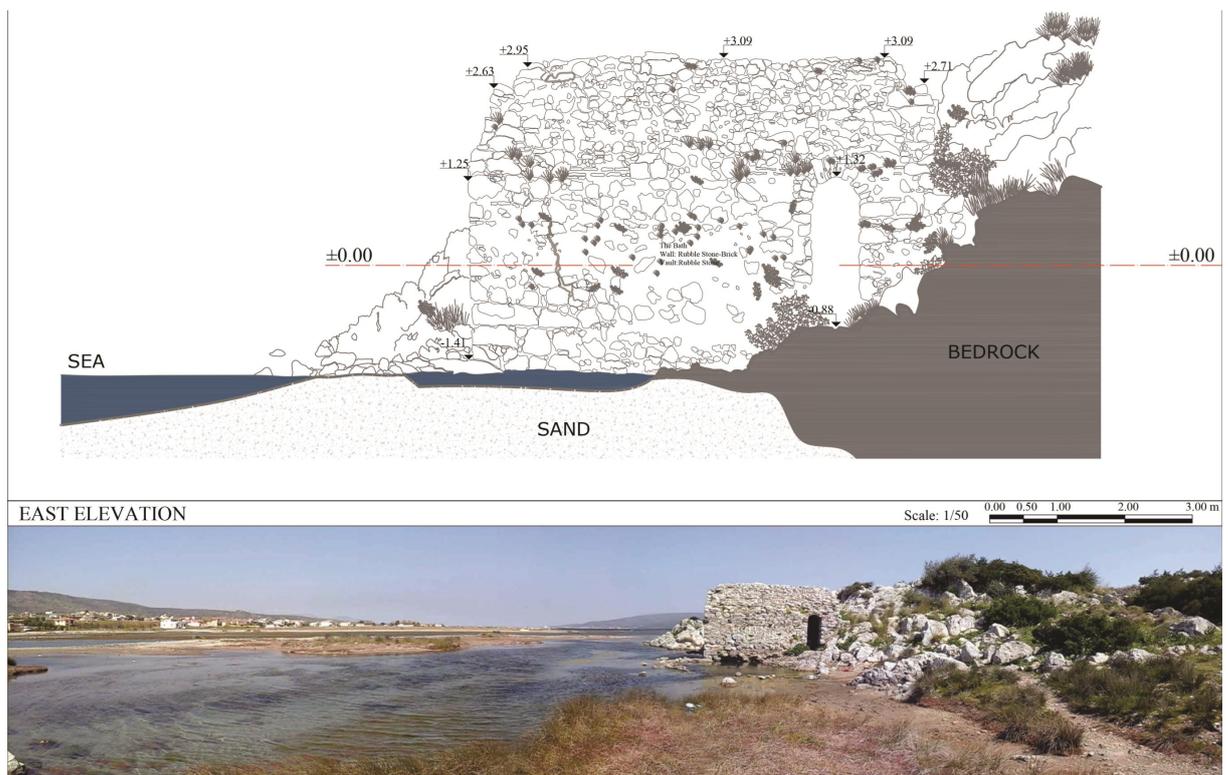
Figure 3.3 The Eastern Façade of The Case Study

This is the entrance facade (735 cm in width and 471 cm in height) that is only one opening to provide coming in the building. The door opening is semi-circular arched (72 cm in width and 180 cm in length) where is at the south corner of the facade. For the entrance into the building steps were not arranged instead of natural ground formation used (Figure 3.3).

Using material for construction is rubble stone, brick pieces and binding with mortar. Current situation of the east facade of the thermal bath's wall has a crack and loss materials but it is still durable. On the left side of the wall down has a cavity and it causes a crack that stretches out the vault. Furthermore, the lower part of the building, being exposed corrosion because of in connecting with the sea water

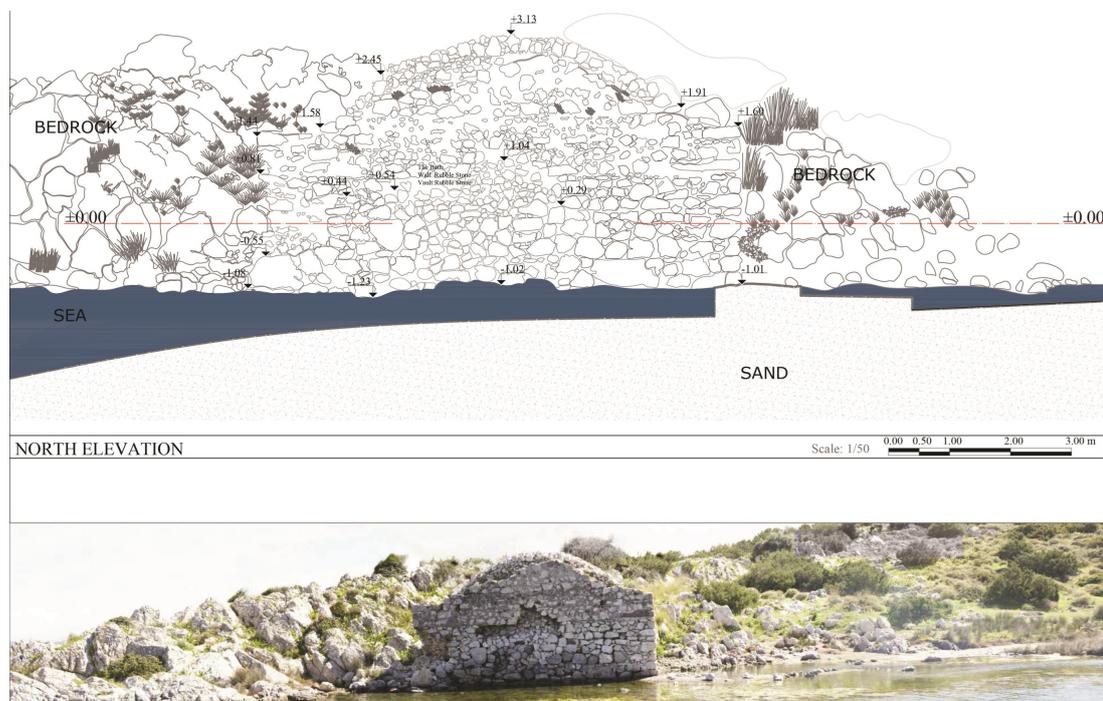
Figure 3.4 The Northern Façade of the Case Study

The northern facade (792 cm in length, 414 cm in height) of the bath faces the sea. It is totally blind. The vault and the wall are composed of rubble stone and mortar and have no plaster on the surface of the wall is blind. The eastern corner and the middle portion have material loss probably caused by the abrasion of sea. There is lack of materials can be seen furthermore the wall's left part demolished and at the middle part is collapsed. The bottom zone interacting with sea, especially the eastern corner and middle portion, has wide spread material deterioration creating risk of collapse (Figure 3.4).

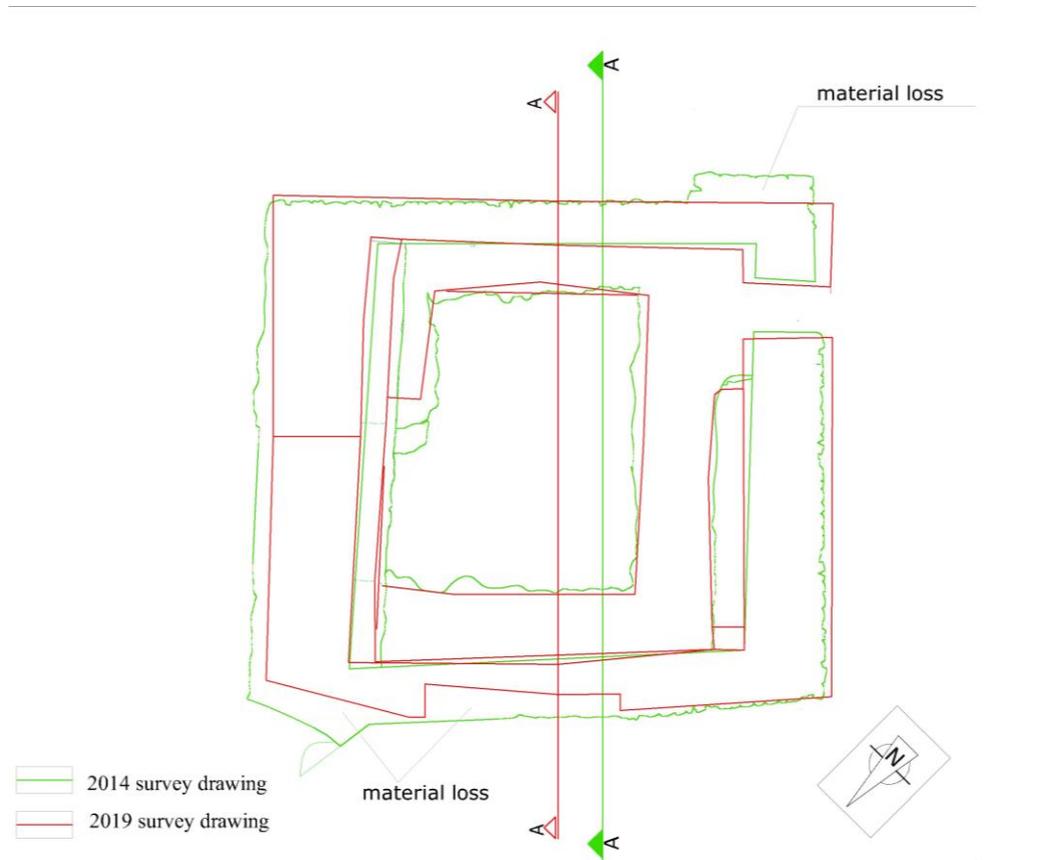
Figure 5.1. Plan Drawing

When a comparison is made between both March 2014 and 2019 survey drawings it is seen that sea is the major cause of failures and deteriorations. The northwestern wall facing the sea has eroded much more compared to the other portions of the bath house in the mentioned five years (Figure 5.1, 5.2). The material loss at the sea façade has probably given way to a movement of the related wall towards the sea direction. In turn, the structural crack at the west side of the entrance façade has become longer and the hole above it has enlarged (Figure 5.3). The most apparent material loss in the other portions is at the south corner of the mass. In addition, the arch of the spring has further eroded. This may be explained with the discharge of the mortar in the joints

in close connection with geothermal water at highest temperature (Figure 5.4). The variation in level differences of sea water may be related with seasonal changes, tide turns and heaviness of rains.

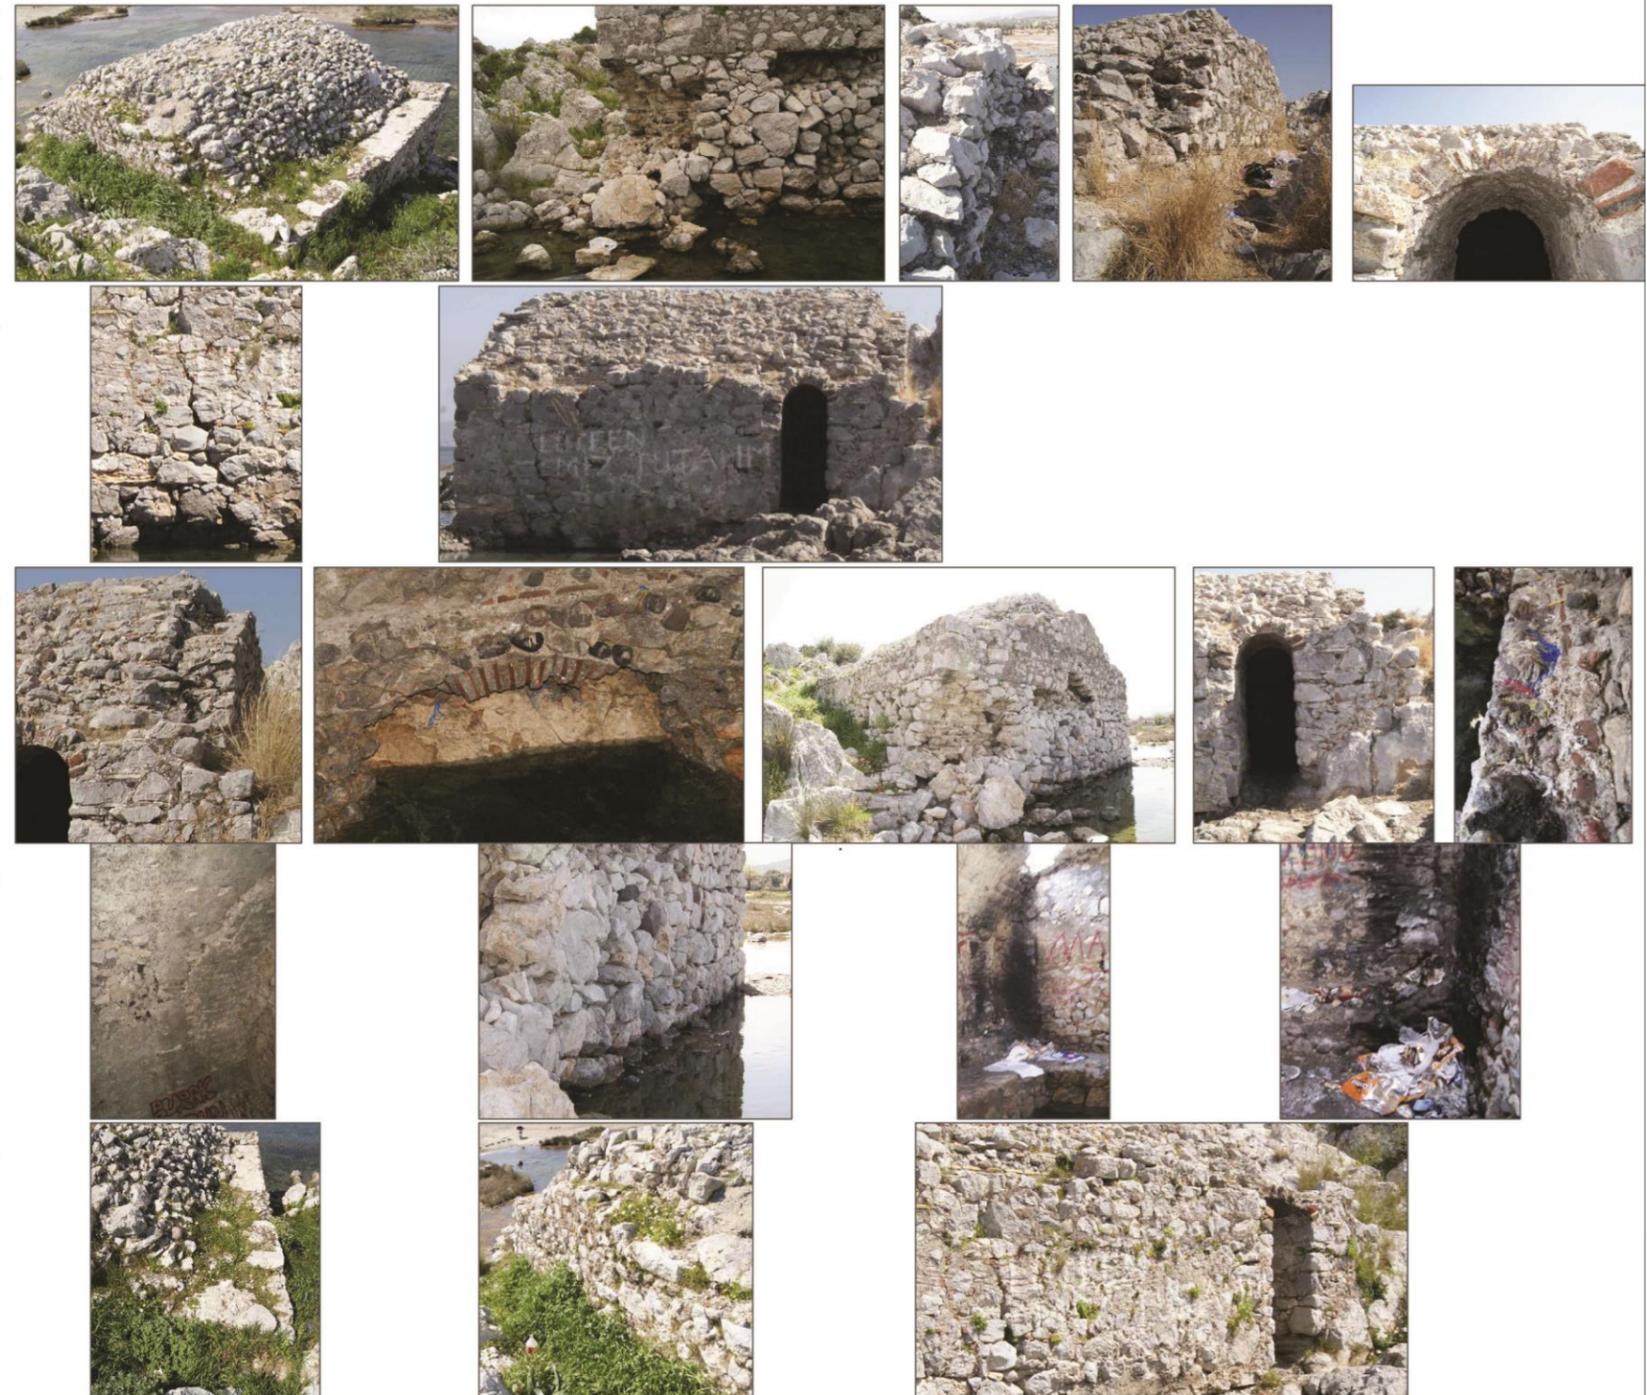
Figure C.2.1. Analytical Drawing -Structural Failures and Material Deterioration

STRUCTURAL FAILURES and MATERIAL DETERIORATION	
PROBLEM	PROBABLE CAUSE
<p>1) PARTIAL LOSS OF STRUCTURAL ELEMENTS</p> <p>Deformation of the load-bearing elements</p> <p><i>Vault</i> <i>Wall</i> <i>Arch</i></p>

<ul style="list-style-type: none"> • Weathering • Abrasion of sea water • Vandalism
<p>2) CRACK</p> <p>The diagonal crack on load-bearing element</p> <p><i>Wall</i></p>

<ul style="list-style-type: none"> • Vandalism
<p>3) LOSS OF BUILDING MATERIALS</p> <p>Surface deterioration</p> <p><i>Stone</i> <i>Brick</i> <i>Mortar</i> <i>Plaster</i></p>

<ul style="list-style-type: none"> • Weathering • Abrasion of sea water • Vandalism
<p>4) DISCOLORATION OF BUILDING MATERIALS</p> <p>Partial surface deterioration</p> <p><i>Stone</i> <i>Mortar</i> <i>Plaster</i></p>

<ul style="list-style-type: none"> • Weathering • Abrasion of sea water • Vandalism
<p>5) VEGETATION</p> <p>Surface deterioration and partial loss of material</p> <p><i>Plaster</i></p>

<ul style="list-style-type: none"> • Weathering
