Geotechnical reconnaissance findings of the October 30 2020, Mw7.0 Samos Island (Aegean Sea) earthquake

Abstract

Keywords Reconnaissance · Samos earthquake · Liquefaction · Lateral spreading · Slopes · Retaining structures · Foundations · Seismic performance

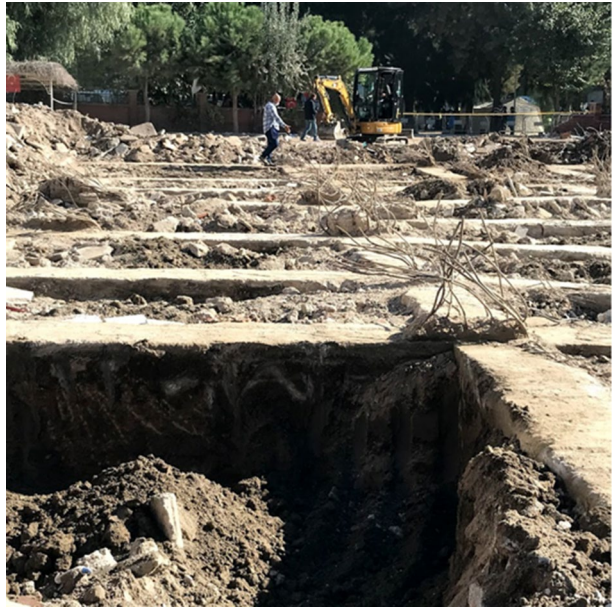
Fig. 2 Two-way combined footing system (grid spread footing foundation) of one of the heavily damaged buildings in Bayrakli, whose collapse is not foundation induced

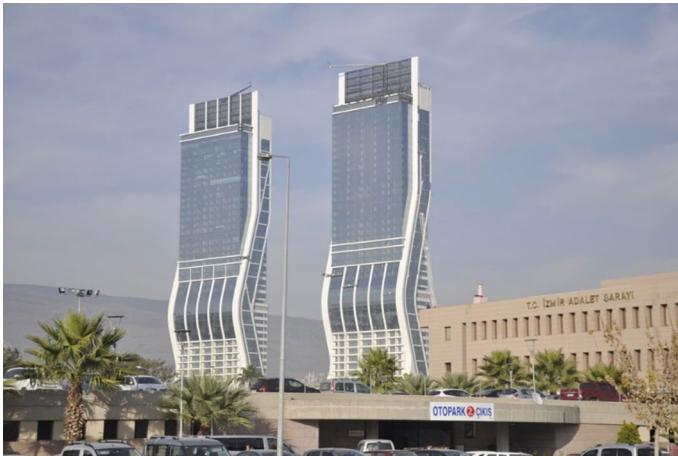
Fig. 3 200 m high Twin Folkart Towers in Bayrakli supported on a piled raft system. No earthquake-induced damage was identified or reported for such foundation systems

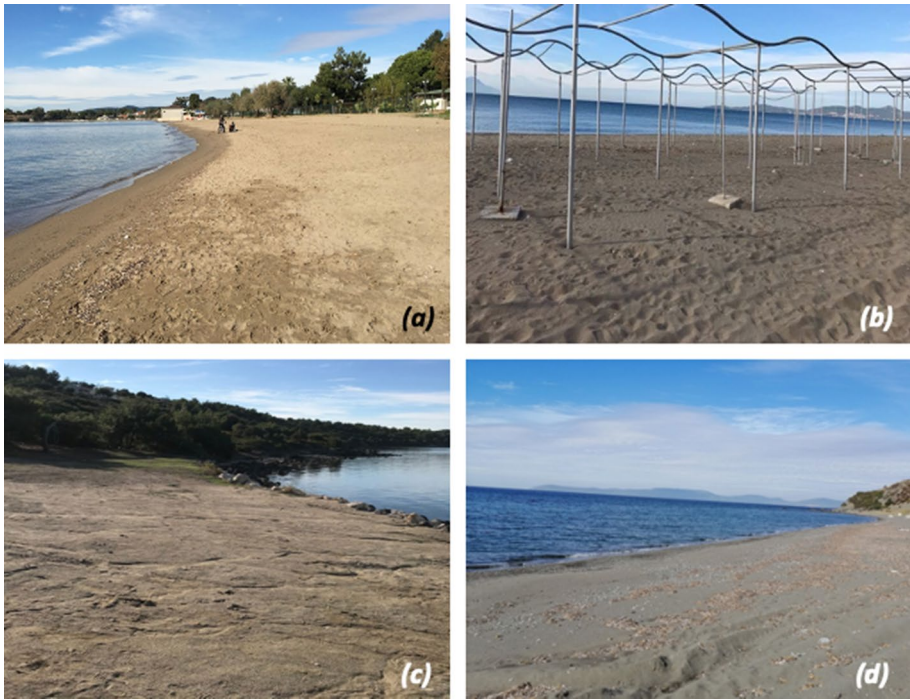
Fig. 6 Selected photographs indicating no earthquake-induced soil liquefaction manifestation near-shore: **a** and **b** shores of Gumulduz city ($38^{\circ}04'30.9''$ N $26^{\circ}58'32.7''$ E/ November 3rd 2020/11:03 and $38^{\circ}03'30.6''$ N $27^{\circ}00'38.3''$ E/November 3rd 2020/10:30 respectively), **c** shores of Cesme ($38^{\circ}20'54.5''$ N $26^{\circ}27'07.6''$ E/ November 3rd 2020/09:54), and **d** shore of the Seferihisar district ($38^{\circ}05'11.5''$ N $26^{\circ}51'39.7''$ E / November 3rd 2020/11:31)

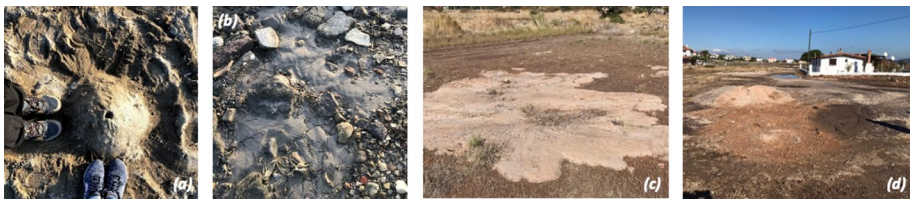
Consistent with the USGS susceptibility predictions, 45–50 km away from the rupture, along the shores of the Icmeler and Gulbahce districts, sand boils were observed, as shown in Fig. 7a through d. These sites were close to the Gulbahce fault zone, and documented artesian pressures along with hot water springs which are known to be present at these sites, which are also believed to have contributed to the observed soil ejecta formation. Figure 8 illustrates the results of grain size distribution analyses performed on soil samples retrieved from the sand ejecta. As can be seen, all samples were uniform and within the bounds typically delineated as liquefiable uniform soils.

Fig. 7 Surface manifestations of earthquake-induced soil liquefaction in the form of sand boils at shores of Icmeler and Gulbahce district: **a** $38^{\circ}20'18.4''$ N $26^{\circ}38'51.0''$ E, **b** $38^{\circ}18'37.3''$ N $26^{\circ}40'47.1''$ E, and **c-d** 38.338088 N, 26.647763 E

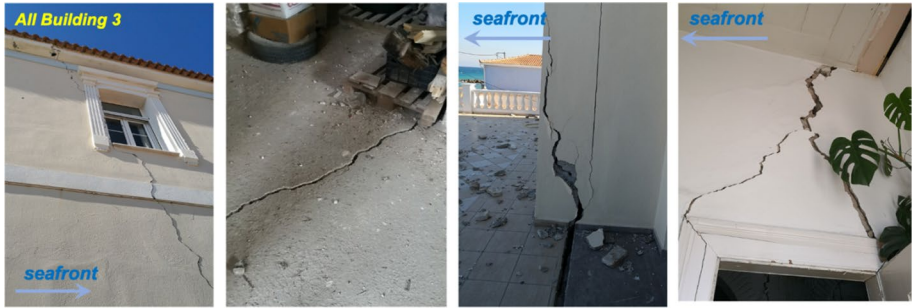
Lateral spreading effects were also evident through structural damage at other nearshore locations in the northern part of the island. Specifically, Figs. 14 and 15 illustrate three buildings and their location close to the north shore of the island, in the neighborhood Vyrsodepsia in Karlovasi. No surface manifestation of liquefaction was identified nearby, but the ground cracking crossing the street pavement and running through the buildings (the two in Fig. 16 are about 70 m inland and the one in Fig. 17 is about 20 m inland), in combination with the level/mildly sloping ground, the shallow water table, and the free face to the sea are all compatible with the hypothesis of lateral spreading.

Fig. 17 Building affected by lateral spreading towards the seafront in the neighborhood of Vyrsopepsia in Karlovasi ($37^{\circ}48'01.1''$ N $26^{\circ}42'20.6''$ E). The cracks observed running across the building indicate 3–5 cm of movement [photos courtesy of Prof. K. Antonopoulos]

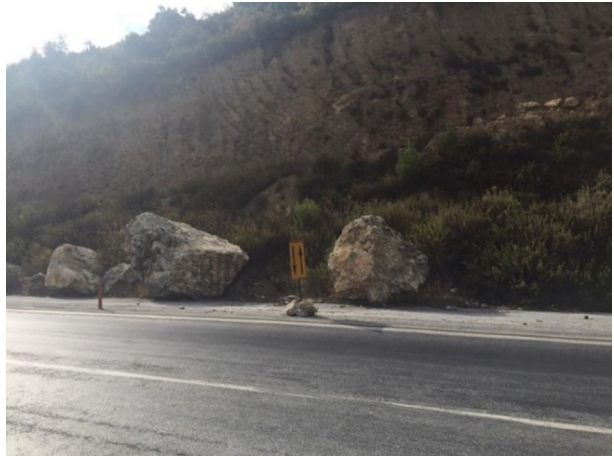
In Anatolia, a limited number of rockfalls were observed by the benches of highways, one of which is illustrated in Fig. 18. Some potential and existing landslide sites were also inspected, but no signs of seismically induced movements were documented and are thus

Fig. 18 Fallen rock blocks in the Anatolian side ($37^{\circ}53'50.4''$ N $27^{\circ}22'06.2''$ E)

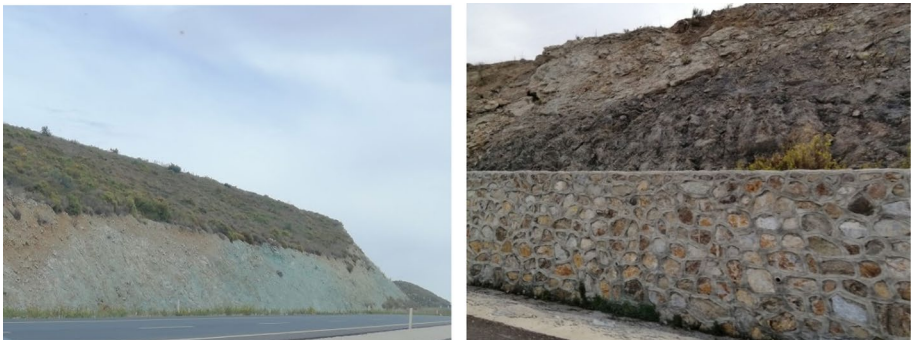
not presented herein. Furthermore, the highways were investigated and no proof of any seismically induced damage both on the highways or on the shoulder slopes was found, as shown in Fig. 19.

Fig. 19 Selected indicative views of highway cuts with no signs of slope instability ($38^{\circ}17'31.6''$ N $26^{\circ}40'14.6''$ E)

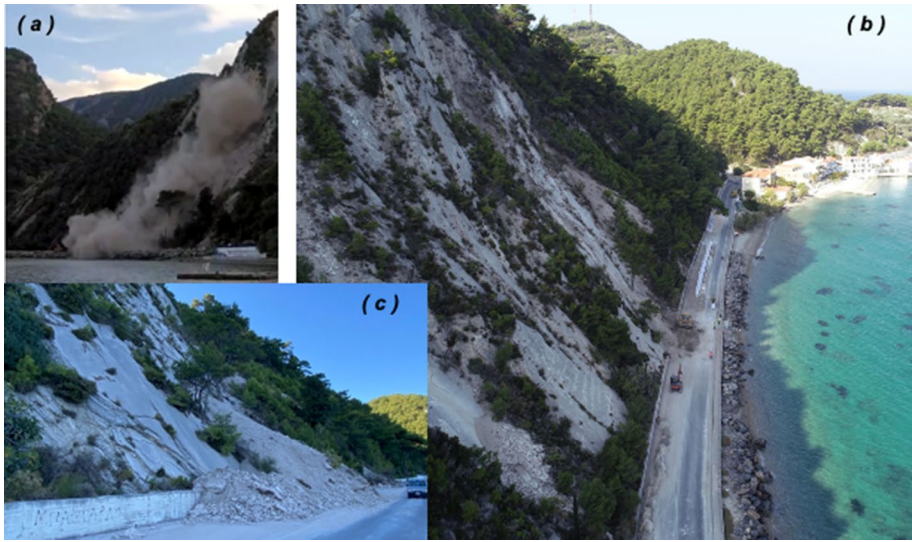
A weathered rock slide was recorded at a steep slope close to Avlakia region (Fig. 21), which caused a temporary closure of the road. The main geological formations in the above area are marbles with intercalations of schist (Cetin et al. 2021). However, the road access

Fig. 21 **a** Snapshot of Avlakia rockslide from a video recorded during the failure (source: <https://www.cnn.gr/ellada/story/240726/seimos-samos-vinteo-apo-katolisthisi-sta-aylakia>) **b** aerial photograph of the slide 2 weeks after the earthquake (courtesy of I.N. Spyrou and Prof. K. Ziopoulou 37°47'48.0" N, 26°51'27.7" E), and **c** a closer view of the rockslide illustrating the rock formation more clearly (picture by HAEE/ETAM reconnaissance team)

was quickly recovered after a few days by temporary restraining measures with large concrete blocks placed at the slope toe (Lekkas et al. 2020). Detachments of sandy marls and marly limestones were recorded very close to a residential building in Kokkari region (Fig. 22), while lighter failures referring to rockfalls and detachments of limestones, were observed close to the villages of Potami and Koumeika (Fig. 23a and b respectively). Slope

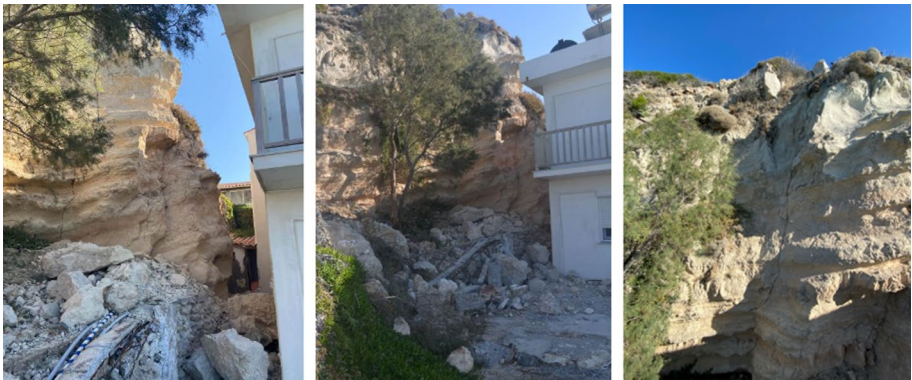
Fig. 22 Detachment of sandy marls and marly limestones recorded very close to a residential building in the Kokkari region (photos taken by the HAEE/ETAM reconnaissance team, 37°46'49.9" N, 26°53'35.0" E). Vertical open cracks are visible, clearly susceptible to detachment and toppling

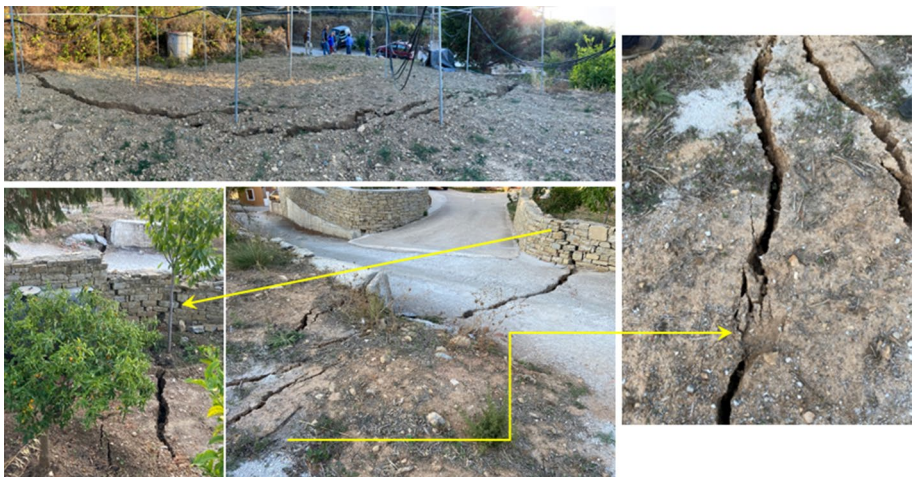
In the village of Kontakeika, extended ground cracks (openings of about 10–20 cm) were observed that were compatible with the mobilization of a larger, albeit very mild, slope or could be more broadly characterized as seismically-induced secondary ground failures (Fig. 24). The HAEE/ETAM team did not locate other similar indications of ground cracking in the near or extended vicinity of Kontakeika so, at this point in time, it is challenging to draw conclusions regarding the nature of this observation. According to local engineers, the Municipality of Samos had repaired the pavement in that particular location several times in the past, which suggests a pre-existing creeping landslide that could have been reactivated by the earthquake. The cracks extended on both sides of the street through soft soil formations (Fig. 24).

Fig. 24 Ground and pavement cracks in the village of Kontakeika (Samos), indicative of the mobilization of an extended but mild slope or more broadly characterized as seismically-induced secondary ground failures. The cracks extended on both sides of the street through soft soil formations. Arrows in the figure explain the relative location of the cracks

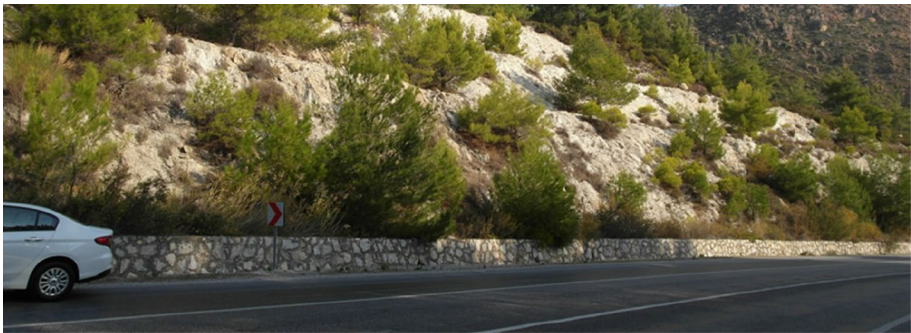
Fig. 28 Short, stoned retaining walls on the toe of the highway cuts between Menderes and Gumuldur in the south of İzmir city center

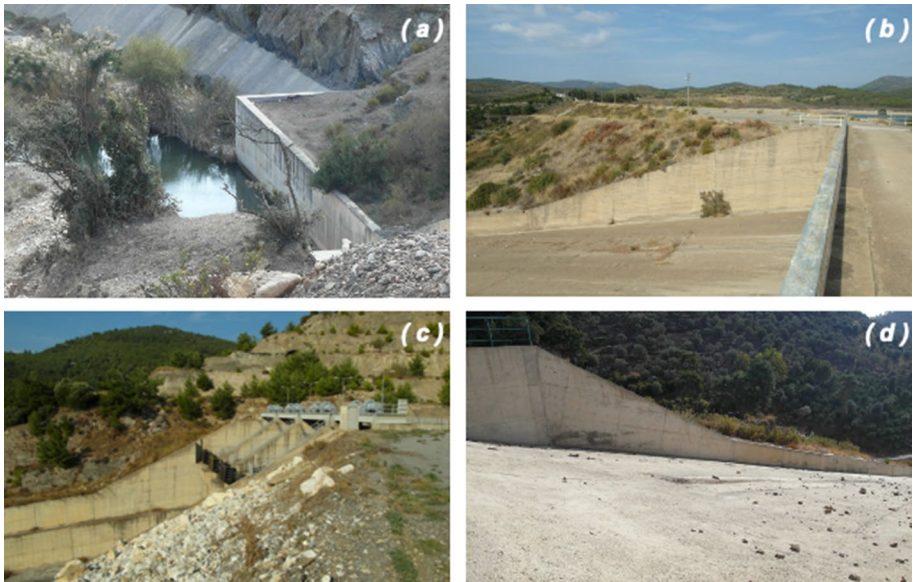
Fig. 29 a Wall on the end of spillway chute of Kavakdere Dam, and side walls of spillways of b Urkmez Dam, c Tahtalı Dam, and d Gumuldur Dam

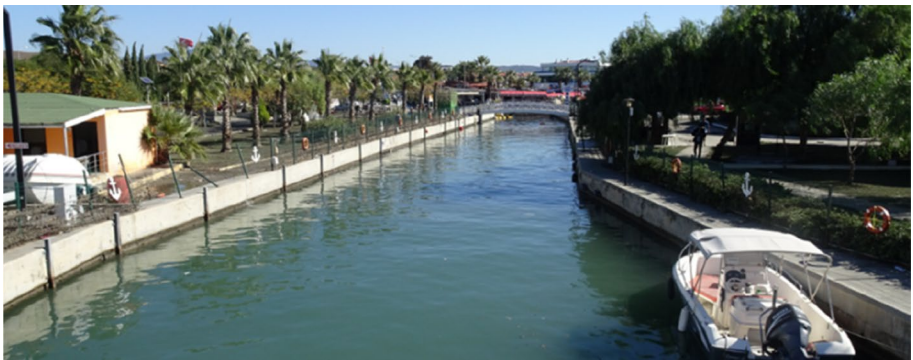
Fig. 30 Sidewalls of the river canal in the Sığacık Marina where no displacements were observed (Photo: Courtesy of Gurel Özdemir). (38°11'33.86"N 26°47'4.07"E 14:16 / 31.10.2020)

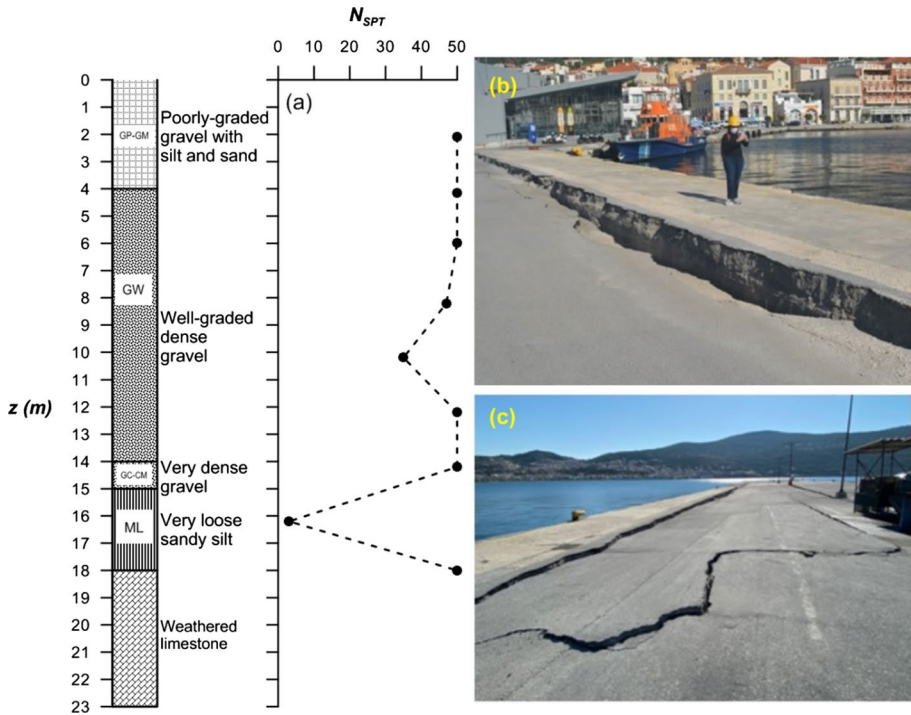
The jetty of the eastern (old) port experienced extensive longitudinal and transverse open cracks—several centimeters wide—whilst the backfill behind the quay wall experienced a subsidence that locally exceeded 50 to 60 cm (Fig. 34). In Fig. 34b, traces of gravels and sand are visible behind the quay wall. These might be remnants of ejecta partially washed out by the tsunami. The presence of ejecta could be the result of liquefaction of a very loose sandy silt layer located 15 to 18 m deep, right beneath the backfill material (Fig. 34a). Similar observations of ejecta behind quay walls have been made in many previous earthquakes (Professor G. Bouckovalas—*personal communication*), even in the absence of any native liquefiable soil layer. As such, any observed ejecta may be due to liquefaction and wash out of a loosely deposited fine silty-sand phase which fills the voids of a typically much coarser backfill gravel skeleton that does not participate in the load-carrying capacity of the wall (Professor G. Bouckovalas—*personal communication*). This could explain the lack of excessive displacements and rotations of the wall towards the sea. Construction records from the said ports and further investigations can elucidate this further.

Fig. 34 a Crude log of borehole BH1 located at the jetty of the old port of Vathy, where the liquefiable layer of the very loose sandy silt layer is located at a depth of 15 m (data provided by G. Milionis—elaboration by Em. Rovithis) and SPT blow count with depth. b Subsidence of backfill material behind the quay wall at the eastern (old) port, measuring up to 60 cm. c 10–15 cm wide longitudinal and transversal open cracks, located on the pavement over the backfill material, in contact with the quay wall

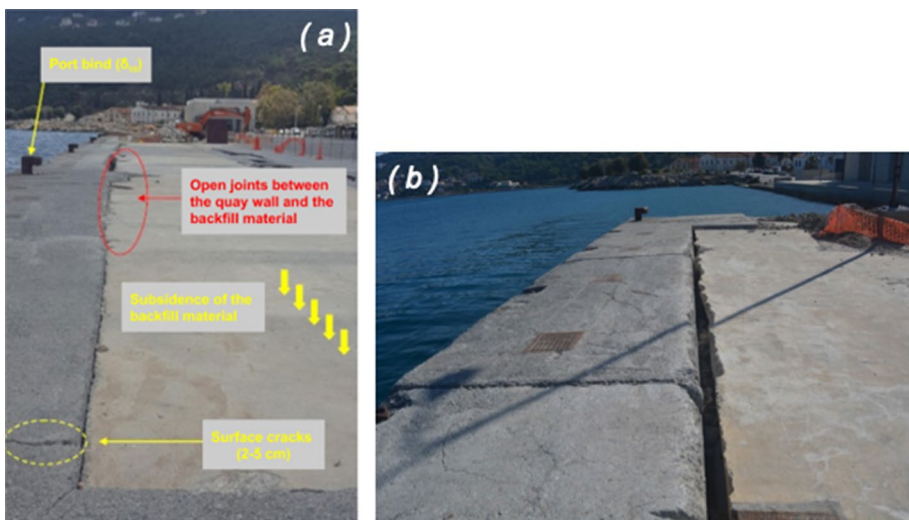
Figure 36a illustrates a view of the pre-existing open joints between the quay wall and the backfill material and the subsidence of the backfill material behind the quay wall about 3 years ago (Triton 2017), and its comparison to Fig. 36b which illustrates its condition immediately after the earthquake (HAEE/ETAM reconnaissance report 2020).

Interestingly, the earthquake damage observed is quite similar, but most probably intensified by the earthquake. At the time the site was visited by the HAEE/ETAM team, the construction operations in response to the Triton (2017) study were ongoing. Hauled construction materials did allow the team to delineate between those and any potential liquefaction-induced ejecta at the site. Nevertheless, given the geotechnical data liquefaction might have taken place on a rather limited scale and probably worsened the existing damage. In addition, the quay walls at this particular site are massive and consequently subject to large inertia forces mostly due to their own mass and not due to seismic earth pressures from the backfill. Consequently, it is likely that the quay walls at the Malagari port rotated somewhat outwards during the earthquake, thus widening any pre-existing gaps (Triton 2017) and also leading to some settlement of the backfill next to the wall. As such, it is rather unlikely that the present picture of the quay wall damage can be attributed entirely to liquefaction and dynamic settlement.

Fig. 36 View of the quay wall at new (Malagari) port, Vathy, from NW to SE direction: **a** photo taken 3 years before the earthquake (Triton 2017); **b** photo taken a few days after the earthquake (HAEE/ETAM reconnaissance report 2020)

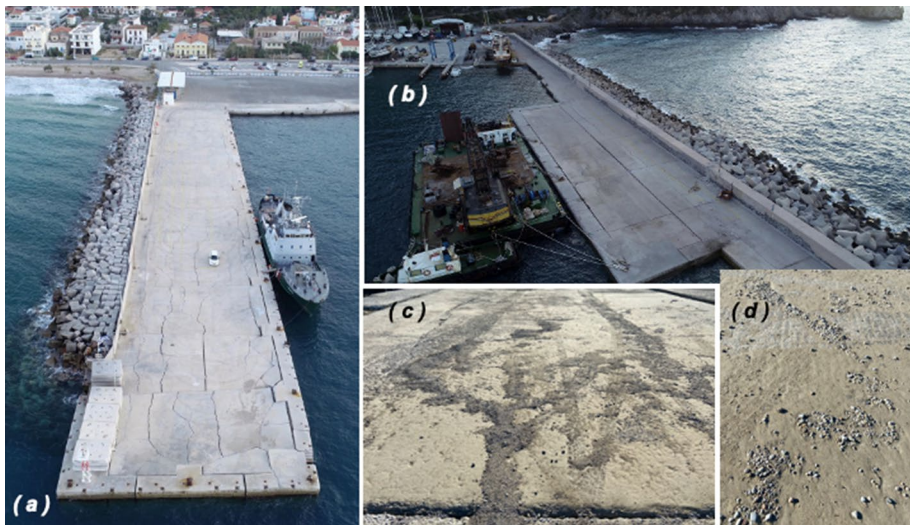
The port of Karlovasi suffered damage to both jetties, namely: subsidence of the backfill material (or the subsoil), mild tilting and displacement of the quay walls towards the sea, cracks (both transversely and parallel) to the quay walls. Also, grey-brown ejecta of sand-gravel mixture was found on the west quay wall, which possibly emerged through the cracks. Even in the absence of sufficient data to substantiate the occurrence of liquefaction, it appears that liquefaction is a reasonable scenario. This possibility is reinforced considering that the surface layer of grey-brownish silty sand identified at the high school area, seems to be continuing and getting thicker close to the sea shore. However, without additional geotechnical data, it is impossible to draw conclusions and this is only a hypothesis in accordance to the subsurface structure at Vathy. Last but not least, the construction details of each port need to be accounted for, since the placement of a backfill under “wet” or “dry” conditions can severely affect its dynamic response in seismic events. Figure 38

illustrates both jetties (east and west), as well as ejecta observed on the western quay wall. Nevertheless, it is hard to tell whether the cracks and subsidence/tilting patterns are earthquake induced, or merely pre-existing gravity-induced effects.

Fig. 38 **a** East quay wall of Karlovasi port, **b** west quay wall of Karlovasi port, **c** ejecta on the west quay wall, presumably the product of liquefaction occurrence, and **d** a detailed view of the ejecta, brownish to grey color, mostly sandy and silty with some gravels (aerial photographs courtesy of I.N. Spyrou and Prof. K. Ziotopoulou)

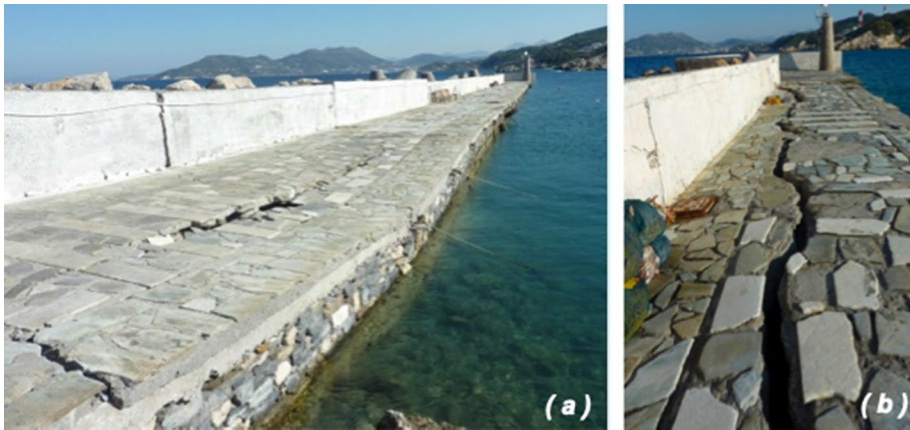
Kokkari is a small village in the northern part of Samos, situated about 10 km NW from Vathy. It has a small port mainly serving fishing boats and small yachts. The reconnaissance team of HEAA visited Kokkari and observed that the quay wall had suffered severe subsidence, 10 to 20 cm wide open cracks alongside the sea front, and mild tilting towards the sea, as shown in Fig. 39. It is unclear whether the deformations were pre-existing i.e.

due to the low quality of the quay wall construction and the lack of protection of its underwater part from scour. Problems related to low bearing capacity and differential settlements due to a soft and compressible surface soil layer at the foundation of the jetty cannot be excluded. However, no clear traces of liquefaction were detected following the earthquake.

Fig. 39 **a** Differential subsidence of the quay wall of Kokkari port with wide open cracks alongside and transversely, **b** close view of an open crack of 10 to 15 cm alongside the sea front (HAEE/ETAM 2020)

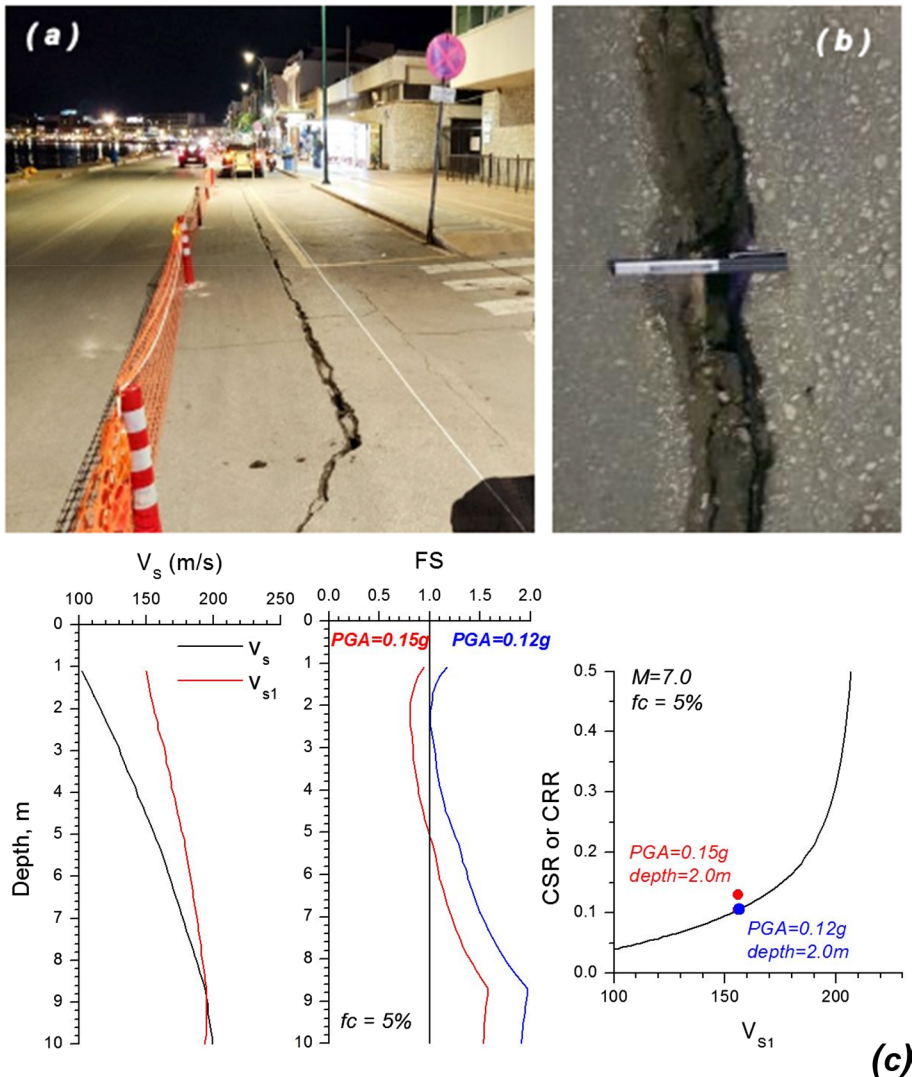
Earthquake-induced failures were also observed in the port of Chios island, situated approximately 80 km north of the fault, referring mainly to surface cracks of considerable width and depth (Fig. 40a), as reported in the post-earthquake preliminary report by Pelekis and Roumelioti (2020). At specific locations these cracks were about 10–15 cm wide and about 40 cm deep (Fig. 40b). Such type of failures in the port of Chios may indicate soil liquefaction that was marginally triggered during the earthquake, and ensuing lateral spreading effects towards the shoreline, as suggested by Pelekis and Roumelioti (2020). The existence of inclined strata below the filling material of the quay walls and pre-earthquake damage due to gravity loads (e.g. scour of its foundation) should be considered when interpreting the observed seismic behavior. The possibility of marginal triggering of soil liquefaction was reinforced following a series of MASW field tests, which revealed the existence of soft/low-strength surficial soil layers with shear wave propagation velocity of about 100 m/s. A preliminary V_s -based assessment of the safety factor against soil liquefaction (Andrus and Stokoe, 2000) revealed a potential triggering of the phenomenon during the $M_w=7.0$ event for PGAs above approximately 0.12 g (Fig. 40c).

Fig. 40 **a** Earthquake-induced surface cracks parallel to the quay wall front in the port of Chios, **b** close-up view of 10–15 cm wide and 40 cm deep surface cracks, and **c** preliminary V_s -based assessment of the safety factor against soil liquefaction at the depth of 2 m for PGA equal to (i) 0.15 g and (ii) 0.12 g (Pelekis and Roumelioti, 2020)
