**CONSERVATION OF
KUSEYRİ SOAP FACTORY
AS AN INDUSTRIAL HERITAGE IN ANTAKYA**

**A Thesis Submitted to
the Graduate School of Engineering and Sciences of
İzmir Institute of Technology
in Partial Fulfillment of the Requirements for the Degree of**

in Architectural Restoration

**by
Derya CAMUZ**

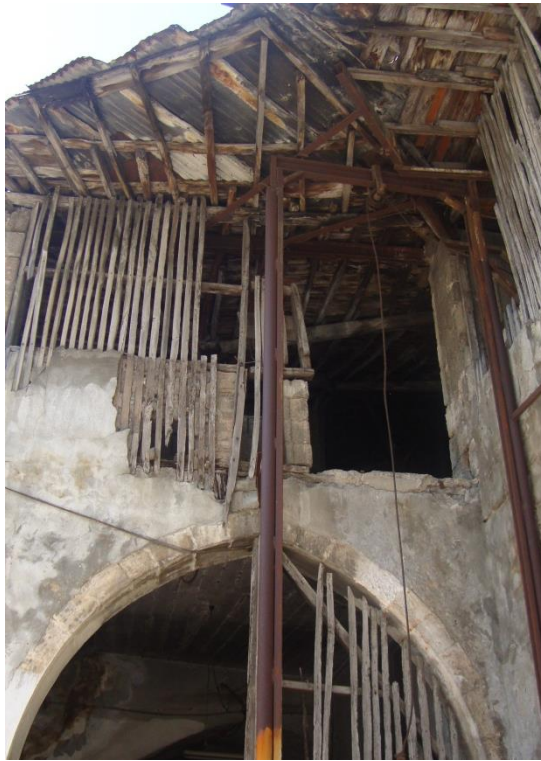
Figure 4.78. Partially missing wooden screen on the first floor on the projected part of the facade

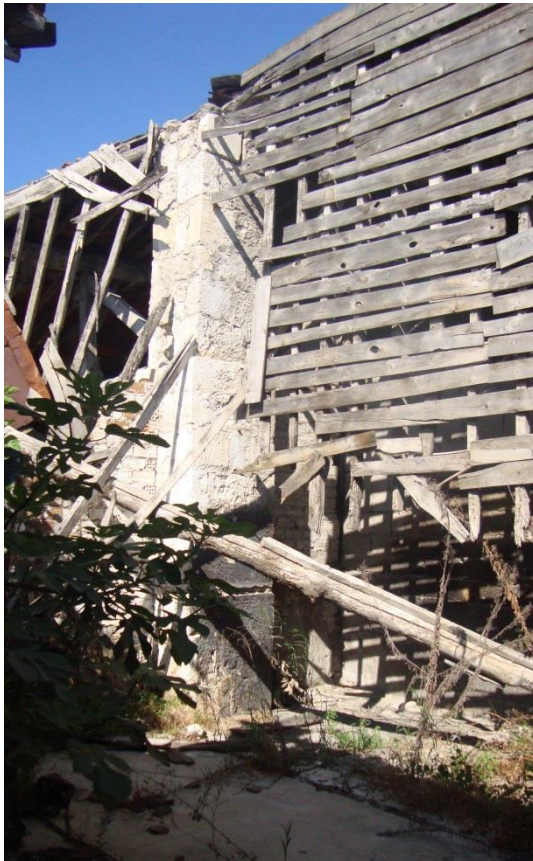
Figure 4.141. The missing part of the roof on the west part of the building

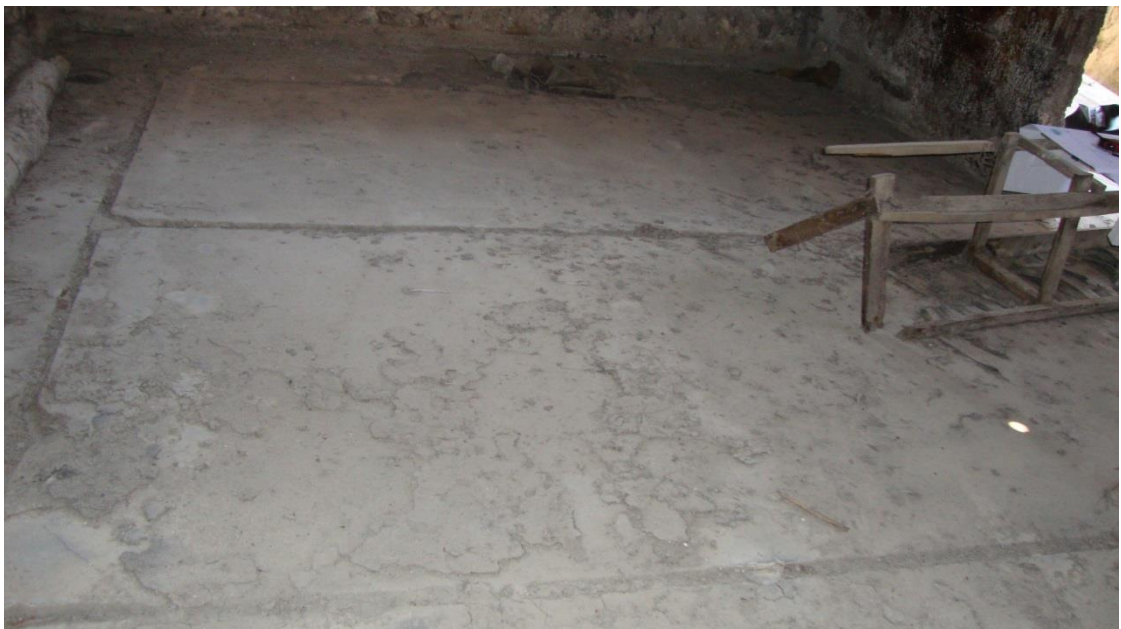
Figure 4.142. Traces of the missing wooden laths of the soap molds on the spreading and drying area on the west part of the building

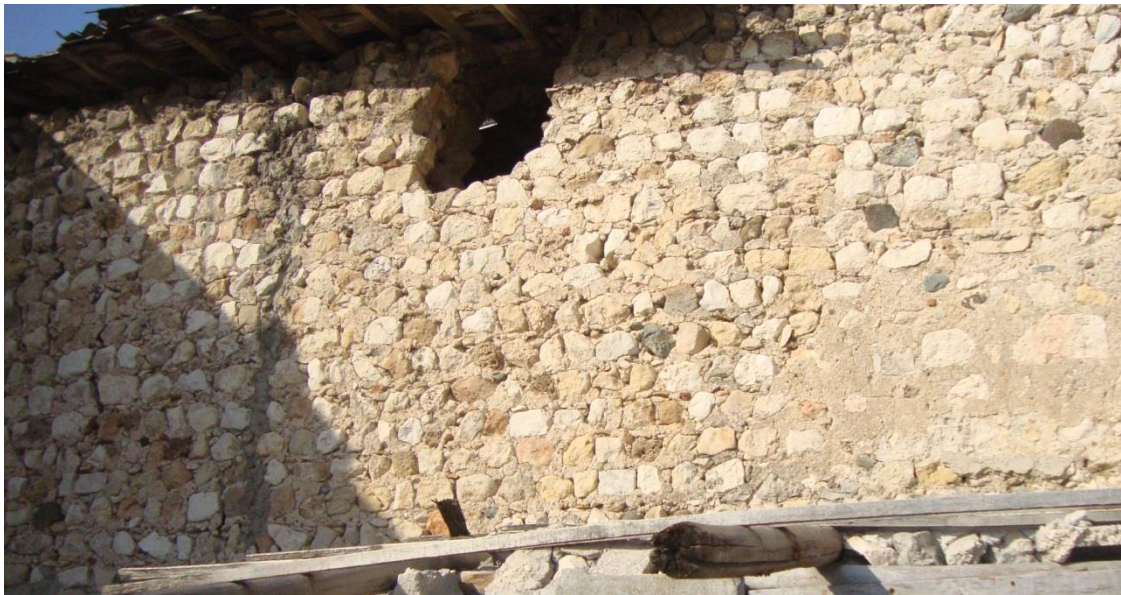
Figure 4.147. Granular disintegration on the stone wall on the west part of the building

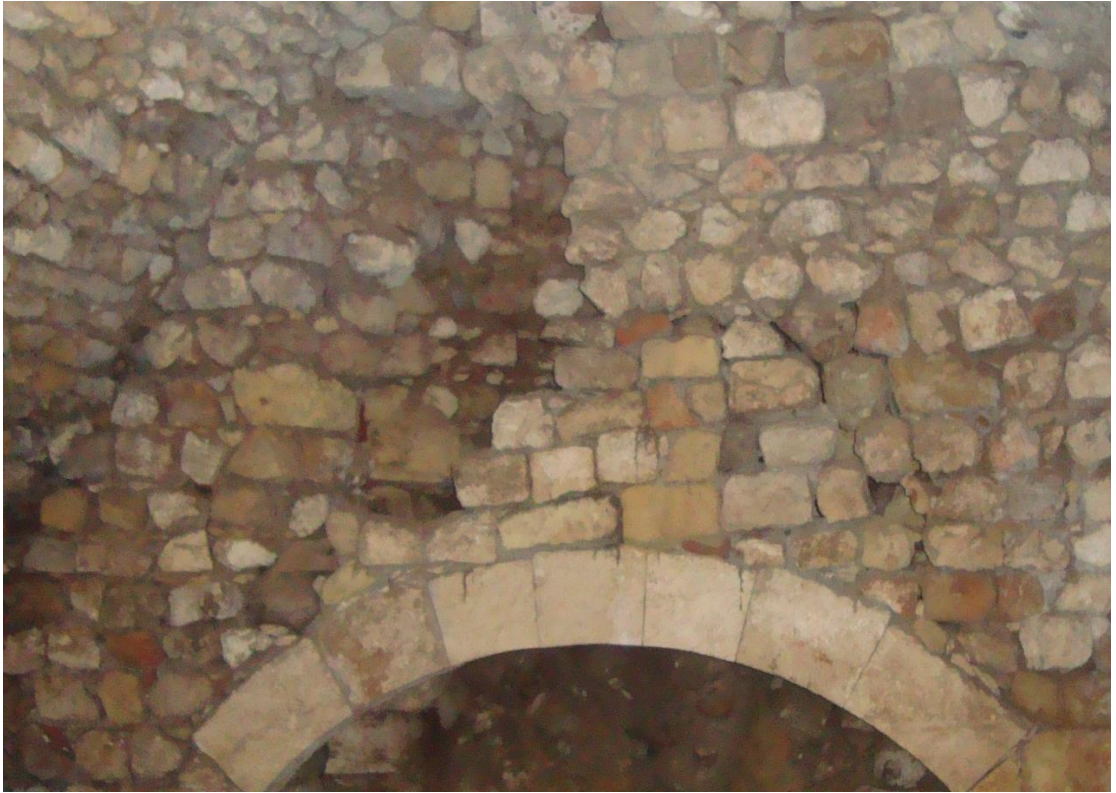
Figure 4.155. Loss of material and cracks on the fireplace on the basement floor

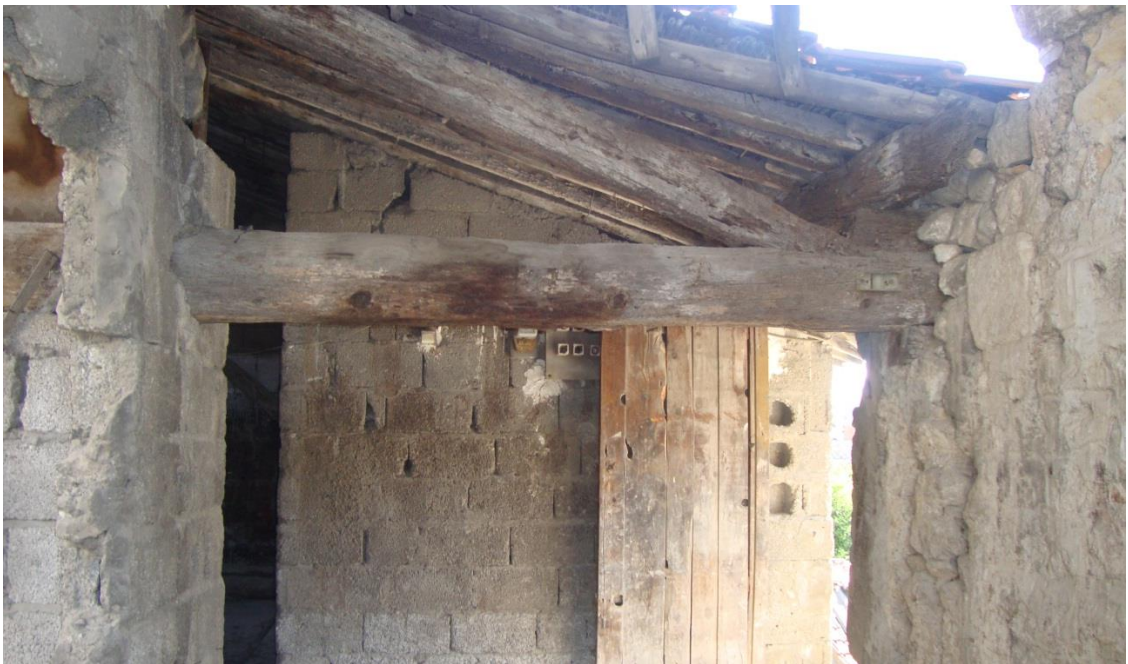
Figure 4.156. Decay on the wooden hipped roof

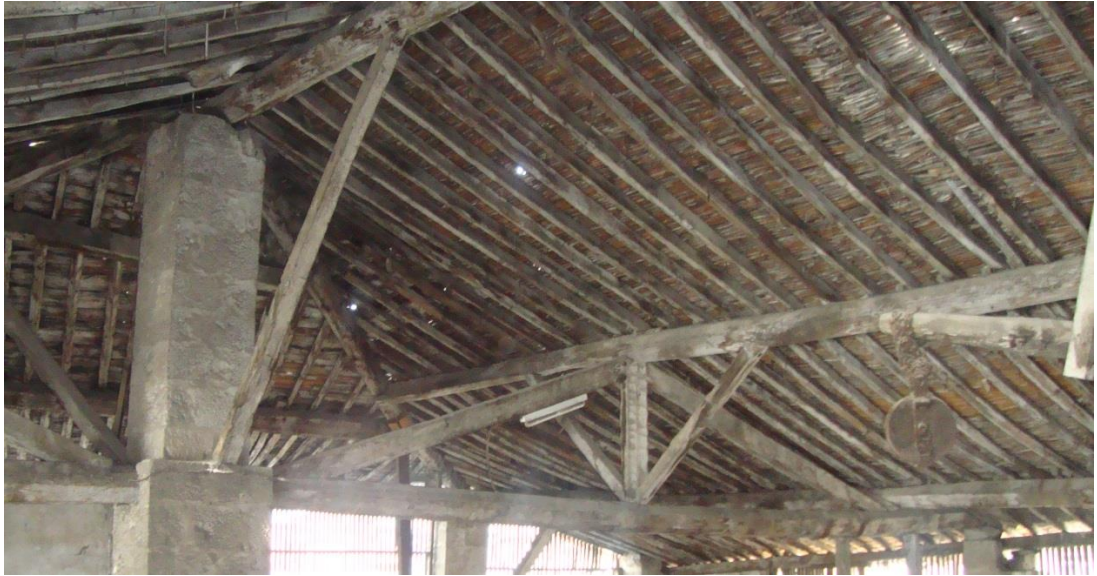
Figure 4.157. Natural aging on the wooden hipped roof
