**RESTORATION OF A TRADITIONAL
RESIDENTIAL BUILDING IN ŞANLIURFA**

**A Thesis Submitted to
the Graduate School of Engineering and Sciences of
İzmir Institute of Technology
in Partial Fulfillment of the Requirements for the Degree of**

in Architectural Restoration

**by
Keziban ÇELİK**

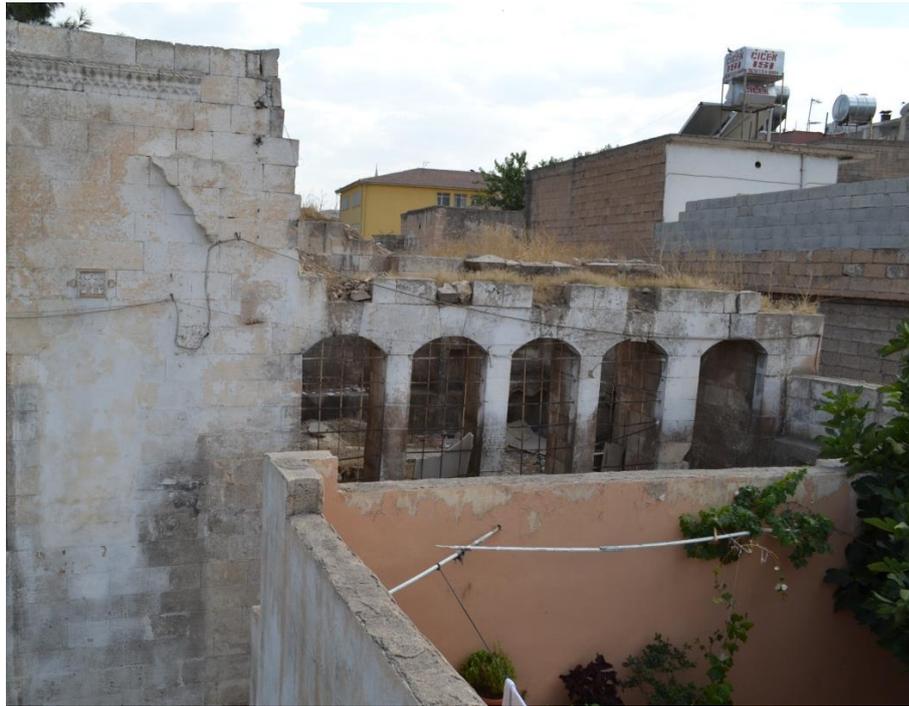
Structural failures are demolition and sagging (Appendix B-Structural failures and material deterioration analyses). The roof, upper part of the window facing the street and upper part of the courtyard wall are demolished (Figure 4.58). These elements belong to the room on first floor in the southwest.

Figure 4.58. The demolition of the room on the first floor in the southwest

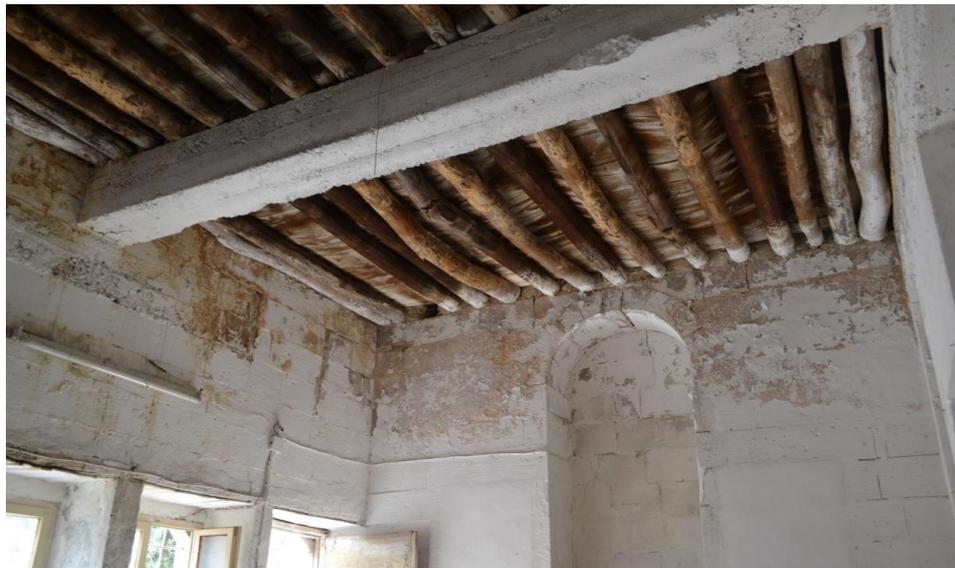
Sagging is in the wooden ceiling system of room on southeast on ground floor. Sagging has occurred on wooden beams because of rain water penetration, beams under earth roof were weakened as a result of neglect (Figure 4.59). The depression of earth needs to be pushed-up with a stone called *loğ* and drained of water on a regular basis. Sagging has occurred because of neglected maintenance.

Figure 4.59. Sagging in the ceiling of room on ground floor in the southeast

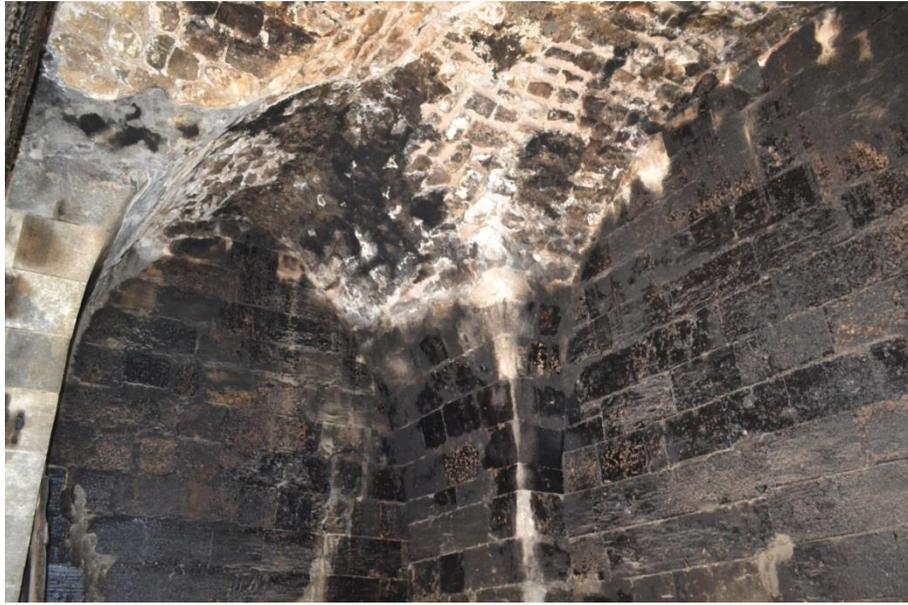
Discoloration is seen on walls of *tandırlık* and both *zerzembe* spaces on ground floor and south courtyard facade. The cause of discoloration on *tandırlık* is exposure to soot and smoke due to use (Figure 4.60). South courtyard wall is exposed to rain water, so discoloration has occurred (Figure 4.61). The reason for discoloration seen in the vaults of *zerzembe* spaces, the walls of the rooms on the first floor and window sill of *zerzembe* space are due to insufficient ventilation for humidity.

Figure 4.60. Discoloration in *tandırlık*

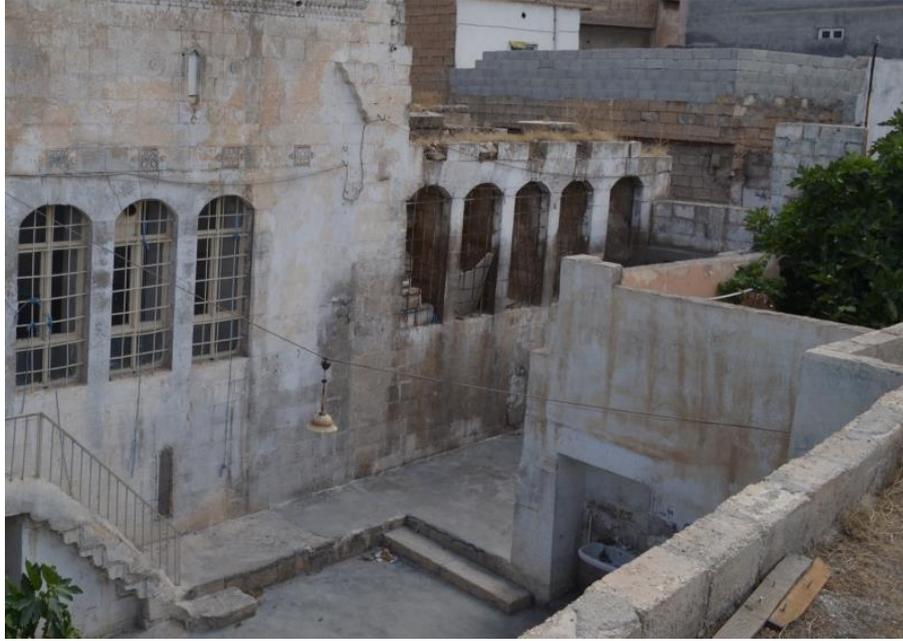
Figure 4.61. Discoloration in south courtyard wall

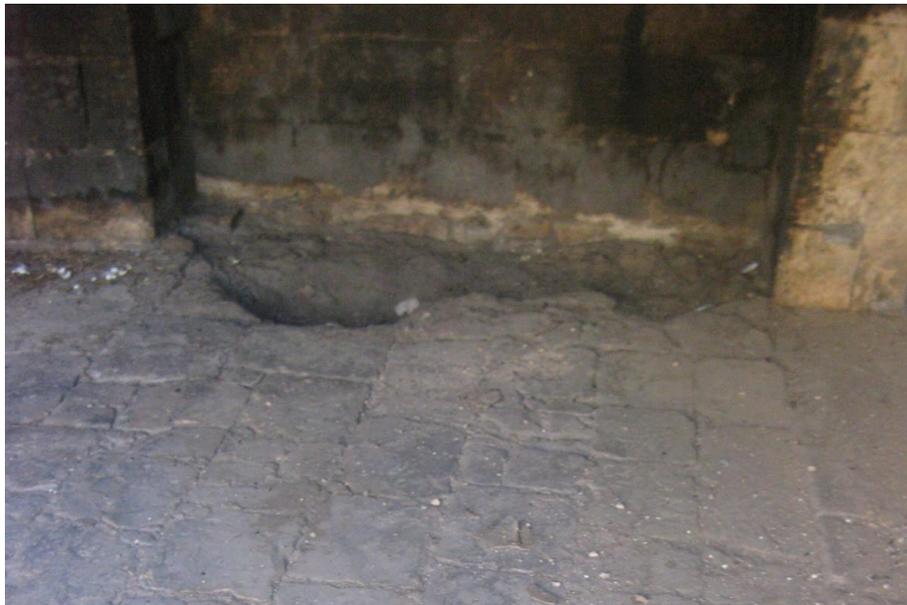
Loss of material is seen in paving stones in front of the *tandır*. A part of the stone floor is missing (Figure 4.62). There is also loss of material due to weathering in the ornamented stones above windows and doors in south and east walls of the courtyard.

Figure 4.62. Loss of material in *tandırlık*

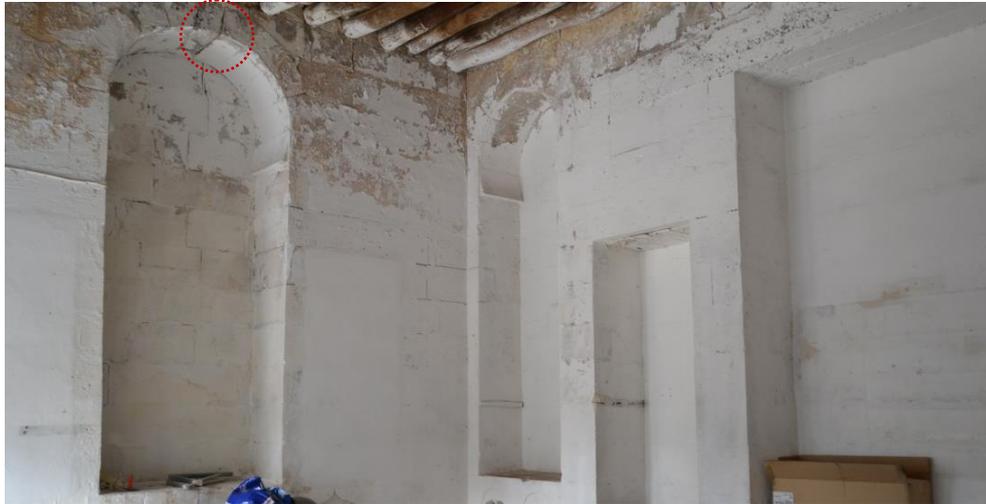
There are no large cracks in the building. Only a capillary crack in the stone and plaster on the north wall of the room in the southeast of the building are observed (Figure 4.63).

Figure 4.63. Crack on plaster and wall

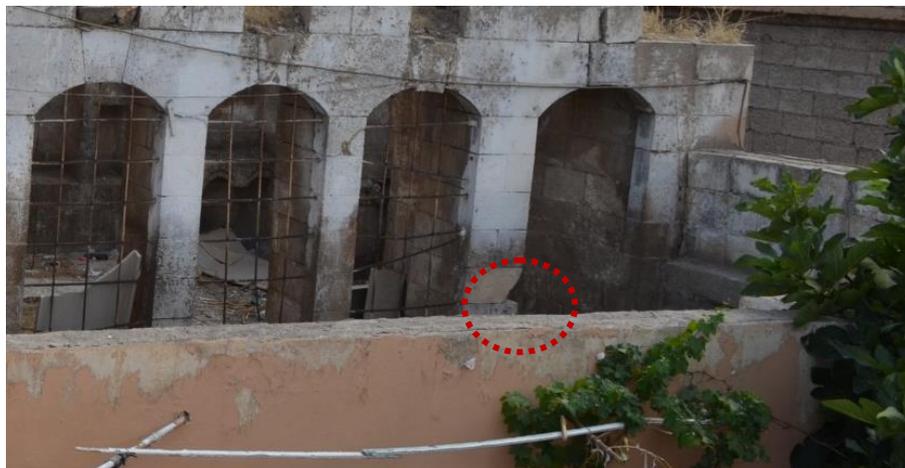
Break up is seen in stone near the entrance to the room on southwest and in the south courtyard wall (Figure 4.64).

Figure 4.64. Break up in facade of room on the first floor in the southwest

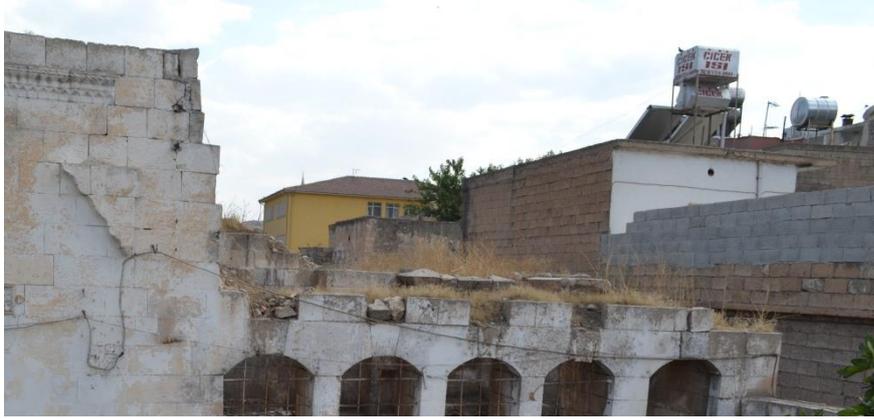
Plantation is seen on the upper part of the walls of the room where the vault is demolished on the southwest first floor and on floor. In addition, plantation is also observed on the roof of the east, west and south wings (Figure 4.65).

Figure 4.65. Plantation in upper part of room on the first floor in the southwest

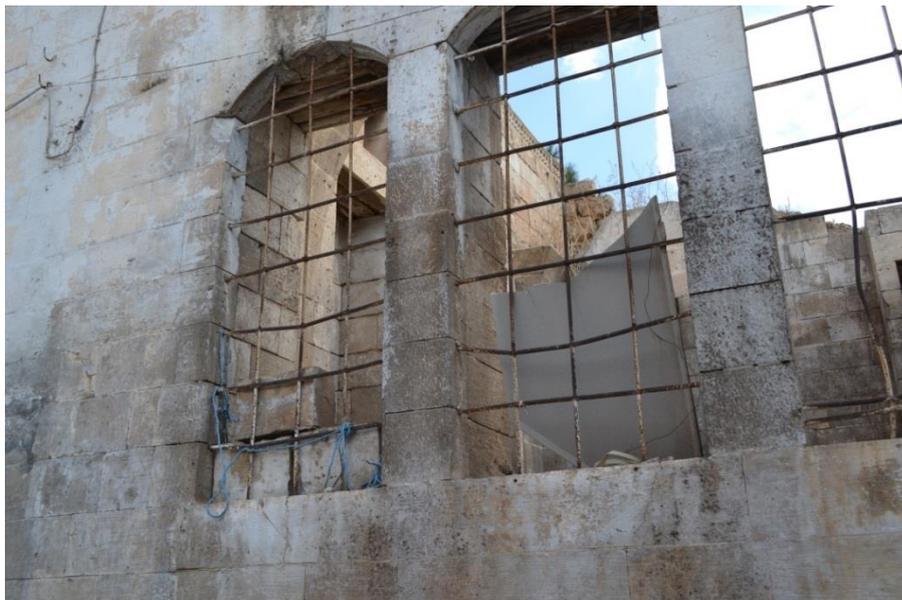
There is rusting on all of the bars of the windows in courtyard facade, metal single winged doors of the rooms on the first floor and double winged metal door of the entrance (Figure 4.66).

Figure 4.66. Rusting bars

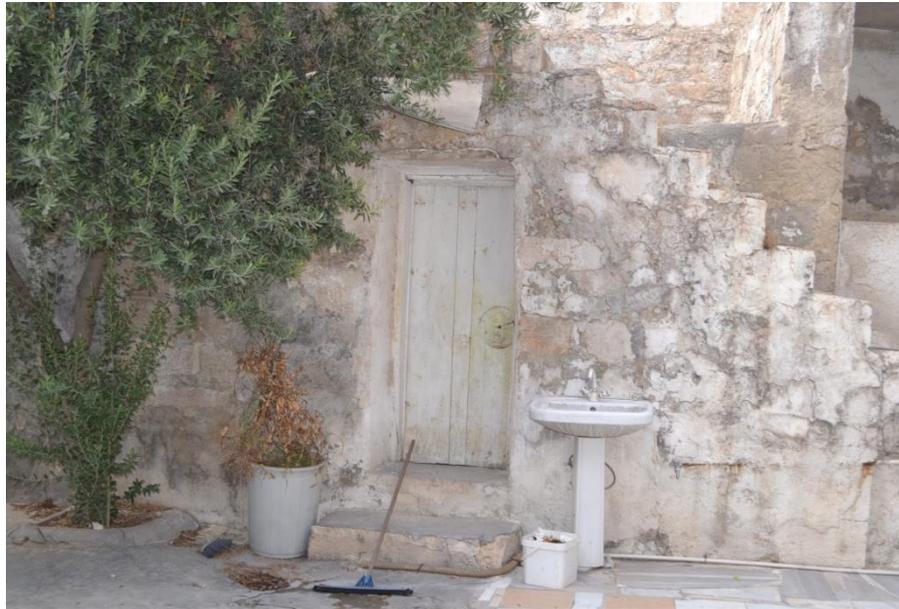
Improper additions were made with the purpose of structural requirements and use. On the ground floor, a reinforced concrete beam was added to support the wooden ceiling system of the room in the southeast. A sink was added in front of the bathroom in the northeast of the courtyard (Figure 4.68). Earth was added to the floor of *zerzembe* space in the middle of the south wing, on the ground floor. Also the door and window

Figure 4.68. Sink added to courtyard

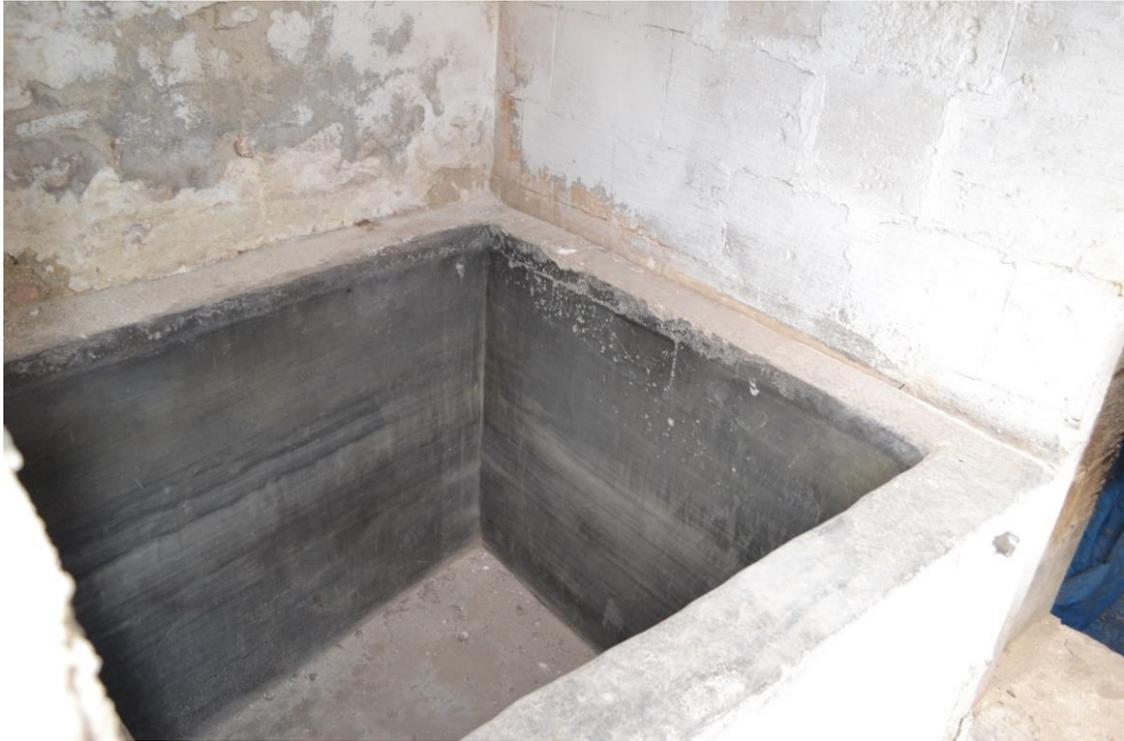
The *eyvan* space is in its original state, however the space which is located between *tandırılık* and bathroom in the northeast of building has become pool or water storage with the addition of a wall in front of it (Figure 4.70).

Figure 4.70. Wall added for water storage

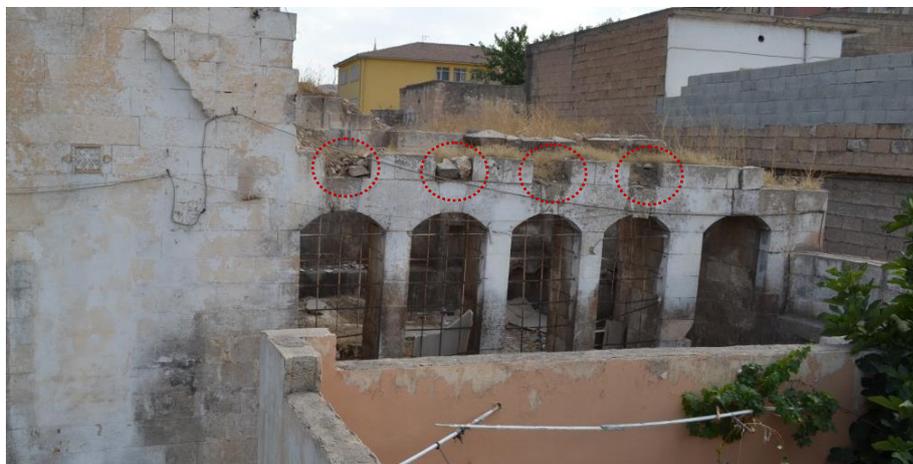
The building was designed around two courtyards as *haremlik* and *selamlık* in the original layout. A part of the original wall separating these two courtyards and door from *selamlık* to *haremlik* has not survived. Other missing elements are the vault of room on the first floor in the southwest, wings of doors and windows, a part of the wall and ornamented stones above the door and windows (Figure 4.71).

Figure 4.71. Missing ornamented stones

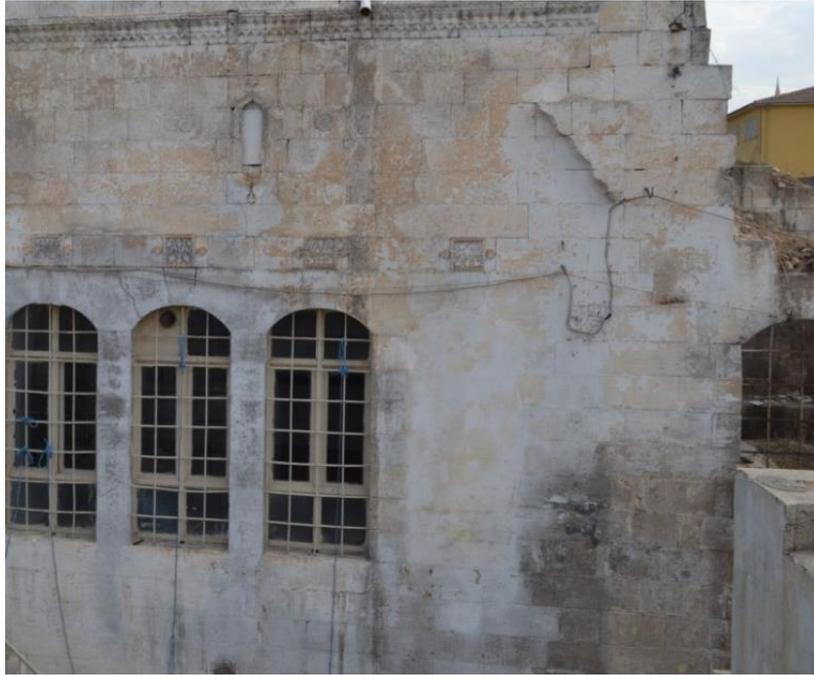
Selamlık section of the building has been transformed into the new house. In addition, the ceiling of the kitchen spaces has been converted into concrete slab. The iron balustrade of *gezenek* has been replaced with a metal balustrade. All window joineries except the east window of the room on the ground floor in the southeast have been converted into a different layout through the use of wood and metal (Figure 4.72).

Figure 4.72. Metal window joineries of the room on the first floor (F03)

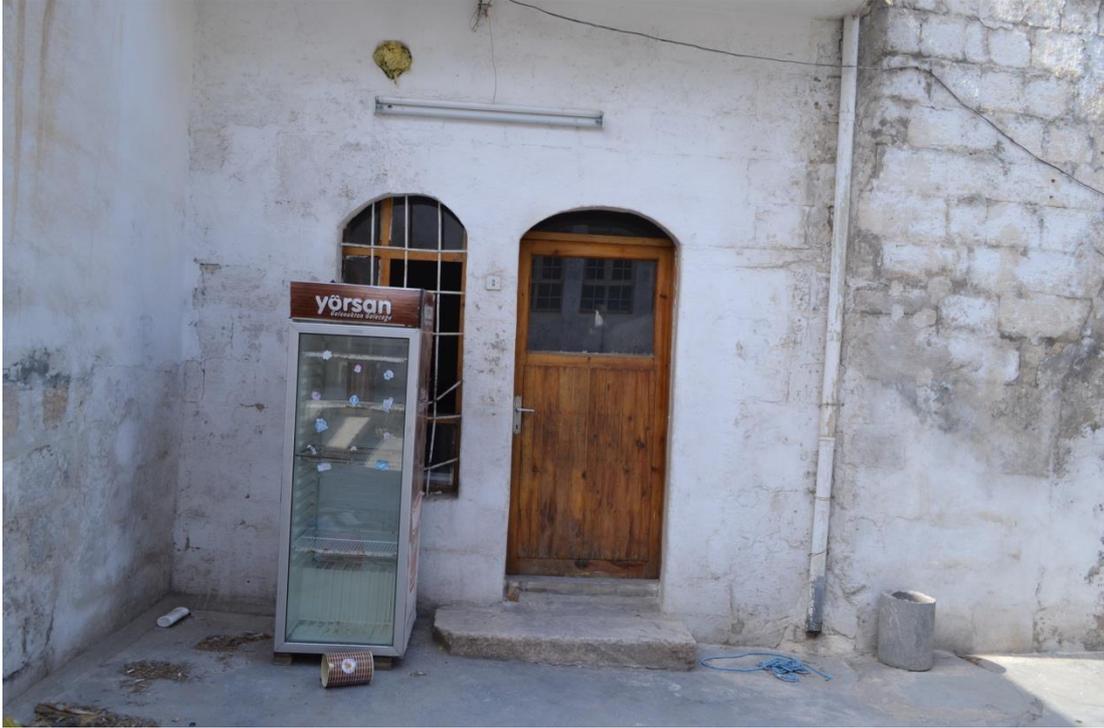
The main entrance door, the doors of rooms near of *eyvan* upstairs have been converted into a new arrangement with metal material. The kitchen door was converted using wood (Figure 4.73).

Figure 4.73. Converted kitchen door wing

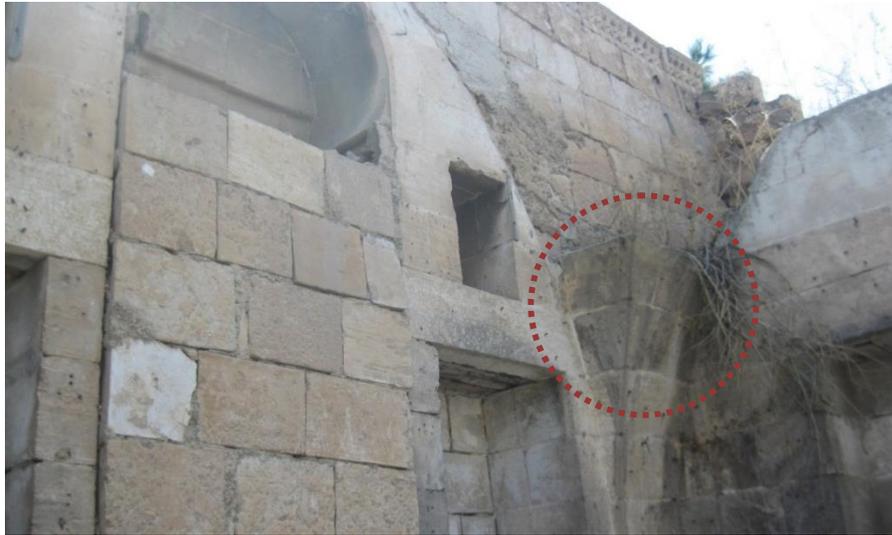
Figure 6.1. Vault remain of the room on the first floor in the southwest

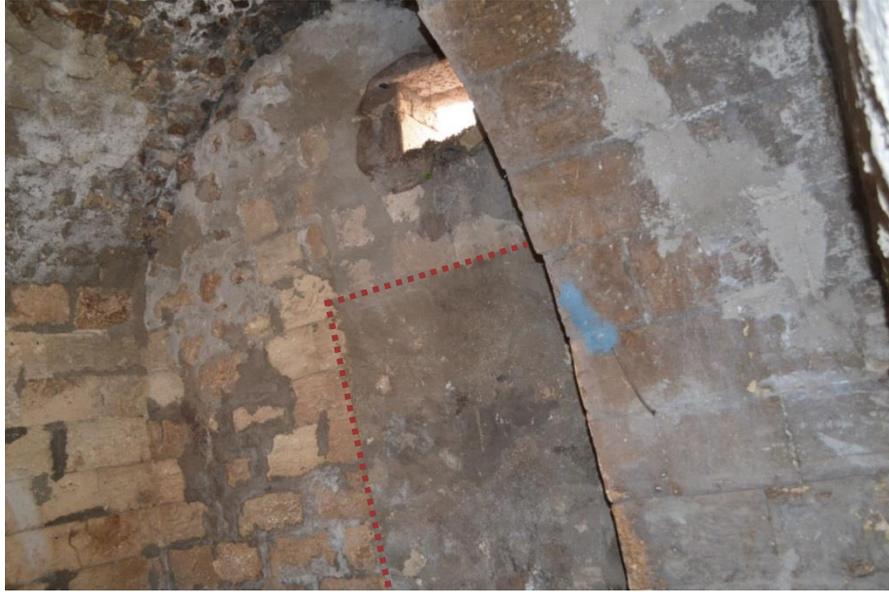
Figure 6.2. Trace of door in *develik*
