**INVESTIGATION OF THE OTTOMAN PERIOD
FOUNTAINS IN İZMİR/ÇEŞME FOR THEIR
PRESERVATION**

**A Thesis Submitted to
the Graduate School of Engineering and Sciences of
İzmir Institute of Technology
in Partial Fulfillment of the Requirements for the Degree of**

in Architectural Restoration

**by
Ahmet KARAÇÖL**

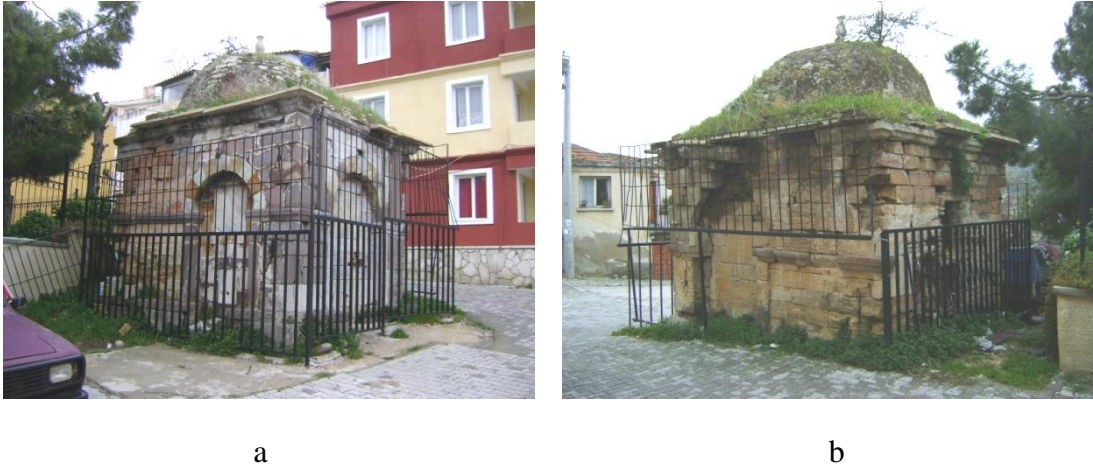
Conservation problems: Weakening in front and right façade walls due to the stolen iron bars, partial collapses at the eaves due to the missing pilaster and some of the voussoirs stones at the right façade (Figure 4.18), partial losses of plaster on the dome and plant growths in the joints of stone bonds.

Figure 4.15. Hamaloğlu Fountain; a) front and left façades, b) rear and right façades

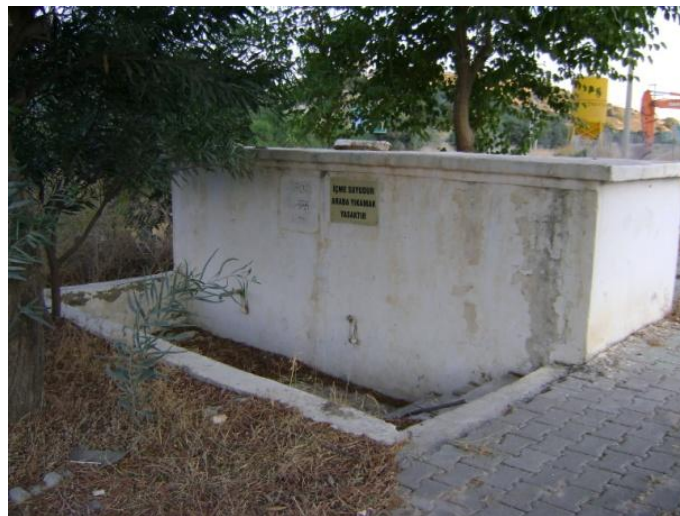
Conservation problems: Damaged original pipe line and front façade. Covered with bush and trees at present.

Figure 4.21. Kandıralı Fountain front façade

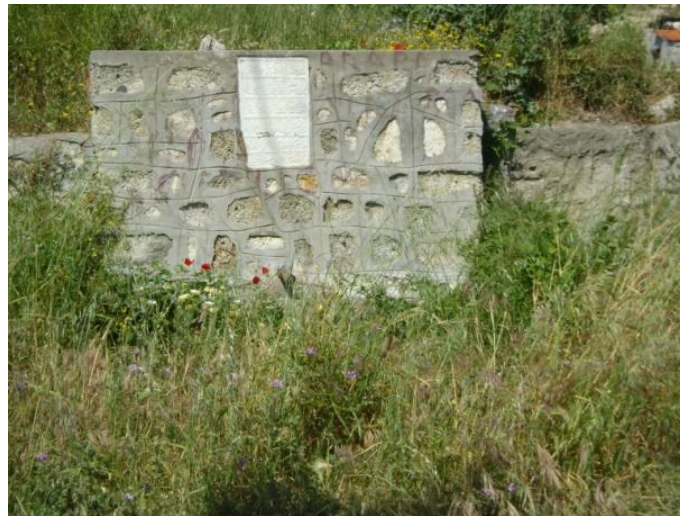
Conservation problems: Repair of damaged water supply system. Requires listing.

Figure 4.32. Şerif Ağa Fountain front façade

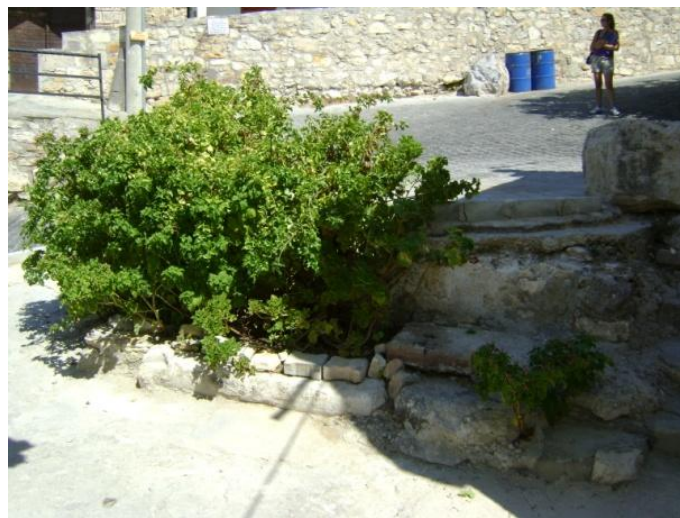
Façade composition: Only foundation walls, a small portion of the pilasters at the right and spout outlet hole remained.

Conservation problems: Listing and further research needed.

Figure 4.47. Fountain to the south of the Castle, the remaining parts, basin and foundation

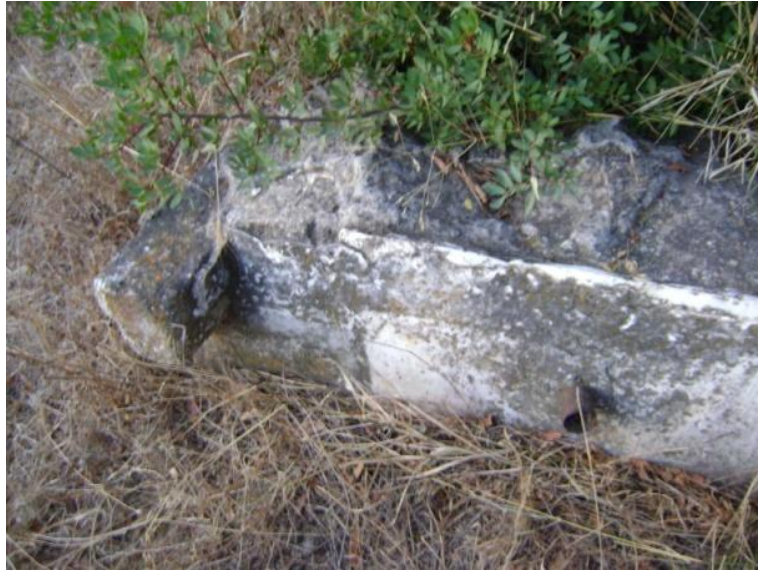
A small portion which includes only lead spout and spout stone found at the distance approximately 200 m in the south of Şerif Ağa Fountain. More finding can be obtained by a simple excavation (Gür 2009). Original land 419, parcel 1 and the owner of the parcel is Çeşme Municipality. No more information available (Figures 4.2, 4.49, 4.50).

Figure 4.49. Fountain to the south of the Şerif Ağa Fountain, the remaining part, lead spout and spout stone

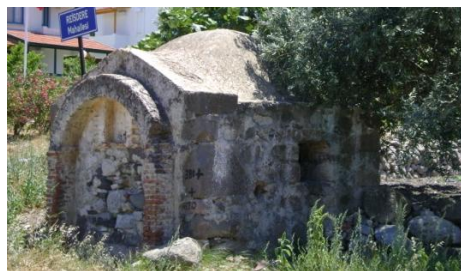
Conservation problems: Partially damages, basin remained below the ground because of the rise in the surrounding soil.

Figure 4.60. Reisdere Fountain front and right side façades

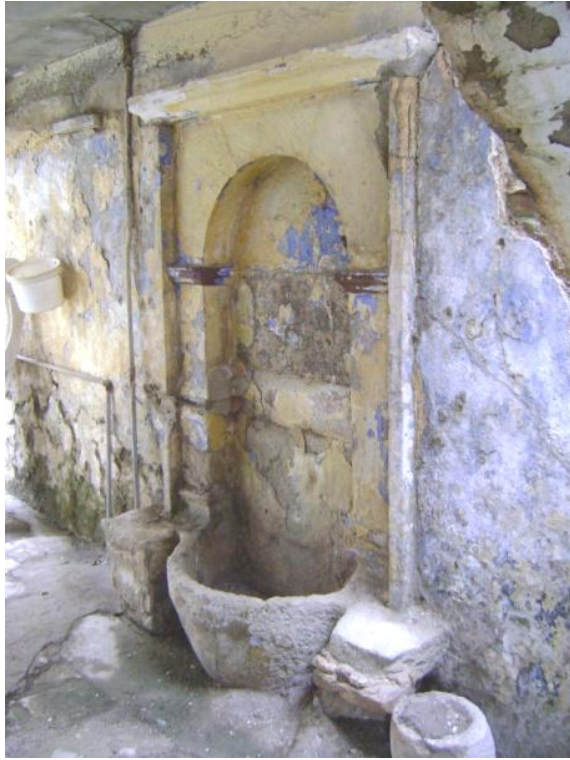
Conservation problems: Damage due to cement pilaster application.

Figure 4.98. 242 land 7 parcel house fountain front façade

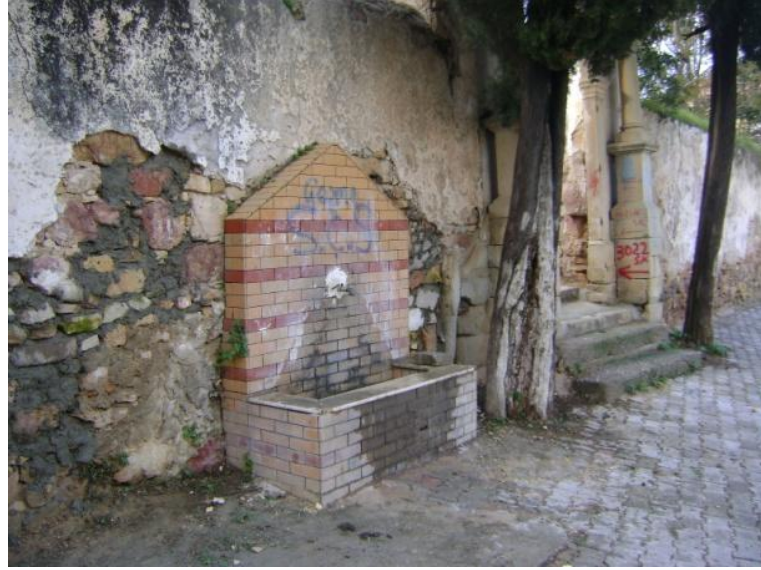
Conservation problems: All original properties and missing. Requires reconstruction according to old photograph.

Figure 4.105. Church Gate Fountain front façade
