**EVALUATION OF INTERVENTIONS
IN WESTERN STOA OF AGORA
IN İZMİR**

**A Thesis Submitted to
the Graduate School of Engineering and Sciences of
İzmir Institute of Technology
in Partial Fullfilment of the Requirements for the Degree of**

in Architectural Restoration

**by
Necmiye Funda YAKA**

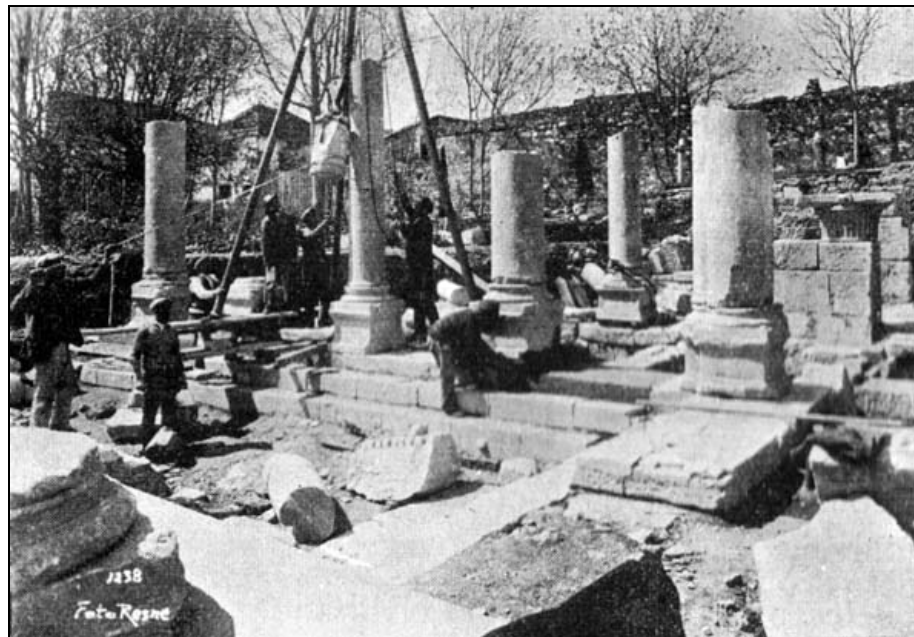
Figure 3.44. The completion of the missing parts by concrete.
(Source: Archives of the Agora excavations)

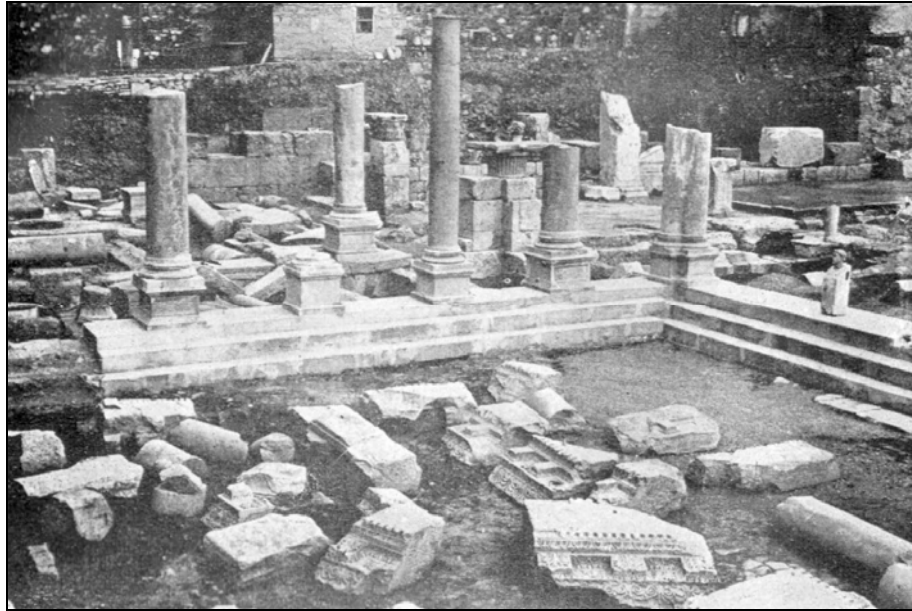
Figure 3.55. The missing parts were completed with concrete.
(Source: İzmir Muhipleri Cemiyeti 1934)

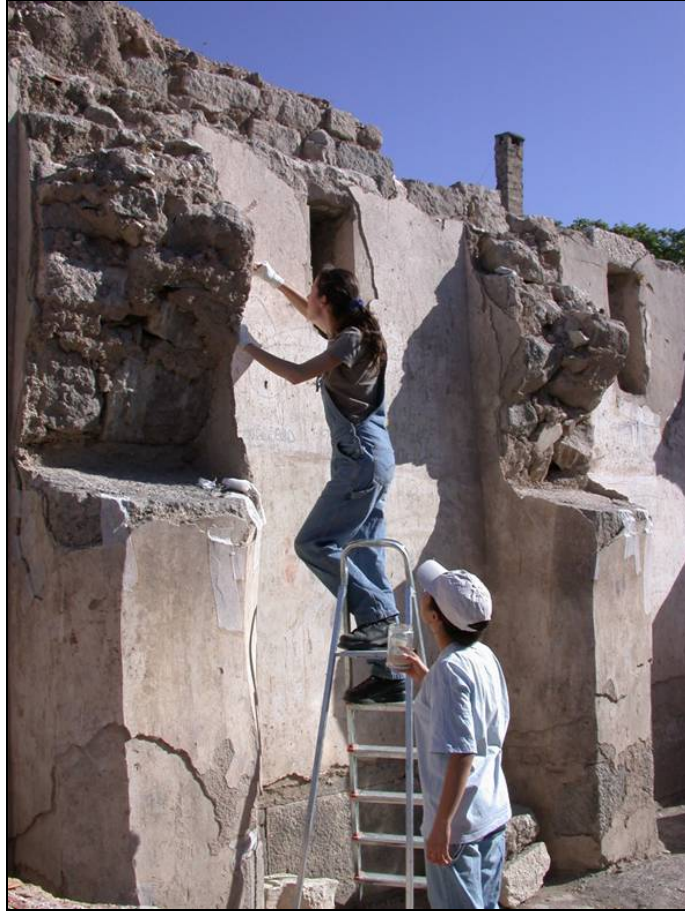
Figure 3.65. The walls of the Basilica cleaned by the conservators, than consolidation studies were implemented.
(Source: The archives of the Agora excavation, 2004)

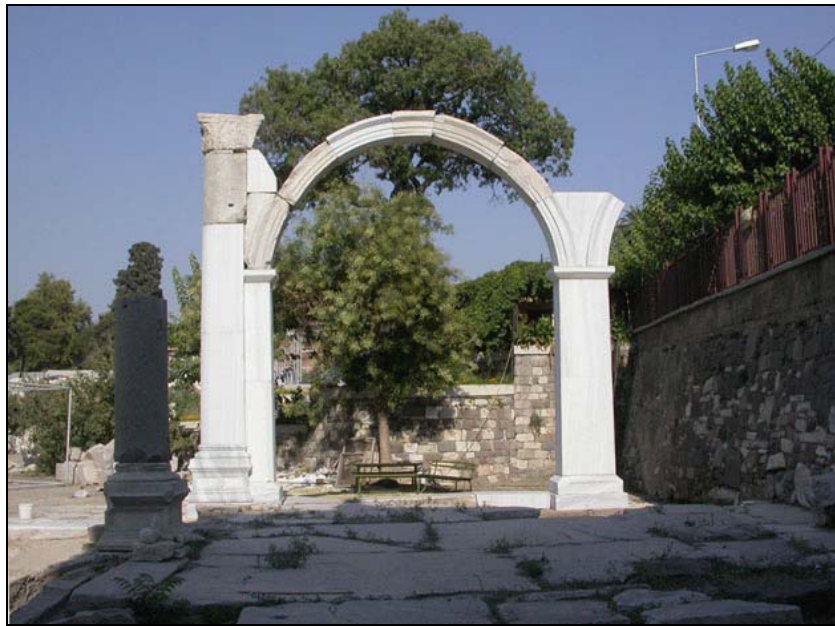
Figure 4.14. The reconstruction implementation of the West Gate.

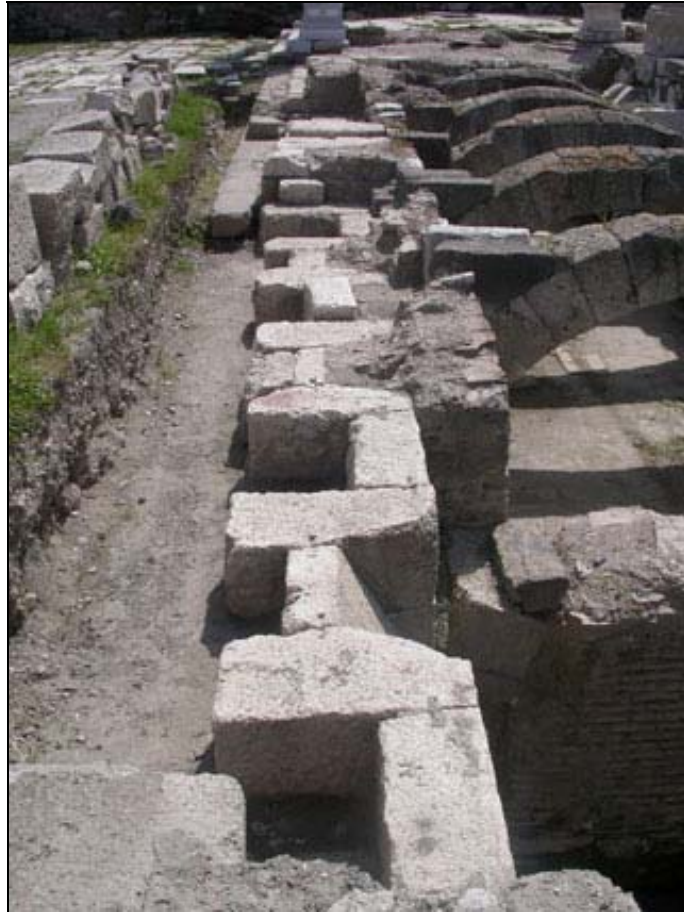
Figure 4.24. The construction style of the wall revealed after the removal of the concrete stylobate implementation.

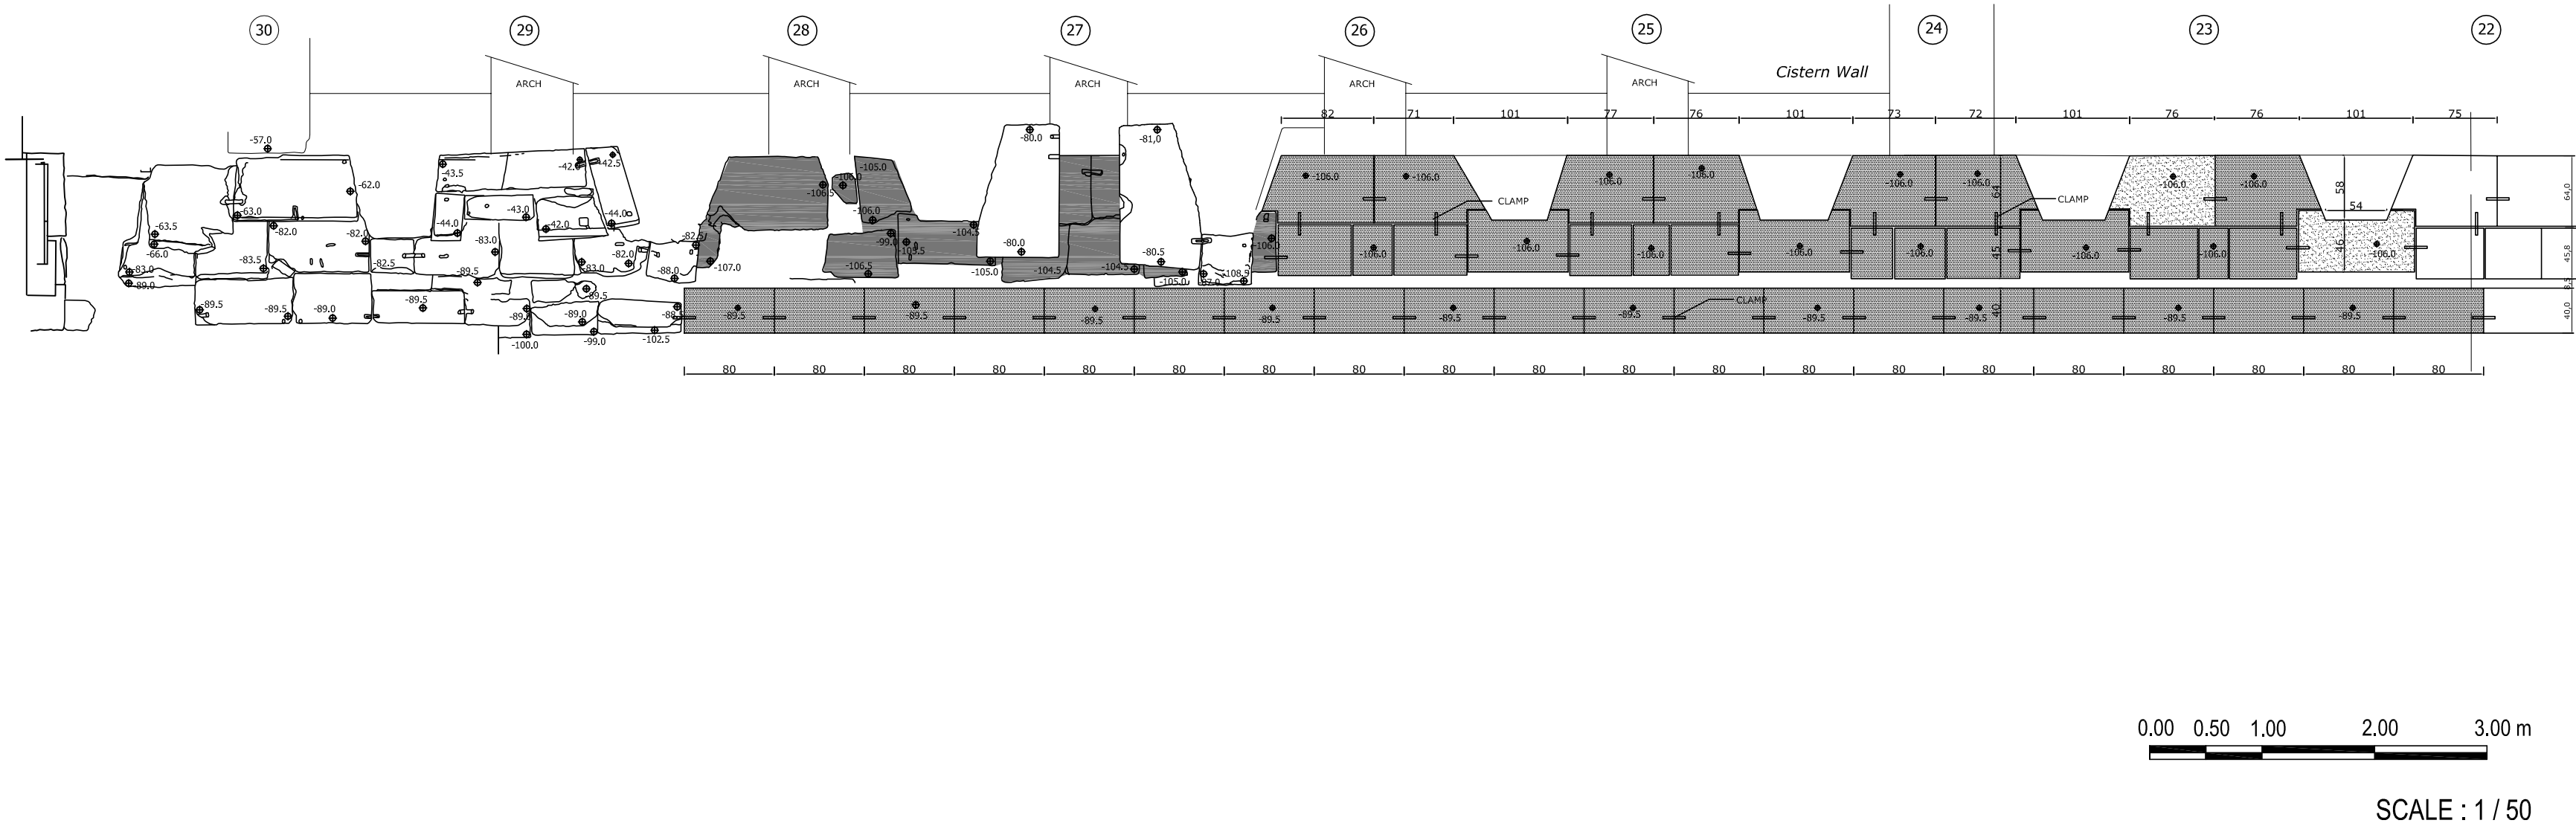
Figure 4.29. Reconstruction project for the 5th course of the east wall between 22nd and 30th axes.

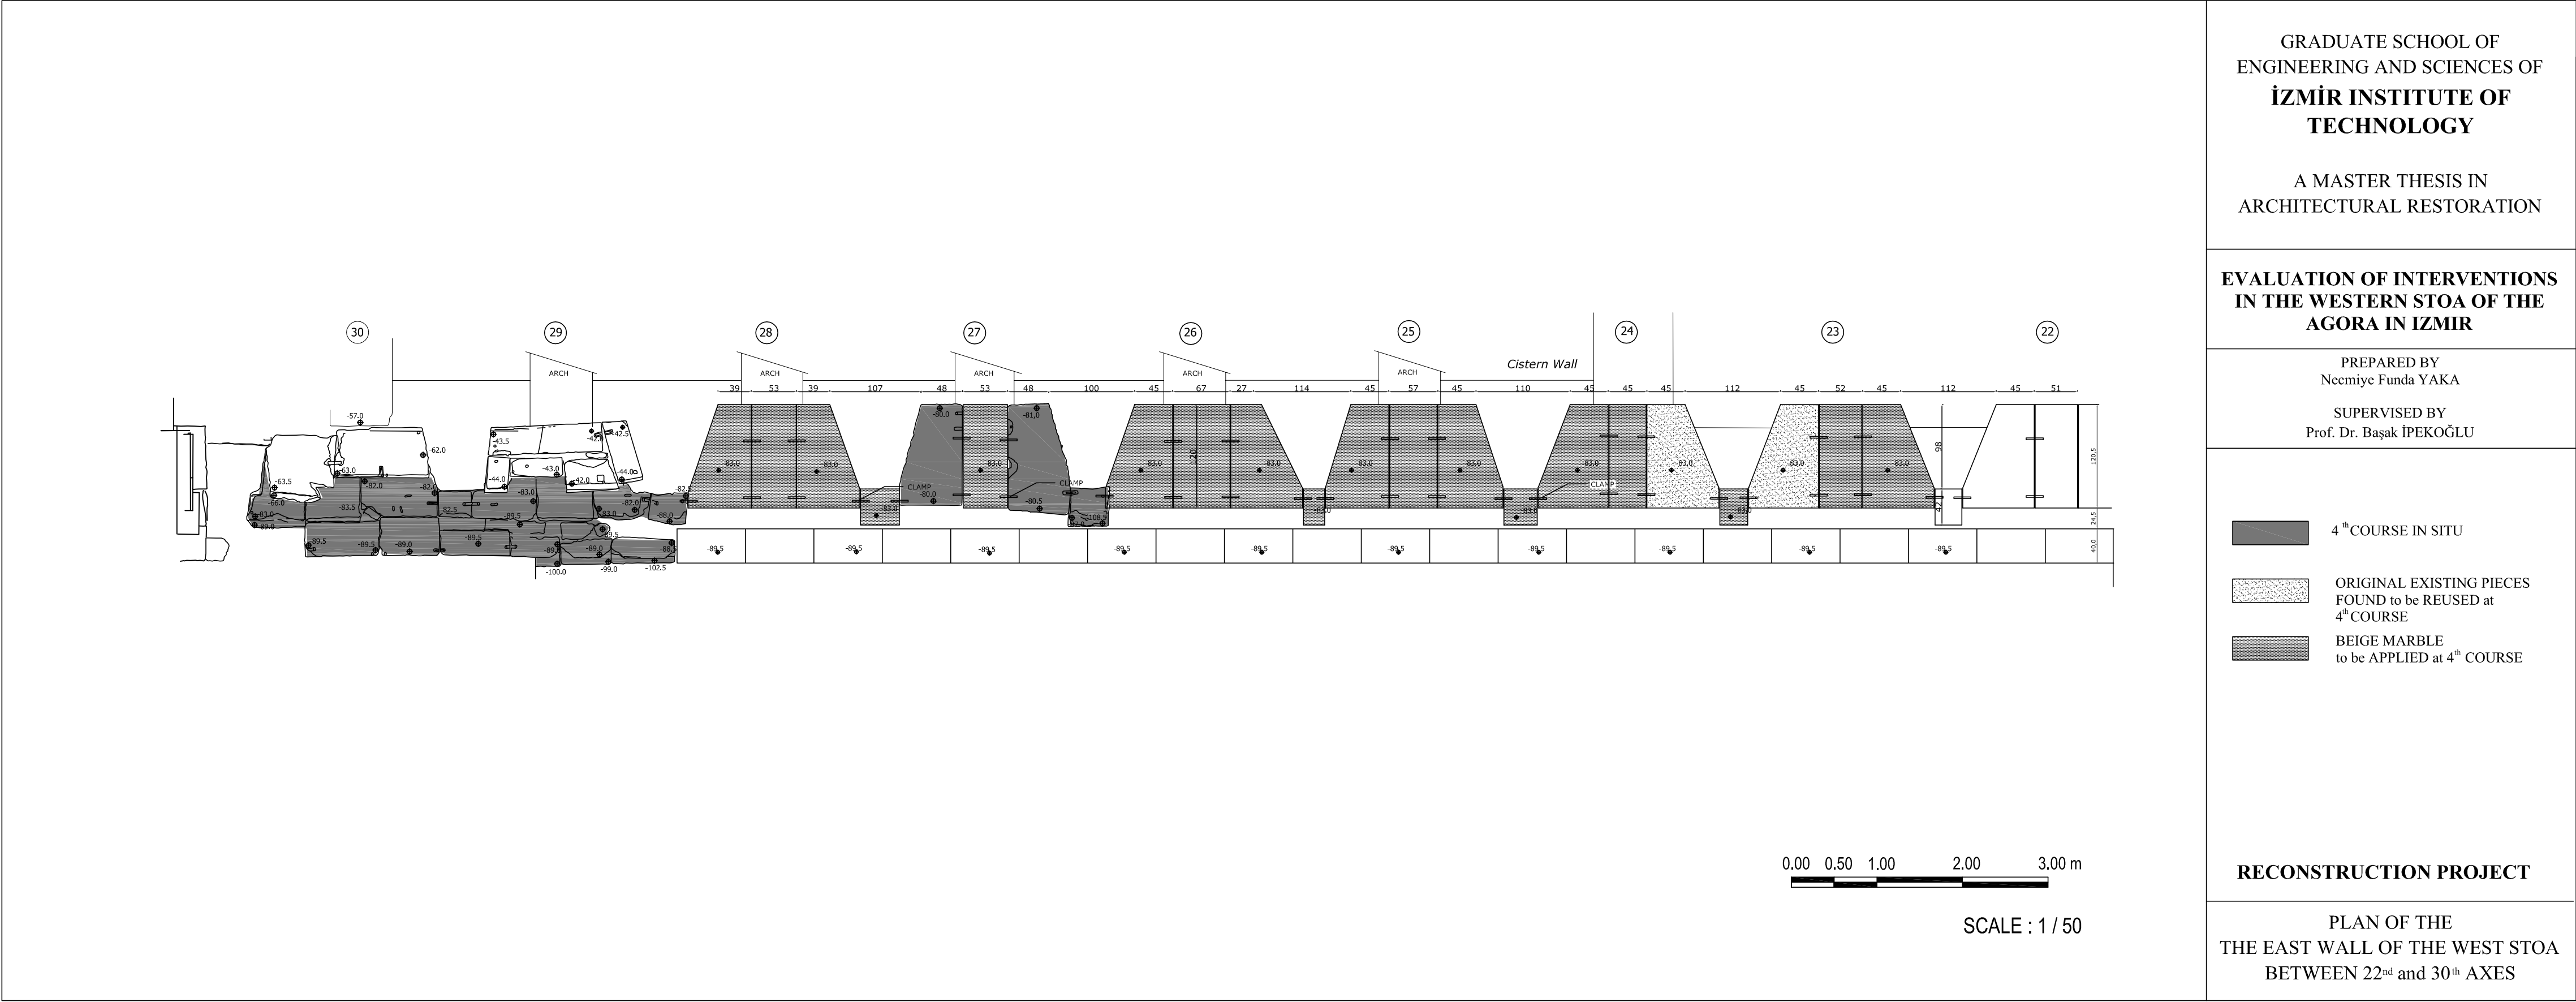
Figure 4.30. Reconstruction project for the 4th course of the east wall between 22nd and 30th axes.

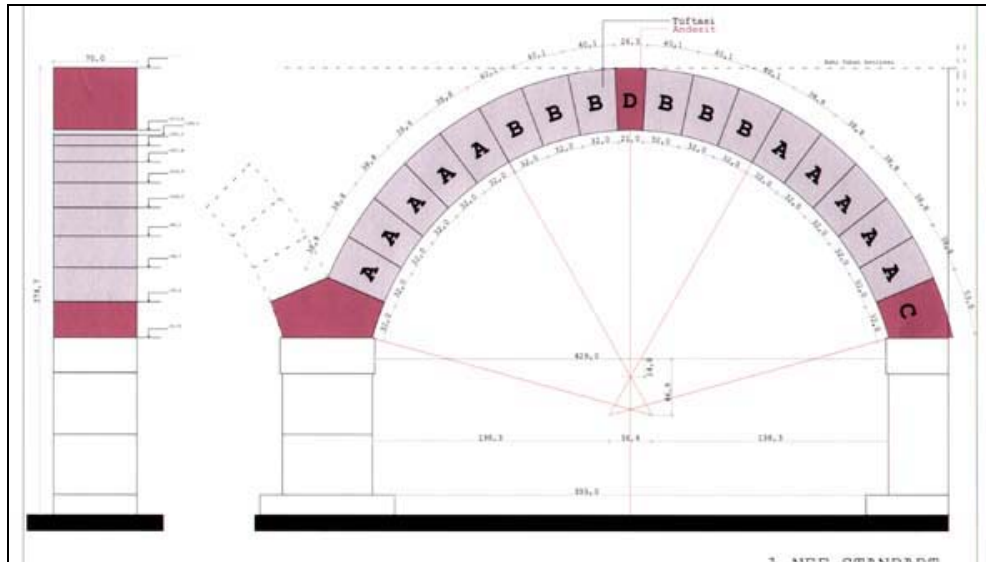
Figure 4.38 The theoretical drawing which shows the state of arches before an ancient repair.
(Source: Archives of the Agora excavations, 2005)

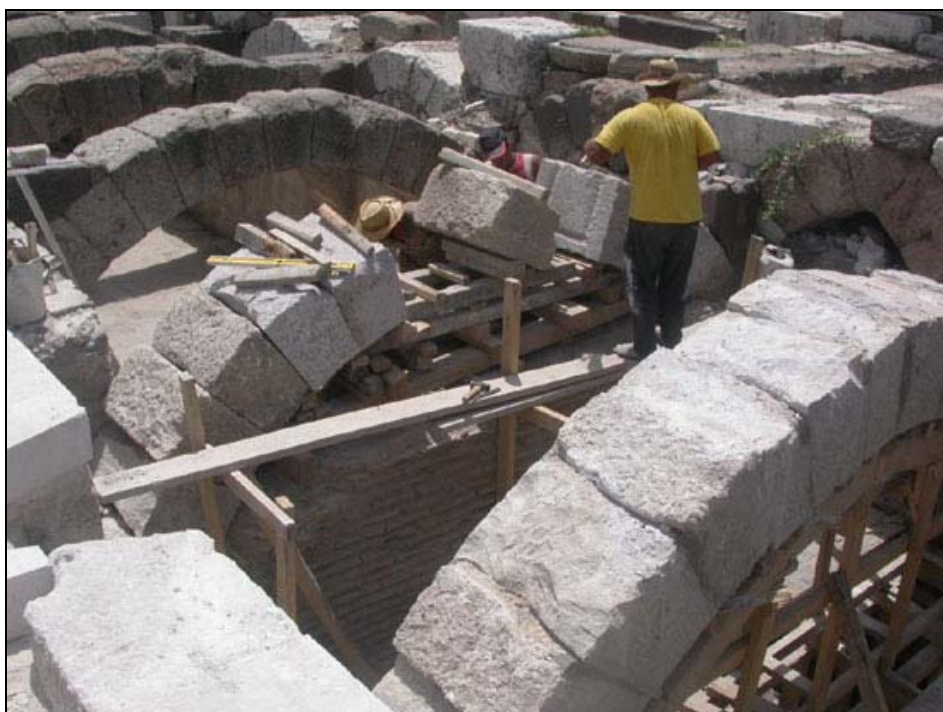
Figure 4.42. The reconstruction process of the arches.
(Source: Archives of the Agora excavations, 2005)

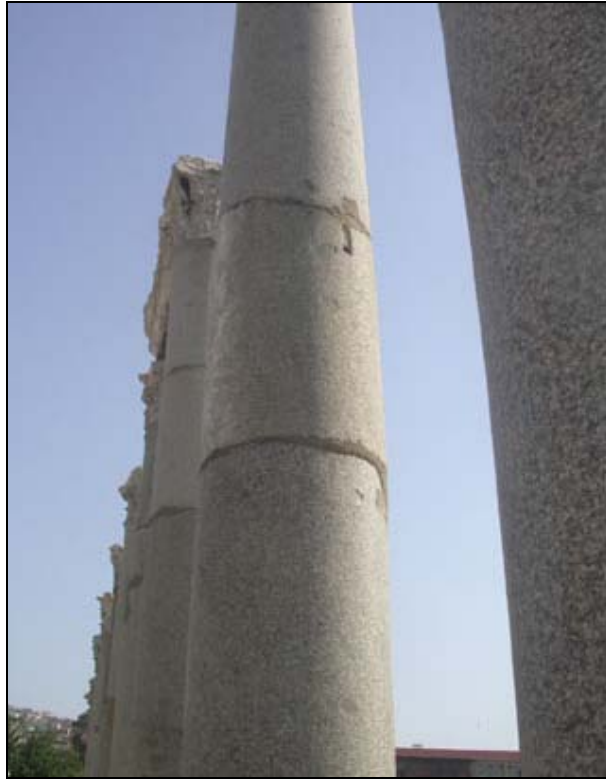
Figure 4.45. The clamp sign leads to an ancient repair.
(Source: Archives of the Agora excavations, 2005)
