**DOCUMENTATION OF THE LOWER BATH IN  
METROPOLIS, TORBALI, İZMİR FOR THE  
ASSESSMENT OF HERITAGE  
CHARACTERISTICS**

**A Thesis Submitted to  
The Graduate School of Engineering and Sciences of  
İzmir Institute of Technology  
in Partial Fulfillment of the Requirements for the Degree of**

**in Architectural Restoration**

**by  
Suna BÜYÜKKILIÇ**

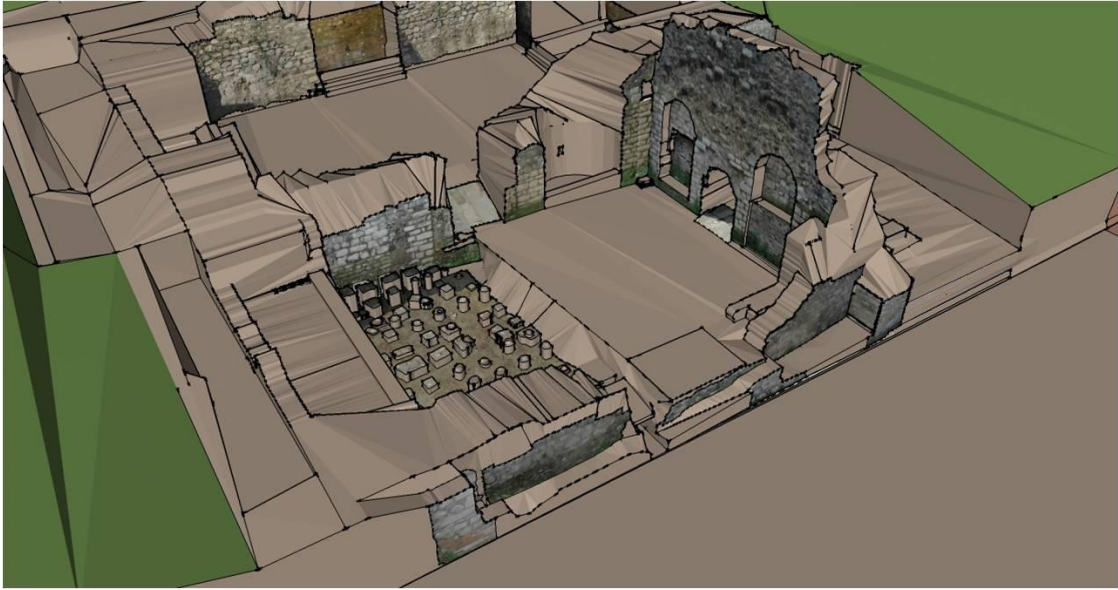
Figure 4.2. Caldarium main space 1

*Caldarium* main space 1 (15.6x8.2 m) is at the eastern part of the bath ruins, and forms the present entrance. The highest wall (hmax: ~6.97 m) of the bath ruins is here and it provides a monumental characteristic to the space. Its *suspensura* is covered with debris layer. Its south part has collapsed. This makes it difficult to perceive the real size of the space and its wholeness. Nevertheless, it provides observation of the hypocaust system under the *suspensura*. There is an *alveus* with a furnace arch at the south of the space. Western wall of the space includes a narrow door opening with two pilasters on its two sides. There are two niches at the west and east of the northern wall and there is a narrow door opening at the centre of this wall. These narrow doors at the west (2.21x2.26 m) and north (1.65x1.81 m) open to the *caldarium* main space 2 and *caldarium* main space 3, respectively (Figure 4.2).

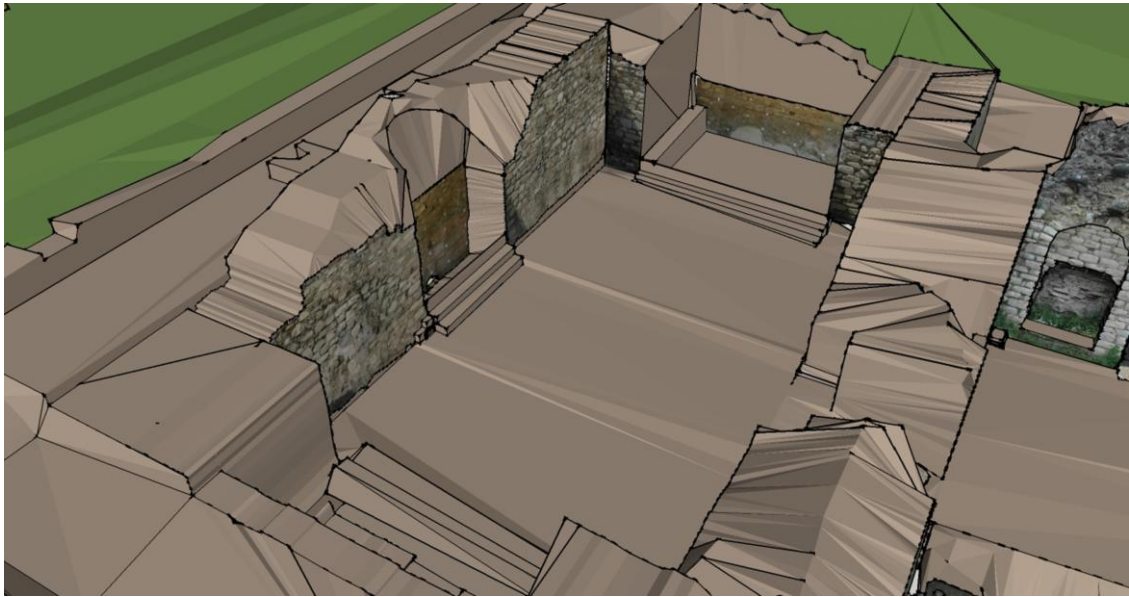
Figure 4.3. Caldarium main space 2

*Caldarium* main space 2, the largest closed space of the bath (14.5x8.7 m), is at the western part of the bath building. Its superstructure is not present today. Its walls are partially lost. Southern part of its eastern wall is the lowest wall (hmax: ~2.87 m) of the space. It has a symmetrical plan organisation with the arrangement of its three *alvei*. These *alvei* are at the centre of southern, western and northern walls of the space. There is a pilaster on south side of the western *alveus*. Other two pilasters are on two sides of the door opening at the centre of the eastern wall. There are baseboards at the southern and northern walls of the space, at eastern and western walls of the northern and southern *alveus* and at all walls of the western *alveus*. The majority of its architectural elements such as pilasters, baseboards, marble coverings, etc. are missing. This situation causes a reduction in the perception of its brilliancy. Its three sub spaces (*alveus*) are covered with protective additional roofs providing control of rain water. Its ground is covered with debris (Figure 4.3).

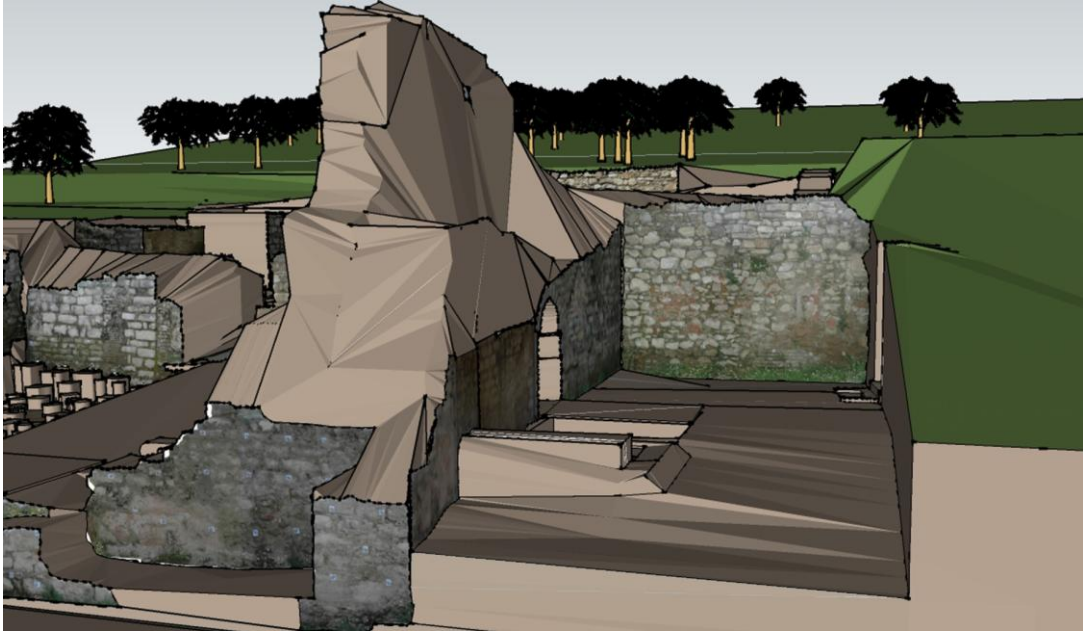
Figure 4.4. Caldarium main space 3

*Caldarium* main space 3 (5.3x11.8 m) is at the northern part of the bath building. The superstructure is completely lost. Its original spatial boundaries are not legible. It is a narrow, unilluminated space with high boundaries: the original wall pieces at the south (hmax: ~6,97 m) and west (hmax: ~4.04 m), and the excavation border at the north (hmax: 3.51 m). So, the original spatial quality can not be deciphered at present. In addition to the narrow door at the south (1.65 m), there is a second door at the north (1.36 m), as traced from the marble steps. The L planned wall piece (w: ~0.5 m, hmin: ~0.45, hmax: 0.99 m) at the southeast is not united with the original southern wall with a construction joint. The sub-space formed within this wall is protected with an additional roof providing control of rain water. There are marble pieces stored in this sub-space. Excavation of this space should be completed (Figure 4.4).

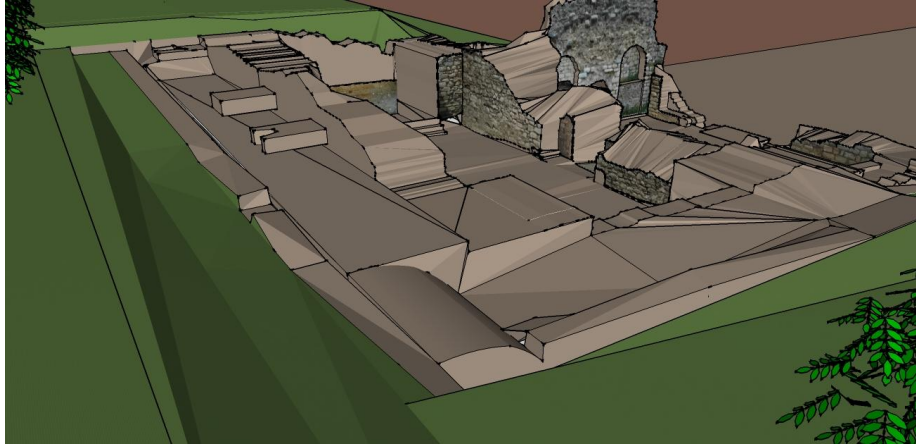
Figure 4.5. A view of service corridor

Service corridor is a U formed space which surrounds the bath building from its three sides: south (w: ~4 m), west (w: ~3 m), east (w: ~2.5 m). It is covered with barrel vault made of brick. Its superstructure is partially covered with debris layer. There are two flues at south and north of its western part. There is an arch at its southern wall of southern part. Excavation of this space should be completed. There are bricks (30x30x5) on the ground independent from the surfaces (Figure 4.5).

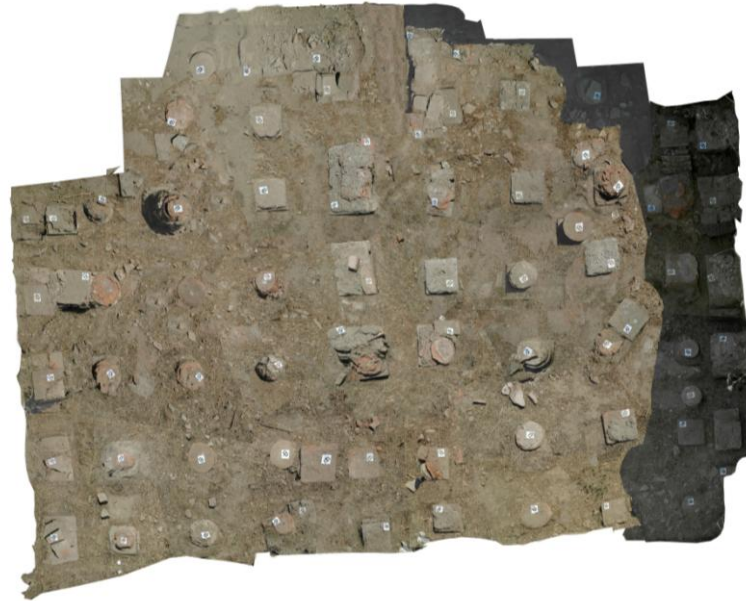
Figure 4.6. Rectified plan of hypocaust

In this section, the hypocaust portion exposed in connection with caldarium main space 1 is to be discussed. The hypocaust (~5.17x7.32 m) is a depressed (~1.10 m) and dense service space underneath *caldarium* main space 1. Its *suspensura* part is missing so, its original spatial character is lost. The columns supporting the *suspensura* are positioned in a gridal order (approximate distance between the axes: ~0.80 m). The 69 columns visible at present are in circular (23), quadrilateral (39) or mixture (7) of a circle and quadrilateral in plan. Ground of the hypocaust is covered with debris layer. Conservation and presentation measures should be developed (Figure 4.6).

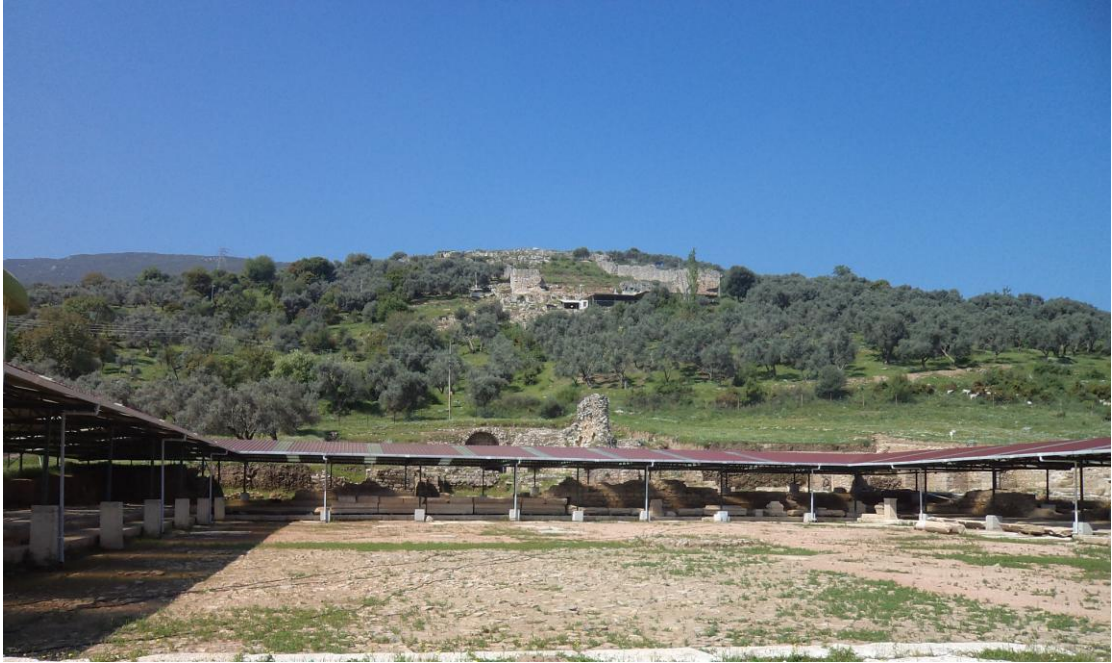
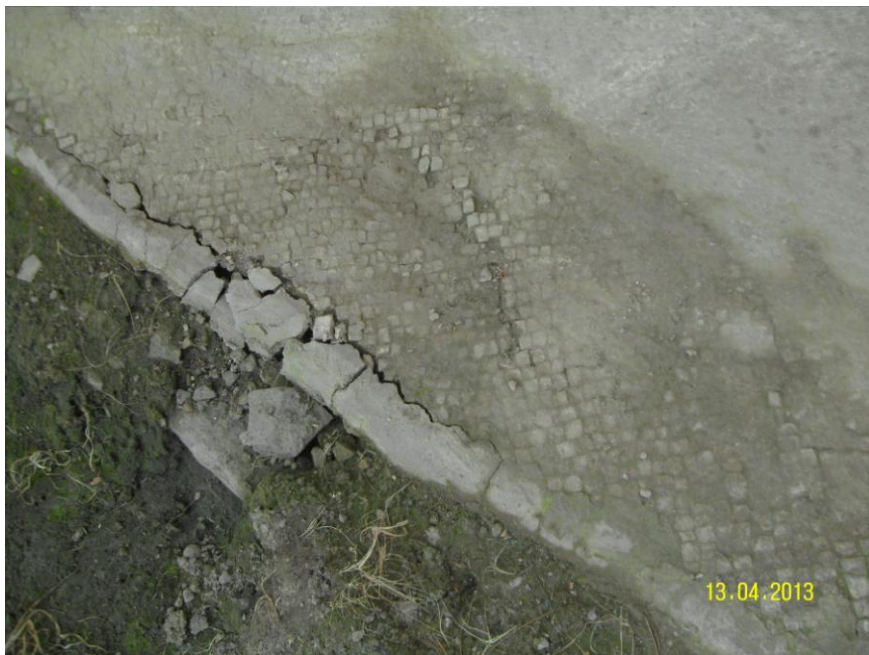
*Palaestra* is at the east of the bath building. It is composed of a squarish courtyard (56x53 m) surrounded by colonnaded porticoes (w: ~7 m). The courtyard is unpaved, while the porticoes are richly decorated with mosaic inlay. Although the original superstructure of the porticoes is missing, a protective roof is provided. In addition, geotextile and sand are used to cover the mosaics. Because of the collapsed columns, it is difficult to perceive the boundaries of the original *palaestra* organisation at present. Nevertheless, the aesthetic quality of the mosaics contributes to the picturesque quality of the antique site (Figure 4.7, Figure 4.8).

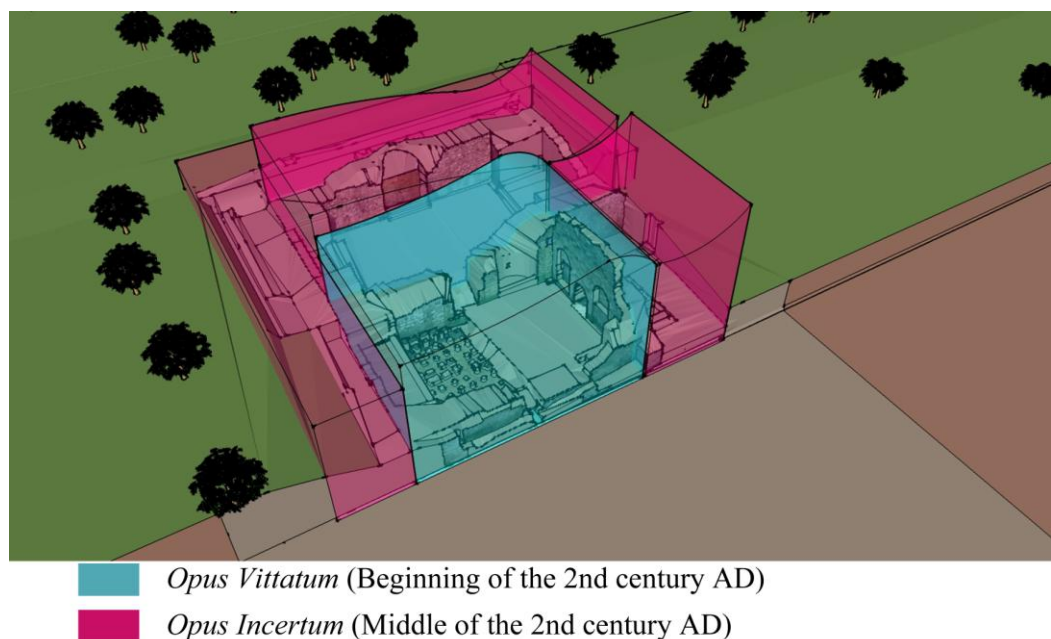
Figure 4.9. Construction Techniques of the Walls

Similar failures and deteriorations are observed at all of the walls of the building. Partial collapse is seen in all of the walls. Plastering layer is totally (15/30), extensively (6/30) or partially (9/30) lost at the walls covered with single layered plastering. Extensive loss of finishing layer is seen at the walls covered with double layered plastering. Problems in the facings are either in the form of well-developed surface loss or in the form of local surface loss. Loss of integrity and discoloration are observed at the facings of the walls. Deposit formation; lichen, alga etc. formation is observed at both facing and core.

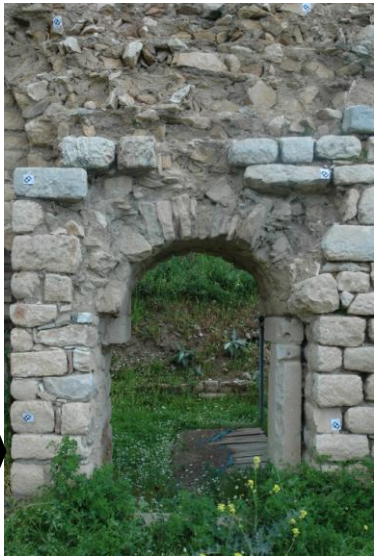
<p>Appendix j</p>
18	Arch - <i>caldarium</i> 1, northern wall, centre, door.	Structural	Semicircular arch (r: 85, cs:168), rubble stone (~16x6x25) embedded in lime mortar (t: 6-7); core; irregular sized rough cut stone facing (~43x19x12).	Extensively damaged facing: only a single rough cut stone remaining.	
19	Arch - <i>caldarium</i> 2, southern <i>alveus</i> , furnace opening.	Structural	Covered with double layered plaster system: brick lime under-layer, hydraulic lime top-layer.	Almost total loss of infill: slight mortar remains.

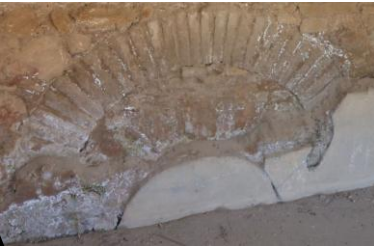
<p>Appendix J</p>
21	Arch system - <i>caldarium</i> 2, northern <i>alveus</i> , furnace opening.	Structural	Two arches, one within the other, radially laid bricks (~32x32x5), brick lime mortar (t: ~0.5-5), upper arch; brick (32x32x5) + brick lime mortar (tvertical: ~0.5-5, thorizontal:7.5), infill covered with hydraulic lime plaster (t: ~2.5).	Slight loss of hydraulic lime plaster, deposit formation.	
22	Arch - service corridor, southern part, southern wall.	Structural	Radially laid bricks (~30x30x5), brick lime mortar (t: ~0.5-5).	Nearly all embedded into earth.

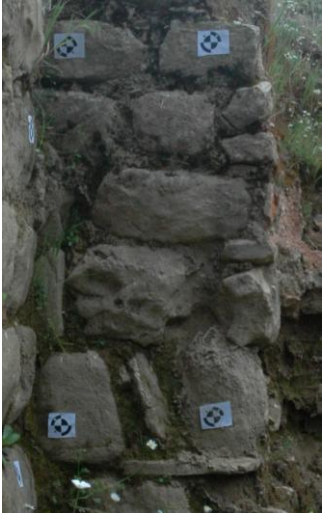
<p>Appendix J</p>
24	Wall - <i>caldarium</i> 1, south, western part.	Structural	Rubble stone (~16x6x25) + embedded in lime mortar (t: 6-7): core; facing with irregular sized rough cut stones (~43x19x12), brick lime mortar (t: 3): <i>opus vittatum</i> , h: ~245.	Partial collapse, total loss of plastering, empty joints.	
25	Wall - <i>caldarium</i> 1, west, southern part.	Structural	Rubble stone (~16x6x25) + embedded in lime mortar (t: 6-7): core; facing with irregular sized rough cut stones (~43x19x12), brick lime mortar (t: 3): <i>opus vittatum</i> , hmax: ~325.	Loss of height: partial collapse, total loss of plastering.

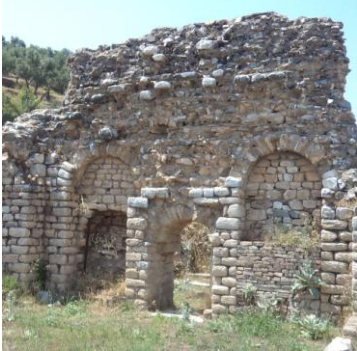
<p style="text-align: right;">Appendix J</p>
28	Wall - <i>caldarium</i> 1, east, northern part.	Structural	Rubble stone (~16x6x25) + embedded in lime mortar (t: 6-7): core; facing with irregular sized rough cut stones (~43x19x12), brick lime mortar (t: 3): <i>opus vittatum</i> , hmax: ~354.	Loss of height: partial collapse, total loss of plastering.

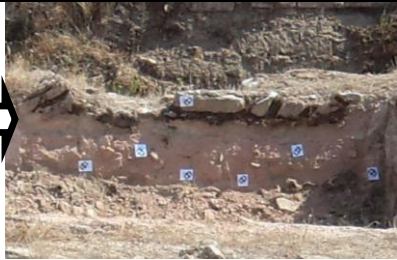
<p>Appendix J</p>
32	Wall - <i>caldarium</i> 1, southern <i>alveus</i> , western wall.	Structural	Rubble stone (~16x6x25) + embedded in lime mortar (t: 6-7): core; facing with irregular sized rough cut stones (~43x19x12), brick lime mortar (t: 3): <i>opus vittatum</i> , double layered plaster: lime under-layer (t: ~3), hydraulic lime top-layer (t: ~2), hmax: ~73.	Loss of height: almost total collapse, partial loss of plastering.	
33	Wall - <i>caldarium</i> 2, south, eastern part.	Structural	Rubble stone (~16x6x25) + embedded in lime mortar (t: 6-7): core; facing with irregular sized rubble stones (~43x19x12), brick lime mortar (t: 3): <i>opus incertum</i> , hmax: ~287.	Loss of height: partial collapse, total loss of plastering.

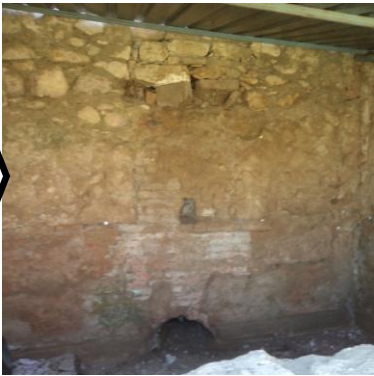
<p>Appendix J</p>
44	Wall - <i>caldarium</i> 2, western <i>alveus</i> , south.	Structural	Rubble stone (~16x6x25) + embedded in lime mortar (t: 6-7): core; facing with irregular sized rubble stones (~43x19x12), brick lime mortar (t: 3): <i>opus incertum</i> , plaster: lime under-layer (t:~3), hydraulic lime top-layer (t:~2), h:~340.	Loss of height: partial collapse, extensive loss of finishing layer of plastering, discoloration.	
45	Wall - <i>caldarium</i> 2, western <i>alveus</i> , west.	Structural	Rubble stone (~16x6x25) + embedded in lime mortar (t: 6-7): core; facing with irregular sized rubble stones (~43x19x12), brick lime mortar (t: 3): <i>opus incertum</i> , repair brick and stone at central bottom part, h: ~521.	Partial loss of plastering, deposit formation, discoloration.

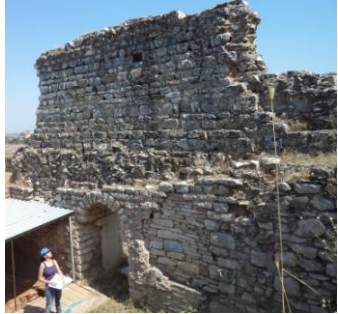
<p>Appendix J</p>
51	Wall - <i>caldarium</i> 3, west.	Structural	Rubble stone (~16x6x25) + embedded in lime mortar (t: 6-7): core; facing with irregular sized rubble stones (~43x19x12), brick lime mortar (t: 3): <i>opus incertum</i> , repair brick at central bottom part, brick lime plaster (t: ~4), hmax: ~404.	Loss of height: partial collapse, extensive loss of plastering, empty joints.

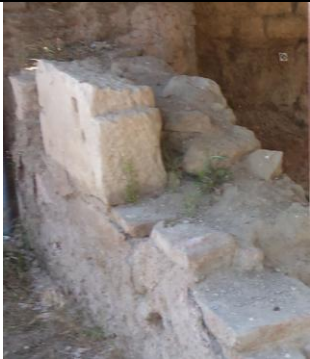
<p style="text-align: right;">Appendix J</p>
54	Hypocaust columns - <i>caldarium</i> 1, south.	Structural	Series of columns (hmin: ~30, hmax: 56) in circular, squarish, linear or L formed plans, circular (di: ~30) or squarish (30x30) bricks (t: ~5) + gray mortar (t: ~4).	Loss of original heights of columns: partial collapse.

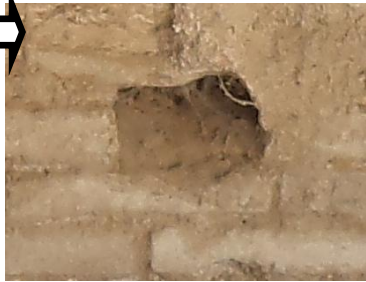
Appendix J
63	Furnace opening - <i>caldarium</i> 1, southern <i>alveus</i> , southern wall.	Architectural	Opening with a wall piece covered brick lime plaster, covered a brick arch system.	Partial loss of the infill.

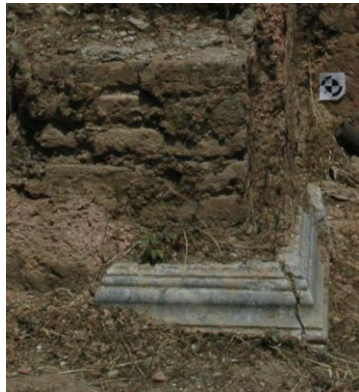
<p style="text-align: right;">Appendix J</p>
83	Pilaster - <i>caldarium</i> 2, eastern wall, southern part.	Architectural	Bricks (~15 or 30x5x30) + lime mortar (t: ~3); brick lime plaster (t: ~5).	Extensive loss of the element: extensive loss of shaft, extensive loss of plastering, deposit formation.	
84	Niche - <i>caldarium</i> 1, northern wall, west.	Architectural	Rubble stone (~16x6x25) + embedded in lime mortar (t: 6-7): core; facing with irregular sized rough cut stones (~43x19x12), brick lime mortar (t: 3): <i>opus vittatum</i> , repair brick and stone at central part, metal supporting elements.	Partial loss of the element, total loss of plastering, deposit formation, plant growth.

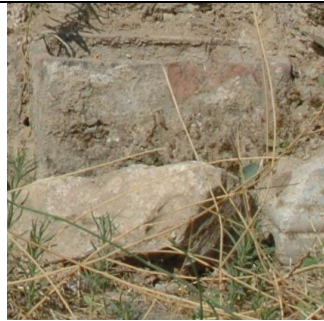
<p>Appendix J</p>
88	<i>Tubuli</i> system - <i>caldarium</i> 2, western wall.	Architectural	A single terra cotta element attached to the wall with lime mortar.	Loss of integrity, deposit formation.	
89	<i>Alveus</i> - <i>caldarium</i> 1, south.	Architectural	Surrounded by three walls, a stair on its sides, marble inlay on the ground.	Loss of the superstructure.

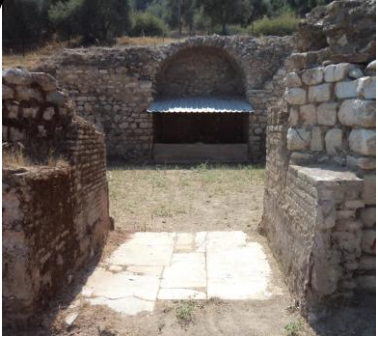
<p>Appendix J</p>
106	Door - <i>caldarium</i> 1, east.	Architectural	Rubble stone (~16x6x25) + embedded in lime mortar (t: 6-7) + irregular sized rough cut stones (~43x19x12), brick lime mortar (t: 3).	Total loss of spanning element, no covering material on side wall, deposit formation.	
107	Door - <i>caldarium</i> 2, east.	Architectural	Brick (15 or 30x5x30) + lime mortar (t: ~4).	Total loss of spanning element, no covering material on side walls, deposit formation.	
108	Door - <i>caldarium</i> 3, south.	Architectural	Rubble stone (~16x6x25) + embedded in lime mortar (t: 6-7) + irregular sized rough cut stones (~43x19x12), brick lime mortar (t: 3).+ stone block.	Total loss of spanning element, no covering material on side walls, loss of integrity, deposit formation.
