**CONSERVATION PROJECT OF LATİFE HANIM
HOUSE IN KARŞIYAKA, İZMİR**

**A Thesis Submitted to
the Graduate School of Engineering and Sciences of
İzmir Institute of Technology
in Partial Fulfillment of the Requirements for the Degree of**

in Architectural Restoration

**by
Esra DİPBURUN**

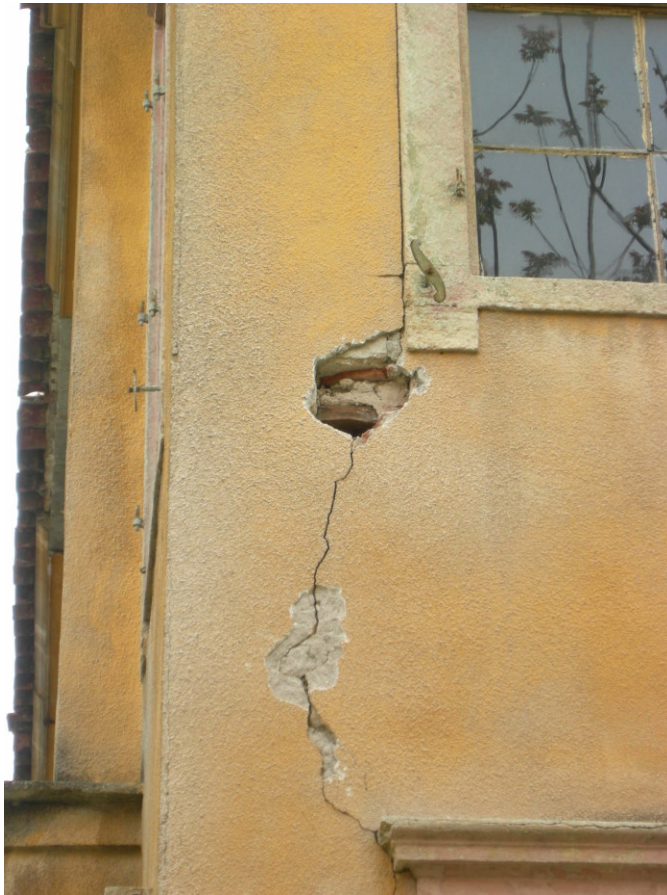
Figure 2.118. The major crack at the bottom level of the window at the northern corner of the western facade.

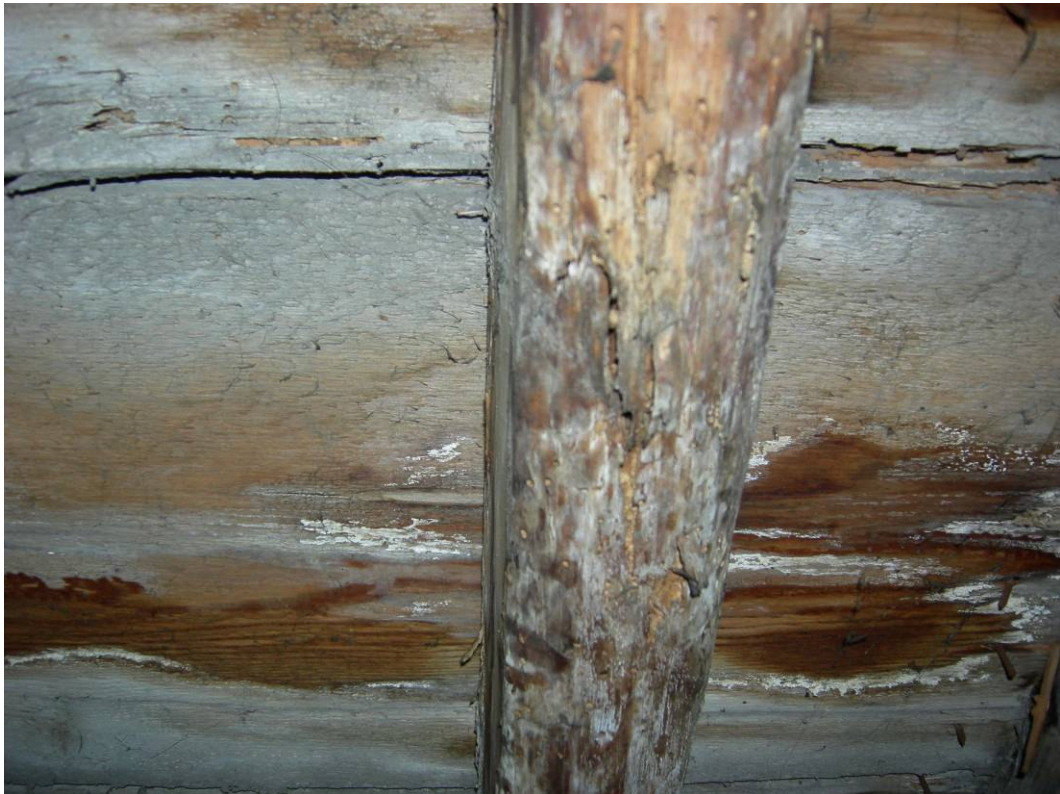
Figure 2.125. Holes in the timber beam, white stains in the timber covering at the basement.
