**IMPORTANCE OF CONDITION SURVEY AND
REPORT OF BUILT CULTURAL HERITAGE:
DÜZCE (HEREKE) BATH**

in Architectural Restoration

IMPORTANCE OF CONDITION SURVEY AND REPORT OF BUILT CULTURAL HERITAGE: DÜZCE (HEREKE) BATH

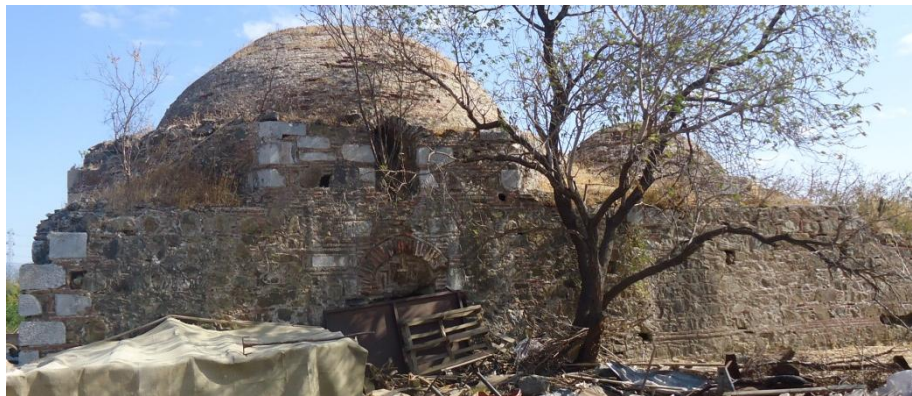
Figure 4.4. West wall of Düzce Bath

According to the findings, west wall displays moderate symptoms and condition class of the wall is CC2, recommendation class of the wall is RC2, and urgency class of the wall is UC2 (Appendix.B, Appendix.C).

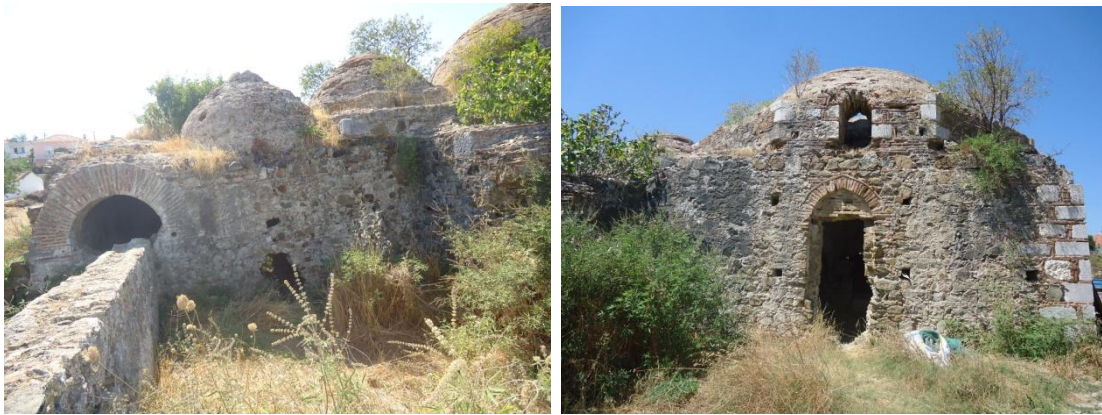
Figure 4.8. East wall - 1 of Düzce Bath

condition class of the wall is CC2, recommendation class of the wall is RC2, and urgency class of the wall is UC2 (Appendix.B, Appendix.C).

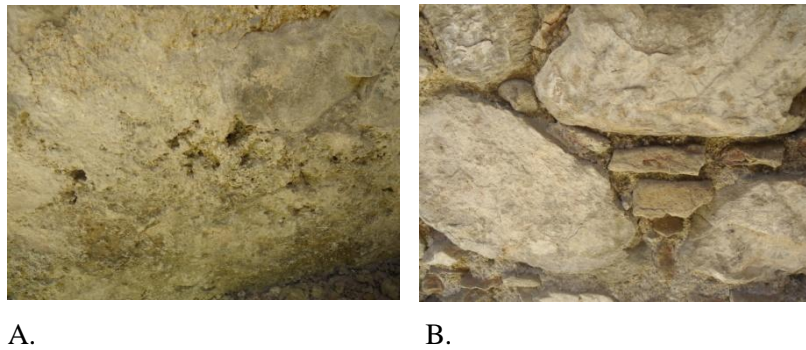
Figure 4.23.A. Alveolizations on the right part of the wall
B. Discolourations on the right part of the wall

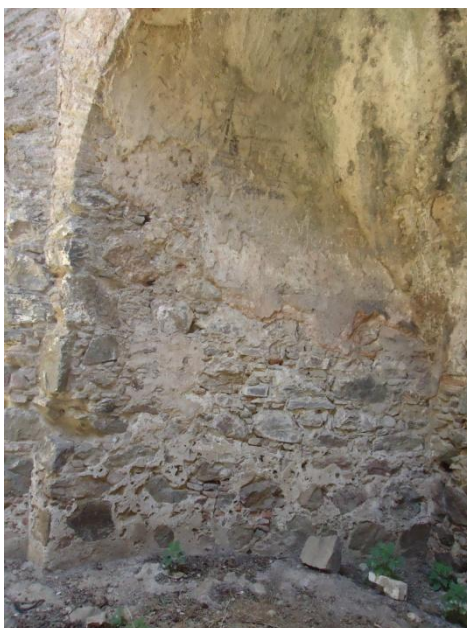
Figure 4.28. Right part of the North wall

No severe damage was seen in the right part of the wall (Figure 4.28). Observed material deteriorations are pittings and discolourations on the unplastered small area. All the findings were evaluated and condition class of right part of wall was defined as CC0.

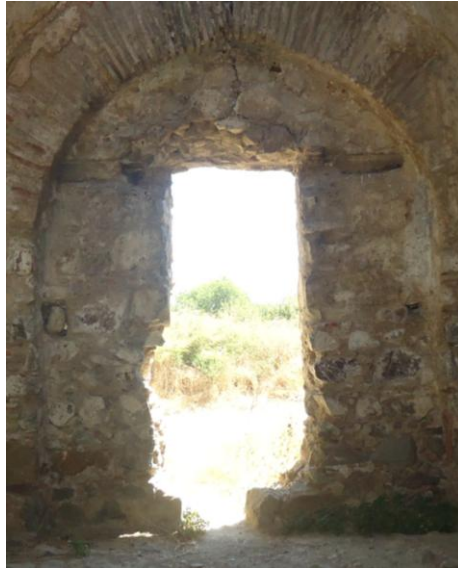
Figure 4.31. Middle part of the East wall

the bricks and stones. All the findings were evaluated and condition class of the middle part of the wall was defined as CC3.

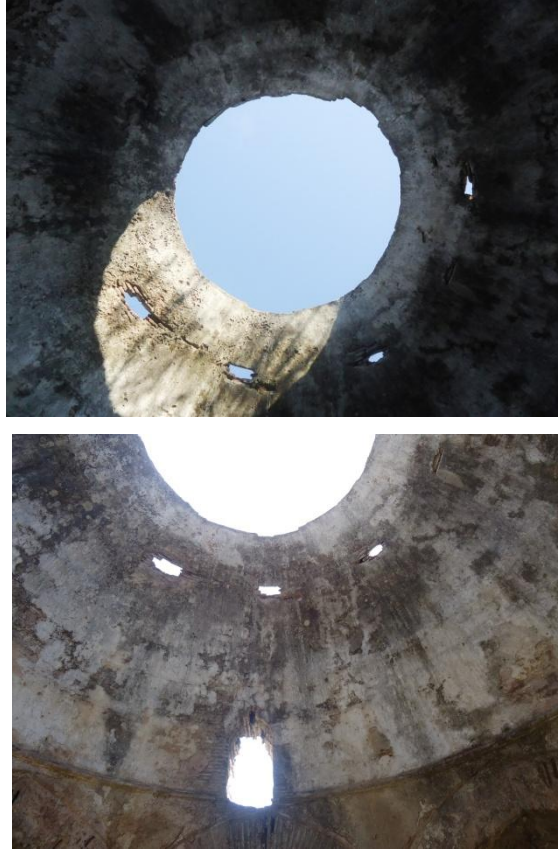
Figure 4.60. Dome of *Soyunmalık*

According to the findings, dome displays major symptoms and condition class of the dome is CC3, recommendation class of the dome is RC3, and urgency class of the dome is UC3 (Appendix.B, Appendix.C).

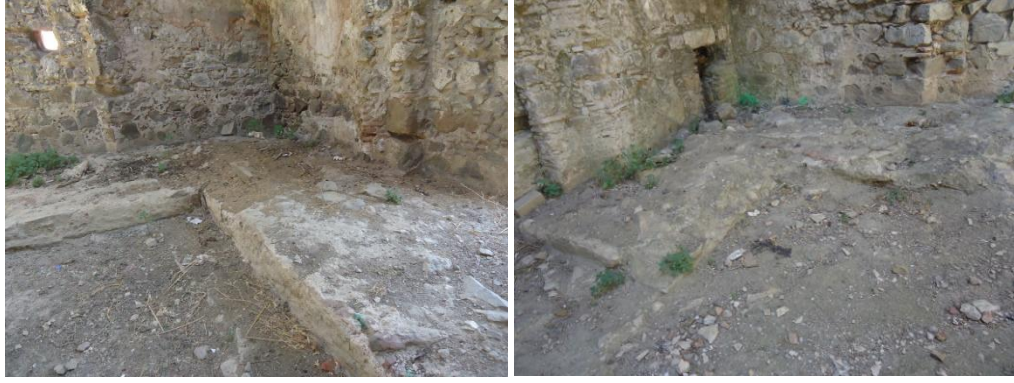
Figure 4.61. *Seki of Soyunmalık*

According to findings, *seki* has moderate symptoms and condition class of the *seki* is CC2, recommendation class of the *seki* is RC2, and urgency class of the *seki* is UC2 (Appendix.B).

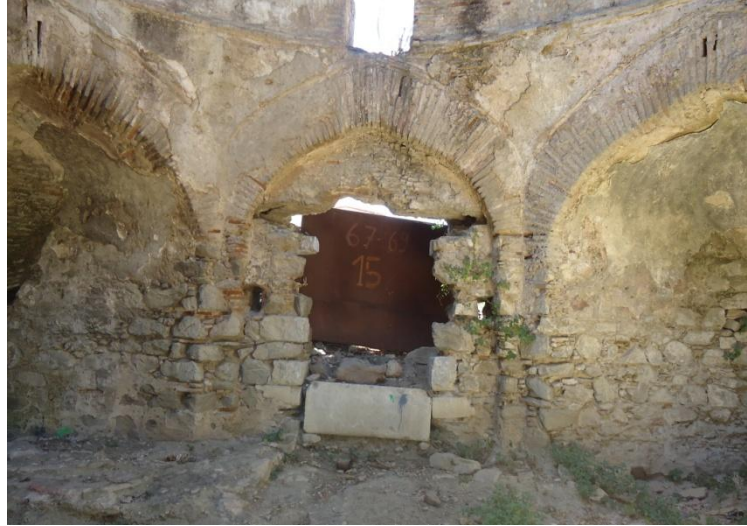
Figure 4.62. West Wall Plaster of *Soyunmalık*

According to the findings, the plaster displays major symptoms and condition class of the plaster is CC3, recommendation class of the plaster is RC3, and urgency class of the plaster is UC3 (Appendix.B).

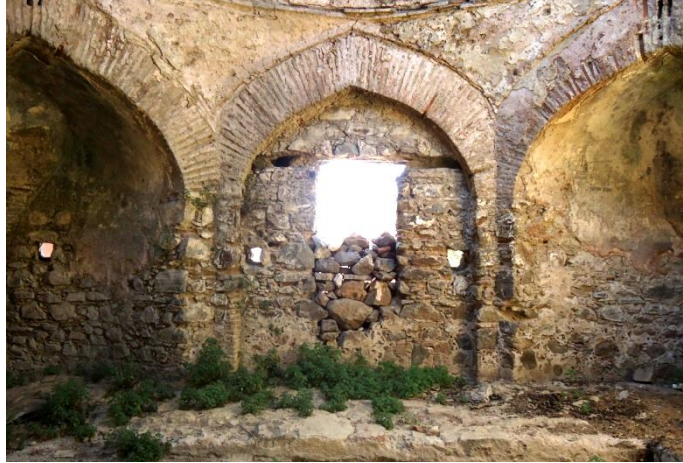
Figure 4.63. North Wall Plaster of *Soyunmalik*

According to the findings, the plaster displays moderate symptoms and condition class of the plaster is CC2, recommendation class of the plaster is RC2, and urgency class of the plaster is UC2 (Appendix.B).

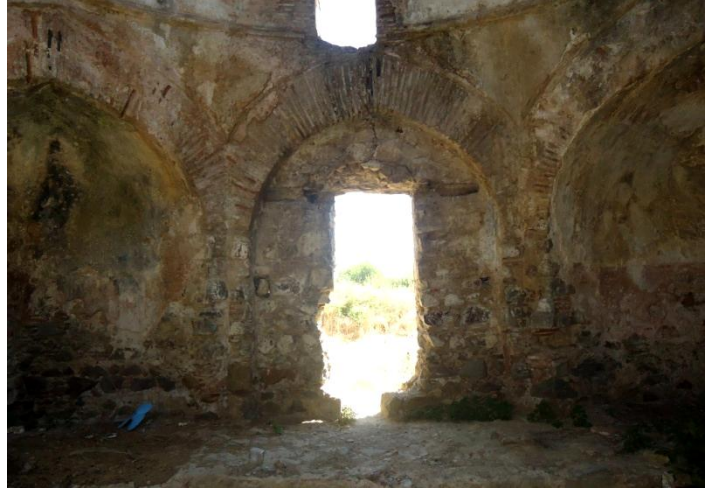
Figure 4.64. East Wall Plaster of *Soyunmalık*

According to the findings, the plaster displays moderate symptoms and condition class of the plaster is CC2, recommendation class of the plaster is RC2, and urgency class of the plaster is UC2 (Appendix.B).

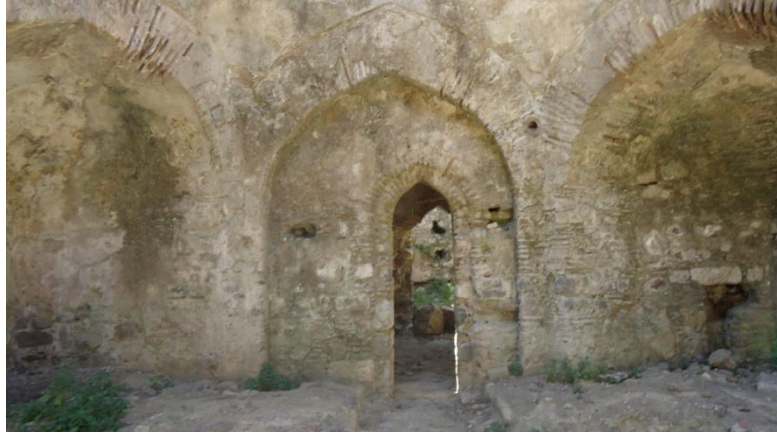
Figure 4.65. South Wall Plaster of *Soyunmalık*

According to the findings, the plaster displays moderate symptoms and condition class of the plaster is CC2, recommendation class of the plaster is RC2, and urgency class of the plaster is UC2 (Appendix.B).

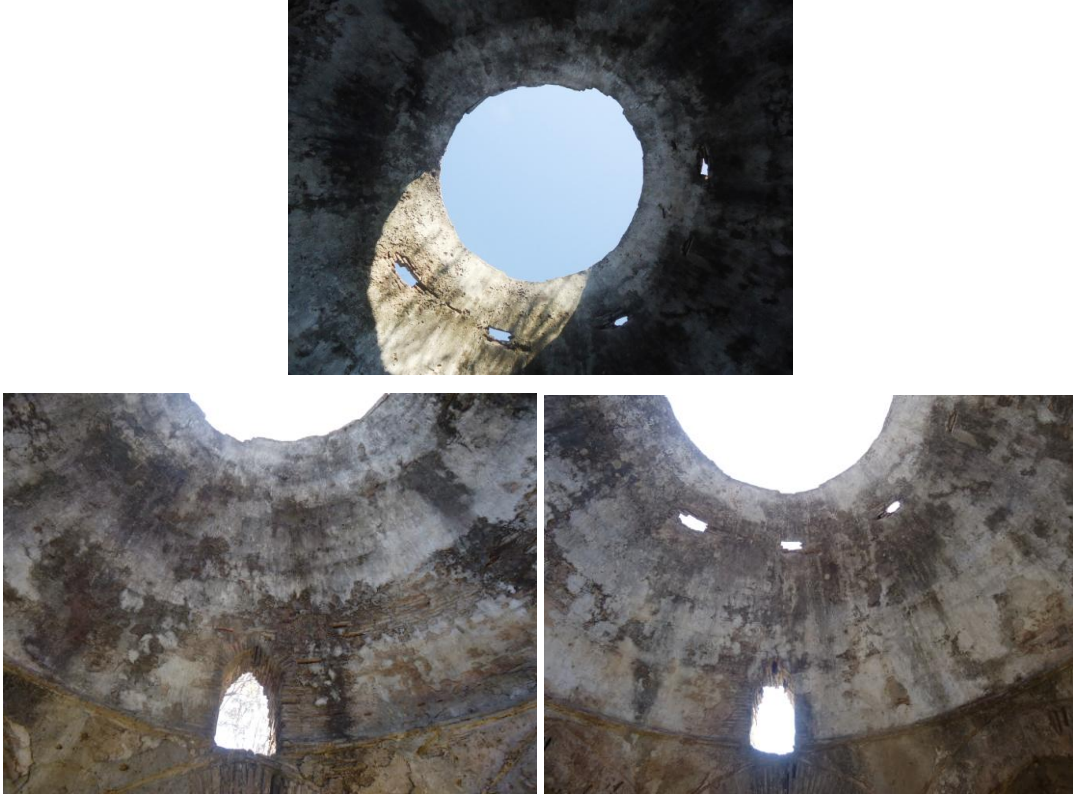
Figure 4.86. Dome plaster of *Soyunmalik*

According to the findings, the plaster displays moderate symptoms and condition class of the plaster is CC2, recommendation class of the plaster is RC2, and urgency class of the plaster is UC2 (Appendix.B).

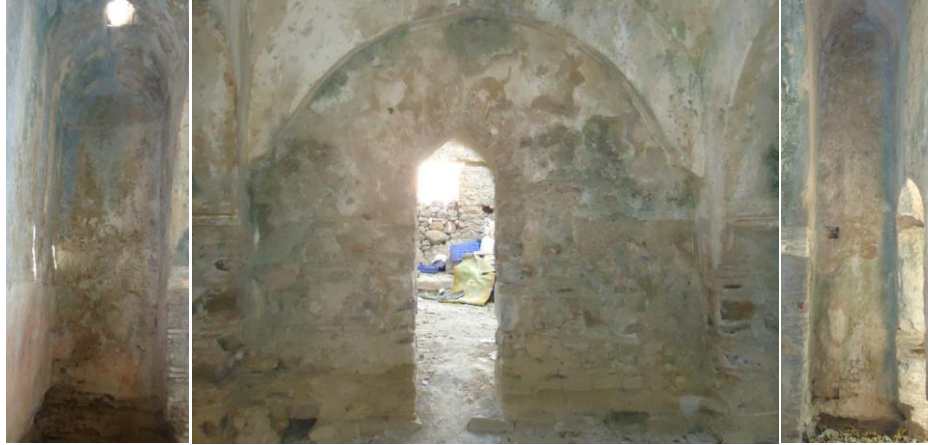
Figure 4.89. North Wall of *Sicaklık*

According to findings, the wall displays minor symptoms and condition class of the wall is CC1, recommendation class of the wall is RC1, and urgency class of the wall is UC1 (Appendix.B).

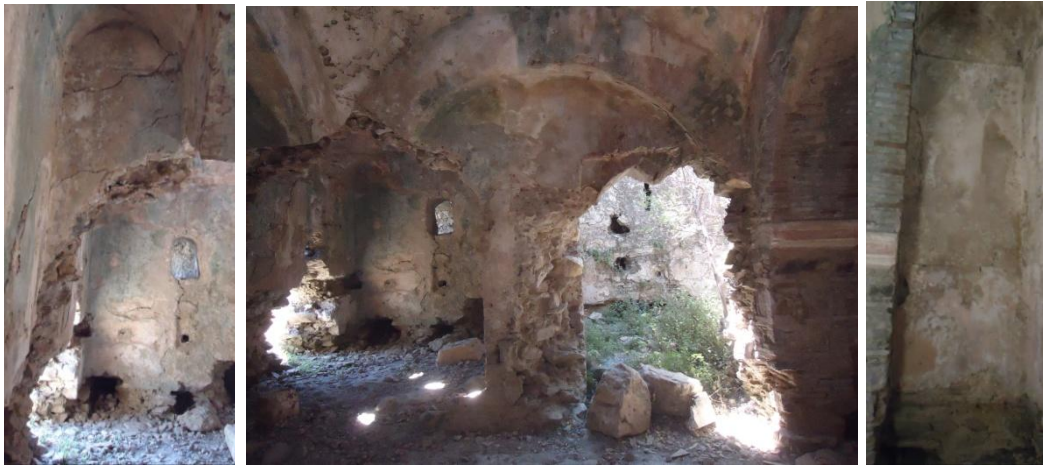
Figure 4.91. South Wall of *Sıcaklık*

According to the findings, the wall displays major symptoms and condition class of the wall is CC3, recommendation class of the wall is RC3, and urgency class of the wall is UC3 (Appendix.B).

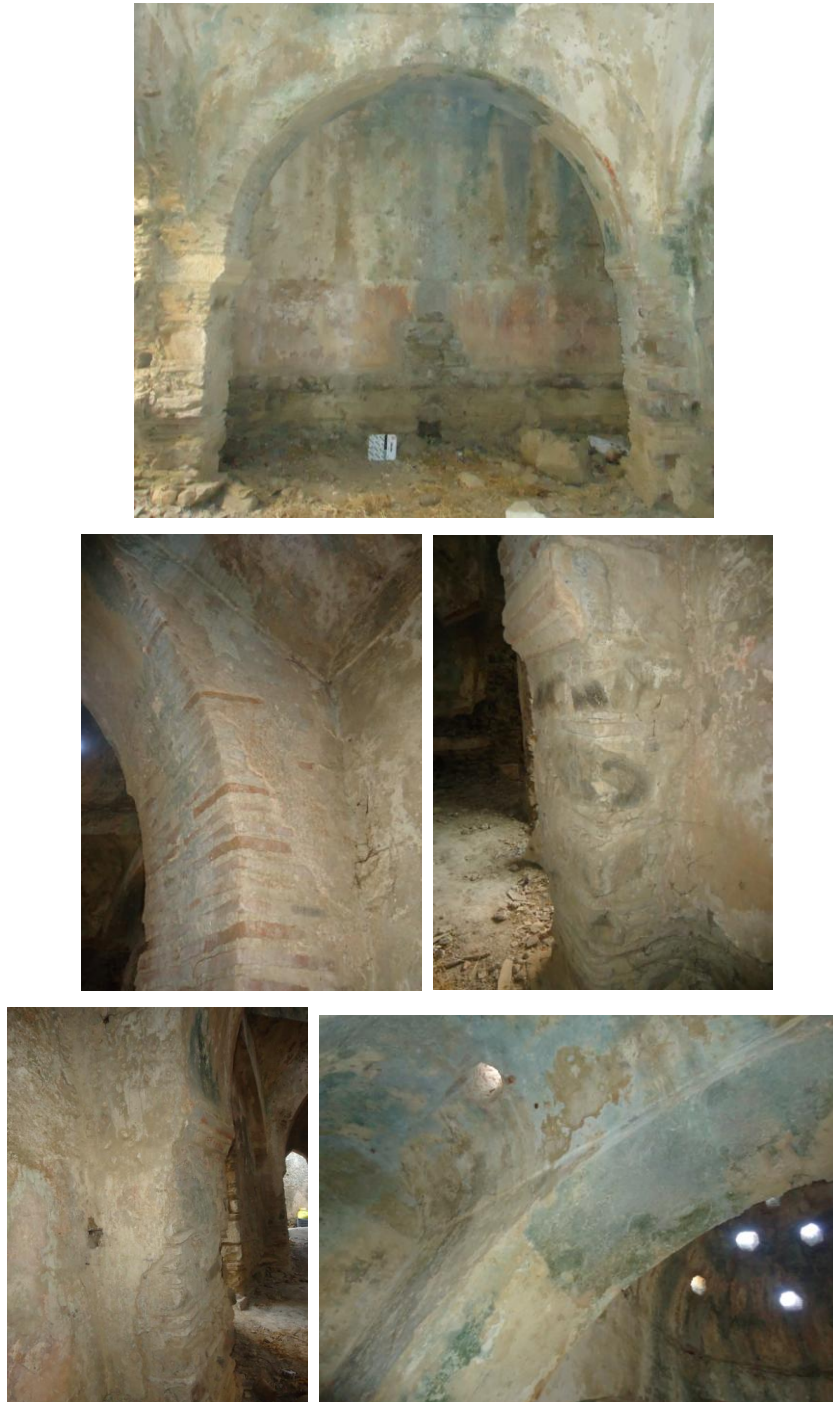
Figure 4.92. West Arch of *Sıcaklık*

According to findings, arch displays minor symptoms and condition class of the wall is CC1, recommendation class of the wall is RC1, and urgency class of the wall is UC1 (Appendix.B).

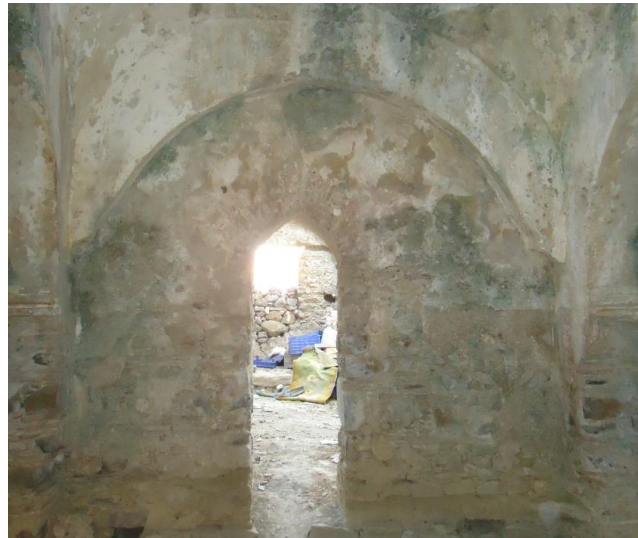
Figure 4.93. North Arch of *Sıcaklık*

North arch is plastered and no visual deterioration can be observed. No symptoms can be seen and condition class of the arch is CC0, recommendation class of the arch is RC0, and urgency class of the arch is UC0 (Appendix.B).

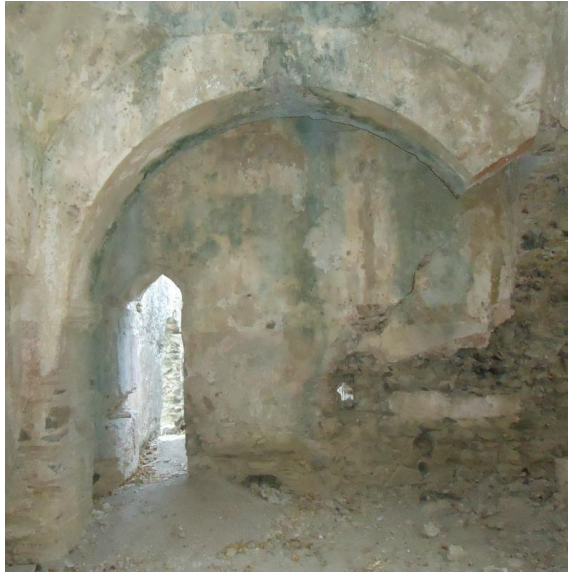
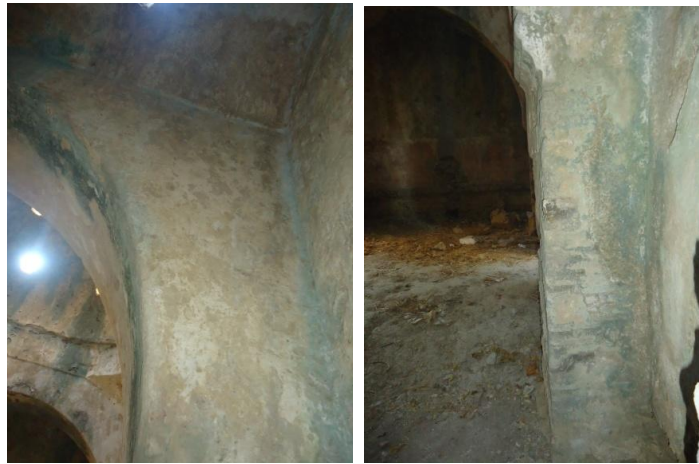
Figure 4.94. East Arch of *Sicaklık*

According to findings, arch displays major symptoms and condition class of the arch is CC3, recommendation class of the arch is RC3, and urgency class of the arch is UC3 (Appendix.B, Appendix.C).

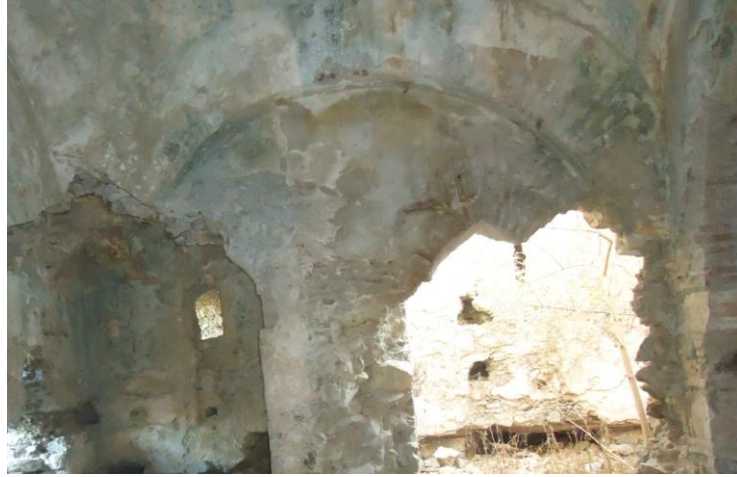
Figure 4.95. South Arch of *Sicaklık*

According to findings, arch displays moderate symptoms and condition class of the wall is CC2, recommendation class of the wall is RC2, and urgency class of the wall is UC2 (Appendix.B).

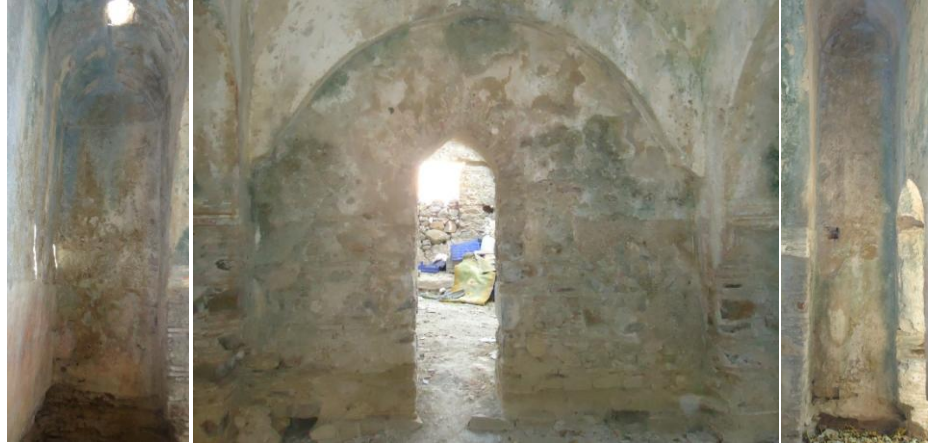
Figure 4.106. North Wall plaster of *Sicaklık*

According to the findings, plaster displays moderate symptoms and condition class of the plaster is CC2, recommendation class of the plaster is RC2, and urgency class of the plaster is UC2 (Appendix.B).

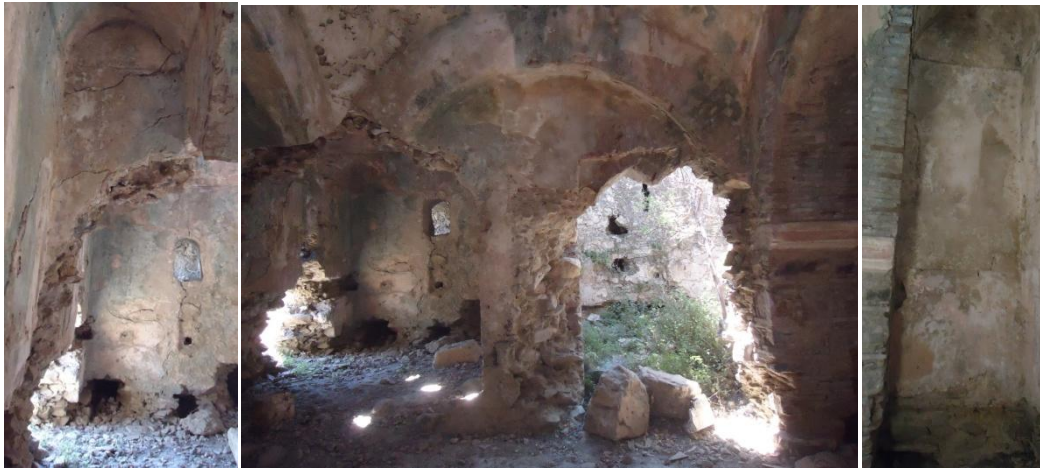
Figure 4.108. South Wall plaster of *Sıcaklık*

According to findings, plaster displays moderate symptoms and condition class of the plaster is CC2, recommendation class of the plaster is RC2, and urgency class of the plaster is UC2 (Appendix.B).

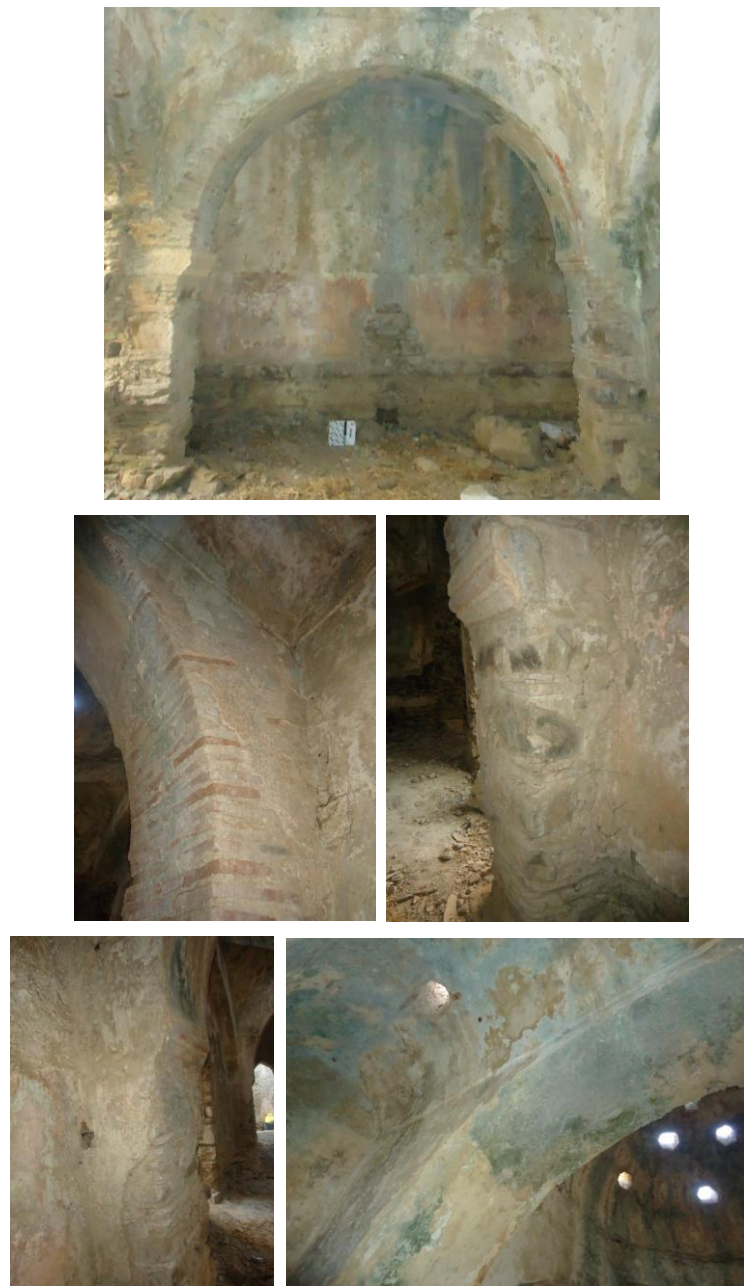
Figure 4.109. West Arch plaster of *Sıcaklık*

According to the findings, plaster displays moderate symptoms and condition class of the plaster is CC2, recommendation class of the plaster is RC2, and urgency class of the plaster is UC2 (Appendix.B).

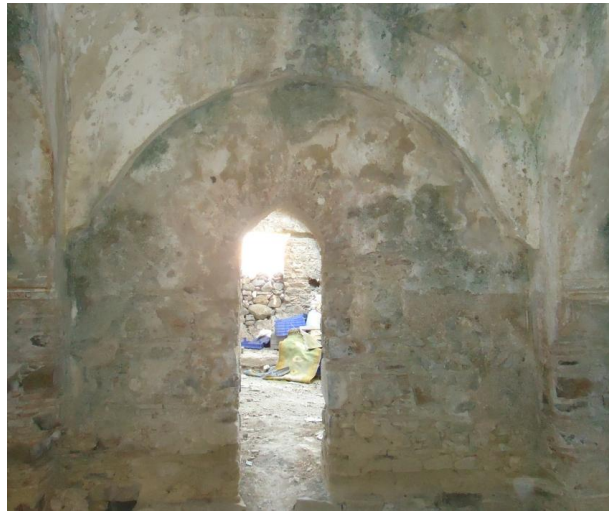
Figure 4.110. North Arch plaster of *Sıcaklık*

According to the findings, plaster displays minor symptoms and condition class of the plaster is CC1, recommendation class of the plaster is RC1, and urgency class of the plaster is UC1 (Appendix.B).

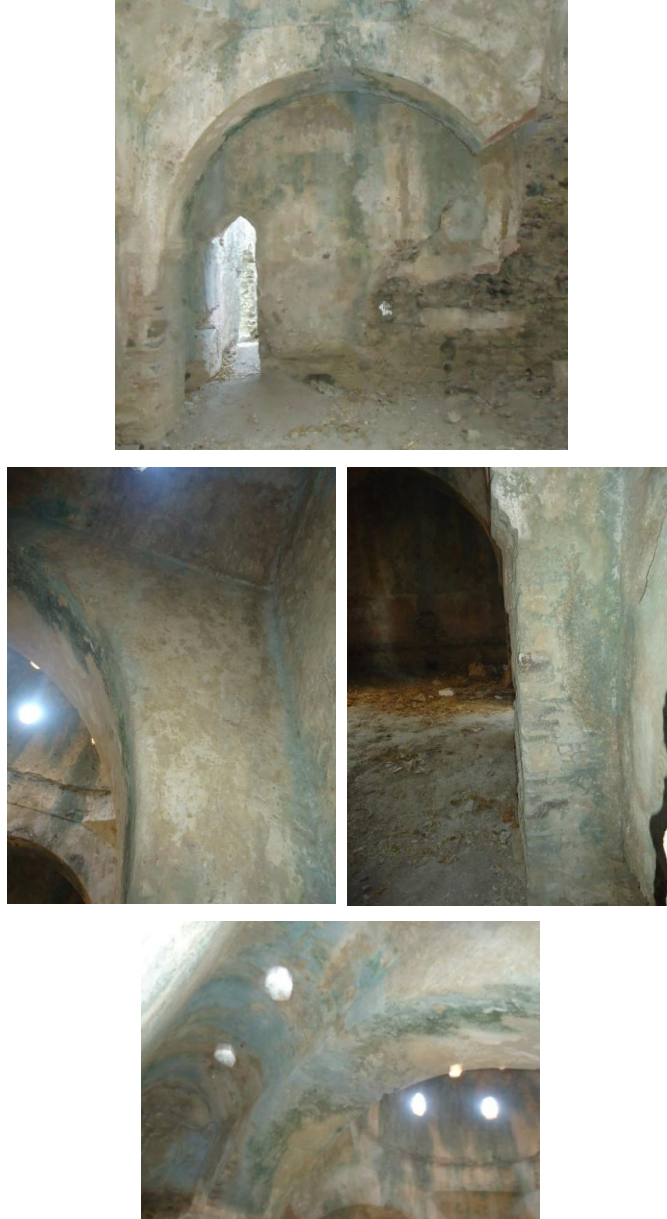
Figure 4.111. East Arch plaster of *Sıcaklık*

According to the findings, plaster displays moderate symptoms and condition class of the plaster is CC2, recommendation class of the plaster is RC2, and urgency class of the plaster is UC2 (Appendix.B).

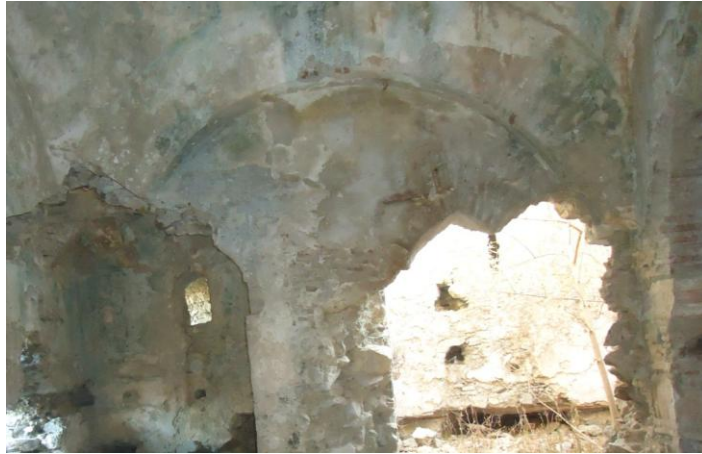
Figure 4.112. South Arch plaster of *Sıcaklık*

According to the findings, plaster displays moderate symptoms and condition class of the plaster is CC2, recommendation class of the plaster is RC2, and urgency class of the plaster is UC2 (Appendix.B).

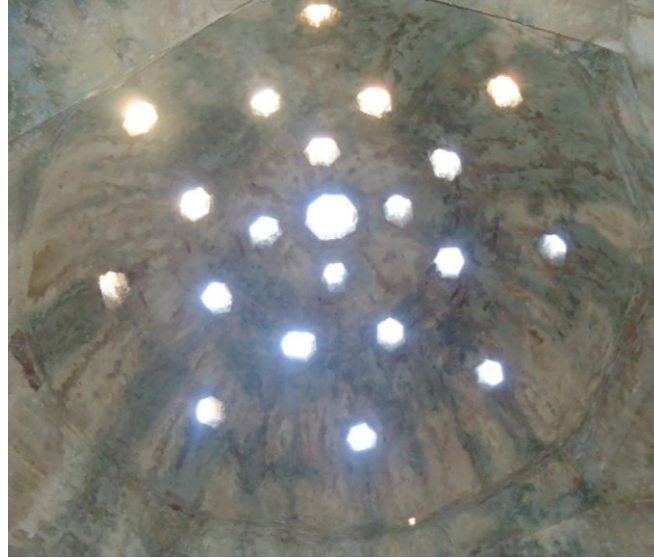
Figure 4.119. Dome plaster of *Sıcaklık*

According to the findings, plaster displays moderate symptoms and condition class of the plaster is CC2, recommendation class of the plaster is RC2, and urgency class of the plaster is UC2 (Appendix.B).

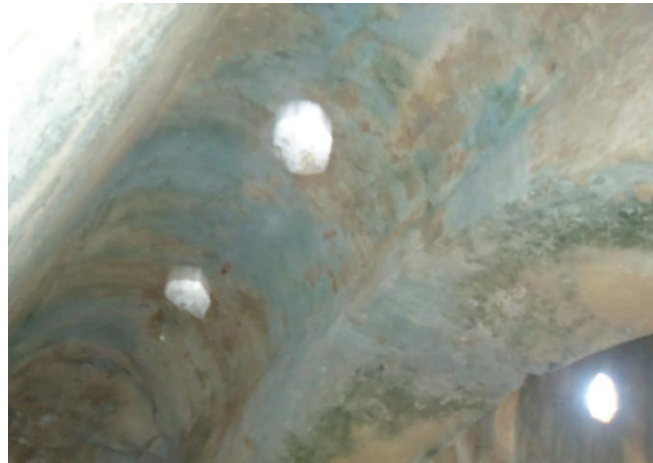
Figure 4.121. East Barrel Vault plaster of *Sıcaklık*

According to the findings, plaster displays moderate symptoms and condition class of the plaster is CC2, recommendation class of the plaster is RC2, and urgency class of the plaster is UC2 (Appendix.B).

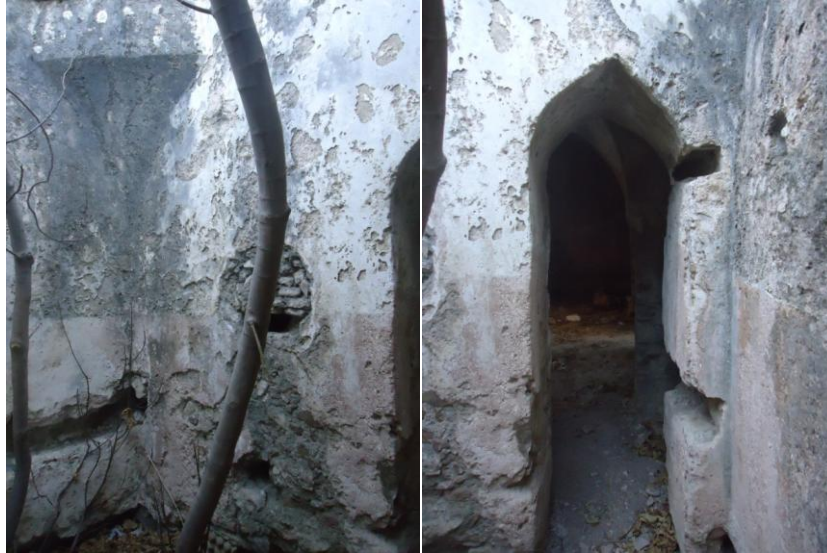
Figure 4.122. West wall of Cleaning Cell

According to the findings, the wall displays moderate symptoms and condition class of the wall is CC2, recommendation class of the wall is RC2, and urgency class of the wall is UC2 (Appendix.B).

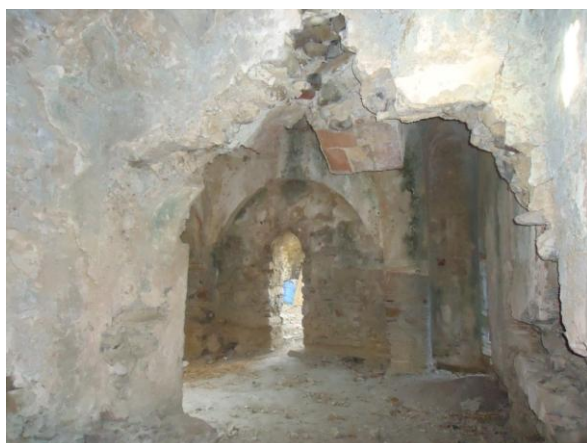
Figure 4.143. North wall of the South East *Halvet* Figure 4.144. Pittings on the North wall

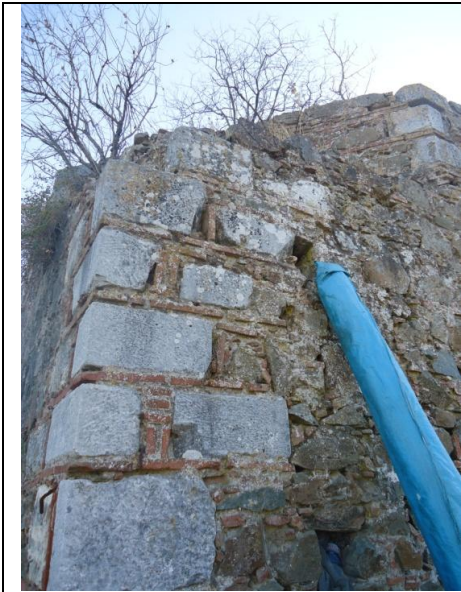
left and right of the wall
 -Efflorescences are widespread, especially on the left and right of the wall
 -Pittings
 -Discolourations are widespread
 -Hair cracks are widespread

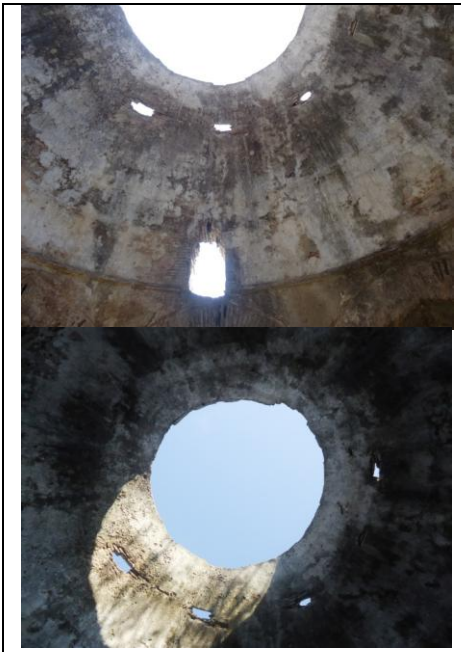
<p>Brick and lime mortar dome has 2 top window. Below of dome, two row brick were used. Surface is plastered.</p>	<p><u>Losses</u> -Top windows</p> <p><u>Structural Failures</u> -Missing wide part (collapsed) in the middle of the dome -Splitting around collapsed area -Missing bricks around the collapsed area -Broken bricks around the top windows traces</p> <p><u>Material Deteriorations</u> -Discoloration in components -Pittings on components</p>	<p>Major symptoms</p>	<p>3</p>	<p>Major intervention based on diagnosis</p>	<p>3</p>	<p>Urgent and immediate</p>	<p>3</p>
---	---	---	-----------------------	----------	--	----------	-----------------------------	----------

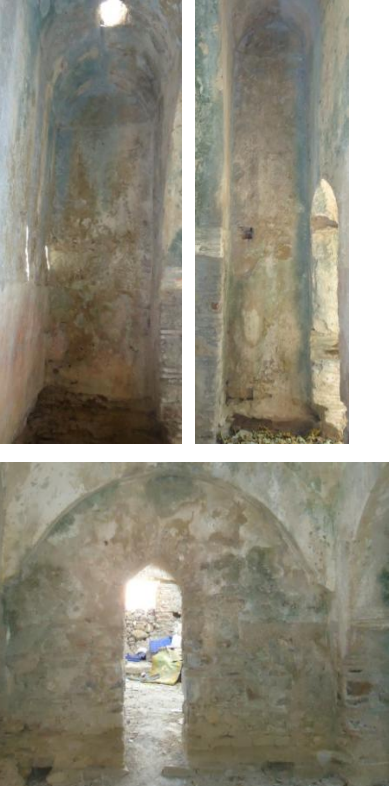
<p>Stone masonry wall which was constructed through bonding technique with rubble stone and brick components in lime mortar. Surface is plastered.</p>	<p><u>Losses</u> -Seki -Basin</p> <p><u>Material Deteriorations</u> -Discolourations -Pittings on middle part of wall</p>	<p>Minor symptoms</p>	<p>1</p>	<p>Maintenance / Preventive conservation</p>	<p>1</p>	<p>Intermediate term</p>	<p>1</p>
<p>East wall</p>	<p>Stone masonry wall which was constructed through bonding technique with rubble stone</p>	<p><u>Losses</u> -Seki -Flue -Basin</p>	<p>Major symptoms</p>	<p>3</p>	<p>Major intervention based on diagnosis</p>	<p>3</p>	<p>Urgent and immediate</p>	<p>3</p>

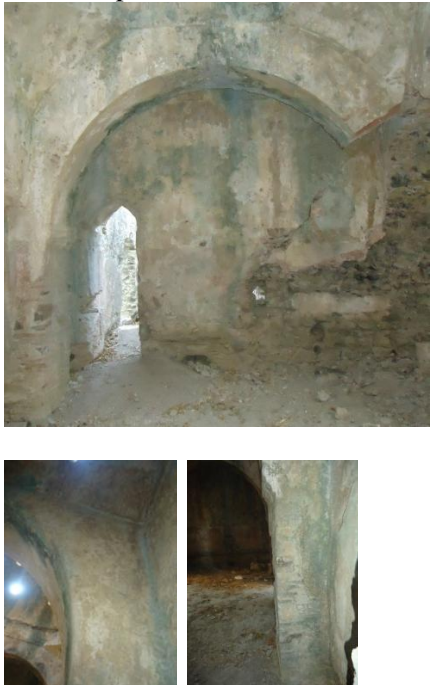
<p>Up to 150 cm, horasan plaster were used as plaster and thin red plaster used as finishing layer. From 150 cm up to dome, 2 layers horasan plaster layer were used and lime plaster were used as finishing layer.</p>	<p>-Microbiological colonizations are widespread from top point to below of wall -Pittings -Black and white crusts -Eflorescences -Hair cracks -Discolourations</p>	<p>Moderately strong symptoms</p>	<p>2</p>	<p>Moderate repair and further investigation</p>	<p>2</p>	<p>Short Term</p>	<p>2</p>

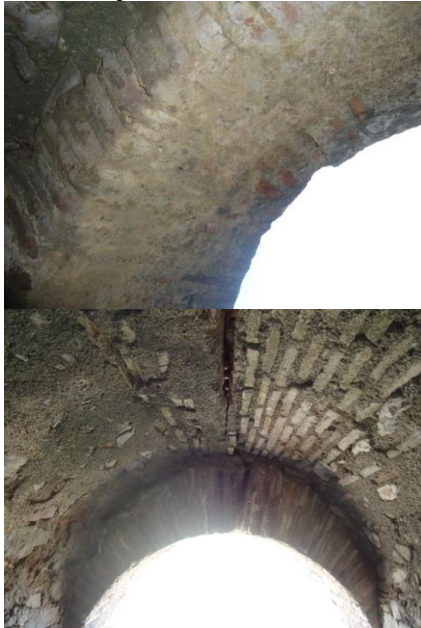
<p>-Missing wide part of the plaster inner surface -Microbiological colonizations were seen on the existing small areas</p>	<p>Major symptoms</p>	<p>3</p>	<p>Major intervention based on diagnosis</p>	<p>3</p>	<p>Urgent and immediate</p>	<p>3</p>
<p>Barrel vault plaster</p>		<p>-Delamination on the right corner of</p>	<p>Moderately strong</p>	<p>2</p>	<p>Moderate repair and</p>	<p>2</p>	<p>Short Term</p>	<p>2</p>

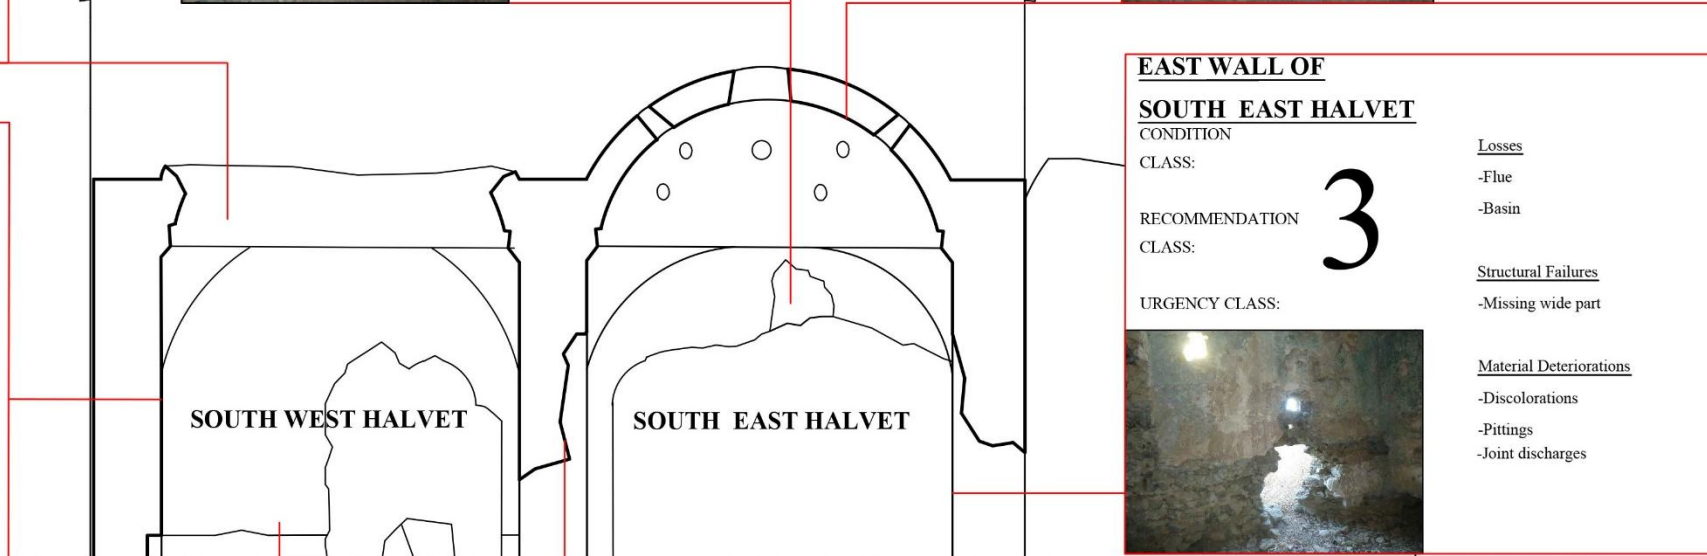
EAST WALL OF SOUTH EAST HALVET
 CONDITION CLASS: **3**
 RECOMMENDATION CLASS:
 URGENCY CLASS:
