**STRUCTURAL MODEL BASED ROOT CAUSE  
INVESTIGATION OF DAMAGE IN URLA  
HELVACILAR MOSQUE AND A PROPOSAL FOR  
STRENGTHENING**

**A Thesis Submitted to  
the Graduate School of Engineering and Sciences of  
İzmir Institute of Technology  
in Partial Fulfillment of the Requirements for the Degree of**

**in Architectural Restoration**

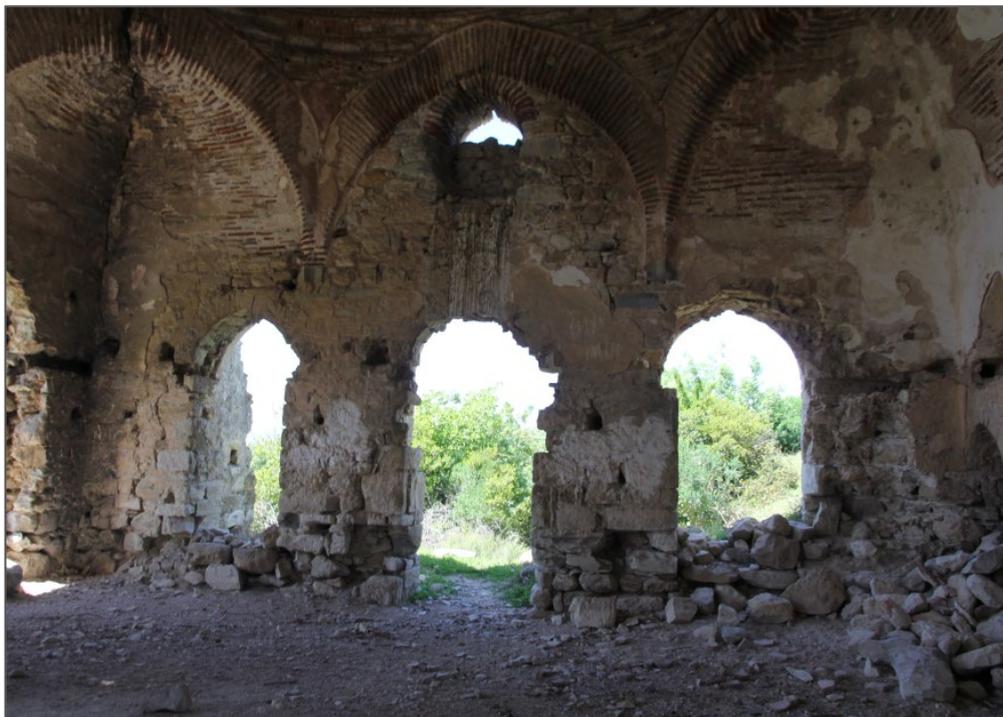
In the middle of the west wall, there is a building entrance which extends to 2.8 meters above the ground and has two large window openings on both sides. The parts of the wall under the window are collapsed and the stones forming the wall are left as a heap of rubble at the bottom of the window openings (Figure 3.7).

Figure 3.7. West wall of the prayer hall (Harim)

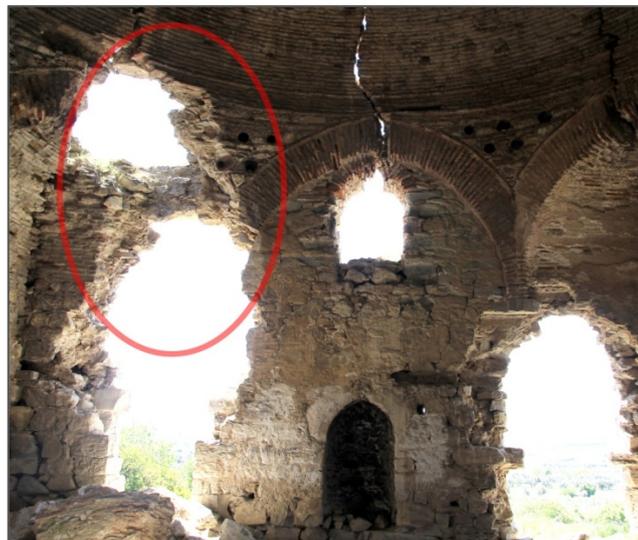
The losses in keystone areas are seen in the arch in the south wall, the south-west and north-east squinches, and the upper-row windows in the north and east walls. These losses can be described as the loss of two or three courses of bricks in the keystone area of the arches. The losses in the center and corners of the south wall should not be considered locally as they are associated with other structural problems, but rather should be addressed in terms of the ripple effect of all damages in the southern wall on each other.

Figure 3.21. Mass collapse on the southeast part of the south wall of Harim

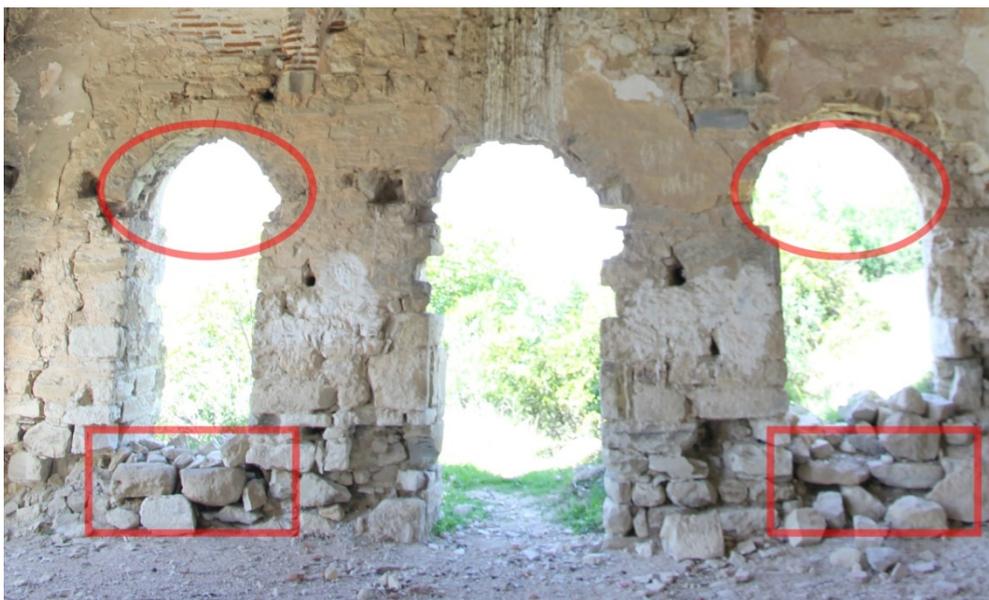
Figure 3.25. Mass collapse of different level of window openings on west wall of Harim

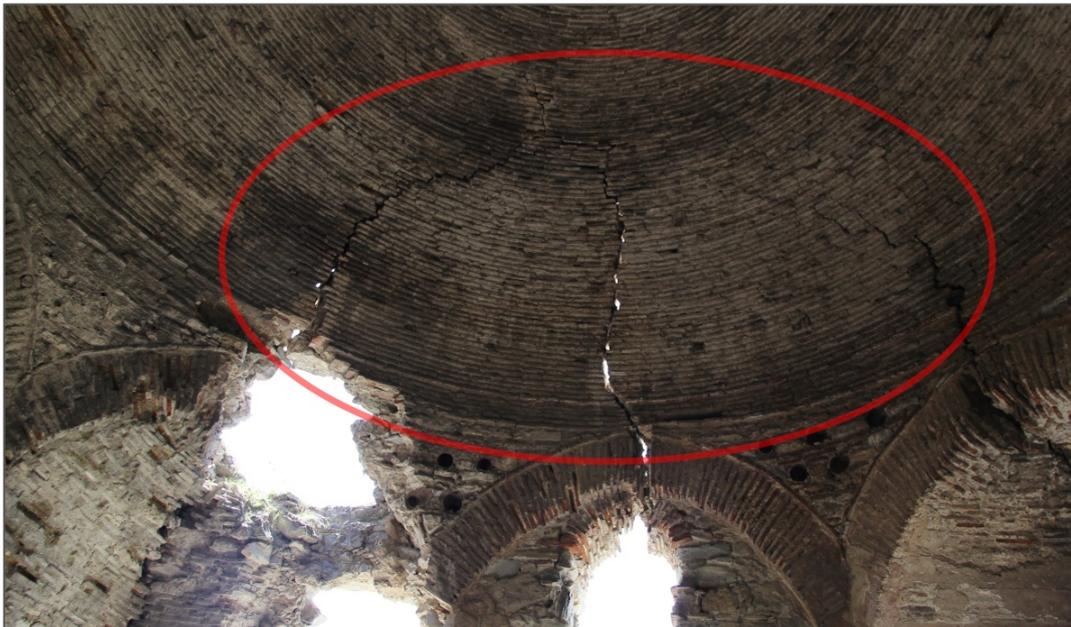
Figure 3.26. Crack on the south part of the dome

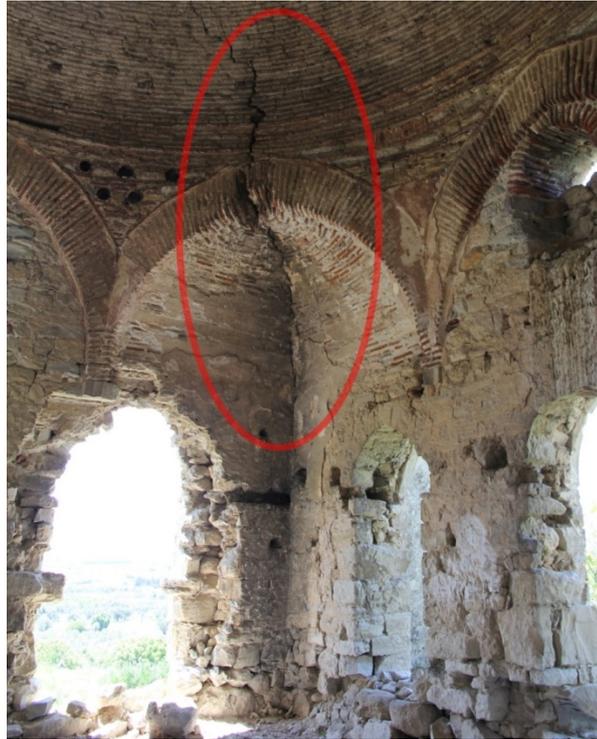
These cracks originate from the joining line in the center of the north-east and south-west squinches and go downwards to the corners of the walls under the squinches. The crack in the north-east corner continues along the squinch, narrowing upwards to the dome. The crack in the south-west corner goes downwards to the wall as a continuation of the main crack originating from the dome. While the cracks in the squinches are clearly visible inside the structure, no cracks are observed in the facade (Figure 3.27).

Figure 3.27. Cracks on the southwest corner of harim

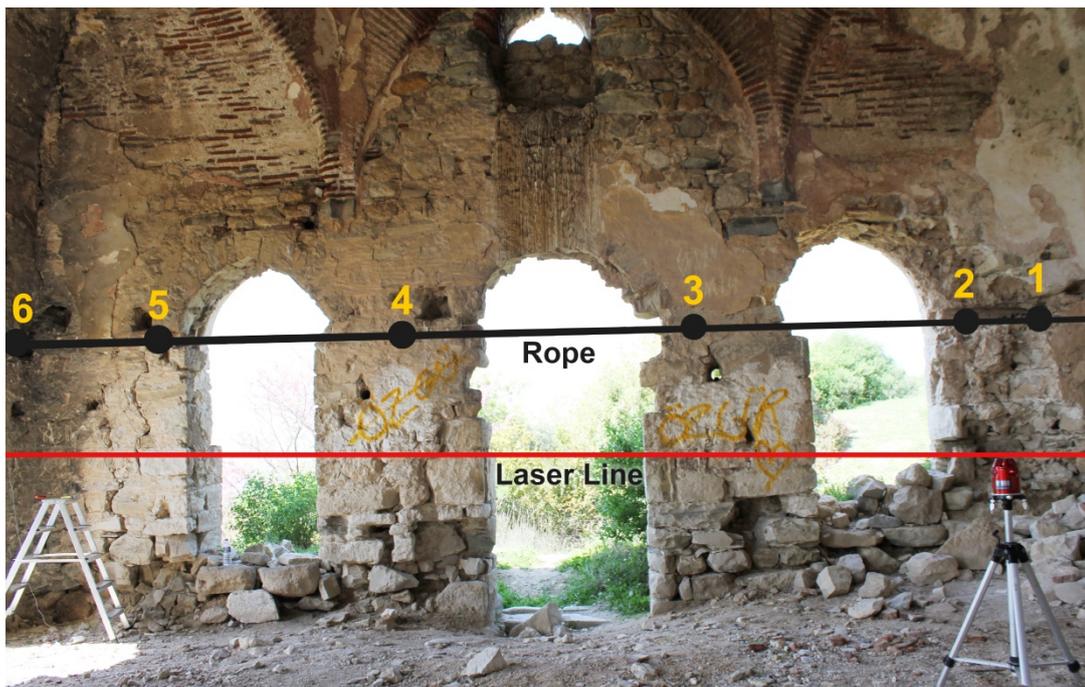
First, inside the prayer hall, a laser line, considered to be the 0.00 level, was set up at a height of 115 centimeters above the ground, and a line was drawn by horizontally stretching out a rope between the lower levels of the lintel spaces in the north, south and west walls of the prayer hall (Figure 3.29). The vertical distance between the laser line and the horizontal rope was measured at certain vertical distances from the north wall to the south. As can be seen in Table 3.1, the distance between the levels from the north wall to the south wall decreased. In other words, the building had a settlement of 14.5 centimeters from inside the north wall to inside the south wall.

Figure 3.29. Settlement measurement between north and south walls of harim

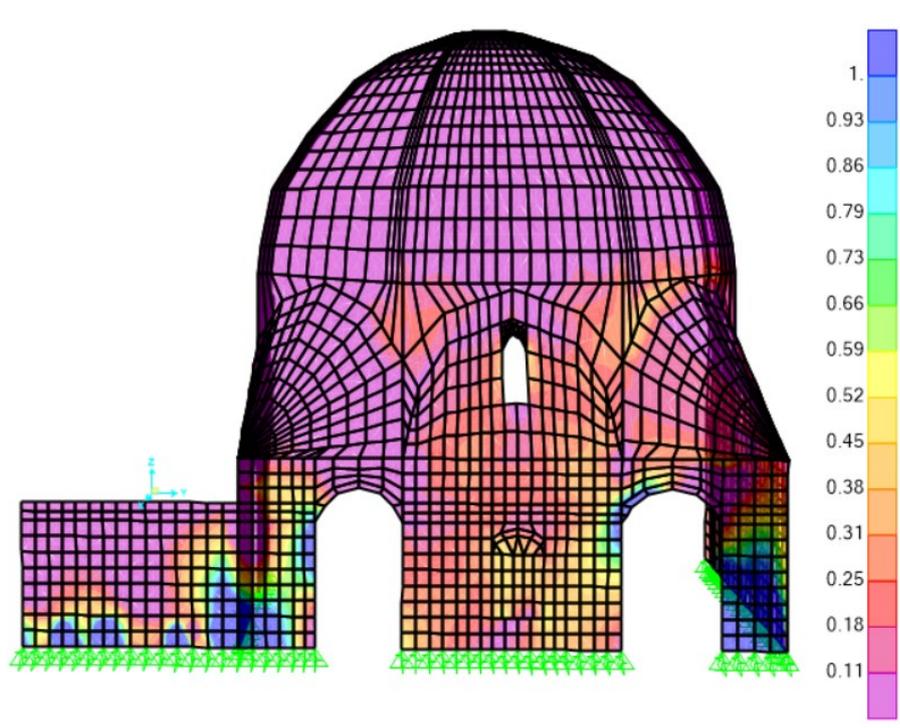
This result supports the idea that a settlement caused by ground motion for years in accord with this scenario has led to the damage mechanism in the southern side of the building.

Figure 4.20. Tensile stress (absolute Smax) contours of settlement analysis on south facade of the structure (kN/cm<sup>2</sup>)

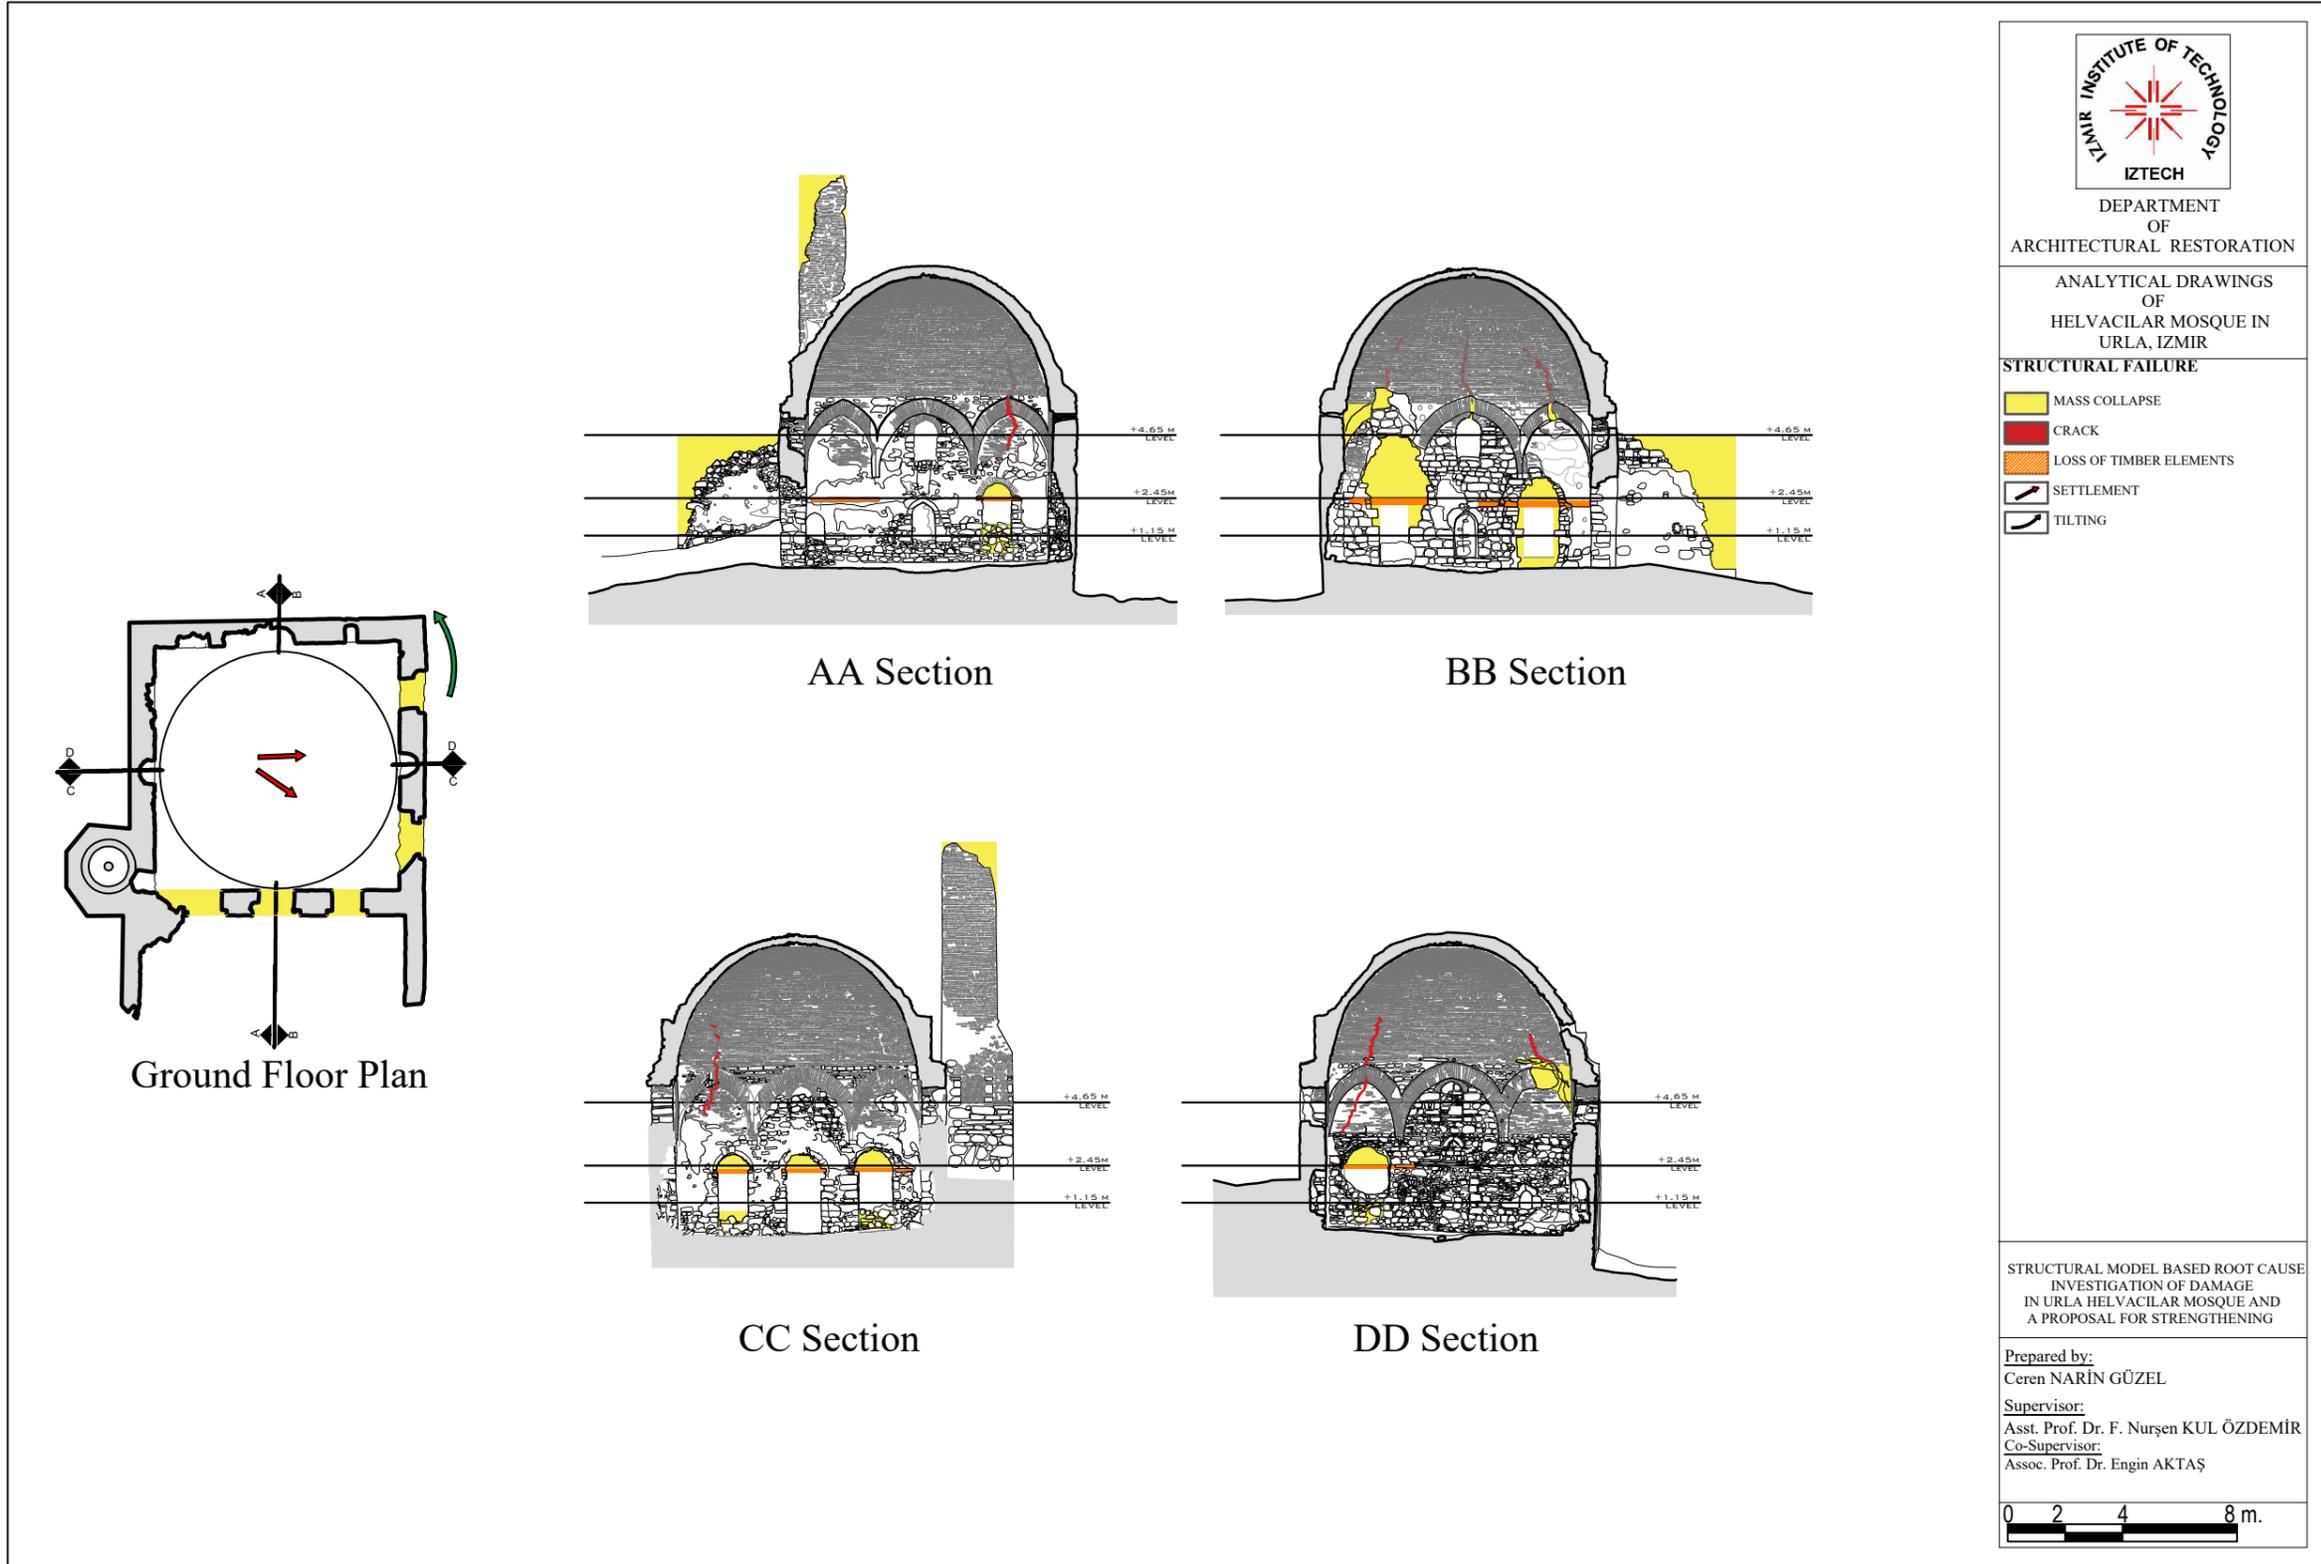
Figure D.1. Structural Failure
