CORROSION OF INDUSTRIAL FRIT FURNACE REFRACTORIES: A POSTMORTEM STUDY

ABSTRACT

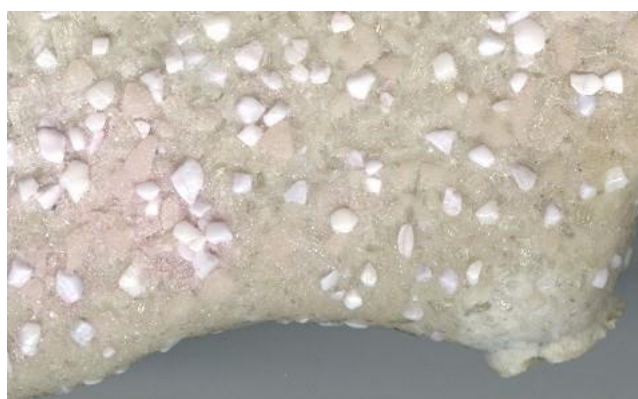
The examination with unaided eye of the corroded melt tank refractory brick as received (GS-M samples) showed that there were widespread white appearing granules embedded within a porous structure. In the refractory-molten glass boundary these white grains protruded, giving the impression that they had better corrosion resistance than the surrounding structure. Translucent type of grains also embedded and distributed diffusely in the structure. The rest of the refractory consisted of a homogeneous glassy matrix (Figure 1).

Figure 1. Photograph of corroded refractory brick (GS-M)

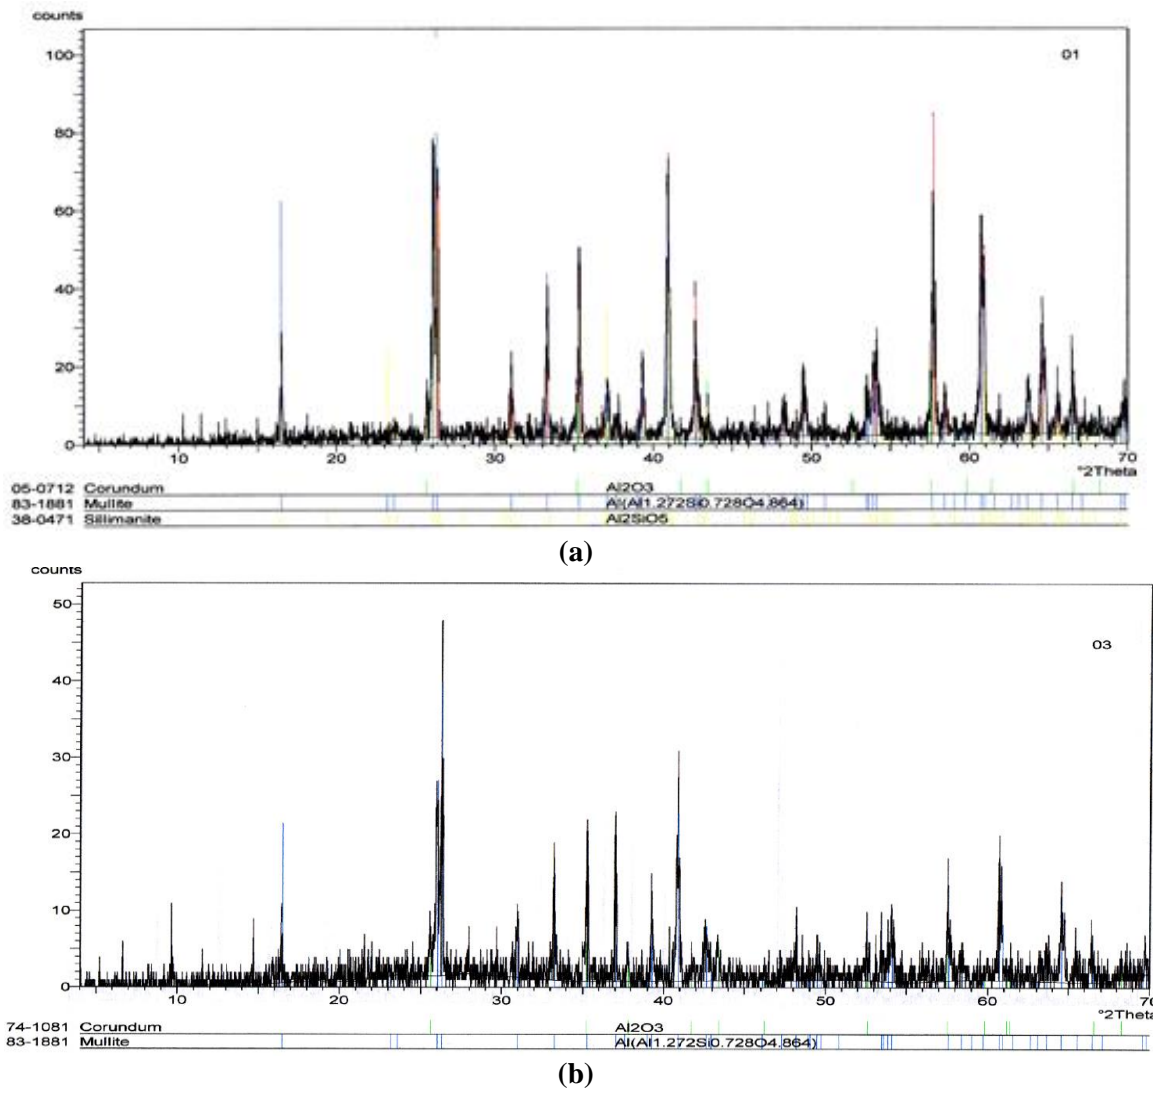
The XRD patterns of the unaffected inner bulk, and the corrosion interface of the corroded brick are given in Figure 2a, and Figure 2b, respectively. The results showed the existence of corundum, mullite and small quantities of sillimanite in the unaffected bulk portion, while corundum and mullite were the only existing crystal phases in the corrosion interface. The relative intensities of the peaks that belonged to corundum with respect to the mullite were greater for the corrosion interface as compared to the unaffected bulk pattern. This pointed out that the dissolution of mullite phase was more extensive than the corundum phase in the molten glass-refractory interface.

Figure 2. (a) The XRD pattern of the corroded refractory brick (GS-M sample), (a) the unaffected inner region, (b) the molten glass-refractory interface

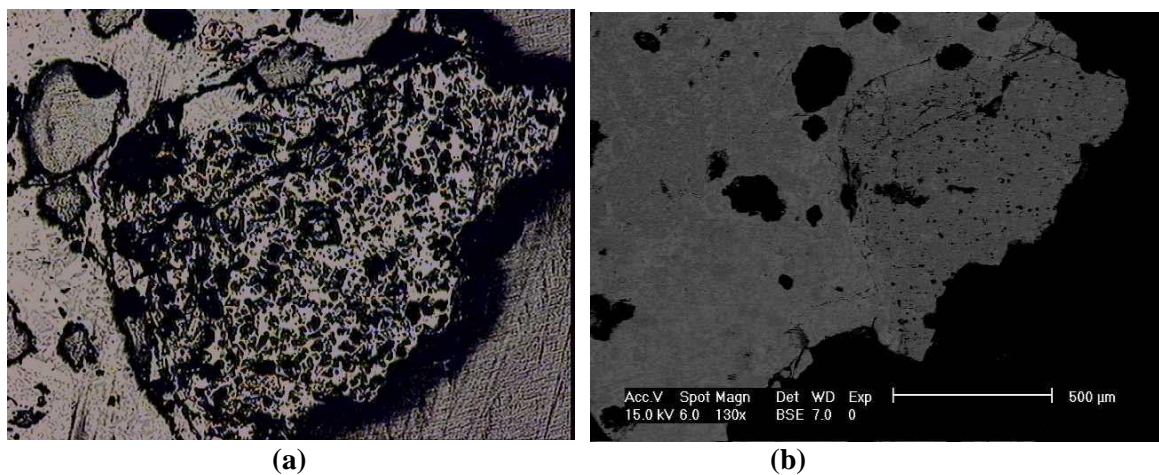
RL-OM and SEM were used for the microstructural examination of the described corroded refractory brick. The RL-OM and SEM images of the protruding grain on the corrosion interface are shown in Figure 3a and 3b. These grains were as large as 2 mm. The EDS analysis given in Figure 4 indicated 52 wt% Al, and 48wt% O, which was in agreement with the theoretical values for pure Al_2O_3 (Al: 52.9 wt%, O: 47.1 wt%). Together with the XRD results these grains were identified as corundum. Most probably, these Al_2O_3 grains had not formed or co-crystallized during the production of the brick, but rather preprepared corundum particles were mixed in the green composition of the refractory before firing.

Figure 3. (a) RL-OM image of corroded melt tank refractory brick; white color filler grain at the refractory-molten glass interface (magnification 150x), (b) SEM image of the same region

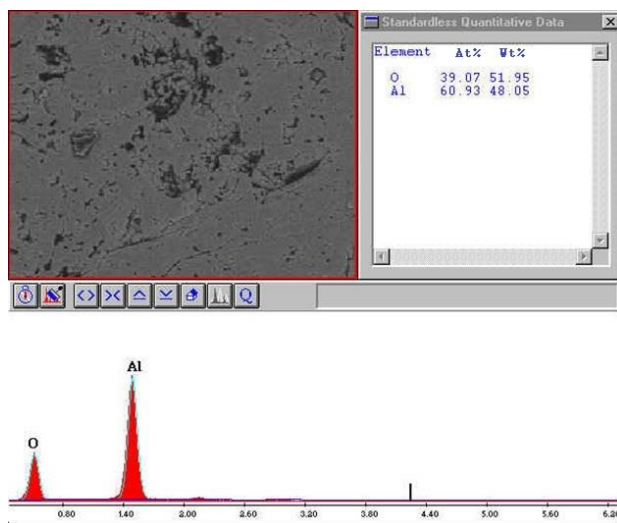
Figure 4. EDS zone analysis of the white color grain

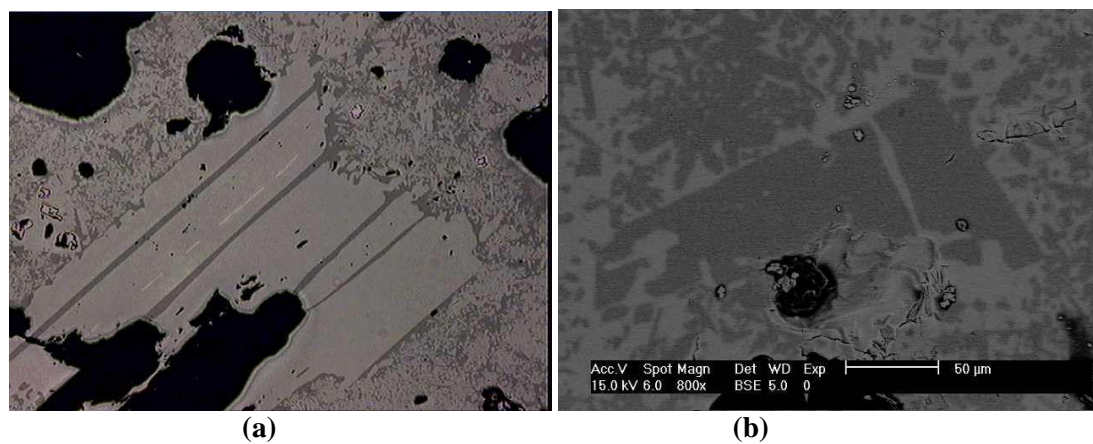
The widespread translucent grains in the structure were determined to be single crystals by the RL-OM and SEM images as shown in Figure 5a and 5b. The size of the grains could be as large as 2 mm. The point EDS analysis of the grain given in Figure 6 indicated that the elemental composition was 37 wt% Al, 11 wt% Si, and 52 wt% O, close to the theoretical values of mullite, $3\text{Al}_2\text{O}_3 \cdot 2\text{SiO}_2$ (Al: 38.0 wt%, Si: 13.2 wt%, O: 48.8 wt%). The XRD patterns in Figure 2a and 2b showed mullite as the major crystalline phase for both of the inner bulk and corrosion interface regions, supporting the translucent grains to be mullite crystals. The slight discrepancy from the mullite composition in the EDS analysis might be due to the existence of embedded Al_2O_3 crystals in small quantities. These were the crystals formed during the heat treatment step of the refractory production.

Figure 5. (a) RL optical microscope image of idiomorphic mullite crystals in the unaffected bulk of the corroded refractory (150x) (b) SEM image of idiomorphic mullite crystals in the bulk

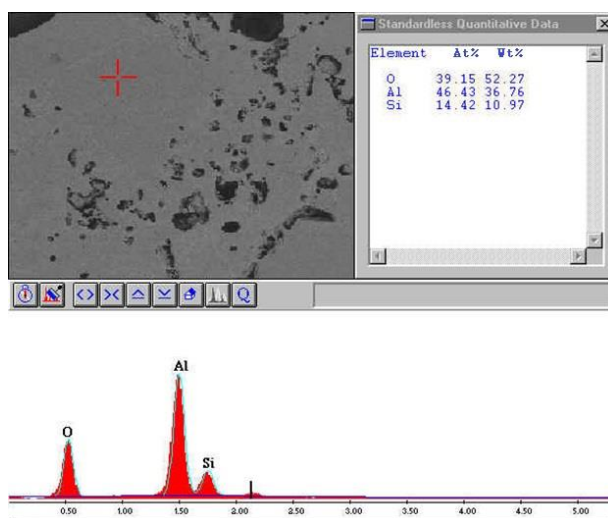
Figure 6. EDS point analysis of the idiomorphic grain

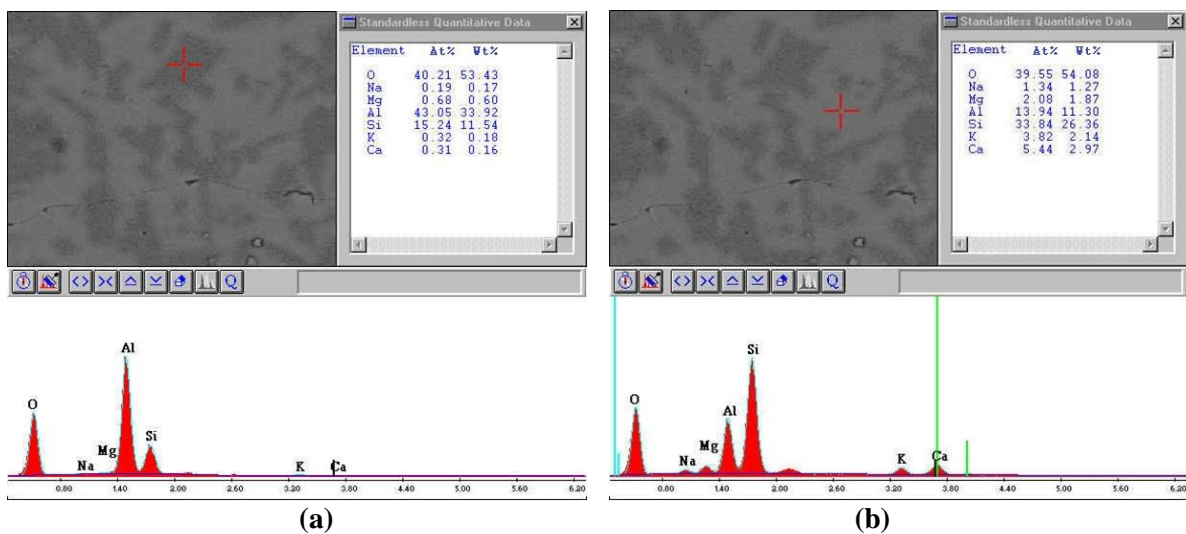
Figure 8. (a) The EDS point analysis of the dark gray portion of the matrix, (b) The EDS point analysis of the light gray portion of the matrix

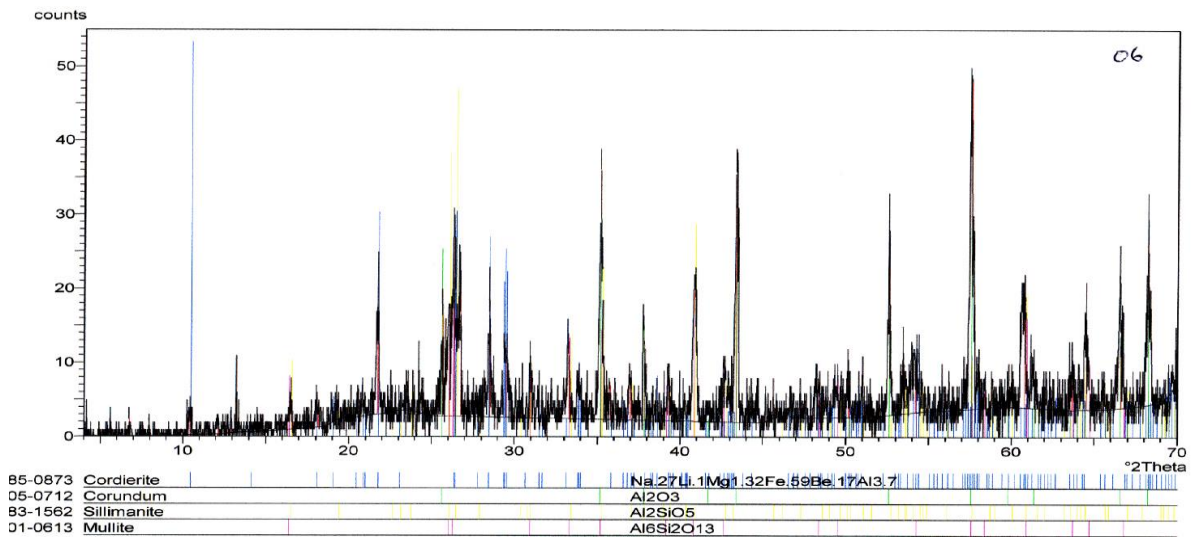
The XRD diffraction pattern of the unused refractory brick of the same type of the analyzed corroded brick is given in Figure 9. The major crystal phase was mullite with minor amounts of corundum and trace amounts of sillimanite and cordierite. The increased ratio of mullite to alumina in comparison to the corroded brick provided evidence of the higher dissolution rate of mullite with respect to alumina.

Figure 9. The XRD pattern of the unused refractory brick (GS-M-Unused)

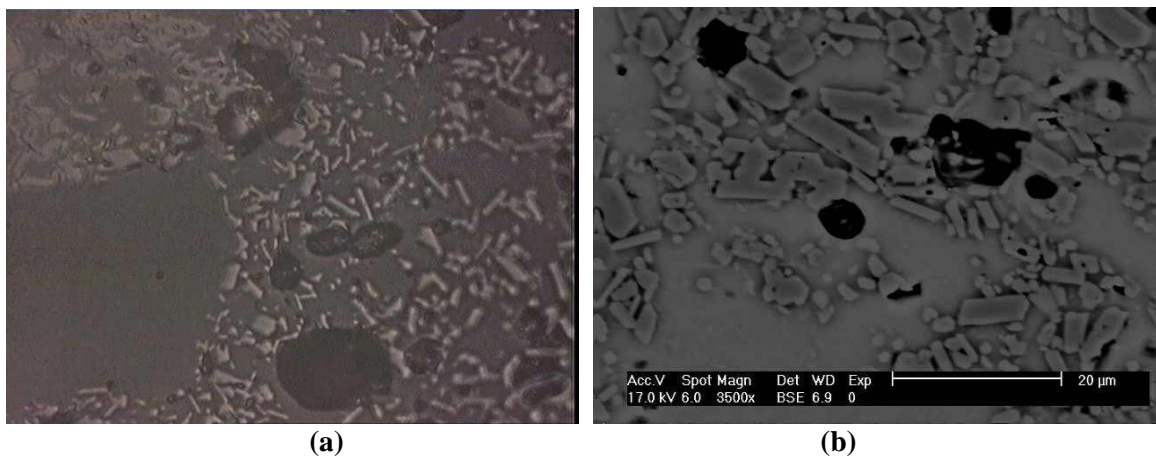
The RL-OM and SEM images of the unused brick are shown in Figure 10a and 10b. The EDS analyses results are given in Figure 11. The crystals of approximately 7 µm size embedded in the matrix were determined to be alumina (Figure 11a). The surrounding matrix was found to be of glass structure incorporating mullite crystals (Figure 11b) deduced by stoichiometric considerations. The EDS analysis of the grain inside the structure revealed that it comprised a mixture of corundum, mullite and glass. The small quantity of polyvalent elements Fe and Ti might cause first push exudation during the initial heating of the furnace leaving behind a porous structure as was the case of corroded brick. The lower porosity of the unused brick as compared to the corroded brick supported the exudation mechanism.

Figure 10. (a) RL optical microscope image of the unused refractory brick (1500x). (b) SEM image of the unused refractory brick

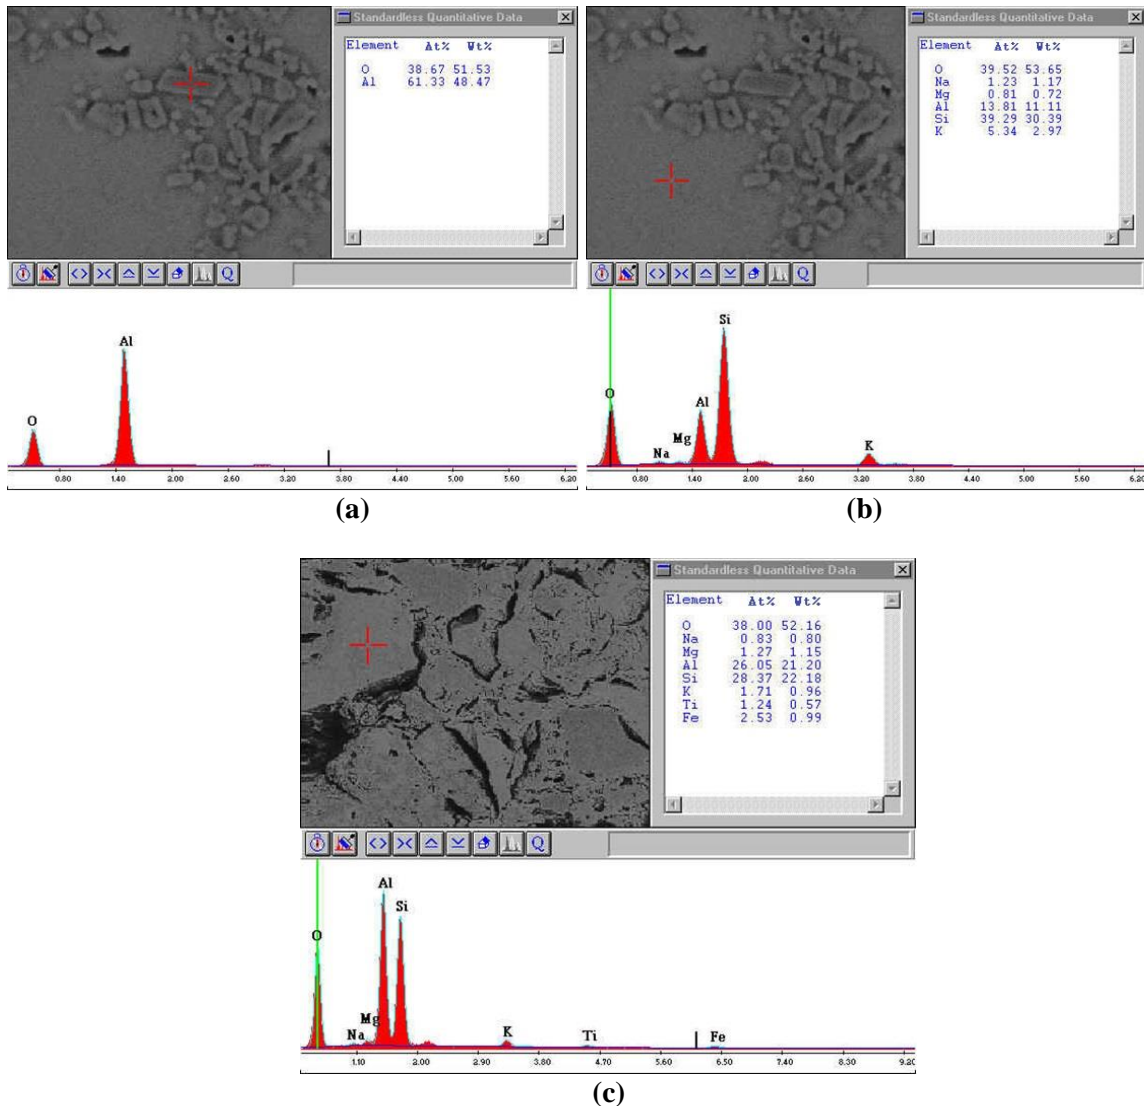
Figure 11. (a) EDS analysis of crystals of size ~ 7 μm embedded in the matrix of the unused refractory brick (b) EDS analysis of the glass matrix of the same unused refractory brick, (c) EDS analysis of a large grain in the structure

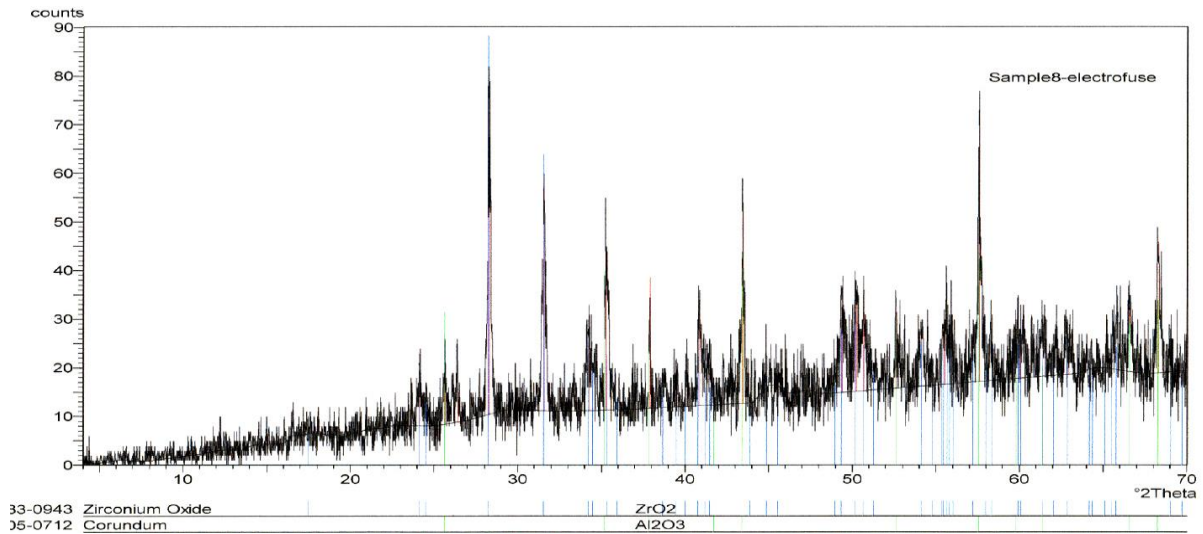
The XRD pattern of the corroded electrofused cast AZS block showed that the only crystal forms comprising the refractory were ZrO_2 and corundum (Figure 14). This might point out to the possibility that the amount of mullite crystals was too low to be detected by the XRD.

Figure 14. XRD pattern of the corroded electrofused cast AZS refractory

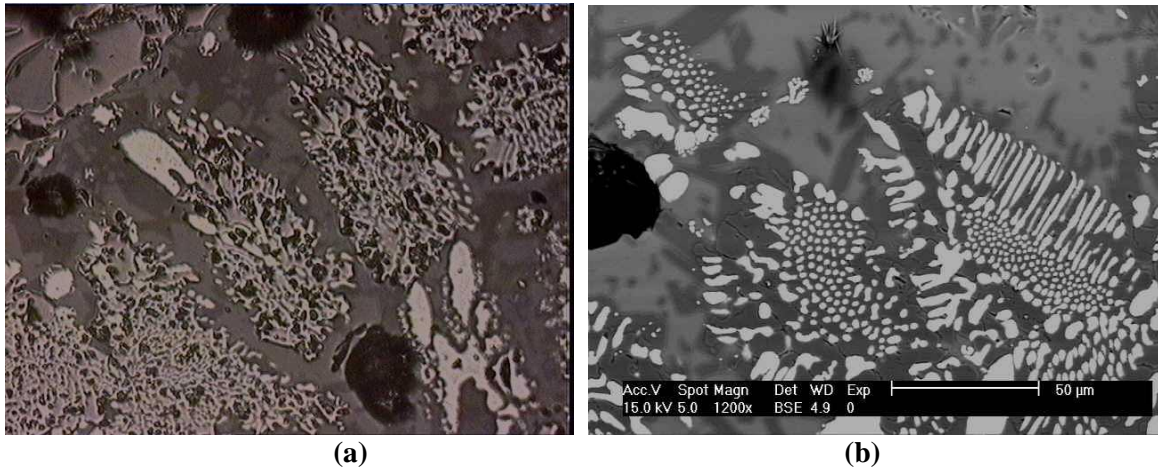
The microstructural analysis of the corroded electrofused cast AZS brick (GB-AZS) was carried out by RL-OM and SEM-EDS analyses. The related images are shown in Figure 15a and 15b. Although the grain structure of the molten glass interface was different from the relatively unaffected bulk, it was not possible to detect any freeze plane. The examination of the interface did not show any solid product accumulation, evidencing the direct dissolution mechanism.

Figure 15. (a) RL-OM image of the electrofused cast AZS refractory, inner bulk, (b) SEM image of the same refractory, inner bulk

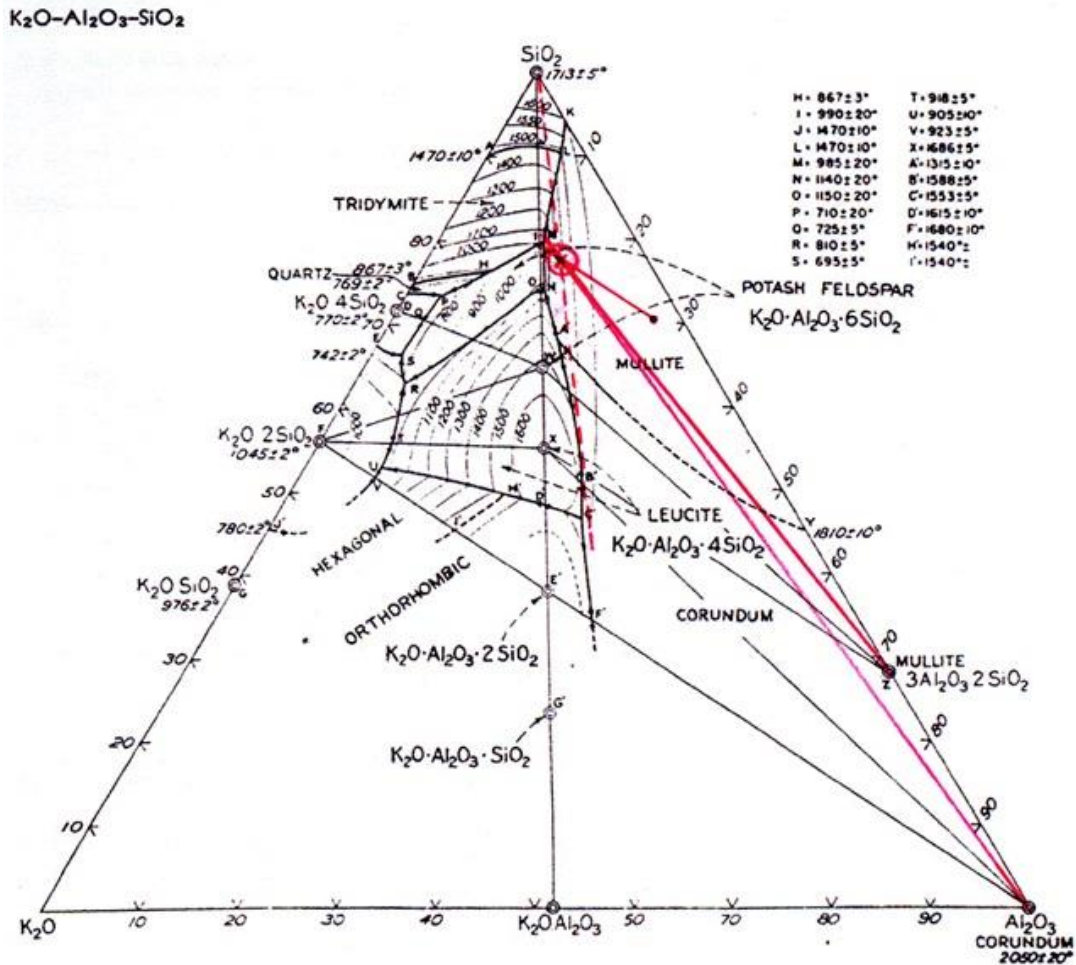
In the examined GS-M refractory the most abundant compounds were that of Al_2O_3 , SiO_2 , and K_2O . Therefore, by predicting the effect of the molten glass on these compounds by the use of the ternary phase diagram of $K_2O-Al_2O_3-SiO_2$ given in Figure 17, it would be possible to predict the corrosion behavior of the refractory in the molten glass environment.

Figure 17. System K₂O-Al₂O₃-SiO₂ [21]

The liquidus temperature for the transparent-1 molten glass composition which is in the primary crystallization field of mullite is 1340°C. Between 1040°C to 1340°C mullite will be fused from the refractory. Between the eutectic at 1000°C to 1040°C mullite and tridymite (SiO₂) will be fused together. At 1000°C potash feldspar (K₂O.Al₂O₃.6SiO₂), tridymite, and mullite fuses to the molten glass. Corundum in contact with the given molten glass will fuse at 1050°C. Only SiO₂ can survive before fusing slightly over 1600°C. The glassy phase of the refractory, the EDS analysis of which is given in Figure 8b, had the relative composition of 3.1 % K₂O, 26.3% Al₂O₃, and 70.6% SiO₂. Alarmingly, this composition is in equilibrium with the molten glass at slightly lower than 1000°C.
