## Performance of structures in İzmir after the Samos island earthquake

### Abstract

The October 30, 2020 Earthquake caused unexpectedly significant damage in İzmir considering its distance to the city. This paper evaluates the recorded ground motions, summarizes the performance of structures affected from the earthquake with emphasis on the reasons of damage. A detailed damage assessment was carried out by the Earthquake Engineering Research Center of Middle East Technical University to compile data on the damage of RC and masonry buildings. It was observed that majority of the damage was concentrated in the Bayraklı district due to its peculiar soil properties where many 7–10 story mid-rise RC buildings suffered heavy damage and collapse. The level of amplified ground motions combined with deficiencies of apparently non-code compliant buildings exacerbated the damage. The main reasons of damage were mainly attributed to the presence of soft stories, lack of proper detailing, poor construction quality, presence of heavy overhangs, and hence significant lack of code-compliance in essence. The influence of infill walls on seismic performance of deficient and inadequate buildings w

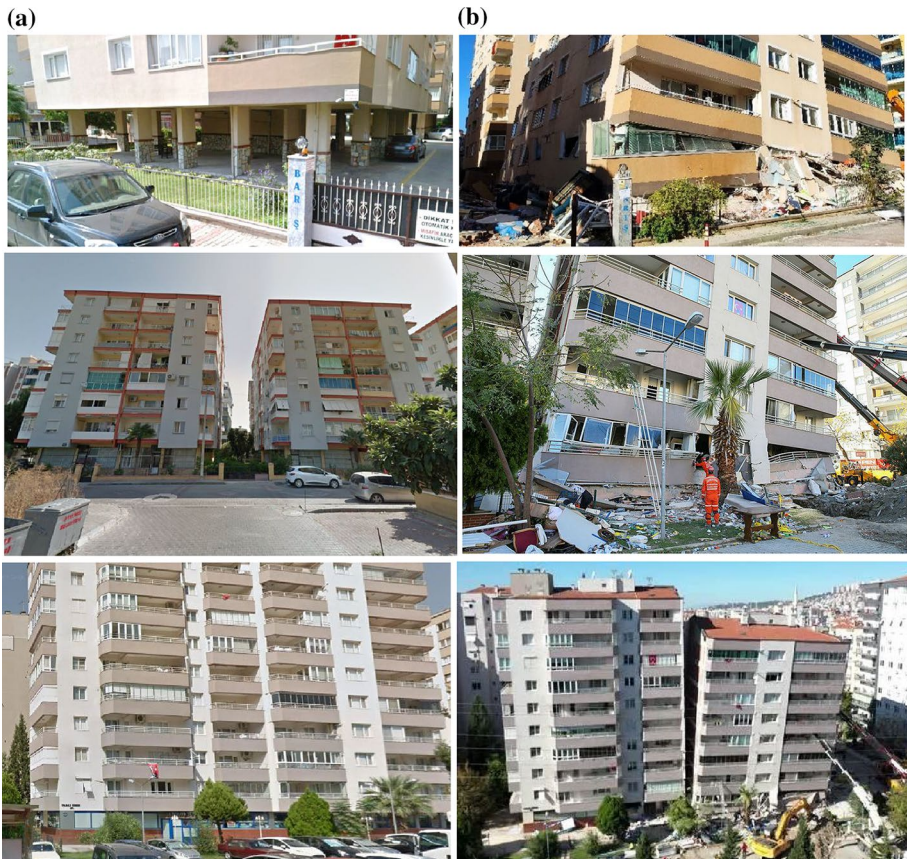
A number of buildings suffered severe damage or partial collapse at their first stories due to the presence of soft story (Fig. 7). A typical feature of the buildings in Turkish city centers is the presence of commercial space at the ground levels. In order to create wider space, infill walls are generally removed in these stories where the seismic demands are maximum. In addition, poor beam-column connections and the presence of weak columns are the key reasons for the development of soft-story mechanisms. The conditions of some example buildings with soft story feature are shown on the left column of Fig. 7 before the earthquake, their performance after the earthquake is shown on the right column of the figure. Due to the soft/weak stories, building collapses occur partially in the ground floor in some cases, whereas total collapse was observed in some other buildings. This is a very common type of failure frequently observed in many recent earthquakes [Elazığ 2020; Van 2011 (METU 2011); Bingöl 2003; İzmit 1999 (Scawthorn et al. 2000)]. The soft story feature does not always imply poor performance but it is clearly a damage exacerbating feature of deficient RC buildings in Turkey.

**Fig. 7** Failure due to soft/weak story. **a** Before the earthquake (left), **b** after the earthquake (right)

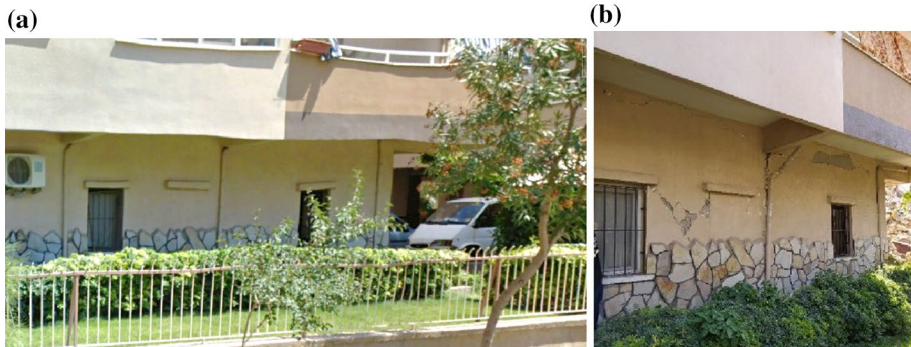
**Fig. 9** Contribution of infill walls. **a** Before the earthquake (left), **b** after the earthquake (right)

can be viewed as a striking example of the “unintended” benefit of infill walls contributing to lateral stiffness, strength, and axial capacity.

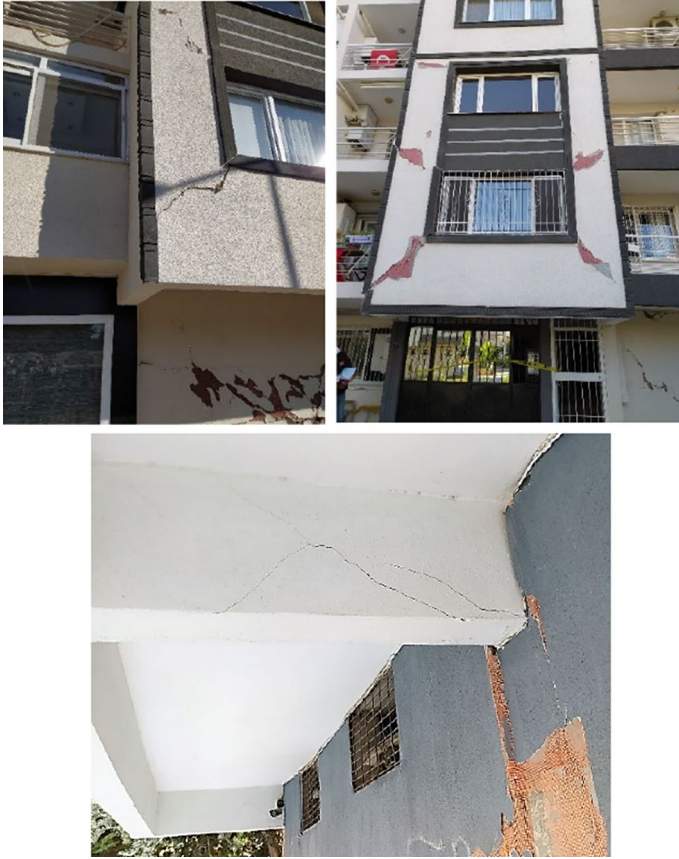
The footprint area of buildings and the upper floor plan areas are significantly different in some of the buildings due to the presence of overhangs. These cantilever overhangs can be excessive, at the order of few meters, and prematurely crack under the weight of the exterior walls carried by the overhangs. Figure 10 shows wall cracking, and severe damage at the corners of heavy overhangs. Damage in heavy overhangs is not only limited to the partition walls, but also exist in the structural system. Flexural and shear cracks (residual crack widths above 1 mm) were observed in the structural members connected to these overhangs (Fig. 10). It is interesting to note that such localized damage in the overhangs resulted in unreparable damage due to residual lateral and vertical deformations reaching substantial cantilever tip settlement; hence these buildings could not be re-occupied. The damage observed in overhangs, cantilever connections and ground floor columns in some buildings did not directly lead to structural collapse, but prevented re-occupation, hence leading to demolition. The effect of these overhangs on the continuity of frames and lateral load path needs to be considered as part of the design. It is also noteworthy that except the most recent one (TBEC 2018), previous Turkish seismic codes did not require consideration of vertical ground motion for such overhangs.

**Fig. 10** Damage in overhangs

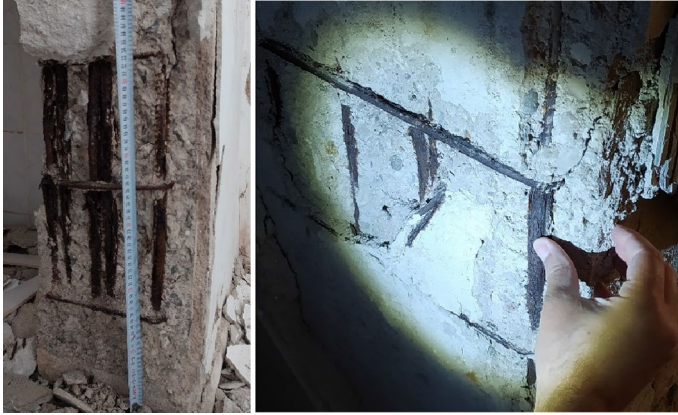
Our investigations revealed that corrosion in reinforcement is a widespread problem in İzmir due to high humidity levels (Fig. 12). Excessive corrosion was especially observed at the bottom of columns in the basement or ground floors. Loss in the cross-sectional area of reinforcement due to corrosion was significant in some instances, reaching the ratios of 25–65%. In certain cases, the earthquake appeared to have triggered spalling in columns that made the corrosion visible whereas in most other cases the level of corrosion was so high that it was clearly seen in the buildings that had no structural damage. The critical problems associated with corrosion in the building columns are reduced moment and

shear capacities due to loss of bond strength, and concrete spalling leading to premature rebar buckling. Hence, addressing problems related to corrosion detection and protection remains critical for seismic risk reduction in regions with high water table level.

Fig. 12 Corrosion induced damages

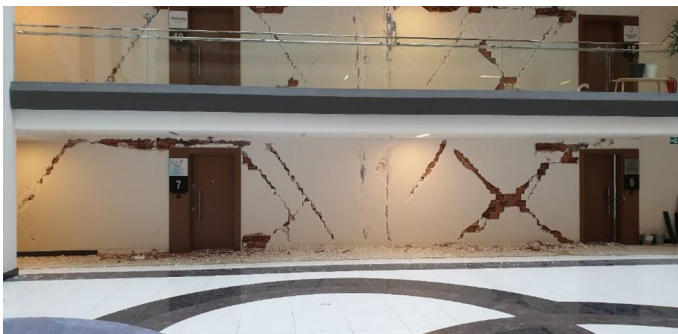
Fig. 13 Non-structural damage in infill walls due to large openings in the slab

and poor design led to excessive drift of office areas, and the infill walls around offices suffered heavy damage. This observation emphasizes the importance of considering slab discontinuity and developing proper load transfer mechanisms to the shear walls. Several other examples of such behavior were observed in the city.

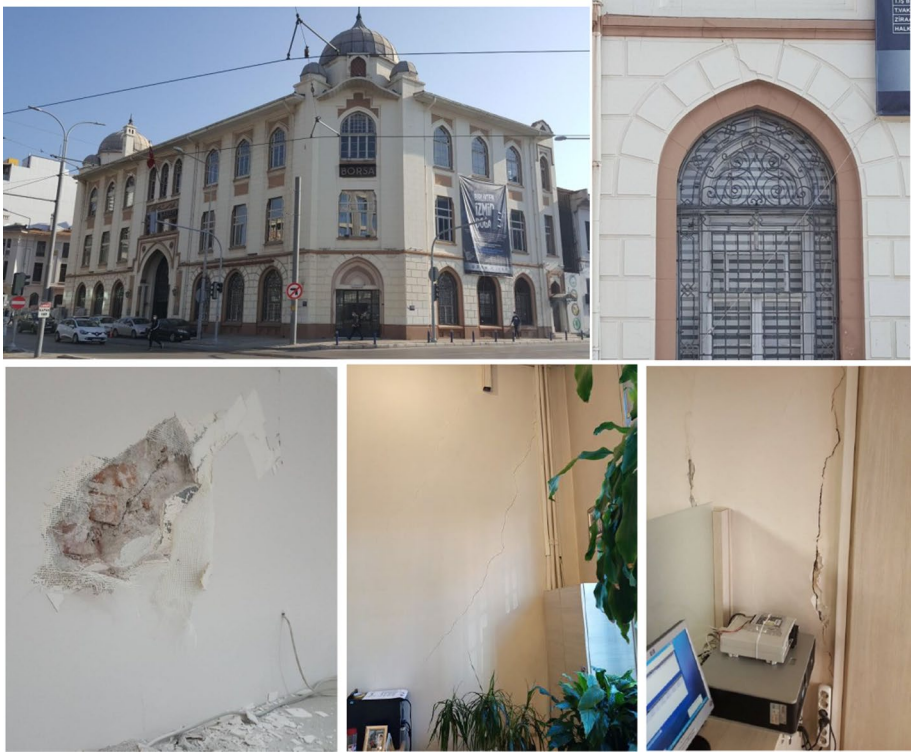
In general, previously renovated historical structures exhibited adequate performance but a few suffered damage. Some early twentieth century structures and historical mosques belong to this class. The İzmir Commerce Building which had a basement and three floors built in 1920's, sustained damage. It is originally constructed as a mixed masonry and reinforced concrete structure. The exterior façade of the building was built with stone-brick mix masonry walls, and the internal spaces were supported with RC frames. Later in its history, internal partial stories were added to the system with structural steel framing. An overview of the building and the damage it experienced from inside and outside are presented in Fig. 14 (Alkan 2020). The building suffered both structural and non-structural damage. Diagonal and vertical cracks in the walls imply that the capacity of these walls was exceeded. It is reported that the disruption of the original frame due to the partial stories added by dividing the stories with high headspace inside the building is the main cause of damage.

Fig. 14 İzmir commerce building: general view and observed damages

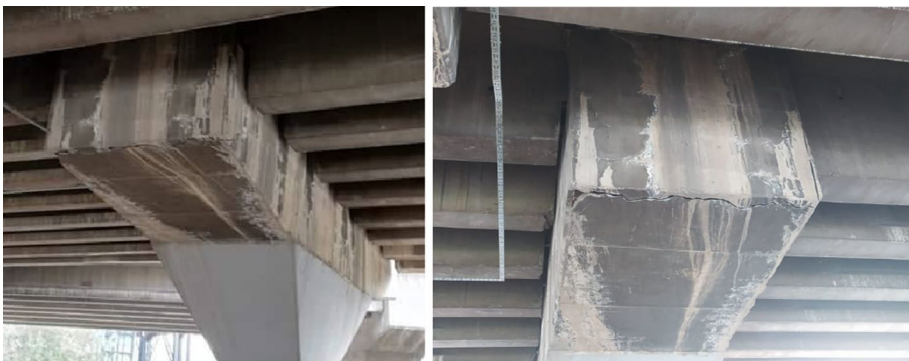
rupture or fracture was observed in non-structural bridge elements (precast panels, pedestrian railings, lighting poles, etc.). The earthquake performances of longitudinal joints between twin bridges were also satisfactory, and some small concrete pieces not more than 2–3 cm fell on the ground only at some local zones. After the examination of the superstructure and infrastructure of the bridges, no earthquake-related damage was detected. Bridges were available for use right after the earthquake. As a result, it was determined that bridges that performed successfully during the earthquake were serviceable without a need of emergency intervention (Fig. 19).

**Fig. 19** A typical before-and-after earthquake photo (December 2019 and November 2020)

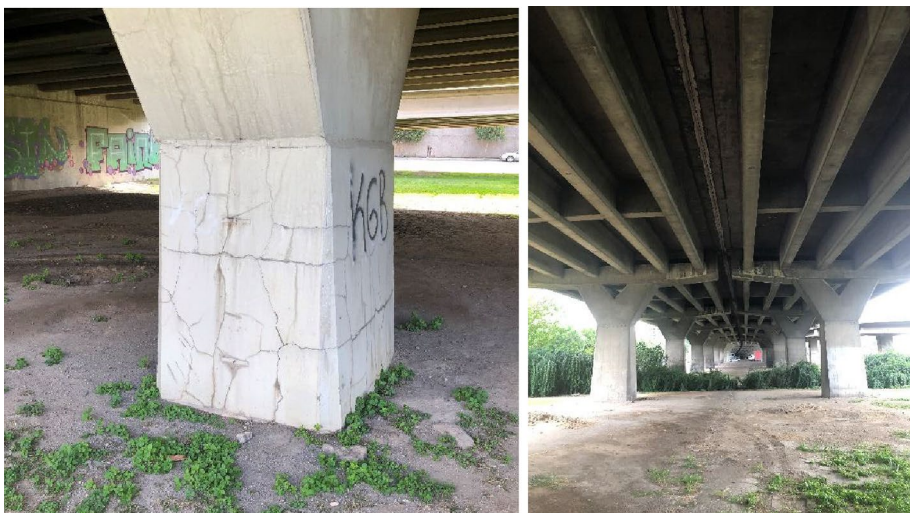
In some of the bridges, cracks, not due to the strong motion, were observed. Most of the cracks are pre-existing ones and were caused by rainwater and are ASR (Alkali-Silica Reaction) cracks, which are the result of a chemical reaction that occurred years ago in the bridge elements. No further opening of the cracks was observed after the earthquake (Fig. 21).

**Fig. 21** ASR based cracks (non-seismic) and general view
