A survey of damage observed in Izmir due to 2020 Samos-Izmir earthquake

An earthquake of magnitude 6.9 hit the city of Izmir (Turkey) on 30 October 2020, resulting in 117 deaths (in Turkey) and considerable economic losses. The earthquake also triggered a tsunami. Following the earthquake, field surveys are being conducted in a *Covid-secure* way to study and document the damages caused. The earthquake caused significant damages to residential buildings mainly located in the district of Bayrakli and Bornova. However, no damages were observed in railway and roadway bridges or tunnels and that helped the rescue operations. The damages were mainly structural which included the so-called pancake collapse (where the entire building collapsed) and soft storey type collapse (weak storey characterised with weak columns collapsed), and in some cases, only the ground floor completely collapsed. Due to the proximity of the epicentre and the geology of the area, it seemed that the ground motions were amplified. This technical note provides a summary of the seismological and recorded ground characteristics of the earthquake together with the lessons learnt.

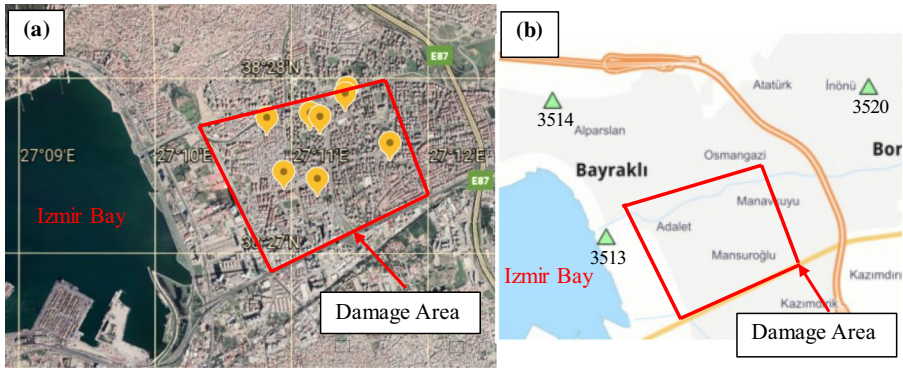
Most of the heavy structural damages to the residential buildings occurred in the district of Bayrakli. The yellow balloons on the map in Fig. 11a show the locations of the collapsed and heavily damaged buildings in Bayrakli. The red lines in Fig. 11 a and b show the area of the damaged buildings in the region. Three accelerometric stations exist in Bayrakli and they are numbered as 3513, 3514 and 3520 as seen in Fig. 11b. The average shear wave velocity in the top 30 m depth (V_{s30}) in the region of the stations are 196 m/s, 836 m/s and 875 m/s, respectively. The distance between the earthquake epicentre and #3513 accelerometric station is 72 km. The ground profile underlying the collapsed and heavily damaged buildings in Bayrakli is similar to that underlying the #3513 station and is composed of alluvium deposit with thickness varying between 80 and 300 m. The alluvium stratum includes layering of soft clay with an average plasticity index (PI) of 30 and silty sand. The groundwater level is close to the earth surface (1–3 m) (Gazi University 2020).

Fig. 11 **a** The map showing locations of collapsed and heavily damaged building in the region of Bayrakli and **b** a map showing the locations of accelerometric stations in the region of Bayrakli

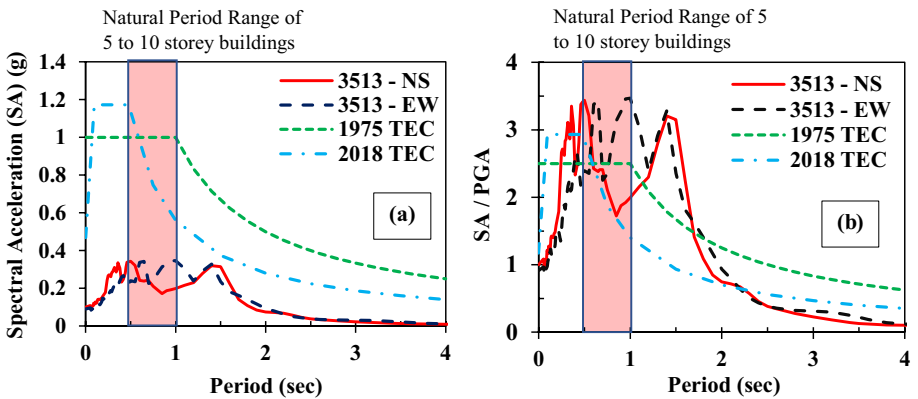
Fig. 14 **a** 5% damped elastic acceleration response spectra for records at the station numbered 3513 within Bayrakli region with the corresponding ones for the 1975 Turkish Earthquake Code (TEC 1975) and the current version of Turkish code (TEC 2018) **b** Normalized acceleration response spectra for station 3513 within Bayrakli region with the corresponding ones for the 1975 Turkish Earthquake Code (TEC 1975) and the current version of Turkish Earthquake Code (TEC 2018)

Earthquake Code with 5% damped elastic acceleration response spectra for records at the station numbered 3513 within Bayrakli region for NS and EW directions. The 1975 Turkish Earthquake Code (TEC 1975) is included in the graph as the heavily damaged buildings were designed and built by considering this earthquake code. The soil type encountered at the site is classed as IV b in the 1975 Turkish Earthquake Code. As mentioned, the latest

2018 version of the code (TEC 2018) is also included in the graph where the soil type is assumed as ZD (similar to Class C soil in Eurocode 8 (EN 1998–1 2004) and design earthquake of DD2 (Return Period of 475 years or 10% chance of exceedance in 50 years). It is important to note that the spectral ordinates of recorded horizontal ground motions (3513 NS and 3513 EW) are below the ordinates elastic code spectrums proposed in 1975 and 2018 (TEC 1975; 2018). This observation is inconsistent with the extent and the degree of structural damage reported. Thus, severe structural damage may have been occurred due to other factors such as poor construction quality, non-compliance with legislation and modification of the structural system. These factors will be discussed in detail in Sect. 5.

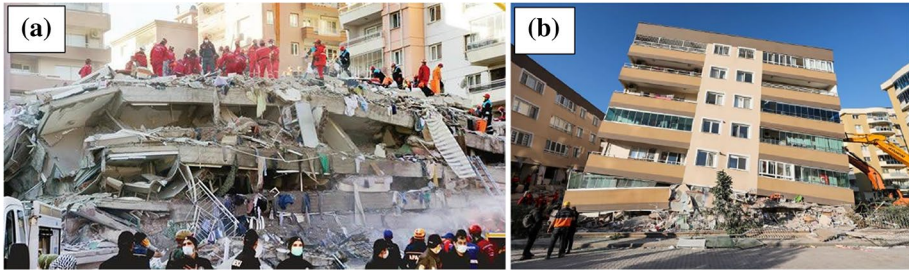
Many residential buildings in the district of Bayrakli were heavily damaged and collapsed due to the 2020 Samos Earthquake. The damaged buildings in the region were 5 to 10 storey buildings and were older than 30 years. It can be assumed that the heavily damaged buildings were designed and constructed following the 1975 Turkish Earthquake Code (TEC 1975). The patterns of building damages are pancake collapse (total collapse) and ground floor failure (partial collapse) as seen in Fig. 15a and b. A similar failure of pancake collapse was also observed in the 1999 Kocaeli (Turkey) Earthquake and the 2011 Van (Turkey) Earthquake reported by Erdik (2000), EEFIT (2003) and Erdik et al. (2012). It was noted that there are many buildings with no significant structural damage in the neighbour of heavily damaged buildings. However, some cracks were noted in the non-structural walls (Fig. 16a and b).

Fig. 15 **a** Pancake collapse, **b** Ground floor failure (<https://www.aa.com.tr/tr/pg/foto-galeri/izmir-depremi/0>)

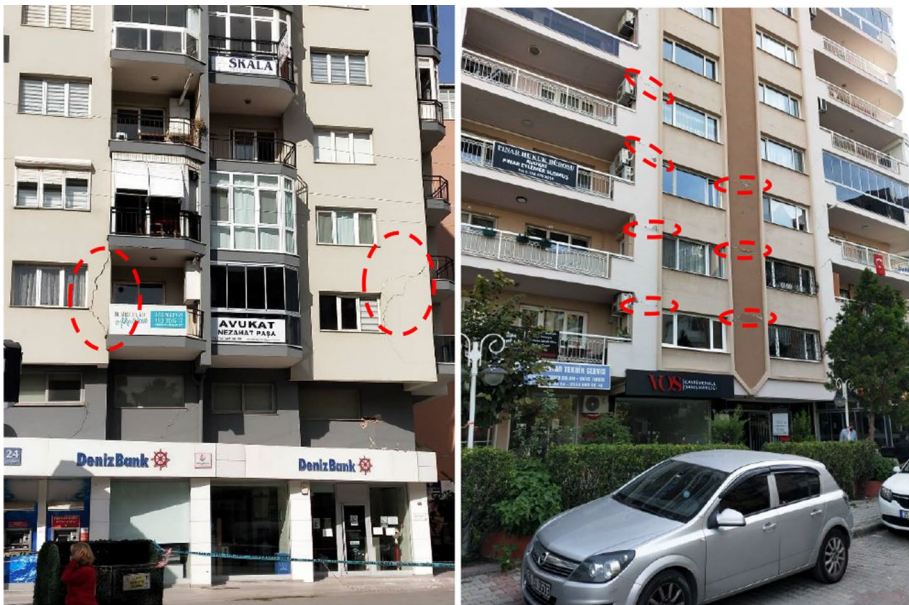
Fig. 16 Cracks in the non-structural walls due to the earthquake (wall cracks are shown with red dashed circles)

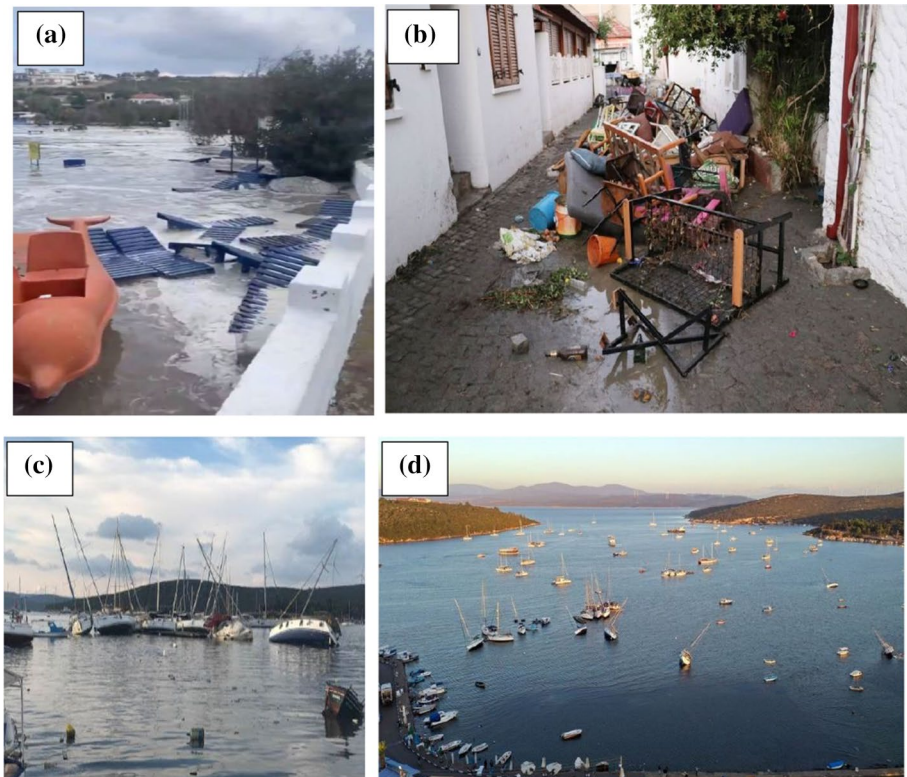
The earthquake caused a tsunami which damaged some structures on the shore between the town of Akarca and Sigacik. The wave generated was 2 m and it travelled approximately 800 m towards the land. The tsunami caused many damages such as floating piers were dragged, (ii) some of the boats in Sigacik port overturned and submerged, and (iii) many buildings, shops and cafes on the shore were damaged (Gazi University 2020 and Izmir Institute of Technology 2020). Various damages associated with the tsunami are shown in Fig. 17a-d.

Fig. 17 **a** Sea level raised at a beach in Sigacik, **b** many tables and chairs in cafes and shops were dragged, **c** many boats overturned and submerged in the port of Sigacik, **d** a photograph showing the port of Sigacik (<https://www.aa.com.tr/tr/pg/foto-galeri/izmir-de-deprem/0>)
