## Dampness Problems in a Historic House in İzmir, Turkey

## DAMPNESS PROBLEMS IN A HISTORIC HOUSE IN İZMİR, TURKEY

*The study, as a preliminary stage of the restoration work of a historic house from Levantine ages of İzmir in the nineteenth century, involves the examination of the dampness basement problems. Moisture contents and temperature of the wall surfaces were monitored by non-destructive techniques, such as direct measurements of electrical conductivity and infrared thermography. The results were evaluated in the light of physical properties, moisture, and soluble salt types and contents in the materials, outdoor, and indoor climatic conditions, layout of the site, and architectural features of the building. In addition to rising damp and lack of sufficient ventilation for years, some faulty details along the intersections with the terraces of the neighbor buildings, and intersection with the asphalt coated street and the basement windows that gave way for rainwater leaks were the other sources of dampness. Some cool but relatively dry parts of the walls were found to be potential zones for dampness problem through condensation between midnight and early mornings, especi

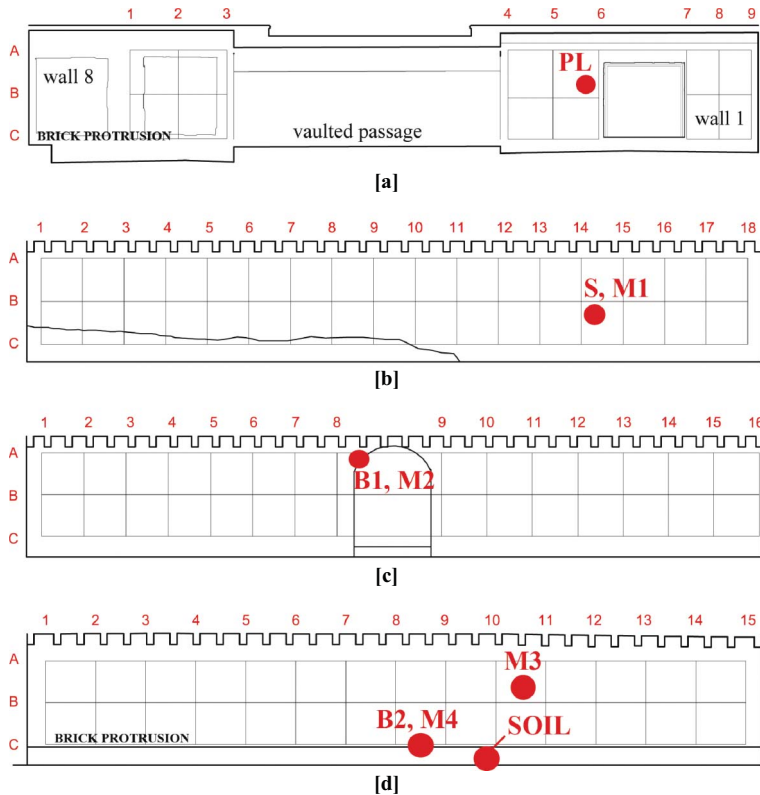
**Figure 7.** Illustration of the material sample collection: A) walls #1 and #8, B) wall #2, c) wall #4, and d) wall #7 (PL, plaster; S, stone; B, brick; M, mortar) (figure is provided in color online).

**3.3.1. Moisture and Water-Soluble Salt Contents of the Materials** Soluble salt content of the materials increased with their moisture contents which were calculated by their wet and dry weights. The highest amount of moisture and salt content was found in the soil sample. It was followed by the moisture and salt contents of brick (B2) and its jointing mortar (M4) from the foundation-like brick bonds protruded from the lower part of the rubble masonry wall #7 (Figures 6, 7D, and 19).

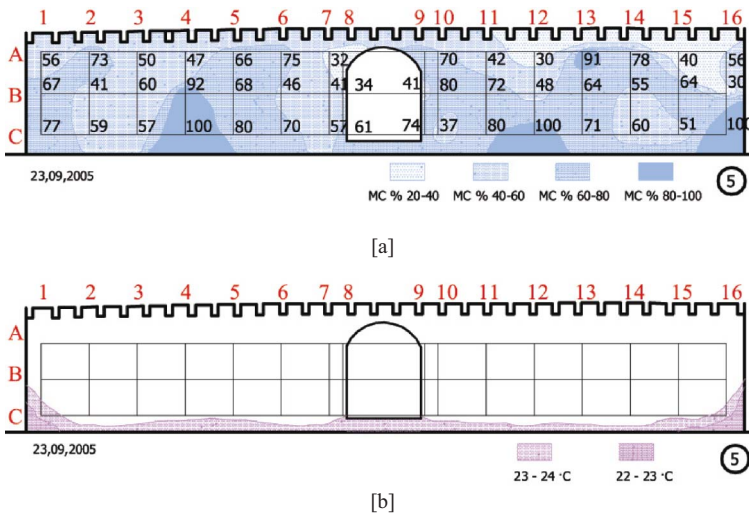
**3.2.2. Moisture Contents and the Surface Temperatures of the Walls** Regarding moisture content measurements and IRT scanning results are concerned, most of the moisture seemed to be raised from the ground (Figures 13 and 14). In addition to the dampness from the ground, the rain water penetration caused by the rainfalls on September 17, which was proven by the wet beams that appeared on the IRT image,

Figure 13. A) moisture and B) thermographic map of the wall # 5 indicating rising damp (September 23, 2005) (figure is provided in color online).

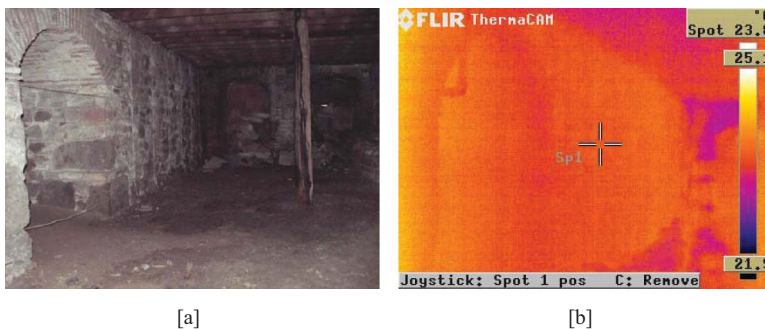
Figure 14. A) Photograph and B) infrared thermographic image of the wall #5 of the basement showing rising damp (September 23, 2005) (figure is provided in color online).

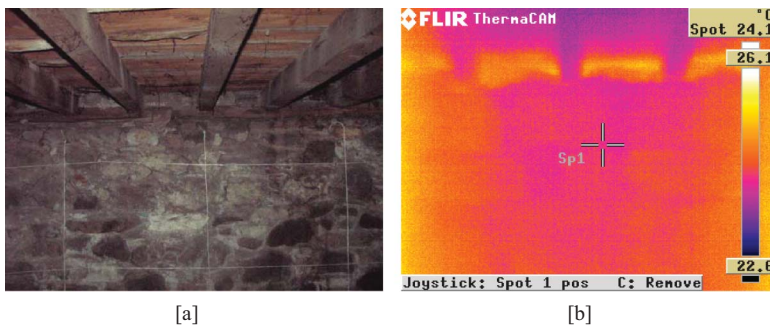
and rainfalls on November 25–27 seemed to affect the dampness that was detected by the survey on December 2 (Figures 15 and 16).

**Figure 16.** A) Moisture and B) infrared thermographic map of the wall #7 indicating cool zones (December 2, 2005) (figure is provided in color online).

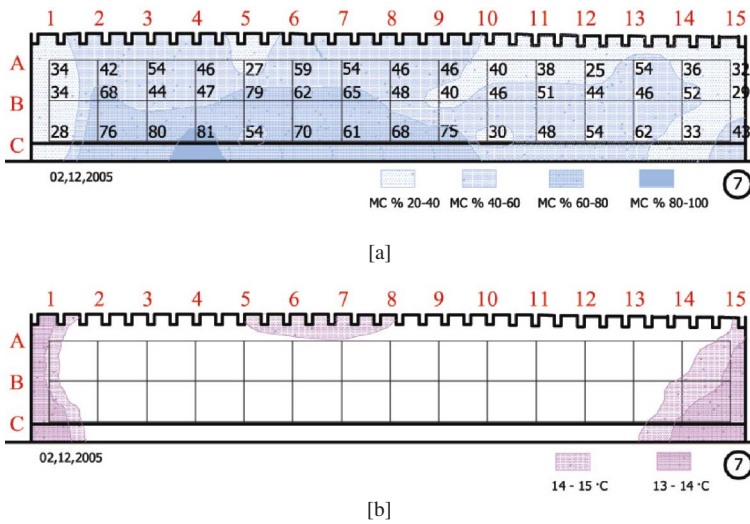
As it was explained in the evaluation of the outdoor and indoor conditions, condensation did not take place during the survey times. However, some cool but relatively dry zones are the indicative of the regions that are prone to condensation when the dew point temperature was reached and the relative humidity increased between midnight and early morning (Figure 17).

**Figure 17.** A) Moisture and B) infrared thermographic map of the wall #7 indicating cool zones (December 2, 2005) (figure is provided in color online).

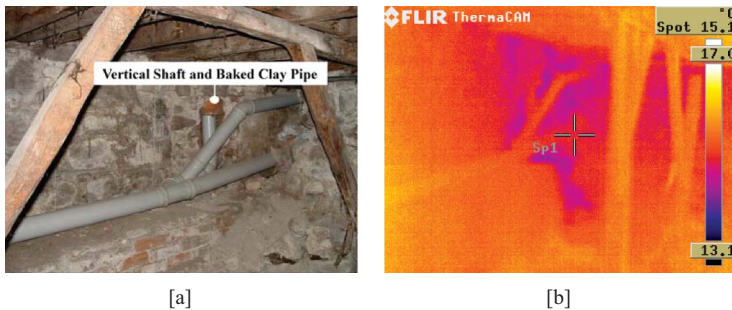
The cooling of these zones was likely caused by air flow through the gaps of the window sashes and the gaps at the upper edge of the masonry walls where the wood beams and planks of the ground floor rested. Such a cool zone was also observed around the vertical shaft through which the former baked-clay sewage disposal pipe passed (Figure 18).

**Figure 18.** A) Photograph and B) infrared thermographic image of wall #7, showing cool zone around the vertical shaft (December 2, 2005) (figure is provided in color online).

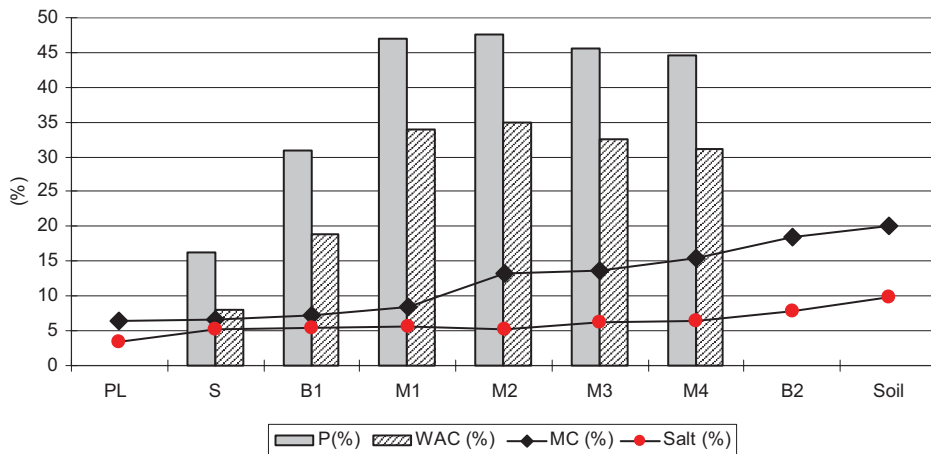
**3.3.3. Physical Properties of the Materials** The porosity values of the mortars varied between 48%–45%. The porosity of brick (B1) was 31%, followed by the porosity of stone (S), which was 16%, being the least. Parallel to the porosity values, water absorption capacity of the mortars varied within a small range, which was not more than 5% (Figure 19).

The comparison between the porosity (P), water absorption capacity and calculated-moisture content indicated to what extent the accessible pores of the materials were saturated with water. Following the soil sample, the brick (B2) and its jointing mortar (M4) both collected from the spots close to the ground had relatively higher MC and salt content, respectively. They were followed by the MC and salt content of the mortars of M3, M2, M1, brick (B1), stone (S) and plaster (PL) in descending order (Figure 19) as the heights of their collection spots from the ground increased (Figure 7). Indicating the reason and initial source of the

dampness, the existence of hygroscopic salts in the walls should also be considered as permanent moisture sources for the walls because they absorbed water from the ambient air which was almost permanent and usually high in the basement. However, as far as the long time of abandonment and inactive water and sewage disposal systems are concerned, such a rising trend in the calculated moisture and salt contents of the materials lead one to think of the possibility of water absorption from the soil ground at present besides the steady absorption from the humid air. Although the sampling, IRT and conductometric surveys were carried out at the surface and/or slightly deeper points from the surface of the walls, the similarity in the conditions of moisture content is probable in the depth of the walls when the long time of moisture absorption is considered.

**Figure 19.** Graph of the porosity (P), water absorption capacity (WAC), moisture (MC) and the water-soluble salt contents of the materials (S, stone; B, brick; M, mortar; and PL, plaster; B2, PL, and soil samples were analyzed only for their moisture and soluble salt contents) (figure is provided in color online).

- Causing damages in the fabric of the structures through efflorescence when dried, hygroscopic salts provided permanent source of dampness, thus, creating discomfort for the occupants. The salts must be removed with proper cleaning methods. If this approach is not practically possible, the salts must be isolated and kept in dry conditions by proper insulation details against moisture intake as much as possible.

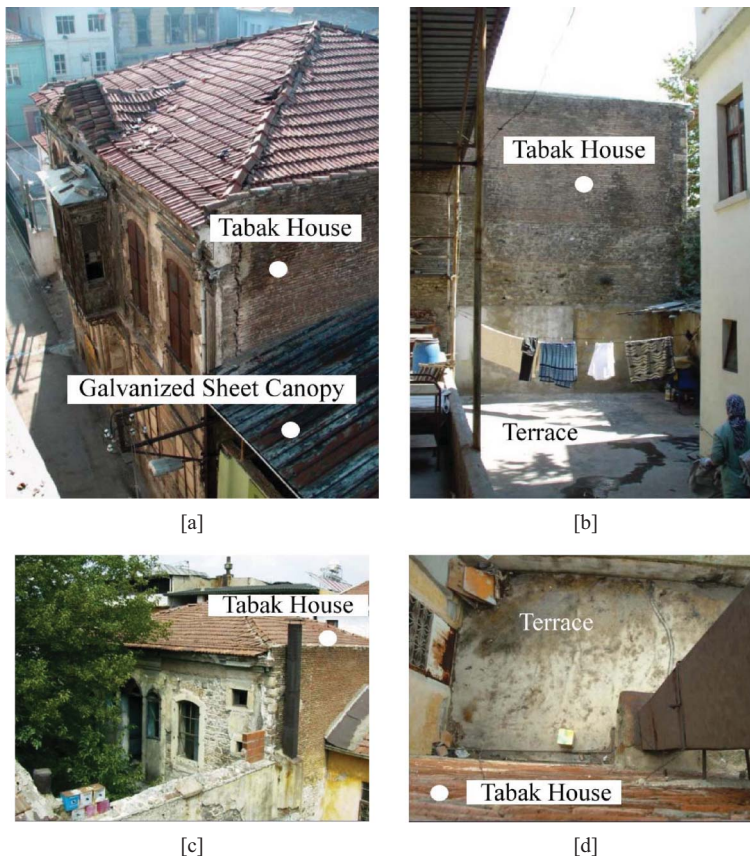
In addition, the north sidewall of the house was neighbor to a semi-open laundry and cloth-drying terrace used by Tan Hotel (Figure 3). The faulty details at the intersection of the north facade wall and the canopy (made of corrugated galvanized sheet which was fixed on steel pipes at the terrace), were the sources of rain water leaks and disposed water from cloth washing. The concrete floor slab of the terrace which was covered with screed without any water protection along the intersection line with the house was the second source of rainwater penetration on this side (Figure 20).

The situation at the south side of the house which was occupied by a leather workshop and its open terrace was similar to the situation described for the north side. The chimney fixed to the south wall of the house, and the intersection with the terrace slab and this wall without proper details seemed to cause water leaks into the house (Figures 3, 20C, and 20D).

**Figure 20.** Photographs of A) and B) the cloth-drying terrace view of Tan Hotel, C) the chimney, and D) the terrace of the leather workshop (figure is provided in color online).
