Structural Interventions for Conservation of the 15th Century Tahtakale Bath, Tire, Turkey

Abstract Tahtakale Bath, which is located in the town of Tire in the province of İzmir, Turkey, was constructed in the 15th century and is one of the outstanding existing examples of Ottoman period baths. The building, which was designed as a double bath, was considerably damaged because of inaccurate interventions after losing its original function, lack of maintenance and natural circumstances. The parts which were reused have considerably lost their original characteristics. This study aims to introduce the construction technique of Tahtakale Bath, which was studied in the scope of a restoration project, and to present the studies on the determination of structural problems, structural strengthening decisions and implementations.

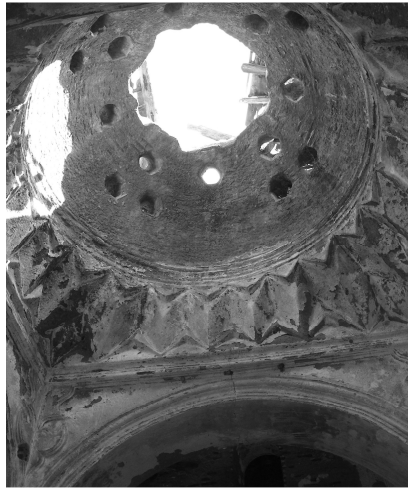
Figure 2: Damages on the domes

In the interior, partial collapses, which are thought to be formed when the building was used as storage, were observed on the upper parts of the domes of bathing spaces and warm area as a result of dilapidation, human intervention and rain penetration.

The rainwater, which penetrated through the partially collapsed domes and vaults of superstructure, caused mortar discharge in joints, partial losses and damages in the bonds of superstructure and walls as a result of freeze-thaw cycle (Fig. 2, Fig. 3).

The detached plaster layers were removed while the sound parts were conserved. The removed parts were rendered with hydraulic lime plaster. The finishing coat was applied on the conserved original plasters using hydraulic lime plaster. The brick-lime plaster was applied on the walls of water storage upto 1.20 m from the floor as in the original. The plaster used in the restoration works is composed of 1 part of hydraulic lime plaster readymade, 2 parts of washed sand and 1 part of powdered brick. The damaged parts of the transition elements were completed in their original forms by using hydraulic lime mortar (Fig. 6, Fig. 7).

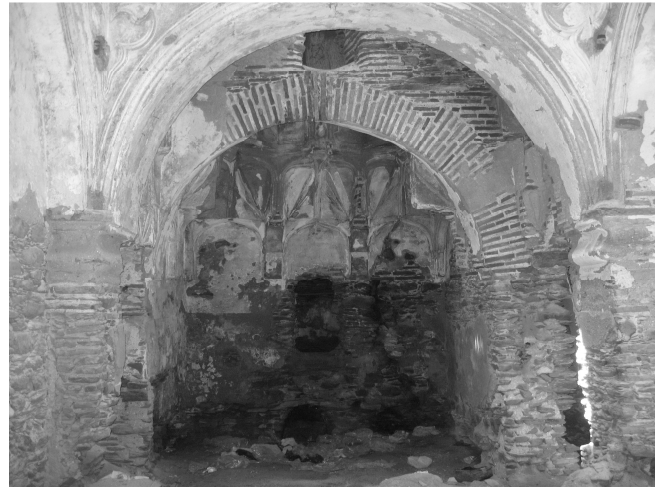
Figure 3: Damages on the walls of bathing spaces of men's section

On the other hand, the removal of floors for reuse, destruction of hypocaust and filling this space with earth caused rising damp problems in the building. It is observed from the damaged lower parts of the walls that the rainwater penetrating into the building accumulated on the floor and caused it to penetrate into the walls. There is loosening of the bonding system at the lower parts of the interior walls and damages on the corners of the walls (Fig. 3). The loss of original plasters were also observed

Deteriorated parts of the wall bonding such as disintegrating mortar, cracks in mortar joints, loose bricks or stones, were consolidated with hydraulic lime mortar, slate and brick material as in the original bonding system (Fig. 4). The mixture used in the filling of the wall pointing was prepared compatible with the original mortar and composed of 1 part hydraulic lime mortar, 1 part powdered and cracked marble and 2 parts washed sand.

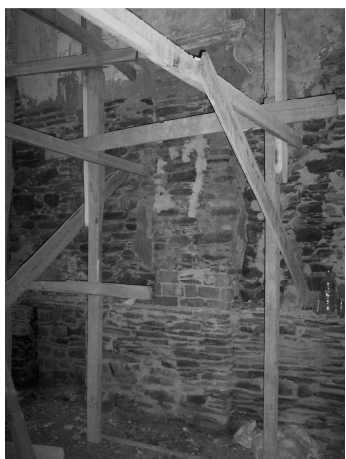
Figure 4: Restoration works on the walls of the bathing spaces

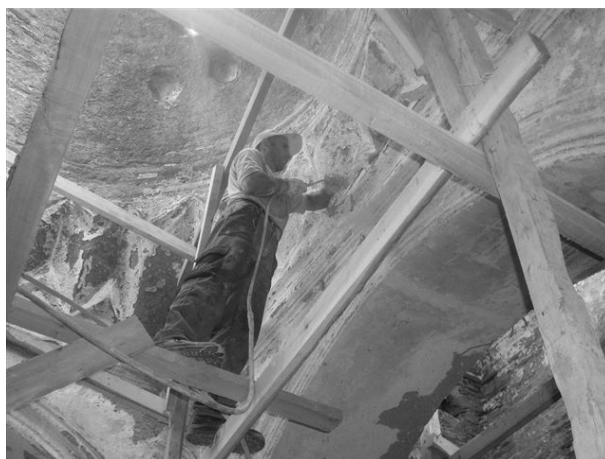
The tension cracks formed on the key section of the arches in the central area of bathing spaces are some of the crucial structural problems. These cracks are thought to be formed because of the load of additional roof.

Figure 5: The strengthening implementations on the arches with injection tubes

Cracked and broken terracotta water pipes were changed with the terracotta pipes in hexagonal form. Tensile cracks in the arches and the cracks in the transition elements were restored by injection method using hydraulic lime mortar. At first, the plasters in 25-30 cm range, around the cracks were removed and the interior parts of the cracks were cleaned. Injection tubes were placed into the interior parts of the cracks and filled with hydraulic lime mortar (Fig. 5). Finally, joints around the cracks were filled and the exterior parts were leveled.

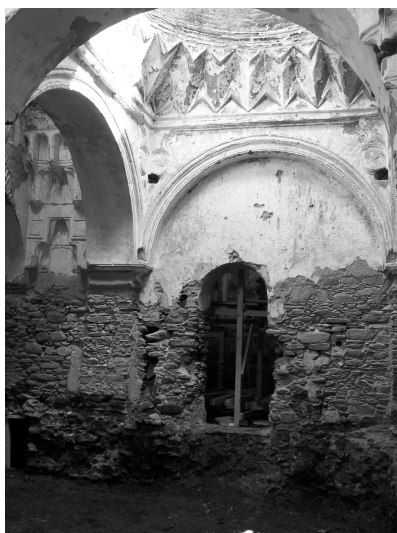
Figure 6: Bathing spaces before restoration

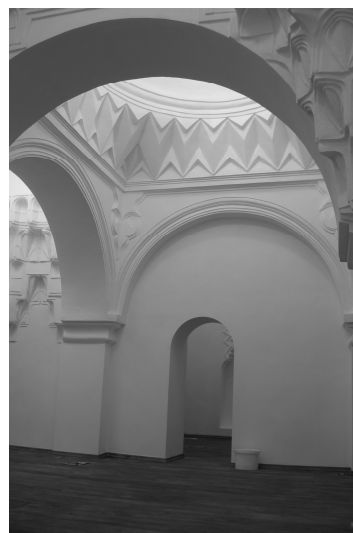
Figure 7: Bathing spaces after restoration
