**ARCHITECTURAL DESIGN CHARACTERISTICS
OF PROTECTIVE STRUCTURES AT
ARCHAEOLOGICAL SITES AND THEIR IMPACT
ON CONSERVATION OF REMAINS**

**A Thesis Submitted to
the Graduate School of Engineering and Sciences of
İzmir Institute of Technology
in Partial Fulfillment of the Requirements for the Degree of**

DOCTOR OF PHILOSOPHY

**by
Necmiye Funda YAKA ÇETİN**

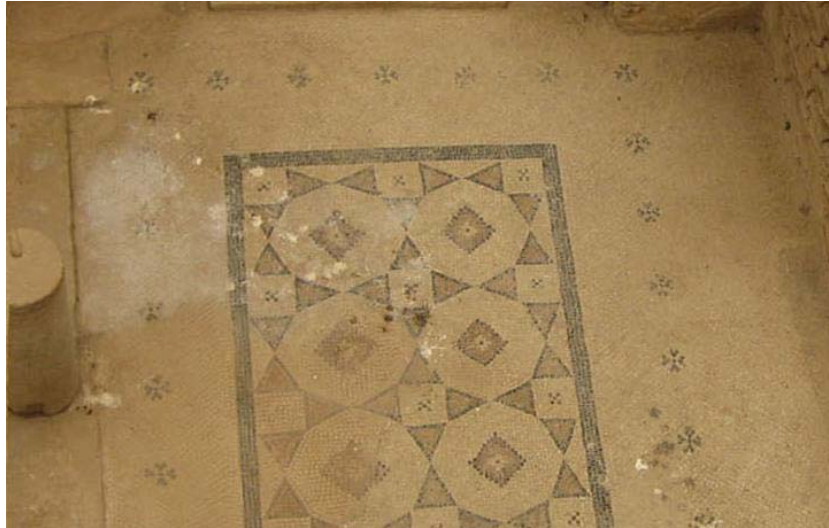
Figure 3. 1. Bird droppings on the mosaics.

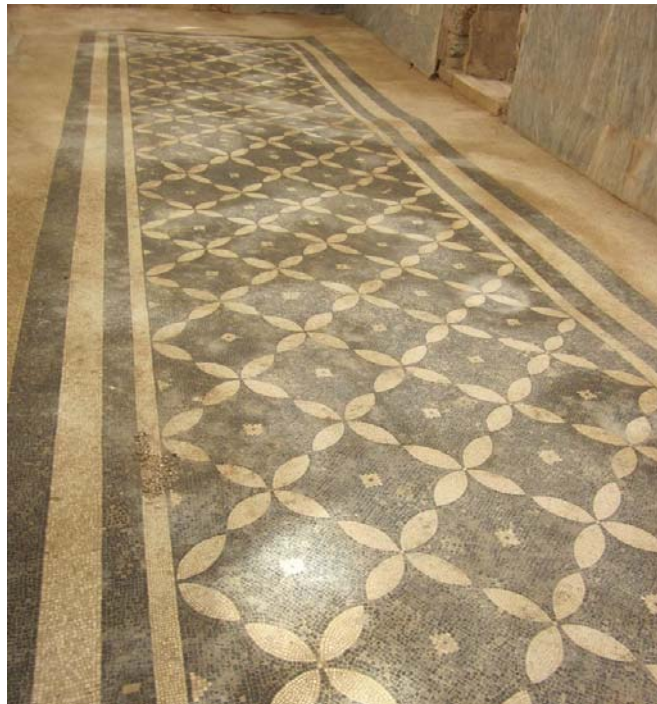
Figure 3. 2. Wetting of the mosaics due to rising damp.

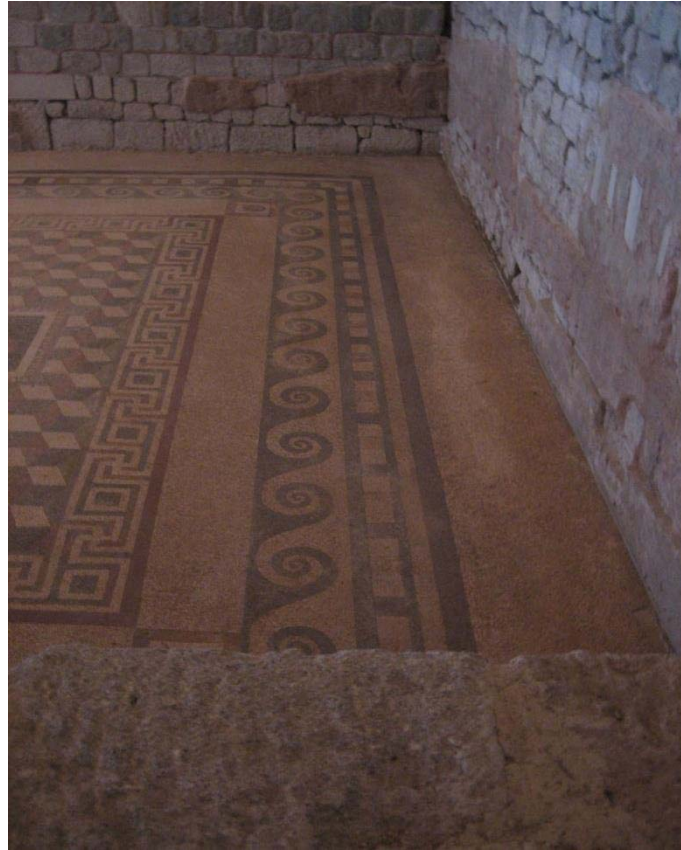
Figure 3. 3. Color alterations due to drainage problems.

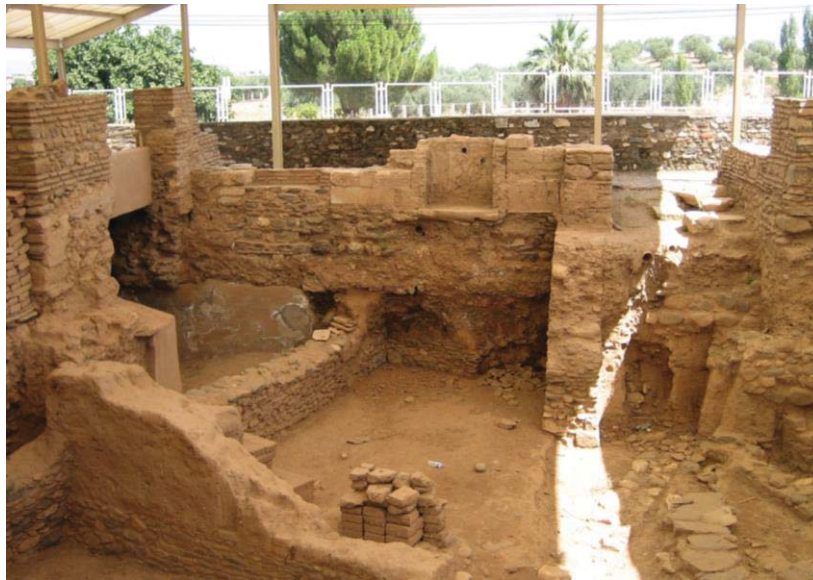
Figure 3. 4. Rising damp due to faulty gutter system.

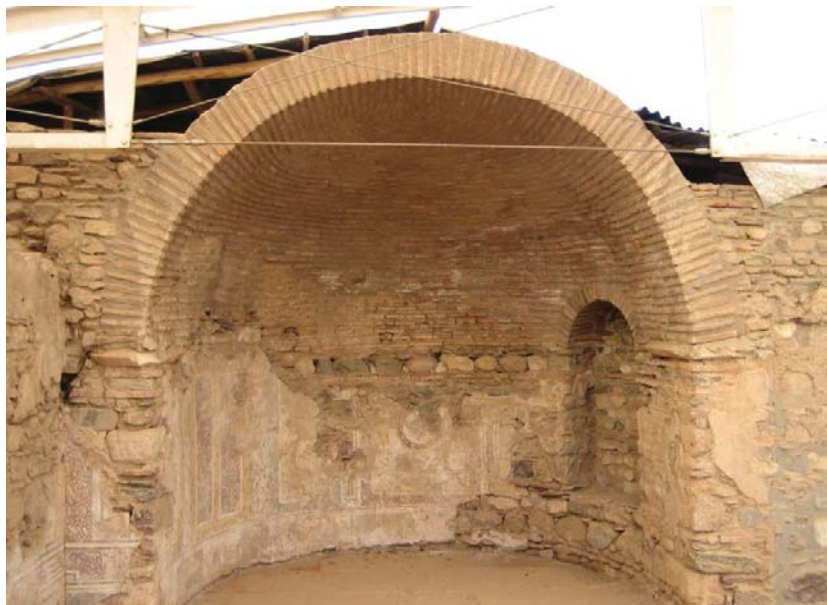
Figure 3. 5. Salt crystallization due to limited shelter area.

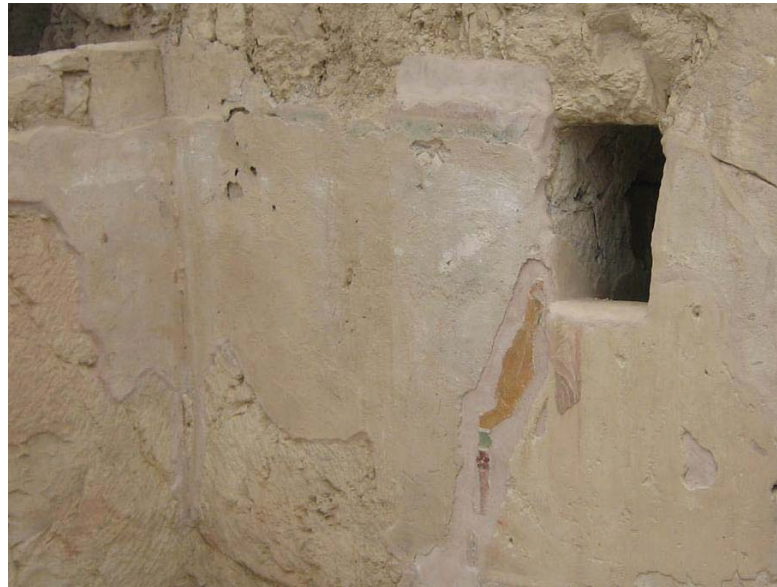
Figure 3. 6. Disintegration of plaster layers due to instable interior microclimate.

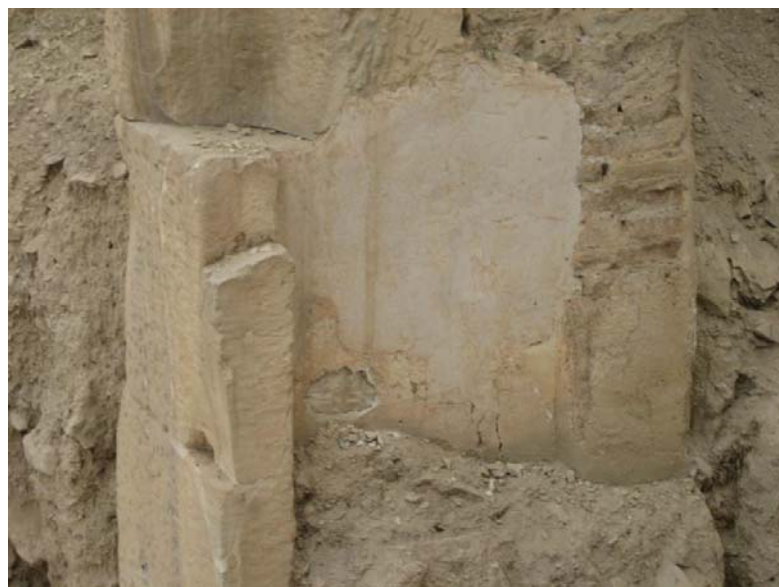
Figure 3. 7. Loss of plaster layers on the wall.

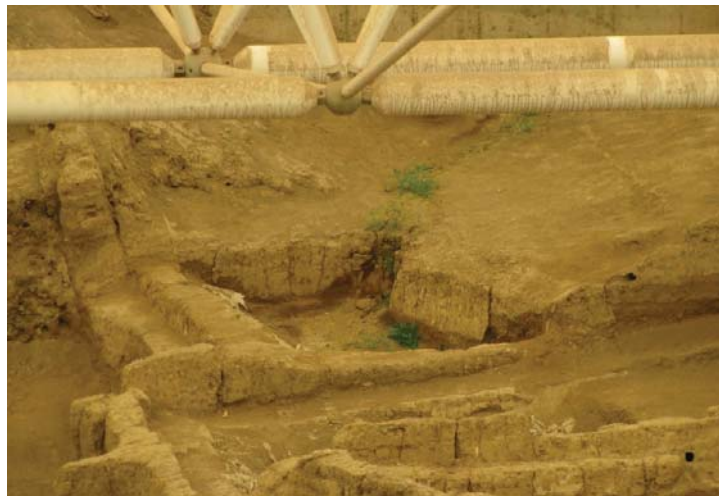
Figure 3. 8. Plants due to lack of roof and site drainage at south shelter.

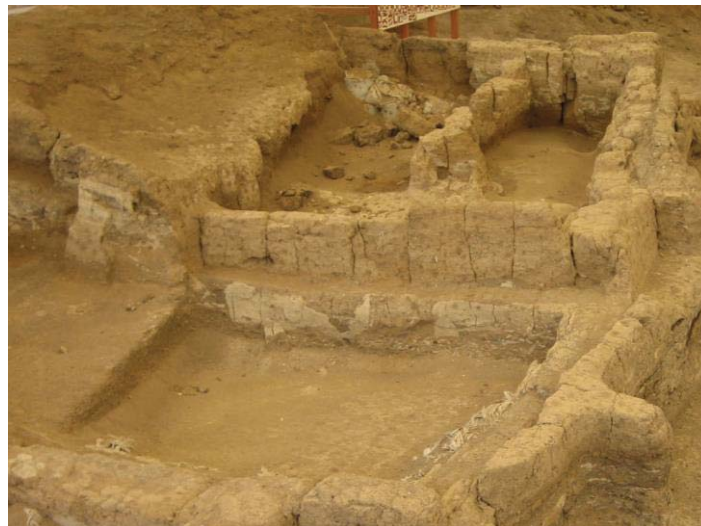
Figure 3. 9. Collapse of mudbrick walls due instable microclimate at south shelter.

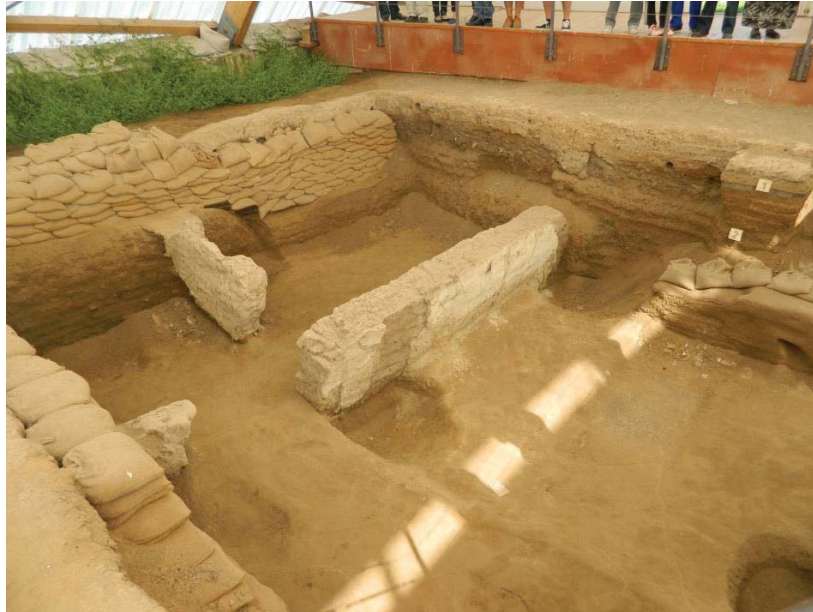
Figure 3. 10. Basal erosion and presence of plants due to rising damp at north shelter.

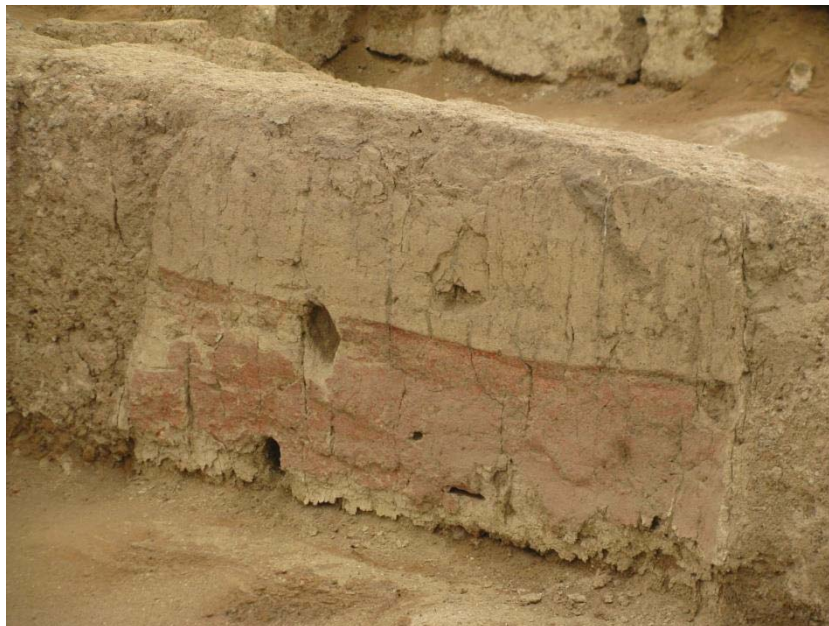
Figure 3. 11. Loss of plaster layers at the north shelter.

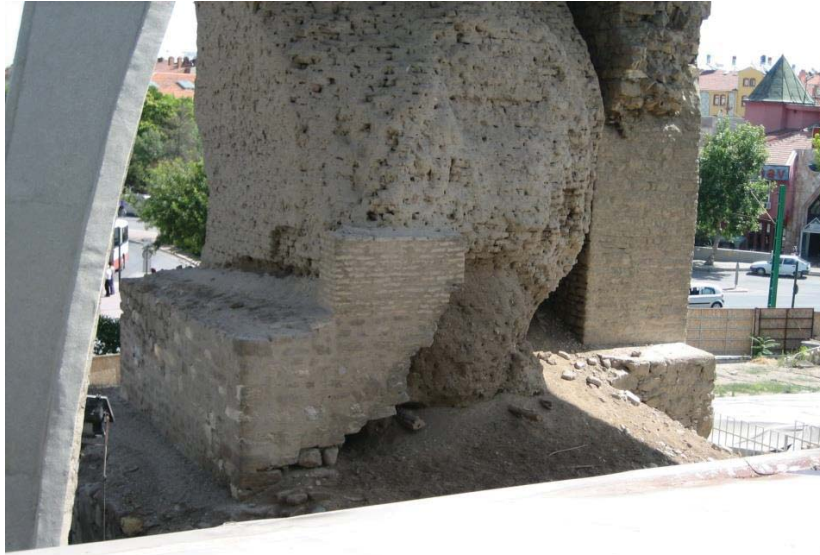
Figure 3. 12. Basal erosion due to rising damp.

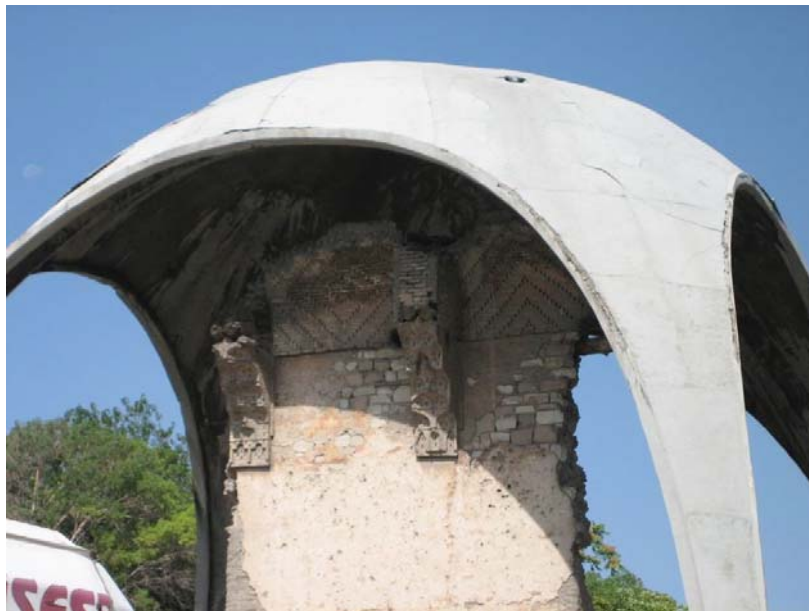
Figure 3. 13. Salt crystallization on the glazed bricks.

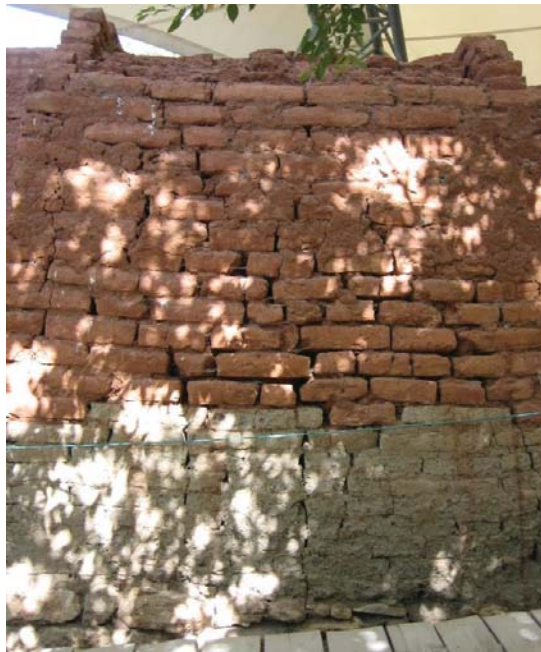
Figure 3. 14. Loss of mud mortar and structural cracks on the reconstructed fortification wall at the Citadel Wall and the Megaron at Troy (Turkey).

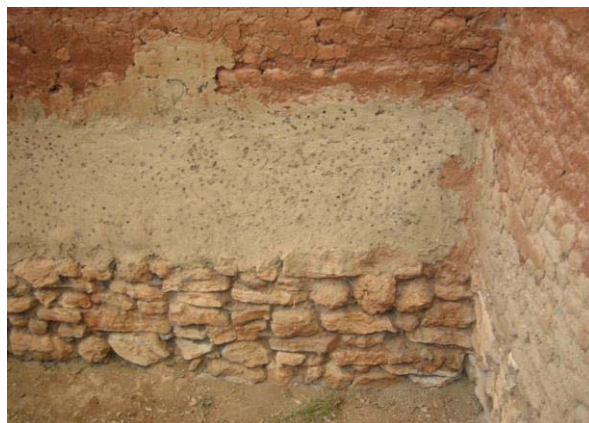
Figure 3. 15. Holes by wasps and arthropods at the Citadel Wall and the Megaron at Troy (Turkey).

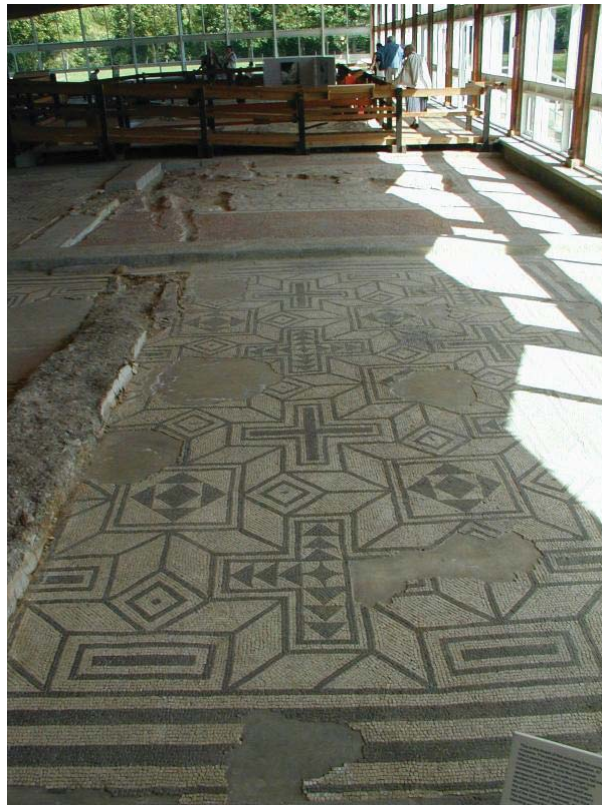
Figure 3. 16. Mosaics exposed to solar gain from glazed south façade before the modification. (Source:http://commons.wikimedia.org/wiki/File:Fishbourne_roman_palace_mosaics.jpeg)

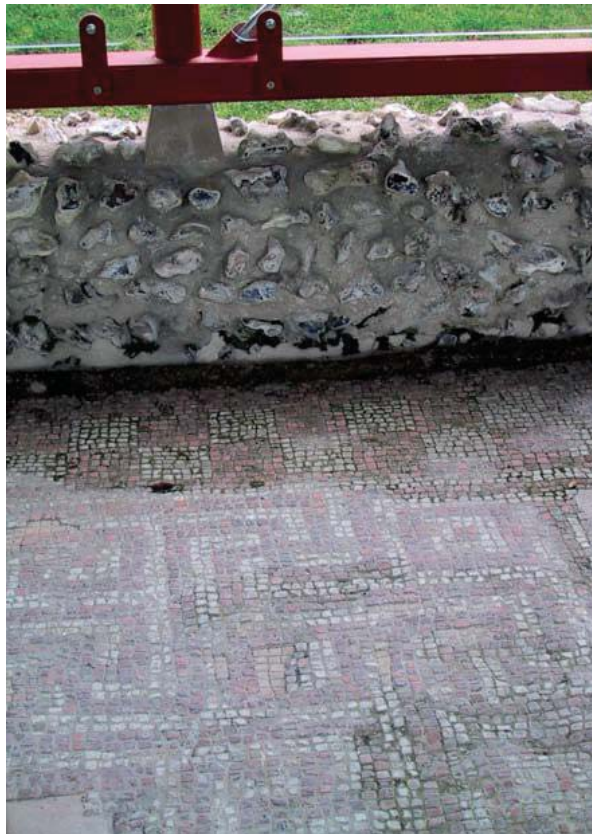
Figure 3. 18. The effects of water that drips down from the walls on to the mosaic floor at Roman Town House at Dorchester (UK). (Source: <http://www.dorsetforyou.com/media.jsp?mediaid=168951&filetype=pdf>)

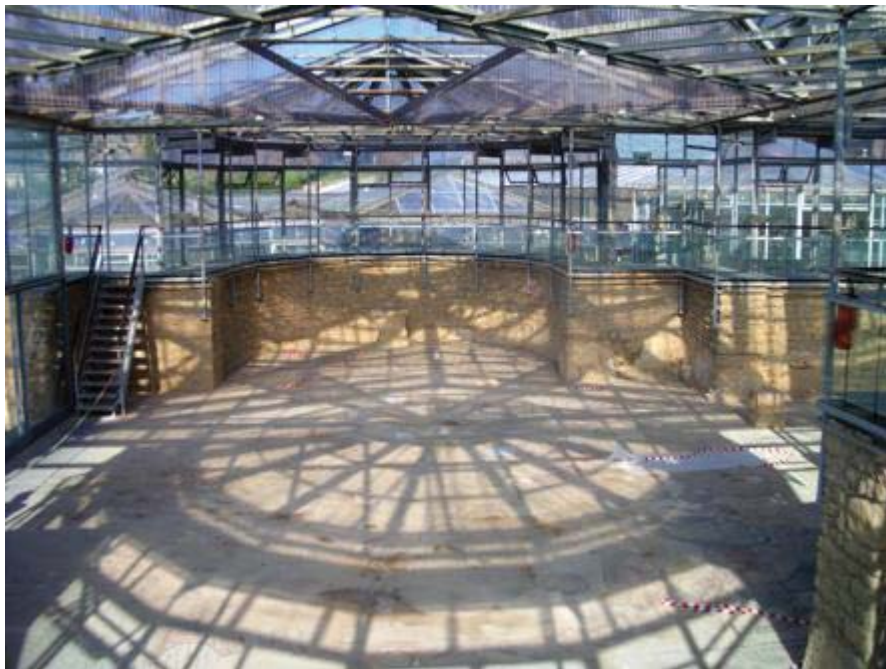
Figure 3. 19. The shading elements fail to prevent direct solar gain and heat built up in the Roman Villa at Piazza Armerina (Sicily, Italy). (Source: <http://www.studiogionatarizzi.com/progetto/galleria/30/#18>)

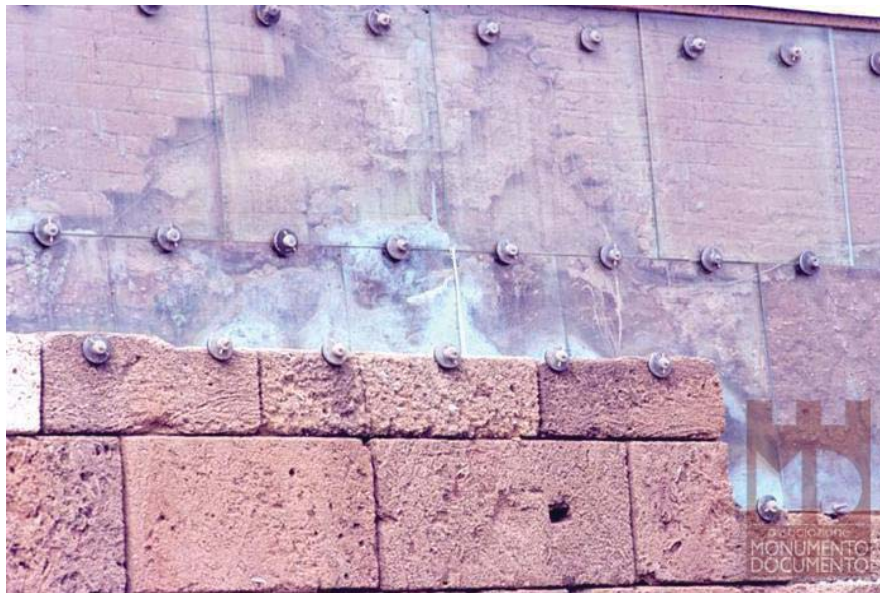
Figure 3. 20. Transparent sheets that were mounted on the façade to prevent rain, caused an ideal microclimate for plants and animals. (Source: http://www.unipa.it/monumentodocumento/villadelcasale/lastre_vetro.html)

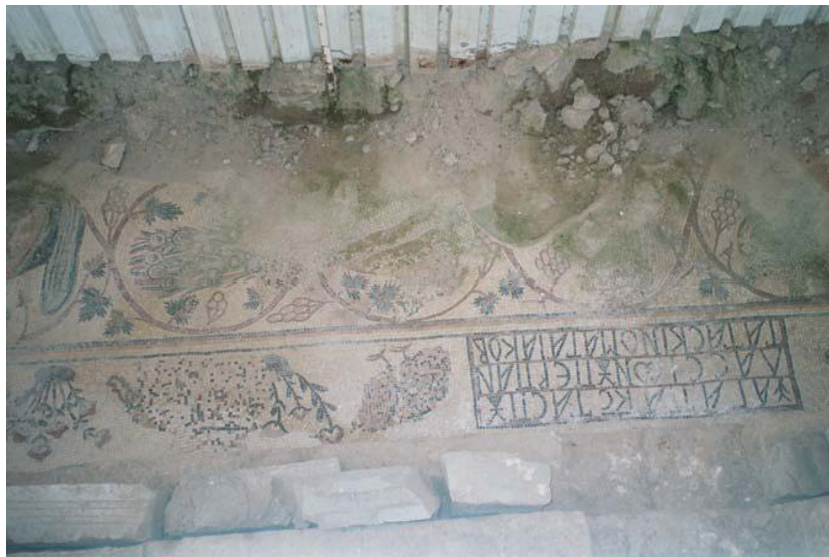
Figure 3. 21. Biological deterioration that affects the mosaics at the St. Stephen Complex at Um er-Rasas (Jordan). (Source: <http://whc.unesco.org/archive/2005/mis1093-2005.pdf>)

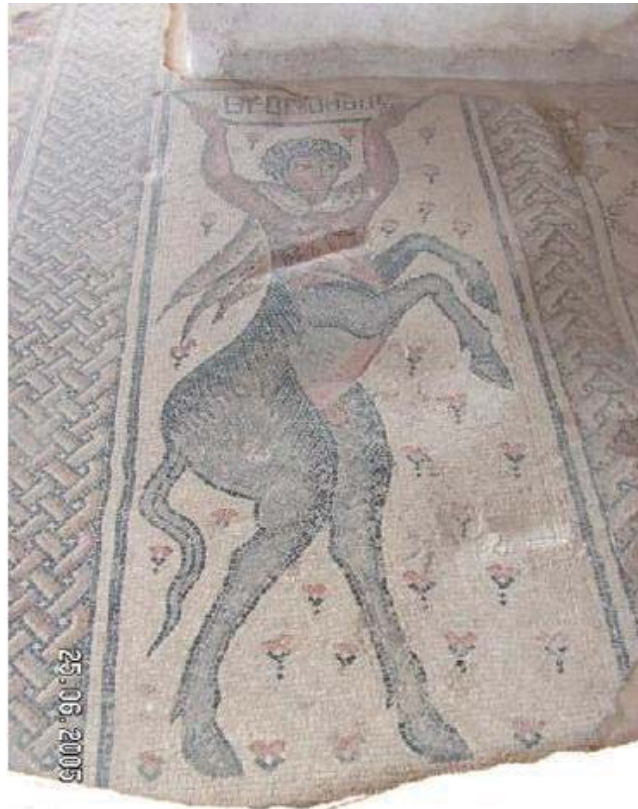
Figure 3. 22. The Centaur panel at the Nile Festival Building at Zippori (Israel) suffered from accumulation of condensed water in summer. (Source: <http://members.virtualtourist.com/m/p/m/13083c>)

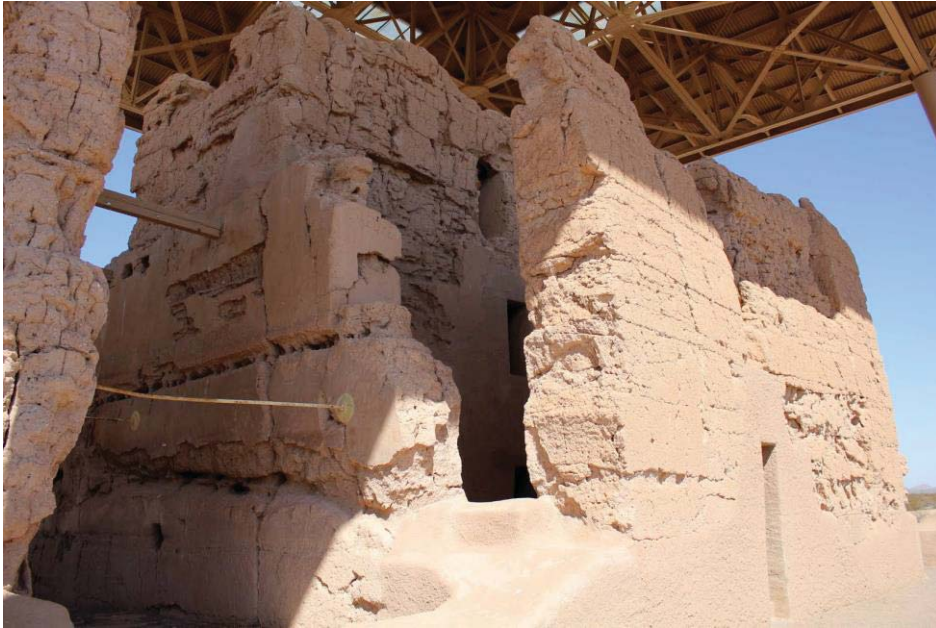
Figure 3. 23. Remains of the Hohokam architecture at Great House Ruins at Arizona (USA), exposure to solar radiation. (Source: http://ivonyoung.blogspot.com/2011_10_01_archive.html)

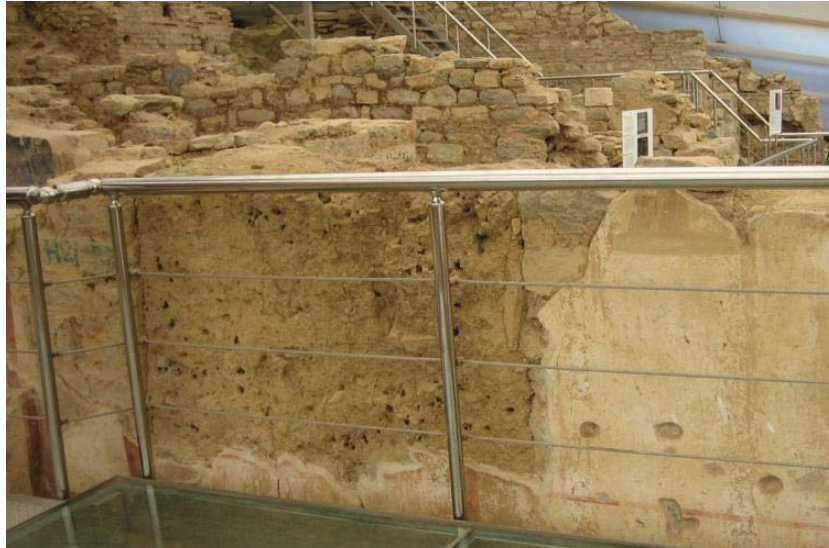
- Presence of wasps caused very severe damage due to the numerous cavities in the mortar at Terrace House 2 at Ephesus (Turkey) (Figure 4. 1).
- Louvers when the distance between the louvers is not narrow enough, birds can enter easily through and nest inside, where it is much safer to live for them. Hence high amount of droppings of these birds caused deterioration on mosaics and wall paintings at the Terrace House 2 at Ephesus (Turkey) (Figure 3.1).
- Although textile canvas was stretched under the roof to prevent birds entering through the gaps between the segments at Villas Dionysos and Danae at Zeugma (Turkey), it could not prevent the bird droppings from filtering through the canvas on to the remains.
- Remains exposed to rain penetration and solar gain due to the limited shelter area resulted in plant growth at the Archaic and late Roman remains at Sardis (Turkey) (Figure 4. 2).

Figure 4. 1. Cavities in the wall structure at the Terrace House 2 at Ephesus (Turkey).

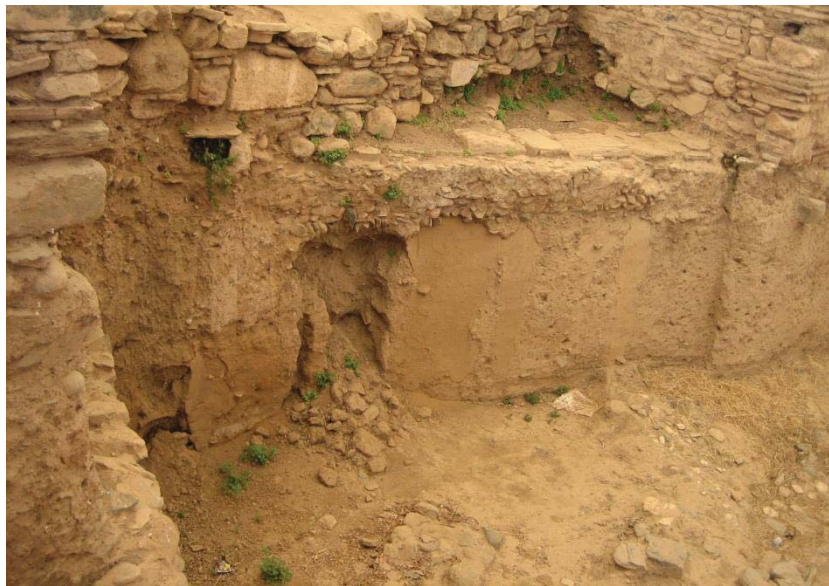
Figure 4. 2. Plant growth on the mudbrick fortification wall at the Archaic and late Roman remains at Sardis (Turkey).

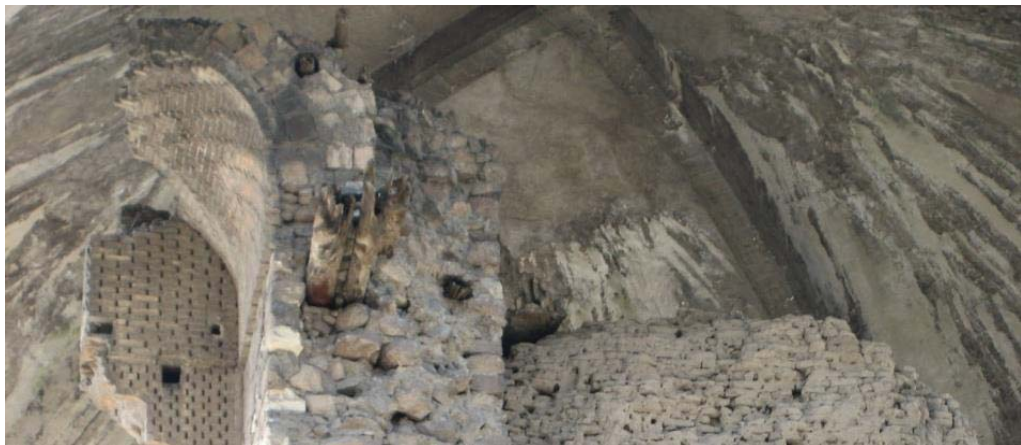
Figure 4. 3. Percolation through cracks in the roof material.

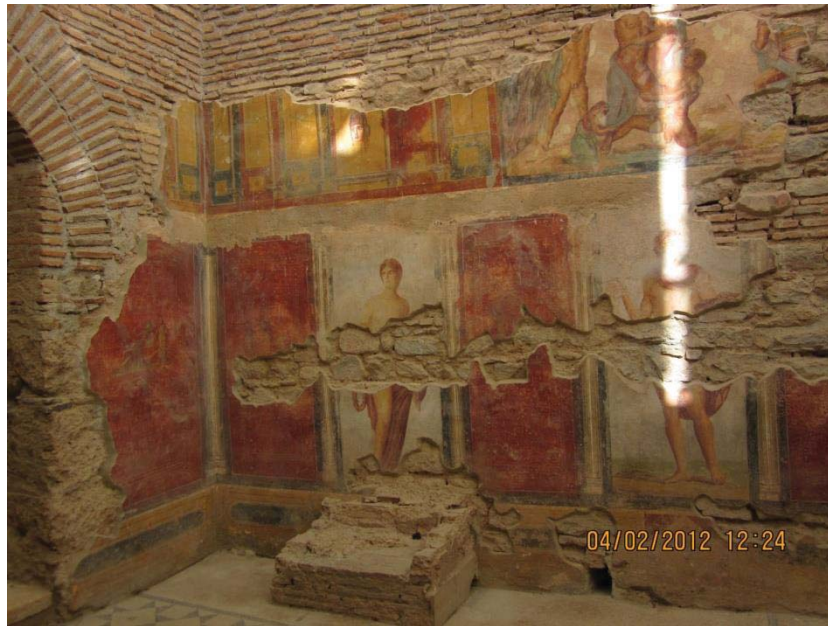
Figure 4. 4. Solar radiation on the paintings at the Terrace House 2 at Ephesus (Turkey).
