Visualisation and evaluation of structural characteristics and problems of a Classical Ottoman bath

Ö. Çizer & M. H. Turan

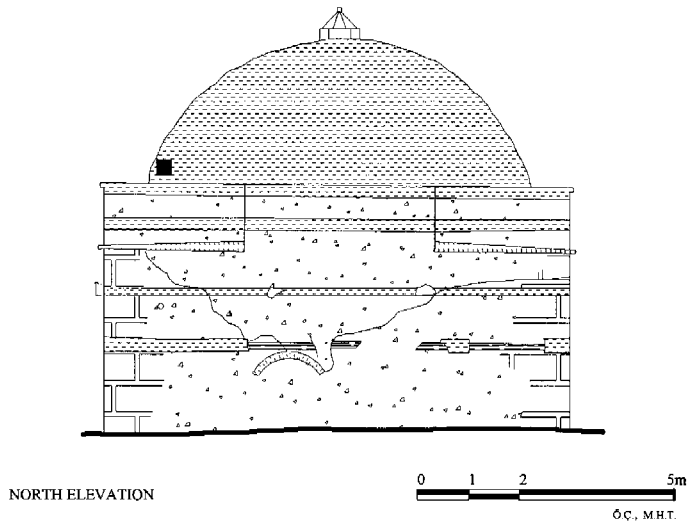
Figure 7. Visualisation of construction techniques and material of the north wall.

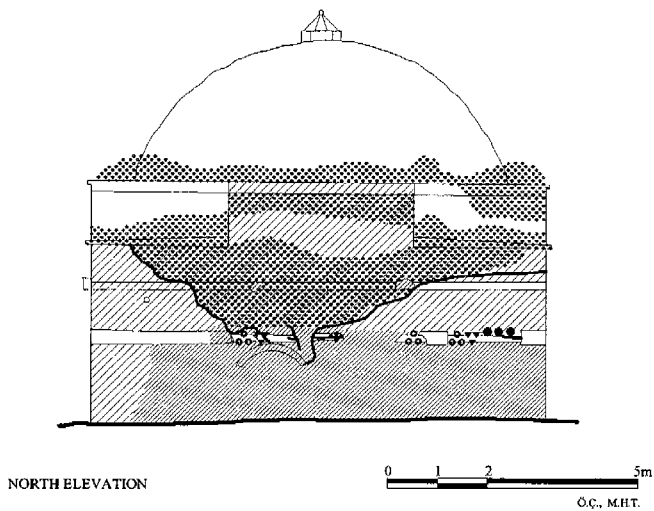
Problems of the historic structure are classified into two groups: structural failures and material deterioration. Loss, partial loss and crack comprise the structural failures. Loss describes that a structural element has got lost totally. This problem is observed at the timber clamps that provide the connection of timber beam with the north wall. Partial loss points out the loss of a piece of a structural element. This has been seen on the timber beam of the north wall. Cracks observed on the walls are not very deep cracks and they do not exceed the width of 2cm. Cracks on the timber beam in the north wall are the results of the cycles of wetting and drying. Rain water is the stimulus.

has the highest quantity of this type of deterioration (Figure 3). Especially up to the level of 150cm, loss of stone is considerably extensive. Especially, granular disintegration in the mortar leads to the loss of mortar, which is in fact the main cause in the loss of stone. In this north wall, another material deterioration is in the form of loss in the material group of brick and mortar that covers the timber beam. This gives rise to the deterioration of timber beam and timber clamps by being exposed to weather conditions (Figure 4). Deposits form the second group of material deterioration. This type of deterioration is in the form of plant formation, microbiological patinas and discoloration. Plant formation is observed at the highest quantities especially on the superstructure and walls. North wall is the one that has this deterioration type at maximum quantities. Microbiological patinas are on the surface of the interior walls where rain water penetrates through the cracks and open light holes on the domes and vaults (Figure 5,6). Discoloration is due to wetting by rain water.

Application of this visualisation technique has exposed the structural failures of the bath as follows: It has been clarified that material deterioration plays an important role in the formation of structural failures. Loss in the course of brick and mortar, which protect timber beam against atmospheric conditions, is the primary cause of partial loss, cracks and discoloration of the timber beam in the north wall. What is more, loss of stone and mortar observed along the below level of the same wall threatens the structural stability of the wall. It is believed

that these types of material deterioration are effective in the formation of cracks on this north wall.

Figure 8. Visualisation of structural failures and material deterioration of the north wall.

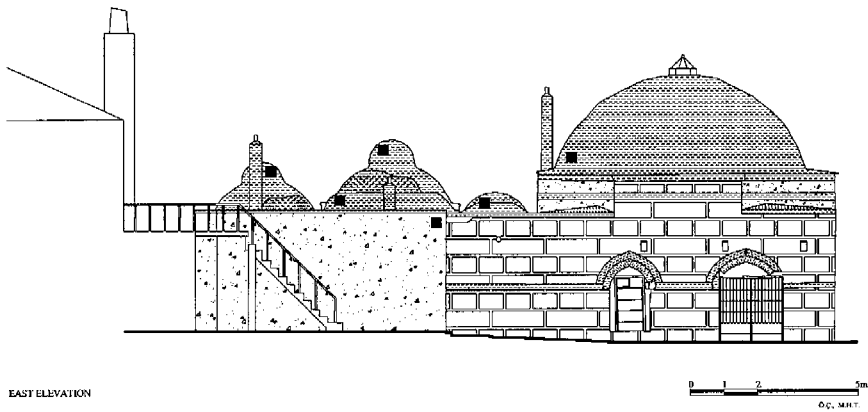
Figure 9. Visualisation of construction techniques and material of the east wall.

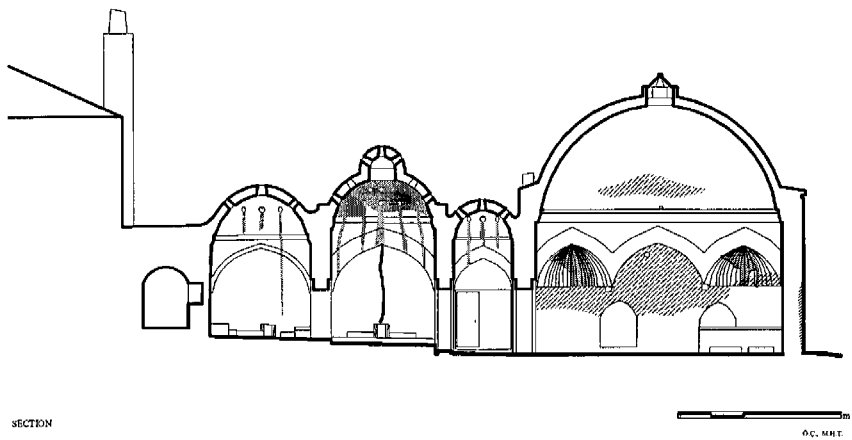
There are three types of structural failures: complete loss of a structural element - timber clamps, partial loss of the timber beam, and cracks on the walls and the timber beam. Material deterioration is evaluated under the headings of loss of material and deposit. Loss of stone and brick in the composition of the masonry bond, loss of plaster material by flaking and detaching from the wall, granulation in stone, brick and mortar, and holes in the timber beam are the types of loss of material. Plant formations such as bush and grass on the mortar of the masonry bond and tiles, microbiological patinas in the form of green, yellow and black stains on the surfaces of interior walls, and discoloration of the timber beam due to rain water and sun light comprise the deposits. Hatching styles for each data are designed and then are applied on the measured drawings (Figure 8, 10).

Figure 10. Visualisation of structural failures and material deterioration of the longitudinal section.
