IDENTIFICATION OF VEZİRAĞA AQUEDUCT IN İZMİR AS A HISTORICAL MONUMENT

**A Thesis Submitted to
the Graduate School of Engineering and Science of
İzmir Institute of Technology
In Partial Fulfillment of the Requirements for the Degree of
MASTER OF SCIENCE
in Architectural Restoration**

**by
Fatma Sezgi MAMAKLI**

**July 2016
İZMİR**

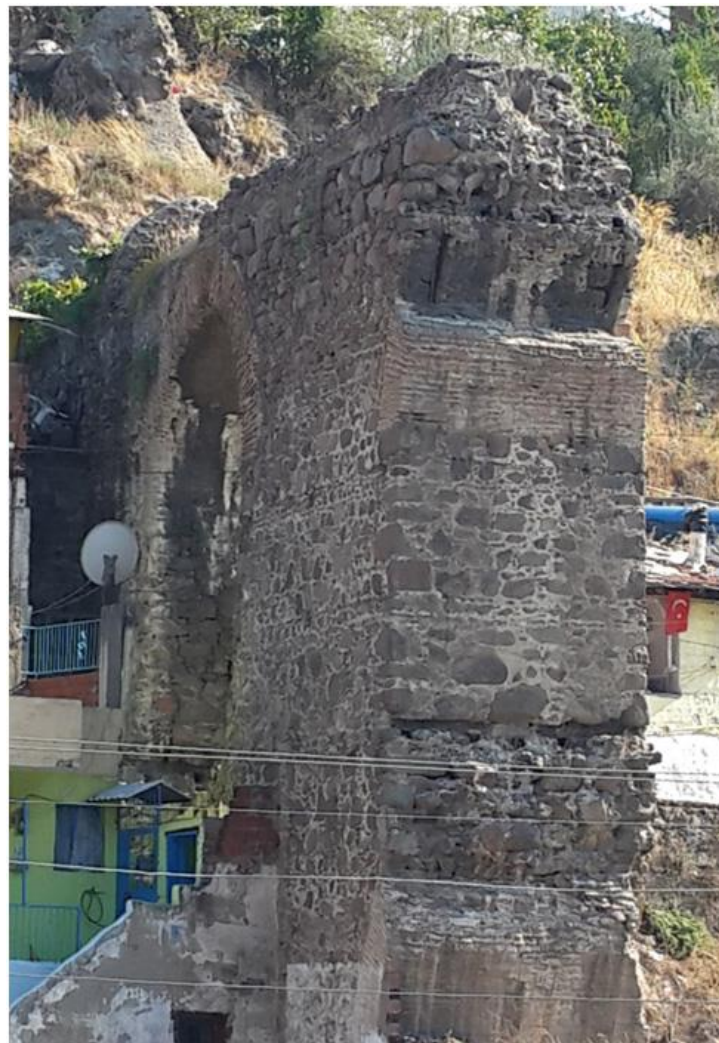
Figure 15. East elevation and demolished arches of wall portion B.

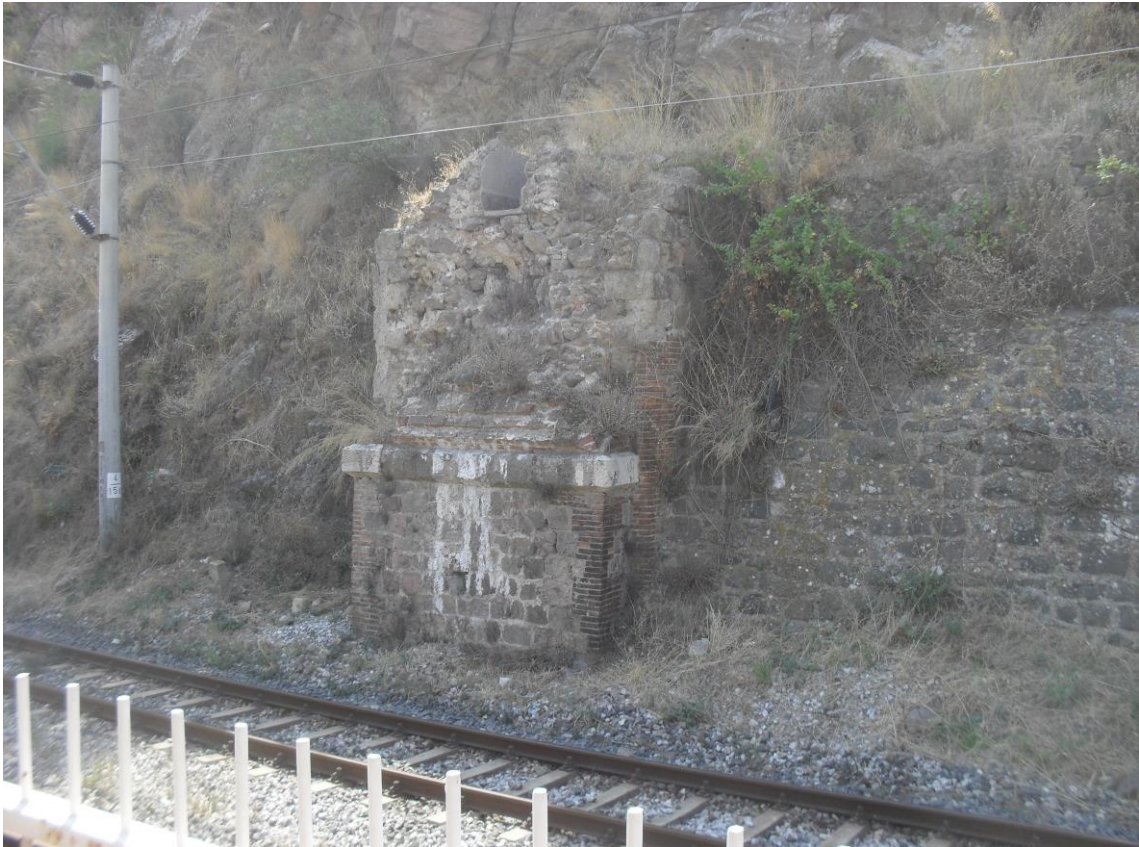
The wall portion C (1.70 x1.00 m) is just next to the railway at its south. It rests on the rocky terrain at its north end (Appendix B, Figure 16). This portion is almost in ruins. On this portion, only the traces of the stone duct are seen with 55 m side walls and 60 m dyke. The total height of this portion from the ground level is 5.40 m.

Figure 16. Wall portion C.

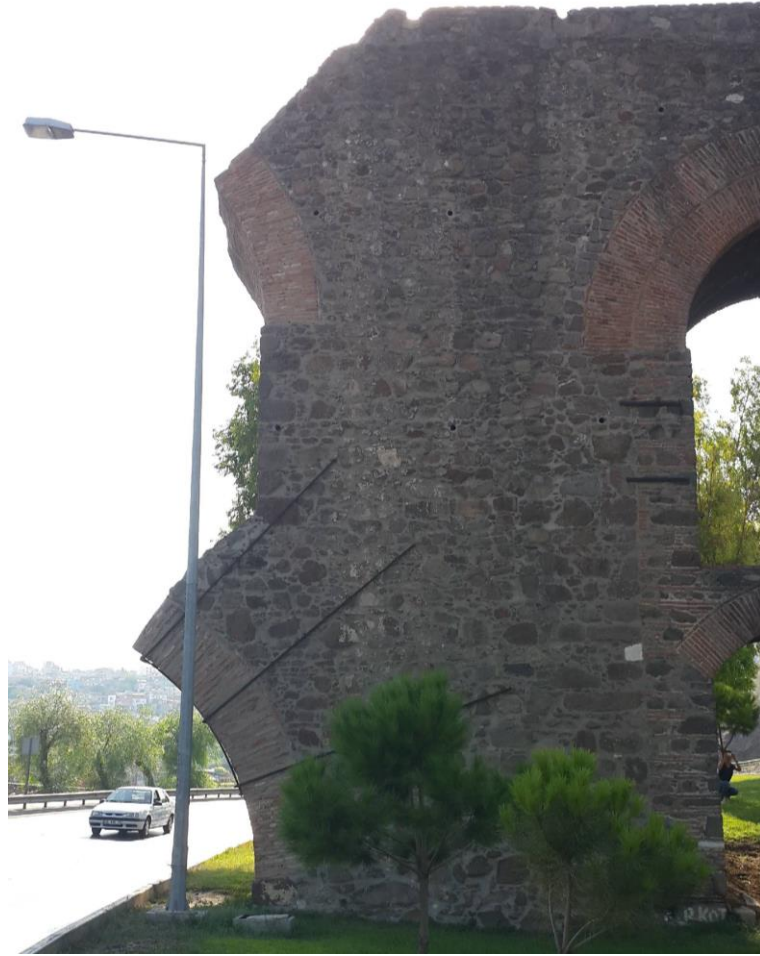
Six iron bars (\varnothing : 2 cm, L: 5.10 cm) are used on the remaining arches of the wall portion A to support the demolished parts of the wall in north-south direction (Appendix C2). There are on the arch remains which are at the southern end of the wall portion (Figure 19).

Figure 19. Three of six iron bars used to support remaining arches.

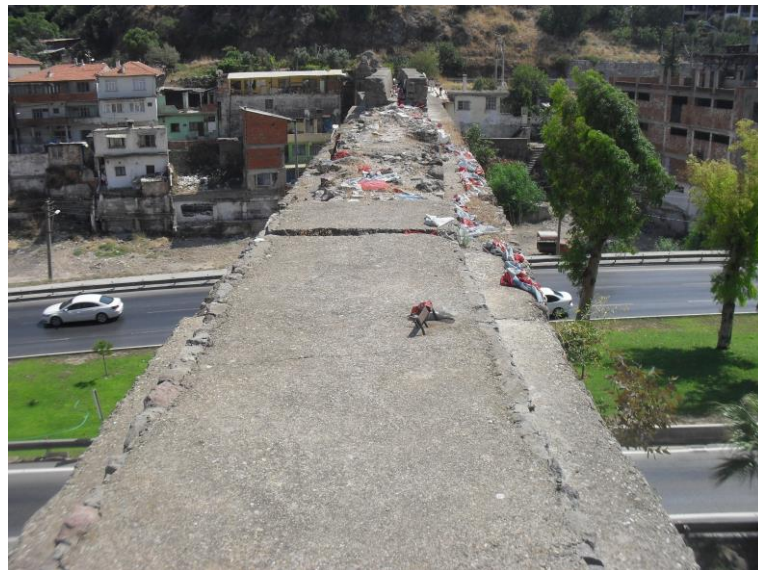
Incomplete concrete covered stone duct (L: 9.05 m) piece is at the south of the concrete covered stone duct above the wall portion A (Appendix C2 and Figure 23).

Figure 23. Incomplete concrete covered stone duct above wall portion A.

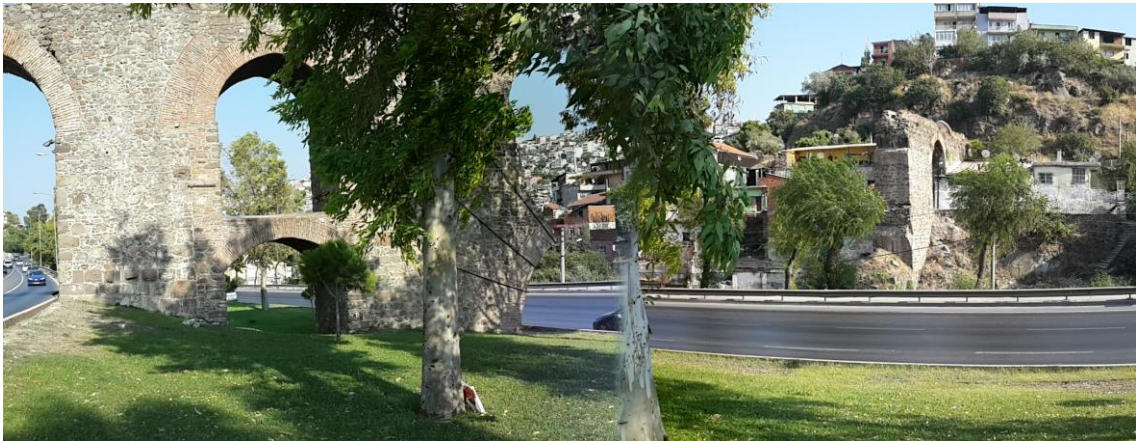
The parts between wall portion A – B and wall portion B – C, 88 m from northern end with 40 m length and 154 m from northern end with 9 m length, were demolished. These demolishment jeopardize the stability of the wall and have caused loss of structural integrity (Appendix D2, Figure 16 and 24).

Figure 24. The demolished part between wall portions A and B.

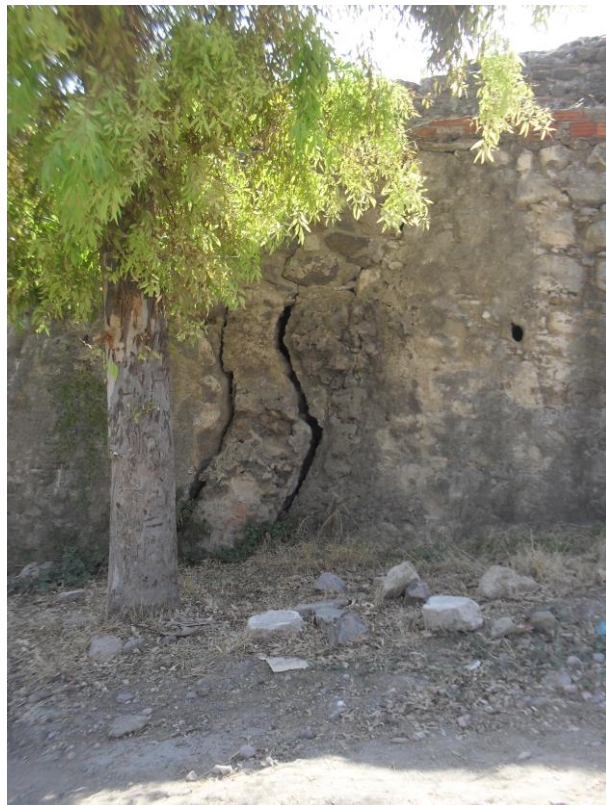
Three different types of fractures are observed during the site survey on the stone masonry wall and on the brick arches (Appendix D2 and Figure 25). Horizontal fractures (F: 2.20 m) are along arch-wall connections in east-west direction, as observed in the cross sections. Vertical fractures (F: ~ 1.20 , 2, 2.50 m) are on the walls continuing from top to bottom. Diagonal fractures (F: ~ 0.90 m) are within the arches, as observed in the cross sections.

Figure 25. The fracture on wall portion A.
