Chapter 13

A Case Study for Seismic Assessment and Restoration of Historic Buildings: The Ardit Residence

ABSTRACT

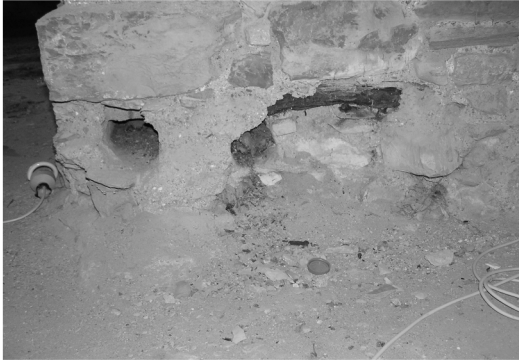
In the basement, about 60 cm thick peripheral walls are made of rubble stone. There exist two rows of wooden horizontal lintel bands, wall plate timbers, with a vertical spacing of approximately 2 meters. At the observable locations, it is seen that the bottom layer of wall plate timbers are totally degraded and almost empty shafts existed in these locations, Fig. 3a. Such a heavy degradation is due to the proxim-

ity of these timber members to the moist soil. Although some of the wall plate timbers had been worn out due to weathering effects for a long period of time, existing timber still has a significant effect on the integrity of the basement walls. Other than the peripherals walls, there are two parallel walls in the north-south (N-S) direction of the building, see Fig. 2 basement plan. These walls are in the same vertical alignment with the ground floor interior walls that enclose the entrance hallway of the building. There exist no interior walls in the east-west (E-W) direction in the basement floor.

a) Deteriorated masonry wall ties, basement floor

As mentioned before, timber tie beams just above the ground level within the basement masonry walls are observed to be totally disintegrated and empty spaces exist in their place (Fig 3a). With the permission of the responsible restorer, these tie beams were decided to be replaced with concrete beams due to the location, type of the wall and the maintenance issues. This is the only location in the building that concrete is used for restoration purpose. Tie beams are spanning all through the basement walls and it is not possible to unload the walls for any purpose. Therefore, it is not an option to cast a single beam spanning all the length. A scheme that permits the casting of the ground beam in stages, considering length and cross section, is selected. Thickness of the wall at this level, which is approximately 60 cm, enables to apply such an approach.

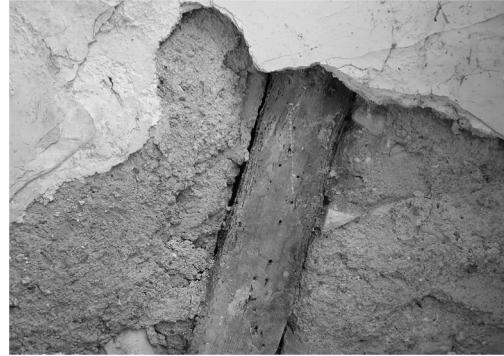
b) Deteriorated timber due to insect activity

Observations in the case study building reveal that majority of the timber framing within the stone walls and the floor diaphragms had lost their structural characteristics due to the insect and fungal activity. Therefore, it is decided to replace the structurally unfit members. Pine is the original timber type for these members. Cypress had been used for some of the main girders as well. Members are planned to be replaced using the original timber types. Wherever it is possible, structural capacities are checked according to current design criteria under gravity loads and it is verified that existing cross section satisfy the current design demands. It is stressed in design drawings that the replacement process should be in stages and should have the minimal impact on the original system. Stages of such an approach are provided in design drawings.

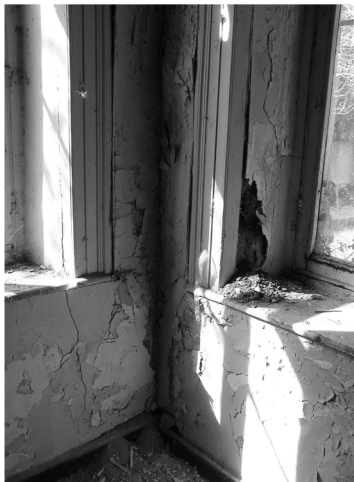
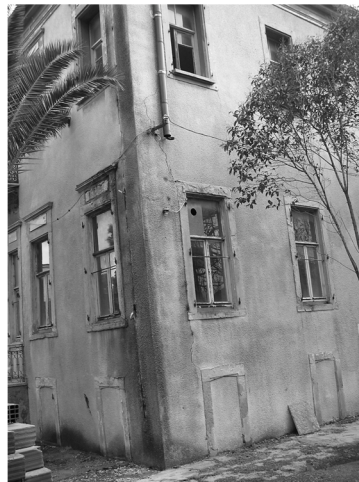
c and d) Deteriorated wall section at the north-east corner due to the crack that permits moisture to penetrate

it is decided to use hydraulic lime mortar injection for the cracks. Extensive cracking and disintegration at some portions of the existing masonry walls necessitates the removal and re-construction. As it can be observed from Fig. 3c and d, north-west corner of the case study building needs such an intervention due to the deterioration, excessive cracking and being out of plumb line.

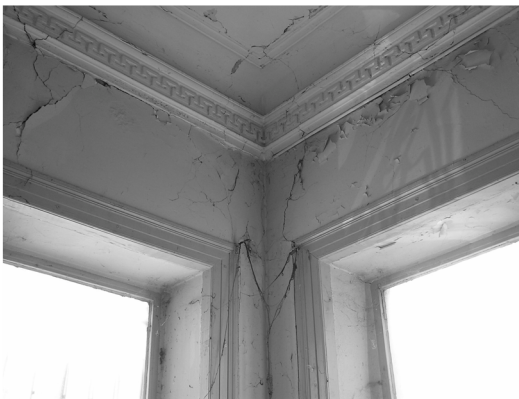
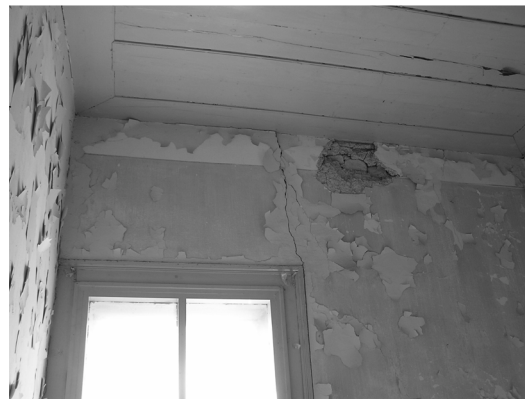
e and f) Typical cracks at the top of the windows

In the ground floor, which has a story height of 4.5 meters, there exist three different types of walls. The perimeter walls had been constructed as two leaves. The exterior leaf is made of rubble stone with lime mortar whereas the inner leaf has a timber frame infilled by rubble stone. The total wall thickness is about 50 cm. The inner walls, with a thickness of approximately 20 cm, had been constructed either as timber framed walls infilled with rubble stone or timber frame with “bağdadi” covering, which is a traditional construction technique from Ottoman era. This is similar to timber lath and plaster technique. It has been observed that the buildings constructed by using this technique behaved in a satisfactory manner during major earthquakes (Gulkan & Langenbach 2004, Guchan 2007). All the structural walls had been connected to a timber floor system. By removing the plaster in few regions of the walls, it was observed that some timber members had been worn out due to weathering, insect and fungal activity, Fig. 3b. In the regions where the cracks at the perimeter walls permit water penetration, heavy deteriorations are observed, Fig. 3 c and d. In some of the walls, shear cracks were encountered. There were extensive cracks in the connections of perpendicular walls, especially between the peripheral and interior walls. This reveals that wall-to-wall connections are poor. Furthermore, the cracks at the bottom parts of the structural walls are indications of improper wall-to-floor connection. There are also cracks extending from the corners of window and door openings toward the spandrels in the peripheral walls, Fig 3e and f.

There are many locations in the building with visible cracking on plaster. Cracks with less than 1 mm width are decided to be disregarded and only cosmetic applications are proposed. Intervention decisions for other locations are proposed to be based on controlling the penetration of the observed cracks to the body of stones in the walls. If such penetrations are observed, walls in the region are planned to be removed and rebuild locally. If the cracks are wider than 1 mm and they are following the mortar lines,

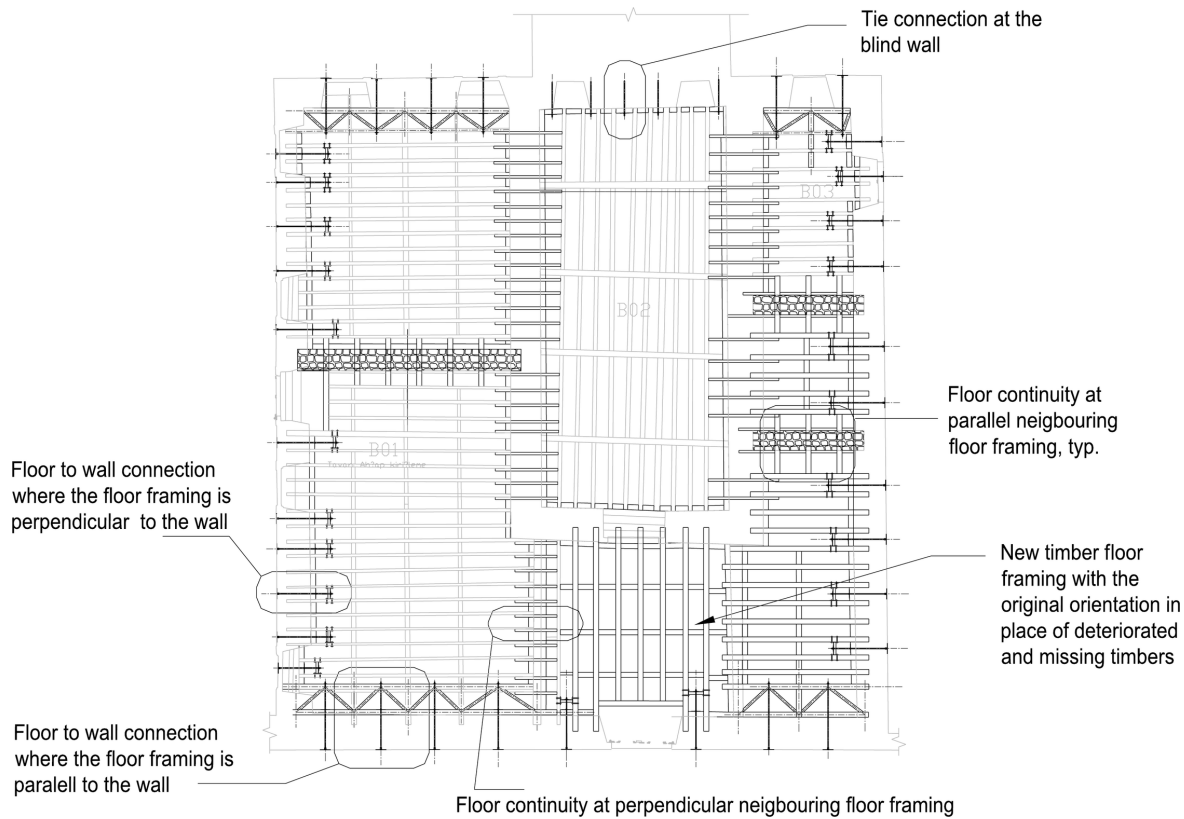
Figure 8. Existing framing of the ground floor diaphragm

Assessment of the floor framing at the internal wall and girder crossings show that most of these connections are not sufficient to provide necessary force transfer from one side to other. Therefore, noting that at the internal wall crossings floor covering is discontinuous, floor is susceptible to tearing or pull out at these locations (Fig. 8). Change in the orientation of the floor joists magnifies the vulnerability. To mitigate this problem, details that enable force transfer are provided. If the joists are along the same direction on each side of the gap, bolts connecting the joist on each side are designed to provide continuity. If there is not enough room for such a connection, new short timber members, which have the same size with the joists, are used. If the joists are changing direction on each side of the gap, joists or crossing timber are extended enough to provide connection to the first orthogonal joist and the floor covering.

Eccentricity between the centers of mass and rigidity of the building and resulting torsion forces cause a significant demand during transfer of forces from flexible to stiffer regions of the building. Existing floor framing is composed of typical 5x13 cm joists with 30-35 cm spacing. There exists same size bridging with 105 cm typical spacing in the perpendicular direction. Joists are covered with single layer, 2.5 cm thick pine planks in a direction perpendicular to main direction of the joists. Main hall in the ground floor have an additional 5-10 cm layer of mortar and tiles as covering. Existing floor framing is not stiff and strong enough to satisfy the required force transfers. Therefore, a double floor cover with a corresponding nailing scheme is developed. New scheme consists of a 3 cm plywood level and a 2.5 cm pine planks level. Bottom layer is designed to maximize the use of the full size plates. Upper layer is

designed to have the same orientation with the original floor covering. Therefore, original layout could be preserved and if possible original wooden planks could be used. The new floor framing is calculated to be sufficient in strength and stiffness for the required force transfers.
