**CURRENT CONSERVATION STATE OF SOME
ART NOUVEAU HOUSES AND APARTMENT
BUILDINGS IN ISTANBUL**

**A Thesis Submitted to
the Graduate School of Engineering and Sciences of
İzmir Institute of Technology
in Partial Fulfillment of the Requirements for the Degree of**

in Architectural Restoration

**by
Gizem TÜR KARSLAN**

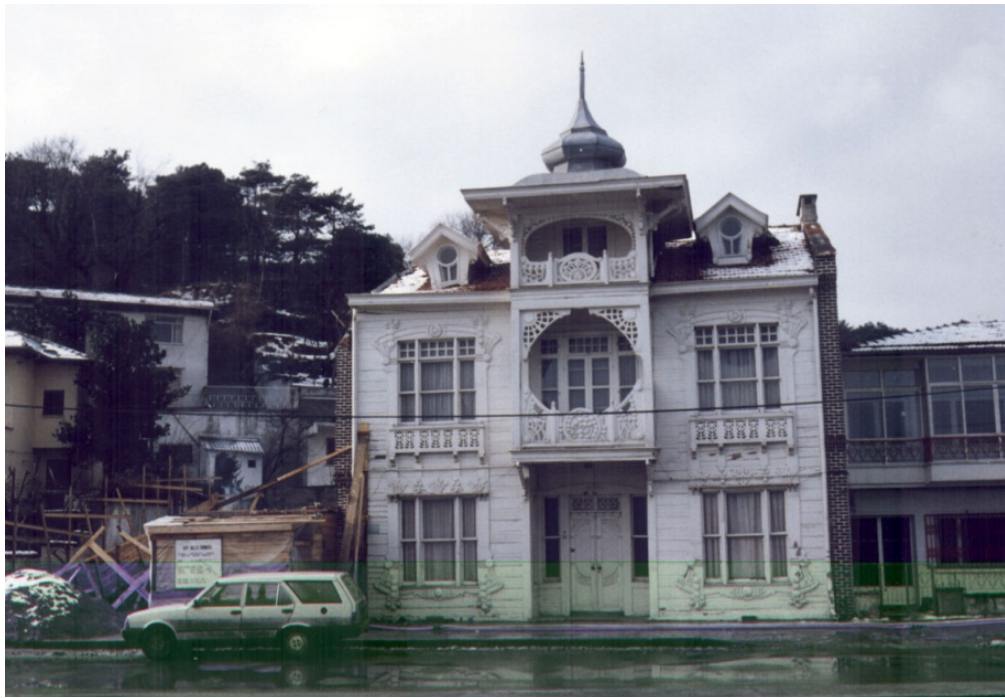
The restoration at the beginning of 2000s is the major cause of alterations. Ruined brick fire walls were completed with a similar material. Damaged roof structure was strengthened with new timber and also partially supported with steel beams. Timber joinery was changed with similar material. Automatic shutters were added to the windows. Bulbous dome was reconstructed again with the similar materials, timber structure with lead covering. During the restoration, marble entrance stairs were discovered and the sidewalk level was decreased to its original level (Appendix I.1.).

Figure 3.5. Dikranyan *Yalı* Before Restoration.
(Source: Akan Mimarlık, 2001)

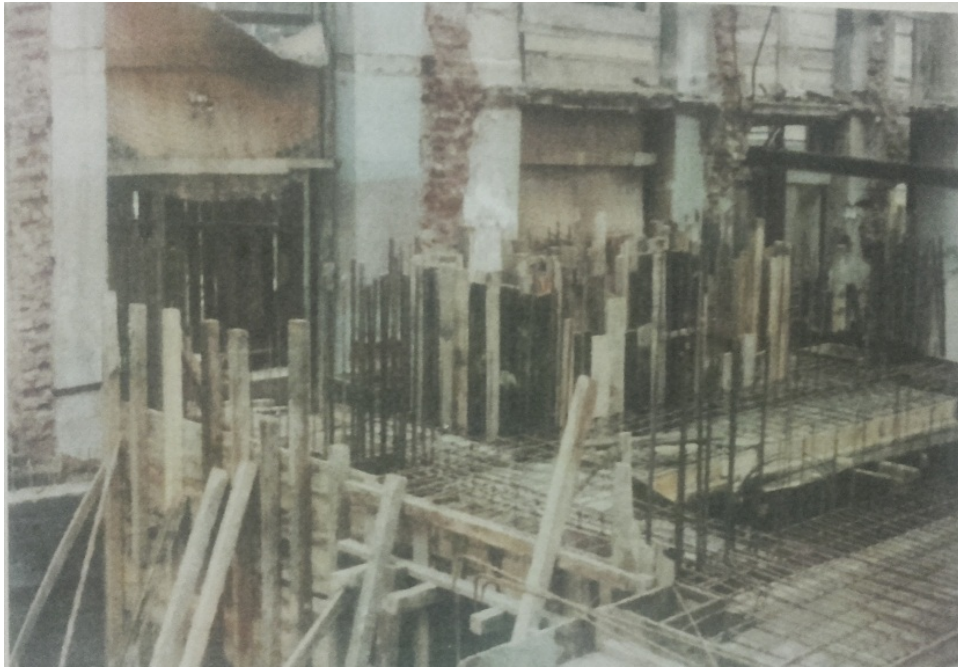
completely renewed and a new steel structural system was erected (Akın and Batur 2015:46). Originally, the building had jack arch floor system and walls were brick masonry (Tanyeli, 2012). In 1999, Directorate of Istanbul Cultural Affairs sent a letter to the council, complaining about the probable damages of the subway construction work on the Frej Apartment Building. The council requested the necessary precautions to be taken by the Beyoğlu and the Metropolitan Municipalities. In 2000, simple repair of the rear façade, namely, its painting was permitted (Conservation Council, 2000) (Figure K.16.).

Figure 3.19. Frej Apartment in 1987-88 during the renewal work, interior structure completely changed and only façade was conserved as a shell (Source: Onat, 1989, cited in Tanyeli, 2012).

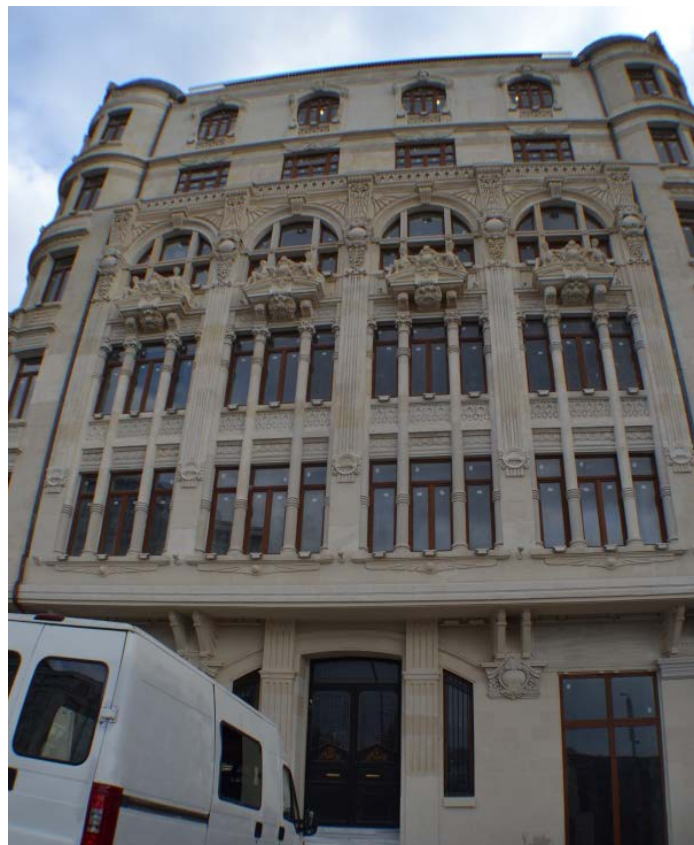
symmetry axis. The façade is divided into three sections horizontally: the first, second and third stories project out, while the ground and top stories recess back. Linear undulation can be observed. There are circular planned towers at the corners of the building and they have their own domes. Linear cornices have a rich variety of ornaments. Wide balcony at the fourth floor has balustrades with geometrical network like decoration. Brackets, supporting the first floor and the balconies of the third floor, have ornaments on their two sides. There is a big variety of ornaments in this buildings and there are some unique elements used in this building's façade decorations. These elements are pilasters uniting stories and the statues between two windows in vertical axis. Like other examples, French windows are used to acces the balconies (Appendix G.3.). The style of decorative elements is interpreted as the combination of Art Nouveau and Baroque (Akın and Batur, 2015: 46).

Figure 3.21. The facade of Frej Apartment Building, 2016.

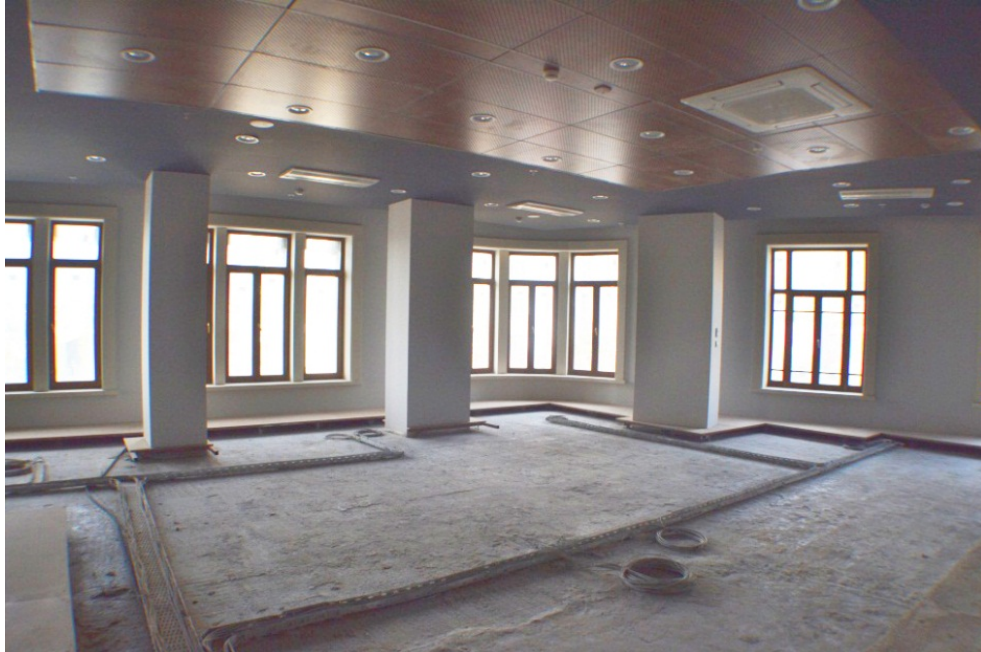
stone covering. Interior structure of the building is totally altered with reinforced concrete and steel. There are some columns added along the north façade of the building to support the structure (Appendix H.3.).

Figure 3.22. First floor of Frej Apartment Building's interior, 2016.

In 1969 restoration; the interior structural and architectural elements were completely altered. A roof floor was added to the 5 storied structure. Original jack arch floor system was removed (Tanyeli, 2012). Instead, there is reinforced concrete system. Windows were renewed. Deteriorated *Malta* stones at the facades were changed with *Kandira* stones. Original stairs were changed with different types of stairs several times. During the current restoration, a spiral timber staircase with black iron ornamented railings has been added. Ground floor windows were changed with a new timber ones that do not resemble the original ones (Appendix I.3.).

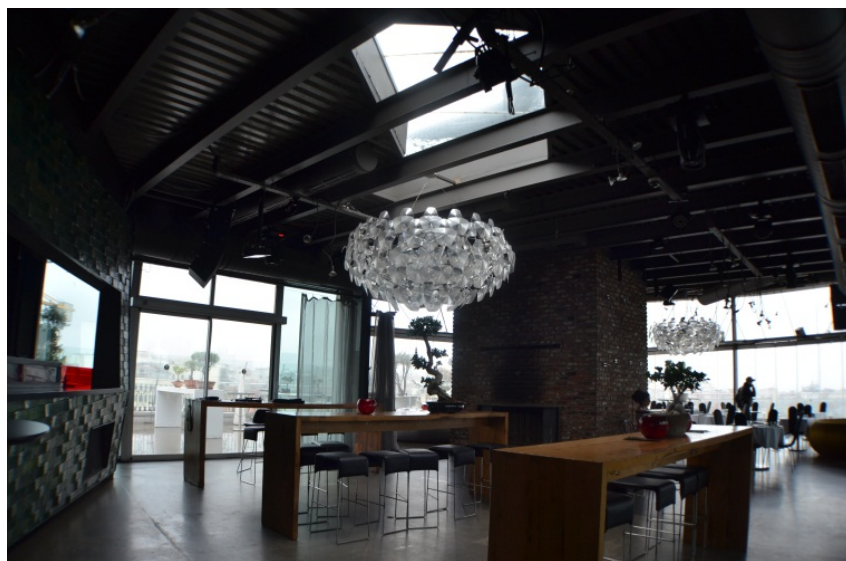
The building is supported with a reinforced concrete frame system at present. The mass addition at the terrace is in steel frame system. Blind partitioning walls have been added parallel to the exterior walls to provide necessary vertical boundaries for the present galleries. Decorative cutstone similar to the original is observed at the exterior surfaces of the walls, while the partitioning walls are finished with various new material such as plaster and white wash. The original marble covering is observed at the halls, while the floors of galleries, offices and the restaurant are finished various new materials (Appendix H.5.).

Figure 3.34. Steel structure of the roof restaurant called 360, 2016.
