ASSESSMENT OF İZMİR HALKAPINAR WATER PUMP STATION FOR ITS CONSERVATION AS INDUSTRIAL HERITAGE

A Thesis Submitted to the Graduate School of Engineering and Sciences of İzmir Institute of Technology in Partial Fulfilment of the Requirements for the Degree of

in Architectural Restoration

by İdil Ece ŞENER

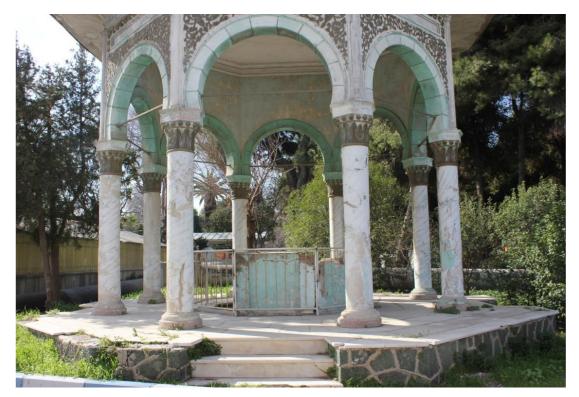
Figure 3. 33. The unqualified railing and wall around the gap in the middle of the Water Distribution Structure

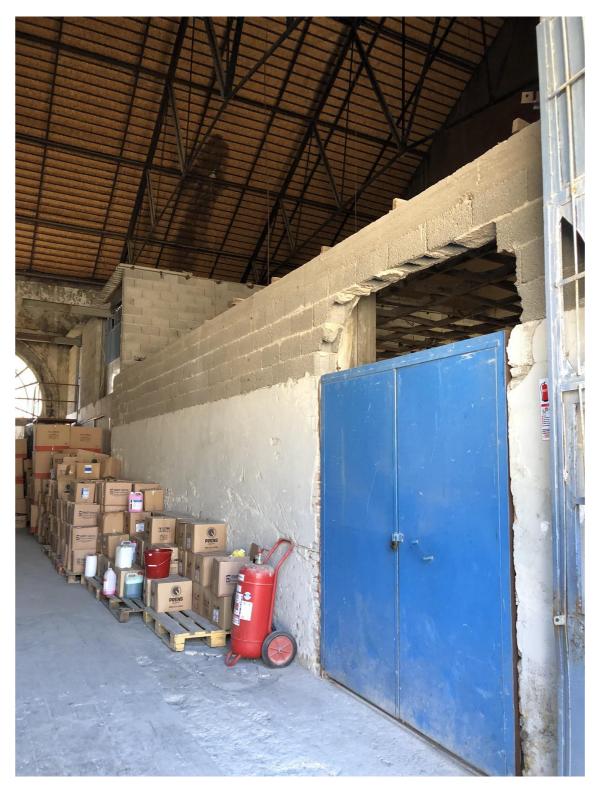
Figure 3. 49. Cinder block additions constructed to the boiler room space

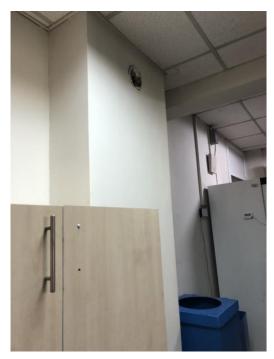
Figure 3. 56. Fireplace converted into a wall
