## ASSESSMENT OF STRUCTURAL DAMAGE IN ADIYAMAN AND CALIBRATION OF RAPID VISUAL SCREENING METHODS AFTER KAHRAMANMARAŞ EARTHQUAKE SEQUENCE

A Thesis Submitted to the Graduate School of Engineering and Sciences of İzmir Institute of Technology in Partial Fulfillment of the Requirements for the Degree of

by Yusuf EKİNCİ

December 2024 İZMİR We approve the thesis of Yusuf EKİNCİ

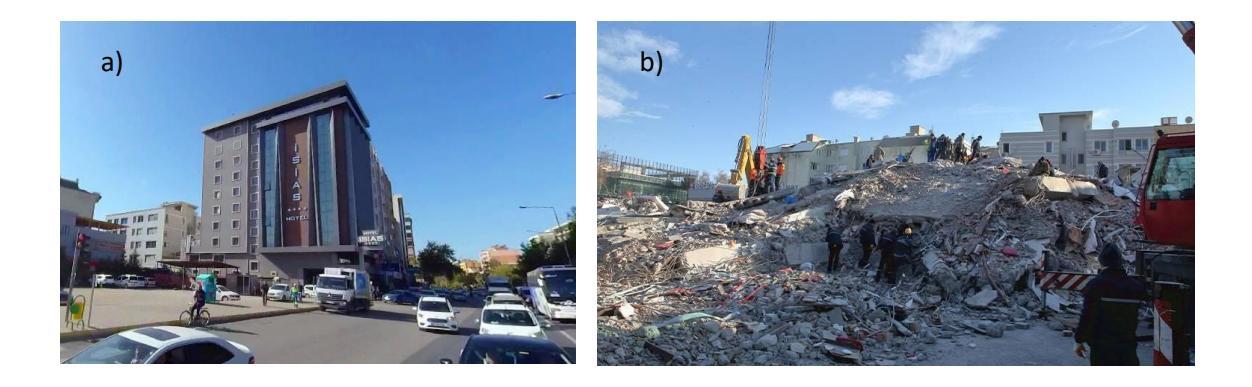
The Isias Hotel in Adıyaman tragically exemplifies the severe consequences of unauthorized modifications (Figure 3.4). According to the expert report prepared on the causes of the collapse of the Isias Hotel in the earthquake, the concrete strengths were insufficient according to the concrete samples taken, the stirrups were missing, and 135-degree connections were not made according to the earthquake regulations of the time it was built. The report also found that the structure had a severe level of soft floor irregularity in the direction of the collapse (Cyprus Union of Chambers of Turkish Engineers and Architects (KTMMOB) Chamber of Civil Engineers (İMO) 2023). Consequently, the hotel collapsed during the first earthquake at 4:17 AM on February 6. Additionally, the building was created by combining two neighboring structures originally designed as dwellings, in violation of the original building permits.

Figure 3.4. a) Isias Hotel, Adıyaman before Earthquake. (Courtesy of Google Street view) b) Isias Hotel, Adıyaman after Earthquake.

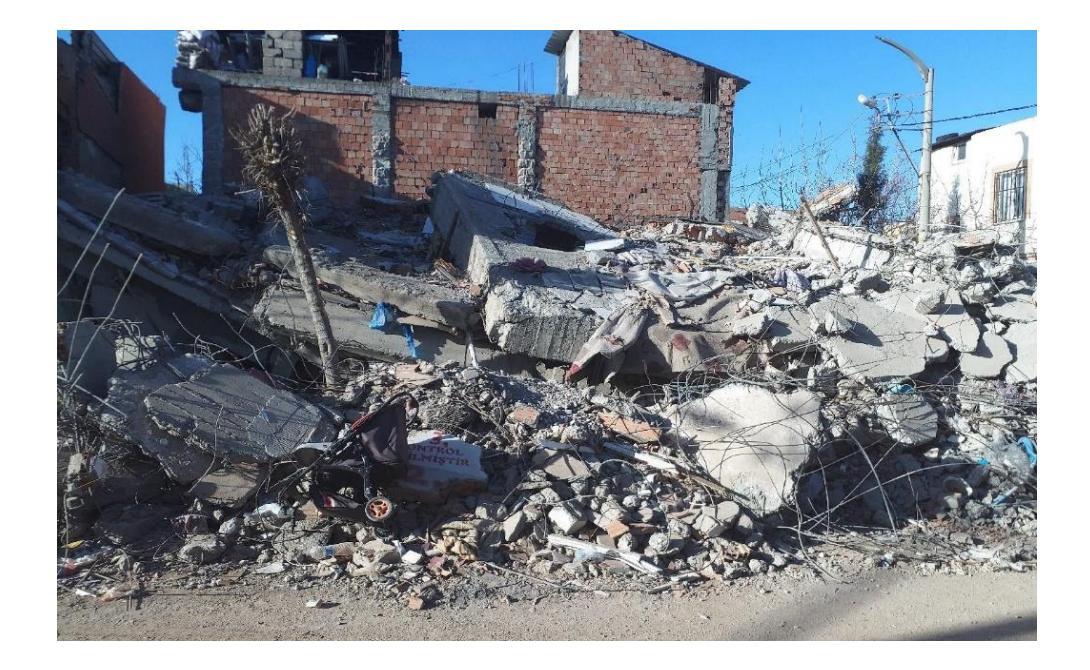
Figure 3.23. Collapsed building from Adıyaman city center (Courtesy of Google Street view).

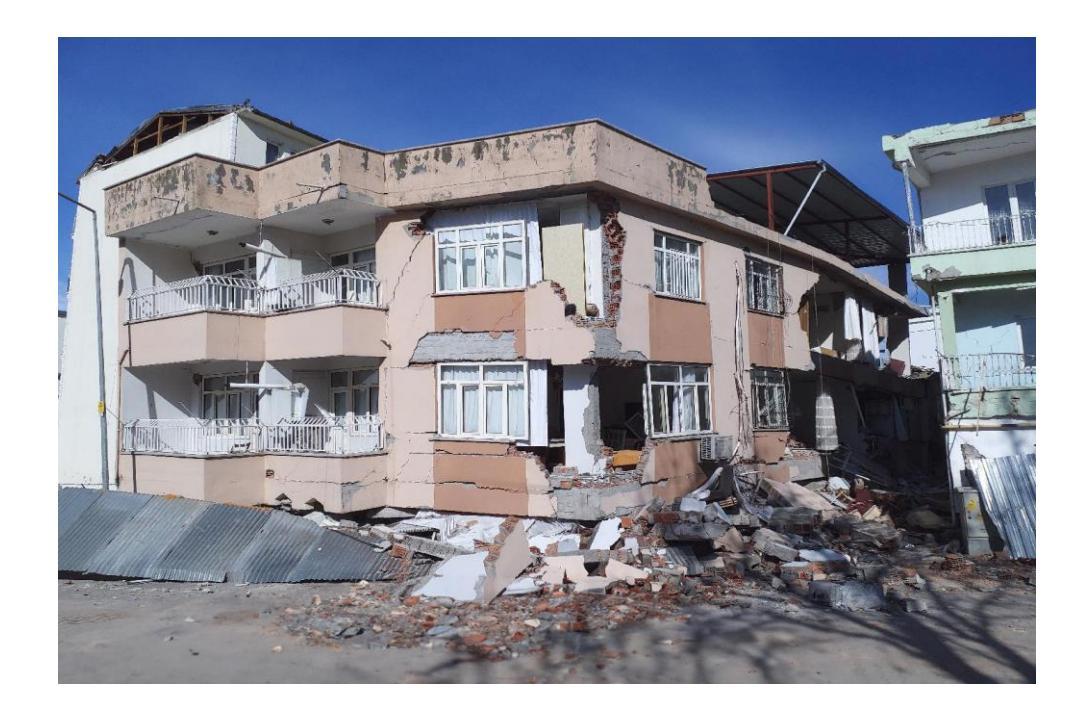
Figure 3.24. Buildings requiring immediate demolition from Adıyaman city center (Courtesy of Google Street view).

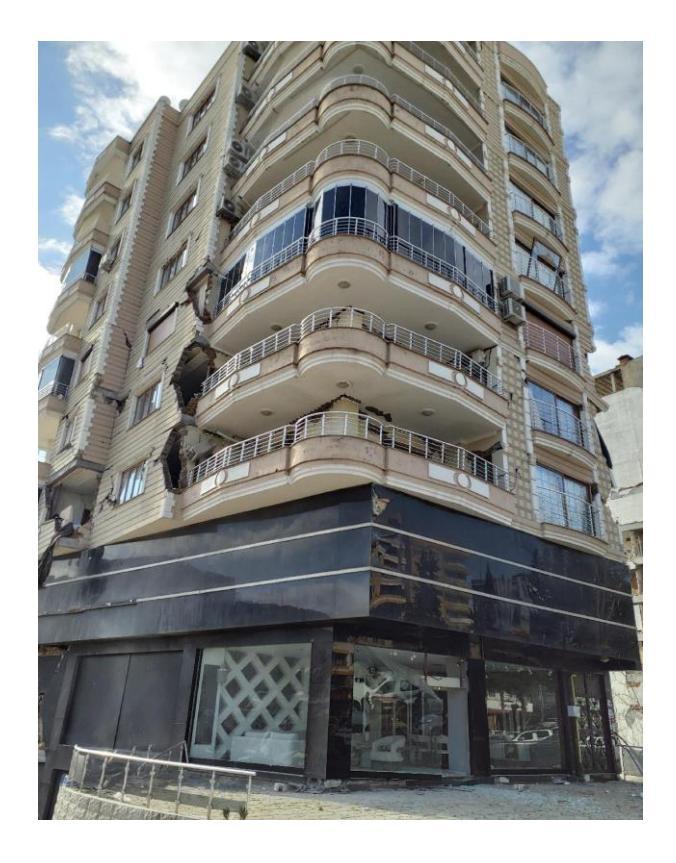
Figure 3.25. Heavily damaged building from Adıyaman city center (Courtesy of Google Street view).

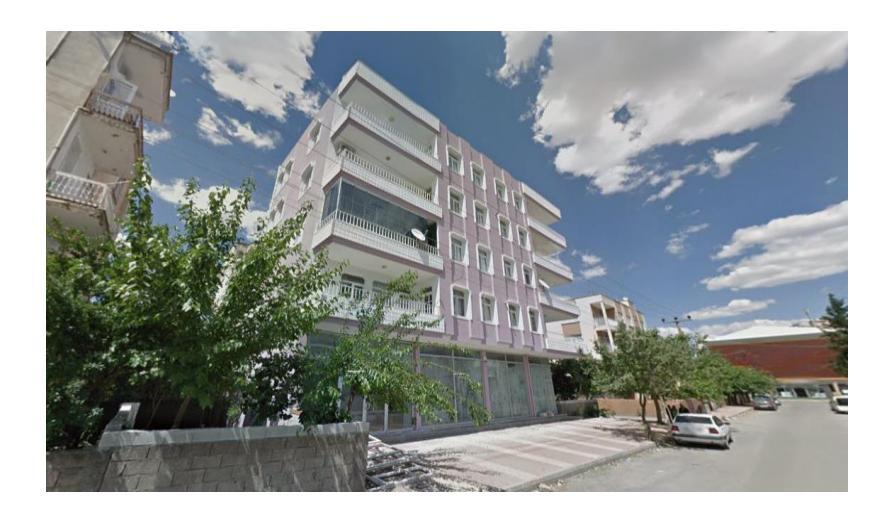
Figure 3.37. Building in Adıyaman collapsed. (Adopted from Google earth)
