**PUNCHING BEHAVIOR OF HYBRID FIBER
REINFORCED CONCRETE PANELS**

**A Thesis Submitted to
the Graduate School
İzmir Institute of Technology
In Partial Fulfillment of the Requirements for the Degree of**

in Civil Engineering

**by
Jamalullah NASERI**

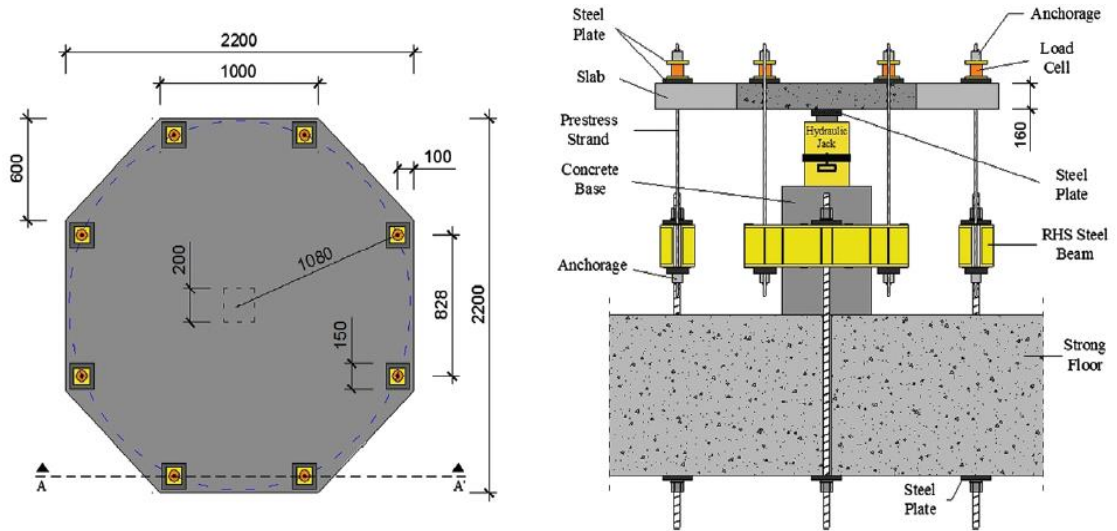
Figure 2.1 Geometry of specimen: top view and section A–A' (All dimensions in mm) (Gouveia et al, 2018)

Results of the study showed that the addition of fibers enhance the punching strength and ductility of flat slabs. Maximum increase in load capacity due to the addition of fibers up to 1% was around 54% compared to the slab without fibers. Moreover, in some instances, the presence of fibers changed the failure mechanism from punching to flexural-punching failure. Also, the deflection capacity was increased in the slabs containing fibers. Authors also analyzed their test results using Critical Shear Crack Theory (CSCT (Muttoni, 2008)) and claimed that the experimental and theoretical results showed a good agreement. In particular, the experimental values were very close to the estimated punching load capacity as presented in Table 2.2.

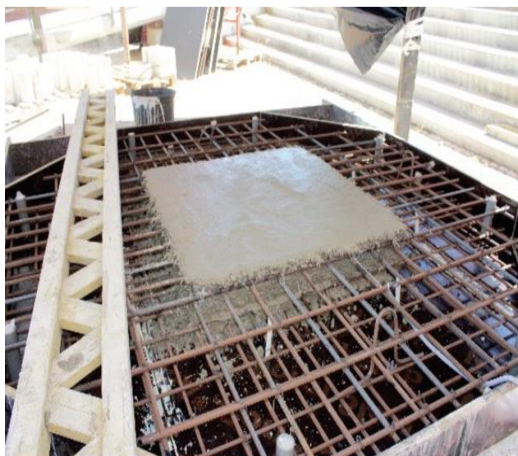
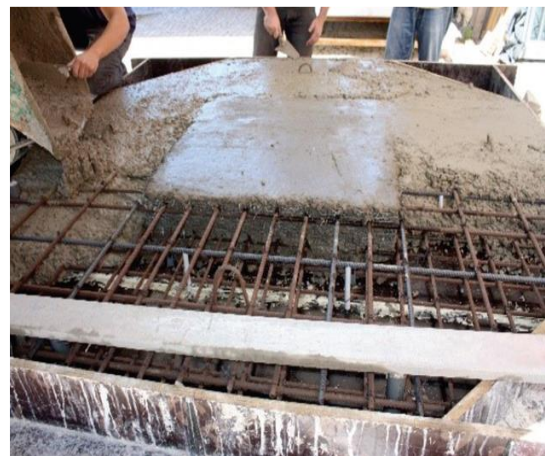
Figure 2.2 Regions of different concretes inside the specimens

a) SFRC in central region

b) outside region with normal concrete

Another study performed by Gouveia et al (2019), investigated the behavior and load capacity of SFRC slab-column connection. The specimens were cast in a manner that steel fiber reinforced concrete was poured around the column region with a square area (approximately the column size plus three times the effective depth on all sides) and the remaining of the slab was cast with normal concrete without fibers as presented in Figure 2.2. The test consisted of six slab specimens of 150 mm thickness with main variables as steel fibers volumetric ratio (0.0, 0.5, 0.75, and 1.0%) and longitudinal bar ratio (1 and 5%). Flexural tests were performed on notched beams as well in order to determine the flexural behavior. The load was applied centrally by a hydraulic jack from the bottom of the specimens through a steel plate of size 250 x 250 mm with a constant rate of 285 N/s.

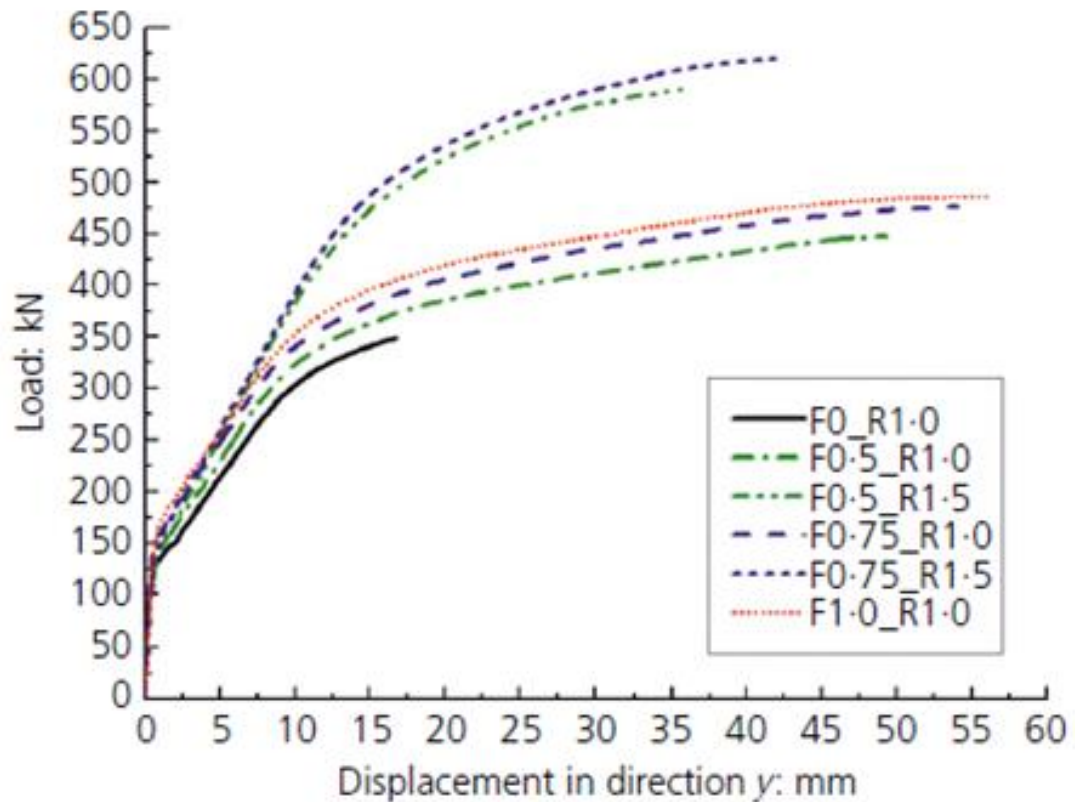
Figure 2.3 Load–displacement test results
(Gouveia et al, 2019)

Results of the tests revealed that addition of steel fibers near the column region improved the load and deformation capacities of the slabs (Figure 2.3). The load capacity increased by 36%, as the fiber volume fraction increased from zero to 1%. Also, SFRC caused changes in failure modes from brittle punching failure to flexural-punching or even flexural failure. It was also found that for improving the load and deformation capacity of flat slab, casting SFRC for an area up to three times the effective depth from column edge is sufficient.

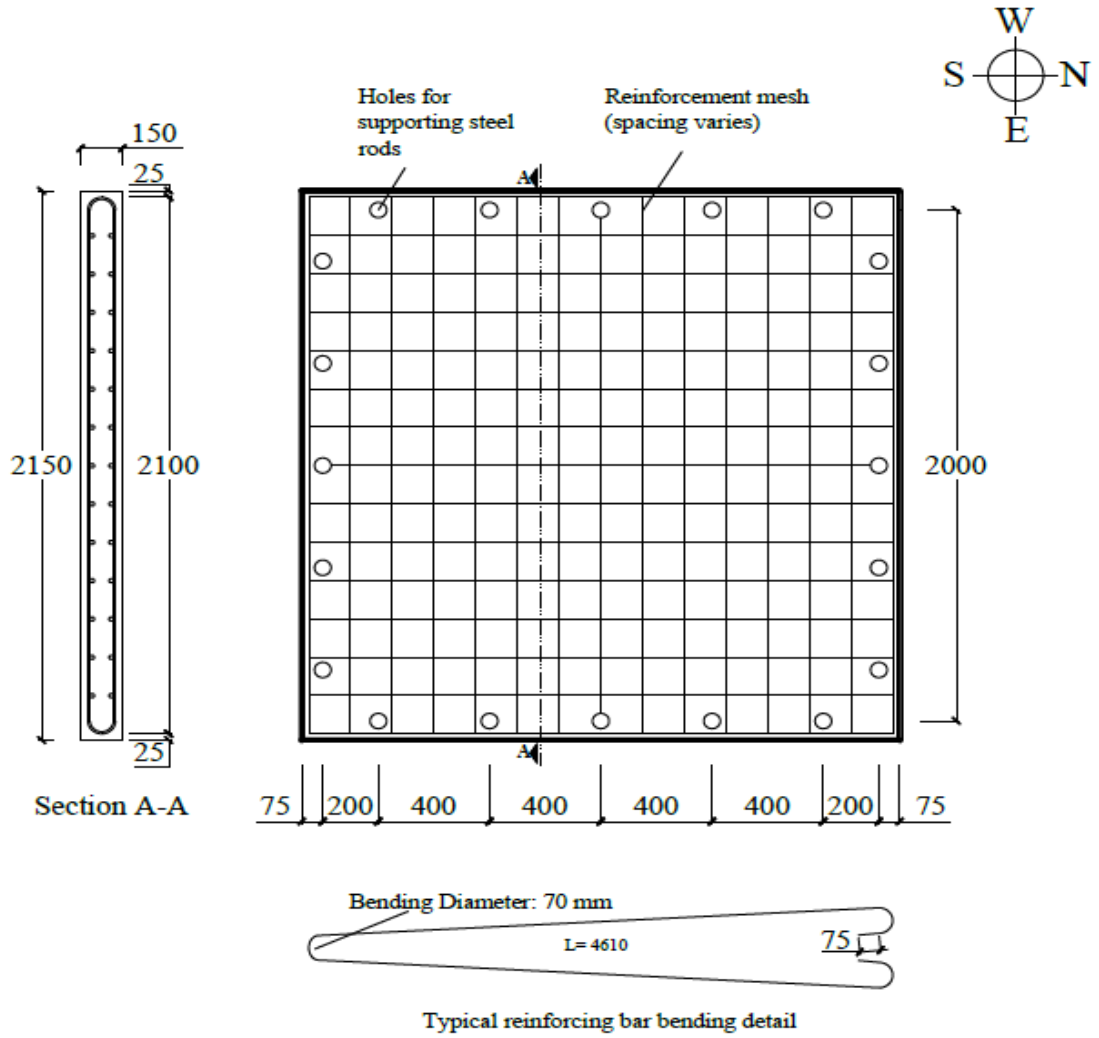
Figure 2.4 Test specimens (all dimensions in mm)
(Saatcı et al, 2018)

Saatcı et al (2018) evaluated the effect of steel fibers on the punching behavior of reinforced concrete slabs. Eight slab specimens were cast in two groups of flexural reinforcement ratio as 0.4 % (D1 series) and 0.2% (D2 series) in two orthogonal directions (Figure 2.4). Both groups had four specimens with varying steel fiber volume content (0.0, 0.5, 1.0, and 1.5%). Simply supported conditions were provided and specimens were loaded by hydraulic jack placed at the bottom of the slabs. The load was applied at the center of the specimen through a circular steel plate of 200 mm diameter.

From the results, it was concluded that the punching shear capacity of both series were increased as the steel fiber ratio increased. The load capacity was increased up to two times compared to reference specimen. The steel fiber ratio had more influence on displacement capacity of the slabs with high reinforcement ratio than the slabs with low reinforcement ratio (Figure 2.5). It was found that flexural reinforcement yielded before punching in slabs with low reinforcement ratio, so the yielding of the bending reinforcement was controlling the displacement capacity in these specimens.

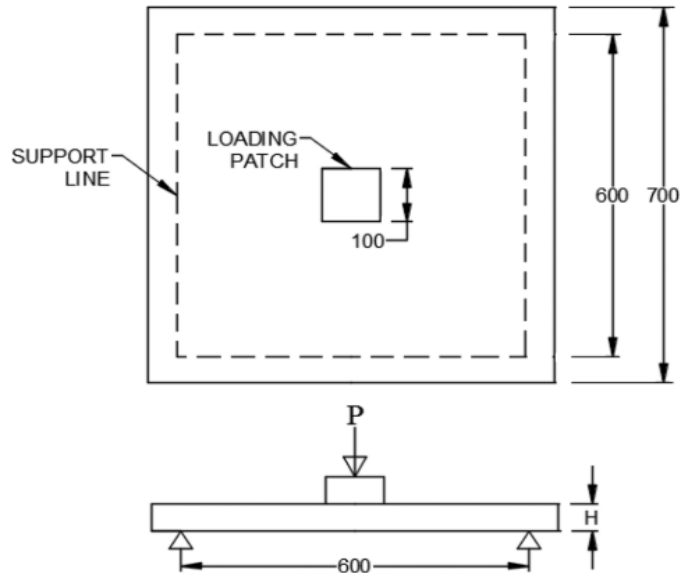
Figure 2.6 Central point load tests on SFRC slabs (Note: All dimensions are in mm)
(Tan & Venkateshwaran, 2019)

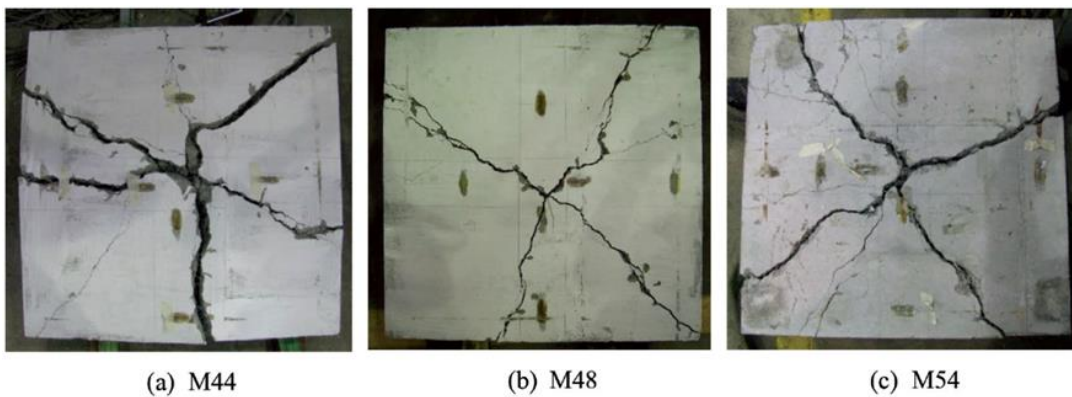
Figure 2.7 Crack patterns on underside of SFRC slabs
(Tan & Venkateshwaran, 2019)

Based on the test results, all slabs specimens failed in flexure, as seen from formation of yield lines at the bottom of the specimens (Figure 2.7). According to the authors, the occurrence of flexural failure was attributed to the lower energy needed to propagate an existing flexural crack than for the development of a new tangential crack around the column edge.

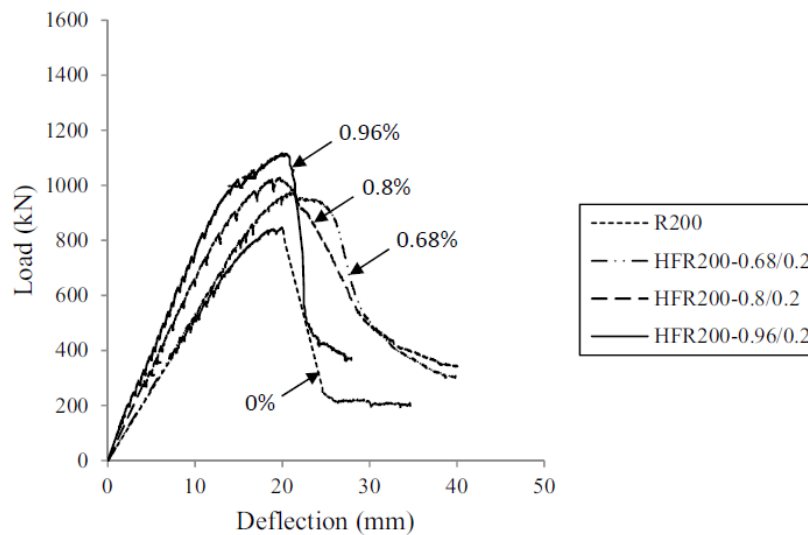
Figure 2.12 Load–deflection characteristics of group 1
(Ramin, 2014)

The study revealed that the presence of fibers had more substantial effect on the stiffness and mode of failure of 200 mm-thick slabs than 250 mm-thick slabs, as seen in load-deformation curves shown in Figure 2.12 & Figure 2.13. Addition of fibers increased the ductility, stiffness, and energy-absorption capacities. Ultimate capacity of slabs with fiber content of 0.68, 0.8, and 0.96 % was increased by 15, 22, and 32%, respectively, compared to 200 mm thick reference slab. For the same amount of fibers, punching load capacity was increased by 20, 14, and 20% for 250 mm-thick slabs, respectively.

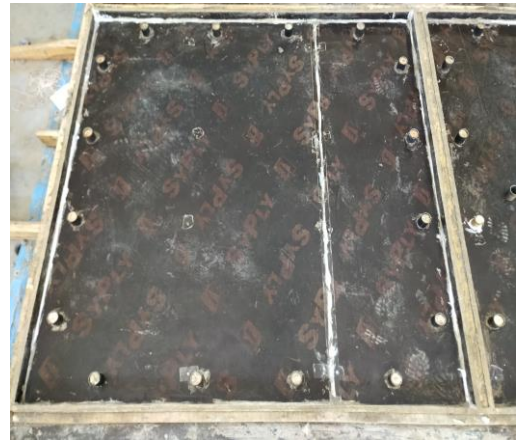
Figure 3.3 Formworks

b) Pieces for supporting holes

Two formworks were fabricated side by side in structural lab at Izmir Institute of Technology (IYTE) (Figure 3.3 a). Sixteen pieces of wood were nailed in the formworks and covered by steel pipes to create supporting holes that would be used to fix the specimens to the test setup (Figure 3.3 b). Also, four U-shaped reinforcement hooks were place at appropriate locations in order to ease lifting and transportation of specimens after casting.

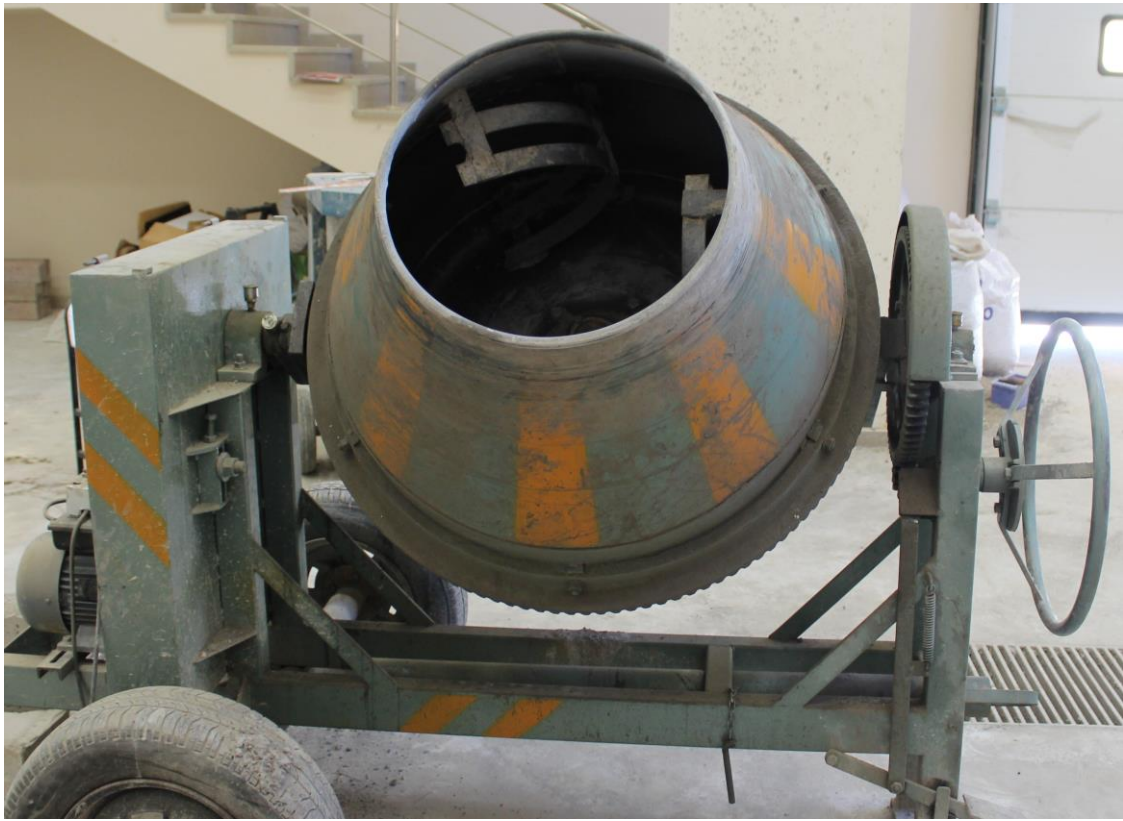
Figure 3.4 Rotating drum mixer

Concrete mixtures were prepared in materials laboratory and carried by wheelbarrows to the structural laboratory nearby. A rotating drum mixer with 200-liter capacity was used (Figure 3.4). The mixing process was performed step by step. First coarse and fine aggregate was mixed in the mixer with some of the water in order to gain a saturated surface dry condition. After then, cement and flay ash content were added, remaining water was poured into the mixer and well mixed. At the last stage, steel fibers and PVA fibers were gradually added to mixer to avoid balling of fibers (Figure 3.5). Concrete for each specimen was prepared in two parts since the mixer did not have sufficient capacity. First half of the concrete volume of mixture was prepared and poured into formwork, then the remaining half done in same manner (Figure 3.6 a). A handheld electric vibrator was used for compacting concrete (Figure 3.6 b). For each mixture, six cylinders ($\phi 150 \times 300$ mm) were cast as well, in order to determine the mechanical properties of the concrete. Specimens were covered with burlap and plastic sheets for more than two weeks for curing (Figure 3.6 d) and kept in humid environment for approximately 90 days before testing.

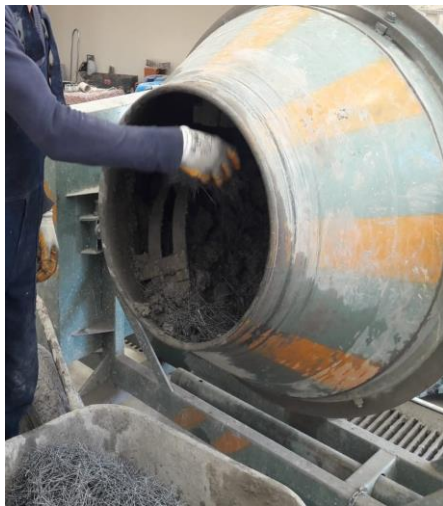
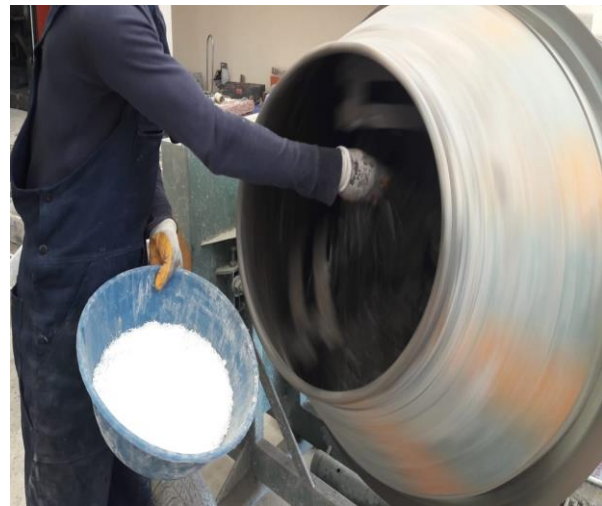
Figure 3.5 (a) Adding steel Fiber into mixer (b) Adding PVA fiber into mixer

(a)

(b)

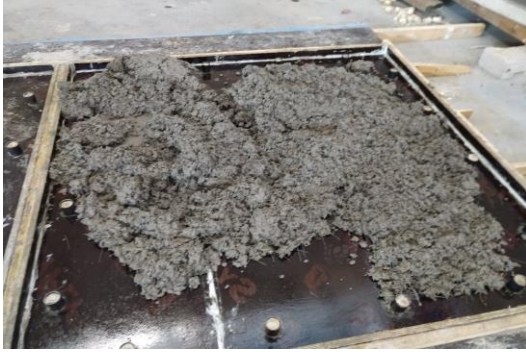
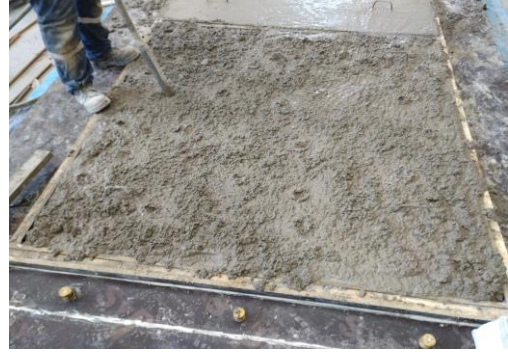
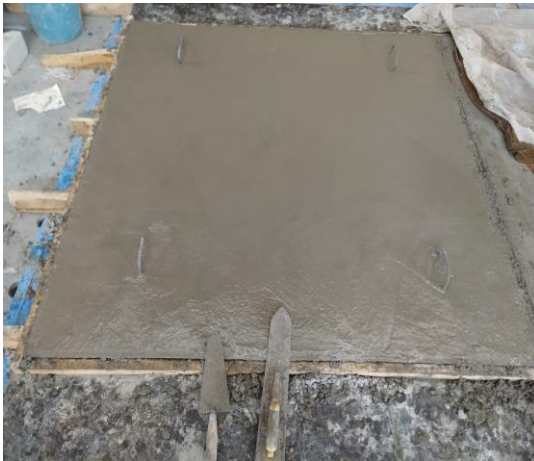
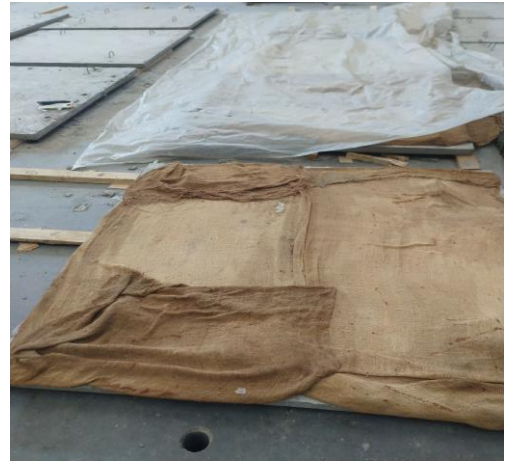
Figure 3.6 Casting of Specimens

a) Pouring half mixture into formwork

b) Compaction by handheld electric vibrator

c) Finishing

d) Burlap and plastic for covering

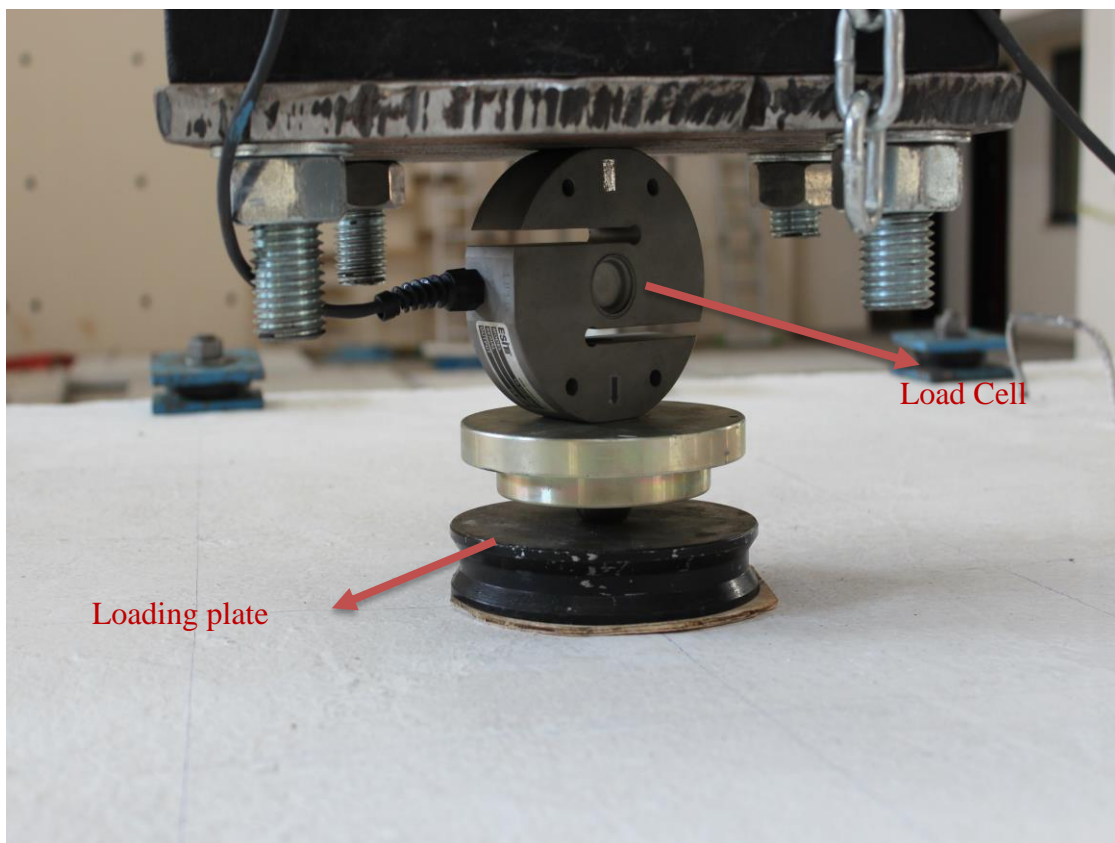
Figure 3.19 Loading plate and cell

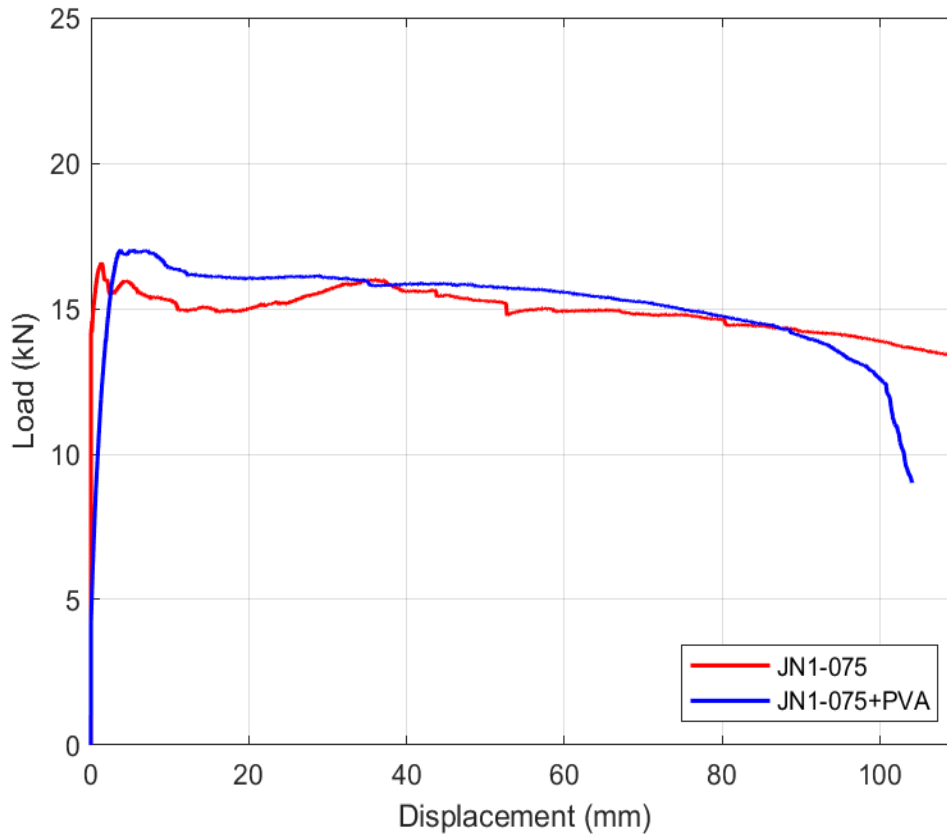
Figure 4.1 Load-midpoint deflection curve of panel JN1-075 and JN1-075 +PVA

Load-midpoint deflection curve of JN1-075 and JN1-075+PVA is shown in Figure 4.1. As seen from the figure, at the initial state, JN1-075 displayed stiffer behavior compared to JN1-075+PVA. In both panels, the applied load increased linearly with displacement. An immediate drop in the load was observed in JN1-075 after the first crack. As the crack formation stabilized, the load picked up again until after a midpoint deflection of approximately 36 mm, after which the load decreased gradually until failure. In specimen, JN1-075+PVA, the cracking load was sustained for a while, which later slightly dropped and continued to decrease gradually until failure. In both panels, punching failure was observed. The specimen without PVA showed more ductile punching failure compared to panel with PVA. However, the load capacity was slightly higher in panel with PVA until for a displacement around 87 mm. First crack observed in JN1-075 and JN1-075+PVA were approximately at 16.6 kN and 17 kN, respectively, which were almost the peak loads as well in both specimens. In specimen JN1-075,

absorption energy capacity was higher than the JN1-075+PVA and the increase in absorption capacity was about 14.3 %.

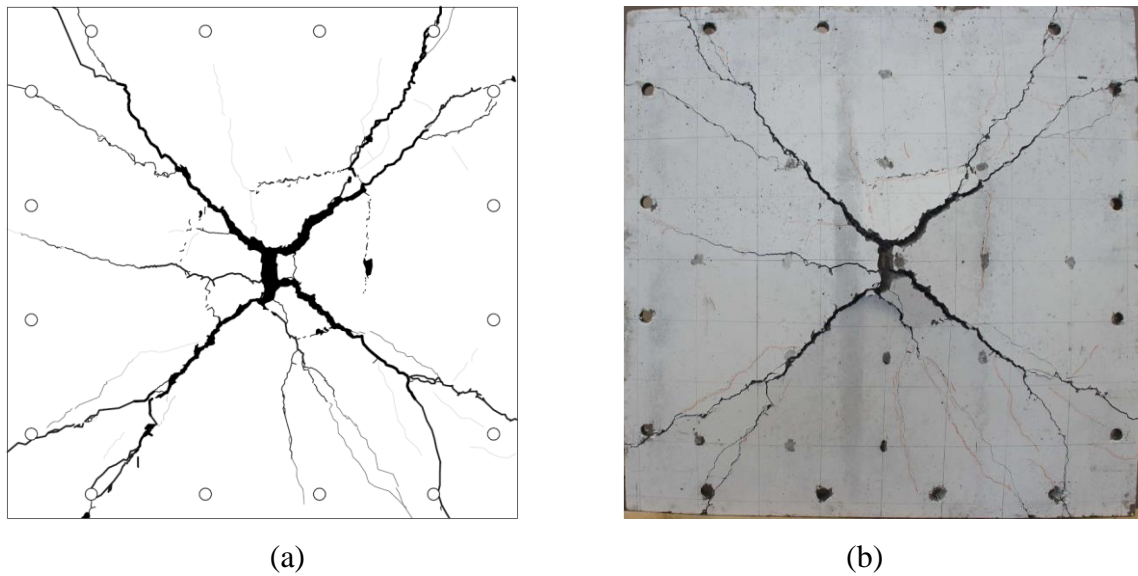
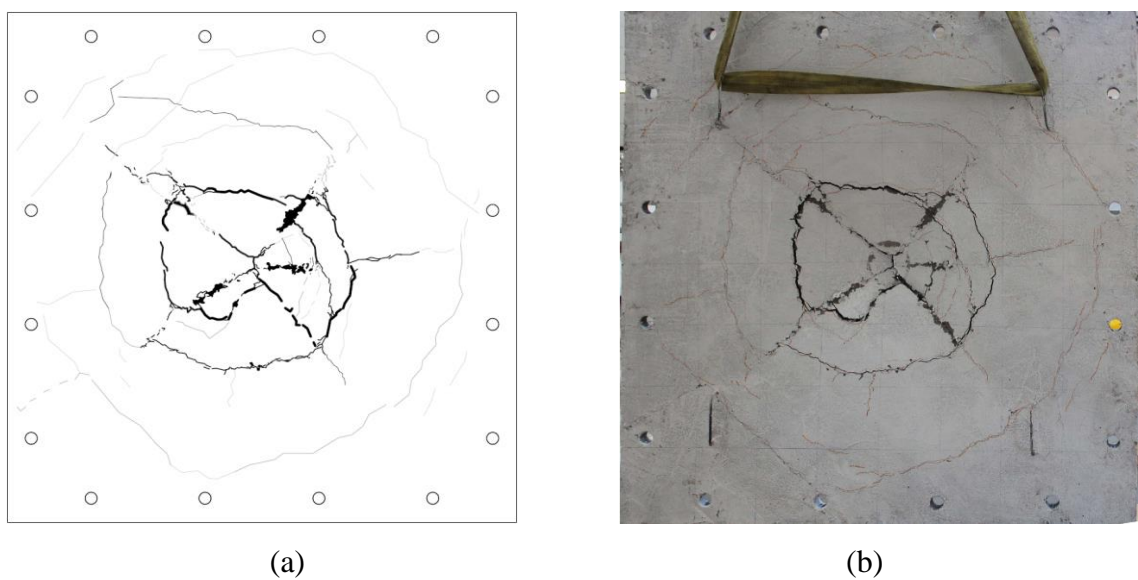
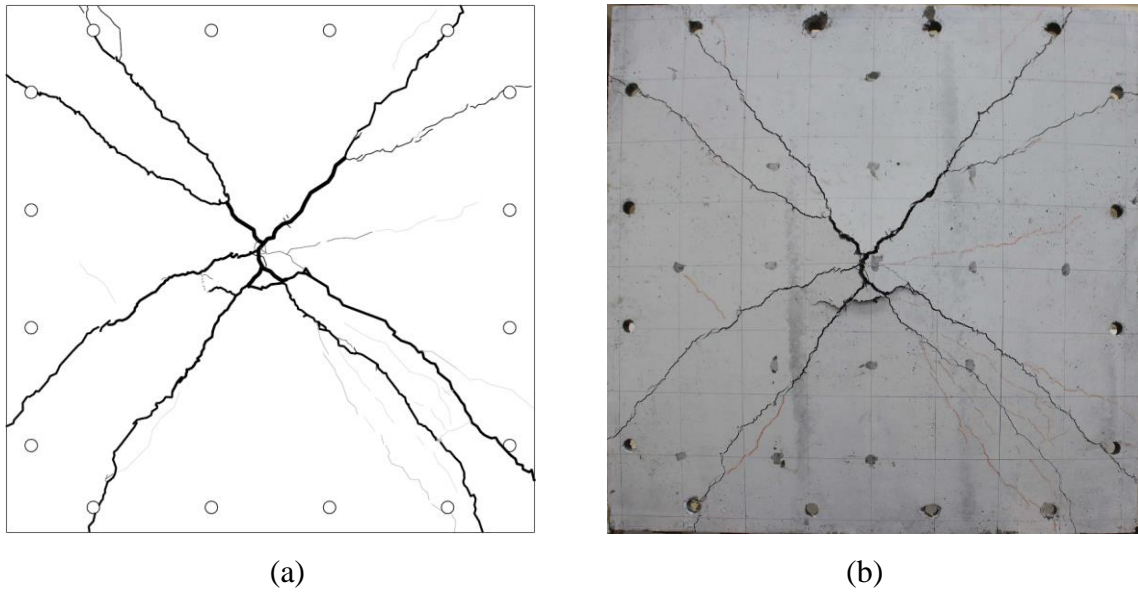
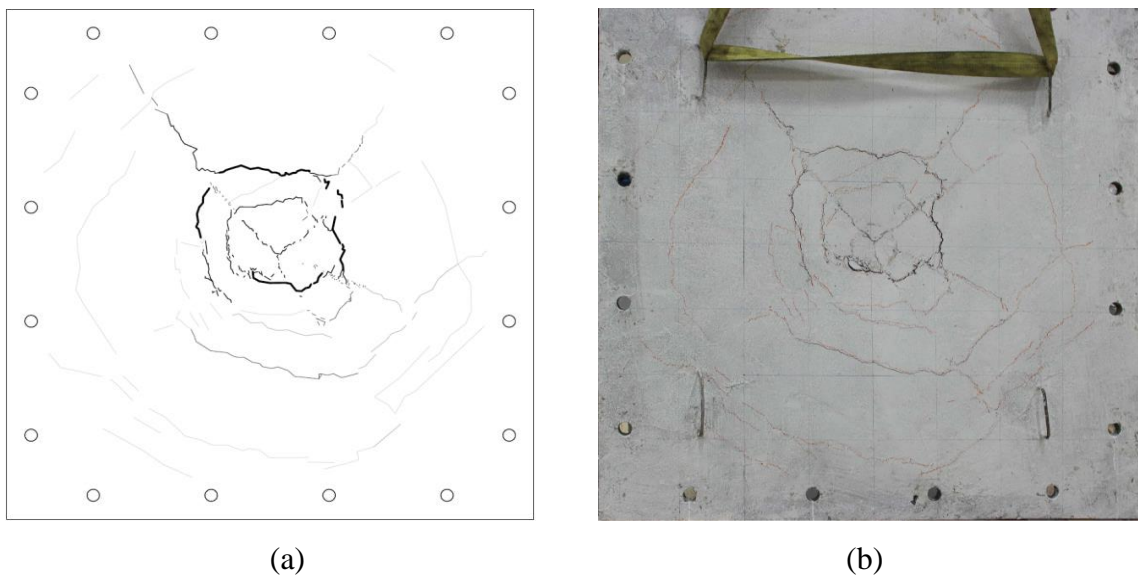
Figure 4.2 Bottom surface crack patterns after testing for panel JN1-075

Figure 4.3 Top surface crack patterns after testing for panel JN1-075

Figure 4.4 Bottom surface crack patterns after testing for panel JN1-075 +PVA

Figure 4.5 Top surface crack patterns after testing for panel JN1-075 +PVA

Crack patterns for JN1-075 and JN1-075+PVA are presented from Figure 4.2 to Figure 4.5. In both panels, JN1-075 and JN1-075 +PVA, first cracks were observed on the bottom surface at the middle extending on diagonals toward the corners of the panels. As load was increased, in panel JN1-075 every diagonal crack divided into two at the middle of the cracks and passed near by the corner supports. However, in specimen JN1-075+PVA two of the diagonal cracks were similar with the one in panel JN1-075, and the other two, a parallel crack occurred with each crack from the center and passed near by the corner supports. In panel, JN1-075 two more cracks were observed between the diagonal cracks. In both panels, only one of the diagonal cracks were spread into small cracks. As the flexure cracks became wider, tangential cracks start to form on the top surface. In panel JN1-075 +PVA, the cracks were nearer to the steel plate than in the panel

JN1-075. The circular punching cracks occurred at the second peak load in panel JN1-075, whereas in panel JN1-075. +PVA, they occurred at a displacement around 16 mm. After the initiation of punching cracks, load started to decrease gradually in both panels. When the punching cone began to separate, decrease in load was faster in panel JN1-075+PVA than in panel JN1-075. Finally, both specimens failed by punching as clearly seen from the punching cone in Figure 4.2 to Figure 4.5.

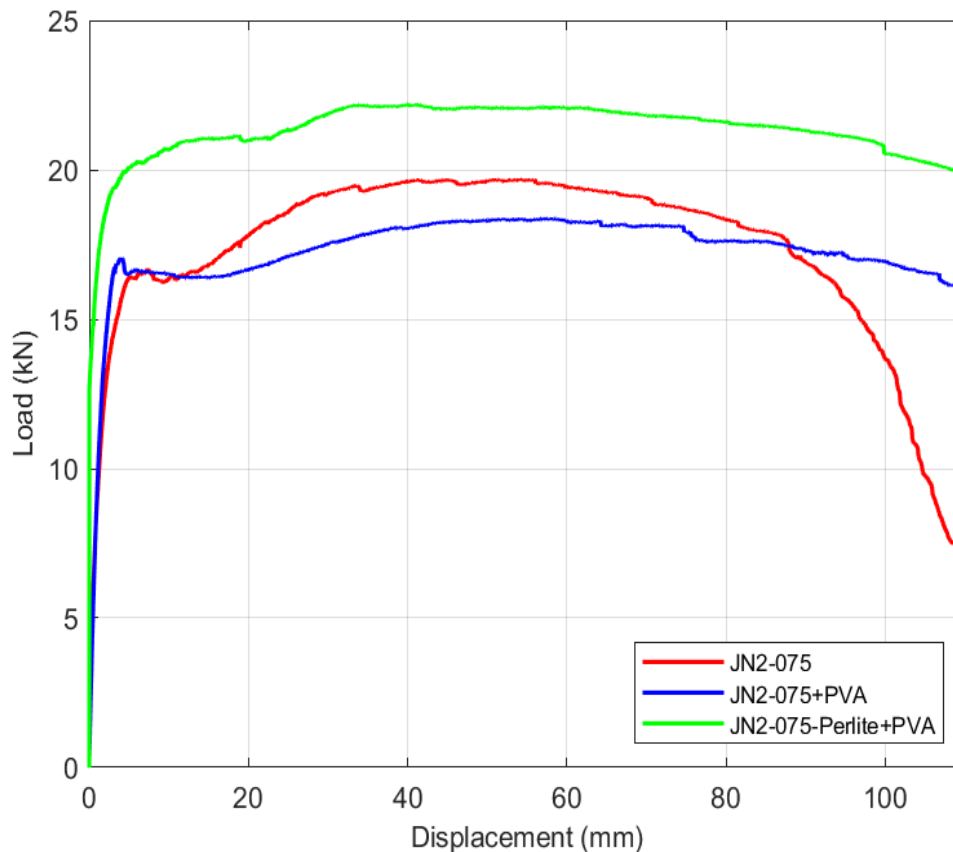
Figure 4.6 Load-midpoint deflection curve for panels JN2-075, JN2-075+PVA and JN2-075-Perlite+PVA

Load-midpoint deflection curve of panels JN2-075, JN2-075+PVA and JN2-075_Perlite+PVA are presented in Figure 4.6. Up to first cracking, panels JN2-075 and JN2-075+PVA had almost same initial elastic behavior as applied load increased linearly with displacement. However, Panel JN2-075-Perlite+PVA displayed stiffer behavior.

Cracking load capacity was slightly higher in JN2-075+PVA compared to JN2-075. The panels JN2-075 and JN2-075_Perlite+PVA displayed more ductile behavior than the panel JN2-075+PVA. A gradual punching failure was observed in panels JN2-075 and JN2-075-Perlite+PVA. However, JN2-075+PVA failed in gradual flexural punching.

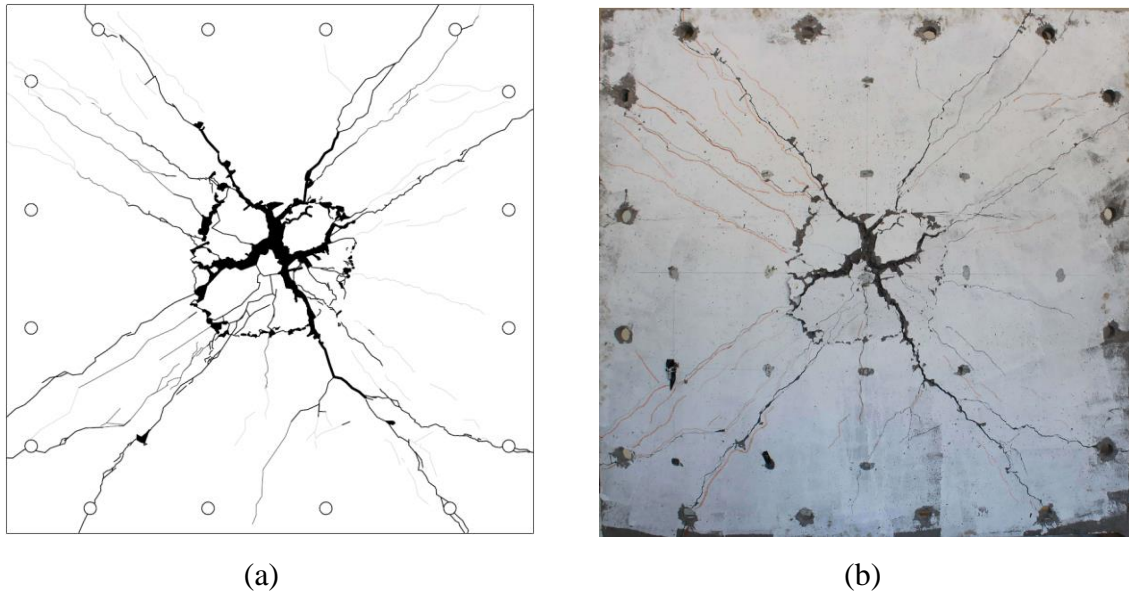
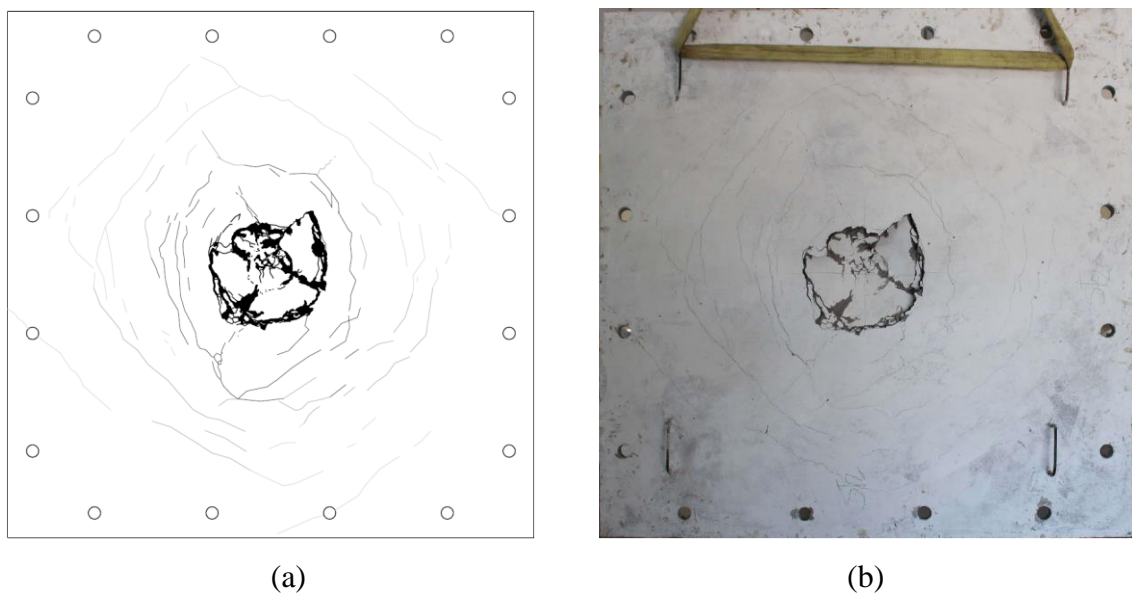
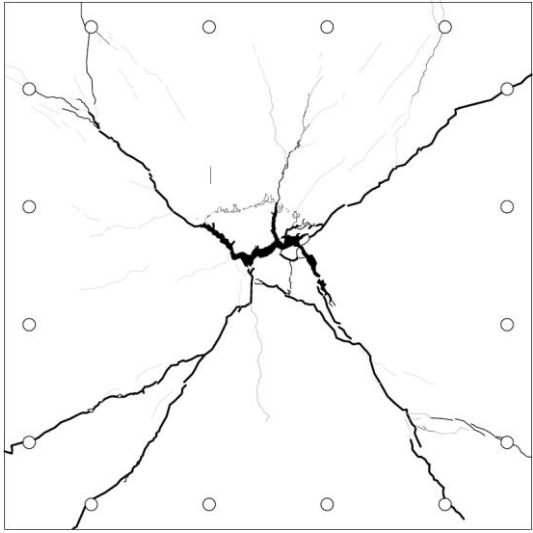
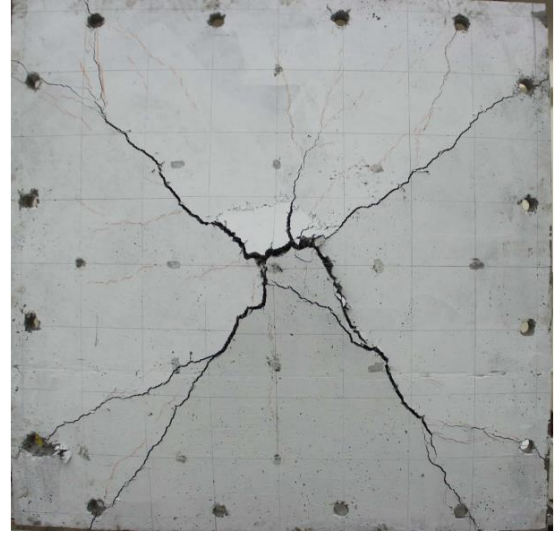
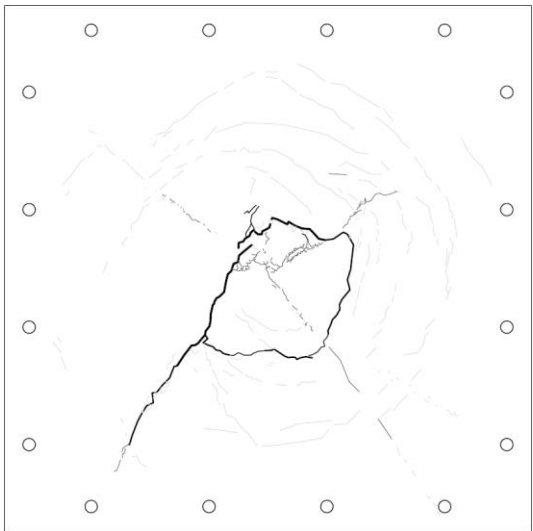
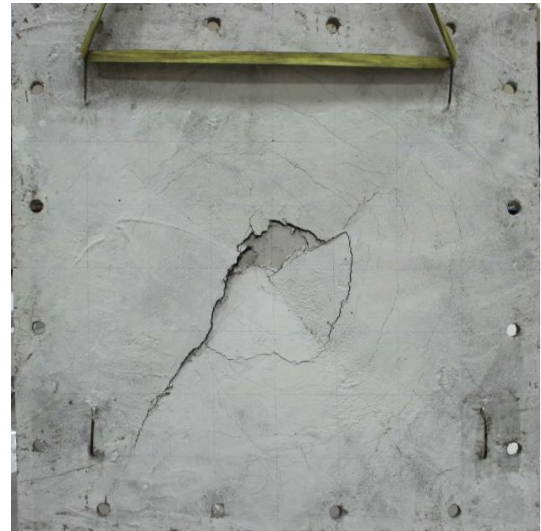
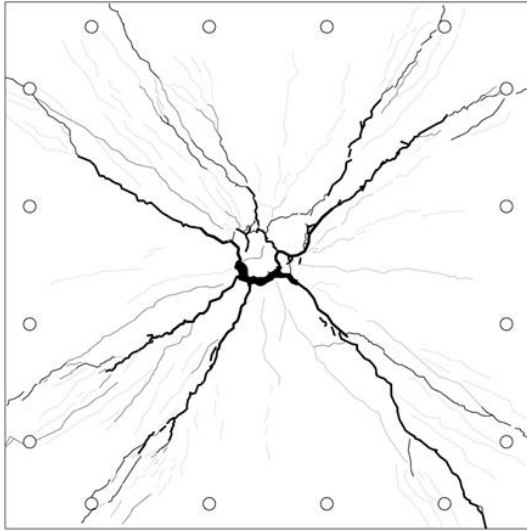
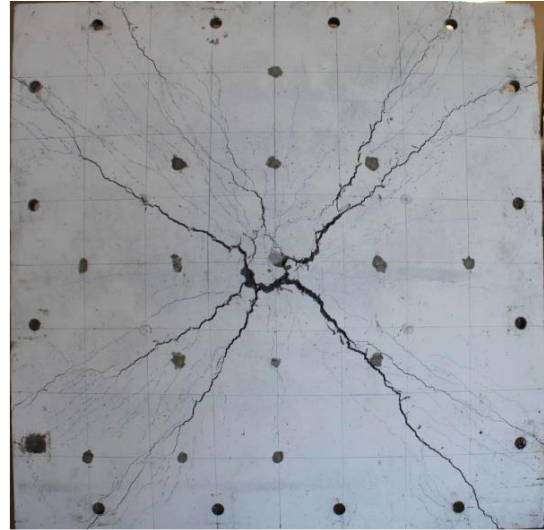
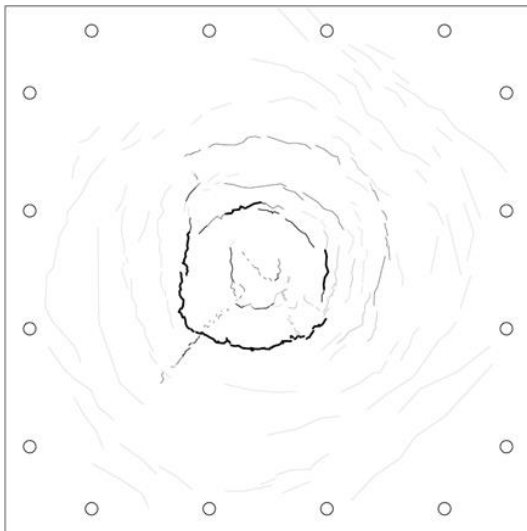
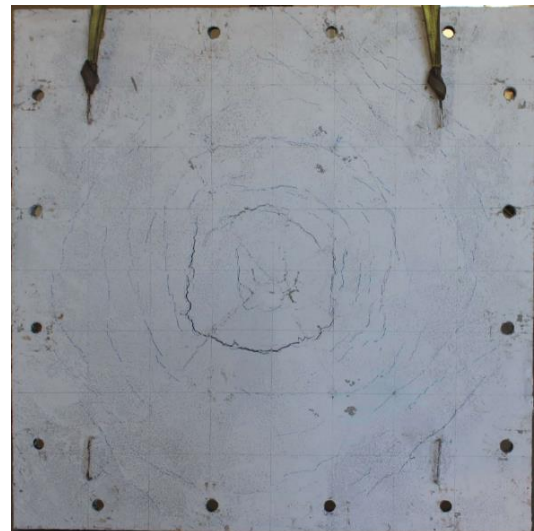
Figure 4.7 Bottom surface crack patterns after testing for panel JN2-075

Figure 4.8 Top surface crack patterns after testing for panel JN2-075

Figure 4.9 Bottom surface crack patterns after testing for panel JN2-075+PVA

Figure 4.10 Top surface crack patterns after testing for panel JN2-075+PVA

Figure 4.11 Bottom surface crack patterns after testing for panel JN2-075-Perlite+PVA

Figure 4.12 Top surface crack patterns after testing for panel JN2-075-Perlite+PVA

Crack patterns observed after tests are presented from Figure 4.7 to Figure 4.12. In specimen JN2-075+PVA, cracks on the bottom surface formed diagonal flexural yield lines and did not show extensive spreading. However, in specimen JN2-075 and JN2-075-Perlite+PVA, numerous small cracks propagated concentrating on the diagonals. The cracks in panel JN2-075+PVA were wider compared to panels JN2-075 and JN2-075_Perlite+PVA. As displacements increased, circumferential cracks on the top surface began around loading plate. In panel JN2-075 and JN2-075-Perlite+PVA, a punching cone was observed, which indicate a punching failure of the specimens. However, in

panel JN2-075, flexural cracks were wider and one of the diagonal cracks extended through the top surface and join the punching cone. So, it was not clear whether the panel failed in pure flexure or flexure-punching.

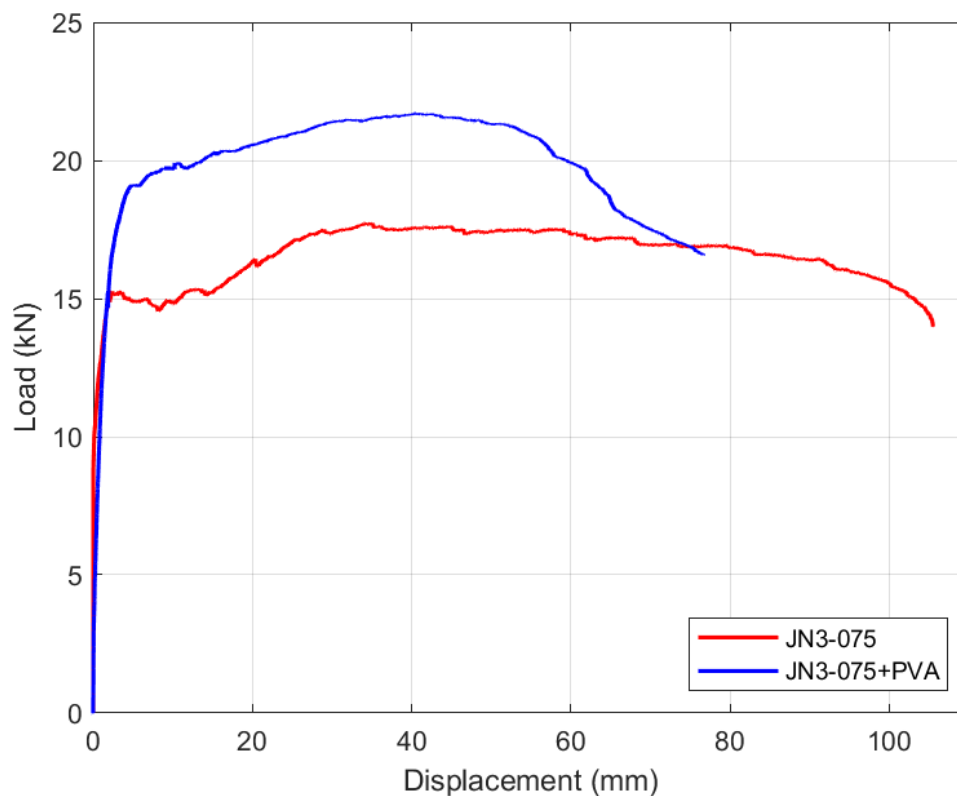
Figure 4.13 Load–midpoint deflection curve of panels JN3-075 and JN3-075+PVA

As seen from the load–midpoint deflection curve in Figure 4.13, the applied load capacity was higher in panel JN3-075+PVA compared to panel JN3-075. First crack load appeared in panels JN3-075 and JN3-075+PVA were around 15 kN and 19.1 kN at displacements of 2 mm and 4.8 mm relatively. The maximum load in panels JN3-075 and JN3-075+PVA were 17.7 kN and 21.7 kN at displacements of 23.7 mm and 28.5 mm, respectively. Specimen JN3-075 experienced punching failure while flexure failure was observed in specimen JN3-075+PVA.

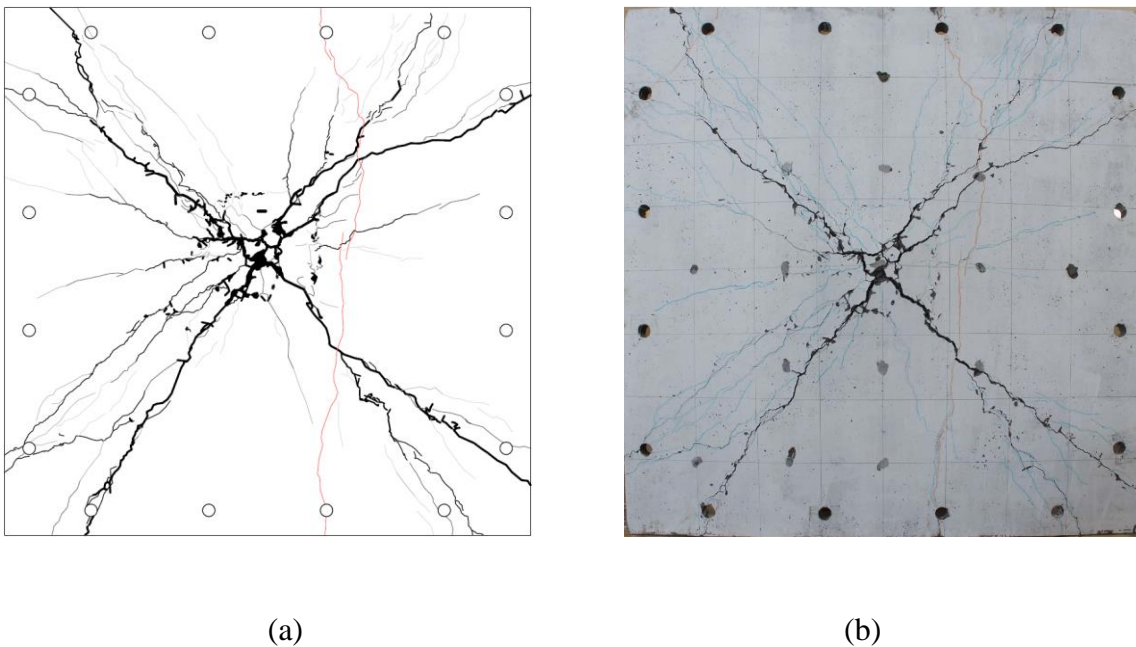
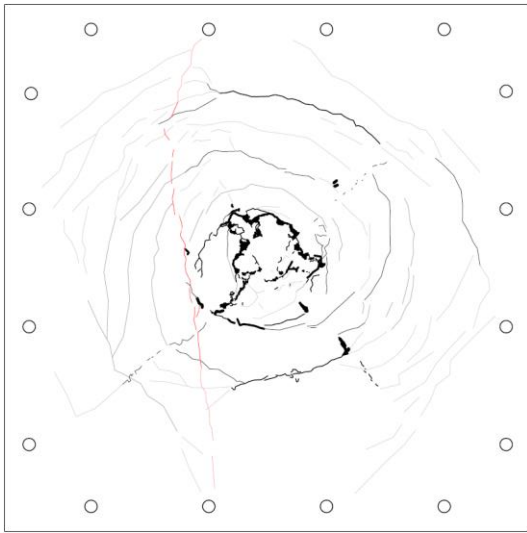
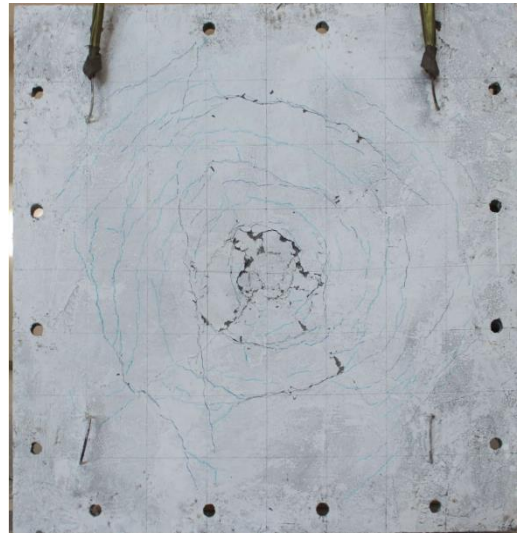
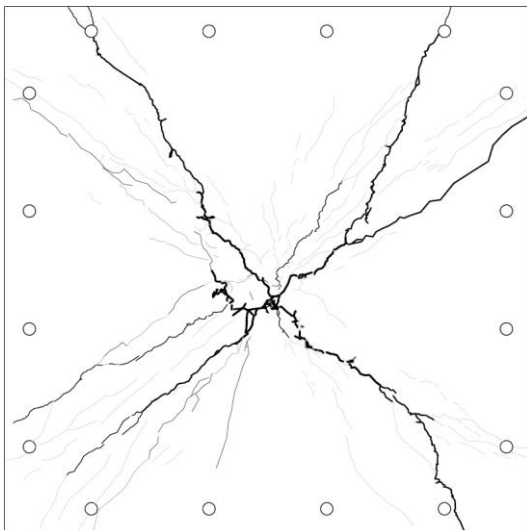
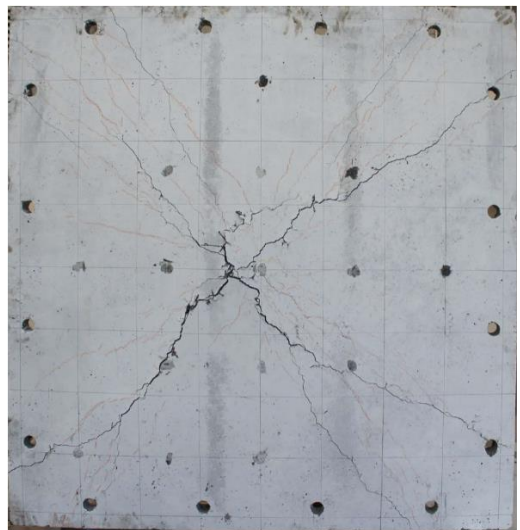
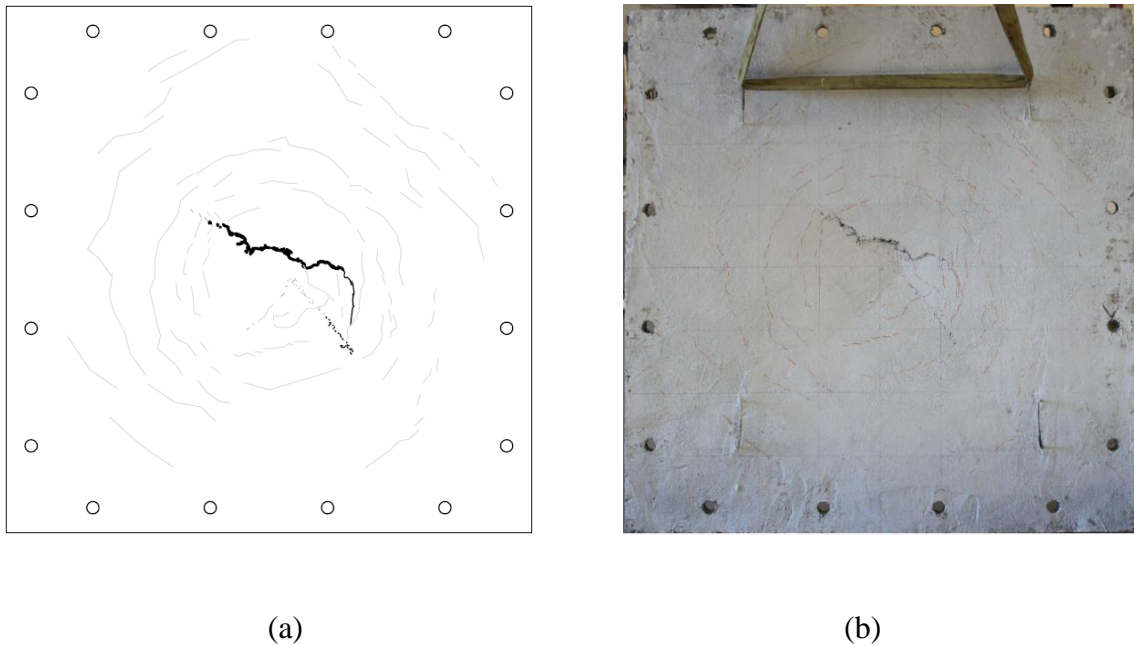
Figure 4.14 Bottom surface crack patterns after testing for panel JN3-075

Figure 4.15 Top surface crack patterns after testing for panel JN3-075

Figure 4.16 Bottom surface crack patterns after testing for panel JN3-075+PVA

Figure 4.17 Top surface crack patterns after testing for panel JN3-075+PVA

Cracks on the tension (bottom) surface of both panel JN3-075 and JN3-075+PVA started from mid-point and extended toward the corners. With increasing load, cracks in both panels spread widely, although still concentrated on diagonals. In specimen JN3-075, some cracks appeared at the center as well. In panel JN3-075, an extra crack was observed on the top surface, similar to the existing crack due to earlier damage. Width of the tangential cracks in panel JN3-075 were larger compared to specimen JN3-075+PVA. Punching cone in specimen JN3-075 indicating the punching failure. However, in JN3-075 +PVA no sign of the punching cone was observed, even one of the diagonal cracks extended through the top surface which shows flexural failure of the specimen. Cracks on bottom and top sides of the specimens JN3-075 and JN3-075+PVA are presented from Figure 4.14 to Figure 4.17.
