**PUNCHING BEHAVIOR OF HYBRID FIBER
REINFORCED CONCRETE PANELS**

**A Thesis Submitted to
the Graduate School
İzmir Institute of Technology
In Partial Fulfillment of the Requirements for the Degree of**

in Civil Engineering

**by
Jamalullah NASERI**

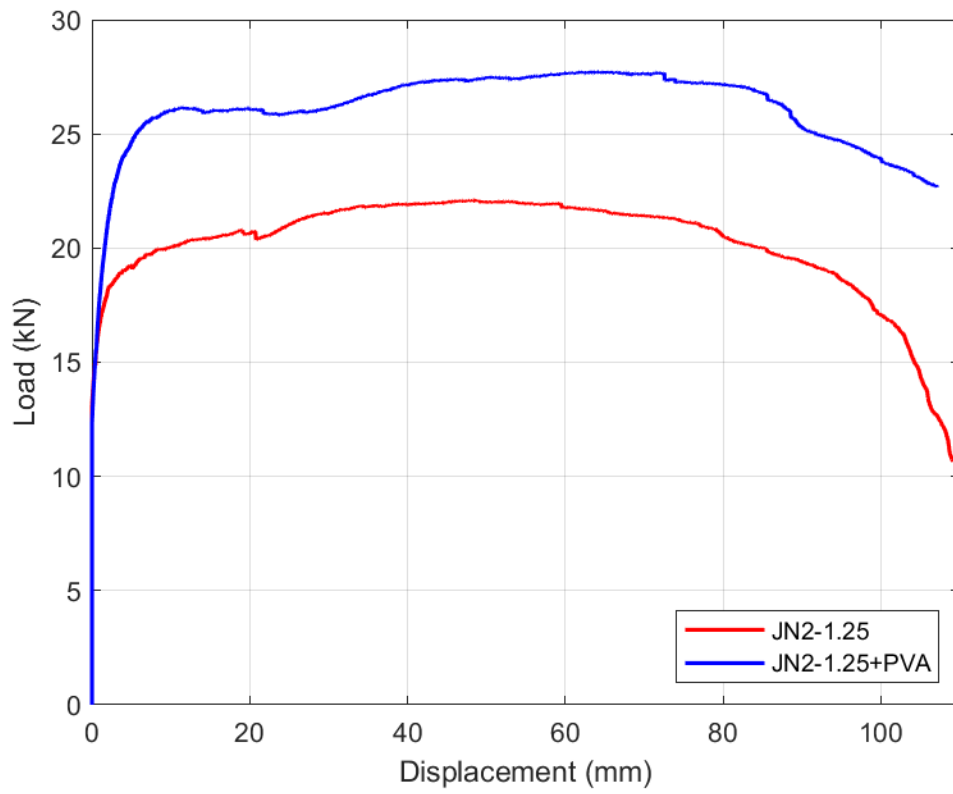
Figure 4.18 Load–midpoint deflection curve of panels JN2-1.25 and JN2-1.25+PVA

Load-midpoint deflection curves of JN2-125 and JN2-125+PVA are shown in Figure 4.18. Specimen JN2-125+PVA sustained a higher load deformation capacity compared to specimen JN2-125. Both specimens had similar load displacement behavior until about 15 kN, after which stiffness of panel JN2-125 began to decrease. Maximum load in panels JN2-125 and JN2-125+PVA were 22.1 kN and 27.5 kN at displacements of 32.7 and 43.8 mm, respectively. Energy absorption capacity was 35.9 % higher in specimen JN2-125+PVA than specimen JN2-125. Panel JN2-125 had a gradual punching failure, however panel JN2-1.25+PVA observed flexure-punching failure.

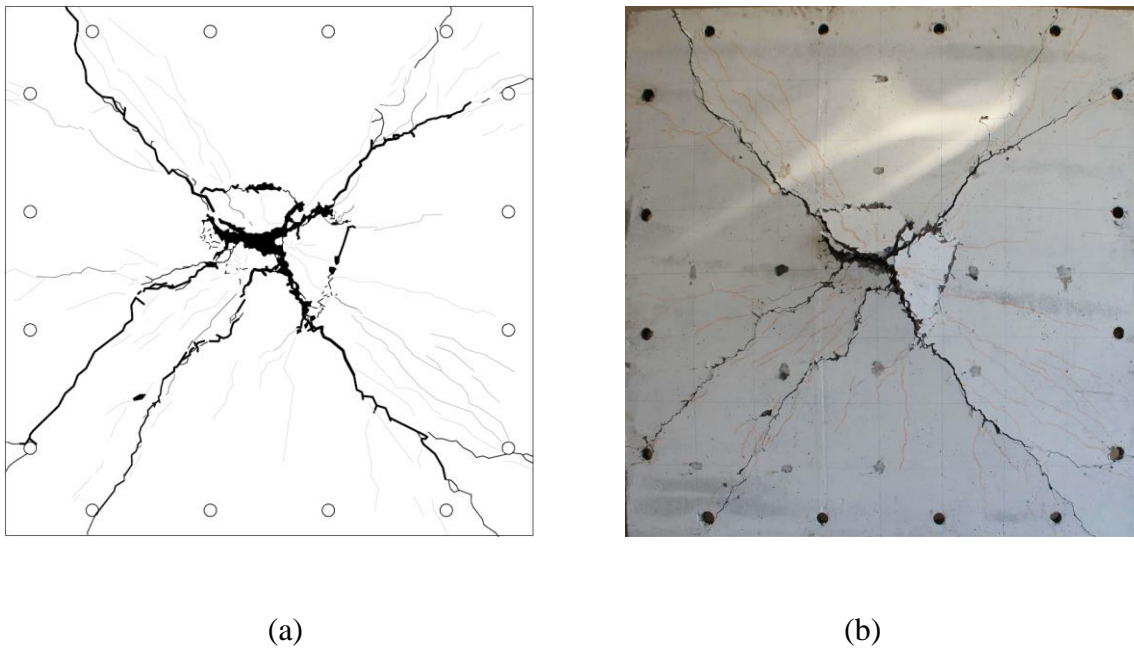
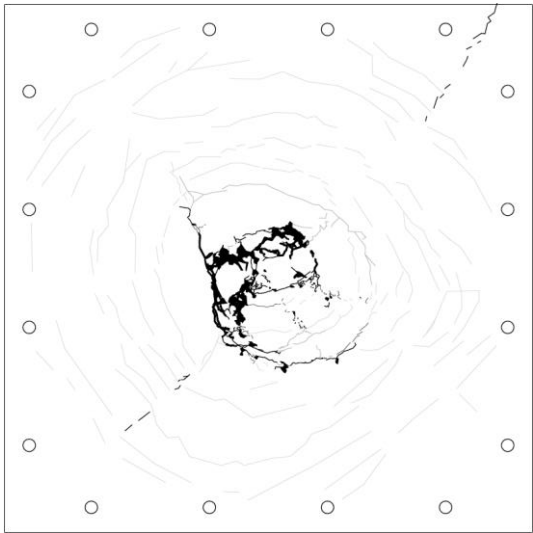
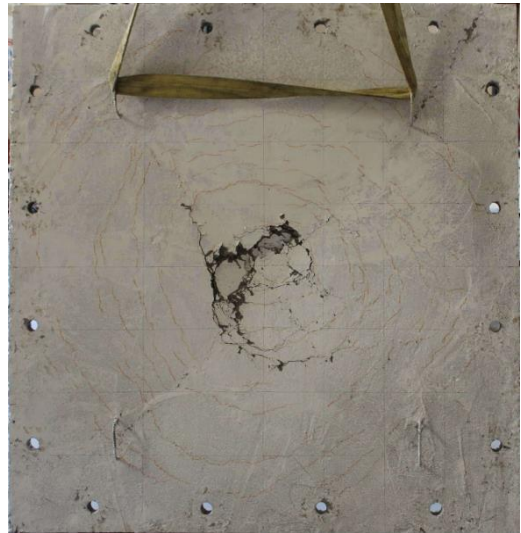
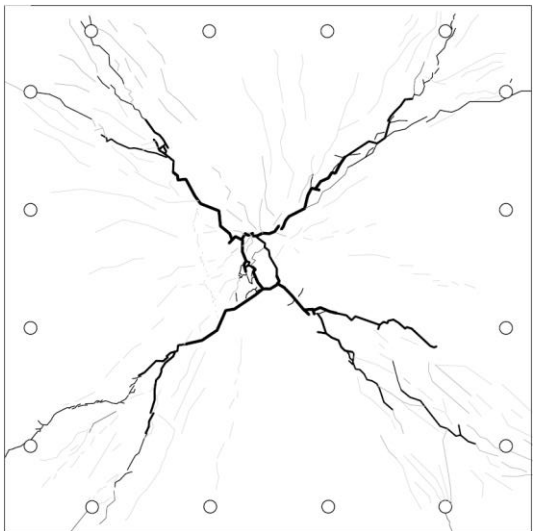
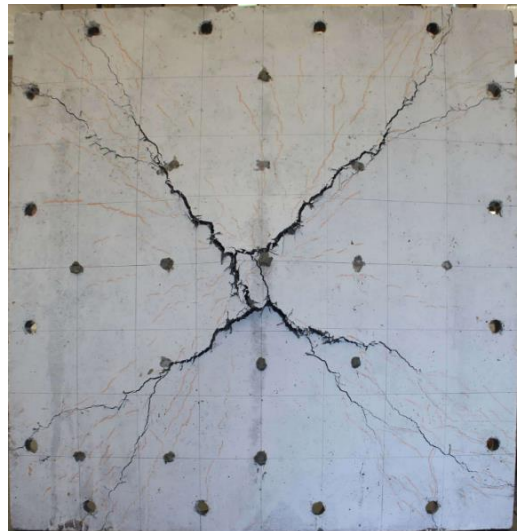
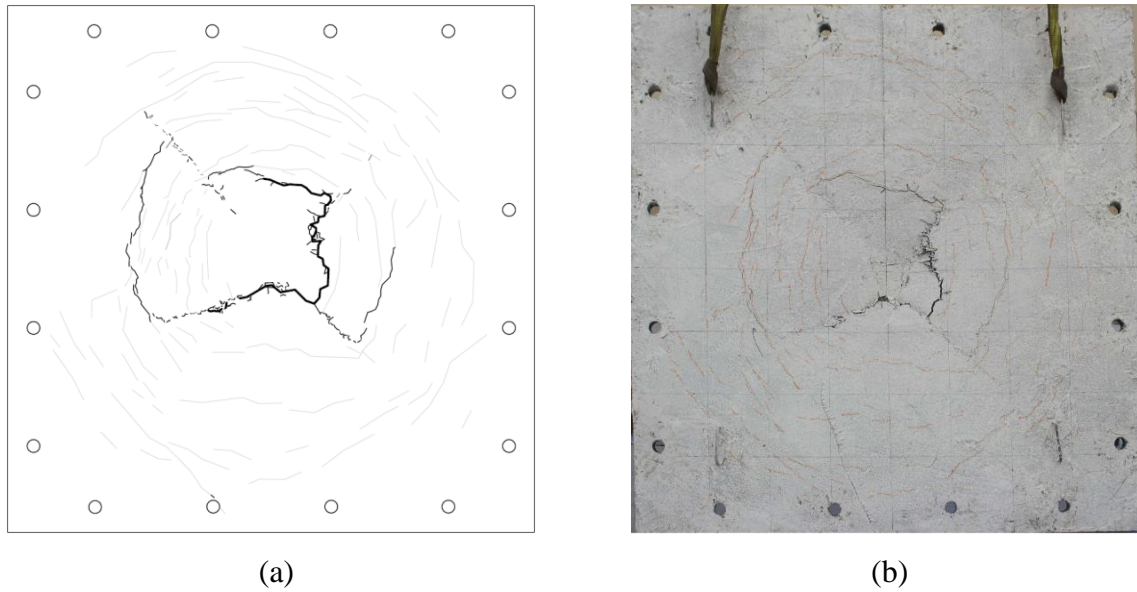
Figure 4.19 Bottom surface crack patterns after testing for panel JN2-1.25

Figure 4.20 Top surface crack patterns after testing for panel JN2-125

Figure 4.21 Bottom surface crack patterns after testing for panel JN2-125+PVA

Figure 4.22 Top surface crack patterns after testing for panel JN2-125+PVA

Crack on the tension surface of both panels JN2-125 and JN2-125+PVA formed from mid-point and extended toward the corners. As the applied load increased, cracks in both panels propagated around diagonal and some smaller cracks were observed perpendicular to edges. Punching cone in JN2-125 indicated a punching failure of the specimen. Tangential cracks on the top surface were very smaller outside of the punching cone in specimen JN2-125. A partial punching cone was observed in specimen JN2-125+PVA and the panel failed in flexure-punching. Cracks on both side of specimens JN2-125 and JN2-125+PVA are presented from Figure 4.19 to Figure 4.22.

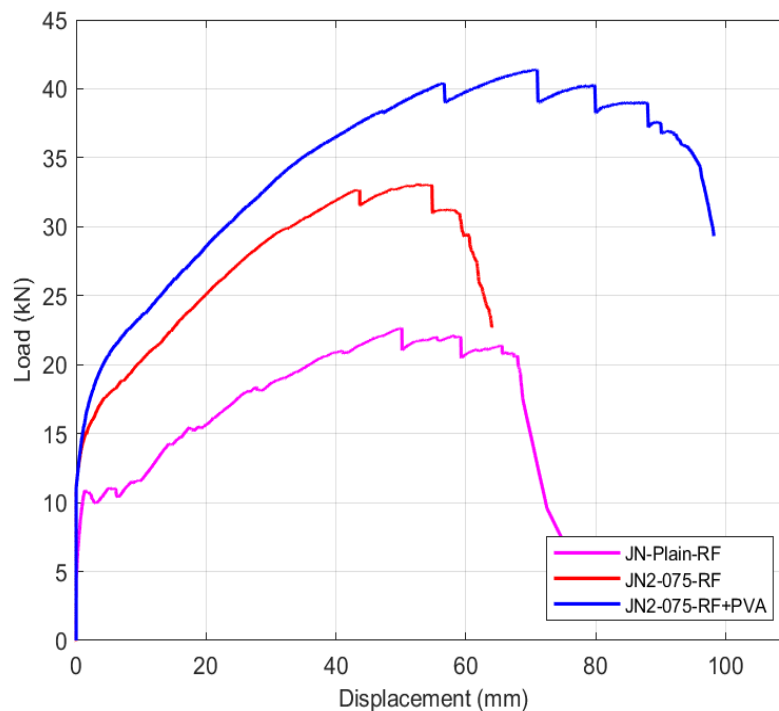
Figure 4.23 Load-midpoint deflection curve of panels with conventional reinforcement

Load-midpoint deflection curve of panels with conventional reinforcement are presented in Figure 4.23. Panels JN2-075-RF and JN2-075-RF+PVA had similar behavior up to cracking and their stiffnesses were higher in both panels compared to JN-Plain-RF panel. Stiffness significantly decreased after the first crack in all three panels. Lower stiffness was measured in JN-Plain-RF panel. Addition of steel fibers increased the stiffness by 39 % compared to JN-Plain-RF. Using PVA fibers with steel fibers increased the stiffness by an additional 4%. Specimen with PVA displayed higher load deformation capacity and more ductile behavior compared to the one with steel fibers only and Plain-RF. Punching failure was observed in all three panels. Cracking and peak loads, corresponding displacements, and energy absorption capacities for all three panels are presented in Table 4.1. Steel fiber increased energy absorption capacity by 31% compared to JN-Plain-RF and addition of PVA fibers further increased energy absorption capacity by 155.3% compared to panel JN-Plain-RF.

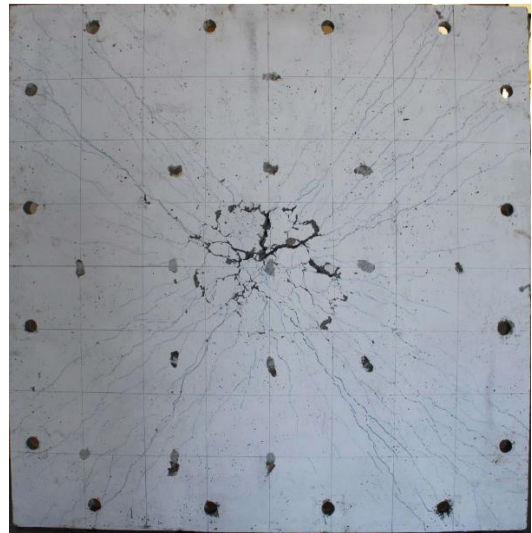
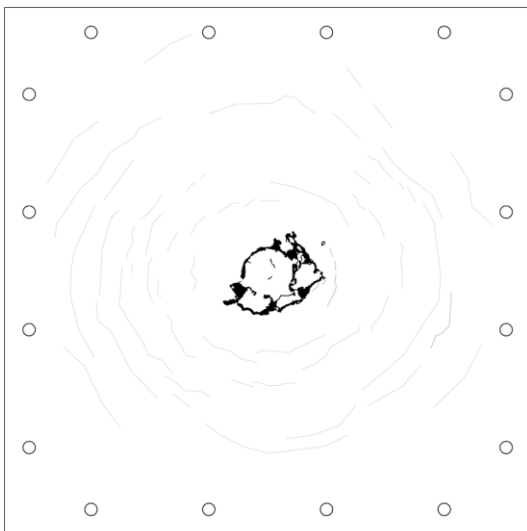
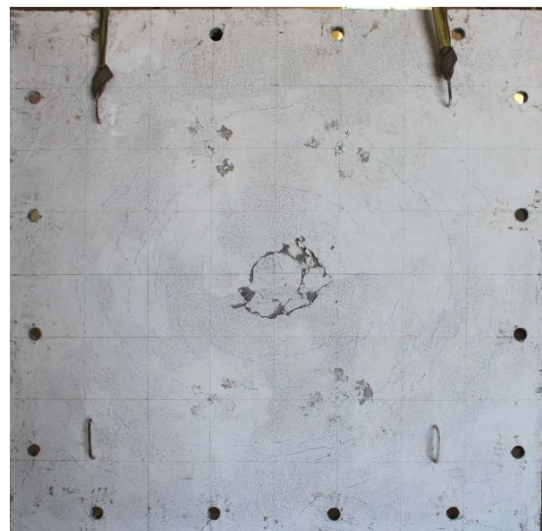
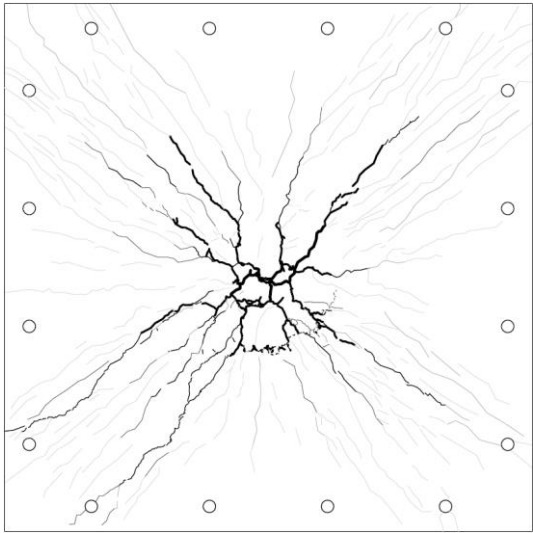
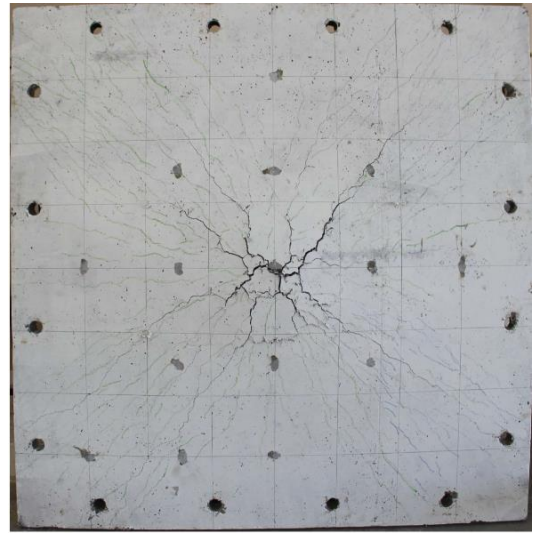
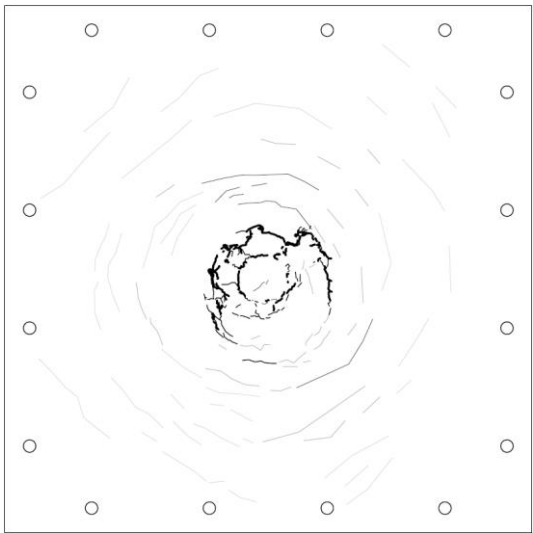
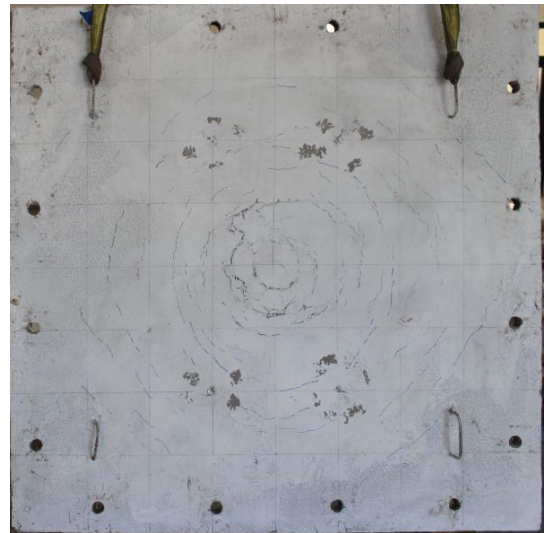
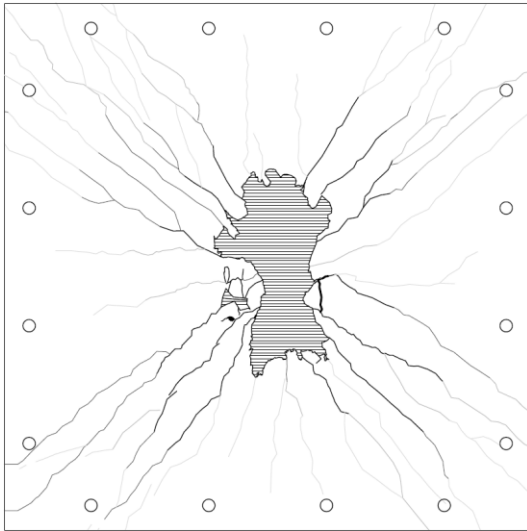
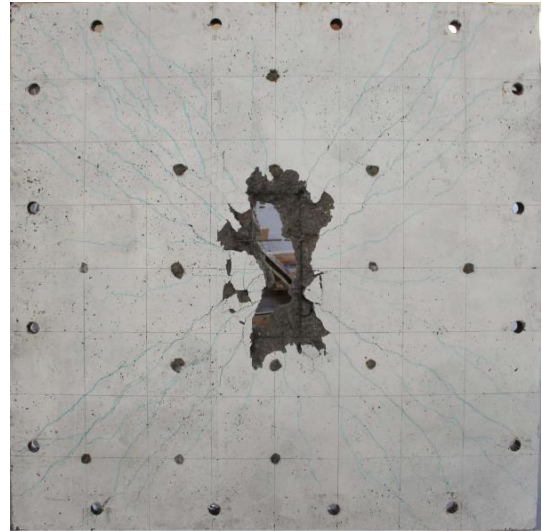
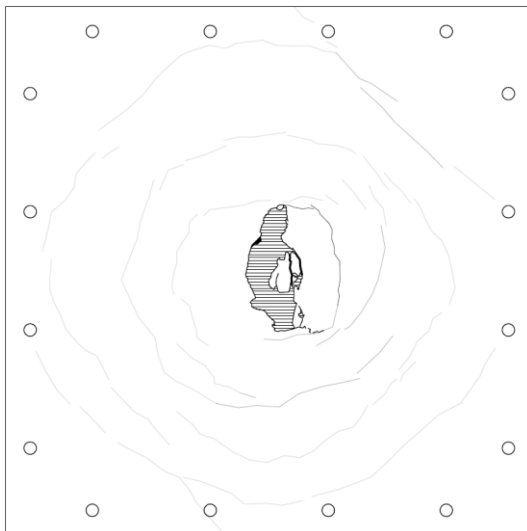
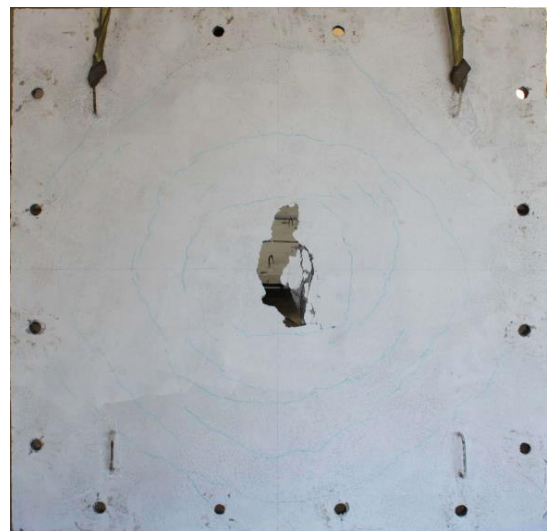
Figure 4.24 Bottom surface crack patterns after testing for panel JN2-075-RF

Figure 4.25 Top surface crack patterns after testing for panel JN2-075-RF

Figure 4.26 Bottom surface crack patterns after testing for panel JN2-075-RF+PVA

Figure 4.27 Top surface crack patterns after testing for panel JN2-075-RF+PVA

Figure 4.28 Bottom surface crack patterns after testing for panel JN-Plain-RF

Figure 4.29 Top surface crack patterns after testing for panel JN-Plain-RF

Cracks on bottom and top sides of specimens JN-Plain-RF, JN2-075-RF and JN2-075-RF+PVA are presented from Figure 4.24 to Figure 4.29. Cracks on the bottom surface of all three panels began to form at mid-point and extended toward the edges. As the applied load increased, cracks in these panels spread around diagonals. Also, with

further increasing load, new cracks developed perpendicular to edges and widely propagated. Number of cracks were higher in panel JN2-075-RF+PVA compared to other panels in this group. With increasing load, circumferential cracks formed on the top surface for both JN2-075-RF and JN2-075-RF+PVA. Near the steel loading plate, the tangential crack became excessively wide. As the load reached to the maximum level, one of the steel reinforcing bars ruptured in the punching cone zone and a sudden drop was seen in load. The load started to rise up again until a second bar ruptured. Finally, the load capacity in JN2-075-RF and JN2-075-RF+PVA panels dropped sharply, and the steel plate started to punch through. However, in panel JN-Plain-RF, the punching cone suddenly spalled and loading plate punched through.

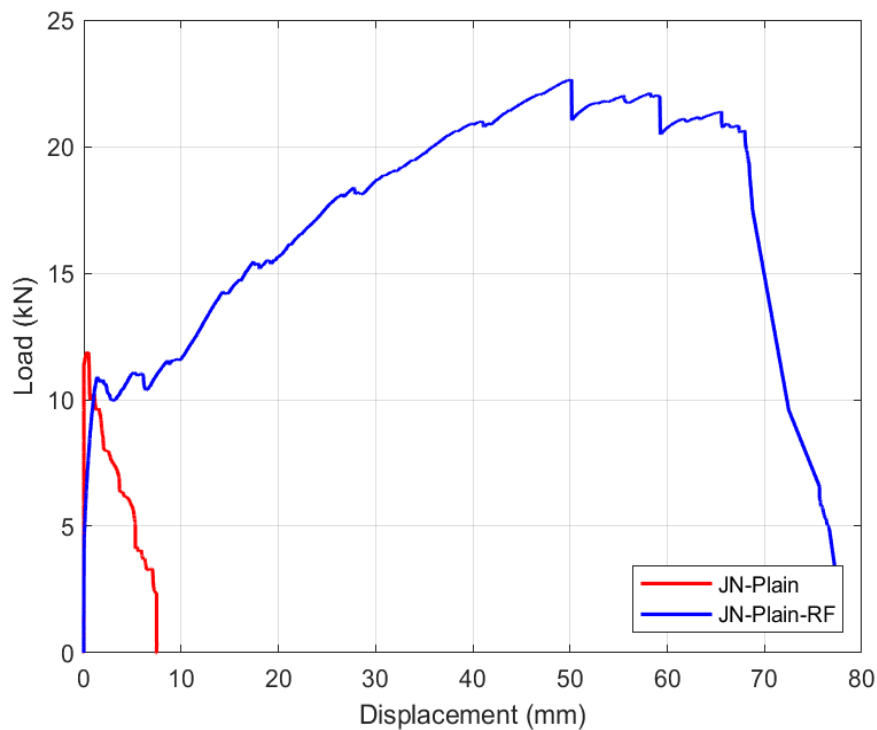
Figure 4.30 Load-midpoint deflection curves for panel JN-Plain+RF and JN-Plain

Load-midpoint deflection curves of specimens JN-Plain and JN-Plain+RF are shown in Figure 4.30. Panel JN-Plain suddenly lost its capacity with the first crack and failed in brittle manner, in which the panel fell apart (Figure 4.31). However, panel JN-Plain+RF continued to carry load after cracking. After cracking panel JN-Plain abruptly lost its stiffness, but stiffness of the panel JN-Plain+RF was sustained, although significantly decreased. Cracking load in panels JN-Plain and JN-Plain+RF were 11.9 kN and 10.9 kN, respectively. Maximum load occurred in panel JN-Plane+RF was 22.6 kN. A brittle punching failure observed in panel JN-Plain+RF. However, the panel JN-Plain failed in brittle flexure.

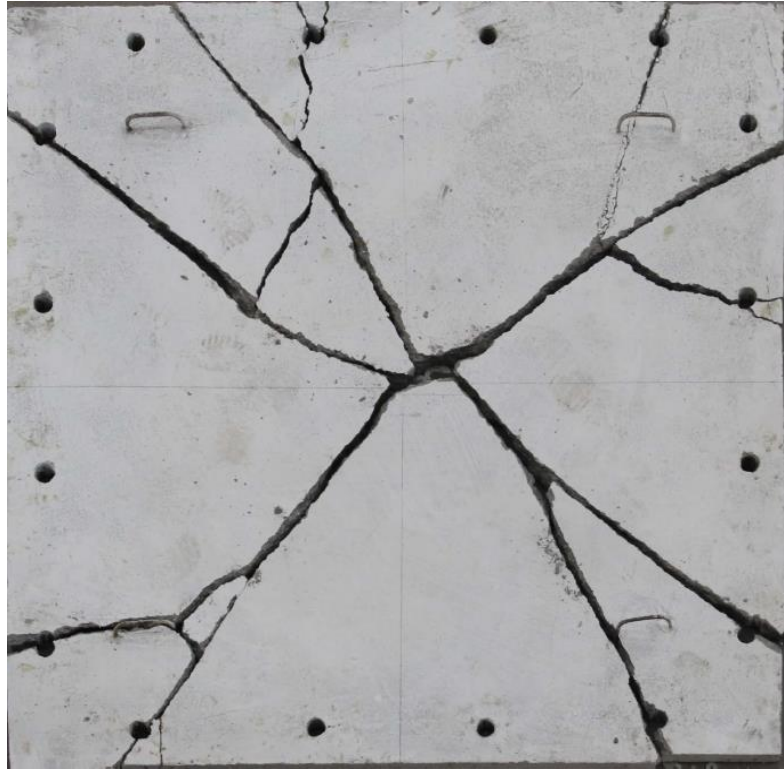
Figure 4.31 JN-plain panel after testing

Crack on the tension surface of both panels JN-Plane and JN-Plane+RF began to form at mid-point and extended toward the edges on diagonals. Panel JN-Plane failed with diagonal cracking (Figure 4.31). However, in panel JN-Plane+RF cracks were widely spread on diagonals and failed in punching.

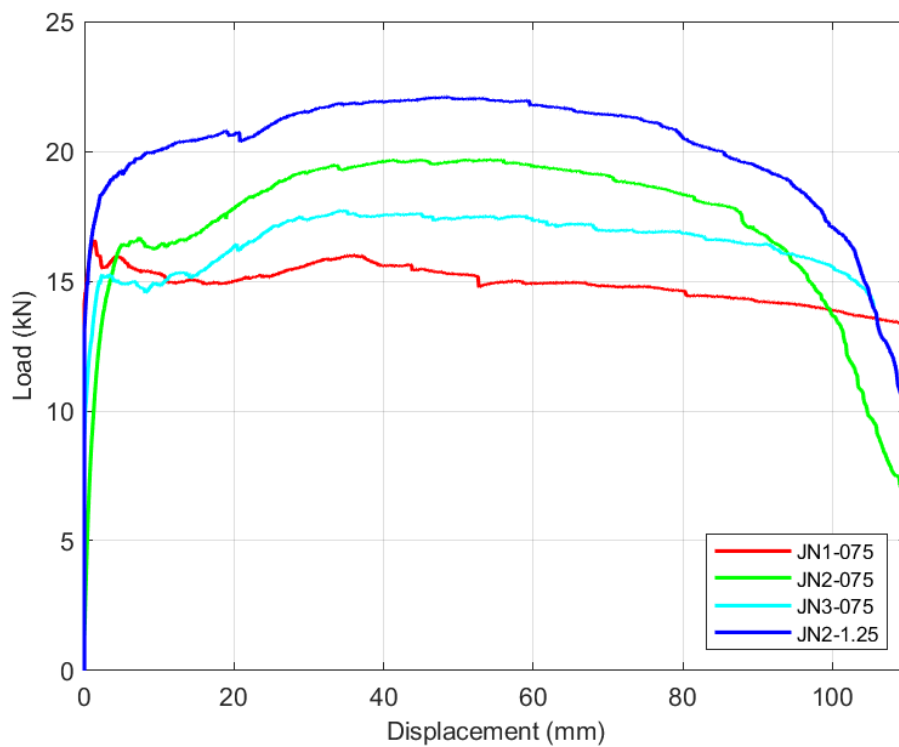
Figure 4.32 Load-midpoint deflection curve of panels with only steel fibers

Load-midpoint deflection curves for panels that had only steel fibers are presented in Figure 4.32. All specimens showed similar initial stiffness prior to crack except for JN2-075, which had a smaller stiffness compared to others. Although higher stiffness was observed in all panels up to cracking, significant decrease in stiffnesses were occurred in post crack region. Cracking and peak loads, corresponding displacements, and energy absorption capacities, as calculated by the area under the curves up to 80% of the peak load in the post-peak region, are presented in Table 4.2.

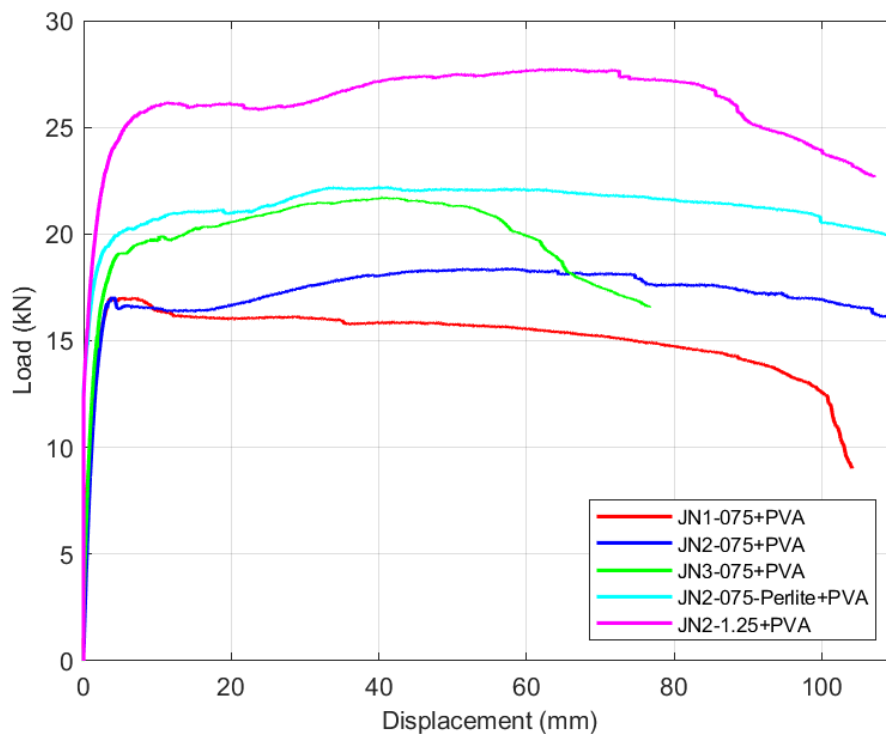
Figure 4.33 Load-midpoint deflection curve of panel with steel fibers plus PVA

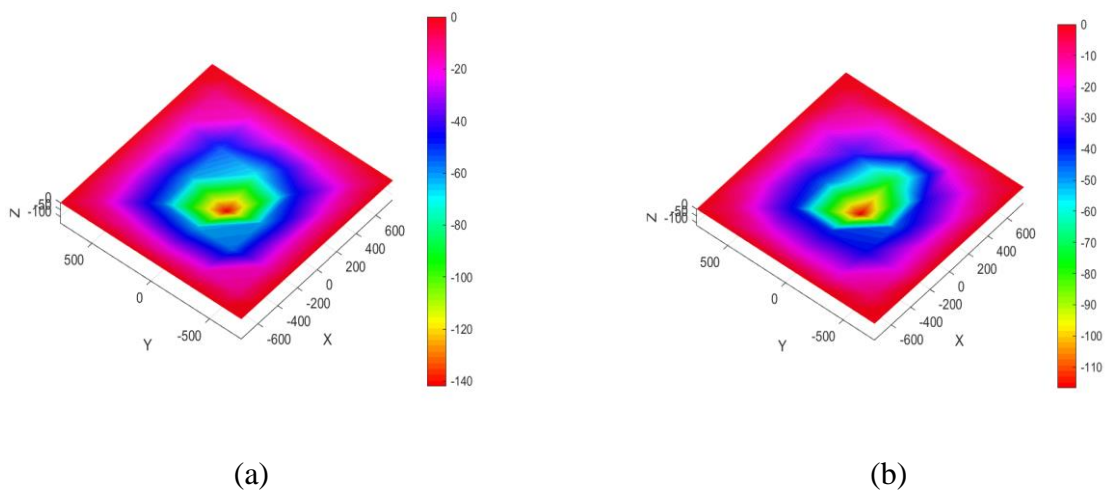
Figure 4.34 Deflection contour of panels at failure; (a) JN1-075; (b) JN1-075+PVA

PVA, deformations were more spread on panels' area rather than concentrating on the midpoint at the punching cone zone. Due to better stress transfer from loading point around the punching cone, these panels were able to deform on a wider area, which contributed their ultimate deflection capacity as well. This is more visible in specimens with conventional reinforcement as seen in Figure 4.44. In JN-Plain-RF, deformations were concentrated around the midpoint, whereas addition of steel fibers in JN2-075-RF and further addition of PVA in JN2-075-RF+PVA resulted in an increased spreading of deformation over the entire panel.

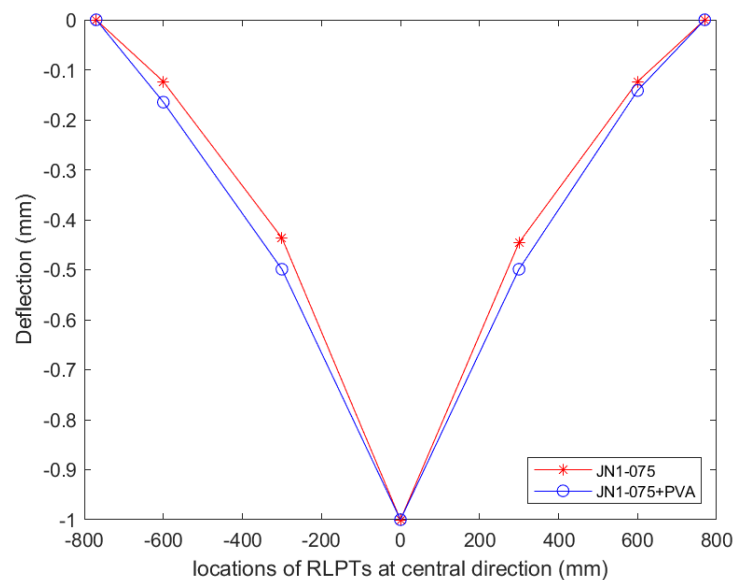
Figure 4.35 Normalized centerline deflection of panels JN1-075 and JN1-075+PVA

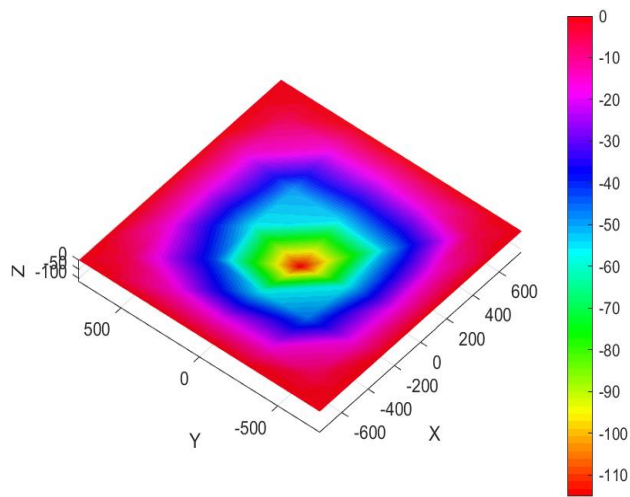
Figure 4.36 Deflection contour of panels at failure; (a) JN2-075; (b) JN2-075+PVA; (c) JN2-075 -Perlite+PVA

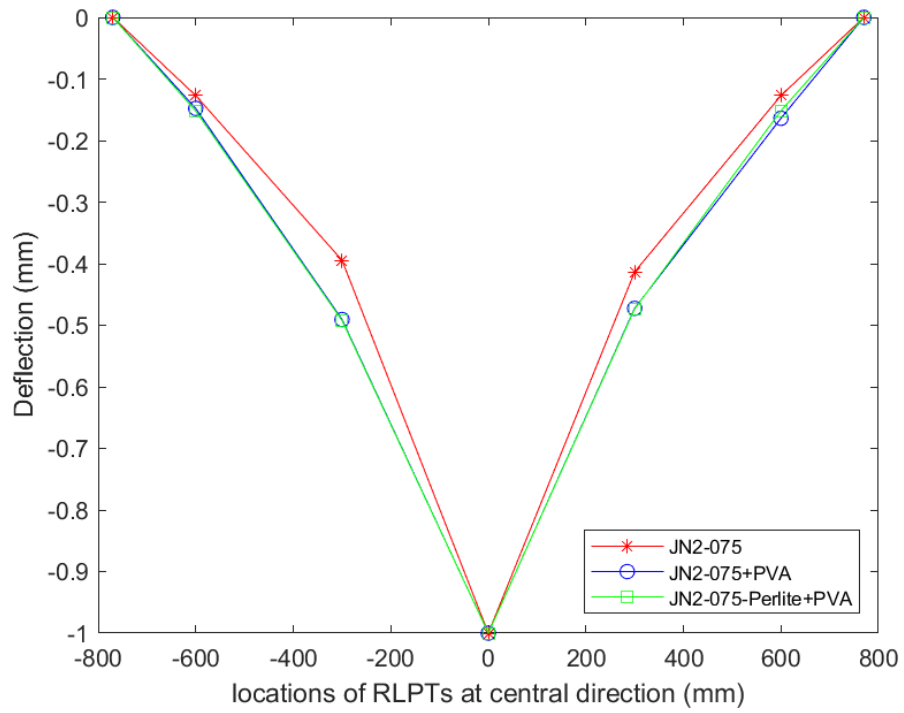
Figure 4.37 Normalized centerline deflection of panels JN2-075, JN2-075+PVA and JN2-075-Perlite+PVA

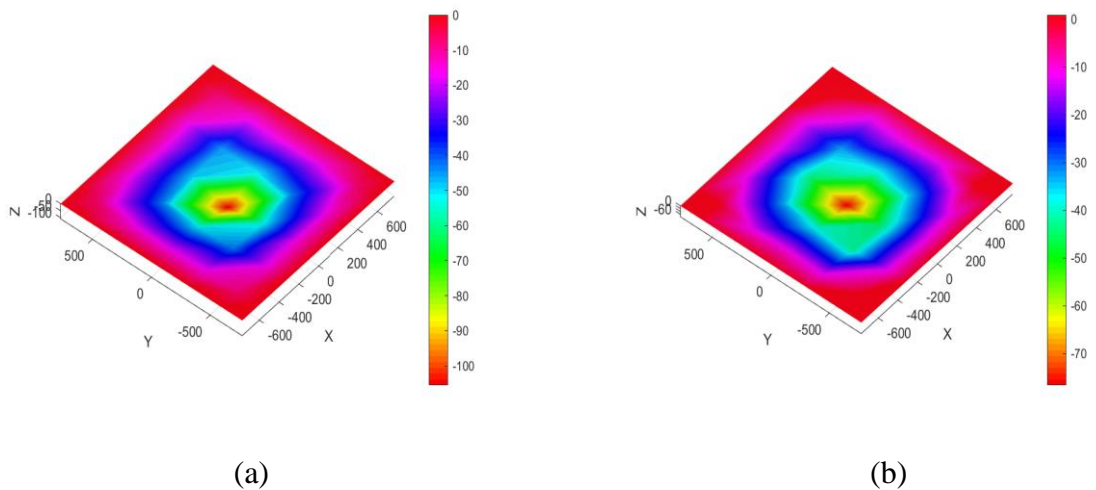
Figure 4.38 Deflection contour of panels at failure; (a) JN3-075; (b) JN3-075+PVA

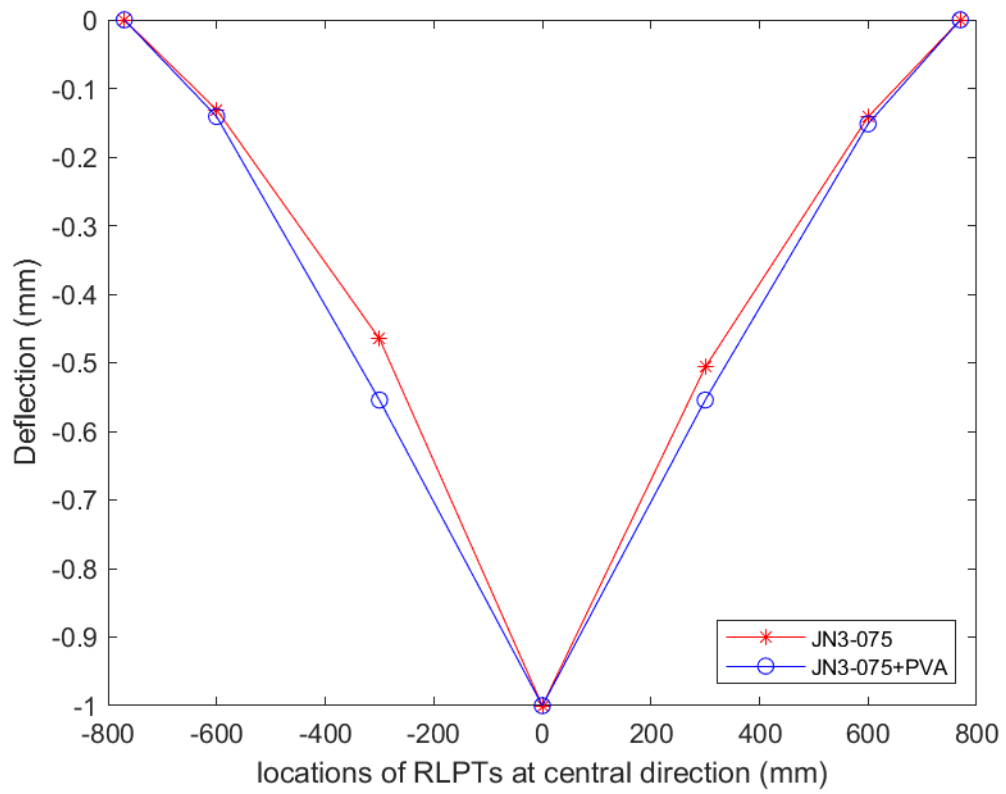
Figure 4.39 Normalized centerline deflection of panels JN3-075 and JN3-075+PVA

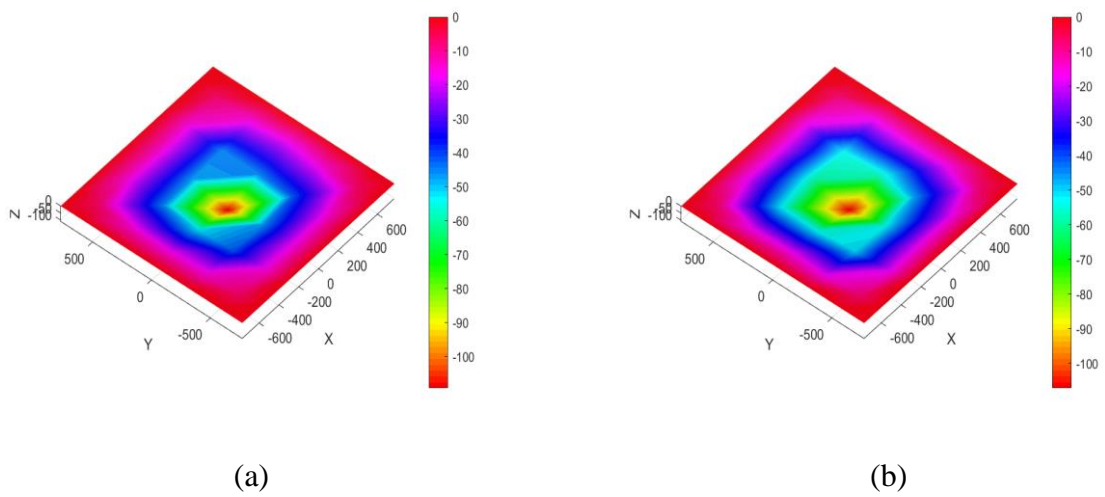
Figure 4.40 Deflection contour of panels at failure; (a) JN2-125; (b) JN2-125+PVA

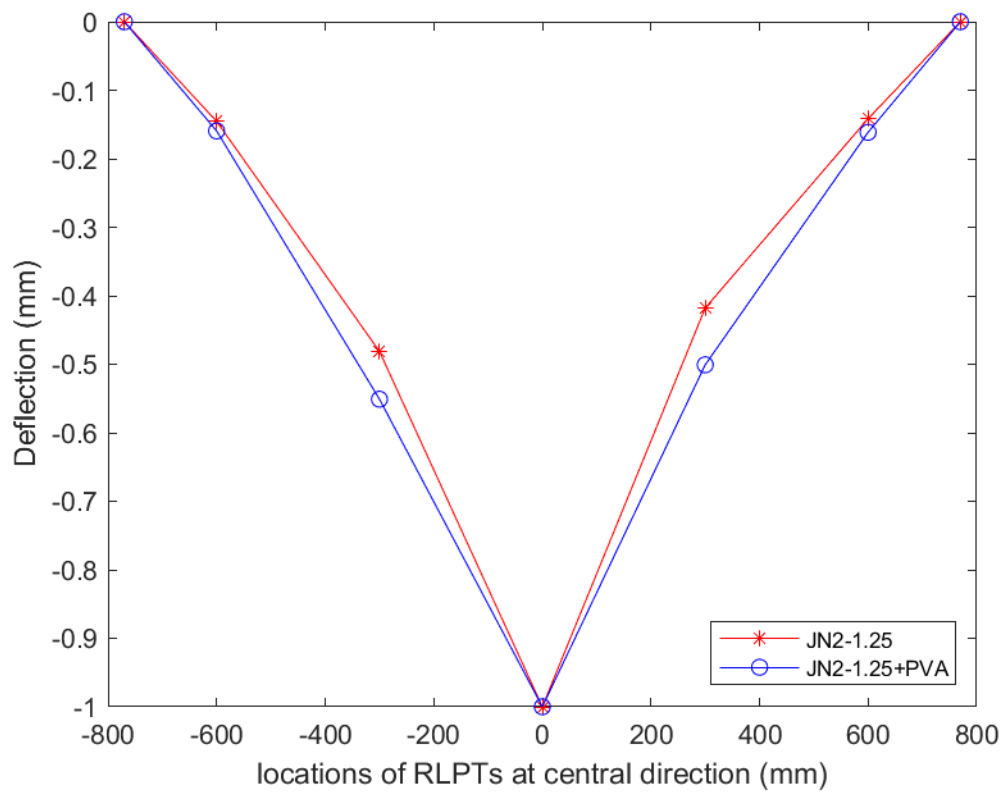
Figure 4.41 Normalized centerline deflection of panels JN2-125, JN2-125+PVA

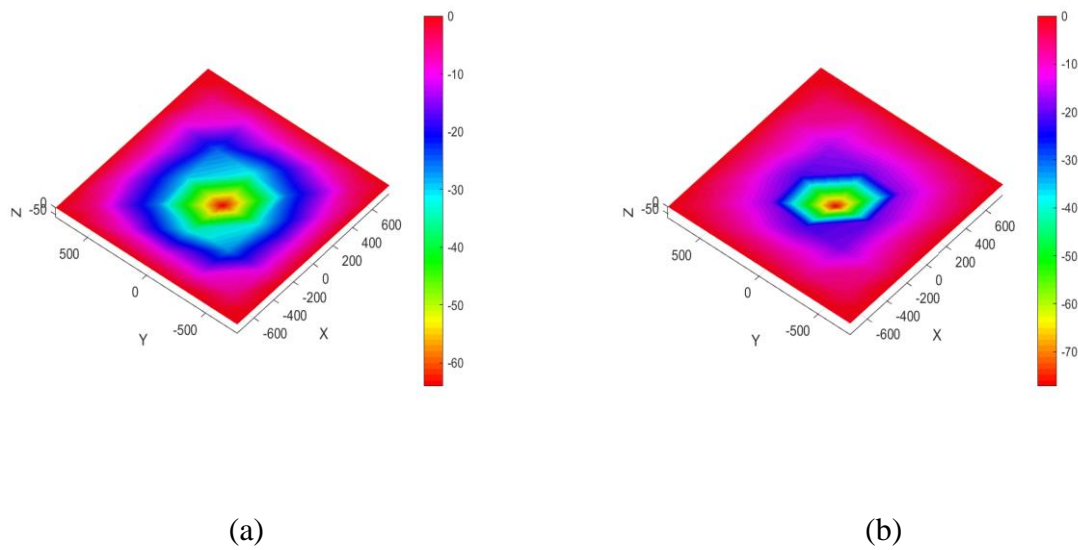
Figure 4.42 Deflection contour of panels at failure; (a) JN2-075-RF; (b) JN2-075-RF+PVA

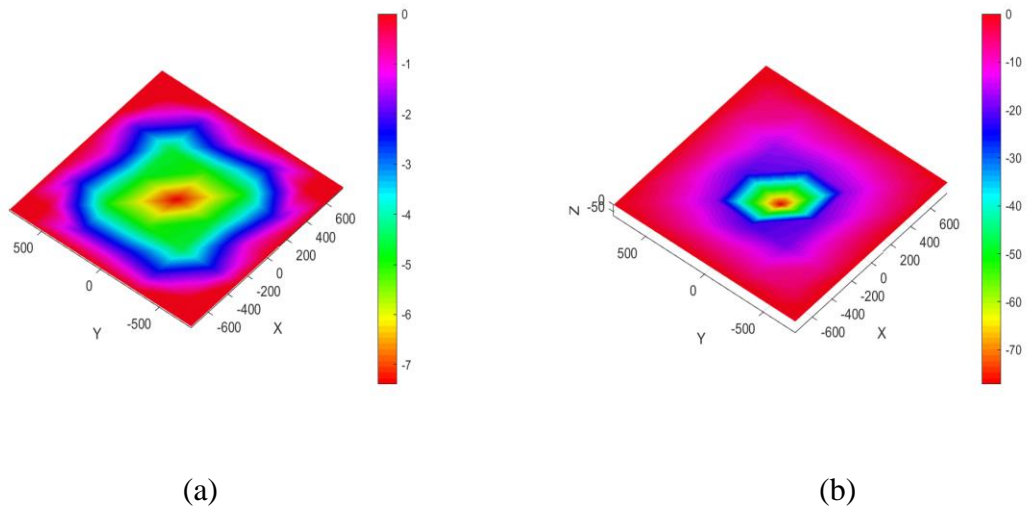
Figure 4.43 Deflection contour of panels at failure; (a) JN-Plain; (b) JN-Plain-RF

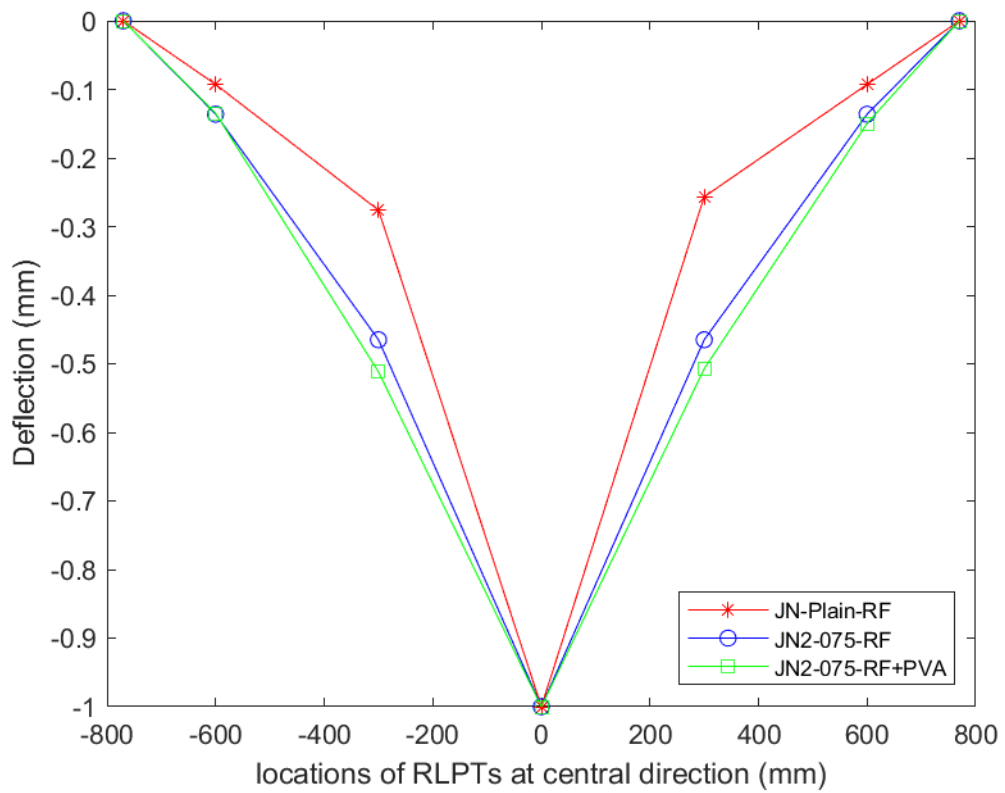
Figure 4.44 Normalized centerline deflection of panels JN-Plain-RF, JN2-075-RF and JN2-075-RF+PVA
