**EVALUATION OF STONE DETERIORATION  
PROBLEMS OF ANAVARZA ARCHAEOLOGICAL  
SITE FOR THE PURPOSE OF CONSERVATION**

**A Thesis Submitted to  
the Graduate School of Engineering and Sciences of  
İzmir Institute of Technology  
in Partial Fulfillment of the Requirements for the Degree of**

**in Architectural Restoration**

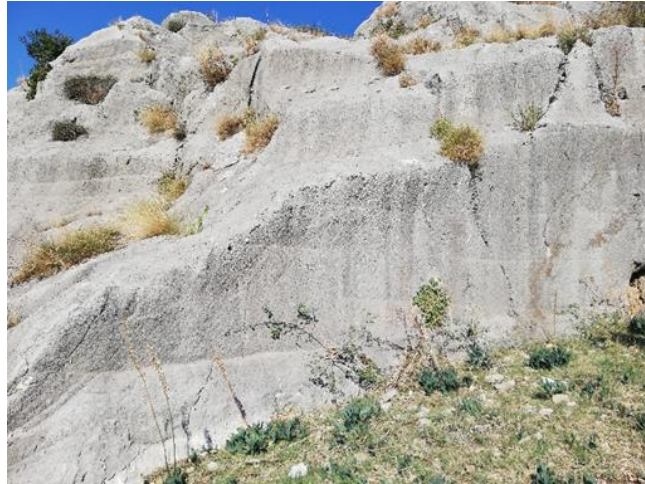
Anavarza is located in a flat area surrounded by calcareous rocks. The ancient city was built with limestones quarried from these rocks (Ergeç 2001). Three places are known to be used as quarry. These places are visible nearby the nekropol area, the amphitheatre area and the area called "Ali kesigi" (Figure 5).

Figure 5. The image showing the traces of processing in the quarry near the amphitheater area.

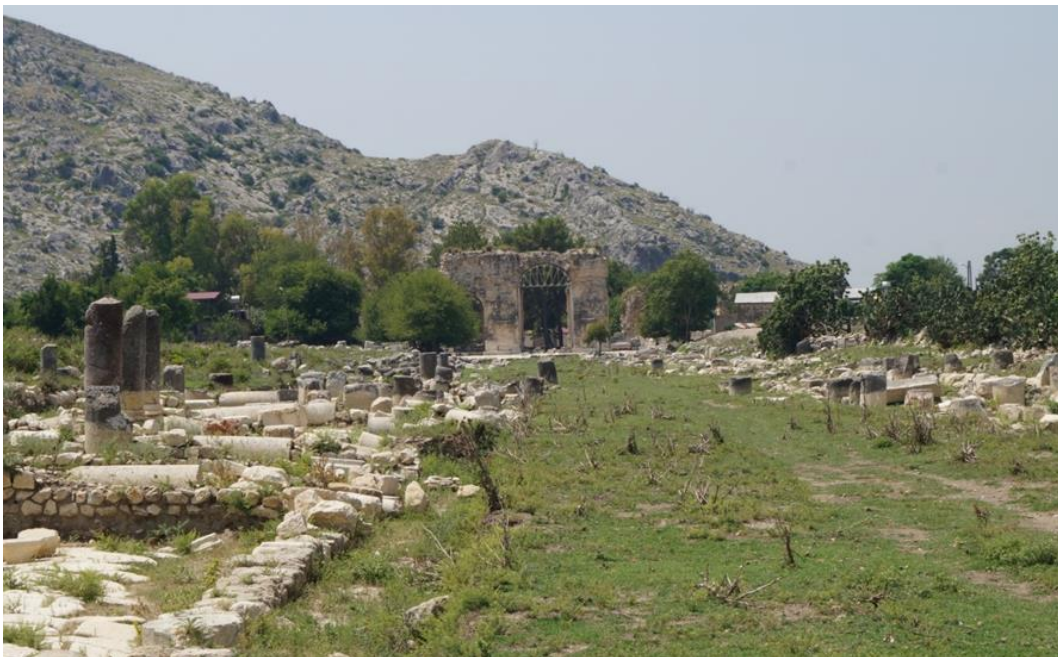
The triumphal arch (Alakapı) is one of the important remaining structure of the Roman period on the site (Gough 1952) (Figure 6, 7). The colonnaded road starting from the triumphal arch is on south to north direction, approximately 1150 m. length and 30-34 m width (Buyruk 2016) (Figure 6). There are stone columns on both sides of this stone paved road (Figure 8).

Figure 6. The image of the triumphal arch (Alakapı) and the colonnaded road.

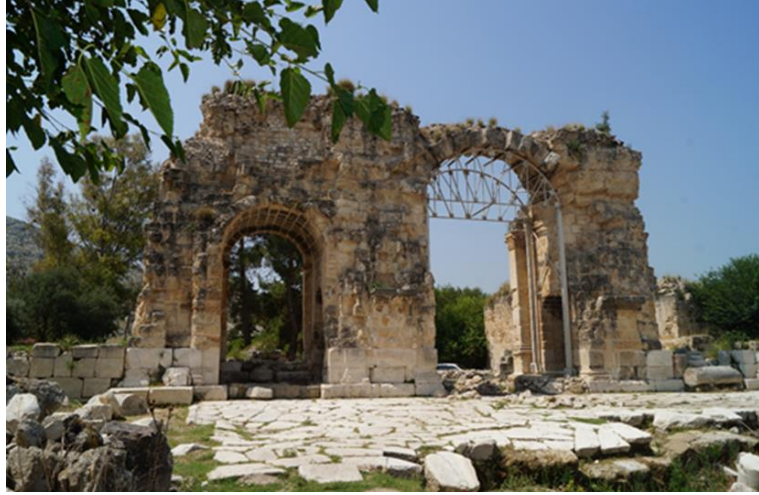
Figure 7. The image of the triumphal arch (Alakapı).

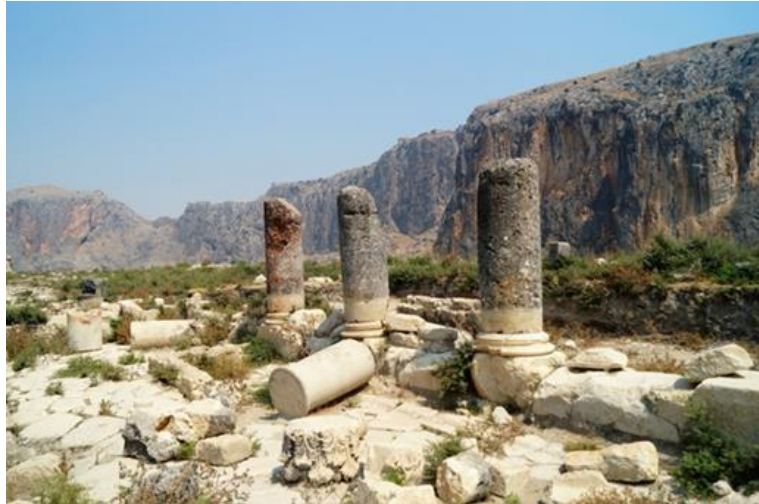
Figure 8. Stone columns on the colonnaded road.

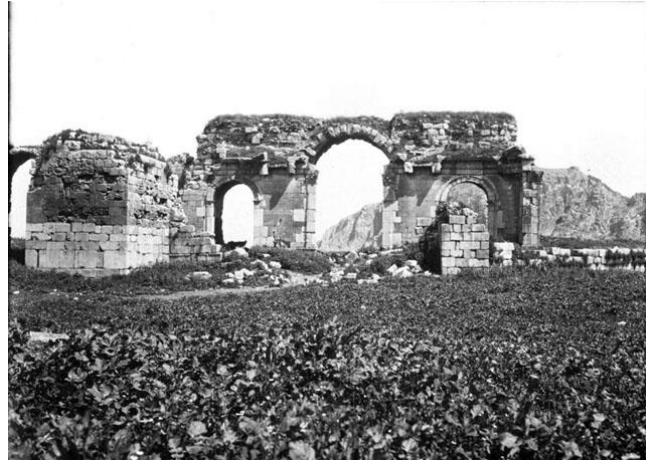
The excavations, which started in 2013 under the Directorate of the Adana Museum, are still ongoing. The excavations were especially carried out in the area around the triumphal arch (Alakapı) and the colonnaded road. Figure 9 shows the old image of the triumphal arch taken by Gertrude Bell in 1905 (Gertrude Bell Archive). Restoration works of the triumphal arch started in 2017 and completed in 2020 (Figure 10).

Figure 9. The image of the triumphal arch (Alakapı) in 1905  
(Source: Gertrude Bell Archive)

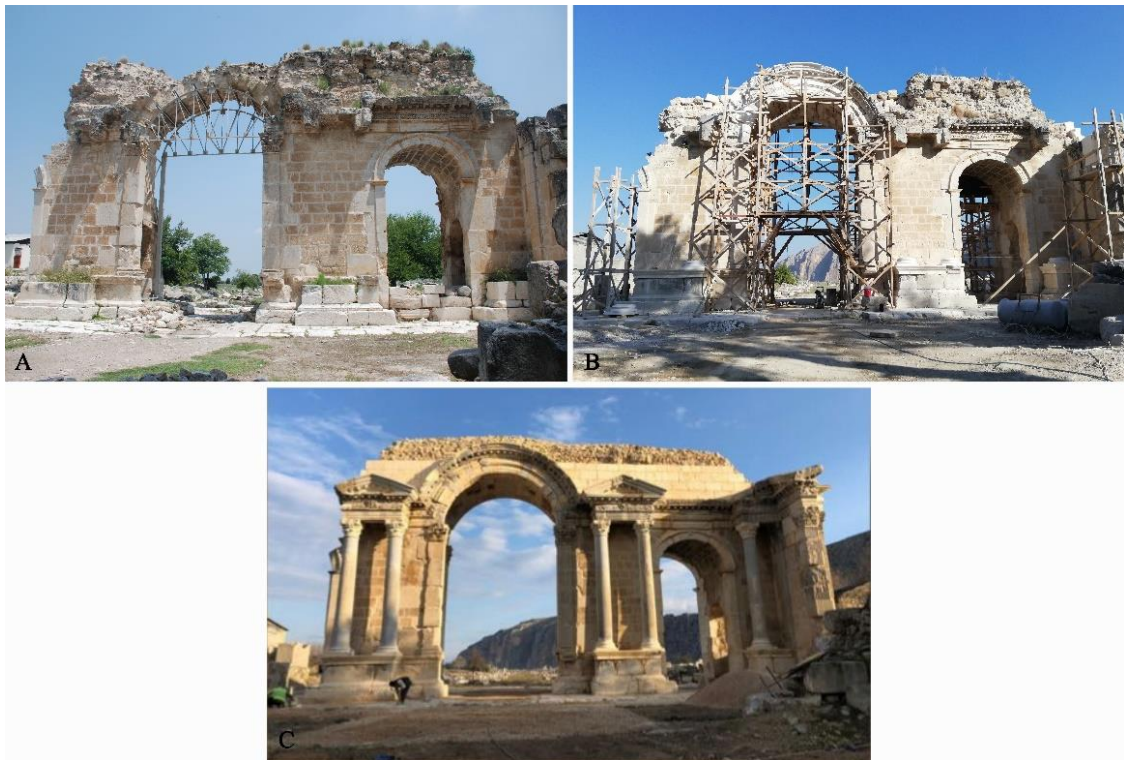
Figure 10. The images of the triumphal arch (Alakapı); in 2018 (A), during the restoration works in 2019 (B) and after restoration in 2020 (C).

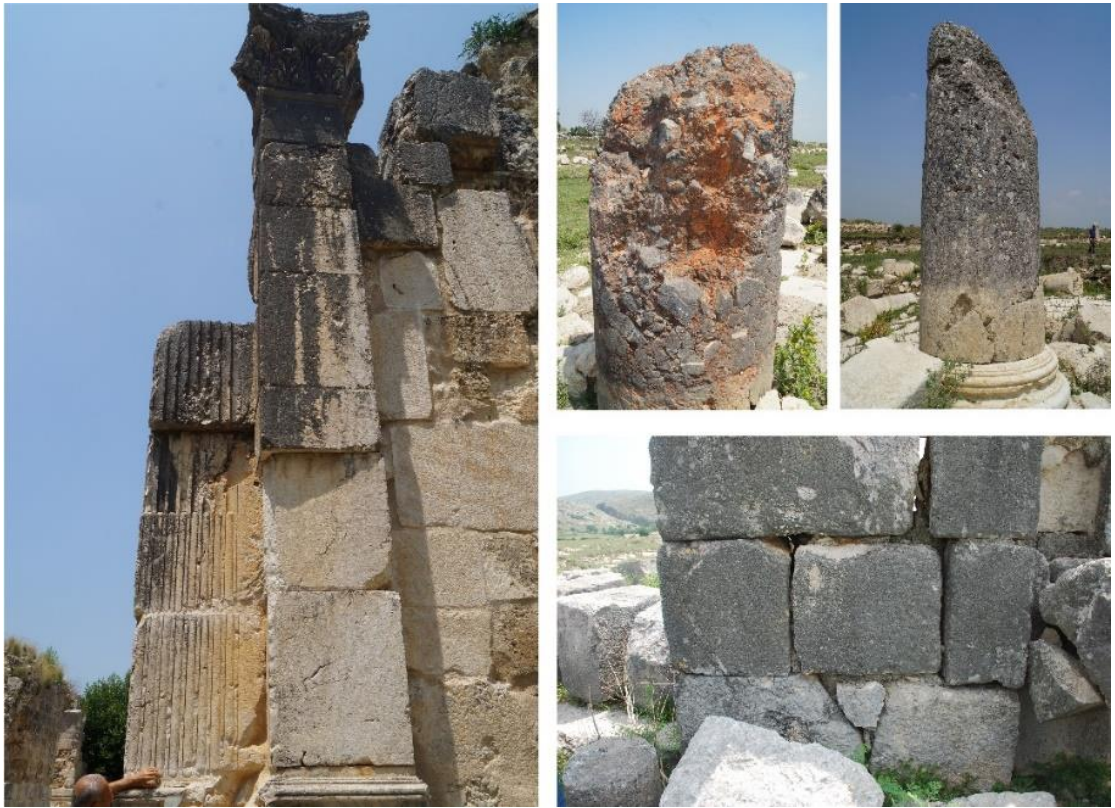
Figure 11. Deterioration on limestones in the forms of black crust, yellow patina, loss of cohesion, biological colonization, cracks.

The structures of the city are mostly made of limestone. Different types of deterioration can be seen on the surfaces of the stone materials. Discoloration, disintegration, cracking and biological growth were observed on the limestone walls and columns in the area, described in details in section 3.1.1. (Figure 11, 12).

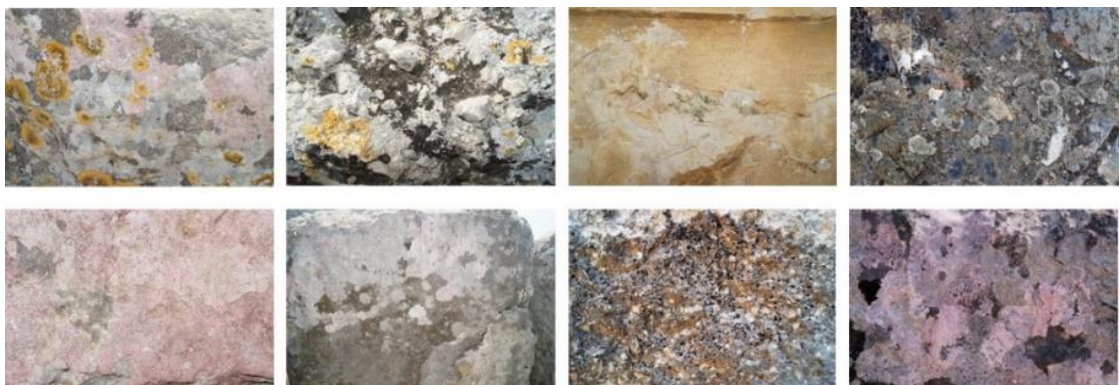
Figure 12. Biological colonization on the Stones.

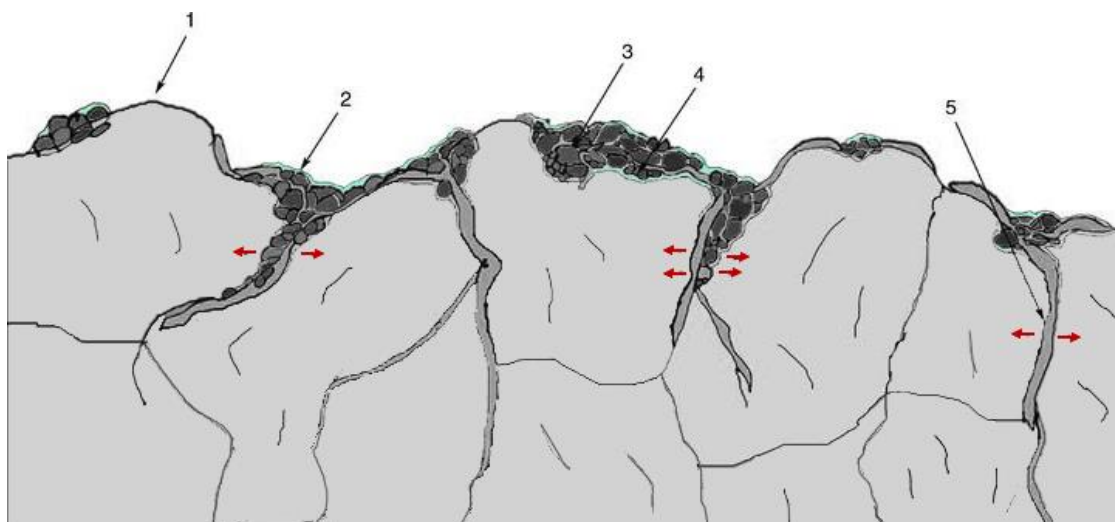
Figure 13. Interactions between stone material, environmental conditions and biofilm, 1: Atmosphere and substrate interaction, 2: Atmosphere and biofilm interaction, 3: Interaction between metabolic compounds and substrate, 4: Physicochemical interaction between biofilm and substrate, 5: Physical forces due to microbial growth (Source: Beimforde 2011)

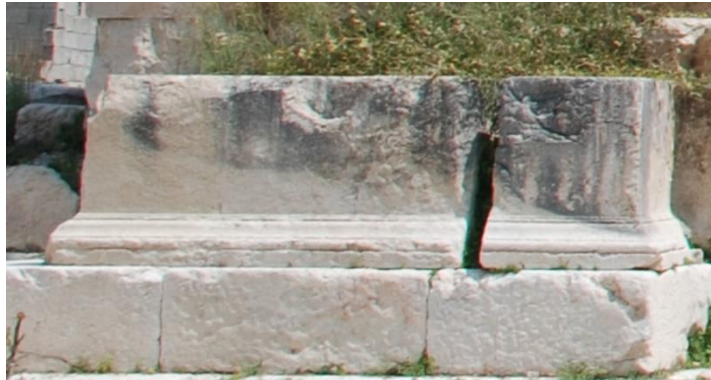
Figure 14. Soiling on the excavated and black crust on the standing parts of stone surfaces.

- Disintegration: Layering in the forms of *exfoliation*, *spalling* and *scaling*; loss of cohesion in the forms of *crumbling* and *erosion (selective weathering)* (Figure 16, 17, 18),
- Cracking: Crack and hair crack (Figure 17),
- Mechanical damage: Scratch (Figure 19),
- Biological growth: Higher plants and thriving micro-organisms in the forms of *lichens*, *algae* (Figure 20).

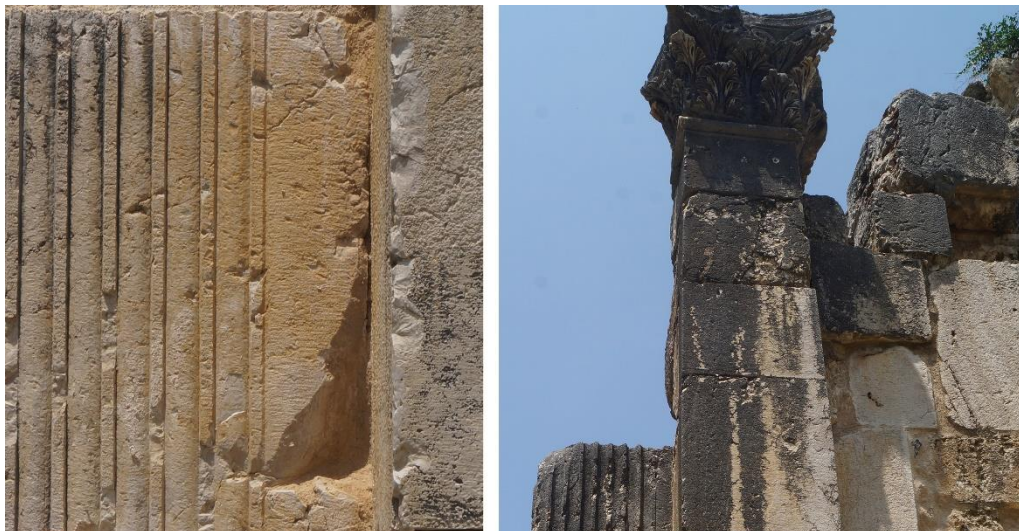
Figure 15. Yellow patina and black crust observed on the stone surfaces.

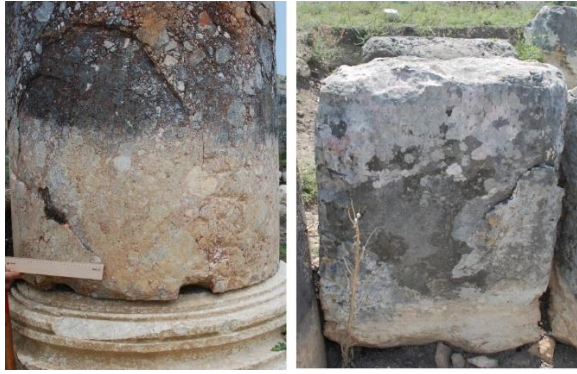
Figure 16. Exfoliation and spalling observed on stone surfaces.

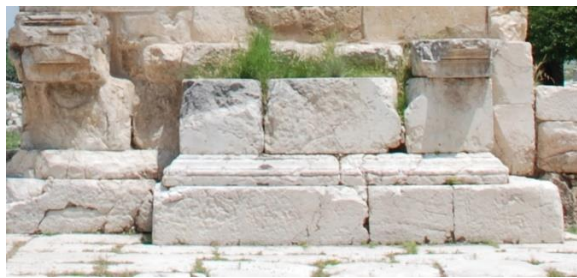
Figure 17. Scaling and hair cracks observed on stone surfaces.

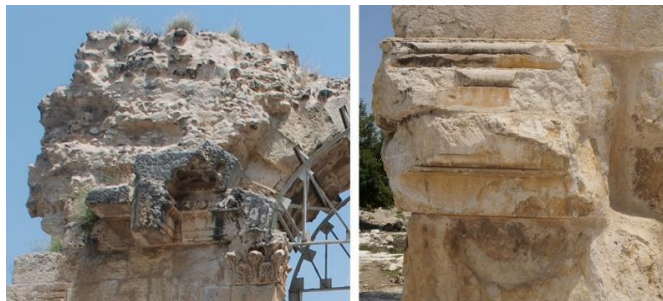
Figure 18. Crumbling and erosion observed on stone surfaces.

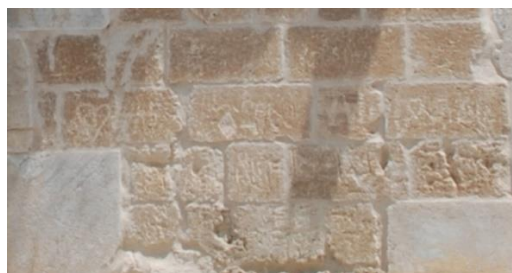
Figure 19. Stretch observed on stone surfaces.

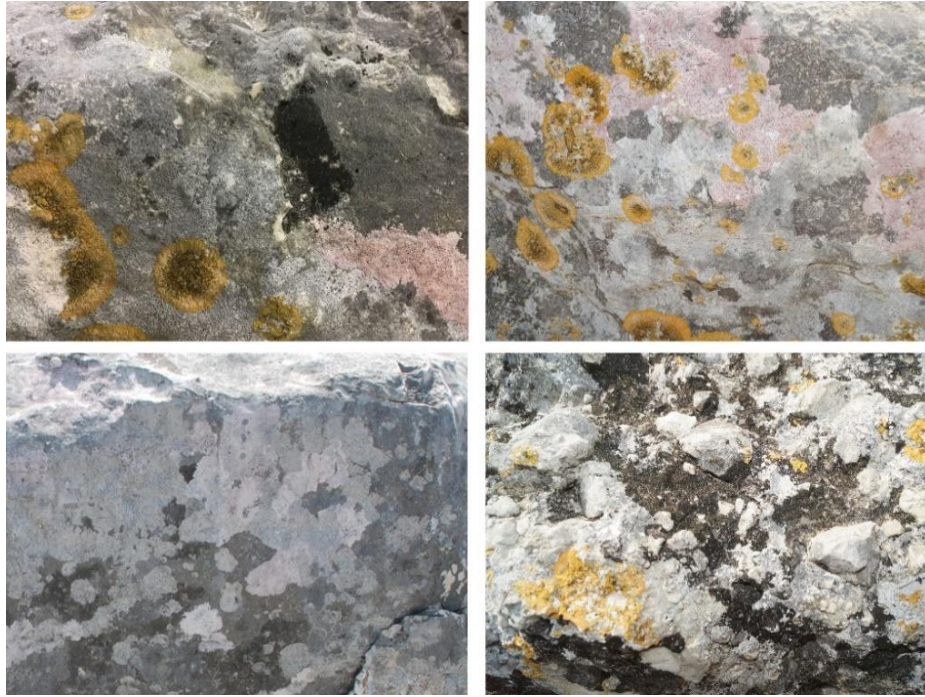
Figure 20. Thriving micro-organisms (lichens, algae, bacteria etc.) observed on stone surfaces.

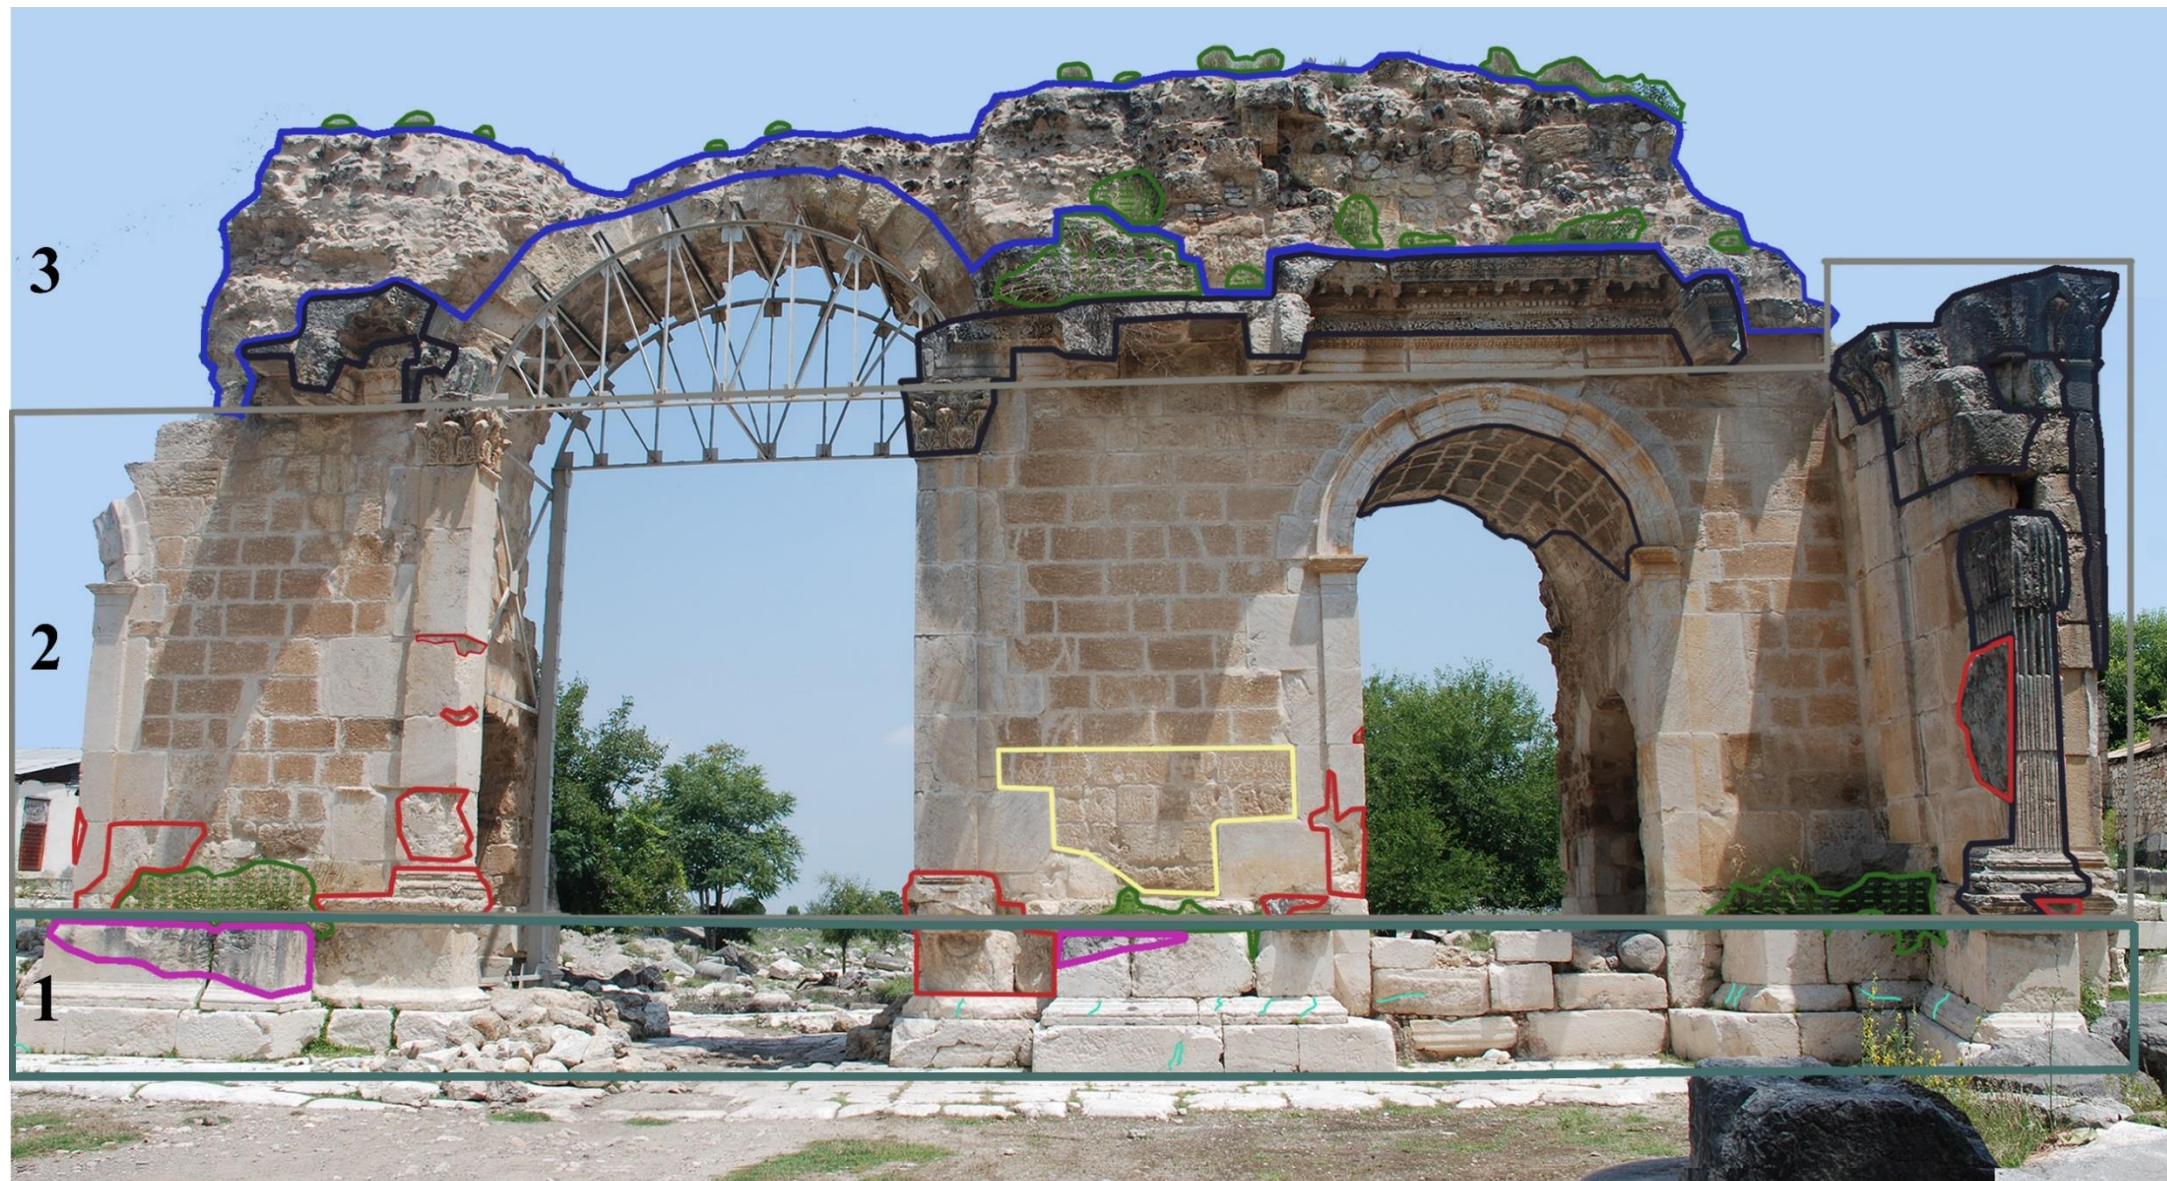
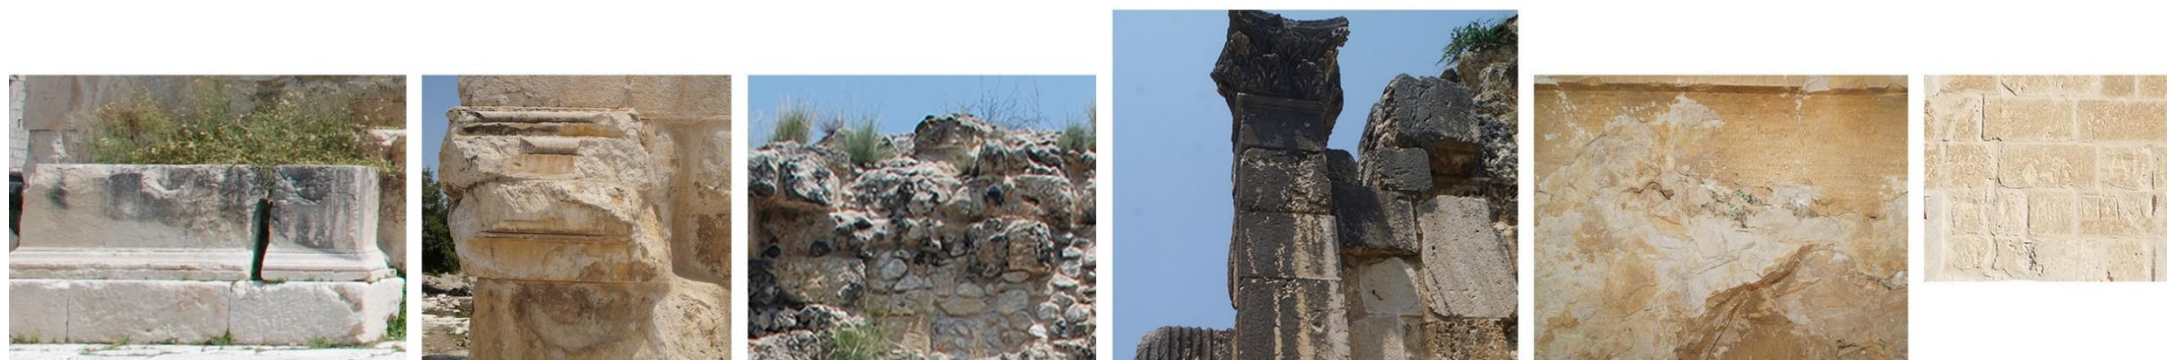
Figure 21. Mapping of the weathering forms of stones used in the triumphal arch (Alakapı)

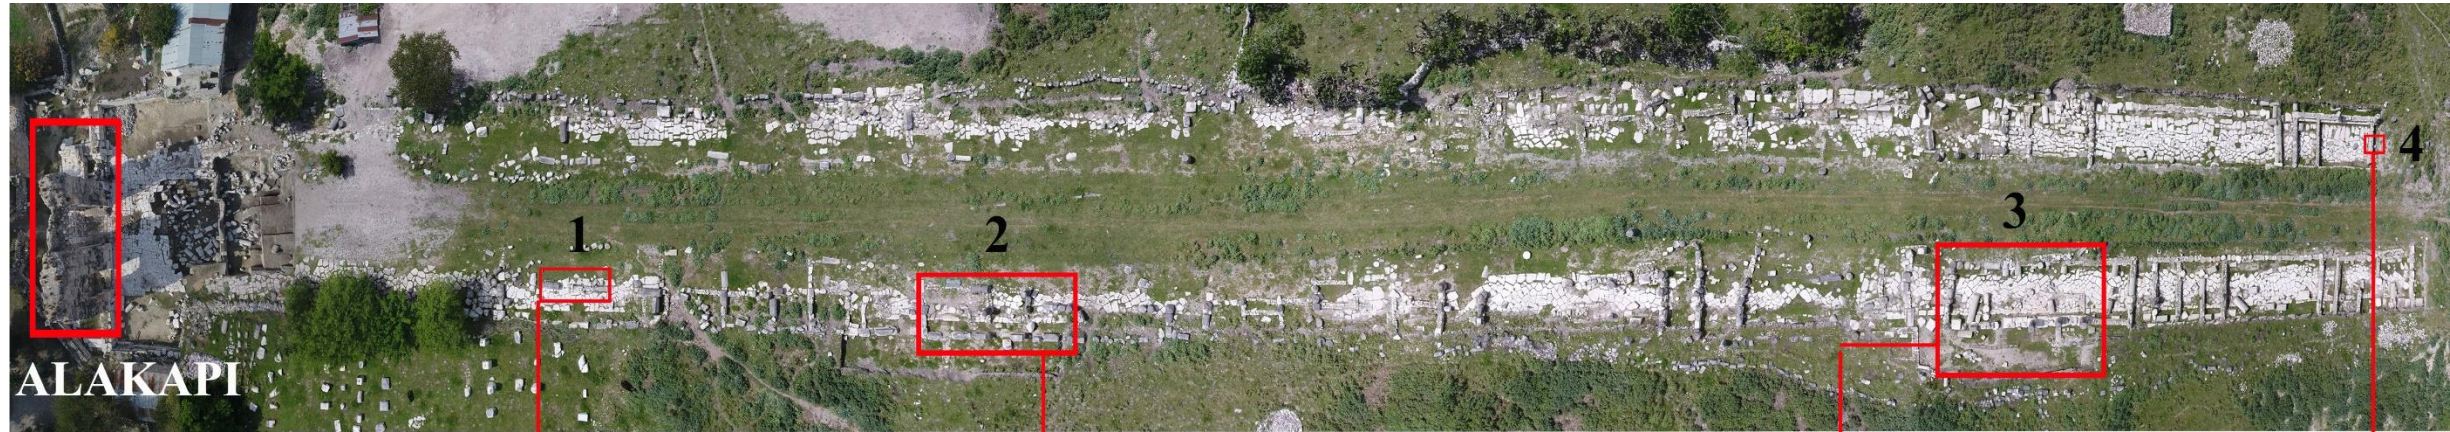
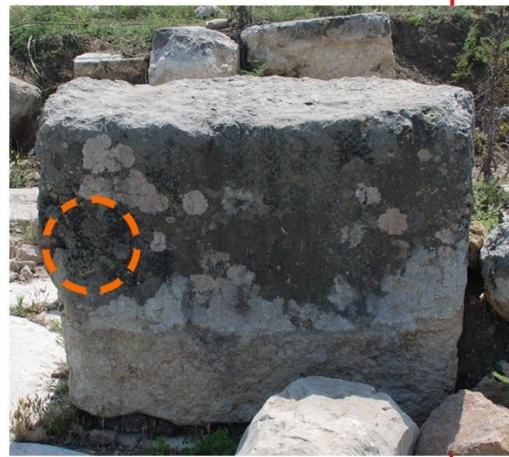
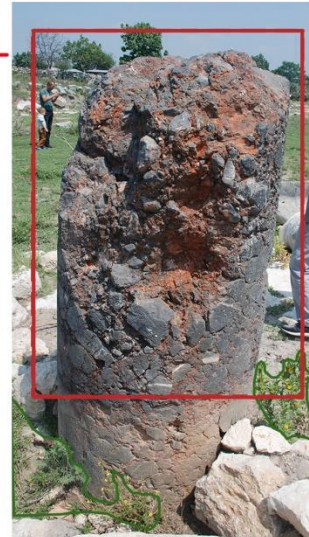
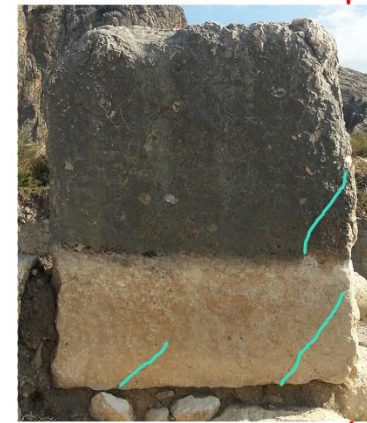
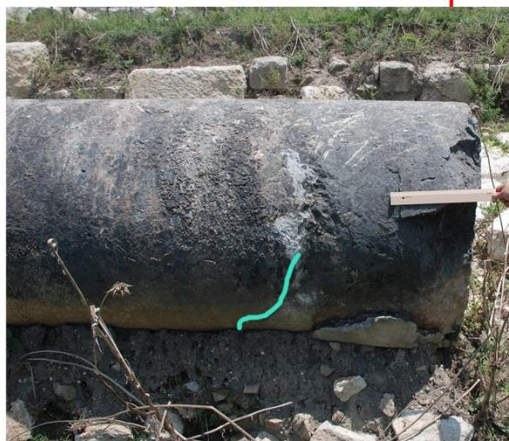
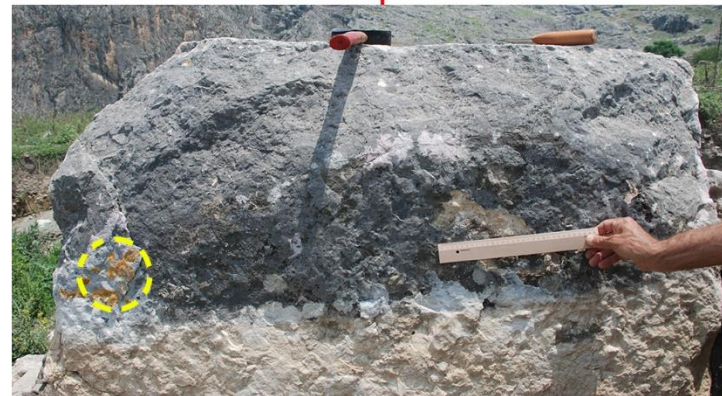
Different damage types are observed on limestones of the triumphal arch (Alakapı) at different heights from the ground level. Three main zones can be distinguished: zone 1, up to 75 cm from the ground; zone 2, including the triumphal arch; zone 3, at the top of the arch (Figure 21). In the zone 1, layering in the form of scaling is observed on that surface of the stone. Besides, biological growth and soiling are seen on some parts, as well. In the zone 2, a yellow patina can be observed on part of the surface. Black crust is clearly observed on the right corner of the structure. Erosion can be observed on many parts of the stones as well, possibly due to rain water, action of wind or cleaning methods. In the zone 3 of the structure, the stone is severely damaged and has lost its cohesion in the form of crumbling (Figure 21).

✓ Surface change » Deposit (thriving micro-organisms/biological growth)

— Biological growth (higher plants)

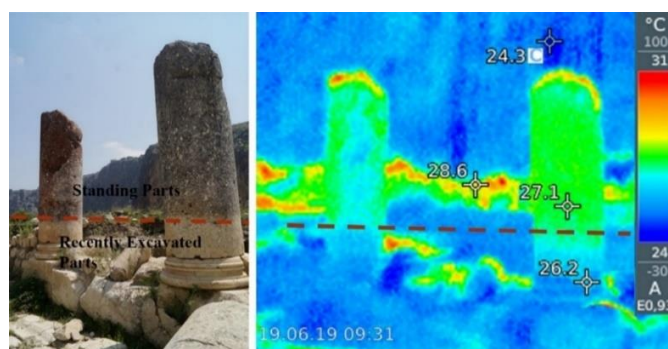
Figure 23. Photo and thermal image of the standing parts and the excavated parts of the stone surfaces

In order to get insight into the surface temperatures, thermal images of both the triumphal arch and of the colonnade were taken. (Figure 23). Thermal camera used in this study, Testo 868 has a spectral range from 7.5 to 14  $\mu\text{m}$ , temperature range -30 to 650  $^{\circ}\text{C}$ . The surface temperatures of the standing parts were higher than the recently excavated ones; thus can be due to the absorption of larger amounts of solar radiation. To support this, further studies including monitoring of the surface temperature in time is required.

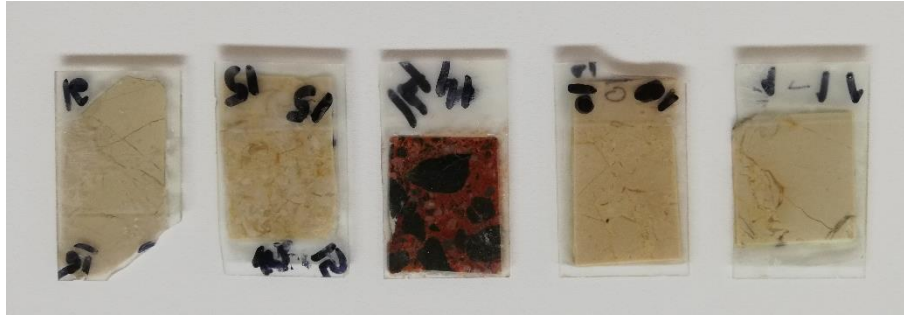
Figure 26. Thin section samples.

epoxy resin. These samples on the glass slide were then placed under pressure for 24 hours. After that, the samples were cut to approximately 2 mm thick slices and ground up to 30  $\mu\text{m}$  thickness (Figure 26). Then, the samples were cleaned in an ultrasonic cleaner to ensure all contamination had been removed. The thin sections were studied by the use of polarized light microscope (OLYMPUS BX51-P).

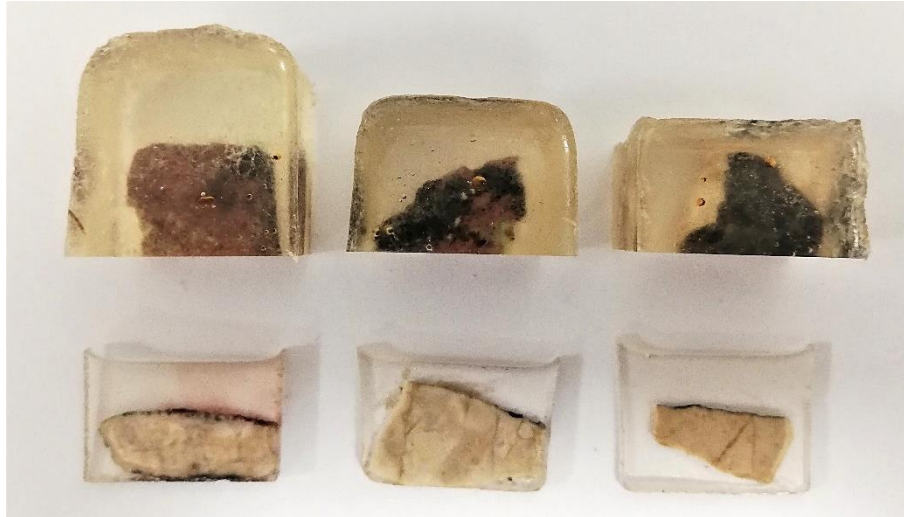
Figure 27. Samples covered with epoxy resin and cut cross section samples.

Different types of samples were prepared. Samples from the surface of the stone, were cut in pieces with dimensions of 2x2x2 cm, dried in an oven at 40 °C for 24 hours and then the originally exposed surface of the stone was investigated by SEM. Other samples were covered with epoxy resin for 24 hours (Figure 27) and cross sections (from surface to depth) were obtained by cutting the stone cut into slices of about 2-3 mm thickness with Buehler low speed saw using water (Figure 27). After that, the cross sections were coated with gold, dried in an oven at 40 °C for 24 hours.

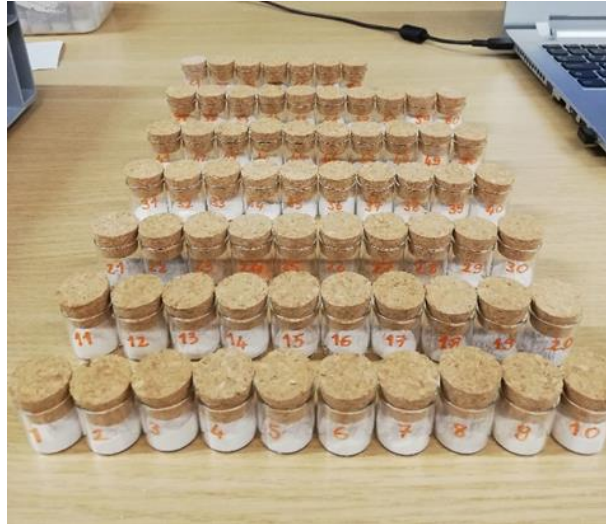
Figure 28. Powder samples for HMC measurements.

$$\text{HMC} = [100 \times (\text{weight}_{95\% \text{ RH}} - \text{weight}_{\text{dry}})] / \text{weight}_{\text{dry}}$$

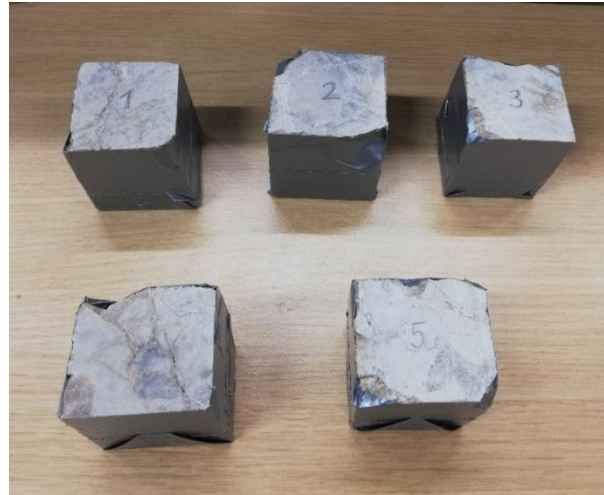
The drying rate was assessed on the same cubic samples (5x5x5 cm) used for the capillary absorption. First of all, the samples were saturated with water by capillary rising absorption and then total immersed into the water to reach their constant mass. After that,

all faces of the samples (except the top surface) were sealed by using a water impermeable material (e.g. tape) and weighed at time  $t=0$  (Figure 30).

Figure 30. Sealed specimens for drying rate measurements.

Then, the samples were placed at  $22 \pm 2$  °C and drying occurs through the top surface. The samples were weighed periodically to measure their drying behaviour. The measurements were performed until the specimens reached the constant weight. The temperature and RH in the laboratory were monitored and varied between 20.5-29.5 °C and 40-74.5 % RH.

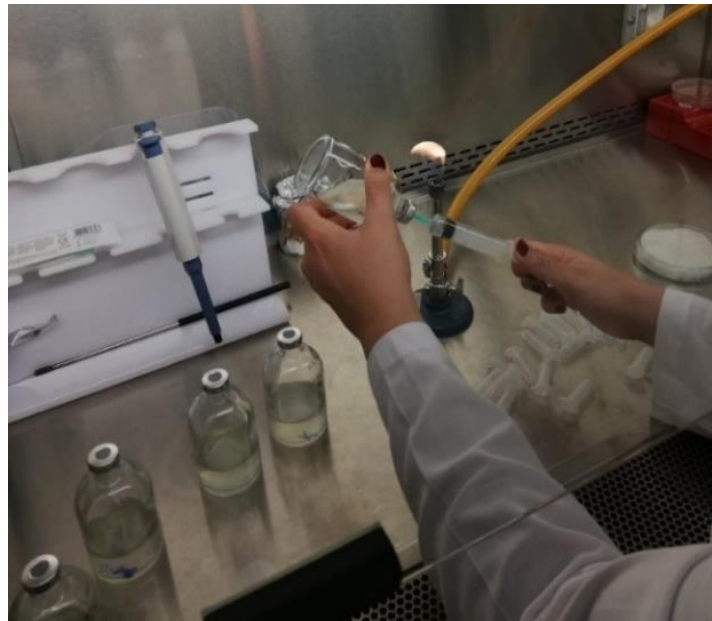
Figure 31. Cultivation of samples in R2A liquid medium.

In cultivation studies of microorganisms in laboratory environments, all species could not be obtained since the environmental conditions present in the field can not always be reproduced in a good way (Bloomfield et al. 1998, Bogosian et al. 2000). To solve this problem, R2A and VL55 medium, and different cultivation methods such as prolongation of incubation time, incubation of samples at relatively high and low temperatures were performed (Figure 31, 32, 33). During cultivation period for three months, their development was monitored daily.

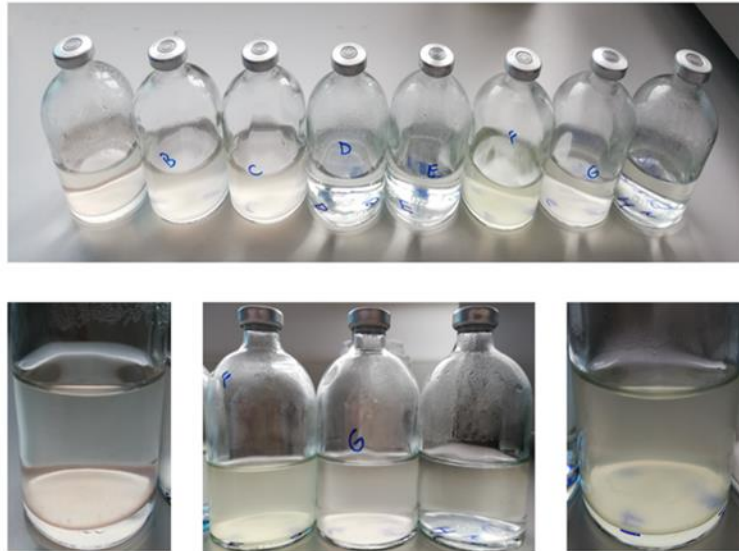
Figure 32. Growth of samples in R2A liquid medium

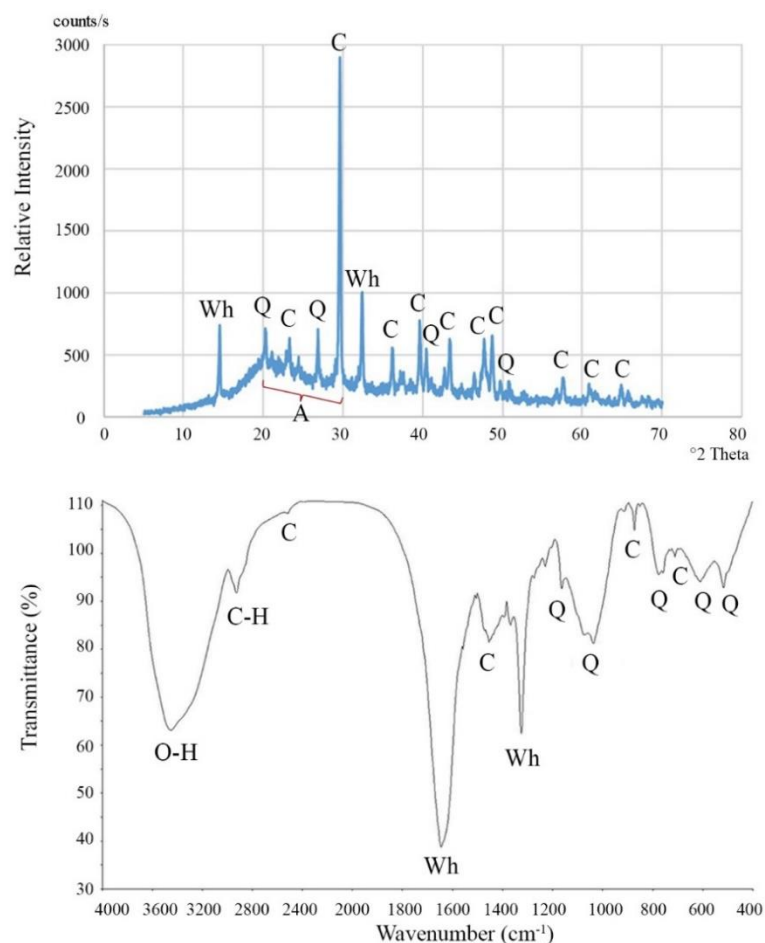
Figure 35. X-ray diffraction (XRD) pattern and FT-IR spectra of standing part of the column 3, sample C3.st.2 (C: calcite, Q: quartz, Wh: Whewellite, A: Amorphous substances (Aluminosilicates), O-H: Oxygen-Hydrogen bands, C-H: Carbon-Hydrogen bands).

Whewellite and weddellite occurs on stone surfaces as result of the reaction between oxalic acids, produced by microbiological formations, with calcium carbonate which is the major mineral of calcareous stones (Reaction I) (Gadd 2007).

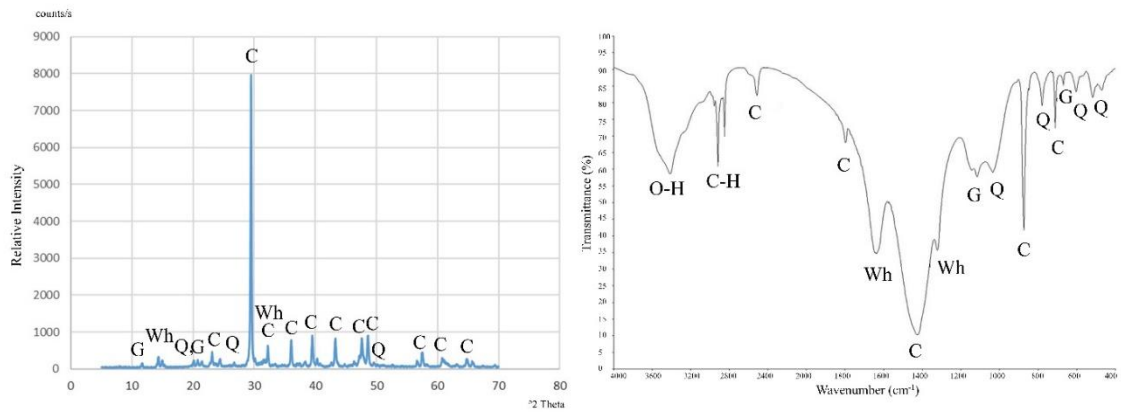
Figure 37. X-ray diffraction (XRD) pattern and FT-IR spectra of the standing surfaces (sample A.st.3) of limestones (C: calcite, Q: quartz, Wh: Whewellite, G: Gypsum, O-H: Oxygen-Hydrogen bands, C-H: Carbon-Hydrogen bands).

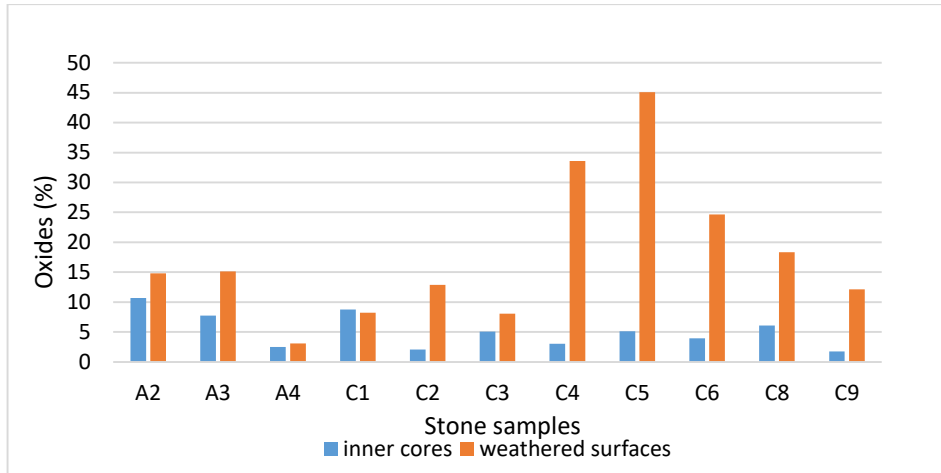
Figure 39. Total % amounts of clays ( $\text{Al}_2\text{O}_3$ ,  $\text{SiO}_2$  and  $\text{FeO}$ ) of samples from inner cores and weathered surfaces.

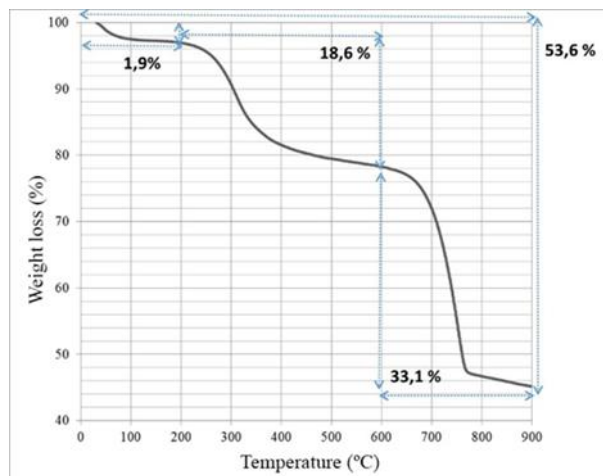
Figure 40. TGA curve of the standing surface of stone sample (C2.st.1).

Thermal analysis supports the SEM-EDS analysis results. In the thermographs of the standing surface of the limestone, weight losses are observed in the range of 30–200 °C, 200–600 °C and 600–900 °C, which are mainly due to absorbed water, decomposition of organic matter and carbon dioxide, respectively. The high percentage weight loss at 200–600 °C and 600–900 °C for standing surfaces shows the presence of higher amount of organic matter due to biological colonization (Figure 40). Figure 41 reports all TGA curves of the stone samples from both the inner cores and the surfaces together. As mentioned before, the inner cores of the stones show that the intense weight loss between 600°C–900°C, as a result of the deterioration of calcite crystals (Figure 41).

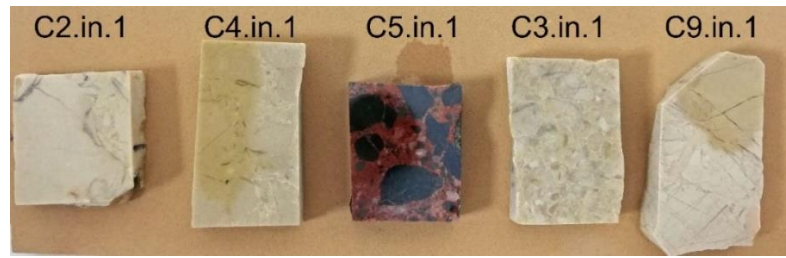
Figure 42. The stone samples for petrographic analysis.

The petrographic observations have been carried out on thin sections of the core of the stone samples (C2.in.1, C3.in.1, C4.in.1, C5.in.1, C9.in.1) (Figure 42). SEM analysis was performed on the surface and cross section of the stone samples collected from the 3<sup>rd</sup> column (C3), the 6<sup>th</sup> column (C6) and the 7<sup>th</sup> column (C7). The results of both studies are described in the following sections 4.3.1 and 4.3.2.

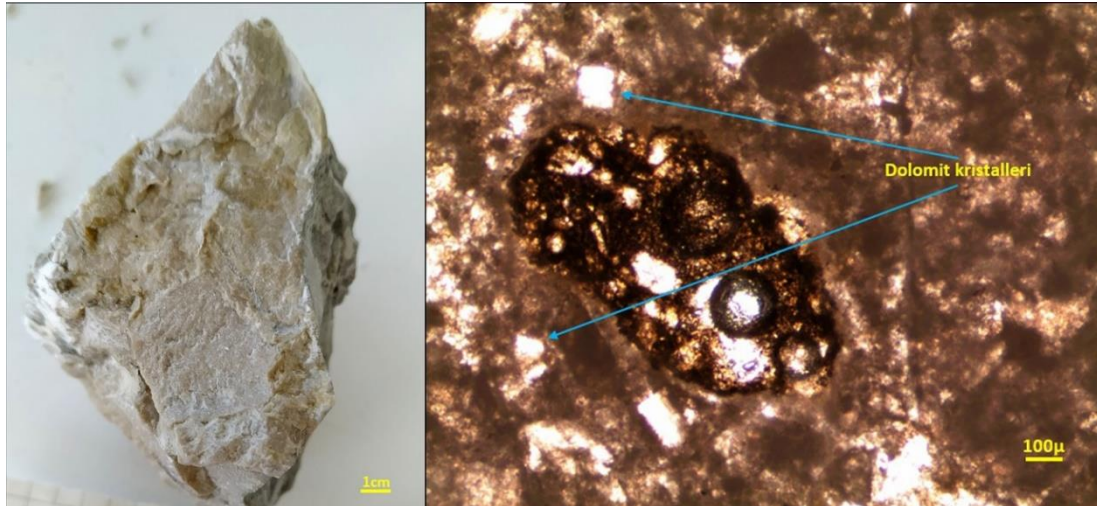
Figure 45. Macroscopic and microscopic images of sample C4.in.1

Stone sample C4.in.1 has a homogeneous micritic calcite structure and contains sparsely crystallized dolomite grains (limestone with low dolomite content) (Figure 45).

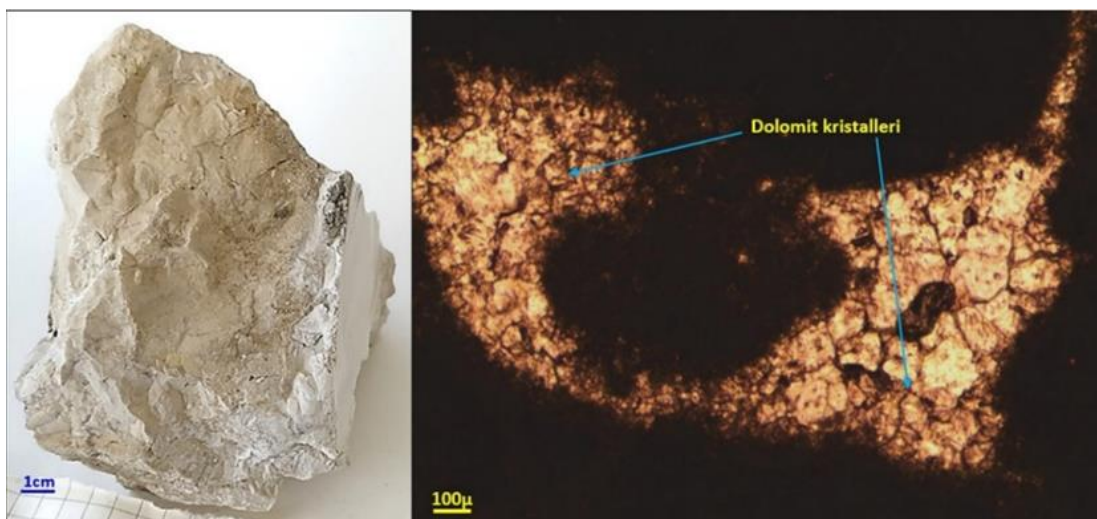
Figure 46. Macroscopic and microscopic images of sample C9.in.1

Stone sample C9.in.1 shows highly micritic calcite and tightly developed dolomite crystals (dolomitic limestone) (Figure 46).

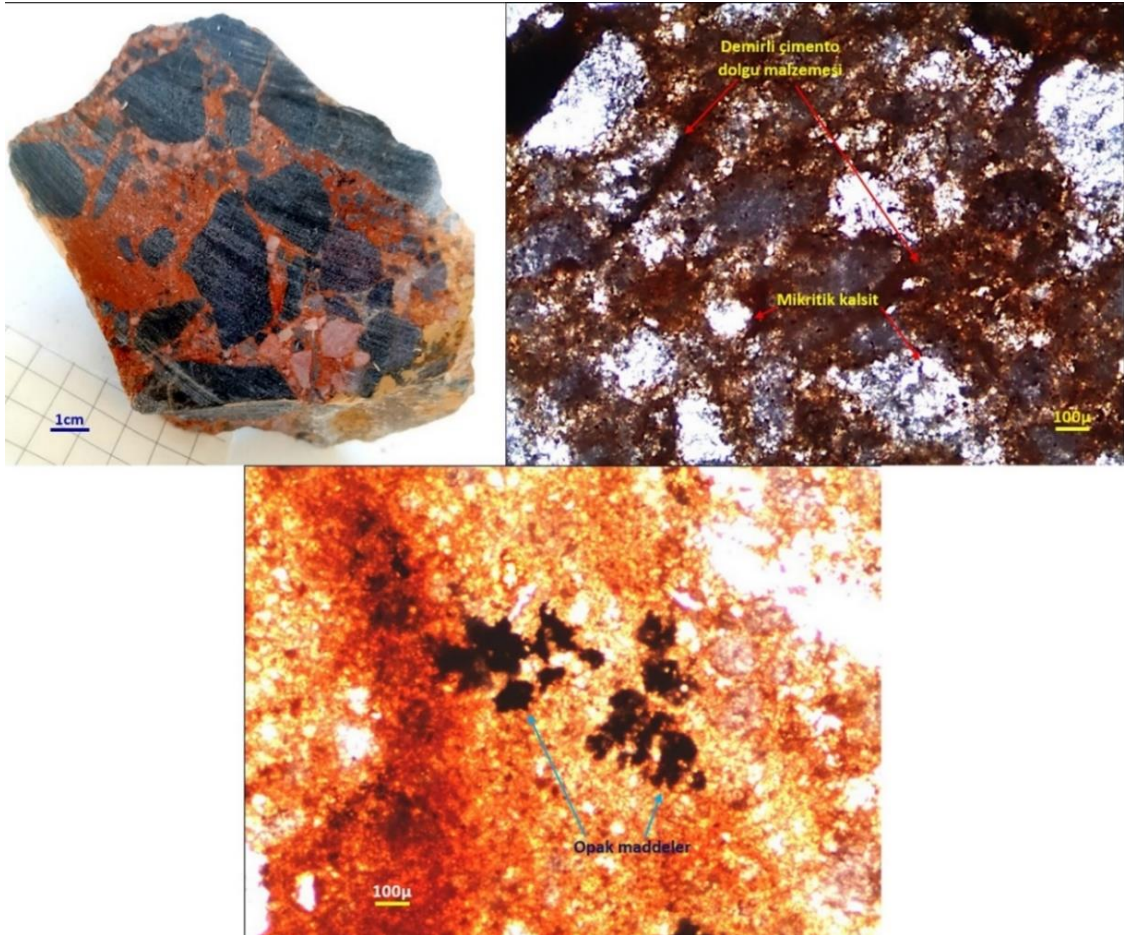
Figure 47. Macroscopic and microscopic images of sample C5.in.1.

Stone sample C5.in.1 is an iron-rich brecciated limestone with microcrystalline calcite crystals in large grains (Figure 47). The opaque materials are observed, which are likely to be micritic calcite and hematite with high iron content, holding the angular grains together (Figure 47).
