**EVALUATION OF STONE DETERIORATION  
PROBLEMS OF ANAVARZA ARCHAEOLOGICAL  
SITE FOR THE PURPOSE OF CONSERVATION**

**A Thesis Submitted to  
the Graduate School of Engineering and Sciences of  
İzmir Institute of Technology  
in Partial Fulfillment of the Requirements for the Degree of**

**in Architectural Restoration**

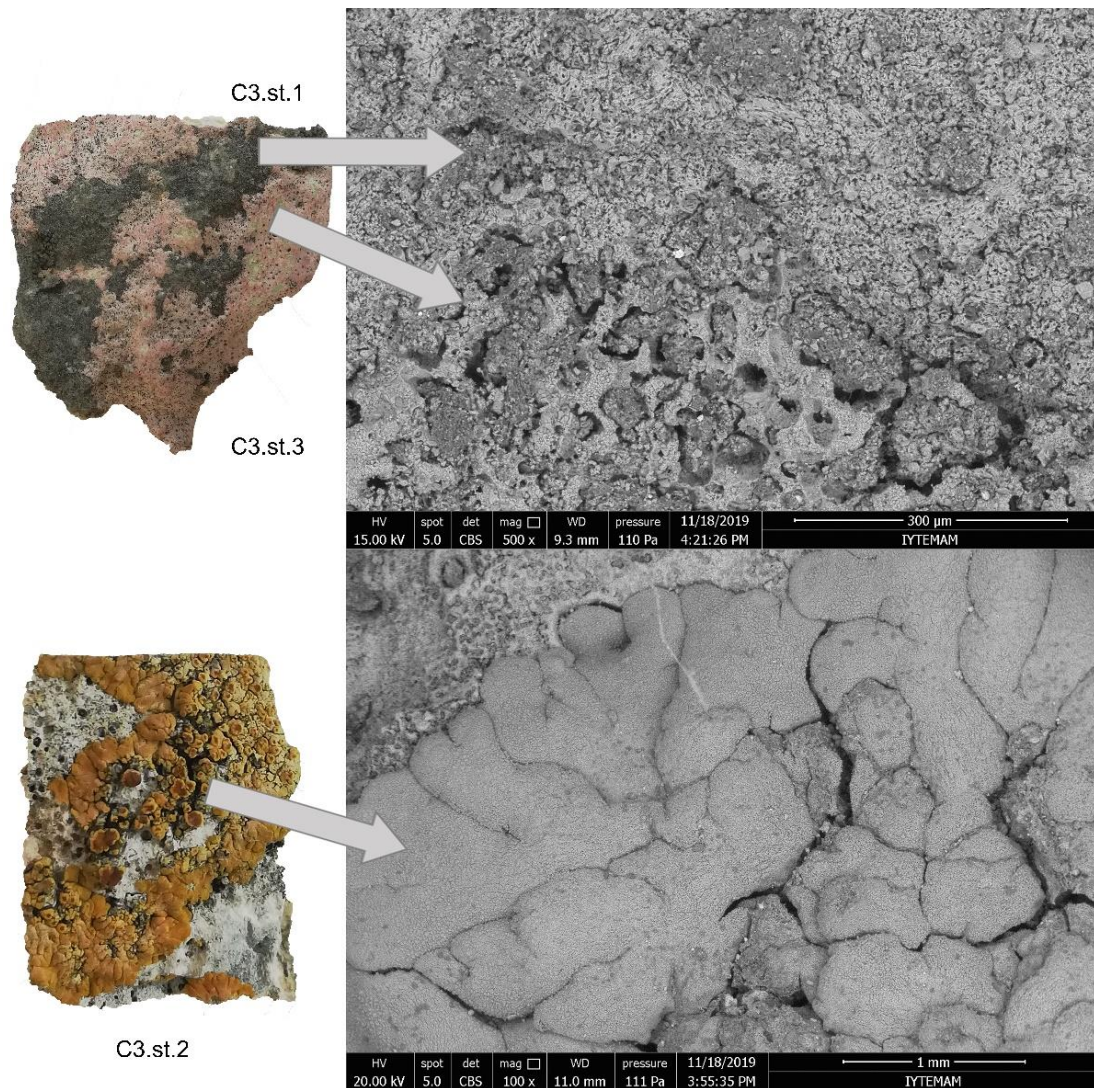
Figure 48. SEM images of the sample C3.st.1, C3.st.2 and C3.st.3.

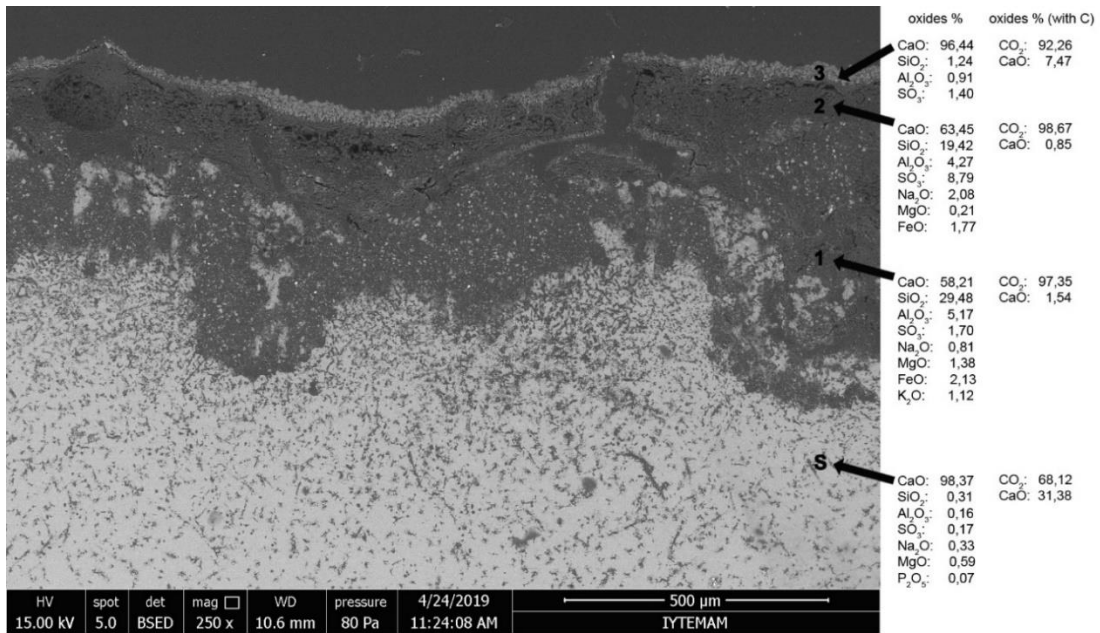
Figure 49. SEM image and EDS results of the intersection of the standing stone sample from the 3<sup>rd</sup> column.

The 3<sup>rd</sup> column (C3) is covered by a very developed microbiological colonization throughout to the inner cores of the stone (Figure 49). This is probably due to the distribution of bacterial communities, also the environmental conditions and the mineral structure of the stone, as described before. Some microorganisms such as bacteria, fungi might penetrate into the materials and cause severe damage (Sterflinger and Piñar 2013). Endolithic microorganisms (fungi, green algae, cyanobacteria) are responsible for biopitting on stone surfaces (Caneva et al. 2008). Presence of biopitting on this stone surface and microbial development throughout to the inside of the stone may show fungi and bacteria formation in this biofilm.

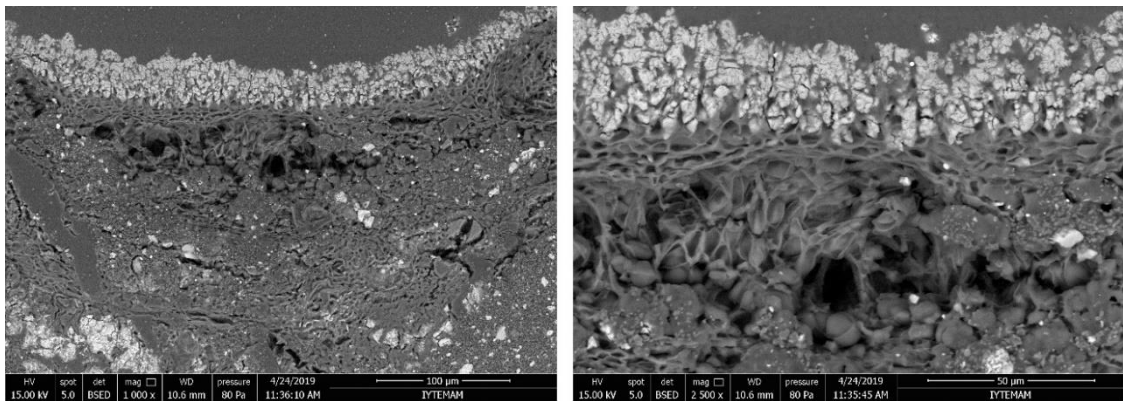
Figure 50. SEM images of the deterioration layers on standing stone sample from the 3<sup>rd</sup> column.

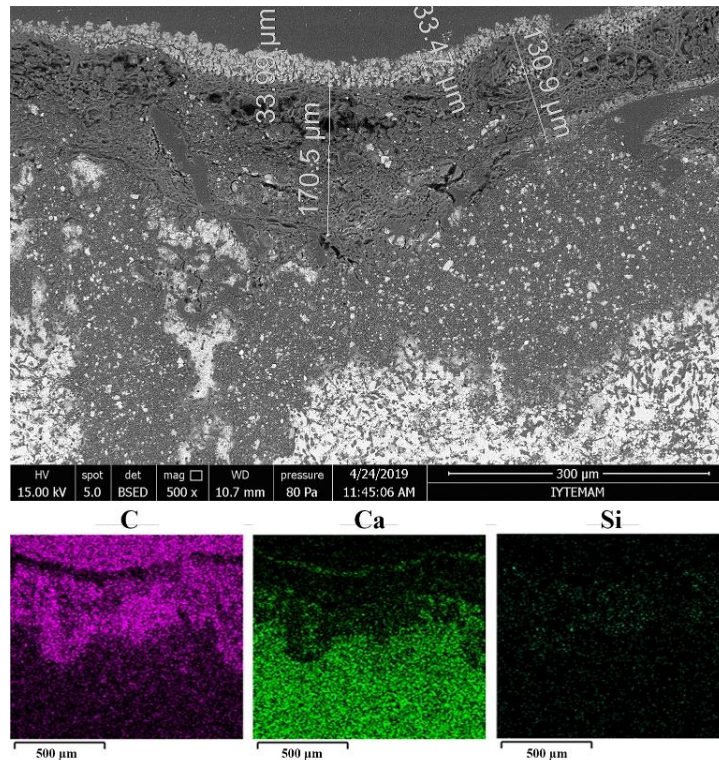
Figure 51. SEM image and EDS mapping of the intersection of the standing stone sample from the 3<sup>rd</sup> column.

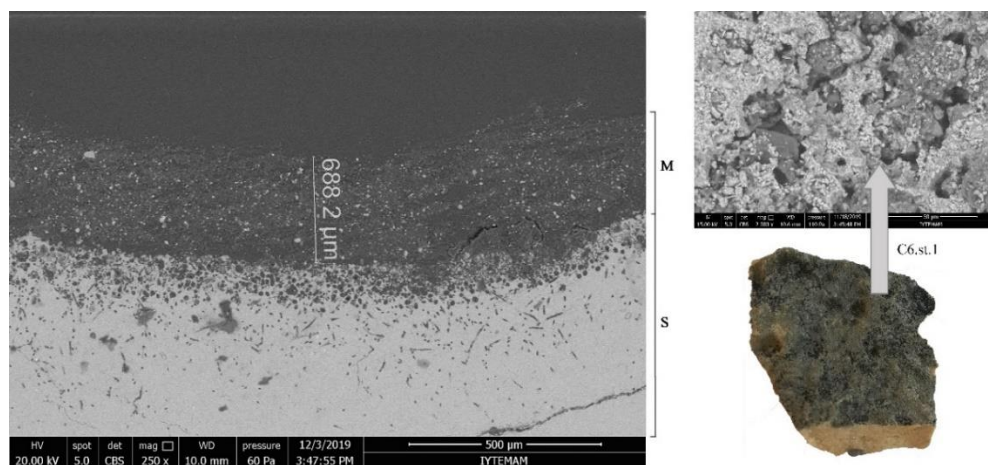
Figure 52. SEM image of the intersection of the standing stone sample from the 6<sup>th</sup> column (C6.st.1), (M: microbiological formation, S: stone inside).

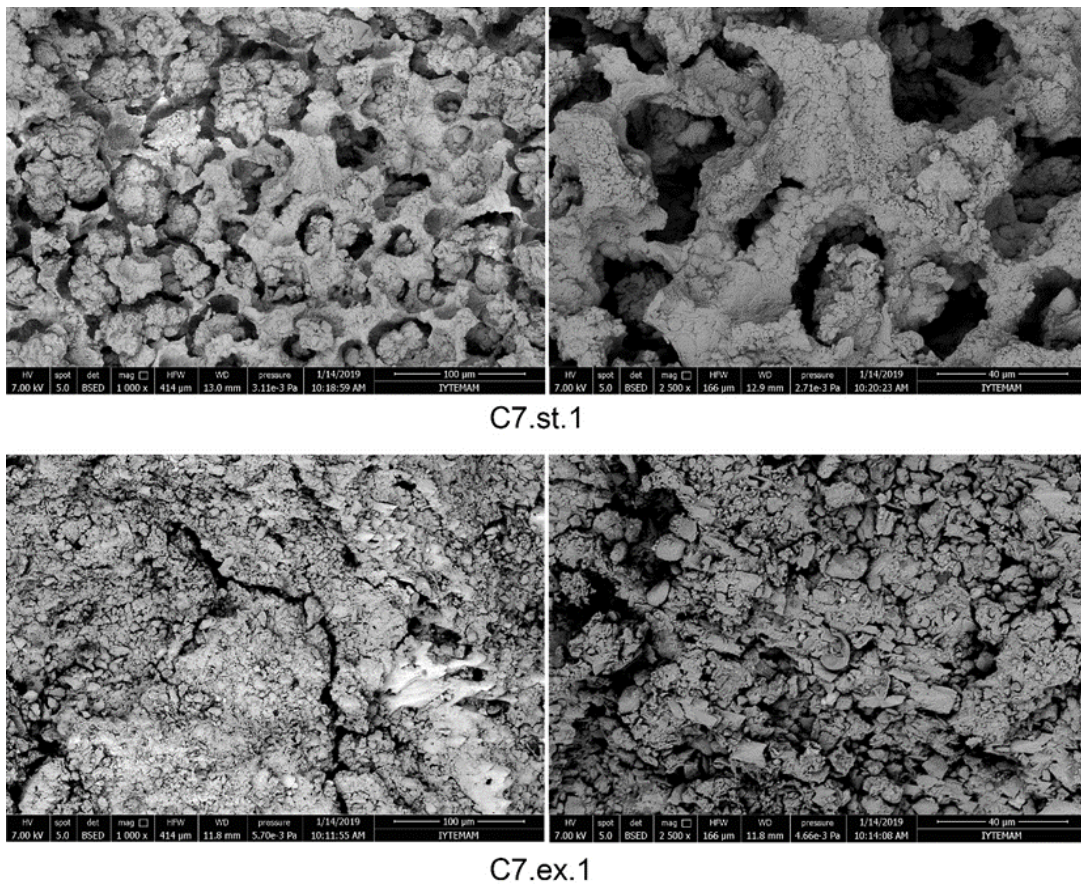
Figure 53. SEM images of the standing surface (C7.st.1) and the recently excavated surface (C7.ex.1) of the 7<sup>th</sup> column.

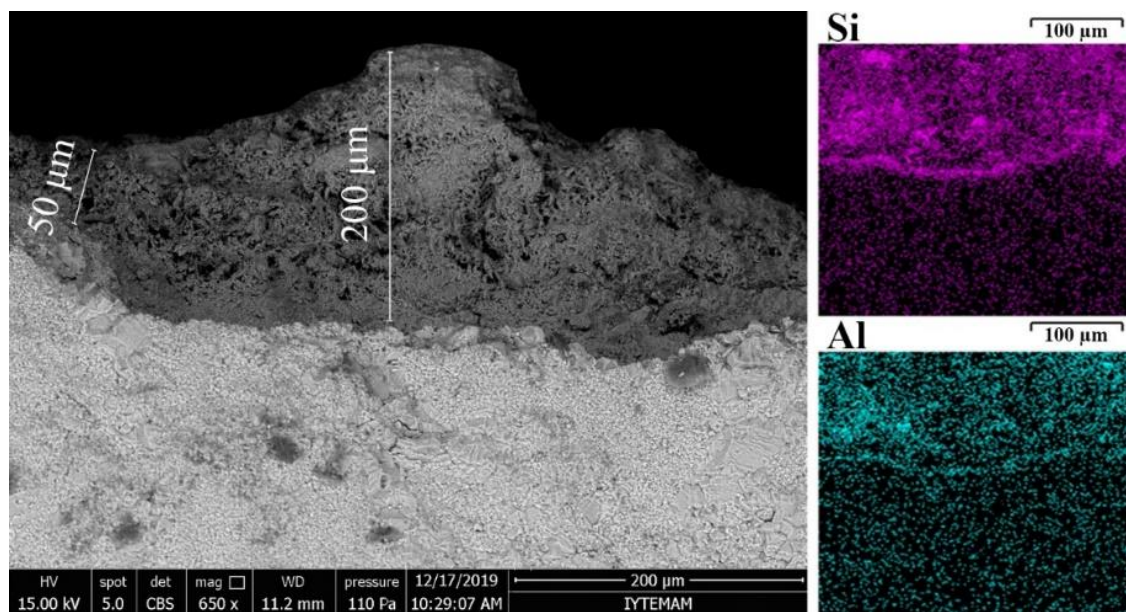
Figure 54. SEM image and EDS mapping of the intersection of the recently excavated part of the 7<sup>th</sup> column (C7.ex.1).

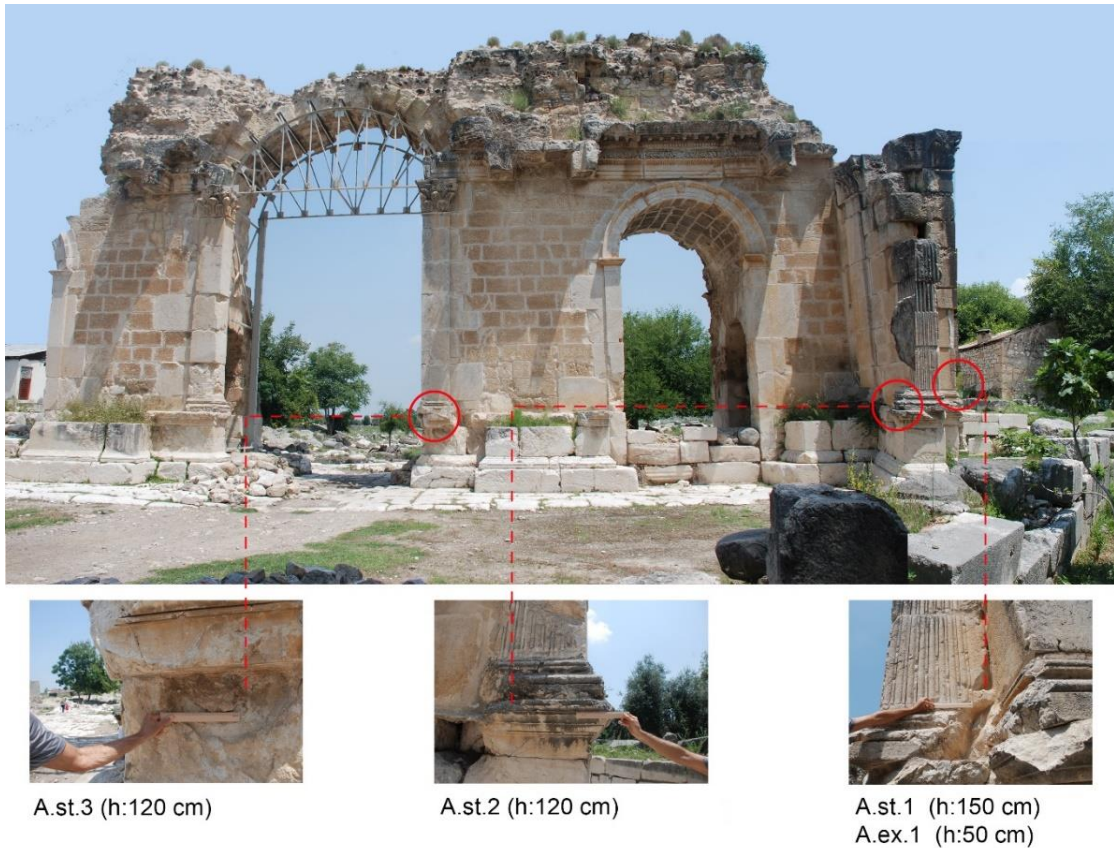
Figure 55. Sample locations on the Alakapı.

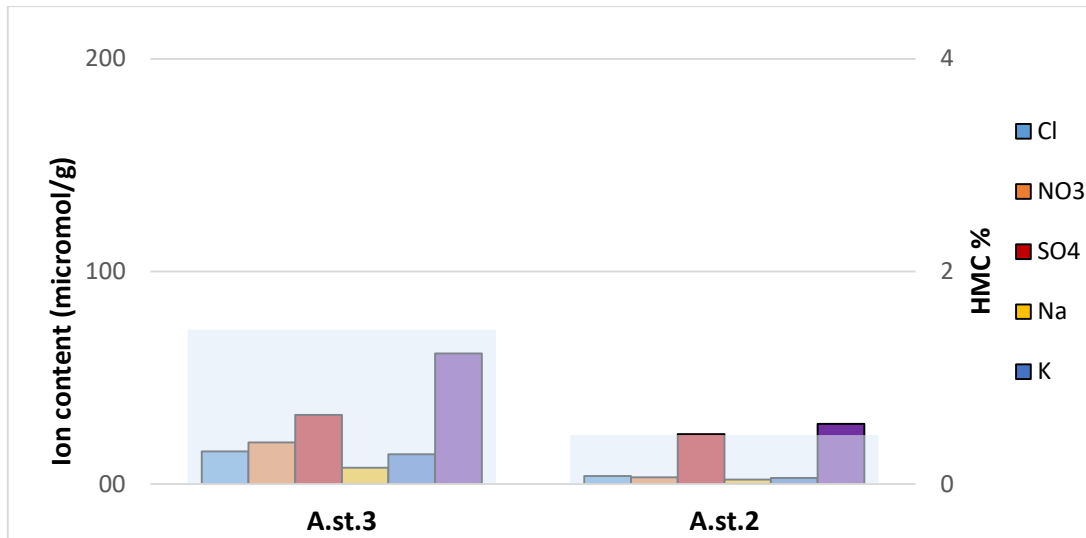
Figure 56. Ion content and HMC graphics of the sample A.st.3 and A.st.2.

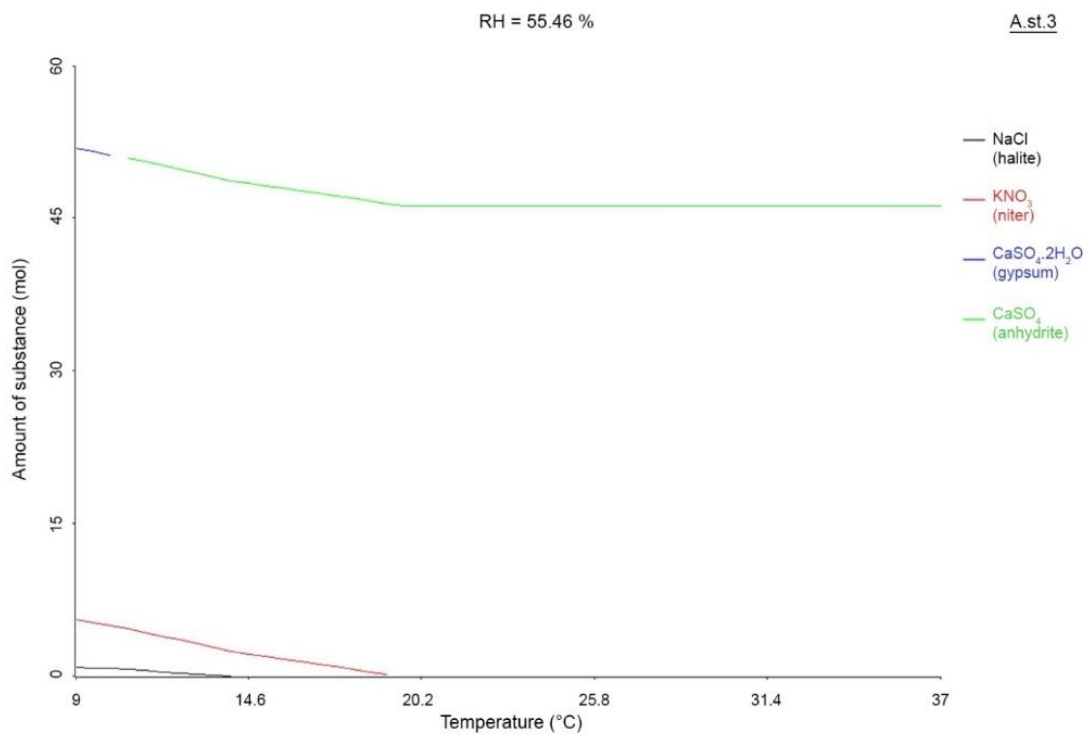
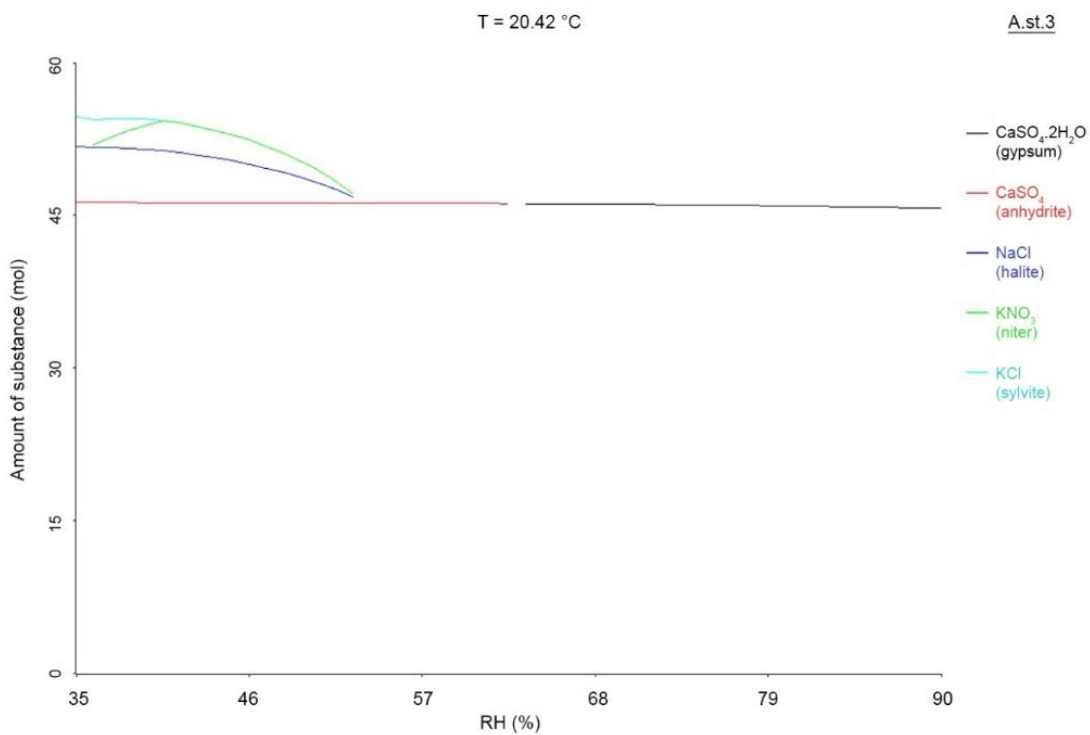
Figure 57. Salt diagram of the sample A.st.3

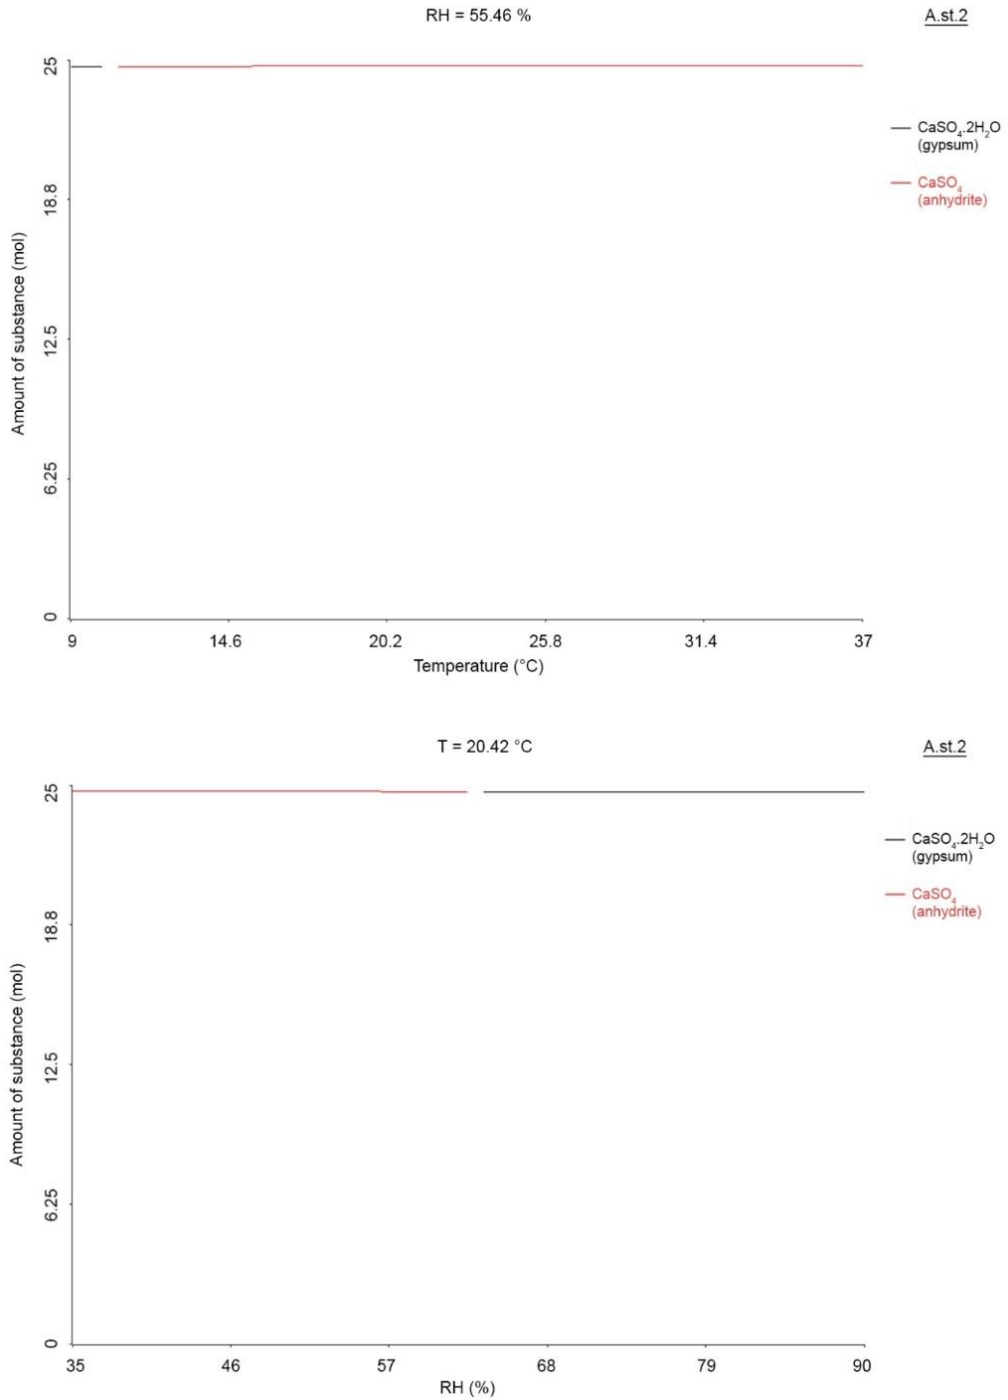
Figure 58. Salt diagram of the sample A.st.2

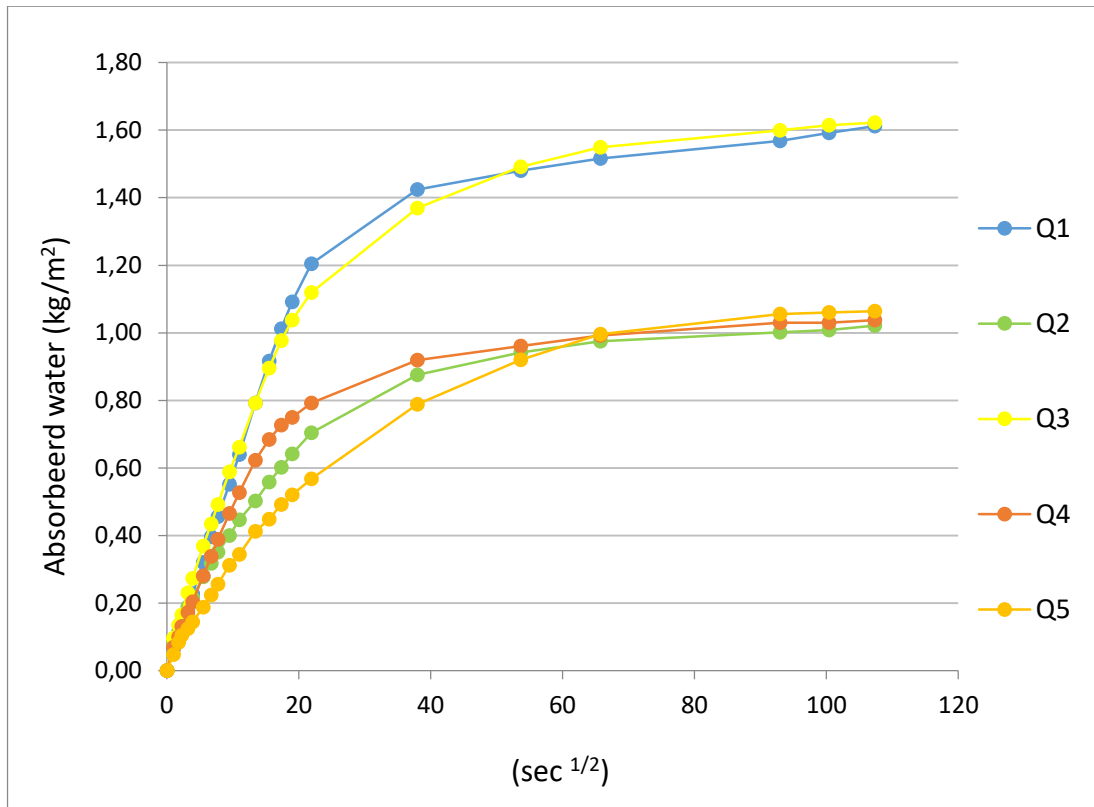
Figure 59. Water absorption by capillarity of the limestones from the historic quarry

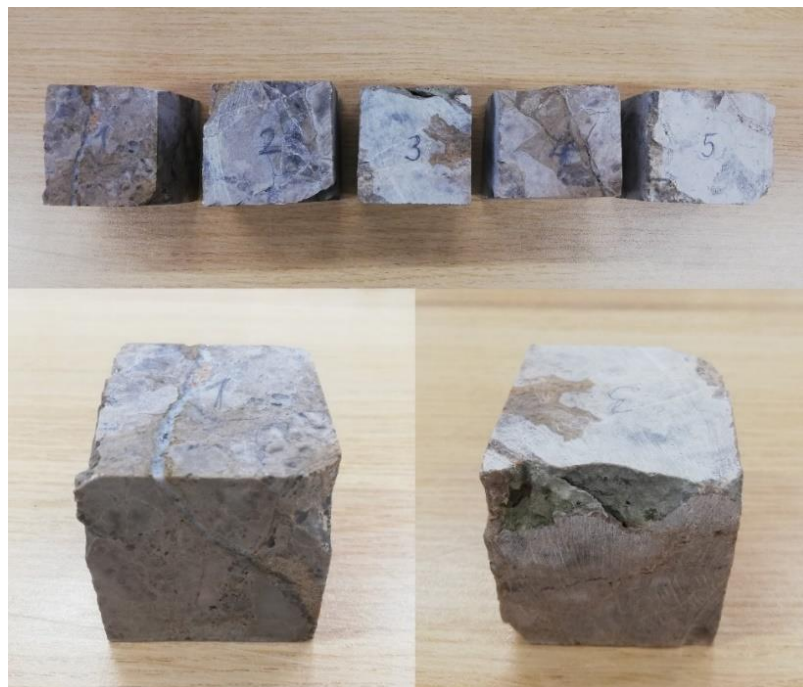
Figure 60. Stone samples after water absorption test, Q1 and Q3

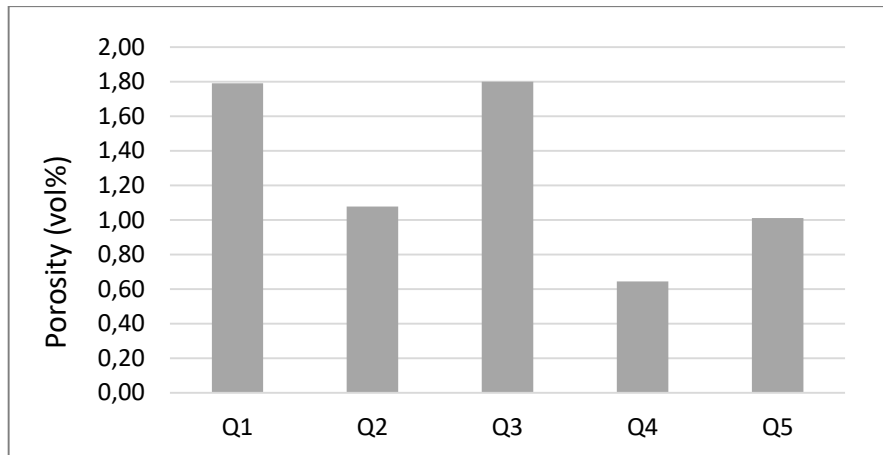
Figure 61. Porosity of stone samples from the historic quarry.

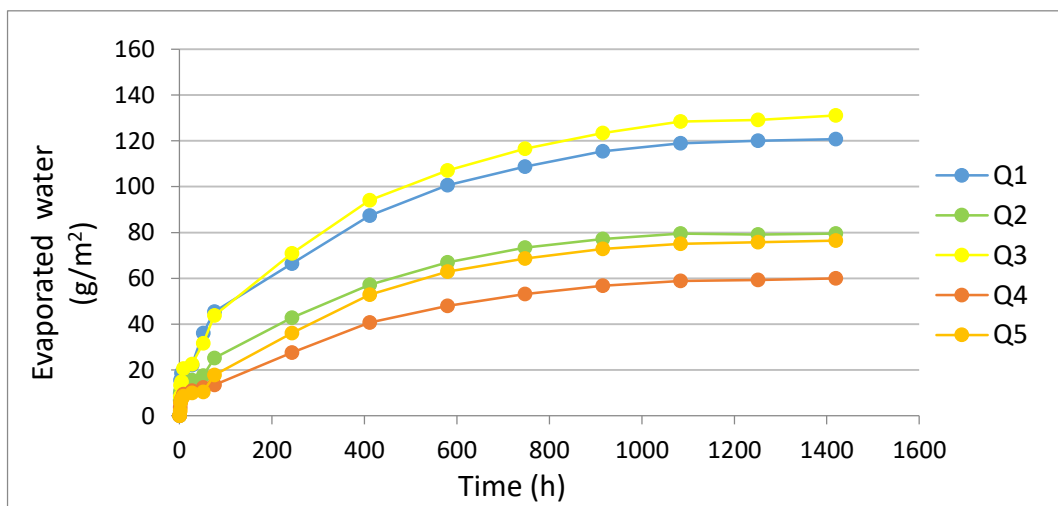
Figure 62. Drying rate properties of the limestones from the historic quarry.

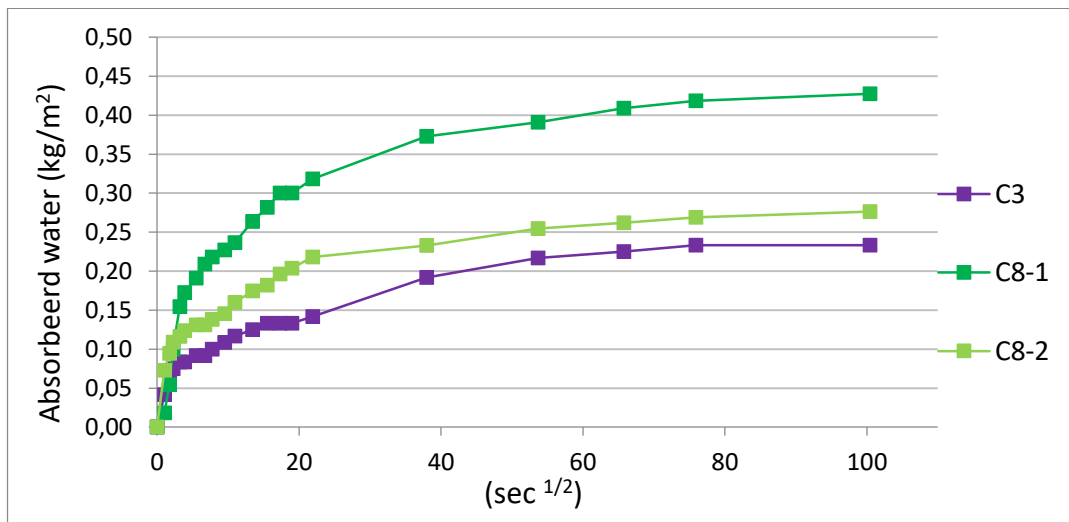
Figure 63. Water absorption by capillarity of the limestones from the site (C3, C8-1, C8-2).

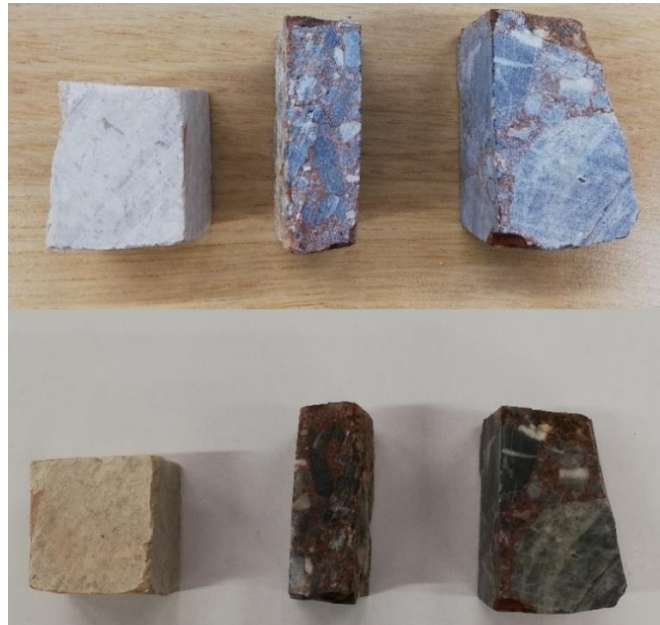
Figure 64. Stones from left to right: C3, C8-1, C8-2, before and after water absorption.

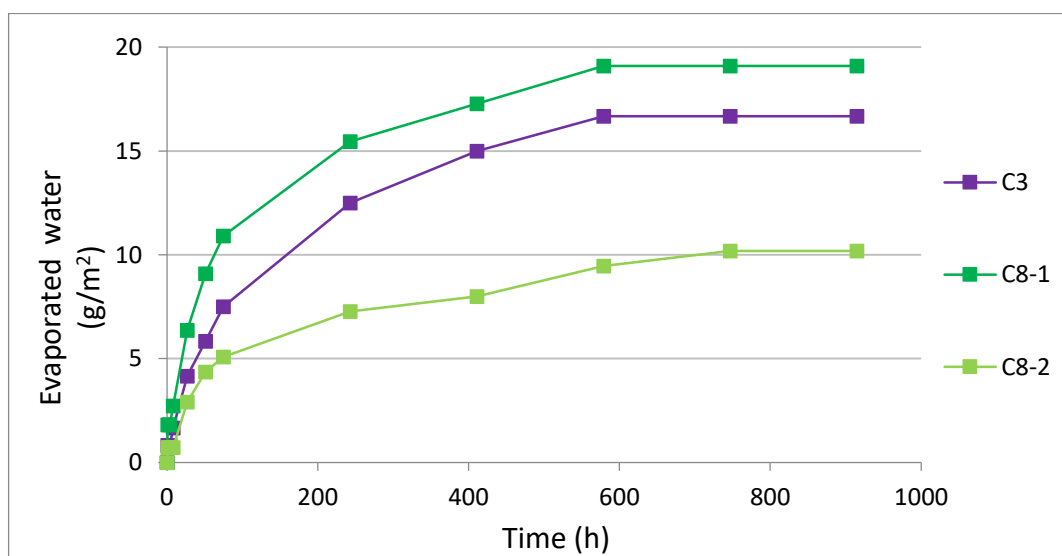
Figure 65. Drying rate properties of the limestones from the site (C3, C8-1, C8-2).

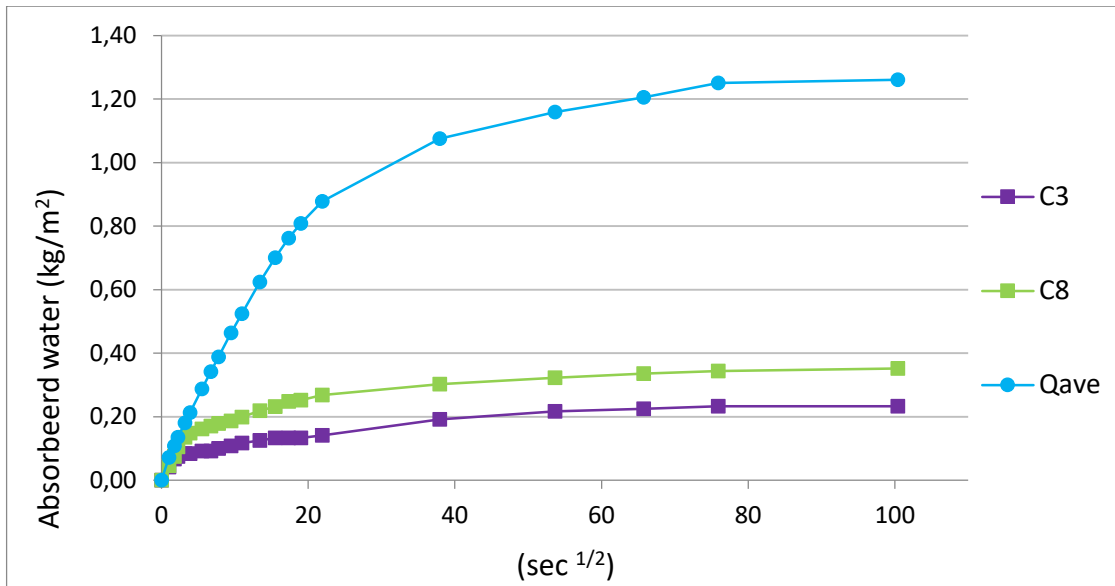
Figure 66. Water absorption by capillarity of the limestones from the site (C3, C8) and from the historic quarry (Qave).

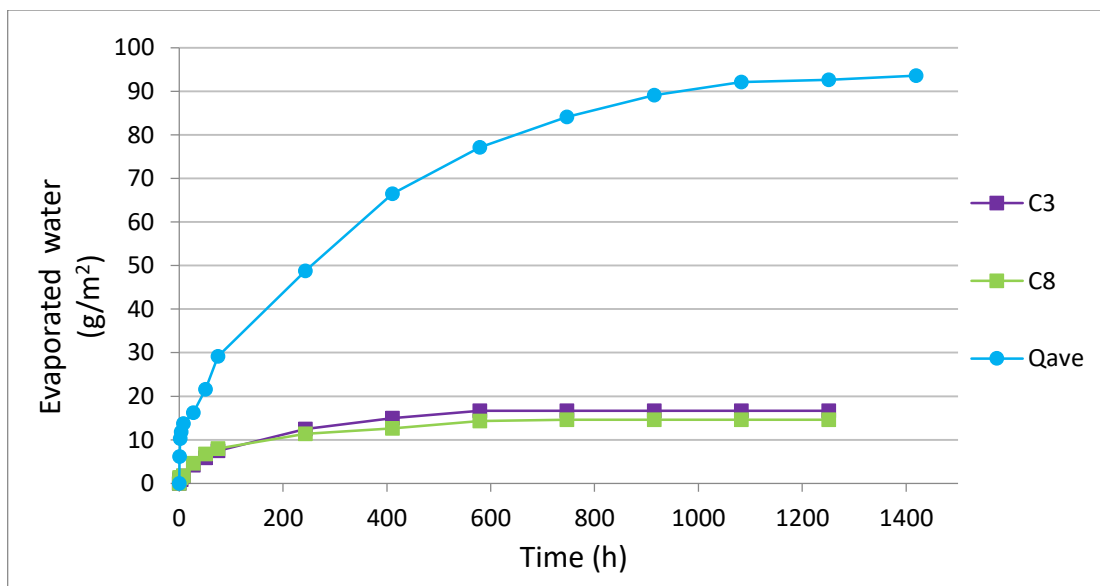
Figure 67. Drying rate properties of the limestones from the site (C3, C8) and from the historic quarry (Qave).

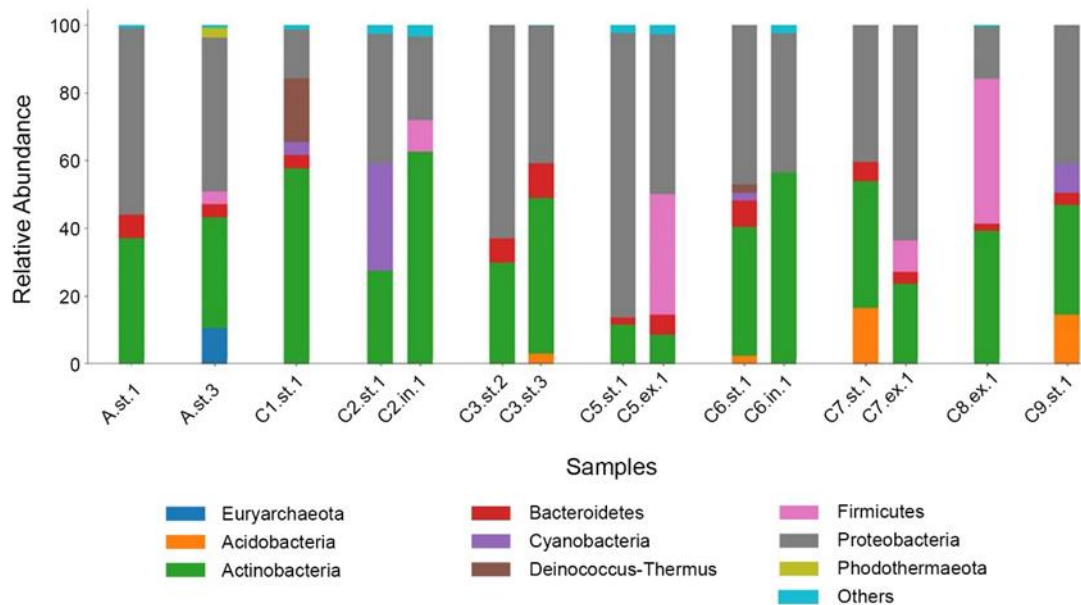
Figure 68. Distribution of bacterial phyla of the samples from Alakapı (A.st.1, A.st.3), from the standing surfaces of the columns (C1.st.1-C9.st.1) and from the recently excavated surfaxes of the columns (C5.ex.1-C8.ex.1) (st: standing part, ex: excavated part, in: inner part)

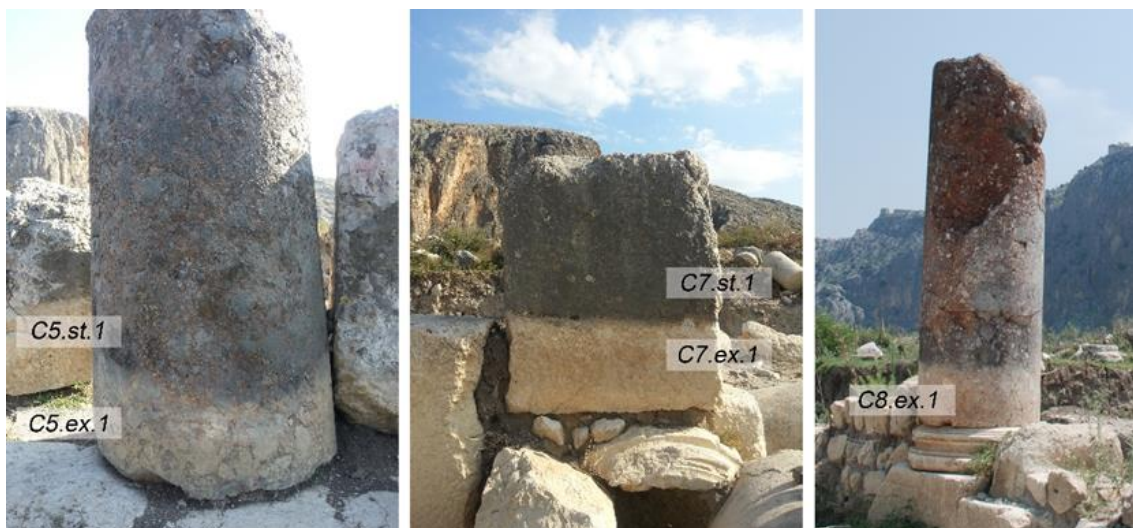
Figure 69. Samples from standing and recently excavated surfaces of the 5<sup>th</sup>, 7<sup>th</sup>, 8<sup>th</sup> columns.
