**LARGE SCALE TESTING OF MASONRY WALLS  
UNDER THE EFFECT OF REPRESENTATIVE  
GROUND SETTLEMENTS**

**A Thesis Submitted to  
the Graduate School of Engineering and Sciences of  
İzmir Institute of Technology  
in Partial Fulfilment of the Requirements for Degree of**

**in Civil Engineering**

**by  
Berkay ÖZDEMİR**

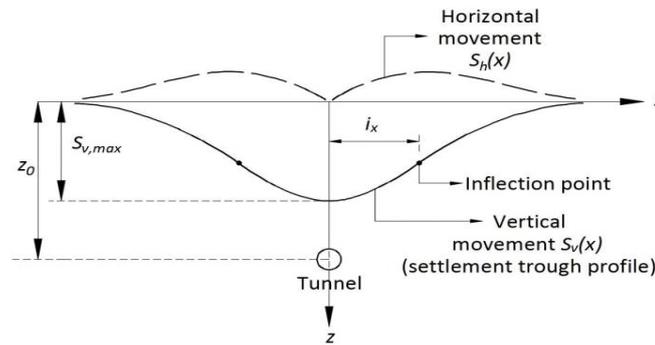
Figure 2.1. Gaussian Normal Distribution Curve Function (Source: Dalgic et al, 2017; (modified from Peck, 1969))

Settlement trough consists of concave or convex parts (Figure 2.1). Concave part of the profile is named as sagging, convex part of the profile is named as hogging. According to Comodromos et al. (2014) and Potts and Addenbrooke (1997), structures can be located at different positions with respect to tunnel line and they could modify ground settlements depending on their restraint abilities such as weight, size, and foundation type. Figure 2.2 shows the different buildings which are in sagging (i), in the

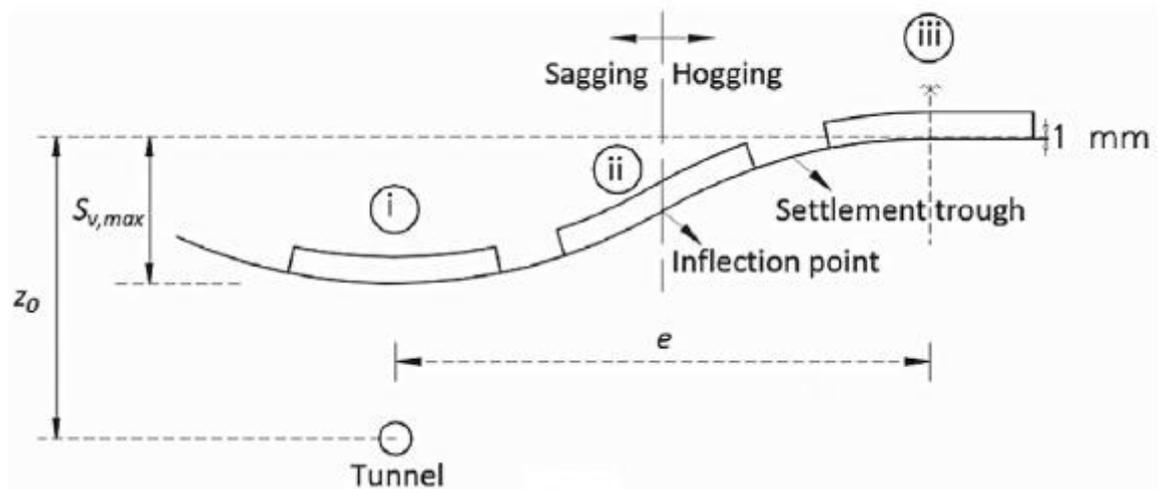
vicinity of the inflection point (ii) and in hogging (iii). In figure,  $e$  represents the eccentricity between the center of the building and the tunnel center (Dalgic et al, 2017).

Figure 2.2. Different positions of buildings in the transverse settlement trough: (i) sagging, (ii) at an inflection point, (iii) hogging. (Source: Dalgic et al, 2017)

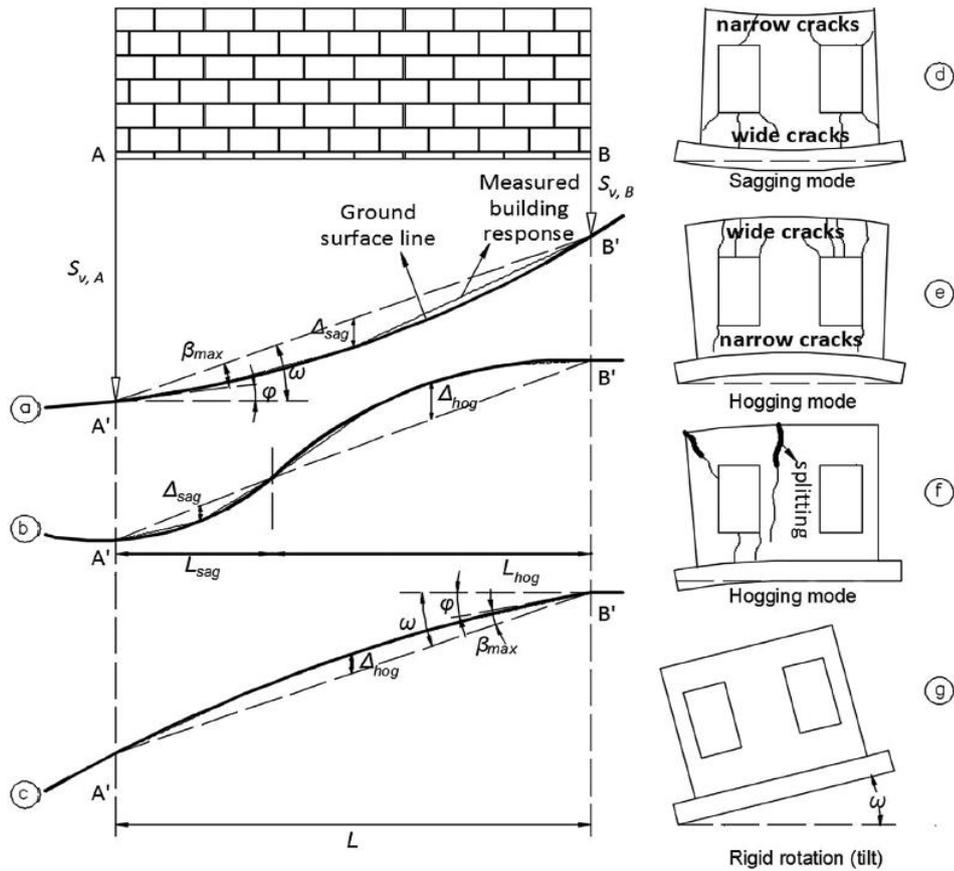
Figure 2.3. Deformation measures for a masonry wall conforming to a ground settlement profile in: (a) the sagging zone, (b) both the sagging and hogging zones, and (c) the hogging zone and the typical building damages or responses (d, e, f, and g). (Source: Dalgic et al, 2017)

In case of tunnelling activities causing the ground settlement, points A and B moves toward to points A' and B', and this motion may generate straining in the wall if building experience any distortion. Equation (2.2) can be used to calculate the differential settlement ( $\delta S_v$ ) between the points A' and B'. Here,  $S_{v,A}$  and  $S_{v,B}$  are the absolute vertical displacements of points A and B, respectively.

The other deformation measure is the deflection ratio ( $\Delta/L$ ) which was proposed by Polshin and Tokar (1957). As demonstrated in Figure 2.3,  $\Delta$  is the distance between displaced foundation line and the linear line connecting points  $A'$  and  $B'$ , and  $L$  is the considered length of the structure. Mair et al. (1996) suggested that, for structures located both in hogging and sagging parts of a settlement trough,  $\Delta/L$  can be calculated separately for both parts (Figure 2.3)

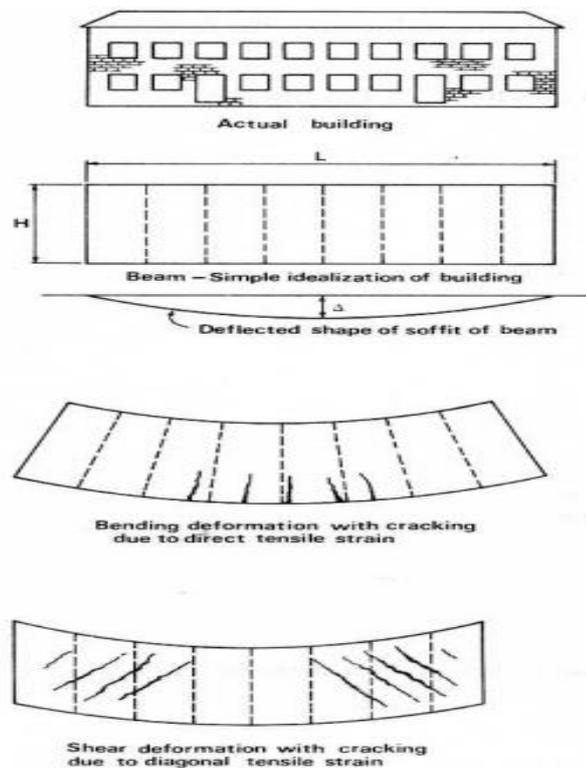
The fictitious beam model considered by Burland and Wroth (1974) is shown in Figure 2.4.  $L$  is the length of the beam (refers to considered length of the real building) and  $H$  is the height of the beam (refers to height of the real building from the foundation to the top).

Figure 2.4. The model of the fictitious beam (Source: Burland and Wroth, 1974)

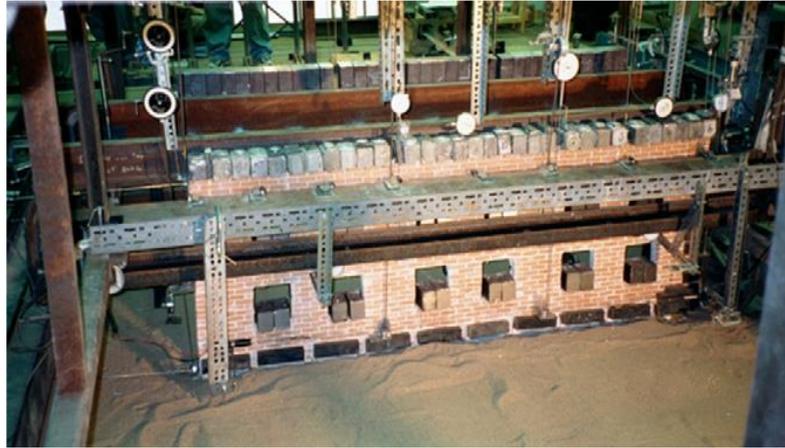
Figure 2.5. Test wall used in the study of Laefer et al. (2011)

To investigate the effects of excavations on masonry walls, they used a test bed filled with sand. Then, they simulated ground settlements caused by an adjacent excavation and focused on the response of the wall specimen. They reported that both ground movements and building damage patterns were in line with the targeted site measurements and findings of previous researchers.

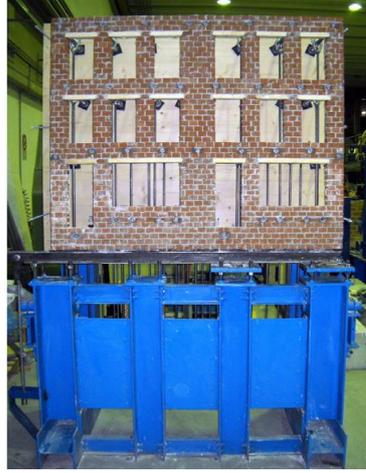
Giardina et al. (2012) reported that laboratory tests provide a better understanding for the response of the structures subjected to support settlements and help to check the validity of computational models. The main aim of their experimental work was to provide accurate data that will be utilized for checking the validation of numerical analyses. They constructed a 1/10 scaled masonry wall specimen and then subjected to an artificial hogging-type settlement profile. The hogging-type settlement imitated the settlement effects caused by a tunnelling activity in the vicinity of the represented masonry building. The wall specimen was a representative of a typical Dutch house. The masonry wall specimen length, width and height are 1.5 m, 0.05 m and 1.2 m, respectively. As shown in Figure 2.6, the wall specimen was built on a steel I beam. I beam was connected to a fixed and rigid steel frame. Mentioned settlement profile was created by applying vertical displacements at one end of steel I beam.

Figure 2.6. The wall specimen built on a steel beam (Source: Giardina et al., 2012).

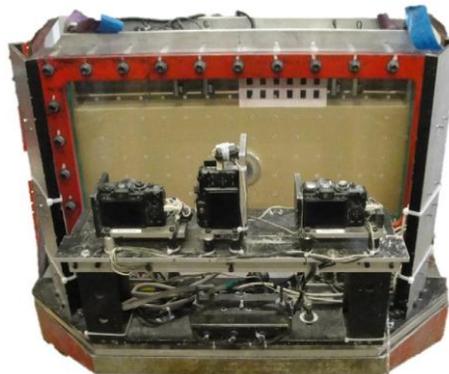
Ritter et al. (2017) performed a series of centrifuge tests to research the settlement response of the masonry specimens. Specimens represented the surface structures subjected to ground settlement induced by tunneling activities in sand. Specimens were constructed by 3D printing adopting an adjusted material density to account for scaled stress states of small, printed walls. Figure 2.7 shows the one of the centrifuge specimens used in the experiments of Ritter et al. (2017).

Figure 2.7. Front view of the centrifuge specimen (Source: Ritter et al., 2017).

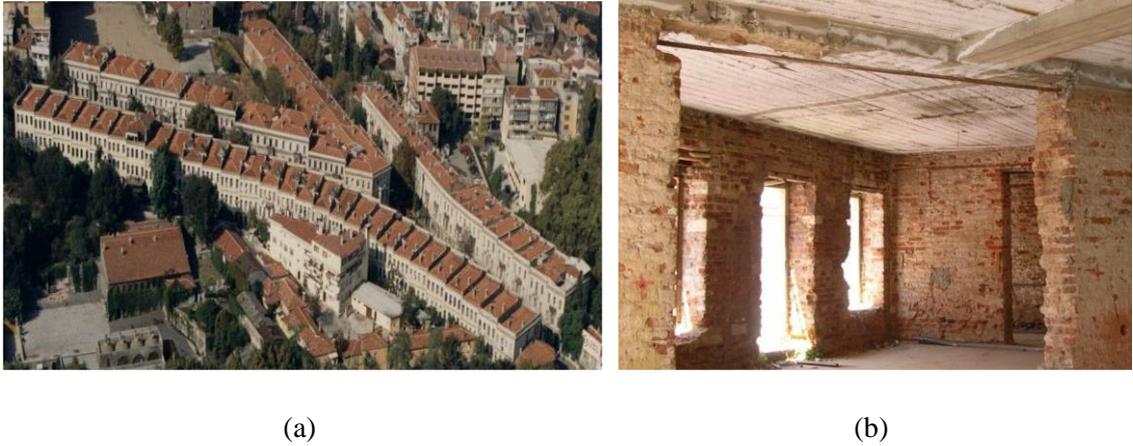
were stone for foundations. A general view of Akaretler Row Houses, its load-bearing walls and RC slabs are presented in Figure 3.1.

Figure 3.1. (a) General view of Akaretler Row Houses, (b) Load-bearing masonry walls and RC slabs of Akaretler Row Houses (Source: Ispir, 2010).

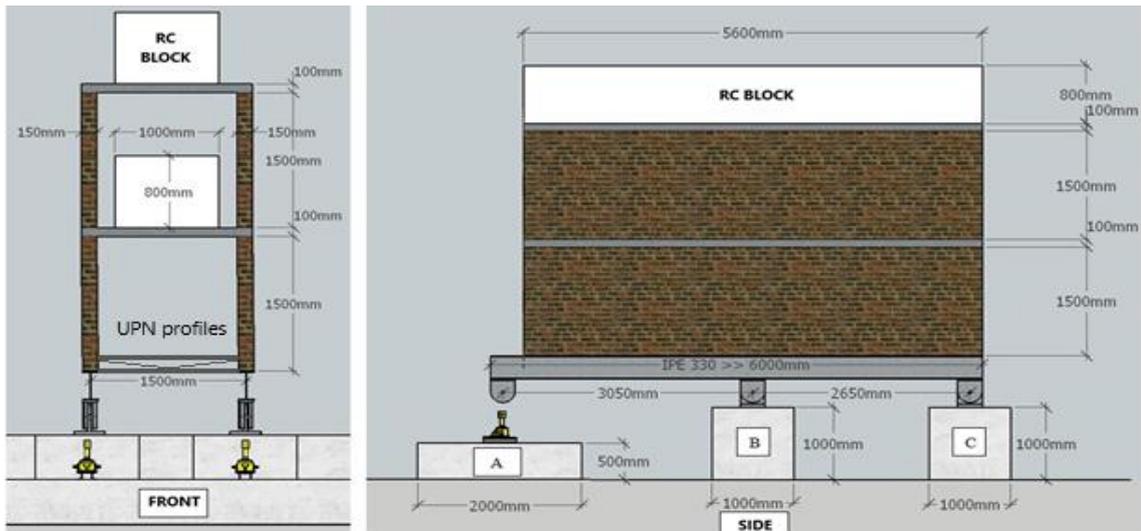
Figure 3.2. Front and side views of a specimen used in this study.

The specimens were constructed on two parallel steel beams (IPE330). Parallel beams were connected to each other by lateral cross-bracings (UPN profiles) to restrain out of plane movements and torsion. As shown in Figure 3.2, parallel beams were supported by three massive reinforced concrete blocks (A, B and C). Connections between parallel beams and reinforced concrete blocks were designed as moment-free pin connections considering estimated reaction forces. Base plates of pin connections were anchored to the reinforced concrete blocks via chemical anchors. Anchor details are shown in Figure 3.3.

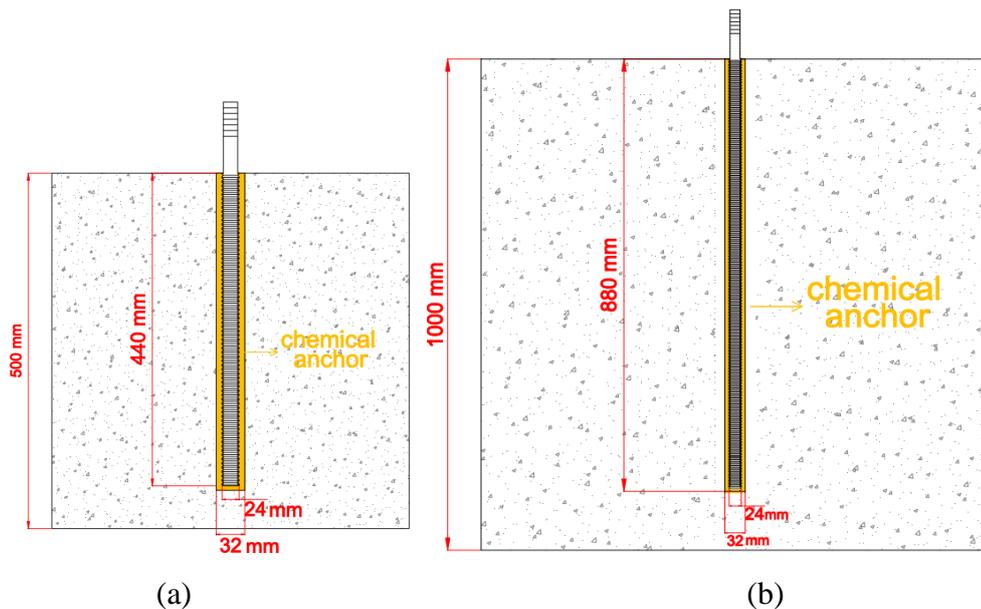
Figure 3.3. Anchorage information of (a) support A, (b) supports B and C.

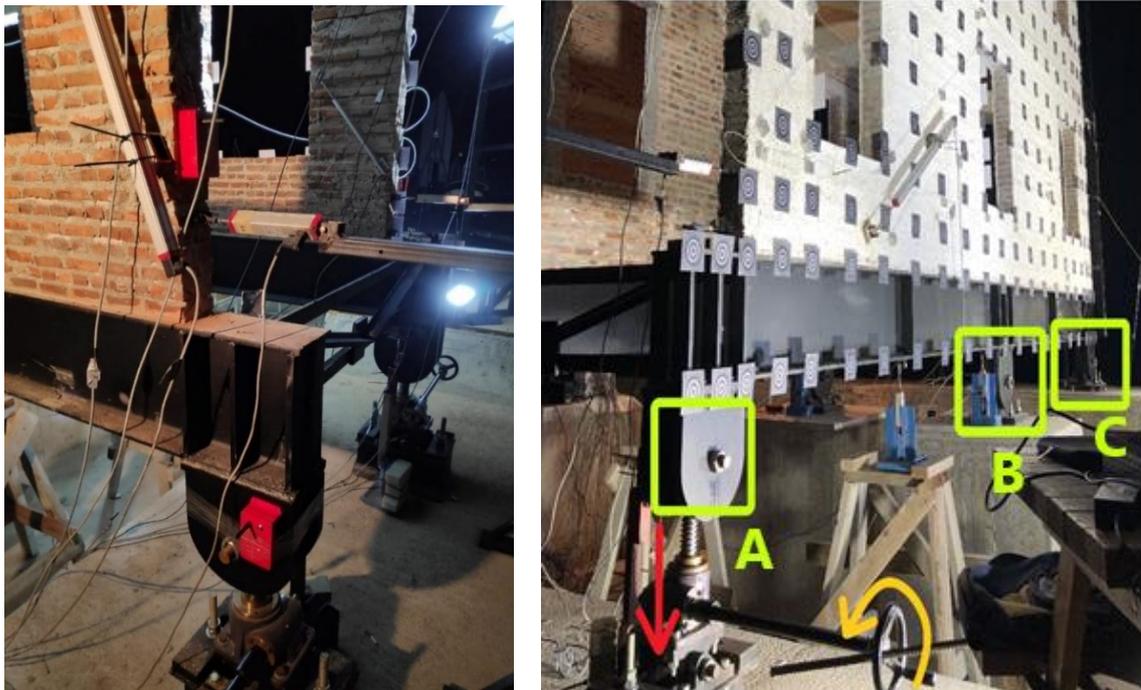
Since hogging type of ground settlements were more critical for masonry structures, a suitable scenario for tunnel construction and position of the building in the settlement trough was determined. To generate an experimental artificial hogging type of ground settlement, a tip displacement to the free ends of the steel beams were applied in downward direction. These tip displacements were applied through synchronous downward pulling forces by means of screw jacks located at support points A (shown in Figure 3.2) of the parallel steel beams. Figure 3.4 shows pin supports and movement principle of screw jacks.

Figure 3.4. Pin supports and movement of screw jacks.

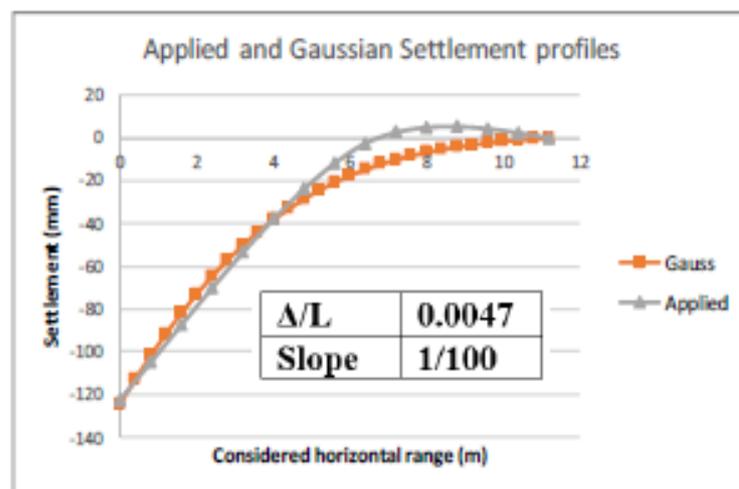
The variation of derived artificial vertical ground displacements in the hogging zone are shown in Figure 3.5. Herein, the magnitude of the maximum settlement is 122 mm. Considered horizontal distance is 11.2 m. The grey curve shown in this figure demonstrates the settlement profile that was applicable using the test setup. Note that the grey curve was determined as similar as possible to considered scenario curve indicated by the Gauss curve. Again, note that the magnitude of the settlements and the horizontal range in this figure is for actual scale 1:1. Due to scaling of the walls (1/2), applied values of both the magnitude of the settlements and the horizontal range should be considered as halves of these values.

Figure 3.5. Applied and scenario settlement (Gauss) profiles (in Actual scale, 1:1).

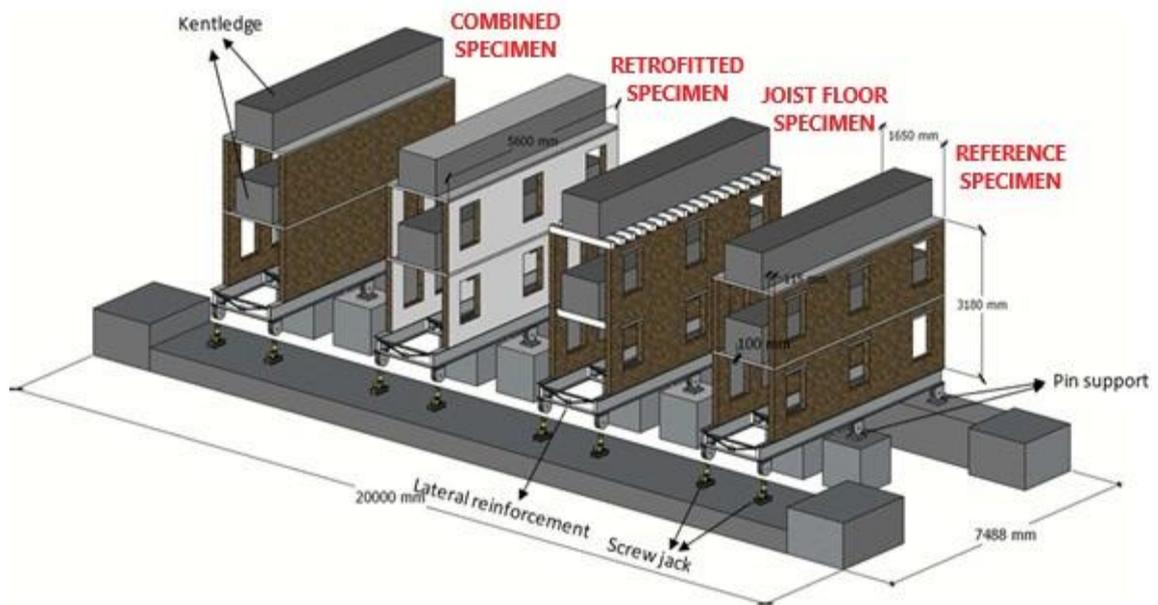
In the design of the wall building models, window opening ratio (OR) of the walls and floor stiffness were the main test variables. In order to examine the effect of OR, masonry walls with OR of 35%, 20% and 0% were tested. The general view of specimens is shown in Figure 3.6.

Figure 3.6. The general view of specimens.

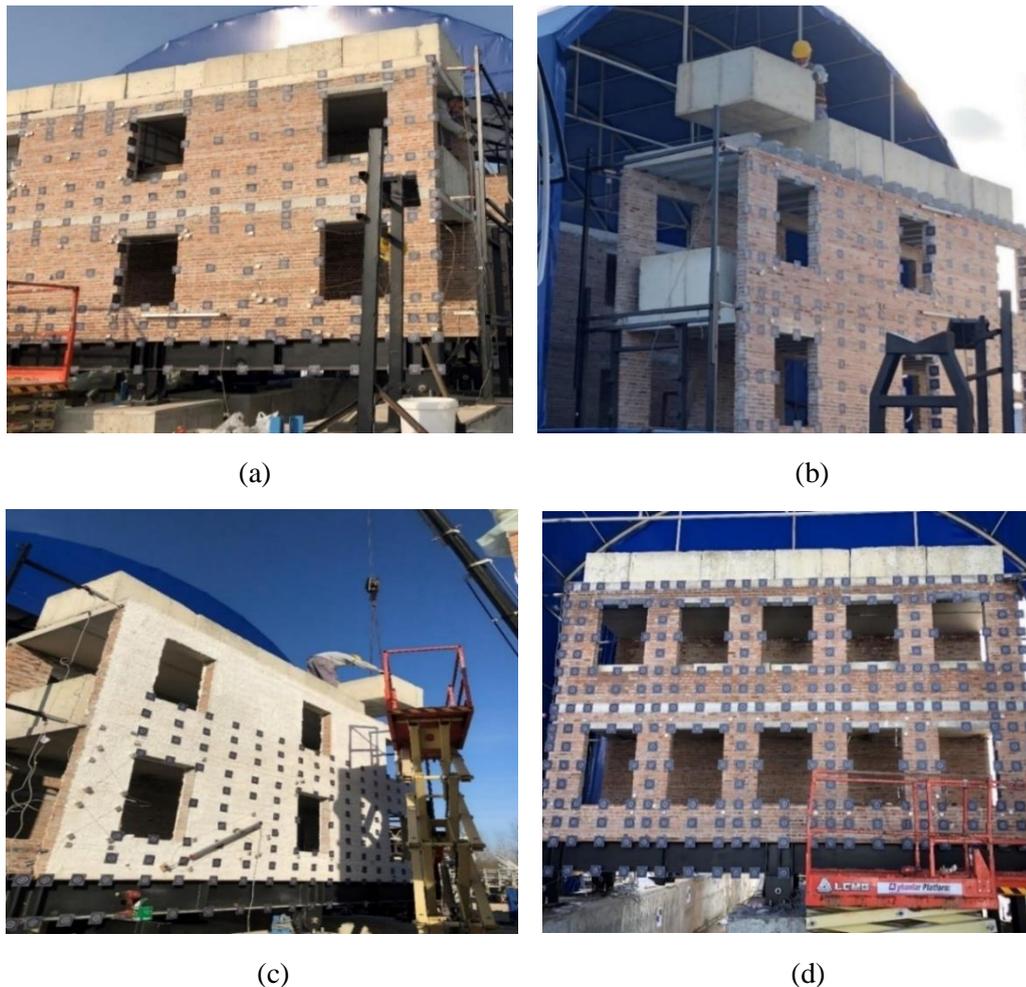
Reference weight application (W1) was made by placing RC blocks on the floors of the specimens at two storey levels. In this way, both floors were loaded up to 7.8 tons (15.6 tons in total). Recall that W1 application corresponds to 0.2 MPa compressive stress level at the bottom of the parallel masonry walls. Reference, joist floor, retrofitted and combined building wall specimens were subjected to W1 in the first run of their settlement tests. Figures 3.7 (a), (b), (c) and (d) show RC block weights on reference, joist floor, retrofitted and combined wall specimens, respectively. It should be noted that first floor RC blocks had been placed during the construction of the walls and top floor RC blocks were placed before the settlement tests began. The RC block loading was executed very slowly and paying attention to symmetrical order of the loads to ensure a stress distribution as even as possible.

Figure 3.7. RC block loadings (a) on reference specimen, (b) on joisted specimen, (c) on retrofitted specimen (d) on combined specimen.

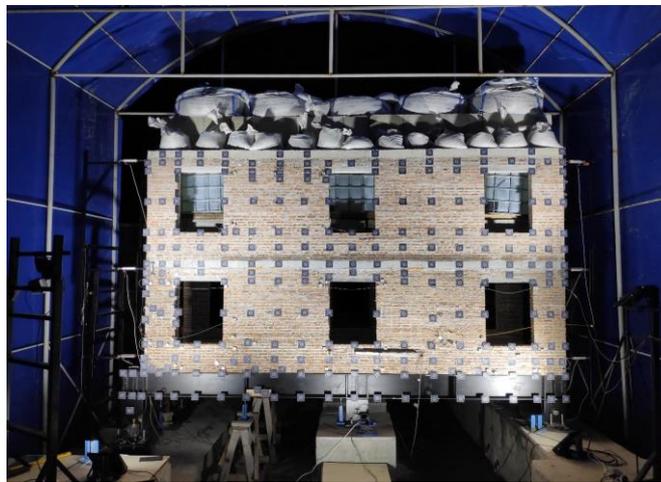
Increase of the building weight was simulated by increasing the amount of additional weight placed on the floors. To this end, in addition to RC blocks, extra weight was placed using sandbags and water tanks. Figure 3.8 shows nearly doubled weight reference specimen. It should be noted that, W2 was applied only for the reference building during its second run of settlement test. For W2, while the top floor was loaded up to 15.6 tons, the first floor was loaded up to 11.3 tons. Total added weight became 26.9 tons in total. W2 loading was achieved slowly and in a symmetrical order.

Figure 3.8. Nearly doubled weight (W2).

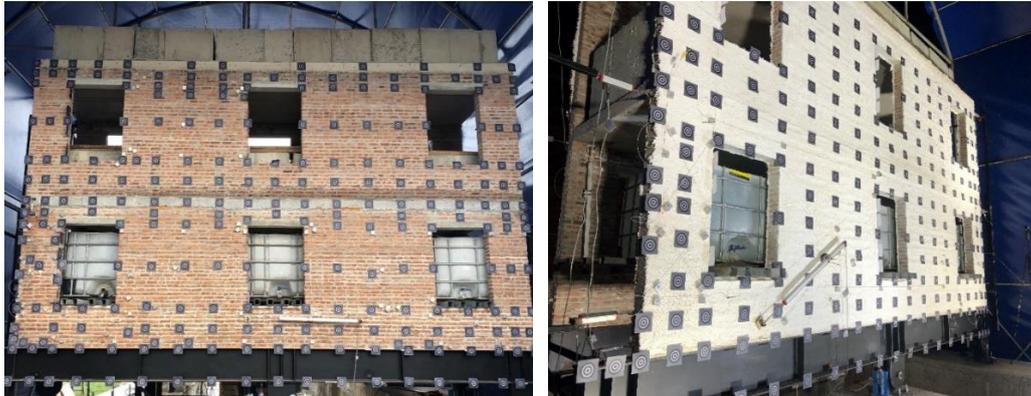
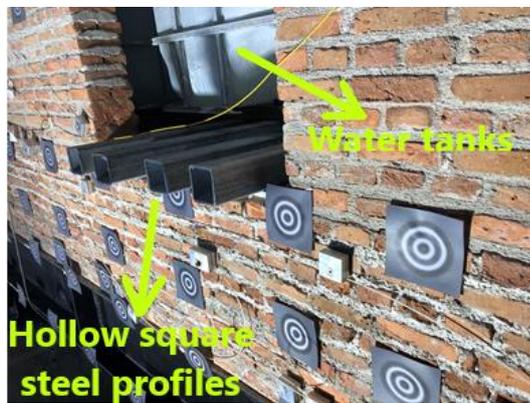
respectively. Also, Figure 3.9 (b) shows the detailed demonstration of application of W3. W3 loading was achieved slowly and in a symmetrical order.

Figure 3.9. Application of W3: (a) on the reference specimen, (b) on the retrofitted specimen, (c) application of loads from the ground floor windowsills.

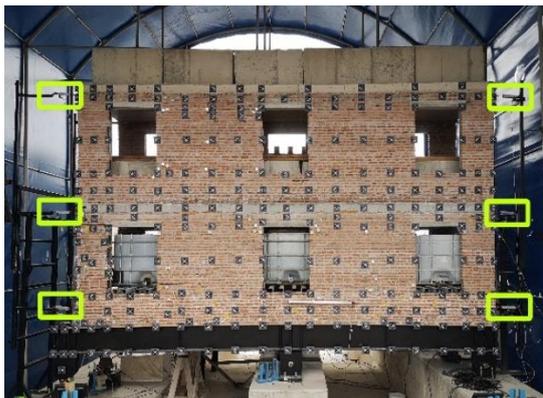
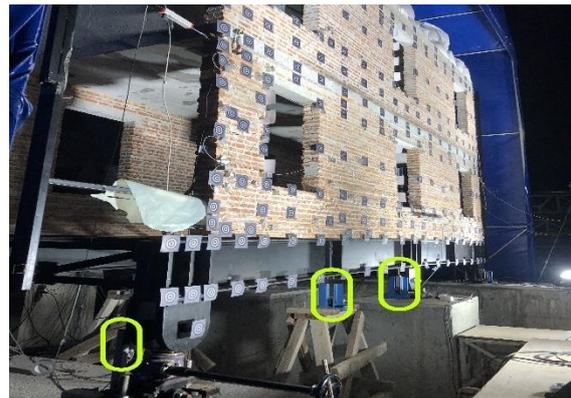
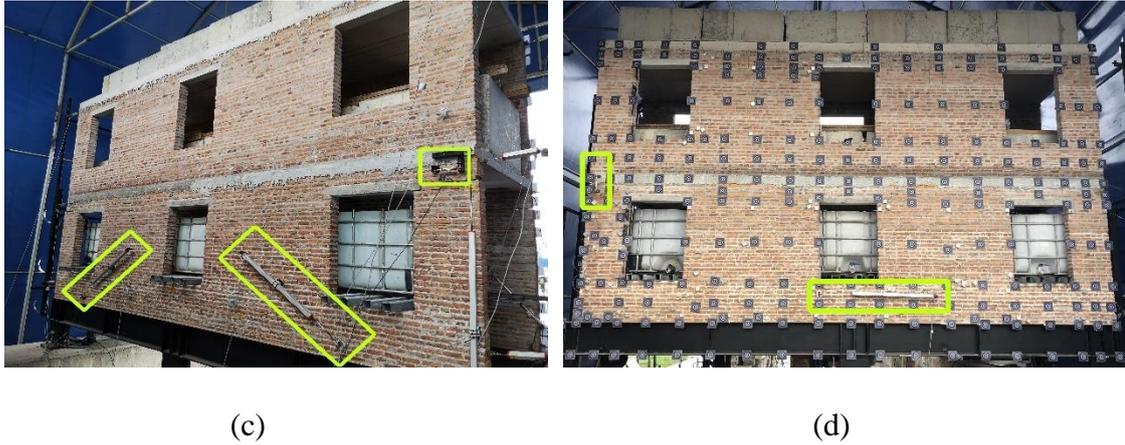
LVDTs were used to measure the displacements at different locations. Twelve LVDTs (6+6) were connected on the narrow sides (along the thickness of the walls) of the parallel walls at three different elevations (nearly bottom, mid-height and the top). As the walls move along with applied settlements, these LVDTs measured in-plane relative displacements of these points on the walls with respect to steel measurement towers standing next to the test setup and fixed to the ground independently. In-plane measurement will be used for the calculation of tilt of the specimens. While six LVDTs (3+3) in total facilitated to measure the vertical settlements on IPE steel beams, two of them were used to track the jack displacements at every step of incremental settlement loading. In addition, some extra LVDTs were also placed on the surface of the walls to measure the local crack openings and closures. One LVDT was always used to follow the out-of-plane displacements during the settlement tests. All the LVDTs were connected to TDG TEST BOX 1001 data logger. Data acquisition frequency was 1 sec. Figures 3.10 show the LVDT's installation plan to measure: (a) in-plane horizontal displacements, (b) in-plane vertical settlement displacements, (c) & (d) local crack openings and sliding.

Figure 3.10. LVDT's installed to measure: (a) horizontal displacements, (b) vertical displacements, (c) & (d) local crack openings and sliding.

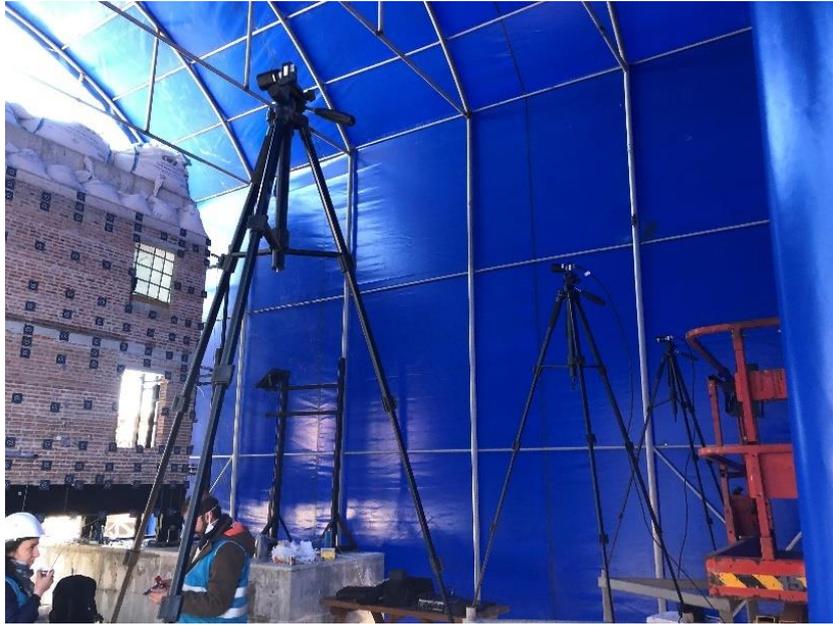
tracked the target points located in the vertical windowsills. The placement of the cameras is shown in Figure 3.11.

Figure 3.11. Placement of cameras to observe reference building front wall.

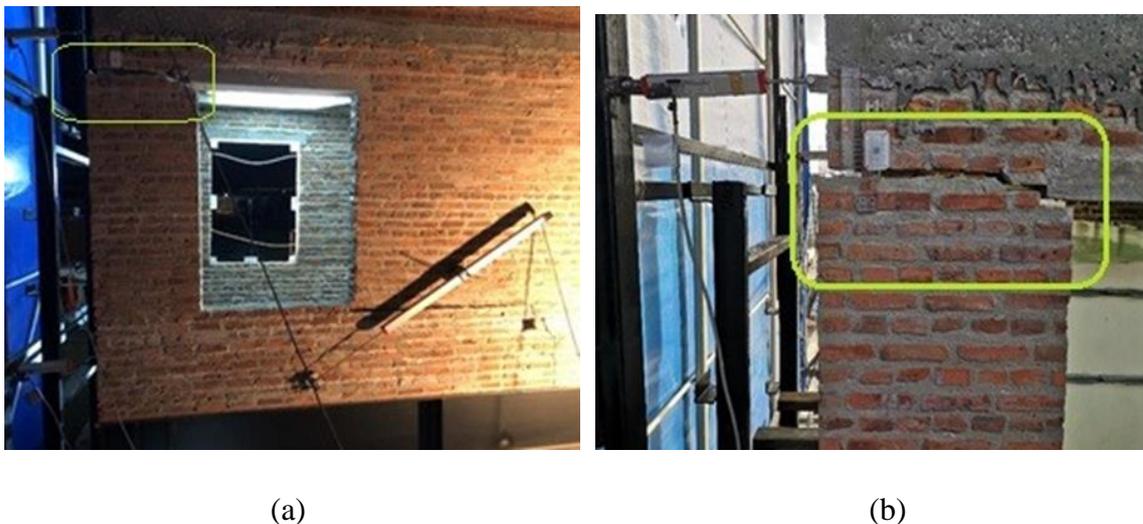
In this test, the reference specimen was tested under W1 weight loading. For this purpose, firstly RC blocks were placed onto the building floors by using mobile crane and then settlement effects were applied by deforming supporting IPE steel beams (tip displacement). Masonry walls significantly modified the applied settlement profile. A clear indication of this modification was the formation of gaps between wall bottom and steel beam. Around -45 mm tip displacement, at one of the corners of the building, a sudden damage occurred. Since the occurrence of this damage was attributed to a local imperfection regarding the masonry bed joint and workmanship in this region, this damage was not considered in the damage class evaluations. Figure 4.1 shows this damage in normal (a) and (b) close-up views. As seen, there was a major horizontal crack, and its width was around 20 mm (Crack 2 in Figure 4.2). The simultaneous inspections at -45 mm tip displacement revealed that there were also several cracks which were much thinner in width (Cracks 1, 3 and 4 in Figure 4.2).

Figure 4.1. (a) The normal and (b) the close-up view of the local crack.

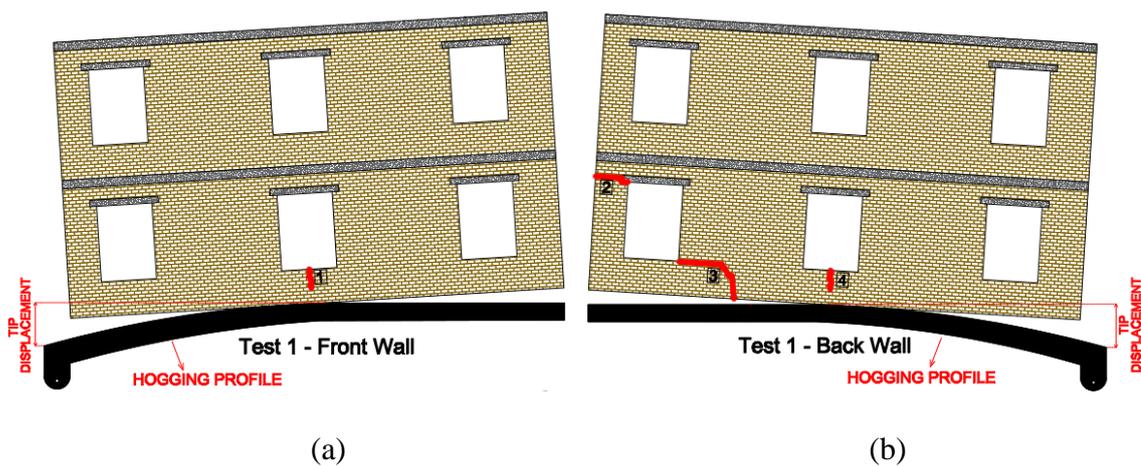
When the tip displacement went down to -65 mm (that was the reference maximum target tip displacement in the tests) no new crack appeared on any of the walls. Schematic views of parallel walls (with applied hogging profile) and cracks observed on their surfaces after Test 1 is demonstrated in Figure 4.2. Cracks were visible from both faces of the parallel front and back walls. Reference specimen had a significant rigid rotation. No new crack occurred even at -85 mm tip displacement. Following unloading (IPE steel beam was lifted back to its original horizontal position), the test setup was forced in upward direction (positive direction) to create a sagging settlement profile. It should be noted that sagging option was just for a trial and not used in other tests. When the tip displacement +30 mm (sagging), neither a new crack nor any plastic displacement (i.e. slippage of the walls over the IPE steel supports) occurred. During all these attempts the existing cracks either opened wider or closed.

Figure 4.2. Schematic views of parallel walls and cracks on their surfaces after Test 1: (a) front wall of the reference specimen, (b) back wall of the reference specimen.

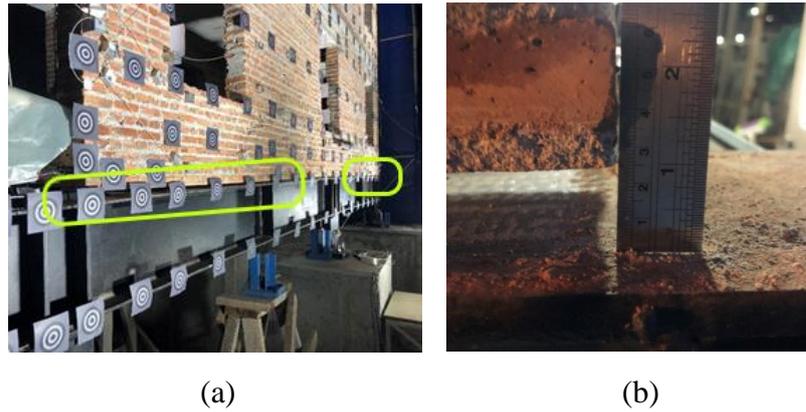
In this test, the screw jack lowered down to -87 mm by exceeding the reference maximum tip displacement of -60 mm. In general, the existing cracks opened or closed. A thin crack in 0.6 mm width occurred on the front wall in addition to the existing cracks observed in Test 1. On the other hand, the gapping between front masonry wall and steel beam was about 25 mm. Figure 4.3 shows the gap opening. Note that no gap opening was observed for almost 1/3 of the wall length at the vicinity of the half length of the walls.

Figure 4.3. Gapping occurred between reference building's front wall and steel beam: (a) general view, (b) close-up view.

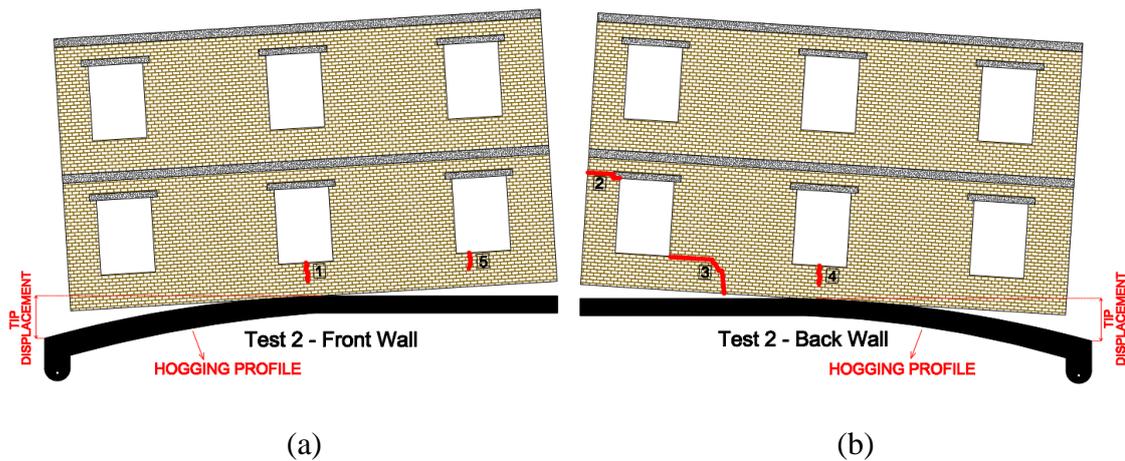
Figure 4.4. Schematic views of walls and cracks after Test 2: (a) front wall of the reference specimen, (b) back wall of the reference specimen.

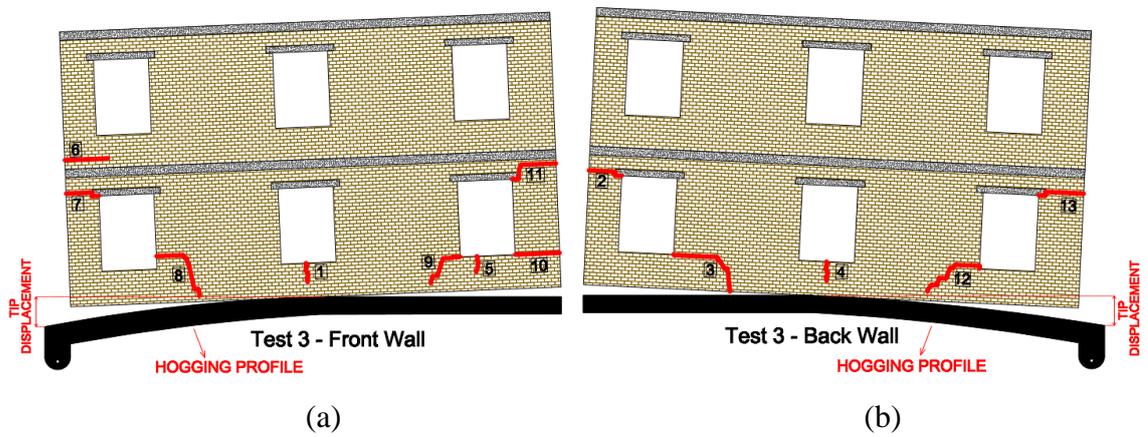
Figure 4.5. Drawings of occurred cracks at the end of Test 3: (a) at the front wall of the reference specimen, (b) at the back wall of the reference specimen.

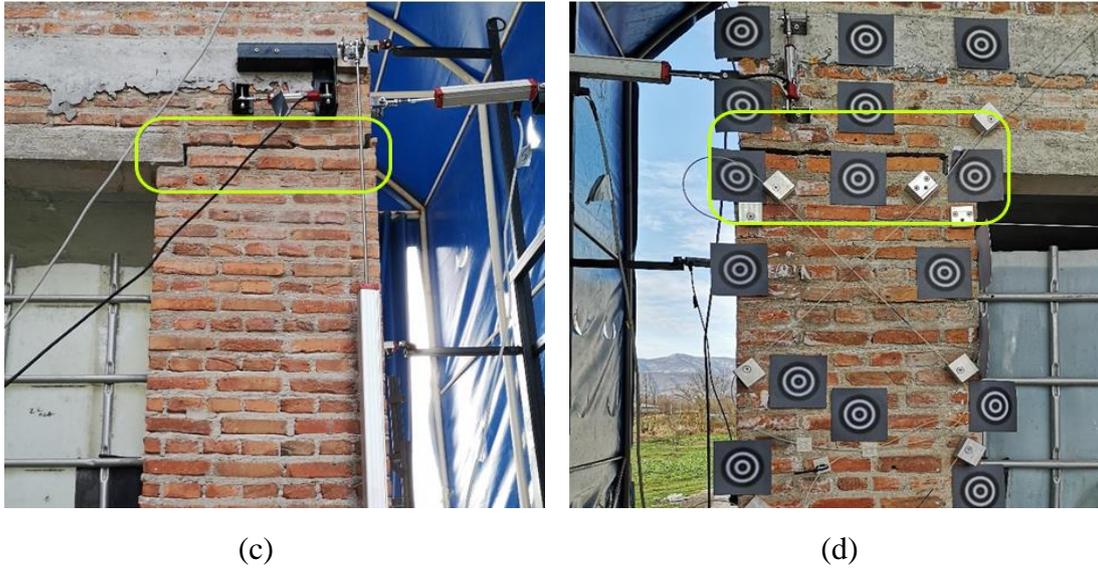
Figure 4.6. Observed cracks after Test 3: (a) at the left part of the front wall, (b) at the right parts of the front wall, (c) at the top-right corner of the back wall, (d) at the top-left corner of the back wall.

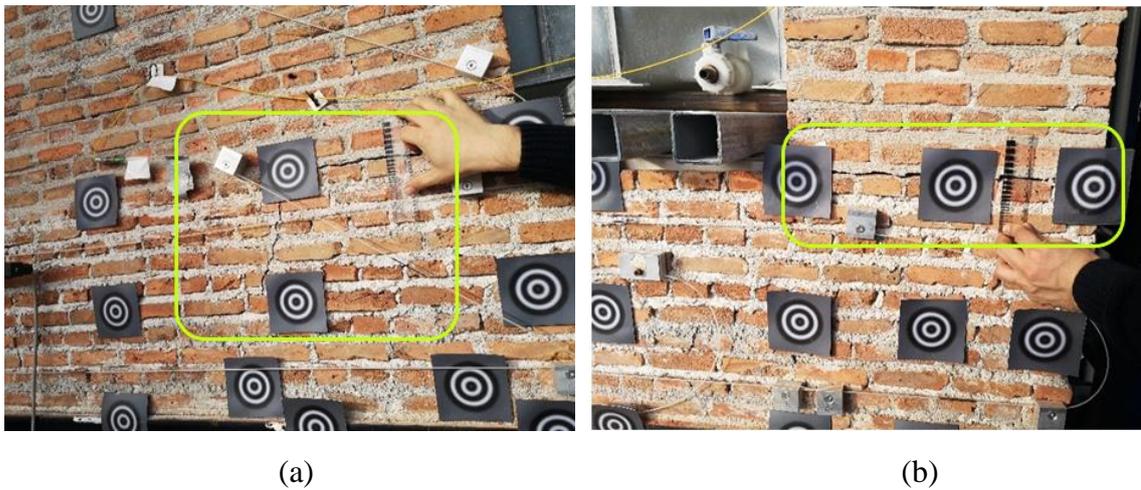
Figure 4.7. Crack width is determined by crack ruler after Test 3: (a) for the middle part of the back wall and (b) for the bottom-right corner of the back wall.

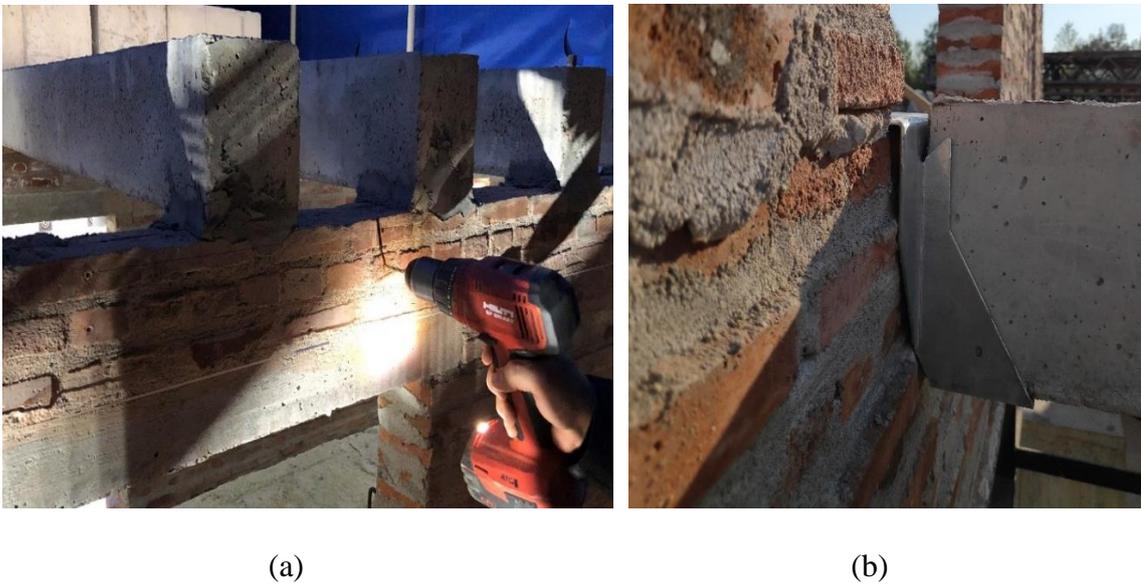
They had 200 mm spacing through the length of the walls. Figure 4.8 shows assembled joists at the second floor and the first floor of the specimen. The absence of continuous slabs allowed this specimen to behave more flexible than specimens with continuous RC floors. Since the joists are located intermittently, they do not contribute to the flexural strength of the building in overall. RC joists have 120×150 mm (width×height) cross-section. They consisted of three steel rebars ( $\phi 8$ ) at tension and compression sides and stirrups at every 100 mm along its length. The connection between the wall and RC joists for the first floor was done by using metal joist hangers. First, the hangers assembled to walls, then RC joists were mounted on these members. Lengths of joists were 1.65 m. Joist floor specimen had 20 % opening ratio in identical parallel walls.

Figure 4.8. Assembled joists: (a) at the top of the specimen, (b) at the first floor of the specimen.

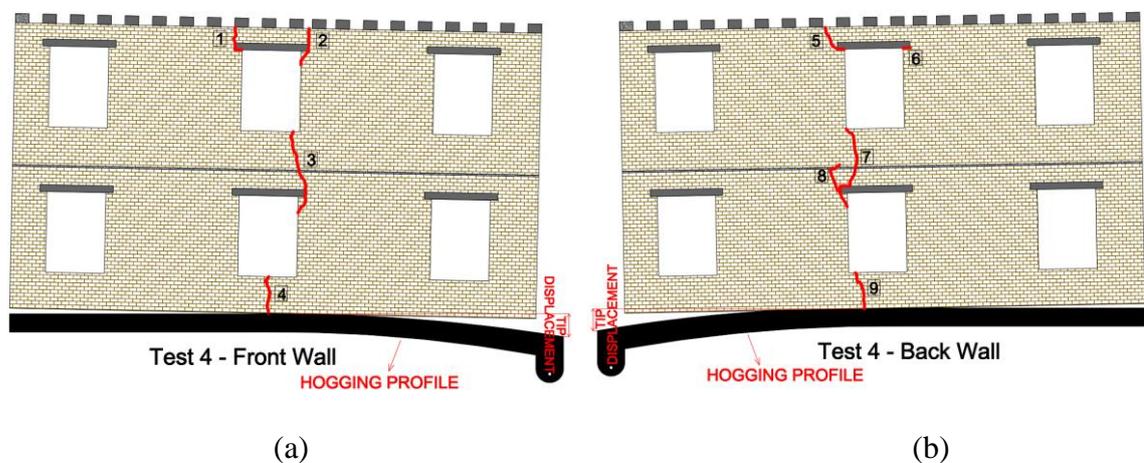
Figure 4.9. Schematic views of cracks occurred at the end of Test 4: (a) at the front wall of the joist floor, (b) at the back wall of the joist floor.

$\Delta/L$ at the end of the test (by DMS)	Crack Line Number (Figure 4.9)	Maximum Crack Width for Each Crack Line (mm)
0.001346	1	3
	2	1
	3	0.2
	4	0.35
	5	0.65
	6	1.5
	7	4.5

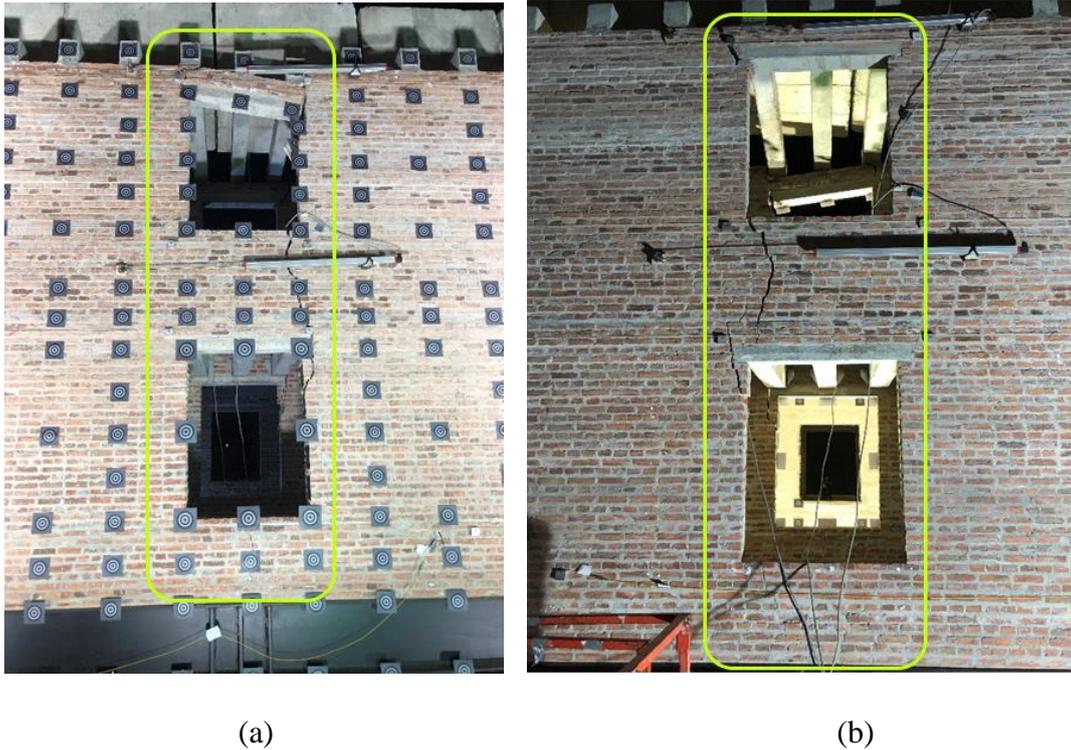
Figure 4.10. Observed cracks after Test 4: (a) at the front wall of the joist floor specimen and (b) at the back wall of the joist floor specimen.

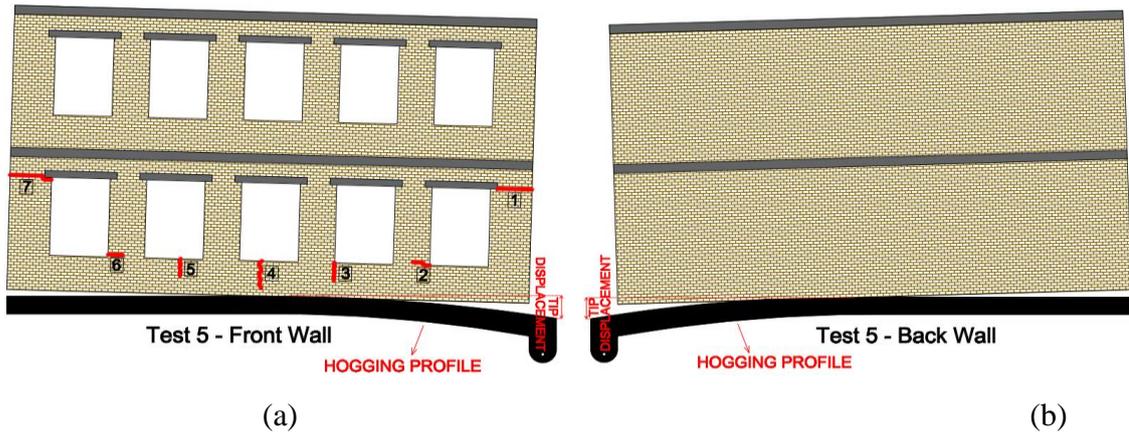
Figure 4.11. Drawings of cracks occurred at the end of Test 5: (a) on the front wall (perforated wall) of the combined specimen, (b) on the back wall (no-opening wall) of the combined specimen.

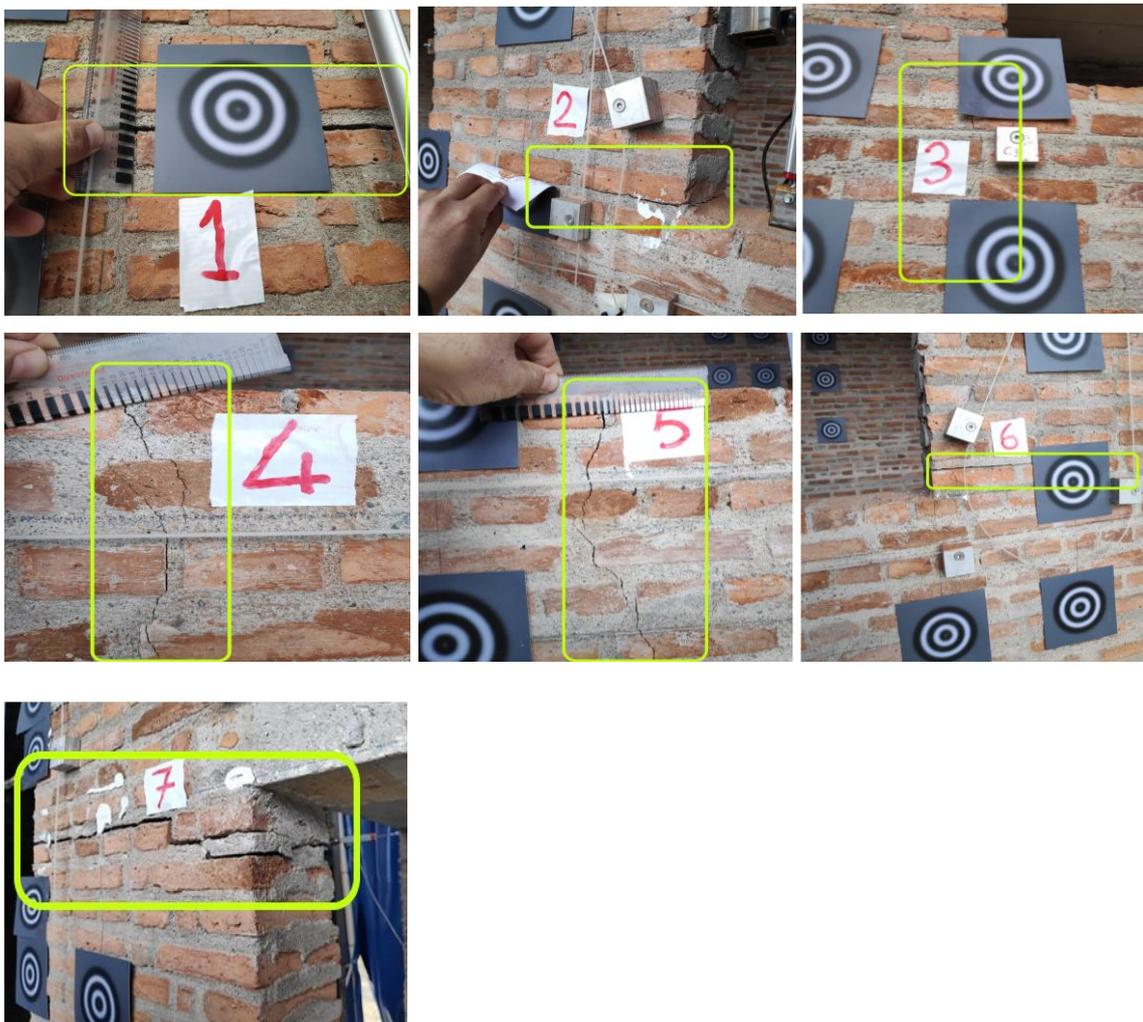
Figure 4.12. Cracks occurred on the combined specimen at the end of Test 5.

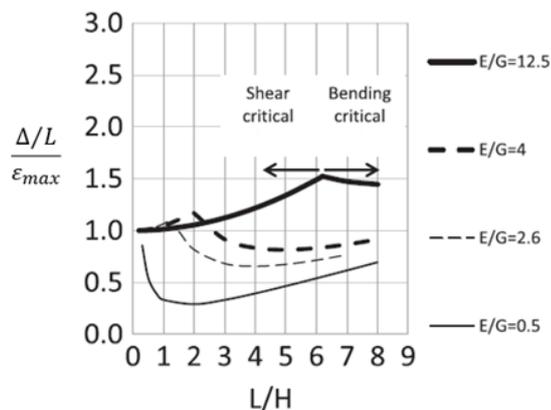
Figure 6.1.  $\frac{\Delta/L}{\epsilon_{max}}$  –  $L/H$  composite curves obtained for different values of E/G for hogging.
