**OPTIMIZATION OF ENERGY CONSUMPTION AND  
THERMAL COMFORT IN HISTORIC BUILDINGS:  
CASE STUDY OF İZMİR NATIONAL LIBRARY  
BUILDING, TÜRKİYE**

**A Thesis Submitted to  
the Graduate School of Engineering and Sciences of  
İzmir Institute of Technology  
in Partial Fulfillment of the Requirements for the Degree of**

**in Architecture**

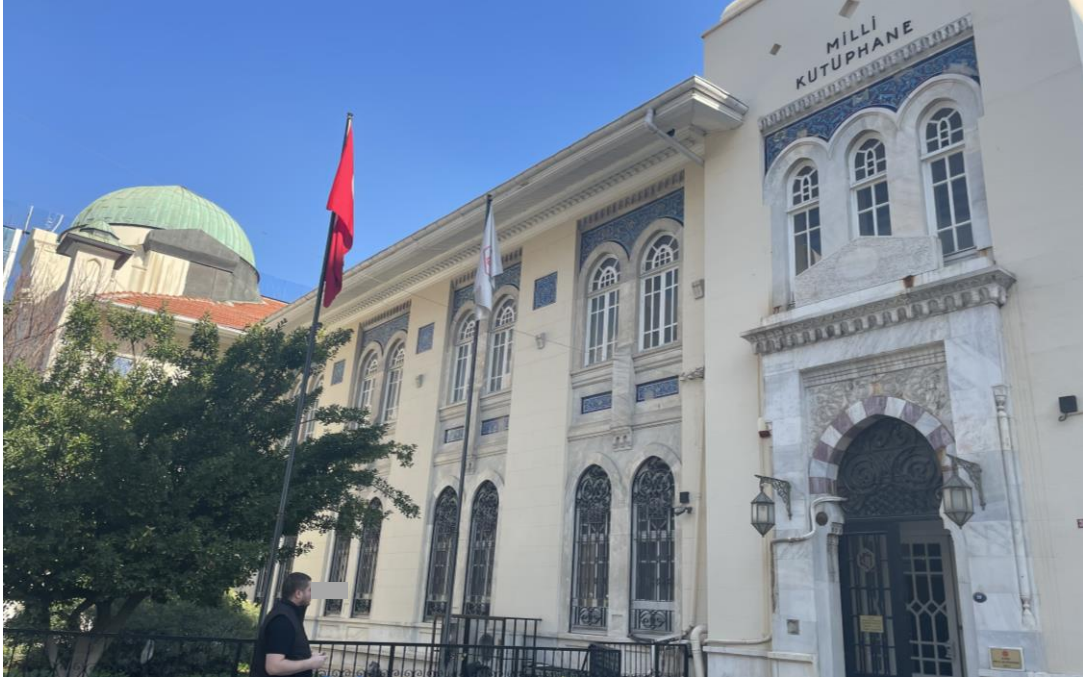
Figure 3. 8 Exterior walls of the library (Source: Umut Özsavaşcı, 2022)

Exterior wall thickness varies between 60 and 80 cm for all the facades. Exterior wall material is masonry andesite. Building's carriers are made up of concrete, rubble and brick was also used (Şimşek Özel 2015).

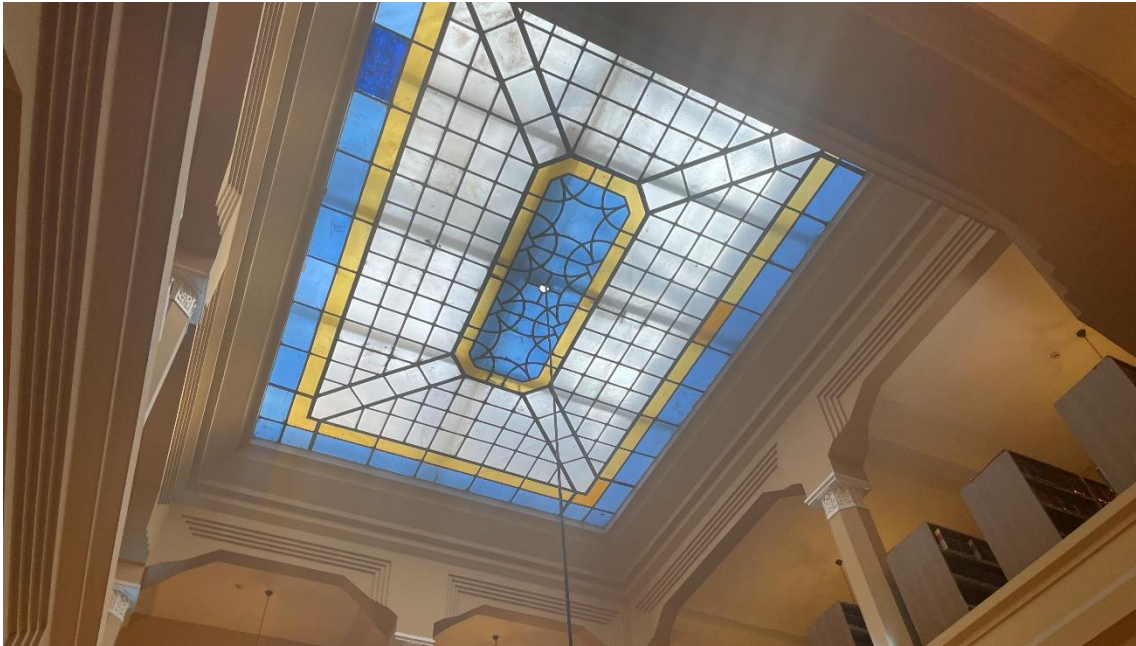
Figure 3. 9 Roof of the building in interior view (Source: Umut Özsavaşcı, 2022)

Stained glass at the roof of the library is providing natural light to the study hall. Pitched roof of the building is covered with Marseille type tile, stained glass is covered with glass tile. Domes at the corners were covered with lead (Şimşek Özel 2015).

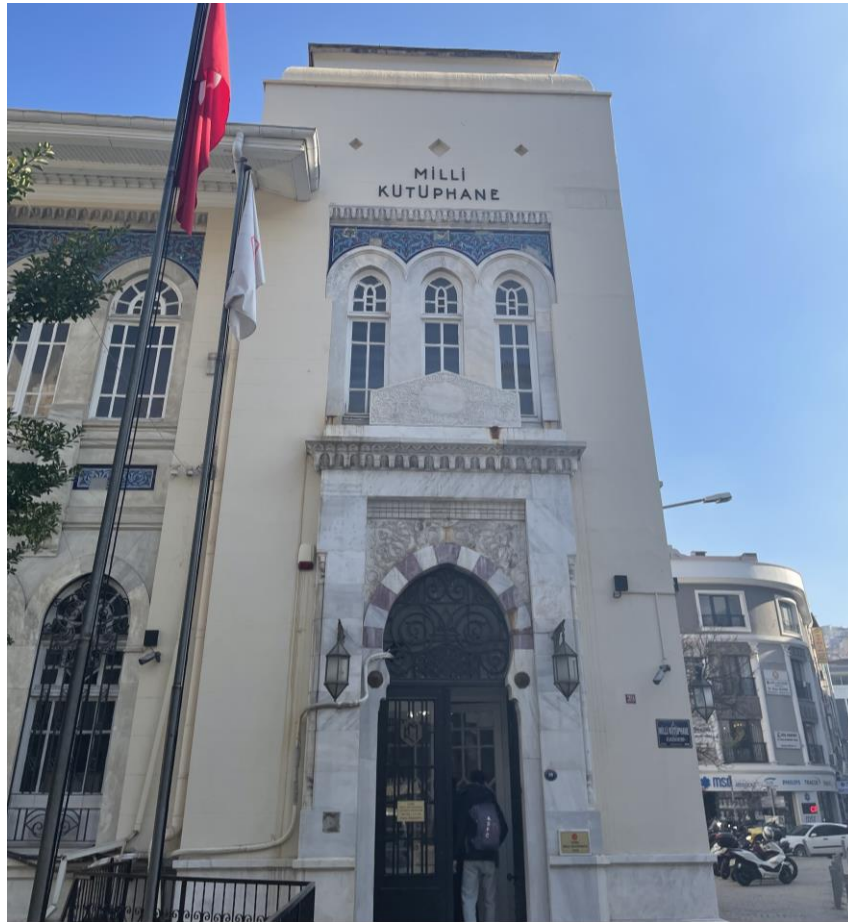
Figure 3. 10 Doors and windows of the library (Source: Umut Özsavaşcı, 2022)

All the exterior windows are single glazed and interior doors are wooden framed doors. In building, there are two exterior door which made of steel.

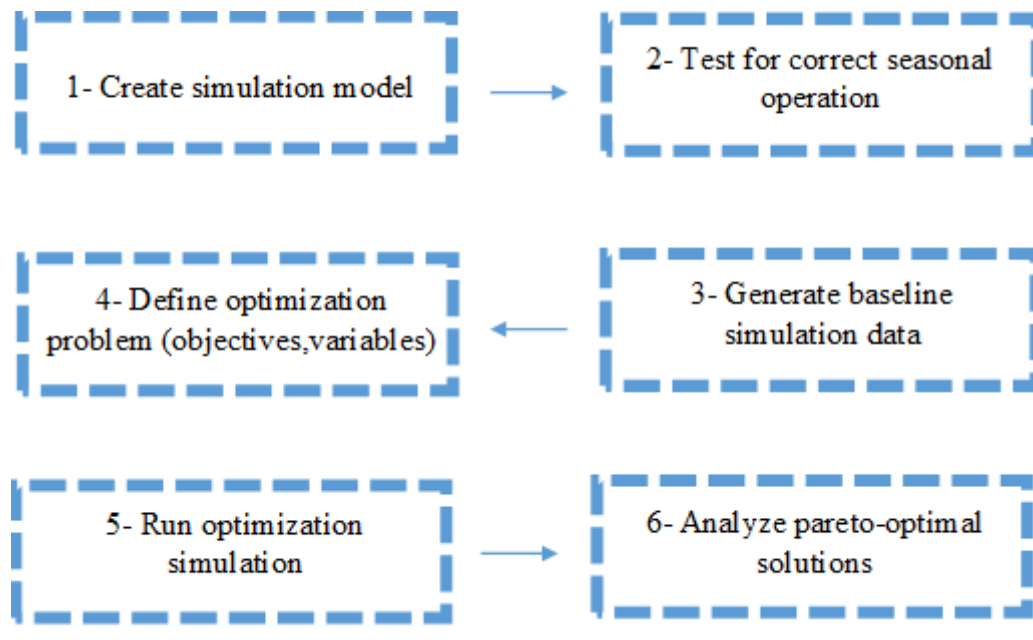
Figure 3. 15. Flowchart of the optimization process

Multi-objective optimization is a process where many simulations are run automatically under the control of an optimizer which favors design options that best meet design criteria and iteratively tests and re-tests new generations of these until the very best set of options have been identified. Optimization is a technique for efficient searching for and identifying design options that best meet key design performance objectives. The technique for analyzing how design performance varies with changes in the building configuration through use of design curves. In multi-objective optimization, where there are conflicting constraints between the objectives, the notion of optimality is different. This is represented by an Edgeworth-Pareto relationship, known as the Pareto optimum. The Pareto optimum is indicated by the red dot in the optimization analysis tables. Figure 3.17. shows process of the optimization simulations.

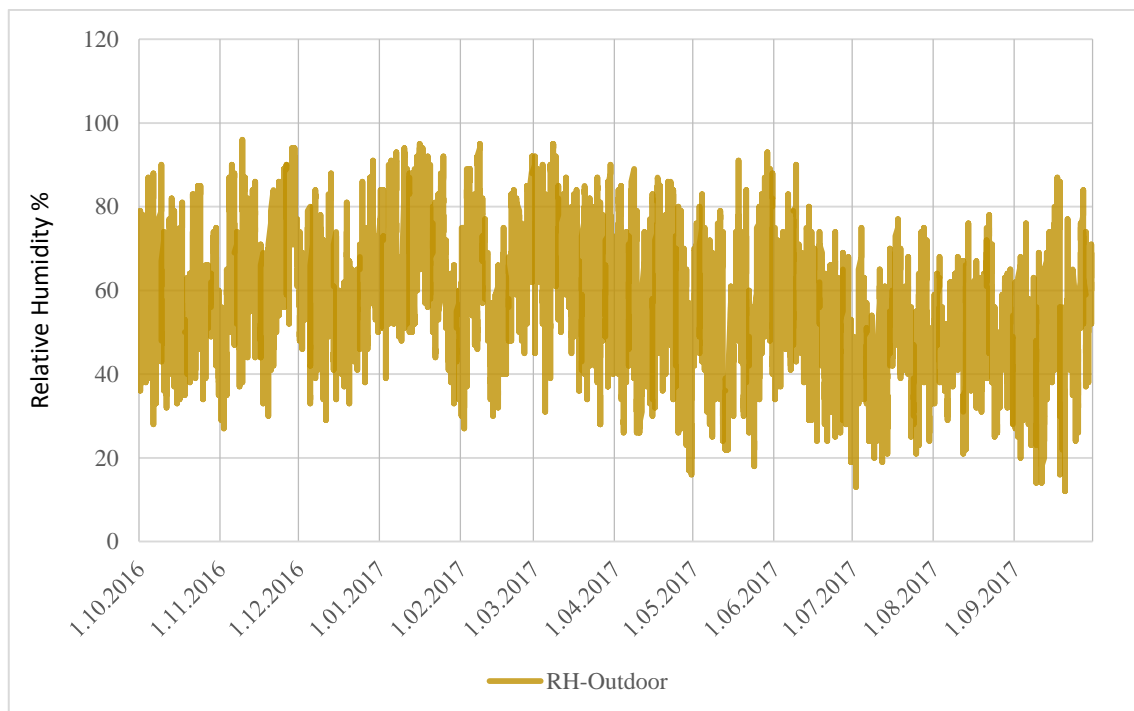
Figure 4. 2. Outdoor relative humidity results (01.10.2016-01.10.2017)

the first floor one is 24.9%. In addition, the annual average of outdoor relative humidity is 56.2%, for the ground floor is 42.3% and in the first floor one is 40.5%.

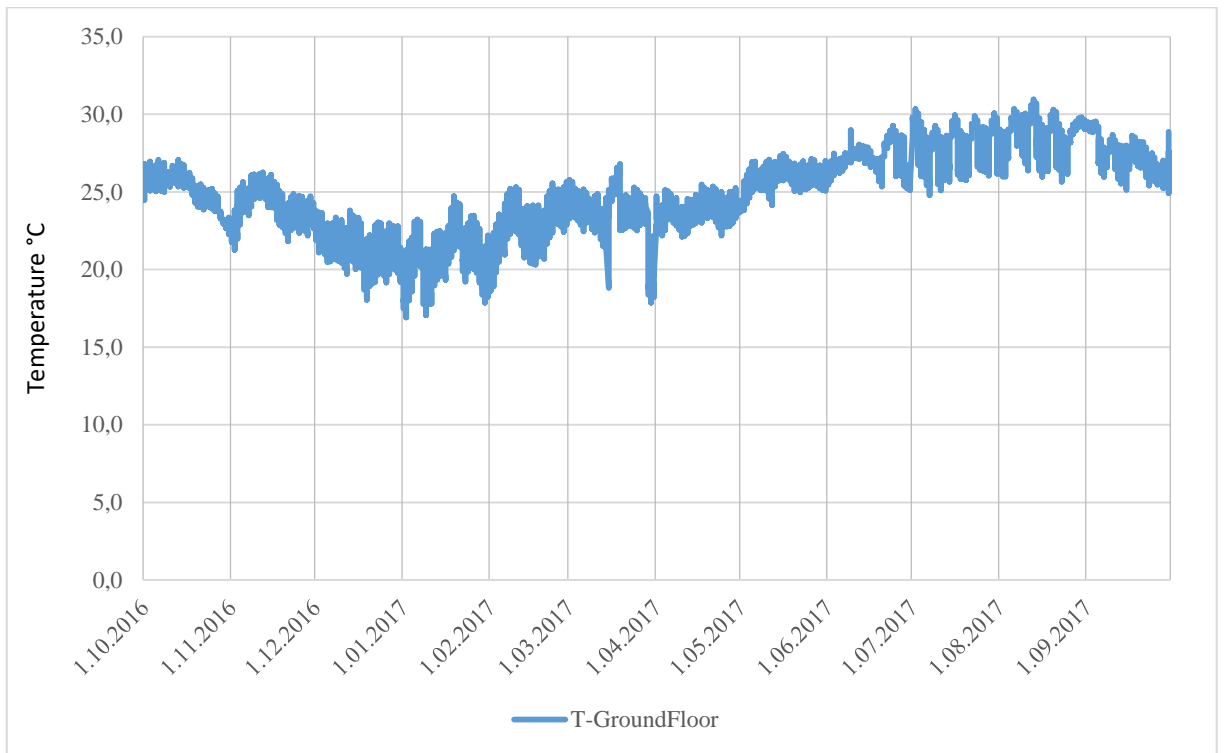
Figure 4. 3. Air temperature results of ground floor (01.10.2016-01.10.2017)

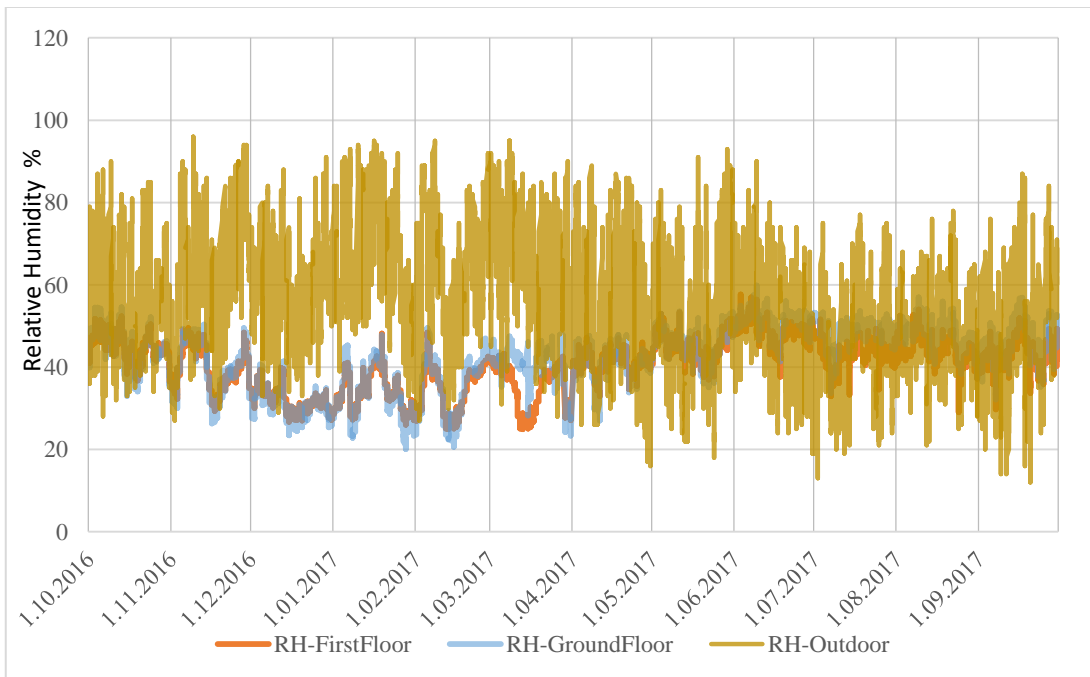
Figure 4. 8. Comparison of relative humidity between ground floor, first floor and outdoor

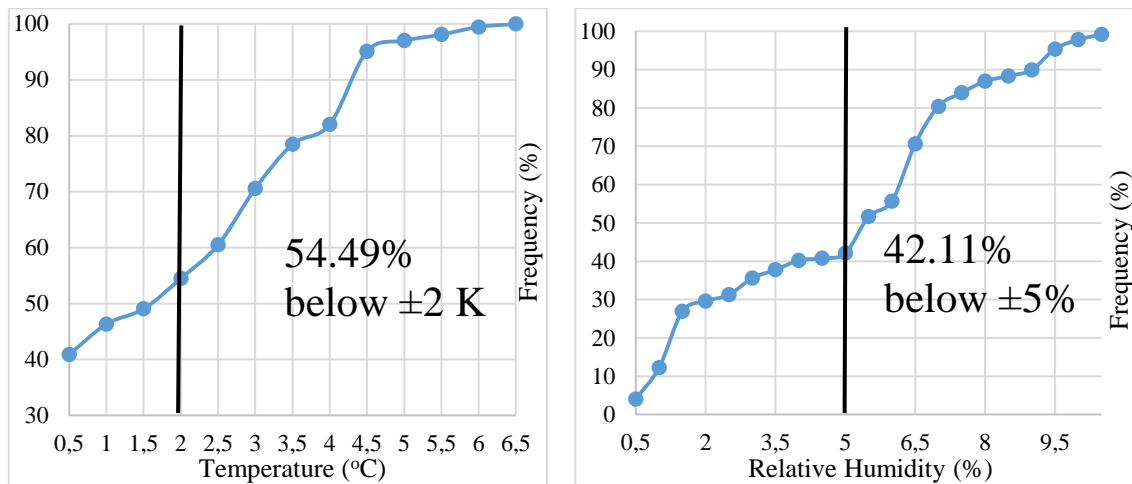
Figure 4. 11. Cumulative frequencies of T (left) and RH (right) differences in ground floor

The cumulative frequencies of the highest daily T and RH variations in ground floor are shown in Figure 4.11. The cumulative frequency calculations revealed that 42.11% of the RH differences were below the  $\pm 5\%$  RH limit and that 54.49% of the ground floor T changes were below the  $\pm 2$  K limit.

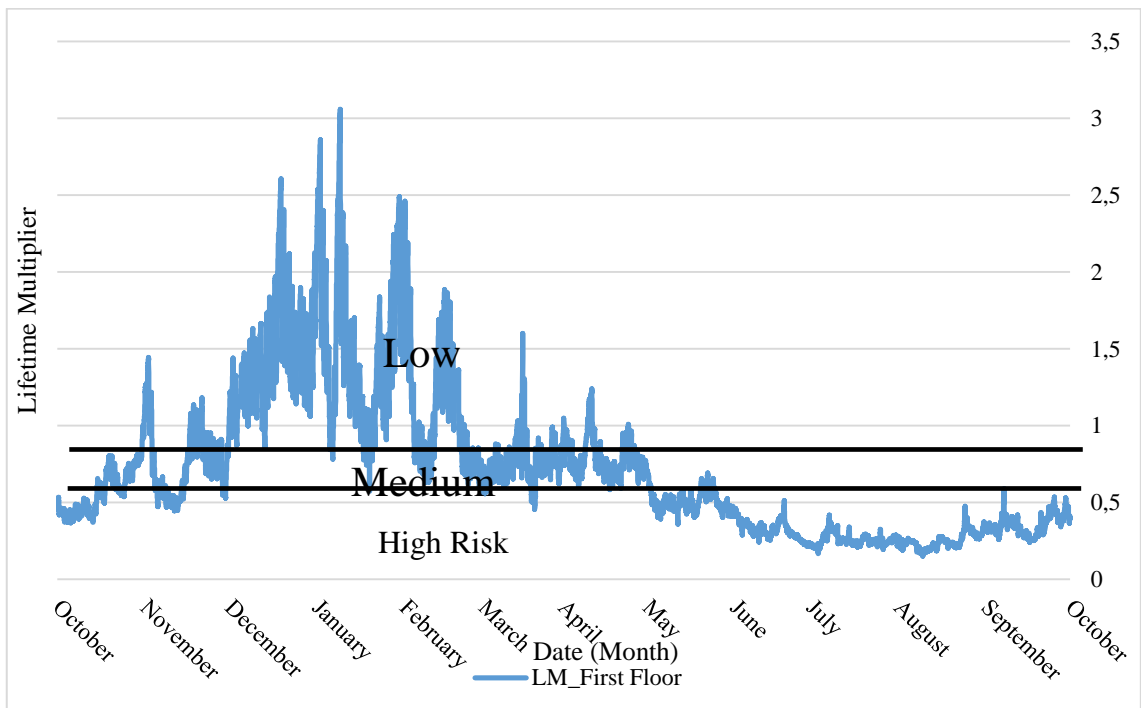
Figure 4. 16. LM values of first floor

According to the first floor results, as same as ground floor result, the manuscripts were under low risk of chemical degradation in December, January and February. Between May to October, manuscripts in high risk in terms of chemical degradation. The lowest calculated LM value was 0.150 in August, while the highest was 3.058 in January.

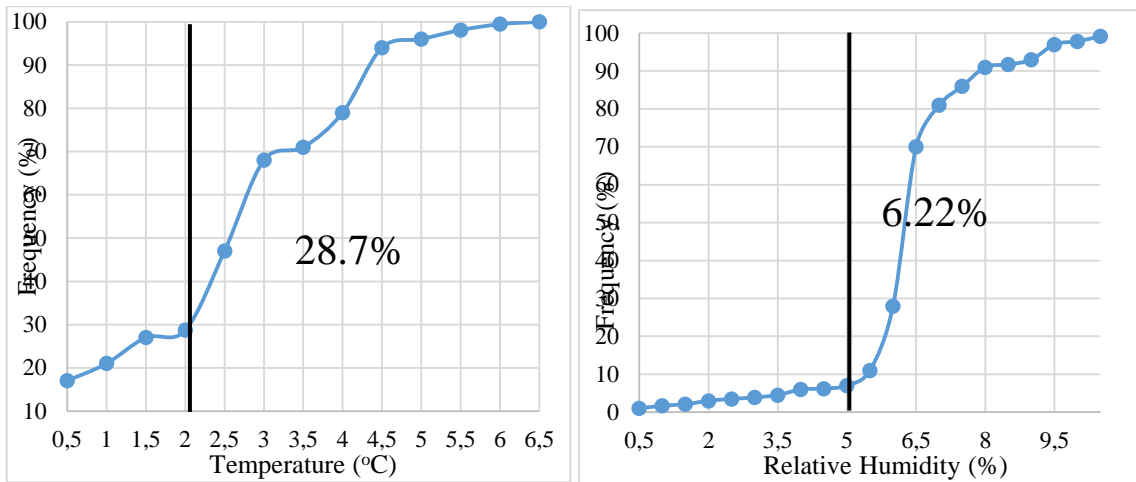
Figure 4. 24 Cumulative frequencies of T (left) and RH (right) differences in ground floor scenario 1 midpoint option

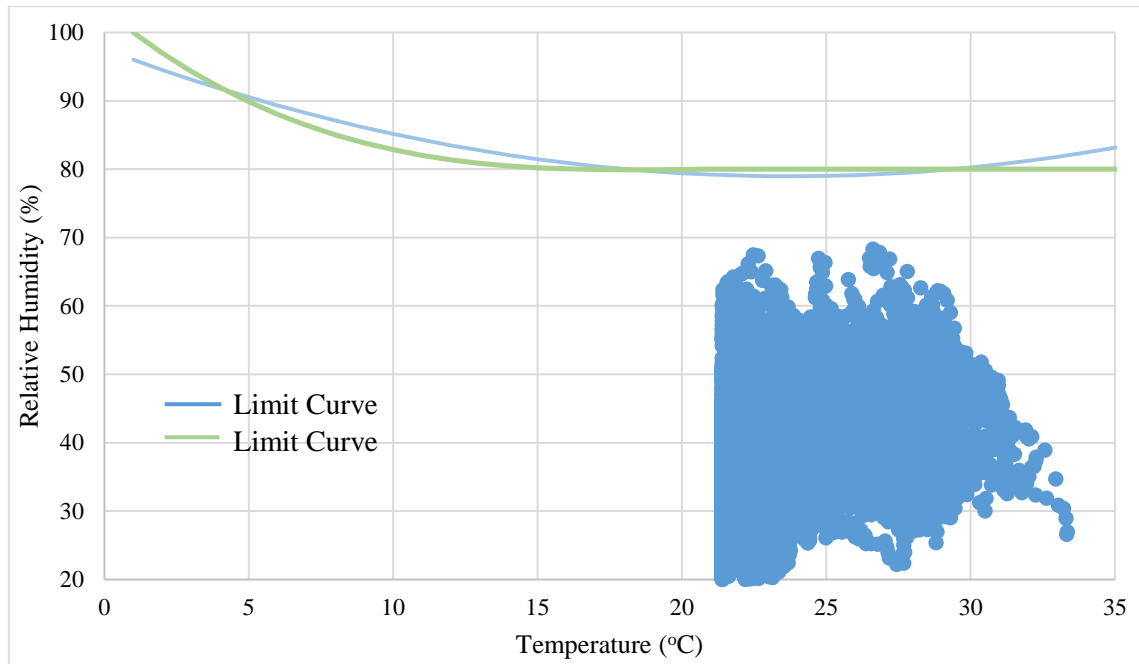
Figure 4. 31. Scenario 2 midpoint option biological degradation risk

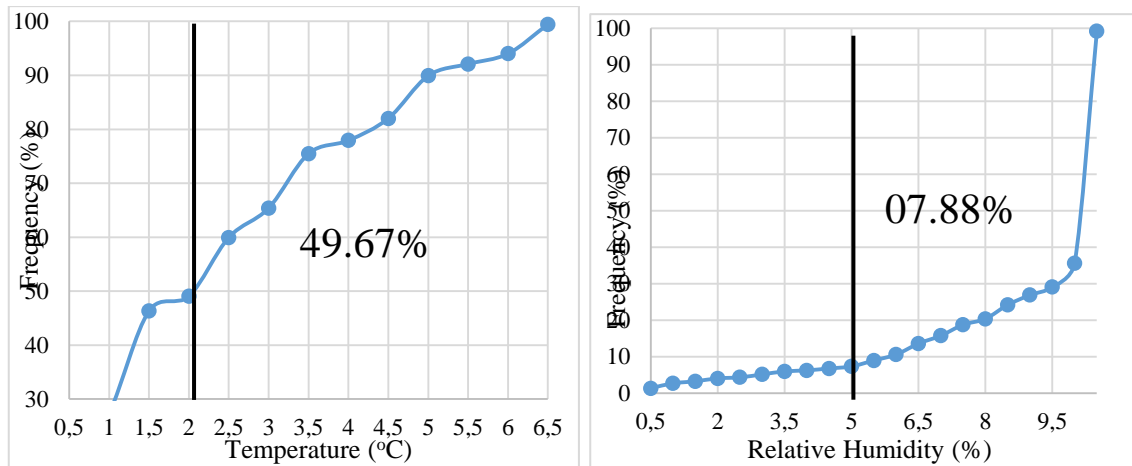
Figure 4. 34. Cumulative frequencies of T (left) and RH (right) differences in ground floor of scenario 3 midpoint option
