# Monitoring Soil Degradation Processes for Ecological Compensation in the Izmir Institute of Technology Campus (Turkey)

**Citation:** Salata, S.; Thompson Couch, V. Monitoring Soil Degradation Processes for Ecological Compensation in the Izmir Institute of Technology Campus (Turkey). *Eng* **2022**, *3*, 325–342. <https://doi.org/10.3390/eng3030024>

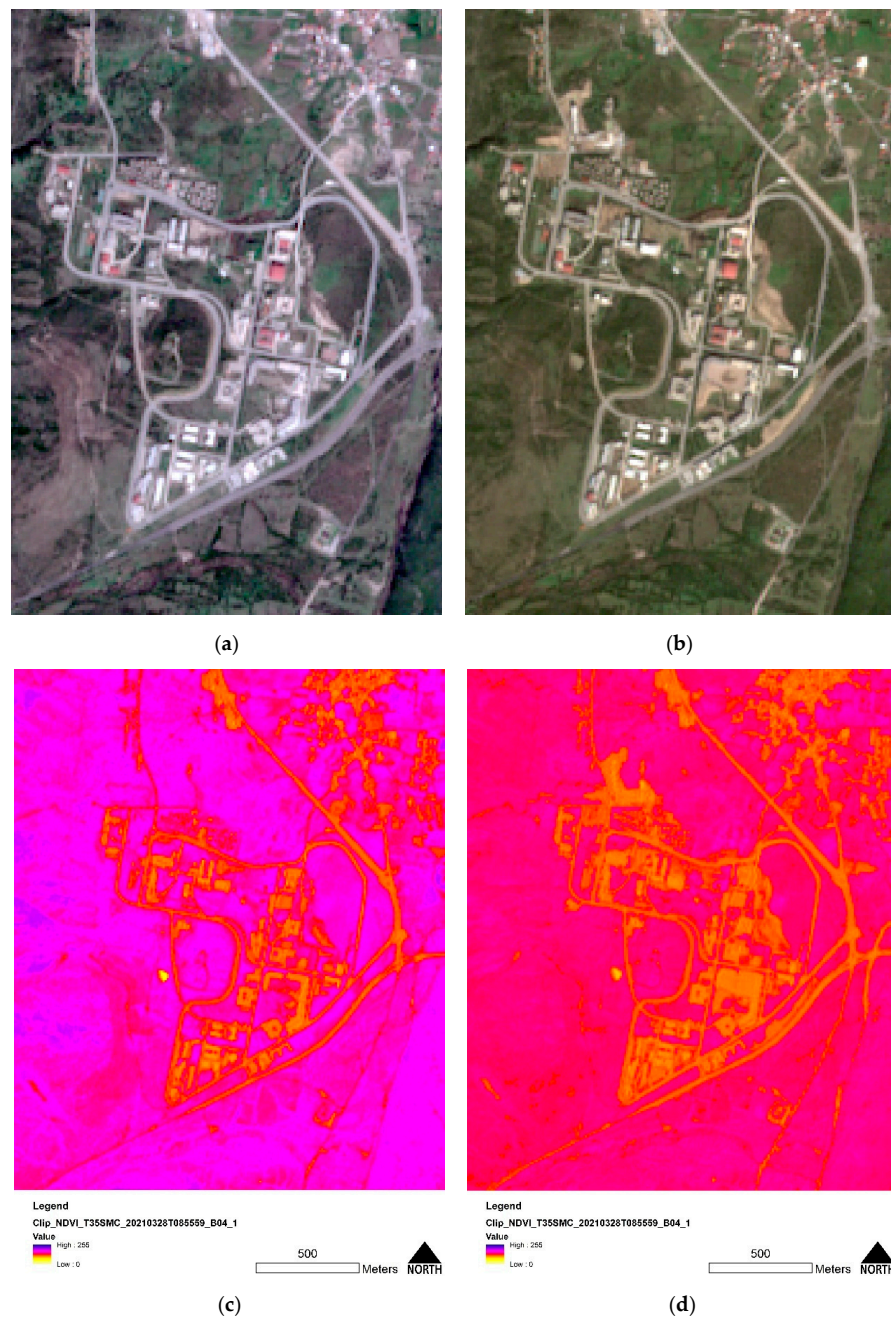
As shown in Figure 2, abrupt changes were recorded diffusely in the campus due to a jeopardized distribution of minor and major new excavation sites, construction areas, and open space design and renovation. Figure 2 represents the RGB images for the years 2021 and 2022, with a comparison of their NDVI indices below. Some differences were directly visible by juxtaposing the pictures, and the NDVI were used to locate and measure abrupt changes empirically.

Figure 2. Comparison of RGB (a) 2021 and (b) 2022 and NDVI (c) 2021 and (d) 2022.

Even though the images we used were acquired during the same season (spring) and around the same time of day, we found that the acquisition condition was different between the two colored images. The second acquisition (13 March) was less contrasted and more “flattened” since the light on 13 March and 28 March was different and since the luminosity of the two images was dependent on the humidity and pollution present in the air on those days. Thus, we decided to correct the 2022 RGB multiband raster by smoothly adjusting the contrast (30) and light (12), to gain higher comparability with the 2021 multiband raster. Once corrected, both multiband rasters were employed to calculate the NDVI, simply by adding the Band 8 (Near Infra-Red) for both years (2021 and 2022). The NDVI tool automatically computes a multispectral image’s normalized difference vegetation index.

The two NDVI were then post-processed by calculating the difference between the pixel values through raster calculator analysis (NDVI 2022—NDVI 2021). Then, to observe the abrupt changes, we employed the Hotspot analysis, thereby avoiding the arbitrary selection of thresholds to consider relevant in calculating the differences (NDVI abrupt changes). Once spatialized, the GIS statistically significant hotspots (abrupt changes) [65,66] were visually checked by a direct survey to observe the sites and identify the soil degradation types that had occurred within the last year.

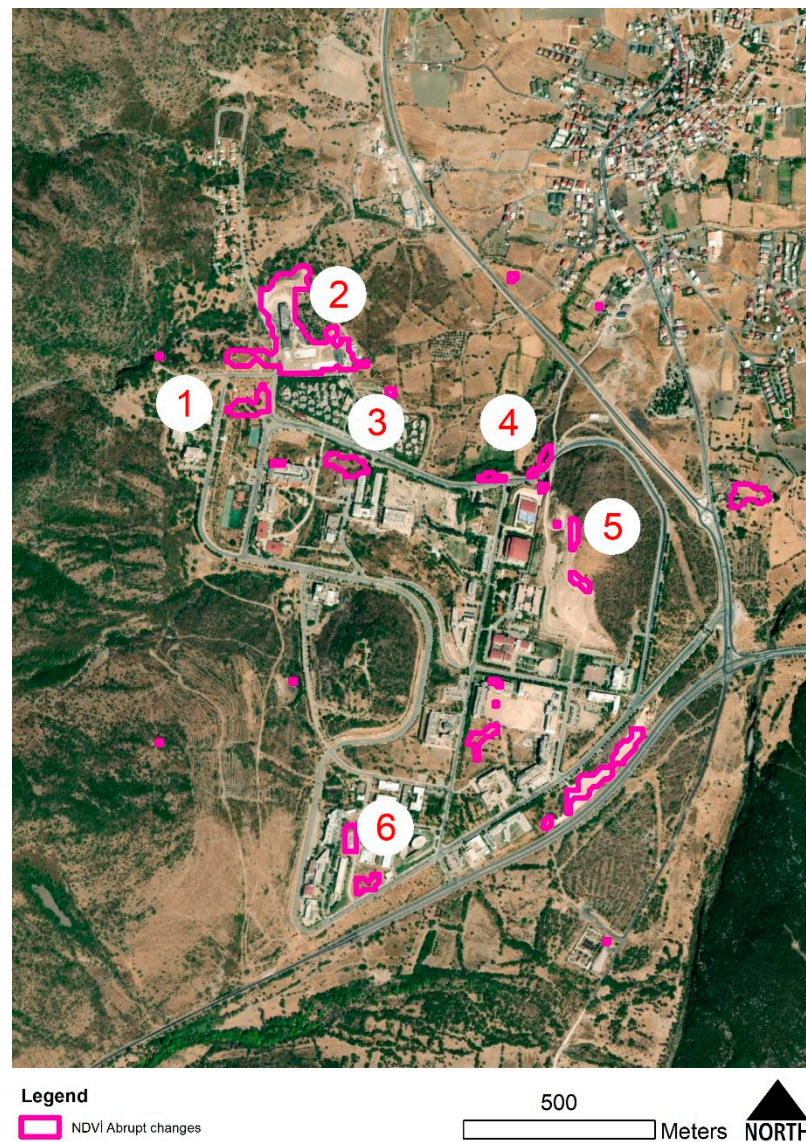
**Figure 4.** The final map of NDVI abrupt changes.

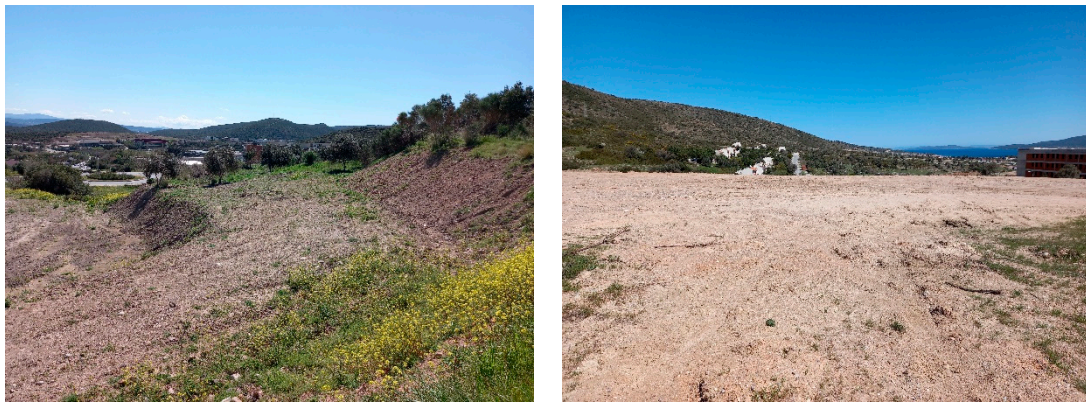
According to NDVI analysis there has been a mean decrease of  $-52.08$  (max variation  $-68$ , min variation  $-37$ ) in this area. These terraces (Figure 5) were created during construction of the adjacent new dormitory (see Figure 6), while moving and replacing excavated soil from the construction site. Replacement of topsoil with new soil and the utilization of these areas as construction material storage created deep topsoil compaction over a few months. The field survey revealed that the terracing system created between October 2021 and March 2022 led to the formation of bare soil that hosts some spontaneous vegetation now in some parts. The areas that are still being used for storage of construction materials are completely unvegetated due to truck and car traffic.

**Figure 5.** New terraces created in front of the Faculty of Architecture.

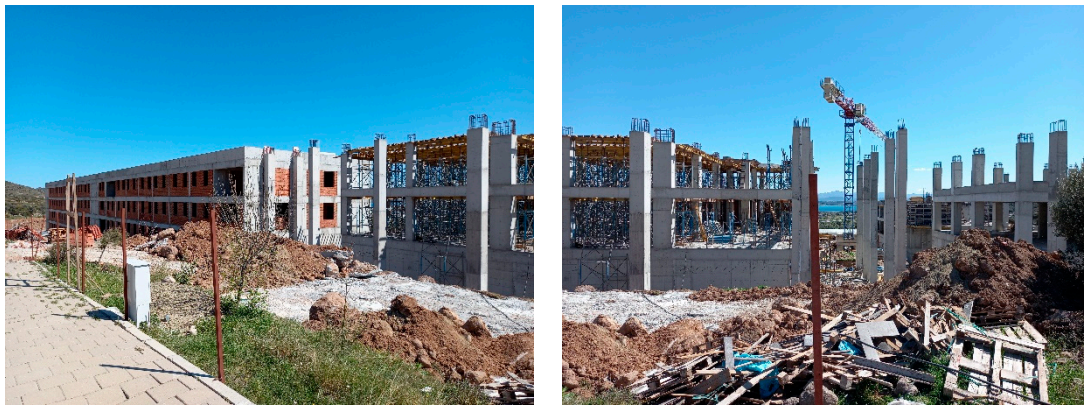
**Figure 6.** The construction site of the new dormitory.

According to NDVI analysis the mean decrease in this area has been of  $-61.14$  (max variation  $-84$ , min variation  $-34$ ). This transformation site (see Figure 6) represents the highest soil and landscape impact of the campus projects studied. The new dormitory is built on an extremely vulnerable and delicate part of the campus land. Indeed, the construction site is located on the northern side of the existent public dormitory and it is replacing typical Mediterranean vegetation. The site occupies approximately 7.5 ha, including building footprint and excavation areas.

In this case, rather than soil compaction and loss of biodiversity, the vast majority of the previously permeable soil has been sealed by concrete and asphalt during an unsustainable urbanization process. Unfortunately, even the orientation of the buildings does not favor the environmental sustainability of this transformation: the main built-up area is located perpendicular to the water stream flow accumulation while generating erosion in the uphill and potential moisture reduction on the soil located downhill, thereby causing biodiversity reduction in the long term. For this specific transformation only ecological compensation measures implemented outside the construction site might possibly equalize the environmental damages caused by the new buildings.

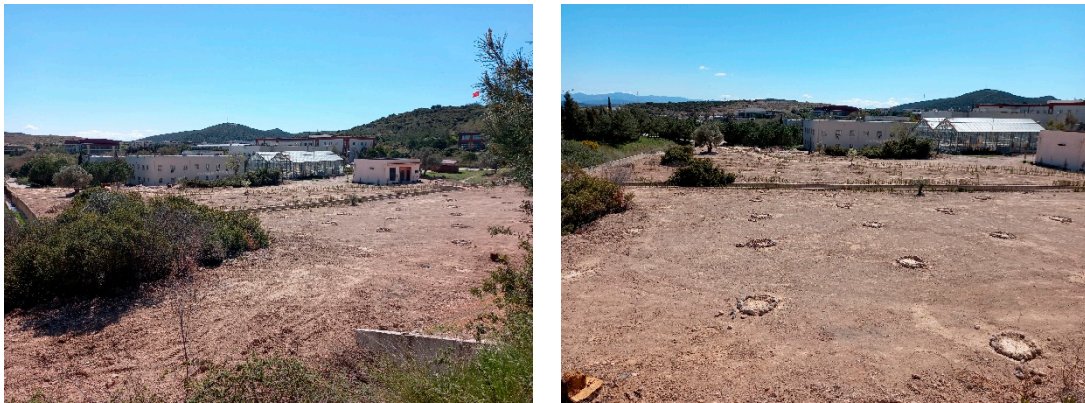
According to NDVI analysis the mean decrease in this area has been of  $-52.73$  (max variation  $-62$ , min variation  $-44$ ). This part of the campus has been used for biodiversity restoration projects, which has led to the new plantation of trees in the central open space in front of the Faculty of Science. Where there was grassland, the soil has been ploughed and prepared for plantation (Figure 7). Unfortunately, trees were planted with lines parallel to the slope direction instead of creating a terraced plantation that could intercept subsurface water flows and reduce run-off while controlling erosion. Nevertheless, this intervention will contribute to achieving higher biodiversity of the campus open space while increasing the canopy and shadowing effects once the plantation reaches maturity.

**Figure 7.** The new soil remediation area and plantation of trees in front of the Faculty of Science.

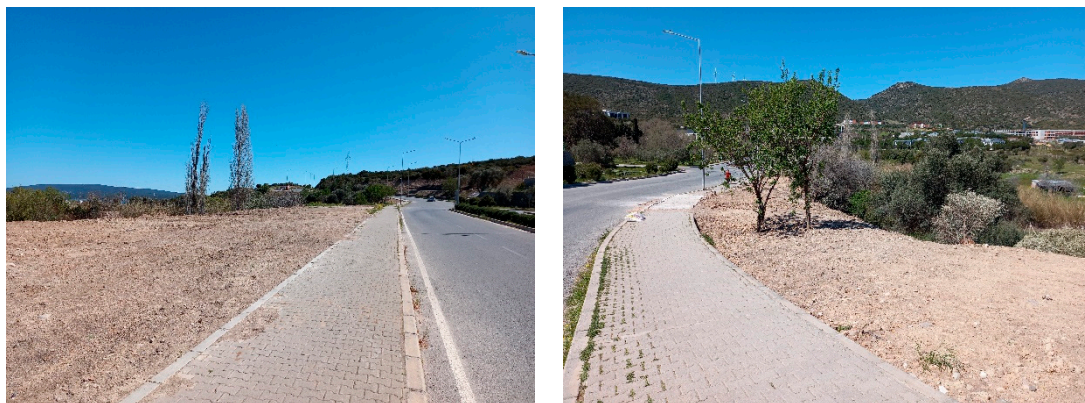
According to NDVI analysis the mean decrease in this area has been of  $-52.42$  (max variation  $-64$ , min variation  $-43$ ). The reconstruction of the road banks is part of a major program to increase pedestrian accessibility to the campus. In this specific area, the northern side of the major road was re-designed and enlarged while the road bank was widened (see Figure 8). The new road bank comprises a compacted bare soil without biodiversity, which replaced a dense spontaneous riparian vegetation that bordered the street in a narrow green strip. Improvement of pedestrian mobility is one of the most important priorities for the IZTECH campus sustainability. Thus, this kind of intervention is made to improve pedestrian mobility in the long term. Nevertheless, this new road bank must be accompanied by the plantation of new autochthonous trees, which can provide shadow and protect the new bank of the road from run-off erosion, create more evapotranspiration and provide shadow for pedestrians.

**Figure 8.** Creation of banks along the main road of the campus.

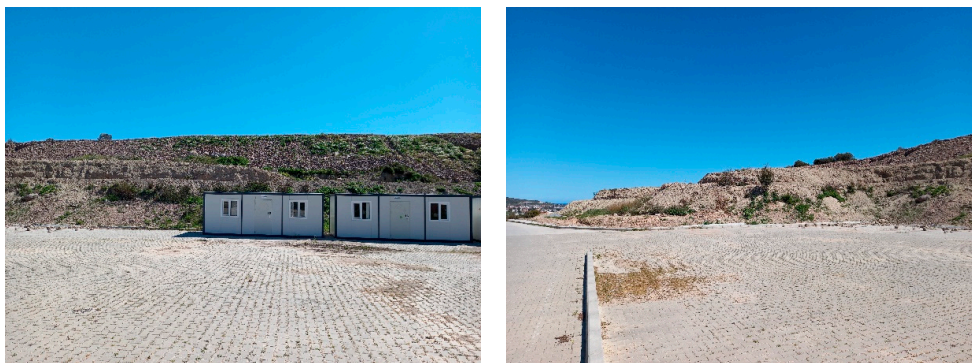
According to NDVI analysis, the mean decrease in this area has been of  $-50.81$  (max variation  $-60$ , min variation  $-32$ ). This area has been subject to two different soil processes: artificial erosion due to excavation and natural erosion on the steep side of the man-made terraces (see Figure 9). In this part of the campus excavation began early in 1992 to create the uphill floodplain for the Rectorate buildings. The natural hill was partially excavated, and the soil was used to level the ground for other building construction on campus. Unfortunately, besides the human-induced erosion, this portion of the campus is also affected by landscape degradation, since the excavation is directly visible from many other viewpoints of the campus. The terraces are composed of a mix of rocks and stones on bare compacted land without vegetation and with low biodiversity. The cessation of excavation, together with some soil consolidation practices, should be considered to re-naturalize these areas.

**Figure 9.** Erosion along the Rectorate Road.

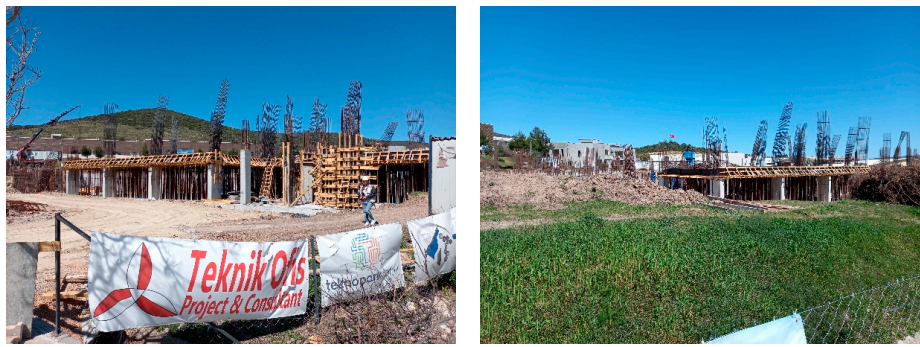
According to NDVI analysis, the mean decrease in this area has been of  $-52.97$  (max variation  $-75$ , min variation  $-38$ ). This area is similar in some ways to Area 2. Both represent new construction sites, and we can see a non-sustainable process of soil sealing during construction of new buildings, with roads and impermeable materials on the new urbanized blocks (see Figure 10). Here, the original grassland has been deeply excavated and replaced by the concrete foundations of the buildings, with a resultant huge decrease in biodiversity. As in the previous case (the new dormitory), mitigation of the direct impacts caused by the sealing is potentially a way to reduce the environmental impact of this transformation. In addition, some compensation measures of re-vegetation, afforestation or ecological connection in other areas of the campus should be considered, to create an ecological balance for the soil degradation in this area.

Figure 10. New construction next to the Electronics and Electrical Engineering Department.

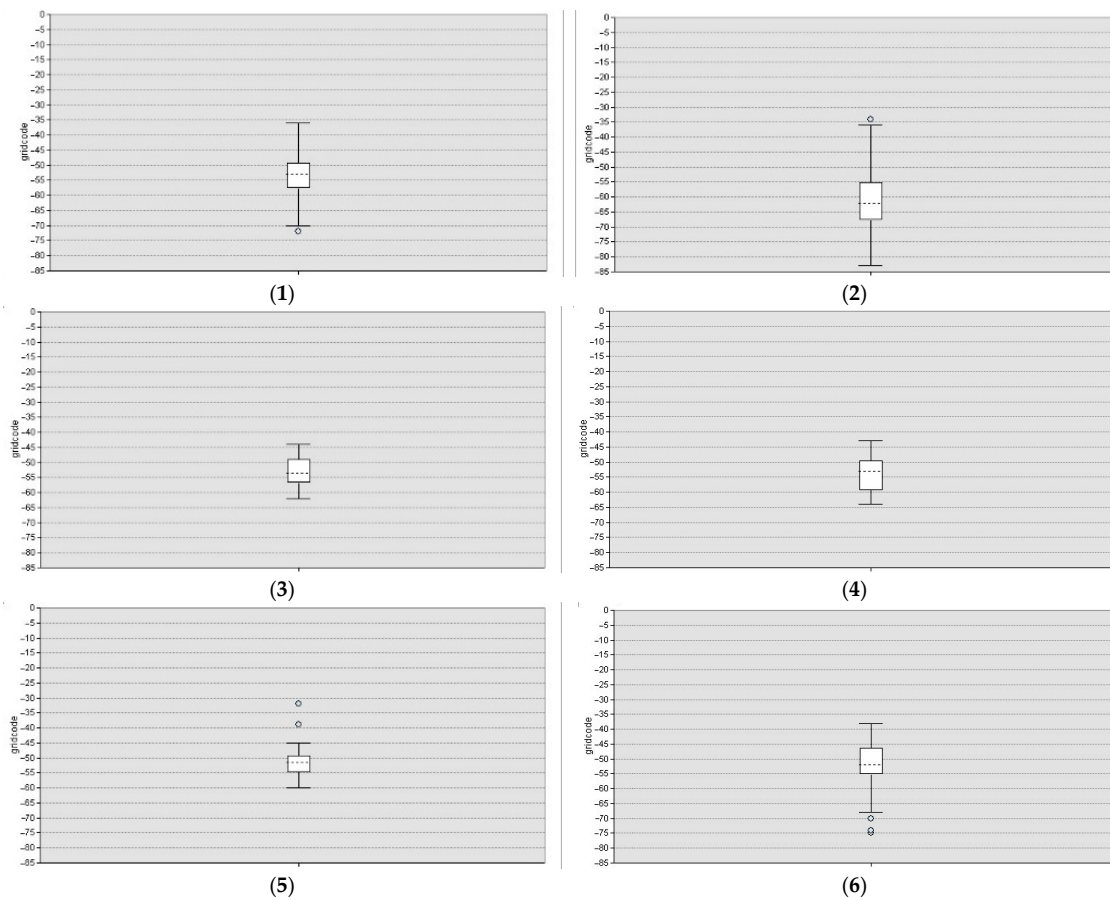
As shown in Table 2 and Figure 11, the boxplot characterization of the pixel-level NDVI difference values in the six areas demonstrates some differences: the maximum impact has been recorded in Areas 2, 6, and 1, which represent cases of sealing, together with compaction. The lowest minimum value was recorded for Area 5 (erosion), while Areas 3 and 4 have the same minimum values (both compaction). The highest average value by far is recorded in Area 2; the new dormitory (sealing) represents the highest impact on the campus in terms of loss of biodiversity.

Figure 11. New construction next to the Electronics and Electrical Engineering Department.

- The sealing process recorded the maximum NDVI reduction. The maximum decrease in NDVI ranged between  $-32.9\%$  and  $-29.4\%$ ; besides, the sealing is also characterized by the highest NDVI variance (NDVI absolute difference values range between  $-37$  and  $-50$ );
- The compaction process has a medium impact. The max decrease in NDVI ranges between  $-24.3\%$  and  $-26.6\%$ , while the min decrease in NDVI ranges between  $-14.5\%$  and  $-17.2\%$ ;
- The erosion process has the lowest impact. The max decrease in NDVI is  $-23.5\%$ , and the min decrease in NDVI is equal to  $-12.5\%$ .
