**CHARACTERISTICS OF MORTARS AND
PLASTERS OF SOME BATH BUILDINGS FROM
AYDINOĞULLARI PRINCIPALITY IN
SELÇUK, İZMİR**

**A Thesis Submitted to
the Graduate School of İzmir Institute of Technology
in Partial Fulfillment of the Requirements for the Degree of**

**MASTER OF SCIENCE
in Architectural Restoration**

**by
Rabia Nur BİLEKLİ**

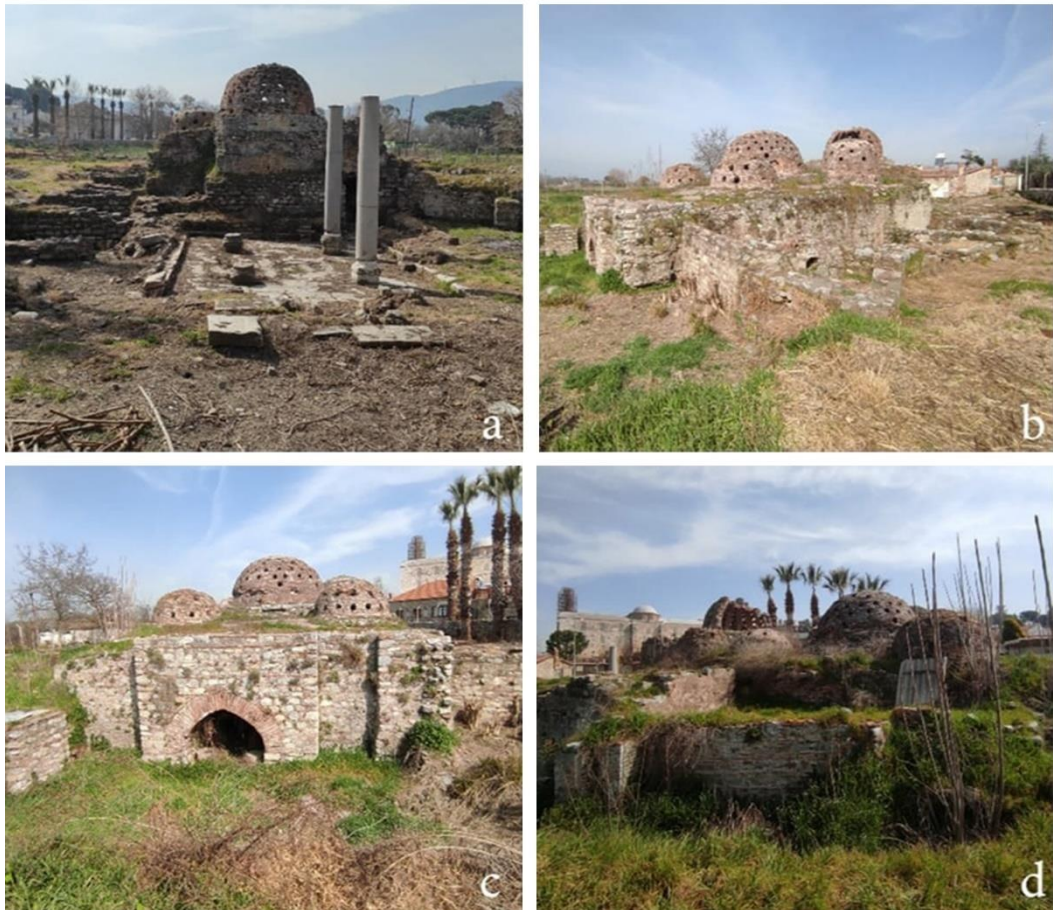
The *Sıcaklık* has four iwans and four *halvets* and is laid out in a central plan schema (Figure 3.6.). The central space and the *halvets* are covered with a dome, while the iwans are covered with a barrel vault. Spolia marble floor tiles of *Sıcaklık* were removed during excavations and investigations (Erat 1997). The *Külhan*, located on the southern side of the bath, is covered with a barrel vault.

Figure 3.6. Plan of İsa Bey Bath (Erat 1997) North view (a), Southeast view (b), South view (c), Southwest view (d)

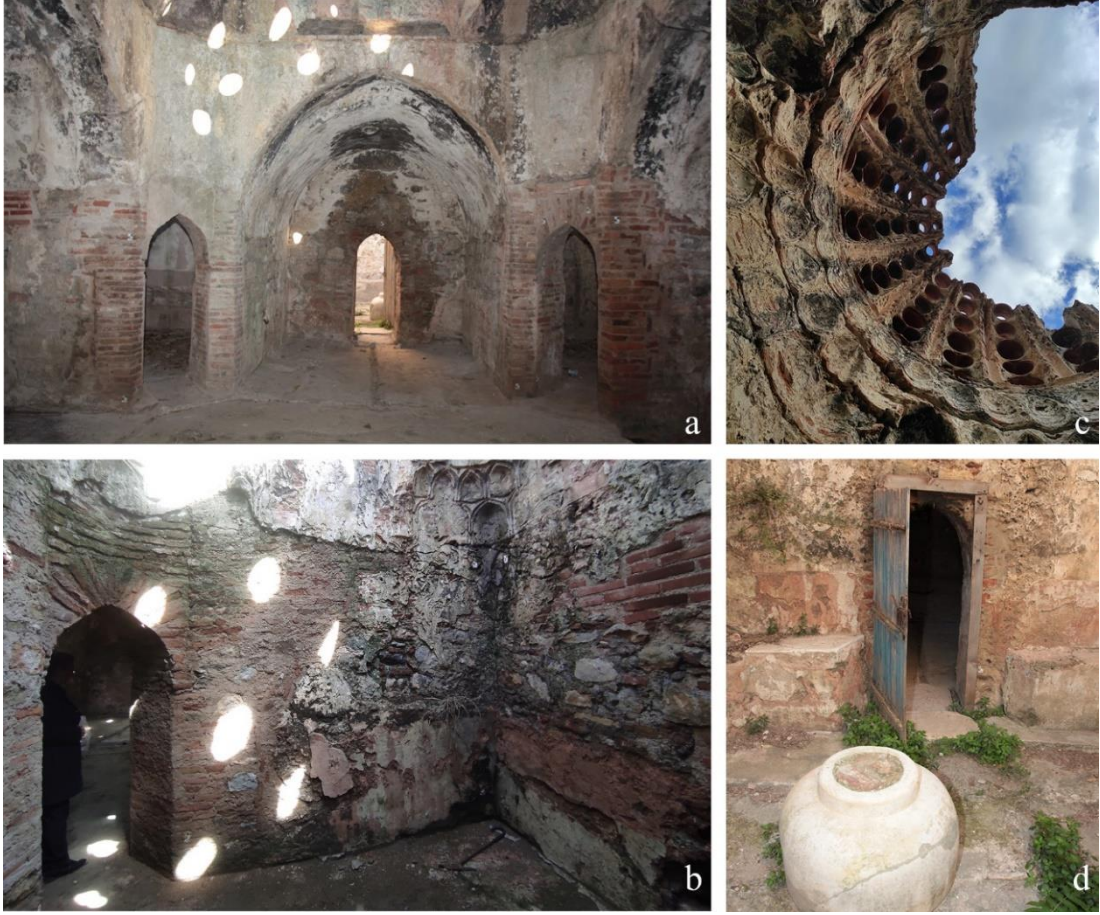
Figure 3. 7. Photos from İsa bey bath; General view from *Sıcaklık* (a), *Halvet*, (b), The dome of the *Ilıklık* (c), General view from *Ilıklık* (d)

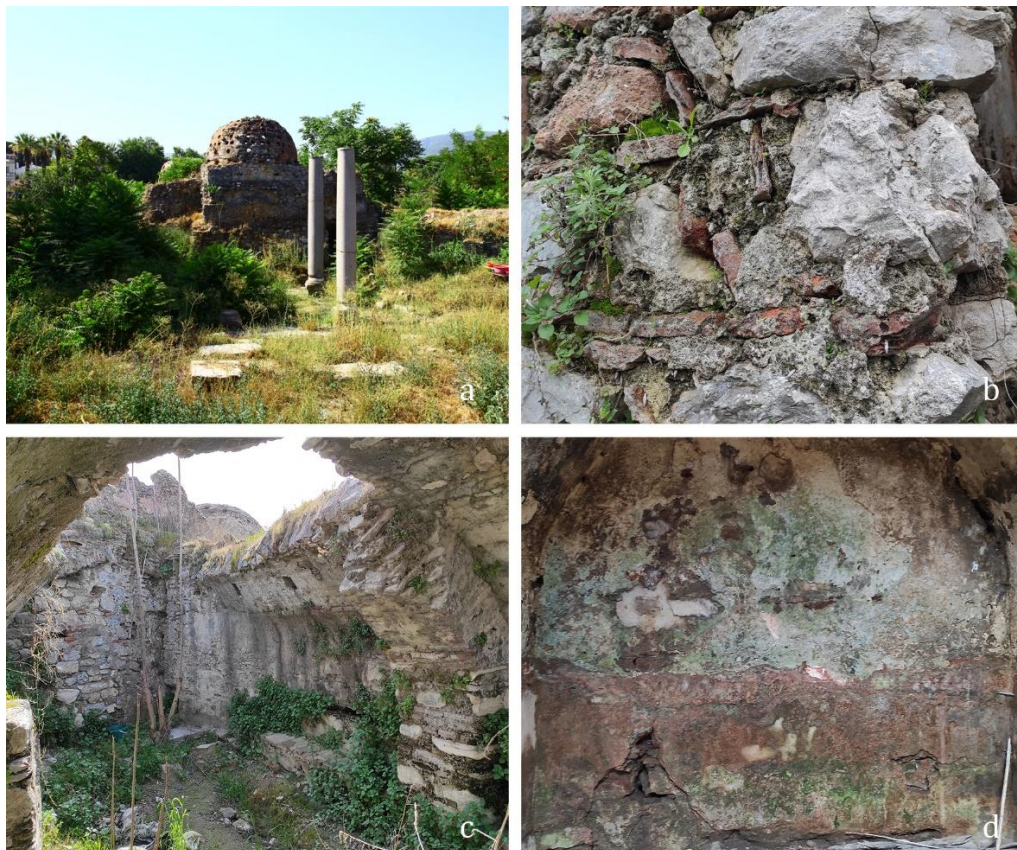
In the Isa Bey Bath, it was observed that the walls, domes, and vaults partially or completely collapsed probably due to a lack of maintenance, seismic forces, or vandalism. Structural cracks were identified at multiple points. The bath was surrounded by vegetation (Figure 3.8(a)). The discoloration of plasters, stones, and bricks and the growth of microorganisms (Figure 3.8 (c) – (d)) were caused probably due to weather conditions, rainwater penetration, and rising damp. The loss of integrity of plaster and mortars due to loss and abrasion caused joint discharge on some of the masonry walls (Figure 3.8(b)). The failure of the structure and material deterioration was probably caused by a lack of regular maintenance and repair, seismic forces, or vandalism (Figure 3.8.).

Figure 3. 8. Structure failures and material deterioration (probably due to weather conditions, rainwater penetration, rising damp, lack of maintenance, seismic forces, or vandalism): Plant growth (a), Joint discharge (b), Discoloration, (c), Microbiological colonization (d)

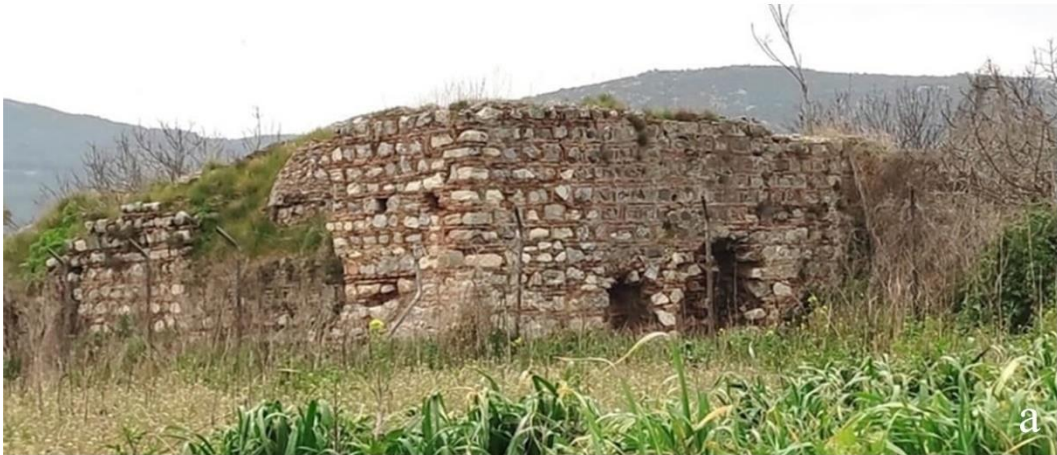
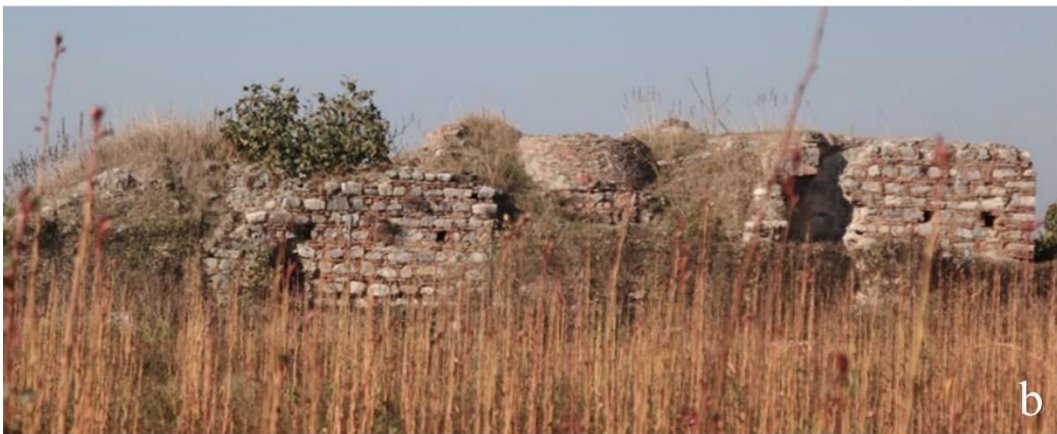
The *Külhan* located in the southern part of the building, has a rectangular plan, and is covered by a barrel vault. The south I of the *Külhan* was supported by triangular buttresses (Özeren and Büyükkolancı 1977b). The northwest of the bath contains the remains of a structure that was added later (Özeren and Büyükkolancı 1977b; Daş 1997).

Figure 3. 9. Plan of Kale Altı Bath (Daş 1997), North-East view (a), East view (b)

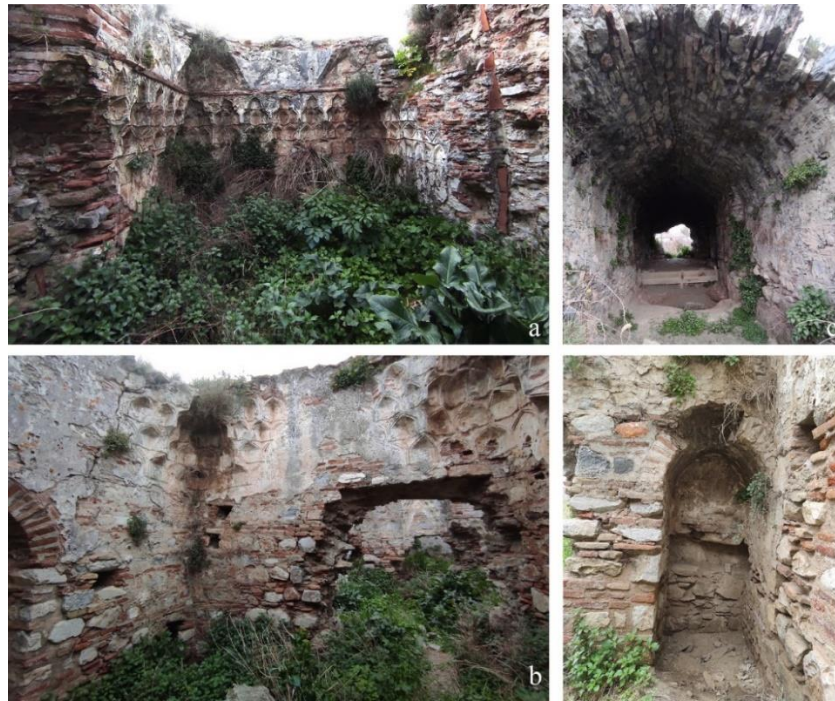
Figure 3. 10. Kale Altı Bath interior photos; *Sıcaklık* (a), *Ilıklık* (b), *Külhan* (c), *Aralık* (d)

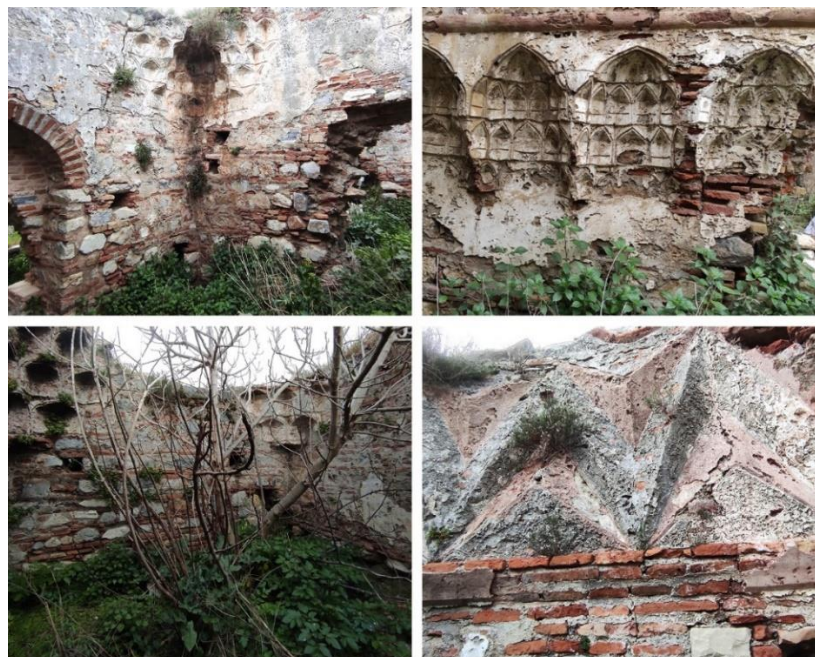
Figure 3. 11. Structure failures and material deterioration of Kale Altı Bath: Structure failures and material deterioration (probably due to weather conditions, rainwater penetration, rising damp, lack of maintenance, seismic forces, or vandalism): Joint discharge (a), Discoloration (b), Plant growth (c), Microbiological colonization (d)

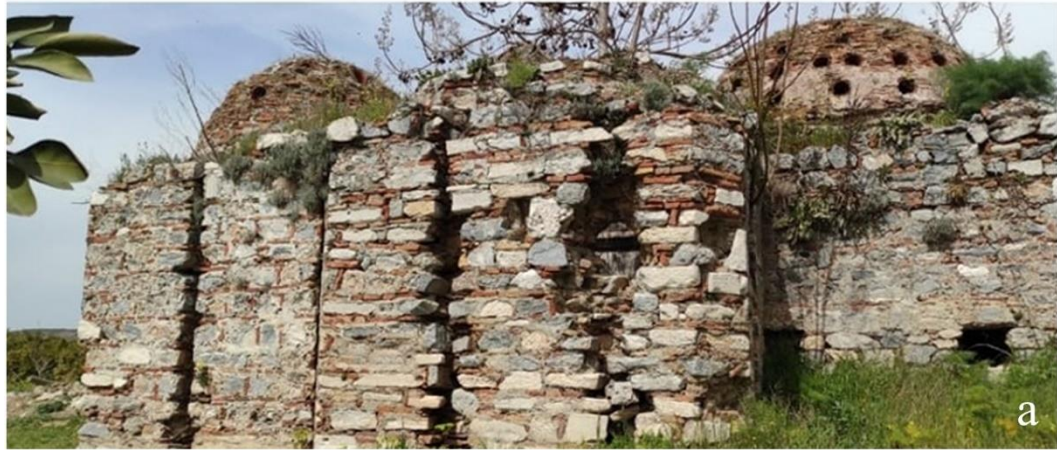
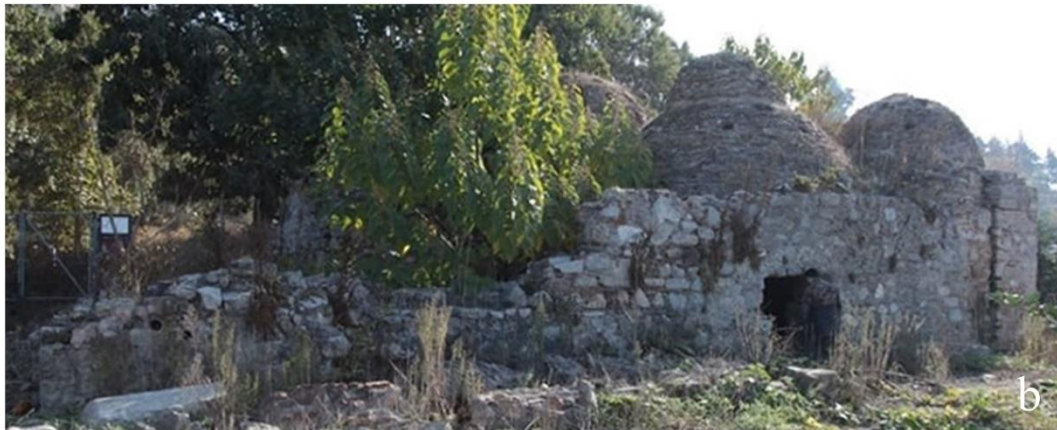
Yahşi Bey Bath was built in the second half of the 15th century during the Aydınogulları Principality, according to historical research and architectural investigation (Özeren and Büyükkolancı 1977c). Due to its asymmetrical plan scheme and irregular masonry technique, it is thought to have been built during the period when the Aydınogulları Principality was losing economic power (Öktem 2002).

Figure 3. 12. Plan of Yahşi Bey Bath ((Daş 1997) South view (a), East view (b)

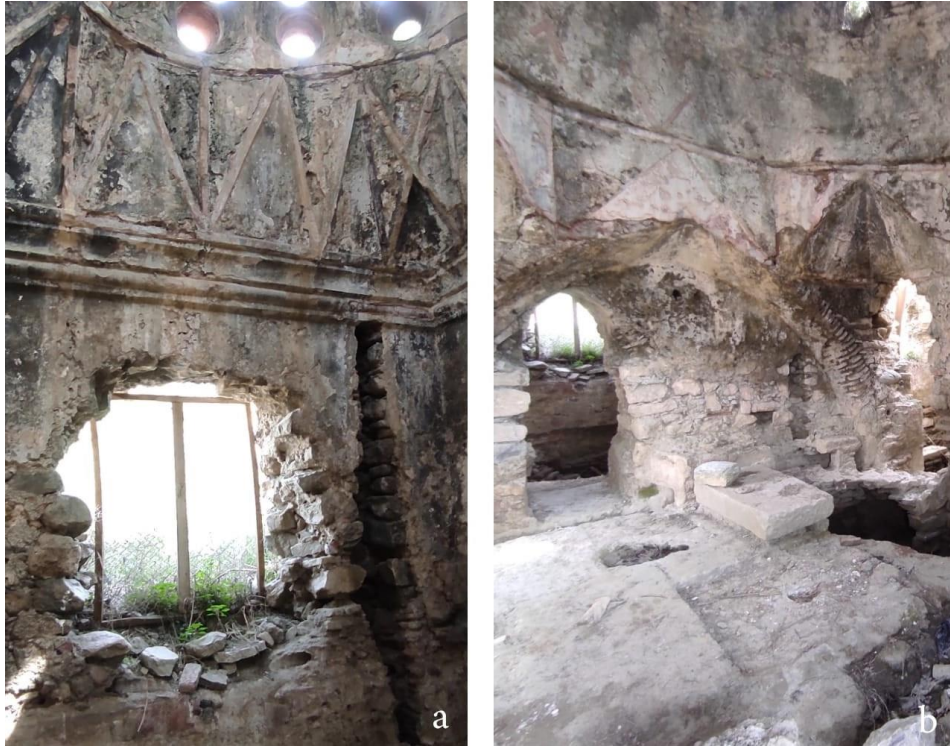
The bath was constructed using rubble stone, pitch-faced stone, brick, and spolia materials in the masonry system İsa Bey Bath, Saadet Hatun Bath, and Kale Altı Bath. The exterior walls of the bath were built with stone-brick alternating masonry wall technique (Öktem 2002; Özeren and Büyükkolancı 1977c; Daş 1997). The domes were built with bricks. In Yahşi Bey Bath there was a clear boundary between the lower and upper levels of plaster similar to previous studies (Böke, Akkurt, and Ipekoğlu 2004; Uğurlu 2005; Gürhan 2018). The lower-level plaster consisted of two layers; one Horasan plaster, and one grayish plaster layer (plaster with natural stone aggregate). The upper-level plaster consisted of three layers, one lime plaster, and two grayish plaster layers (Table 3.1.). In the Yahşi Bey Bath, it was observed that the walls, domes, and vaults partially or completely collapsed probably due to a lack of maintenance, seismic forces, or vandalism. Structural cracks were identified at multiple points. There was plant growth inside and outside the bath (Figure 3.14. (a)). It was observed that in some spaces of the bath building, the floor covering has been entirely collapsed. The discoloration of plasters, stones, and bricks and the growth of microorganisms were probably caused by rising damp (Figure 3.14. (b)). The loss of integrity of plaster and mortars due to loss and abrasion caused joint discharge on some of the masonry walls. The failure of the structure and material deterioration was probably caused by a lack of regular maintenance and repair of seismic forces or vandalism.

Figure 3. 13. Photos from Yahşi Bey Bath: *Soyunmalık* – Discoloration (a),
Ilıklık – Vandalism (b)

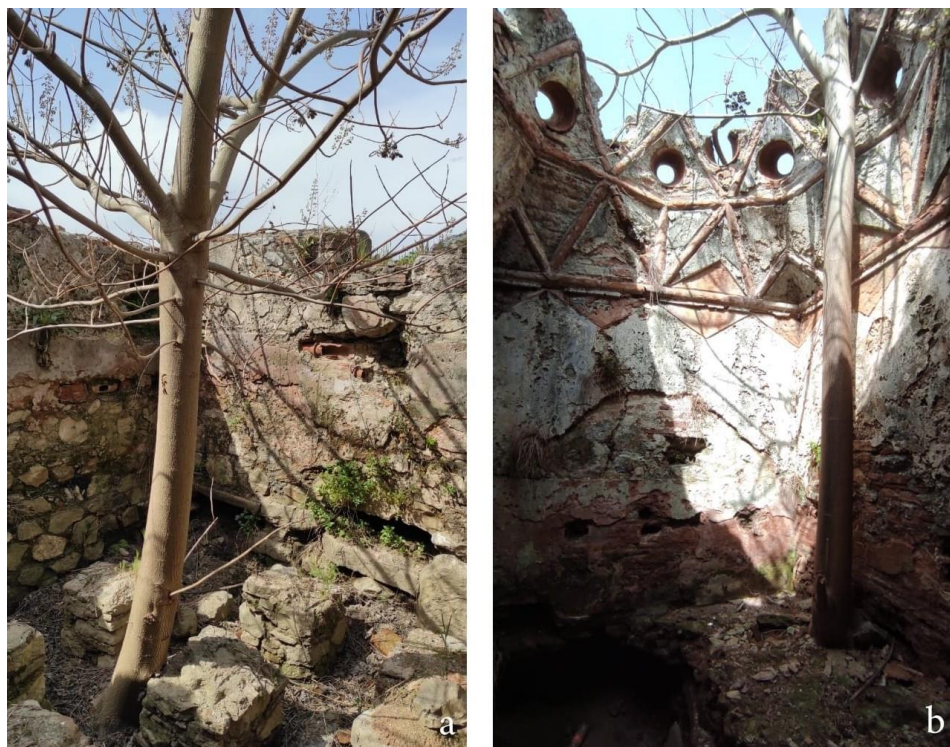
Figure 3. 14. Photos from Yahşi Bey Bath: East *Halvet* – Plant growth (a),
 Weast *Halvet* – Microbiological colonization (b)

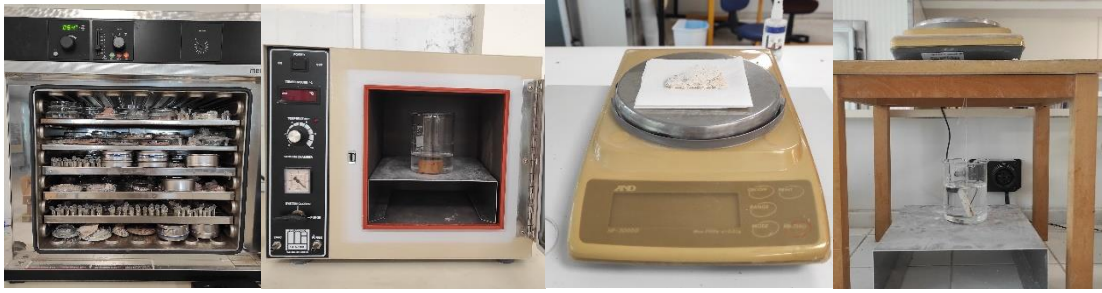
The densities and porosities were determined using two parallel specimens for each sample. First, the samples were dried in a 45°C oven for at least 24 hours (Figure 4.8.a), then their dry masses (M_{dry}) were weighed using a precision balance (AND HF-3000G) (Figure 4.8.b). Subsequently, immerse the samples in distilled water in a vacuum oven (Lab-Line 3608-6CE Vacuum Oven) at -25 kPa for 24 hours. The water level should be approximately 2 cm above the samples (Figure 4.8.c). The saturated weights (M_{sat}) were then measured, and the Archimedes weights (M_{arch}) were determined through hydrostatic weighing in distilled water using a precision balance (Figure 4.8.d).

Figure 4. 6. a: Oven for drying samples b: Precision balance used to weigh dry and saturated samples c: Samples in vacuum oven d: Archimedes weight measurement
