**PHYSICAL TRANSFORMATION OF HISTORIC
BUILT ENVIRONMENT:
THE CASE OF KESTELLI STREET**

**A Thesis Submitted to
the Graduate School of
Izmir Institute of Technology
in Partial Fulfillment of the Requirements for the Degree of**

in Conservation and Restoration of Cultural Heritage

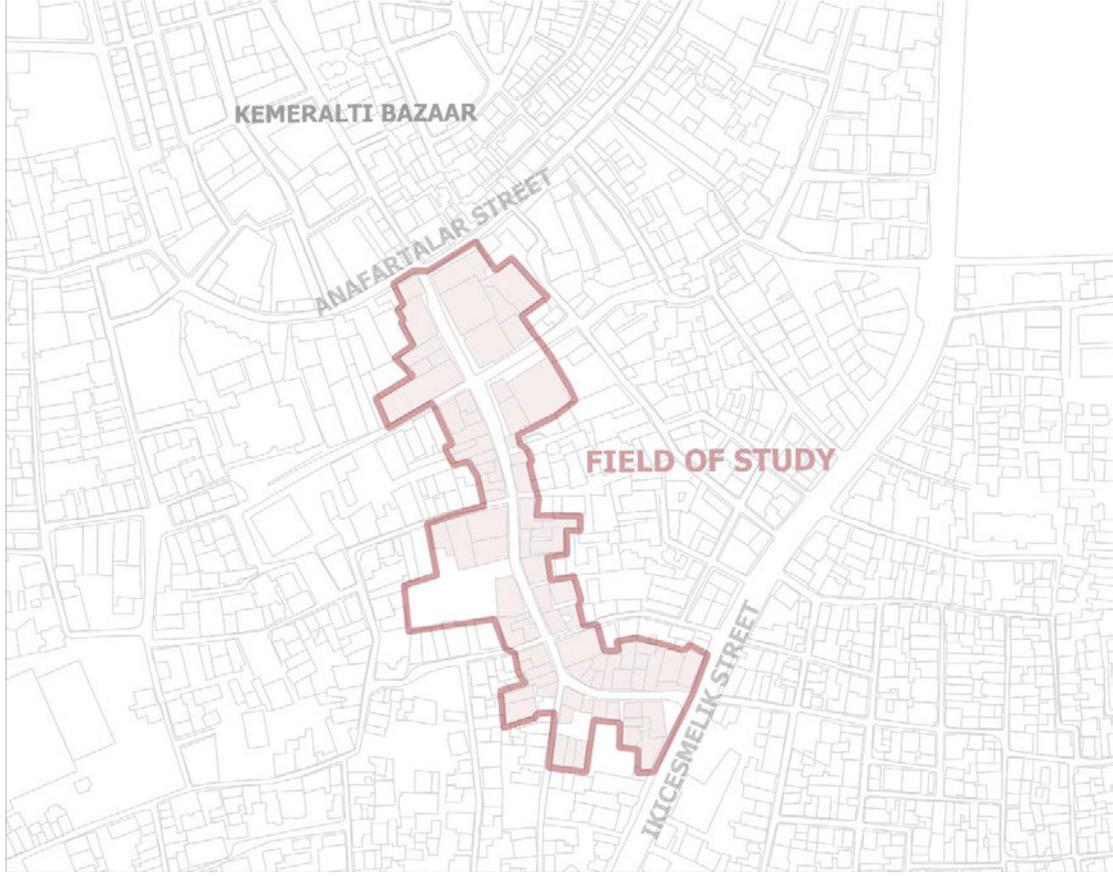
Figure 1.1 Field of the study

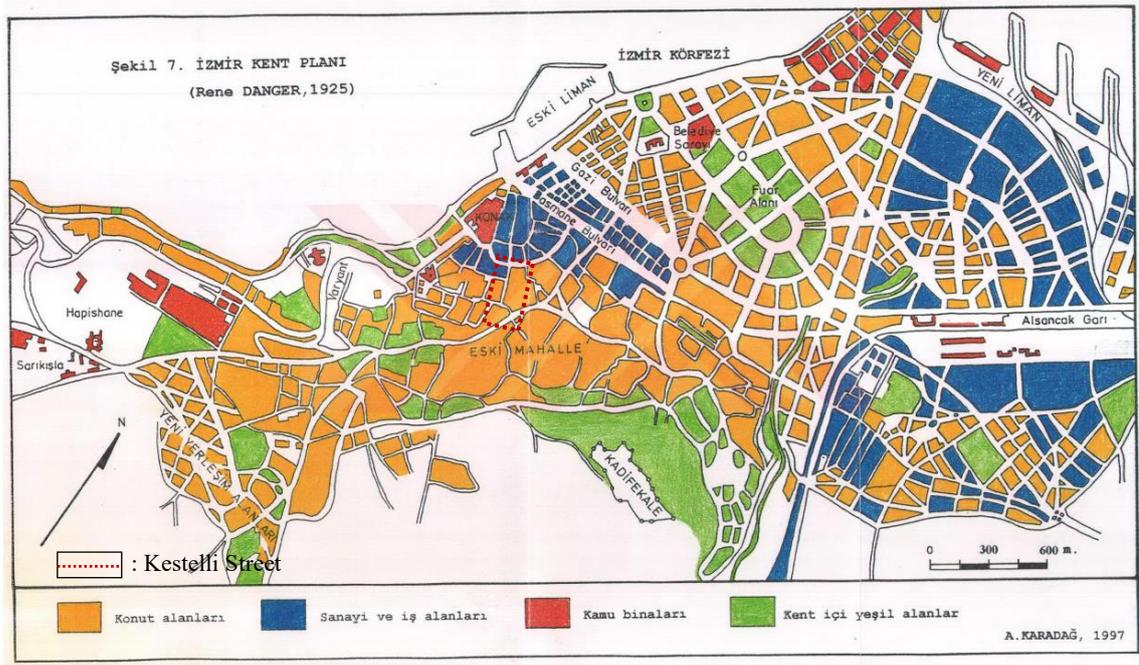
Figure 3.10. 1925 Rene Danger - Henri Prost İzmir city plan diagram, 1997
 (Source: Arife Karadağ, 1998)

The plan divides the city into three distinct zones: residential, commercial, and public buildings (Figure 3.10). On the west side of Kestelli Street, between Anafartalar Street and 442 Street, all of today's 186 and 187 Blocks are designated for commercial use. The remaining lots on Kestelli Street are planned for residential purposes, with the exception of the aforementioned two lots. It is well documented that the exchange of Thessaloniki, which occurred after the establishment of the Republic, led to a significant increase in the population of the city. This phenomenon has had a profound impact on the residential character of the urban plan. The most notable and enduring legacy of the Danger-Prost plan for Izmir is the Kültürpark. Kültürpark is one of the urban heritages from the 1930s to the present day and is still in use today as a fairground.

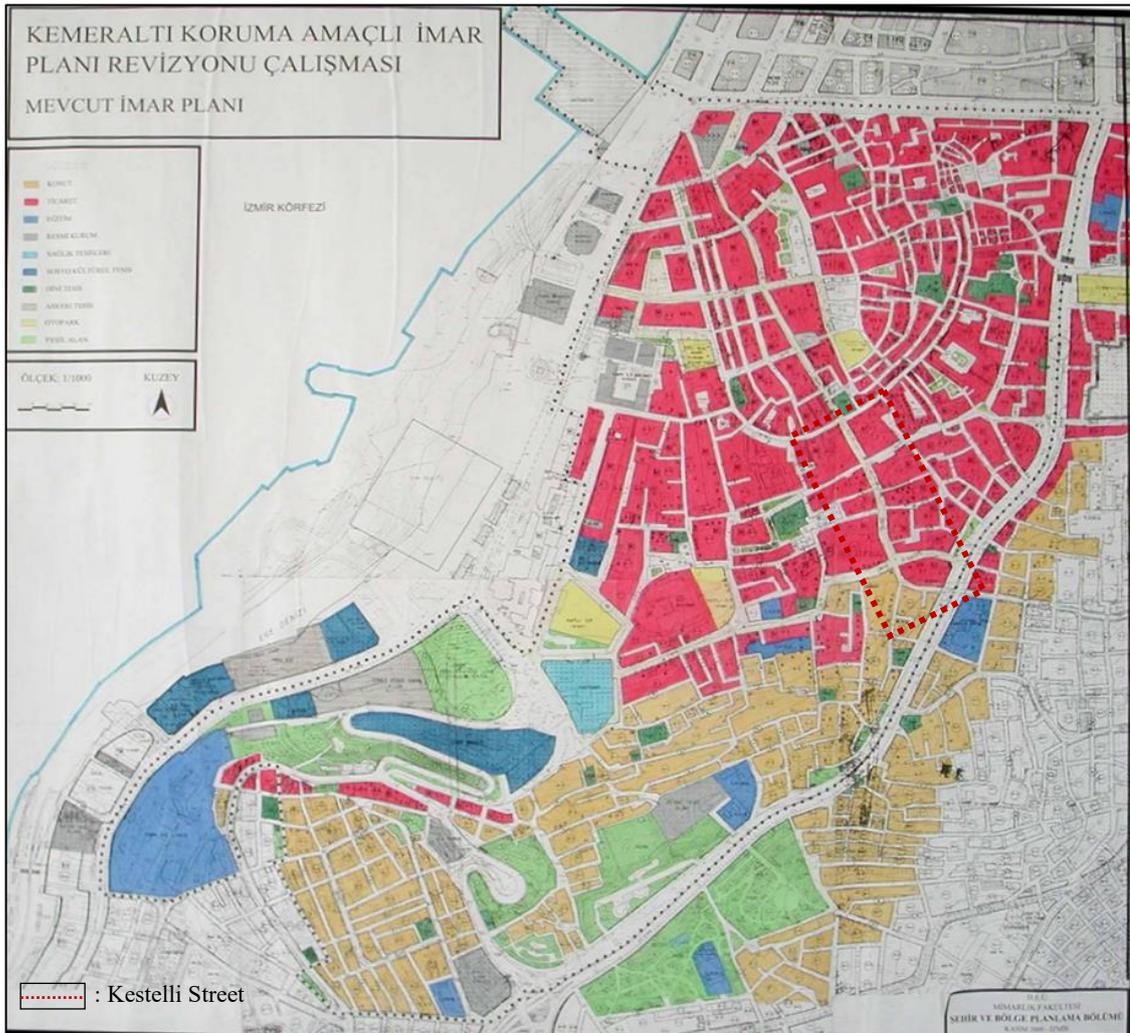
Figure 3.17. Kemeraltı and surroundings conservation development plan, 1984, (Source: Kemeraltı and Surroundings Conservation Development Plan Report, 2002)

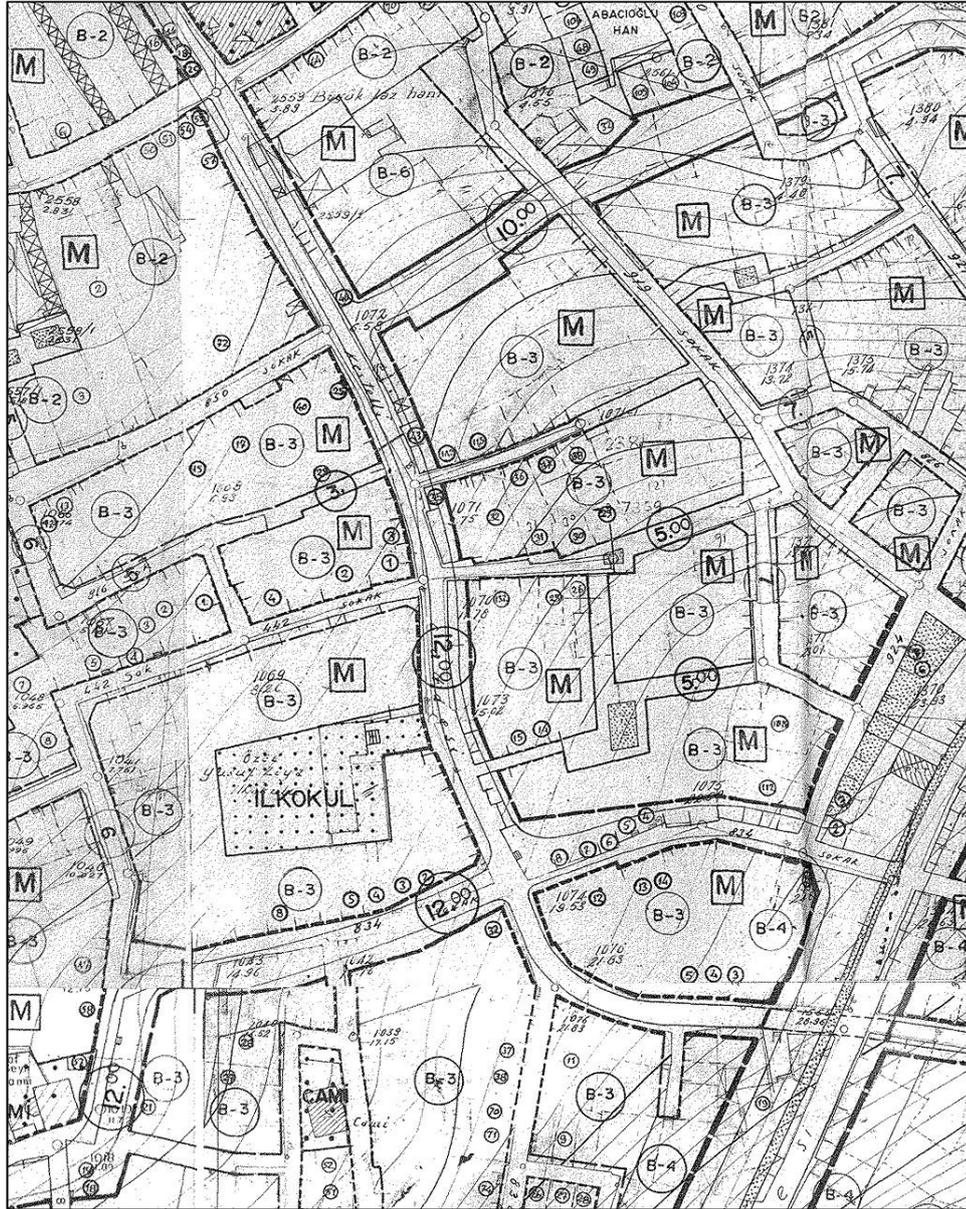
Figure 3.18. Kestelli Street and surroundings in Kemeraltı and surrounding development plan, 1984
(Source: Konak Municipality)

In accordance with the recently implemented development plan, the Kemeraltı neighborhood, encompassing Kestelli, has commenced a new construction phase. During this period, it has been observed that numerous buildings in the area have been demolished and reconstructed in a manner that accommodates the elevated floors permitted by the development regulations and the entire lot boundary.

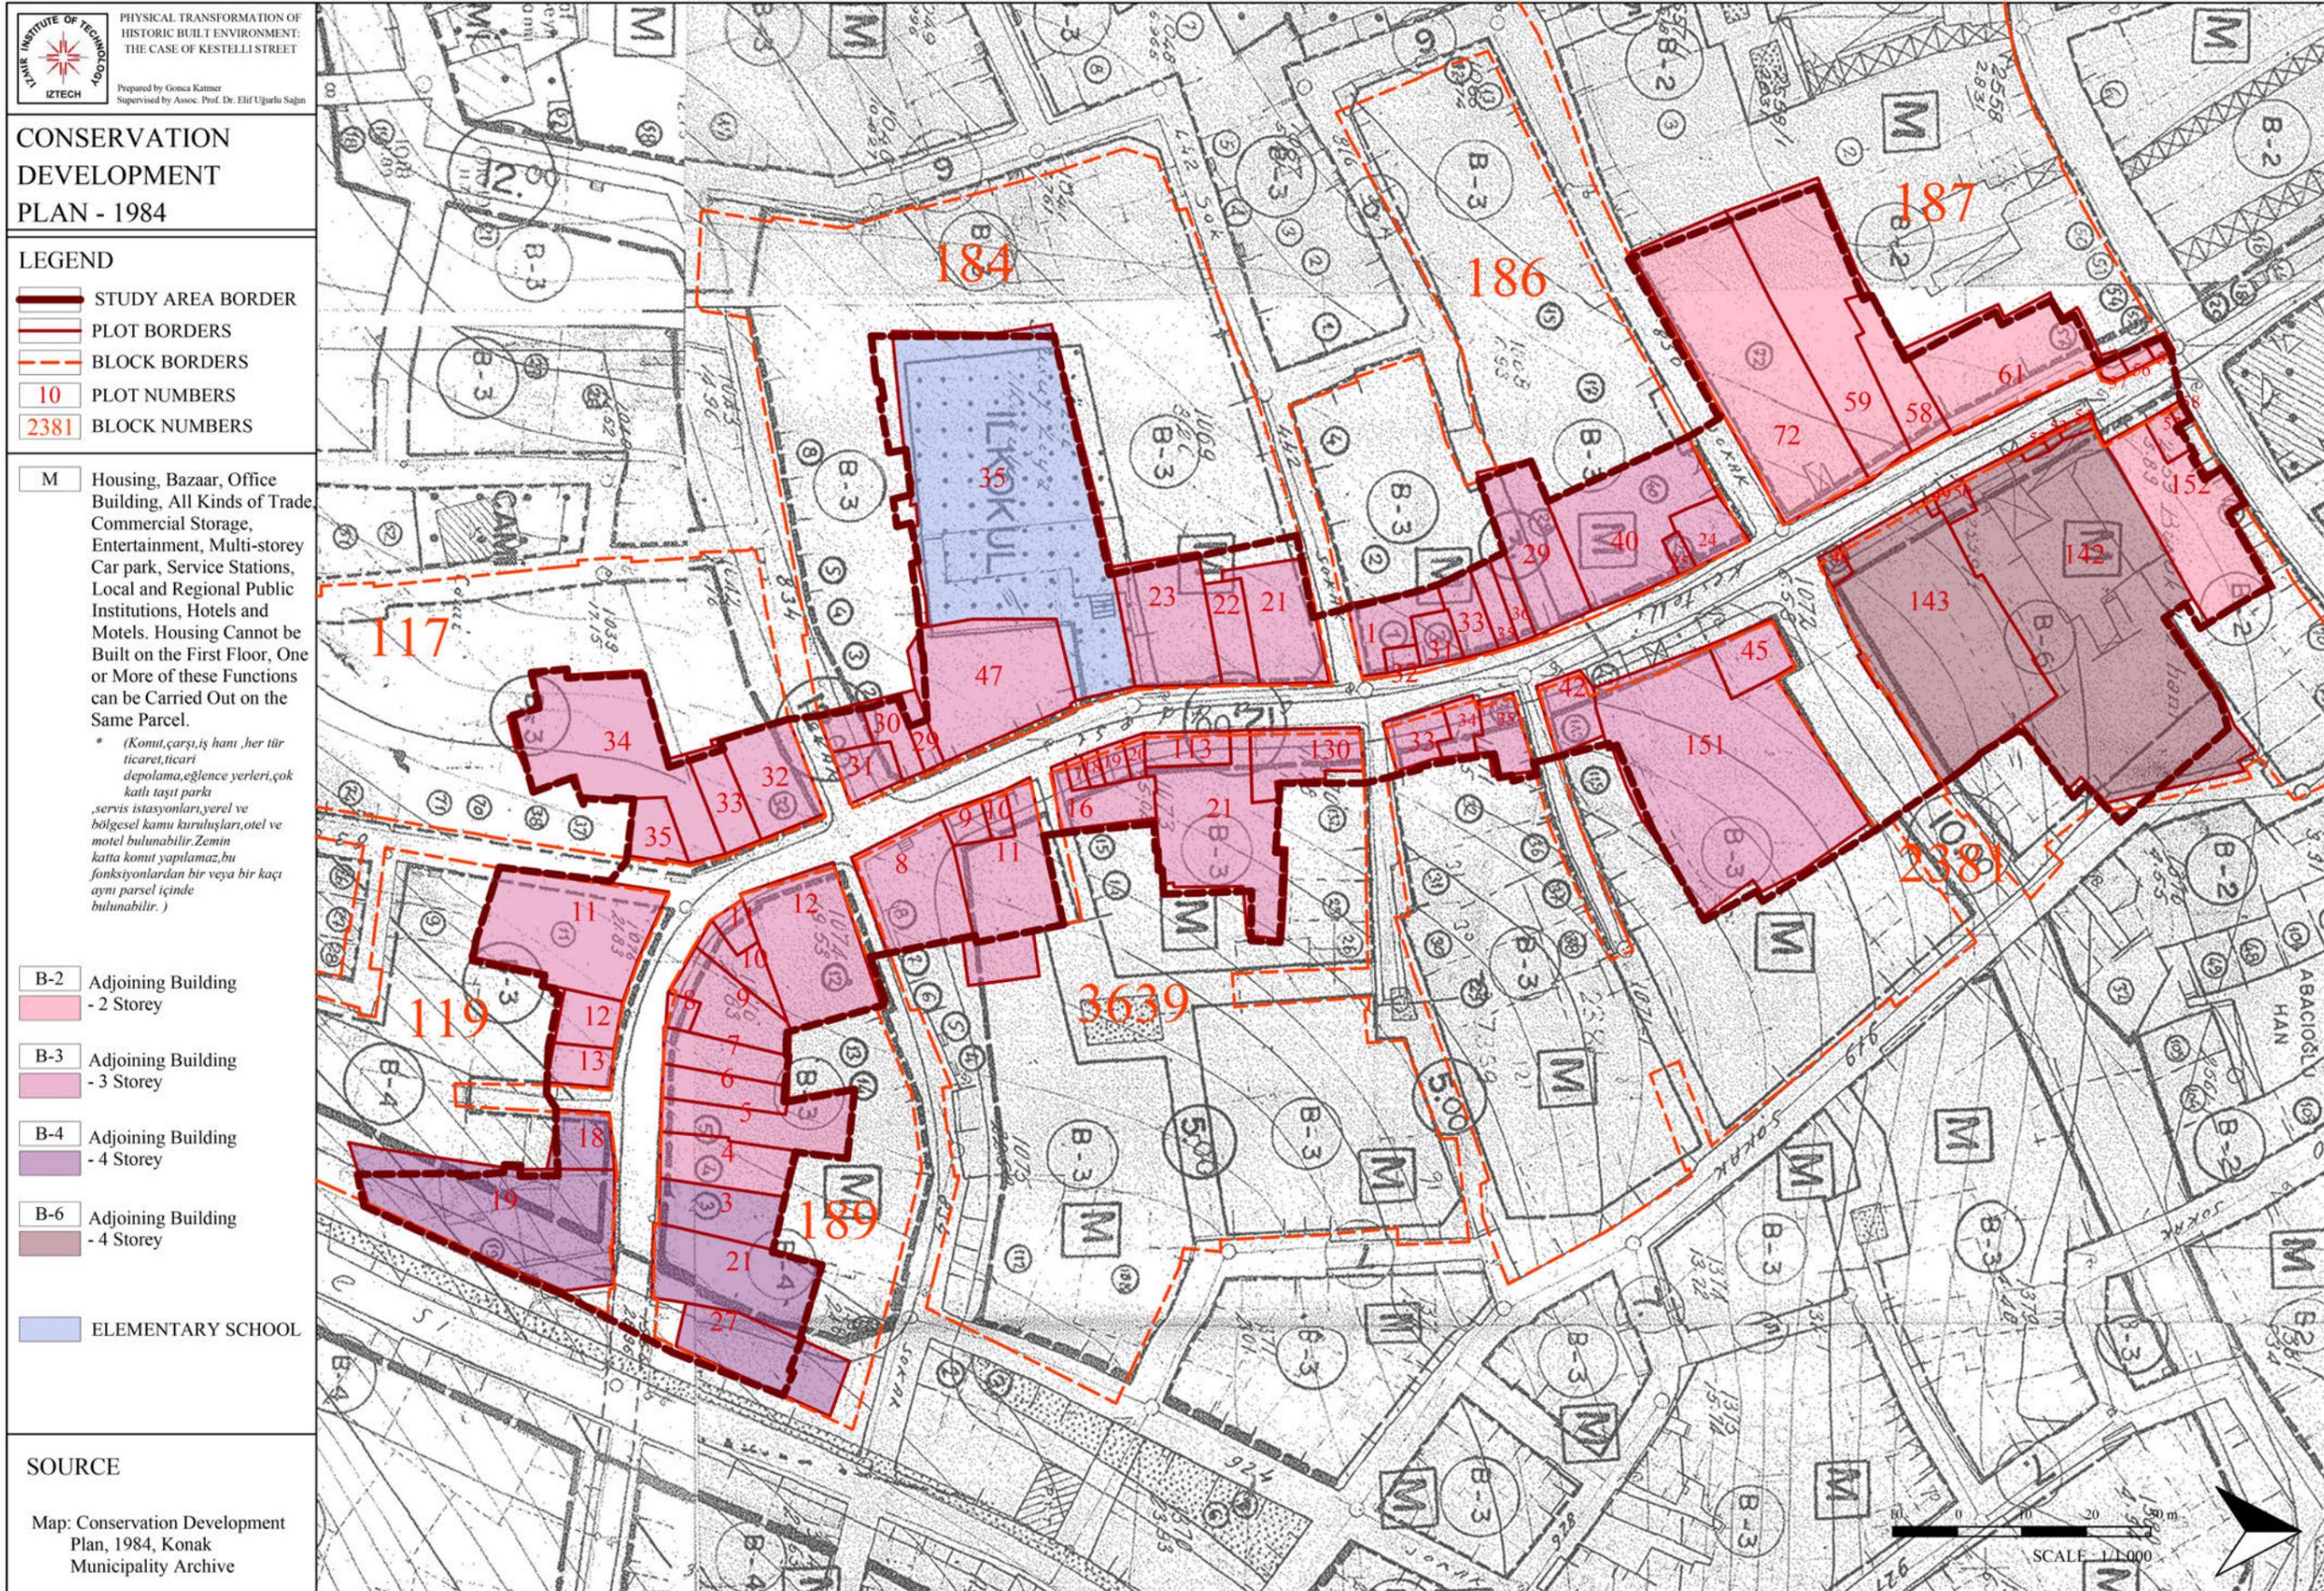
Figure 4.2. Conservation development plan analysis 1984

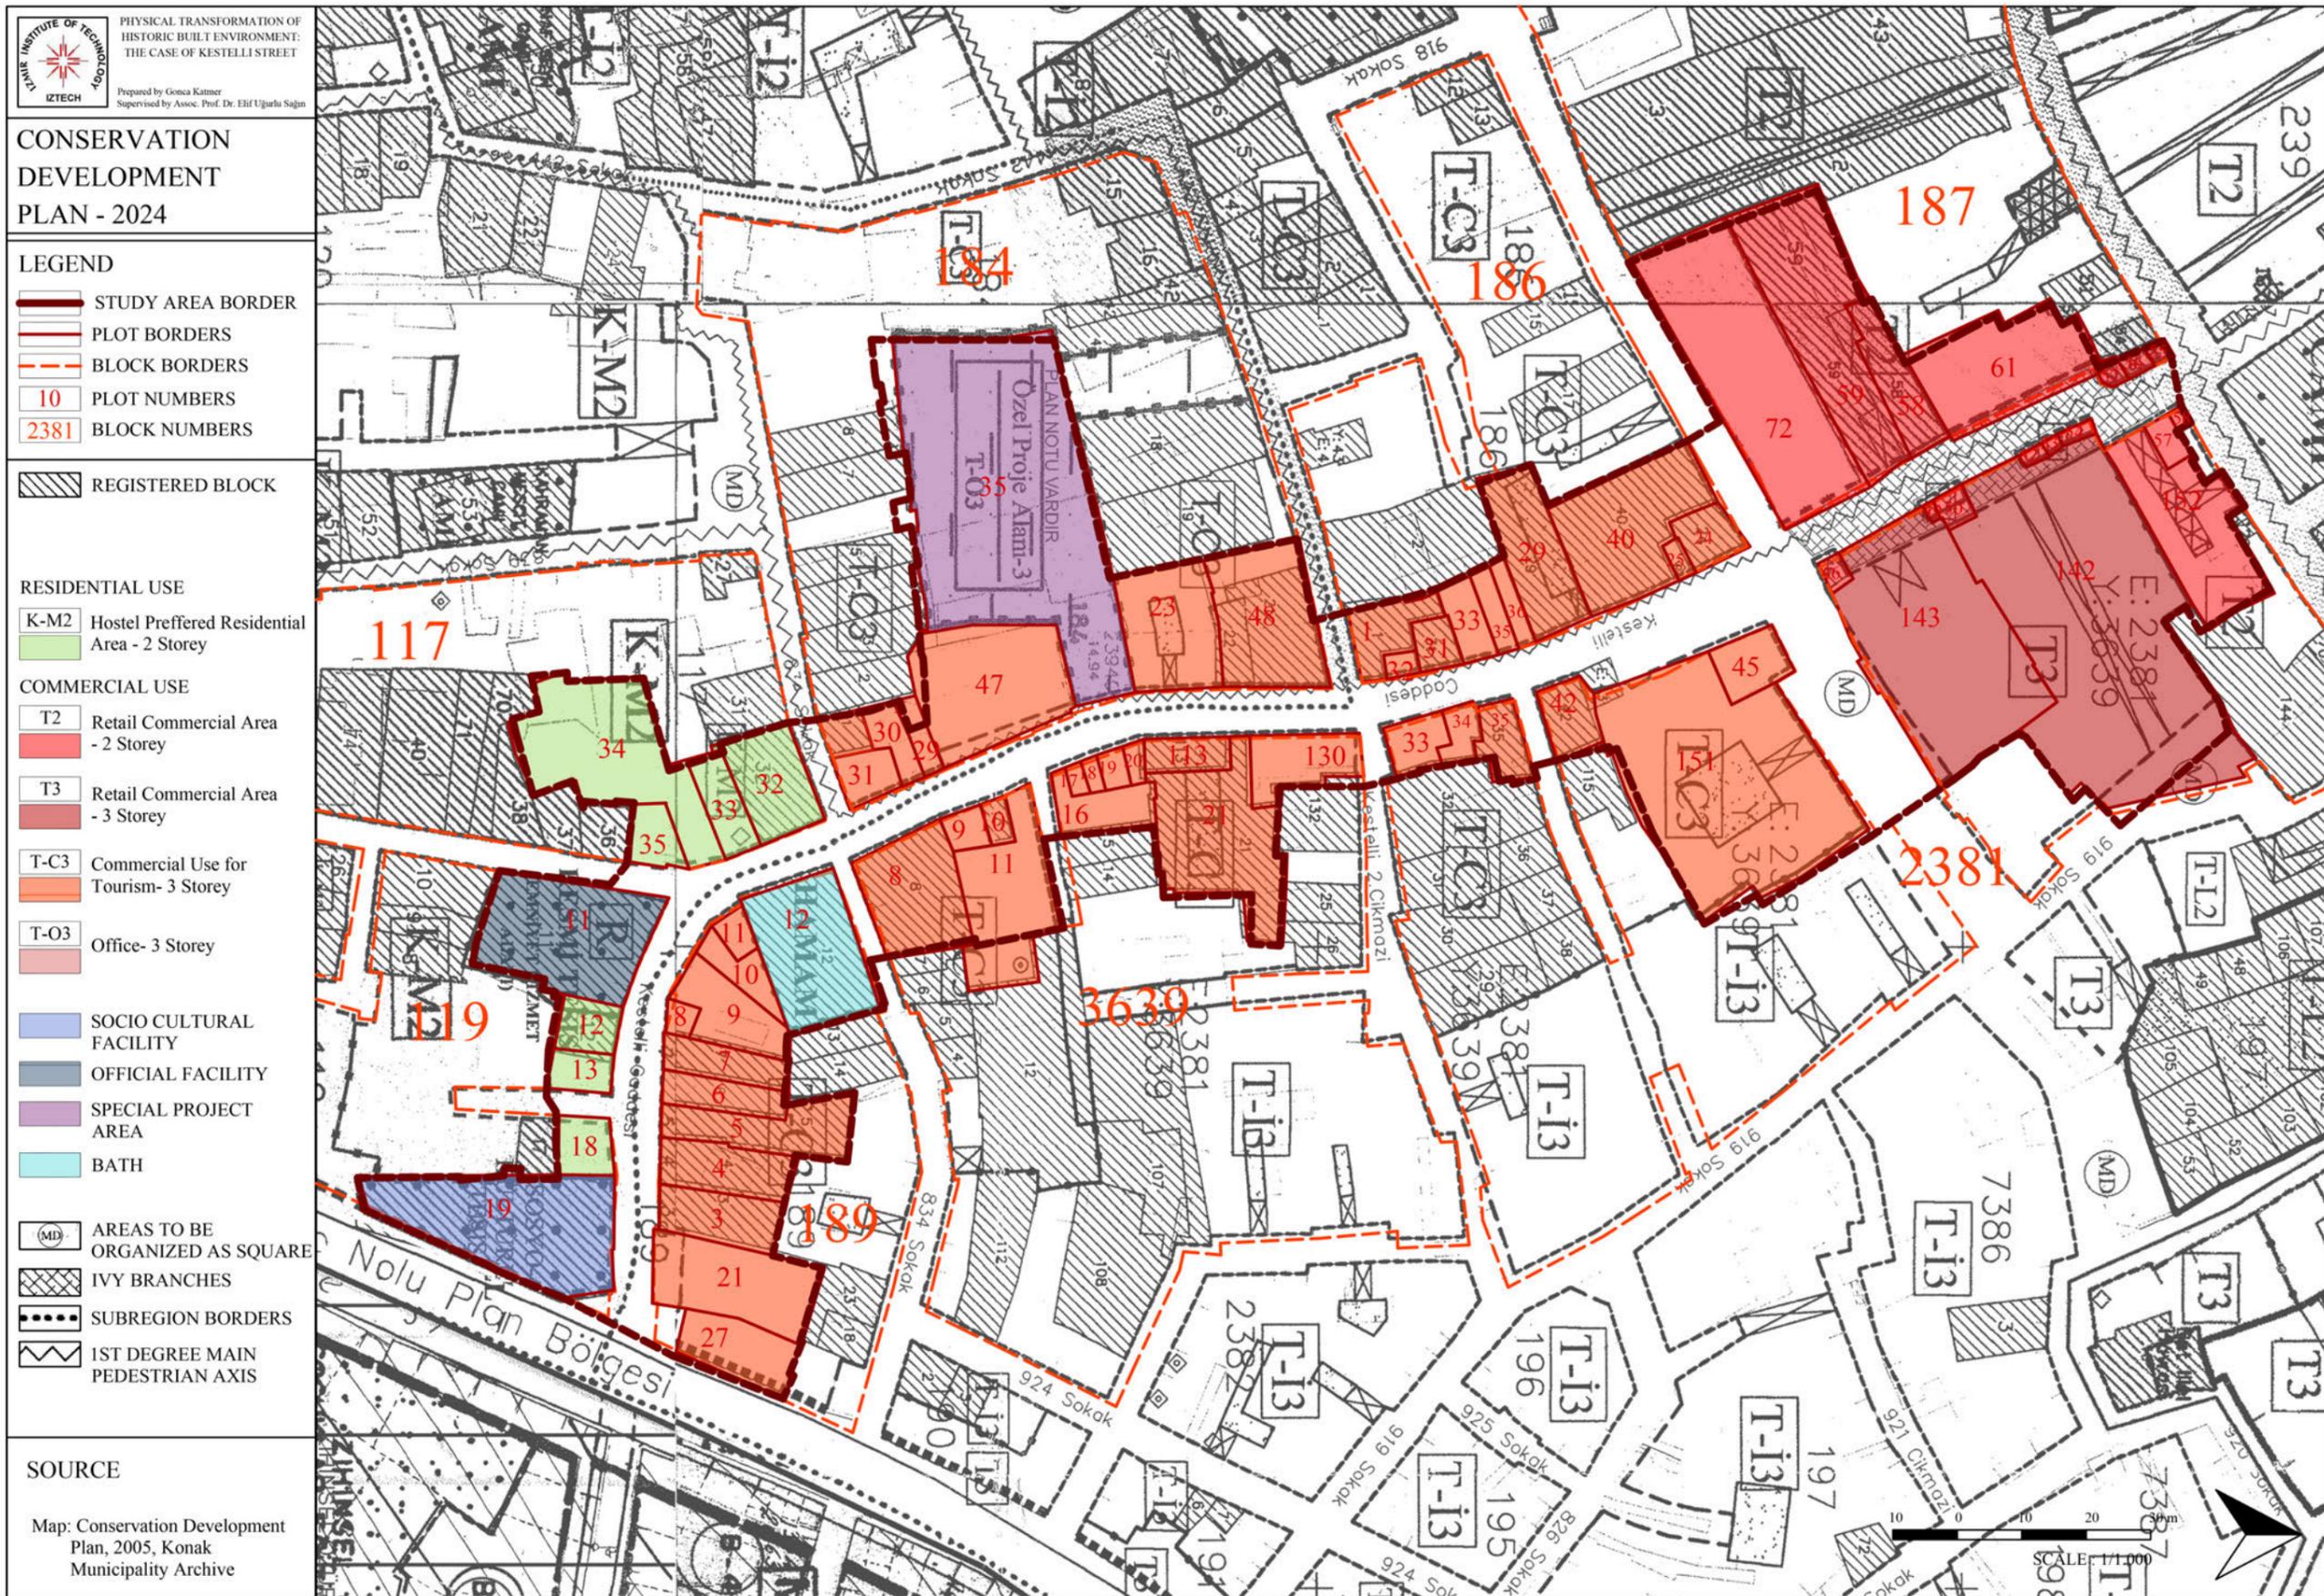
Figure 4.4. Conservation development plan analysis 2024

The current 2024 Conservation Plan indicates that 74 lots within the area were analyzed (Figure 4.4). Among the 74 lots, seven (9%) remain in the plan as a 2-storey hotel preferred residential area, as determined in 2005. Similarly, 16 lots (20%), which were planned as 2-storey retail commercial area in 2005, are also included in the current plan in the same way. A total of 39 lots (52%) in the area are planned as 3-storey commercial buildings for tourism purposes. Six lots (8%) in Block 184 have been converted into 3-storey office buildings. In addition, the area in block 184, lot 35 has been designated as a Special Project Area. Furthermore, it is planned to have one socio-cultural facility, one official facility, and one bathhouse in the area.

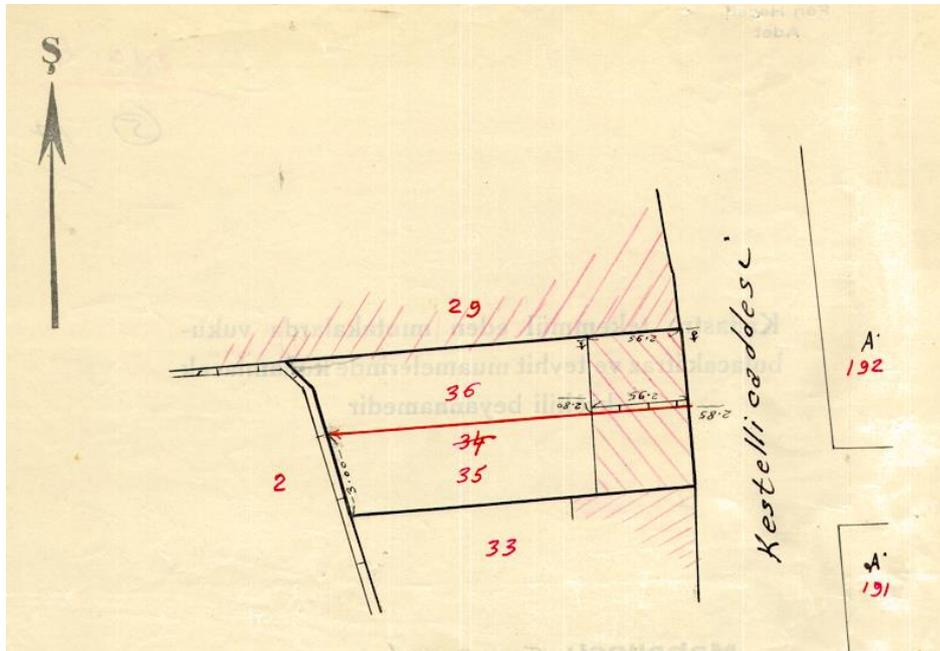
Figure 4.11. Formation of Lots 35 and 36, 1941
(Source: General Directorate of Land Registry and Cadastre)

In the document issued in 1941 for Lot 34, the lot was divided into two separate lots, 35 and 36. In addition, the two shops on the area were also distributed as one shop each.

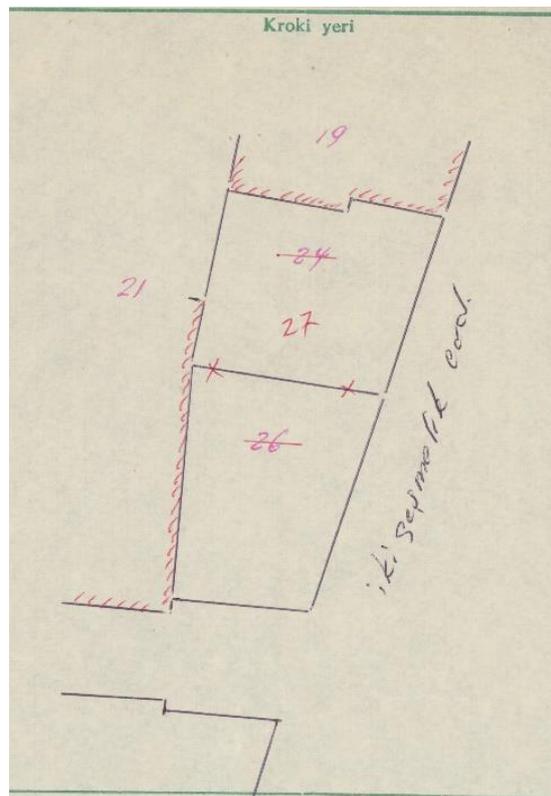
Figure 4.15. Formation of 27 Lots by combining Lots 24 and 26, 1969
(Source: General Directorate of Land Registry and Cadastre)

BLOCK 189, LOT 27: Lot 27 lots were created by the merge of two different lots. Later, the lot type changed. It is observed that the area where Lot 27 is located today consists of two lots, namely Lots 1 and 20 on the cadastral map dated 1930. These lots were first merged into two lots, Lots 24 and 26 (Appendix B.13).

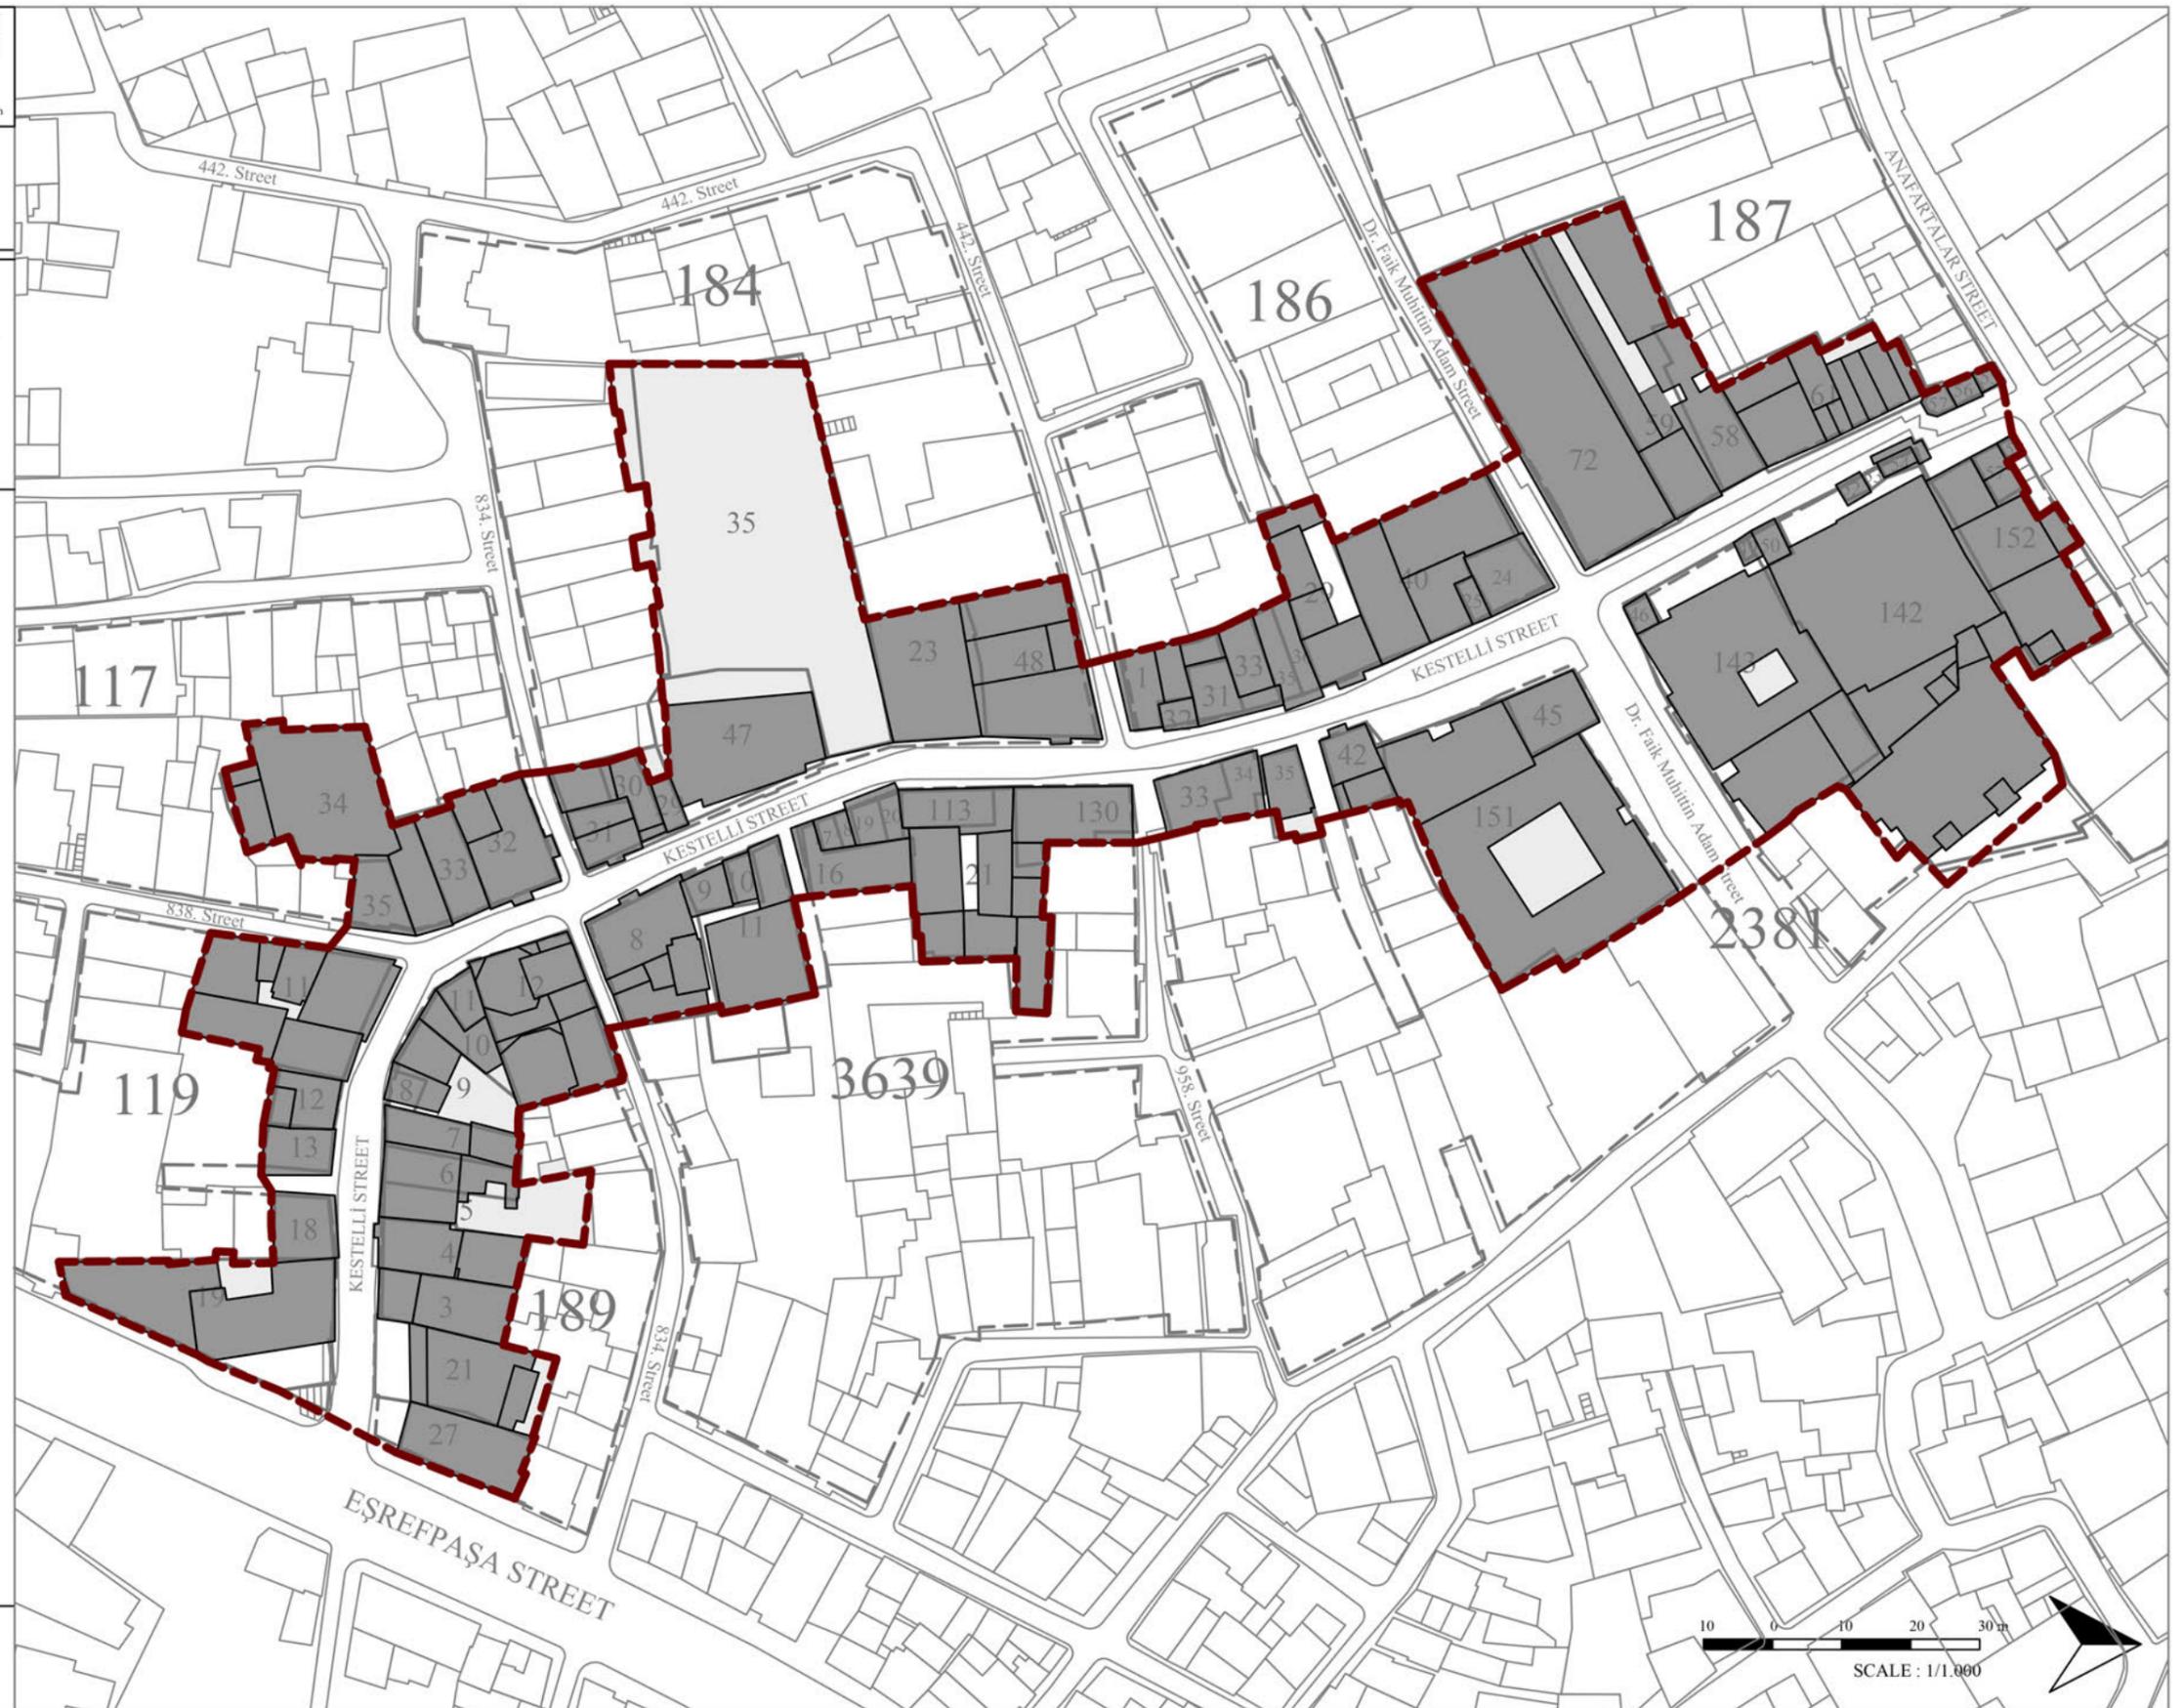
Figure 4.47. Solid void analysis 2024

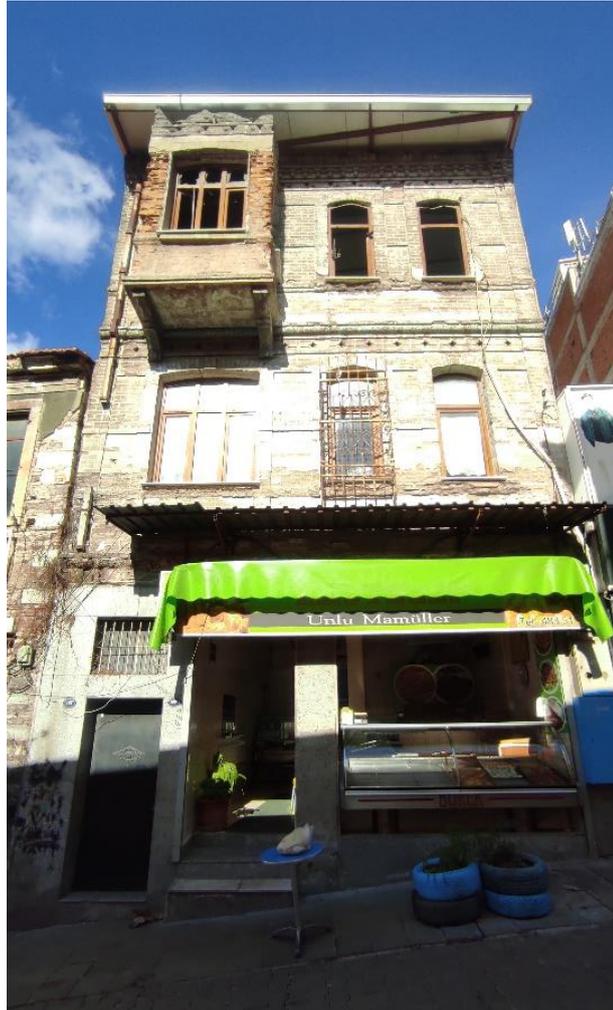
Figure 4.62. Stone & brick masonry building example, Block 189, Lot 4

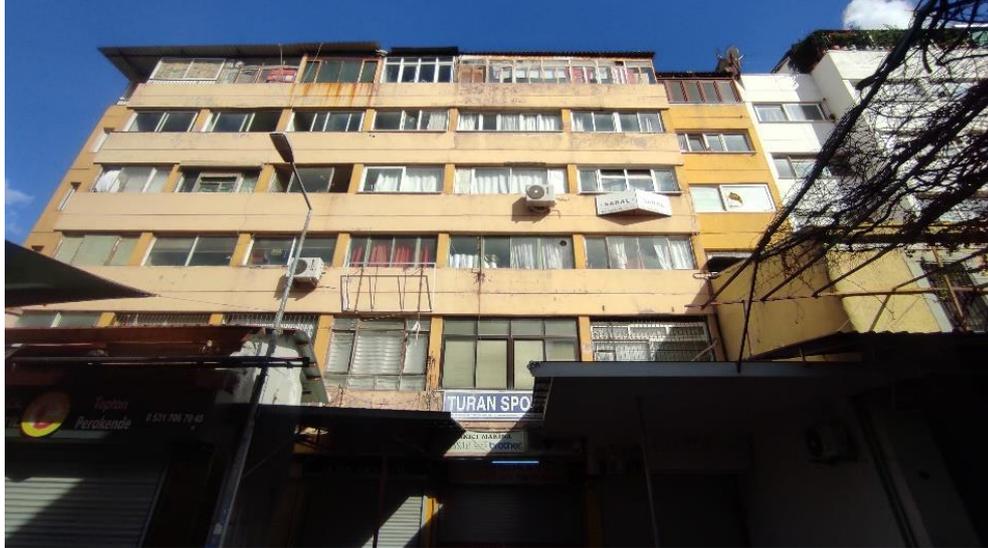
Figure 4.63. Reinforced concrete building example, Block 2381, Lot 142

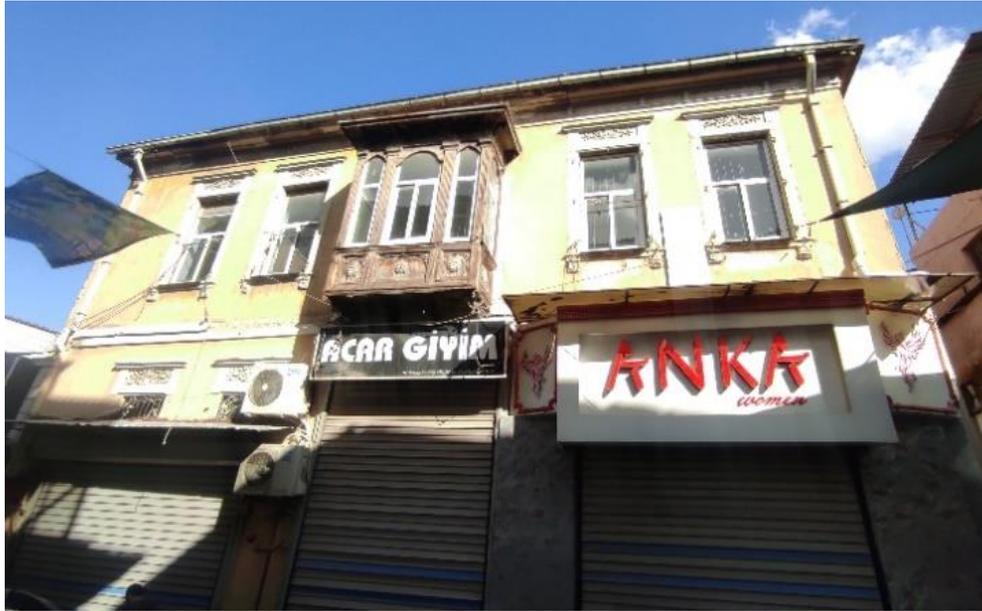
Figure 4.69. Example of a building built before 1930 and in moderate condition,
Block 3639, Lot 8

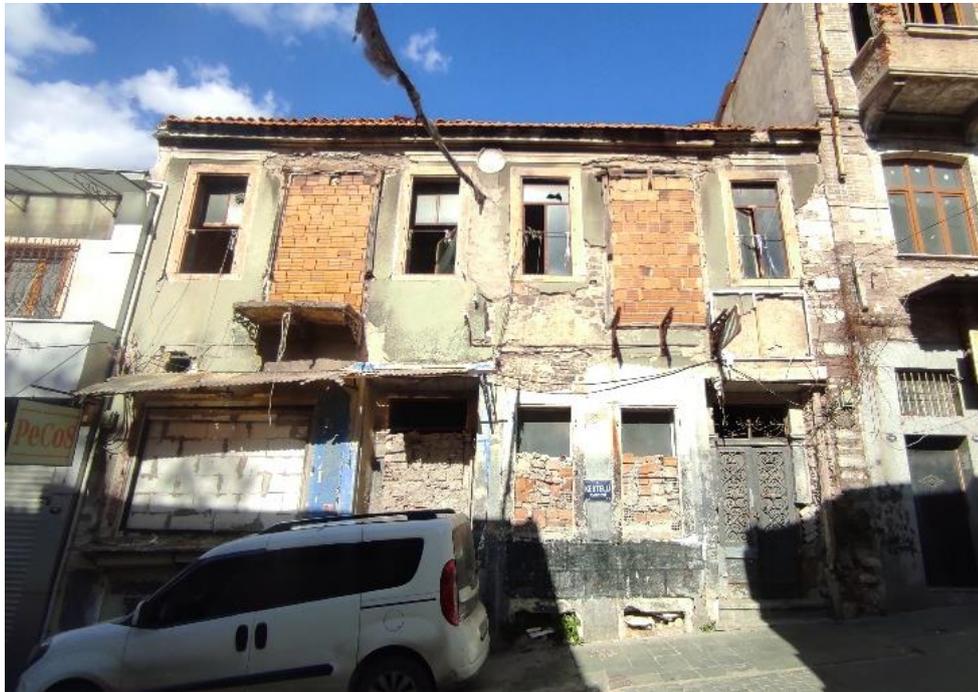
Figure 4. 70. Example of a building built before 1930 and in poor condition,
Block 184, Lot 5&6

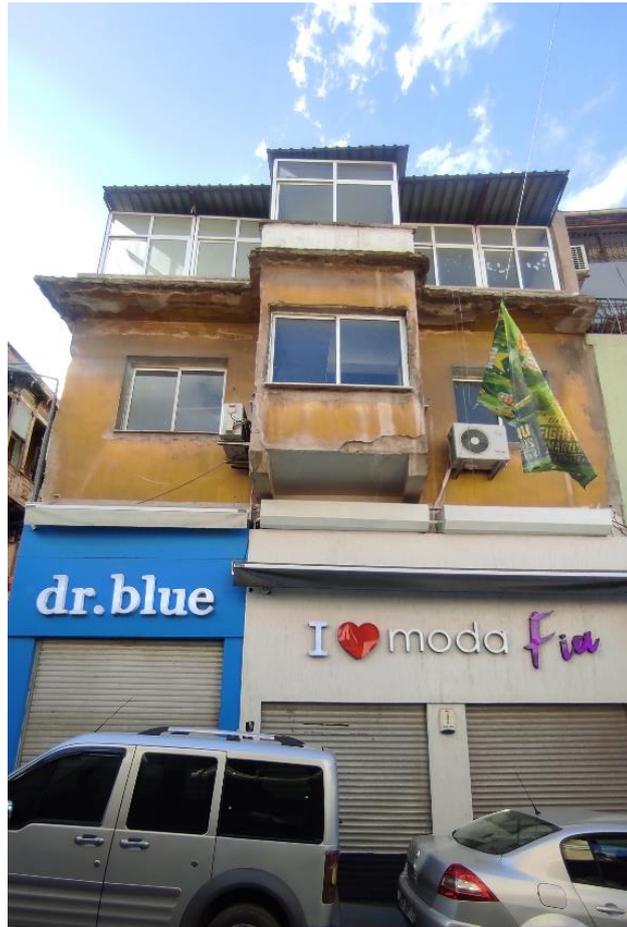
Figure 4.73. Example of a building built between 1975-2005 and in poor condition,
Block 184, Lot 31

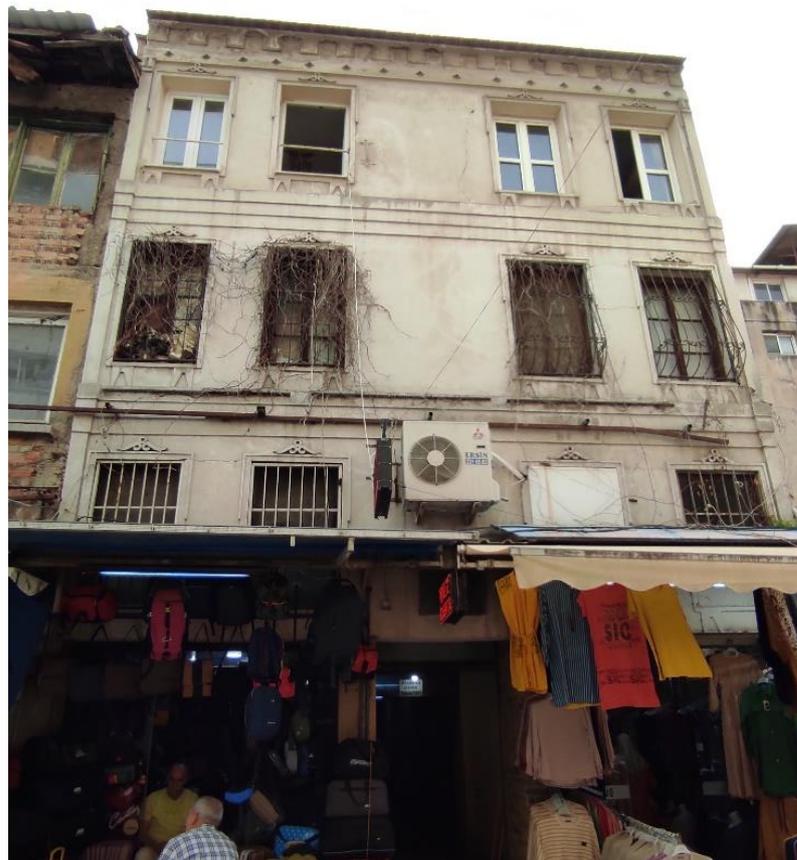
Figure 4.78. Example of a building with floor and roof cornices, Block 187, Lot 58

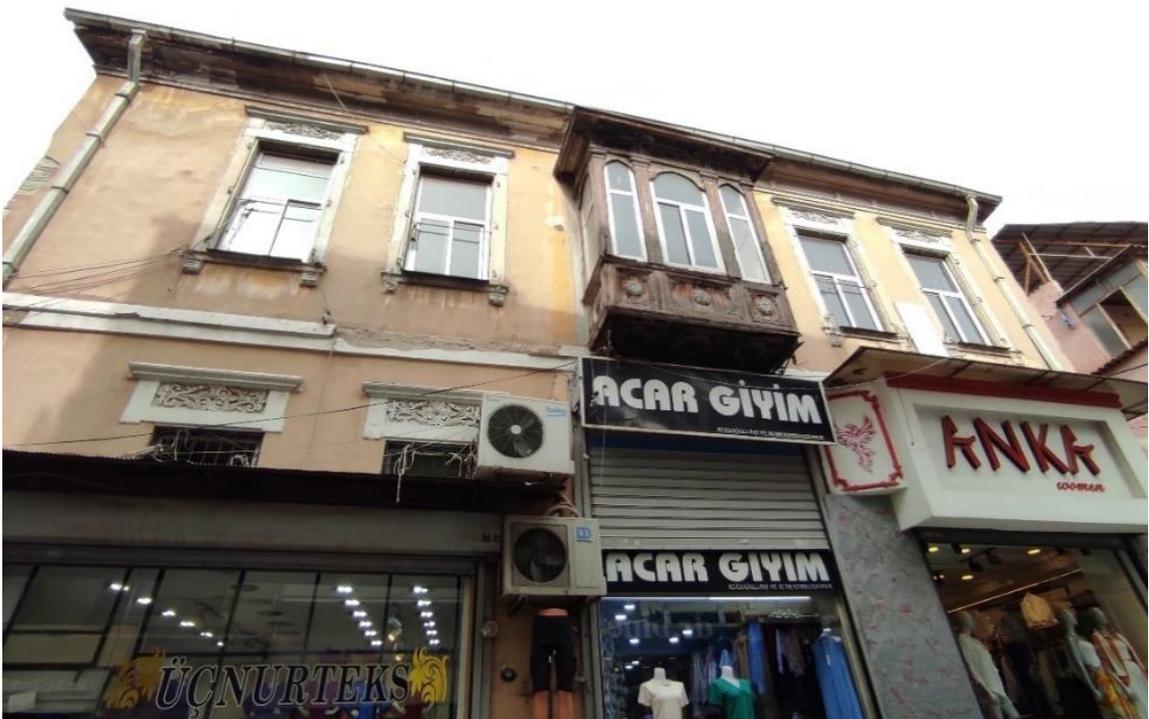
Figure 4.79. Example of a building with window jamb ornaments, Block 3639, Lot 8

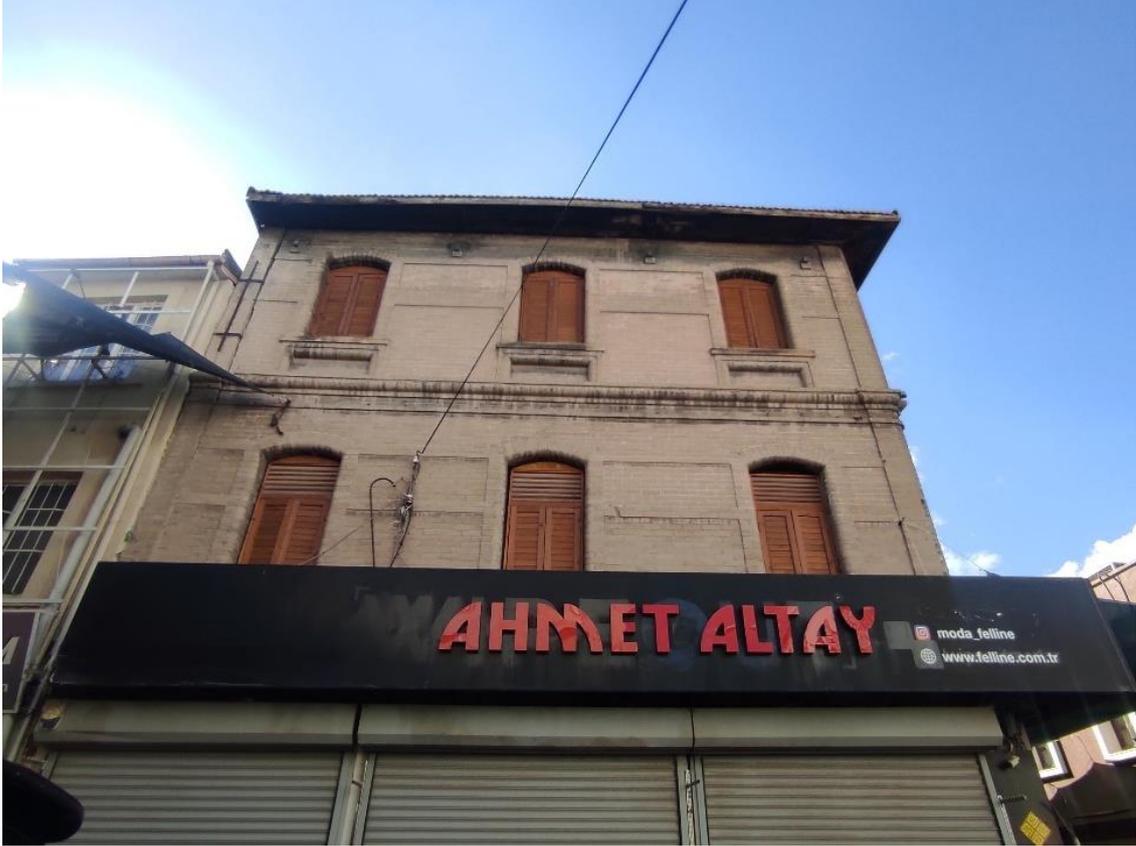
Figure 4.80. Example of a building with stone pilasters, Block 186, Lot 24
