**PHYSICAL TRANSFORMATION OF HISTORIC
BUILT ENVIRONMENT:
THE CASE OF KESTELLI STREET**

**A Thesis Submitted to
the Graduate School of
Izmir Institute of Technology
in Partial Fulfillment of the Requirements for the Degree of**

in Conservation and Restoration of Cultural Heritage

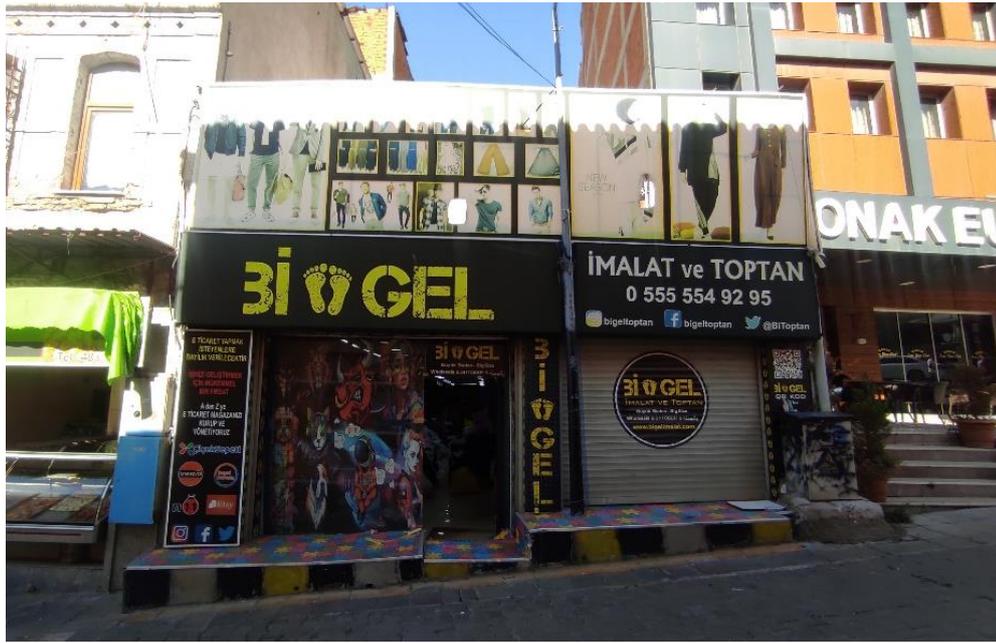
Figure 4. 83. Example of a building with signboards and mechanical shutter, Block 189, Lot 3

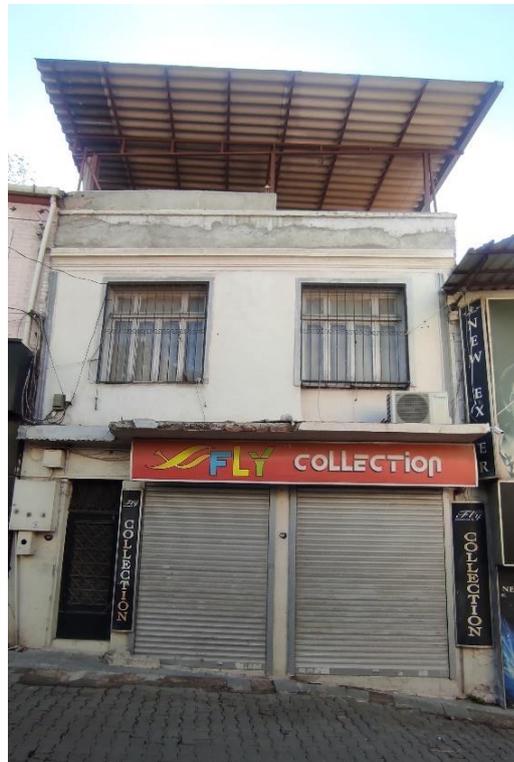
Figure 4.84. Example of a building with ondulin eave and air conditioning unit, Block 119, Lot 11

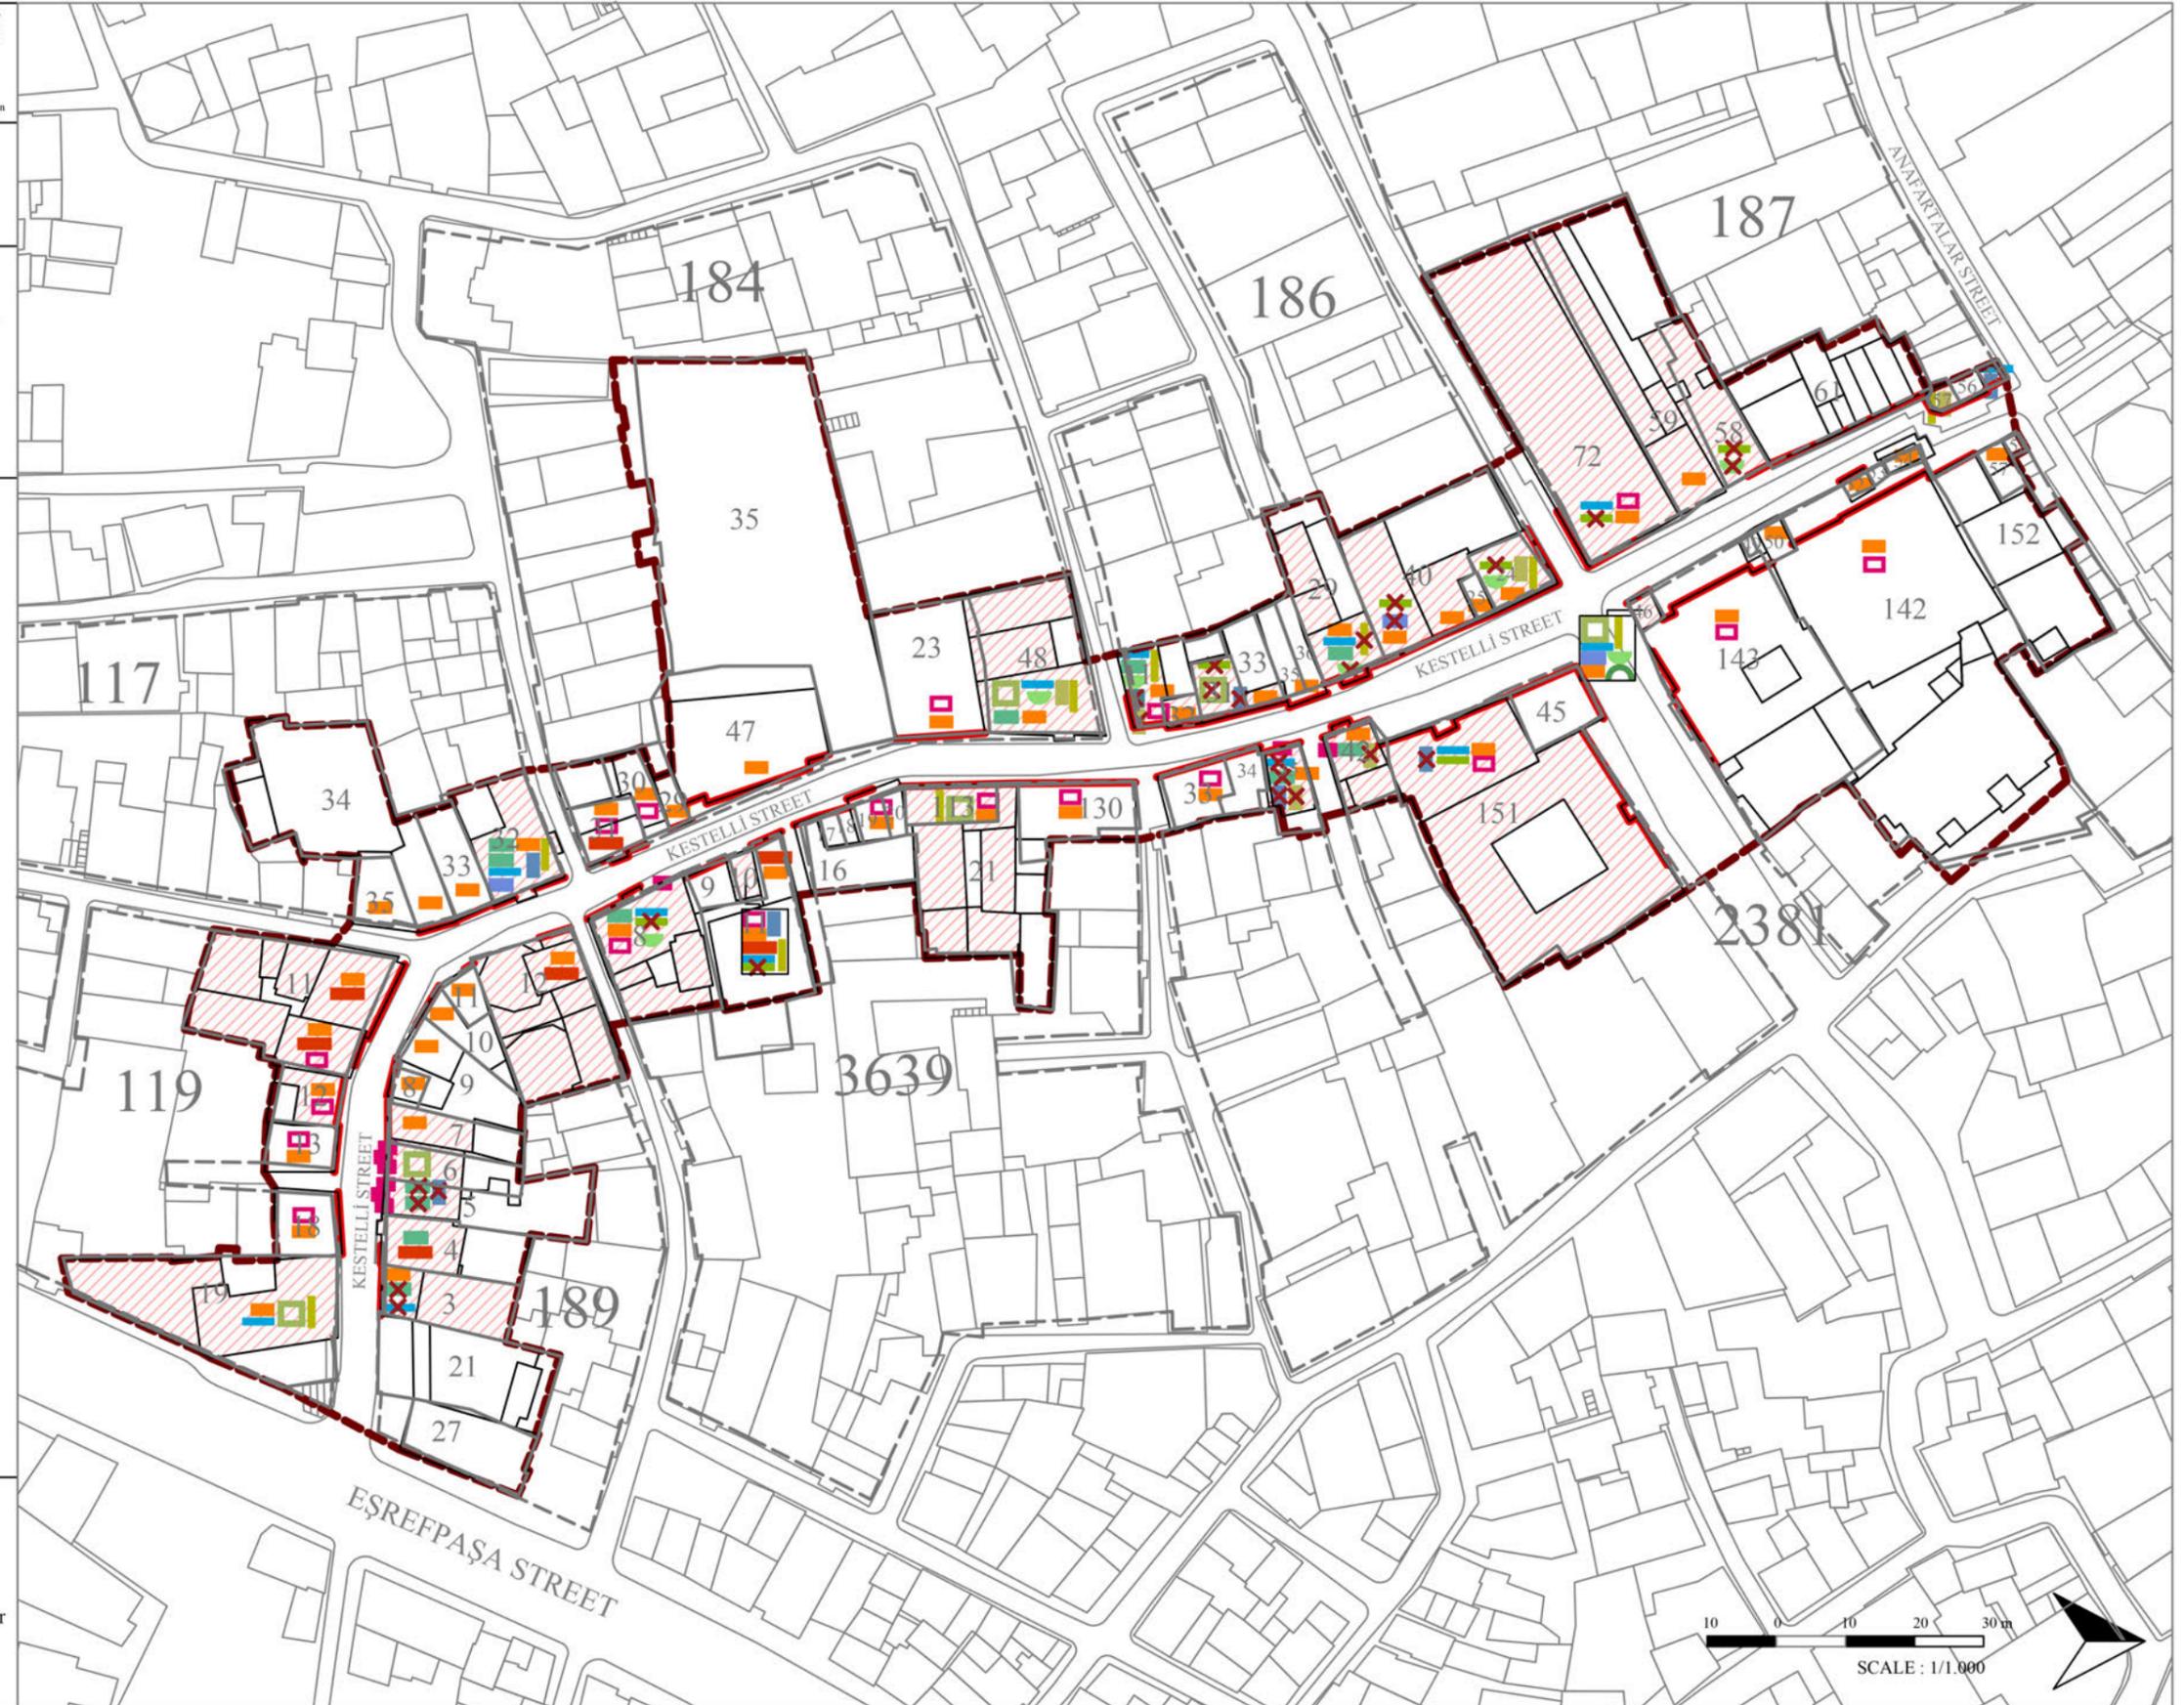
Figure 4.85. Architectural elements analysis

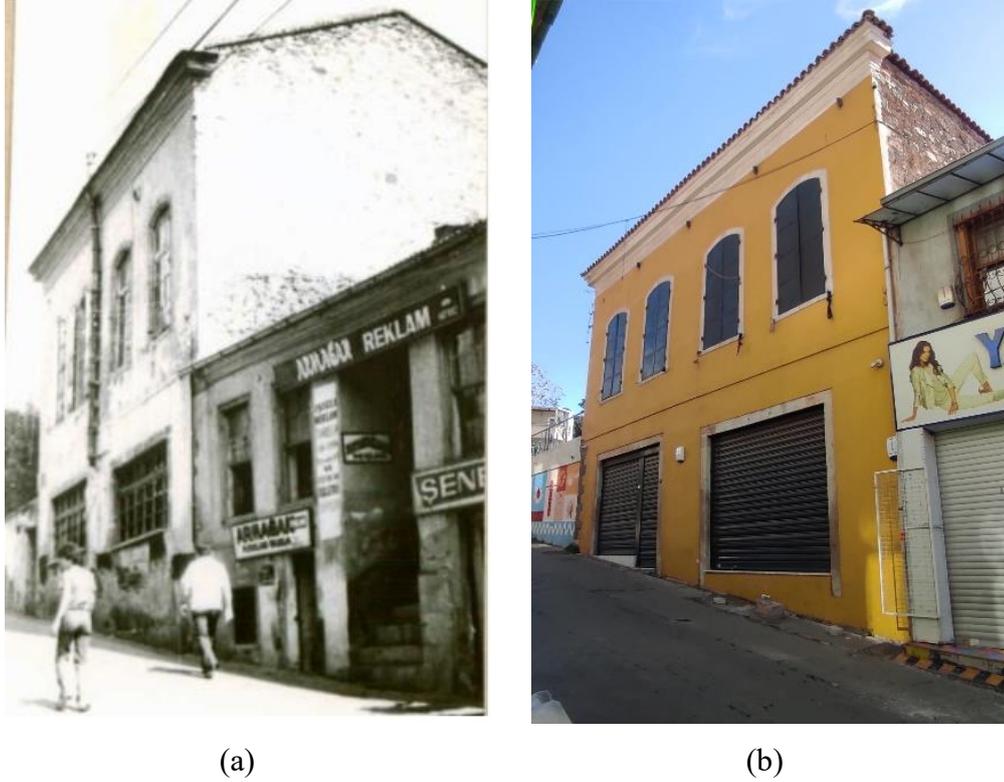
Figure 5.31. Original facade organization example, Block 119, Lot 19 north facade (a) original facade of the building, 1981 (Source: Izmir No. 1 Cultural Heritage Conservation Regional Board Directorate, 1981), (b) After restoration, 2024

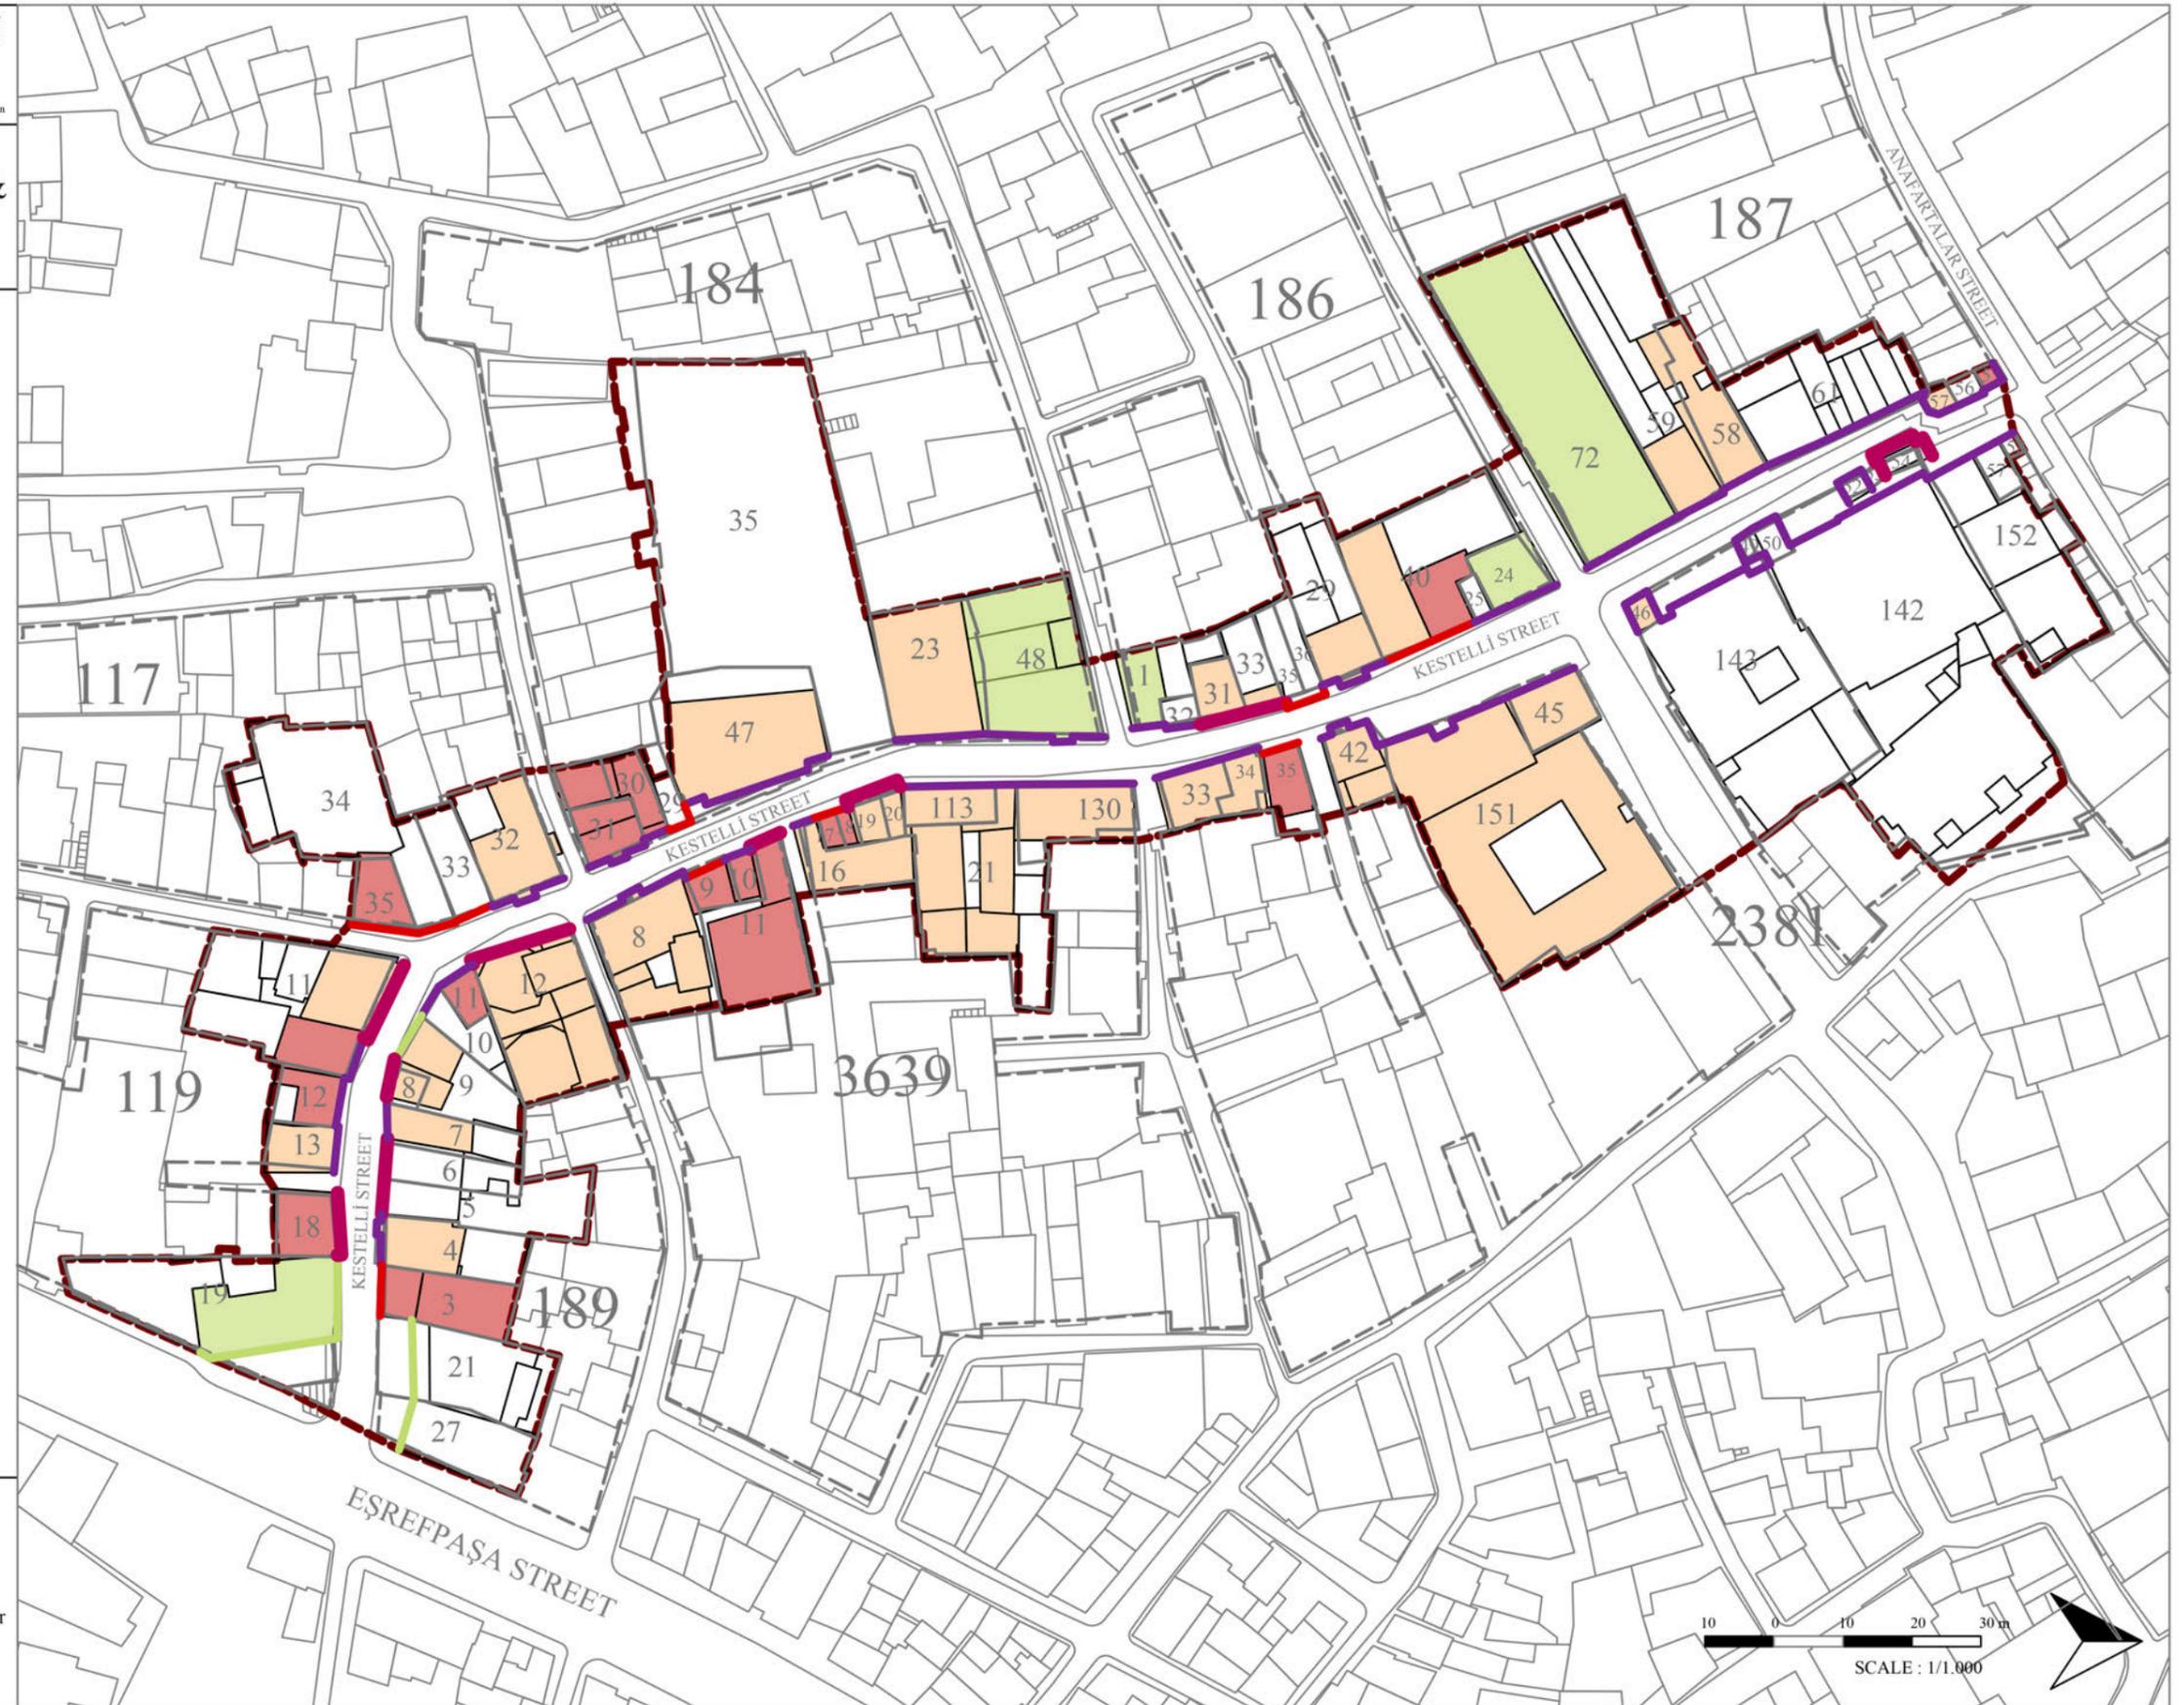
Figure 5.35. Interventions & renovations analysis
