# **CHARACTERISTICS OF COURTYARDS OF TRADITIONAL HOUSES IN KURTGAZI, BİRGİ**

**A Thesis Submitted to  
the Graduate School of  
İzmir Institute of Technology  
in Partial Fulfillment of the Requirements for the Degree of**

**in Architectural Restoration**

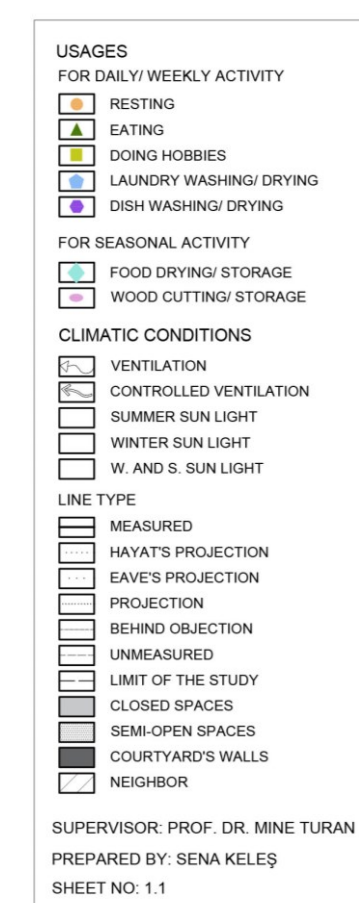
Figure 2. Legend of the drawings (Source: Prepared by Author 2024)

Prof. Dr. Mine Turan, and aerial photos from the archive of the Ministry of National Defense General Directorate of Mapping. The areas of the courtyards and related spaces were noted for their current and authentic states. The usages of the spaces for their daily or weekly activities were classified as resting, eating, doing hobbies, laundry washing and drying, dishwashing and drying. For seasonal activities, it was classified as food drying and storage, and wood cutting and storage. The schemes of natural ventilation and natural illumination were mapped on the plans and sections based on observations and also controlled ventilation was mapped based on position of gates and elevated roofs (Figure 2) (Figure 3).

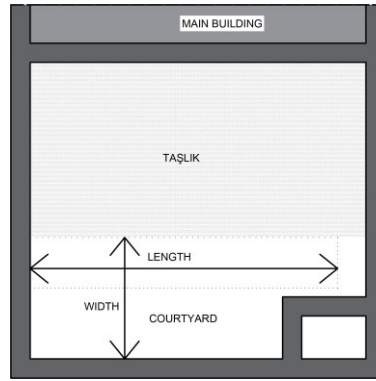
Figure 4. The width and length (Source: Prepared by Author 2024)

Length is the long edge of the courtyard and width is the short edge of the courtyard. The ratios of lengths to widths are calculated by dividing the length of each courtyard by its width. In the calculations, the boundaries of the transition from open space to semi-open spaces were determined as the courtyard boundary: the beginning of *taşlık* and entrance eaves etc. (Figure 4).

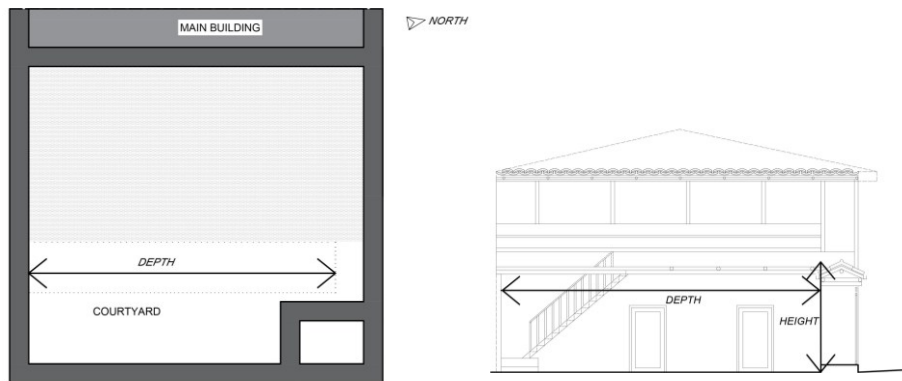
Figure 5. The depth and height (Source: Prepared by Author 2024)

Depth is the perpendicular distance from the southern courtyard wall to the northern boundary of the courtyard. Height corresponds to the height of the southern courtyard wall for the analysis of the natural illumination and the height of the northern courtyard wall for the analysis of the natural ventilation. The ratio of height to depth is calculated by dividing the height of the courtyard wall to the depth of the courtyard. In the calculations, the boundaries of the transition from open space to semi-open spaces were determined as the courtyard boundary: the beginning of *taşlık* and entrance eaves etc.(Figure 5).

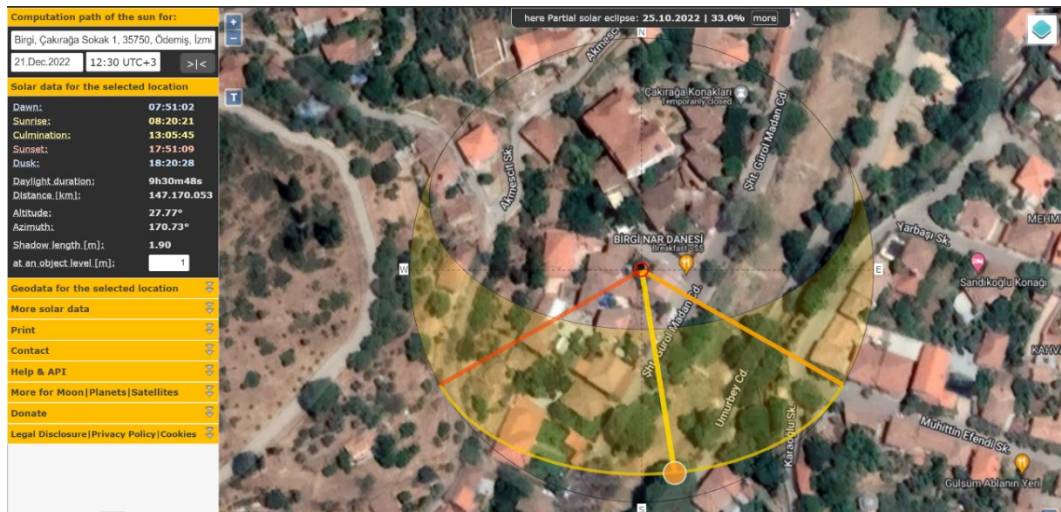
Figure 6. Solar data for the case 1 on 21<sup>st</sup> December at 12.30

The amount of natural illumination was calculated with respect to the orientation of the studied courtyards and azimuth and altitude values. The portion exposed to direct sunlight in the mornings (08.30 AM) and the noons (12.30 PM) during winters and summers for each courtyard was calculated with respect to altitude and the length of the shadow. In winters, sunlight reaches at a more horizontal angle than in summers so the value of the altitude is less in winters than in summers. The azimuth and the altitude values and shadow lengths were taken from Sun Calculator (2022). (Figure 8).

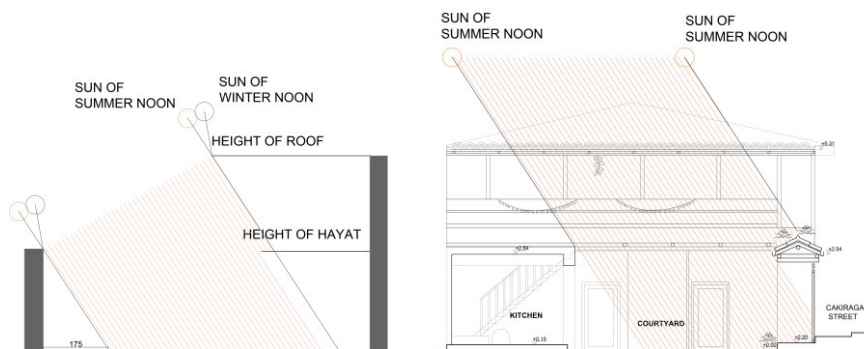
Figure 10. Shadow's length in sections in case 1 (Source: Prepared by Author 2024)

The illuminated area on the ground of courtyards and *taşlıks* was measured according to information on the orientation of the sun and the shadow's length on the objects (courtyard walls, roofs, eaves, etc.). The area of the shadow was measured according to objects in sunlight and their height, and the illuminated area was measured by using sections and plans (Figure 10) (Figure 11). The illuminated area is calculated and divided by the total area for each courtyard for the current and authentic states of the cases (Figure 12).

The shadow's length depends on the height of the object, which is at the sun's direction, and azimuth and altitude values. The shortest shadow's length is in summers at noon: if the object is 1 meter high, the shadow's length is 0.31 meters. The longest shadow's length is in winters in morning: if the object is 1 meter, the shadow's length is 50.88 meters. The shadow's length was measured by using shadow's length information from the Sun Calculator (Figure 9).

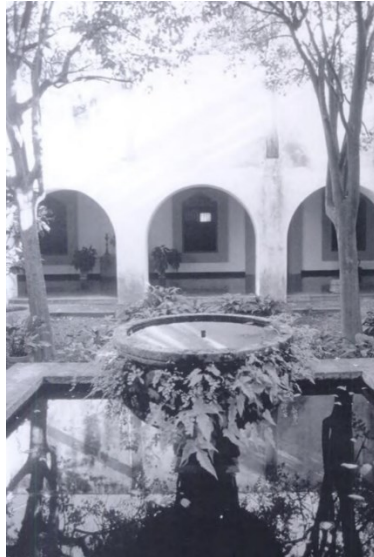
Figure 13. A courtyard of a house in Spain (Reynolds 2001)

In Spain, the courtyards are located in the traditional settlements with an organic street layout. There are water elements such as fountains and wells, flowerpots, and fruit trees in these courtyards. Water has roles such as providing coolness, freshness and naturalness. The courtyard is used as a resting area. Its ground is covered with white marble, and it reflects daylight. The courtyard walls are plastered and painted (Reynolds 2001) (Figure 13).

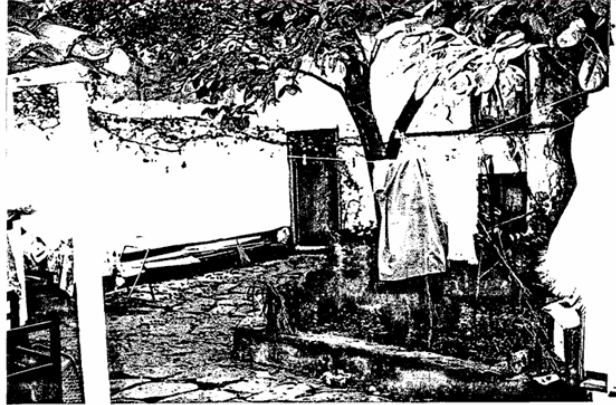
Figure 14. A courtyard in Bursa (Erdoğan, 1996)

In the Anatolian traditional houses, built before the Ottoman modernization are introverted and organized around their courtyards traditional houses are positioned on sloping lands by terracing. The main materials of the houses are stone and wood found in the region. Traditional houses were built with a sustainable design approach, with the ability to be dismantled and rebuilt (Sümerkan 1990). It is designed to be open to nature and water elements were used in the courtyards. The traditional courtyards are entered through a wooden gate finished with tiles. The courtyard walls are made of rubble and stone, and the courtyard floor is covered with indigenous material which is slate. There are plants in the courtyard. Units such as the kitchen, storage barn and laundry are located

around the courtyard. Activities such as sitting, resting, drying food, drying laundry and cooking take place here throughout the year (Kuban 1995) (Figure 14).

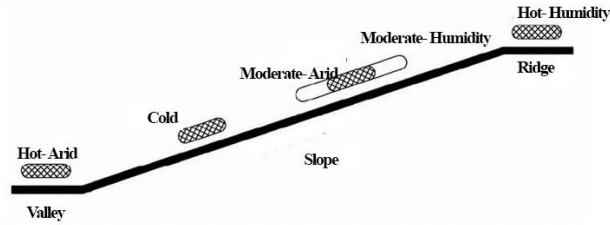
Figure 15. Climate altitude relations Source: Revised from (Zeren 1978)

1978). The extent of the sun's impact on the land surface depends on the altitude (Figure 15) (Gregersen 2024).

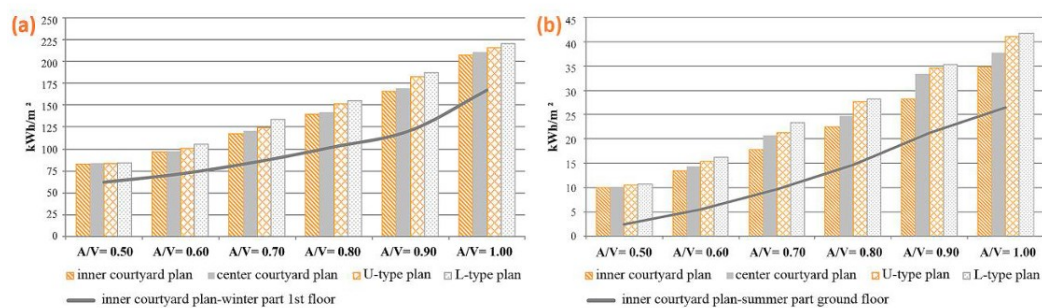
Figure 17. Cooling and heating loads in courtyards which have different forms for (a) winter and for (b) summer (Kocagil and Oral 2015)

Among the courtyards, possessing the same heights and same floor areas; heating and cooling loads increase as the ratio of the total surface area (A) that loses heat to the total volume (V) that is sheltered within the building increases. When with L-planned, U-planned, inner and center-planned courtyards are considered; the L-planned courtyards provide the highest heating and cooling loads. The inner ones provide the lowest heating and cooling loads (Kocagil and Oral 2015) (Figure 17).

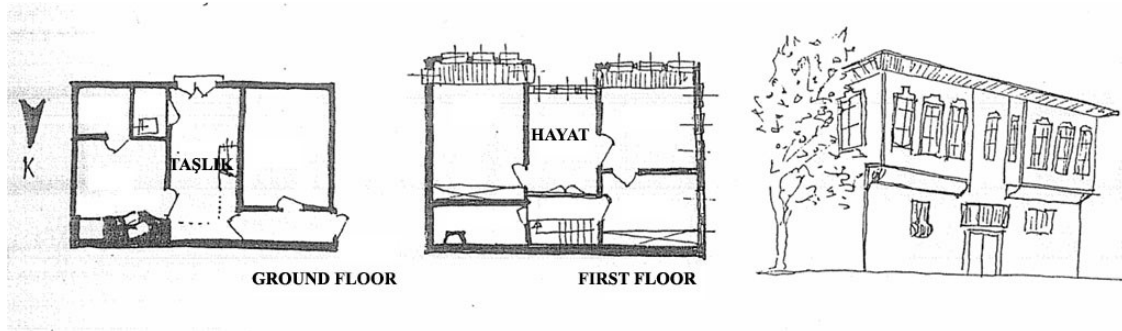
Figure 18. A house with *taşlık* Source: Revised from (Onat 1990)

In many of the *hayat* houses, the main building is positioned generally at the west of the lot. The upper floor is the elevated living place, and the rooms are open to the semi-open *hayat* with a view of the scenery. There is a kitchen and storage on the ground floor, and they are actively used in the winters, they have been located at the south of the building lots as much as possible (Figure 18). Similarly, they are actively used in the summers. The courtyard in between them is entered through a gate from the street (Onat 1990). Minimum heat gain is desired on hot days. In order to minimize energy losses, spaces that need to be hot during winter are located at the south (Nikolic 1983).

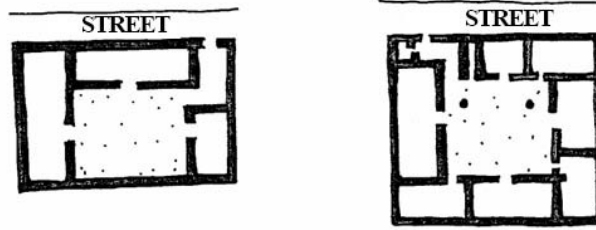
Figure 19. Plan of Morocco traditional houses

In Morocco, the courtyard was surrounded by closed spaces on all four sides and used as a kitchen, toilet and storage. Circulation between spaces and illumination of the rooms, kitchen, toilet and storage are provided from the courtyard. An inner courtyard design was preferred to protect it from sun and sandstorms. This also provides privacy for domestic life (Figure 19) (Schoenauer and Seeman 1962).

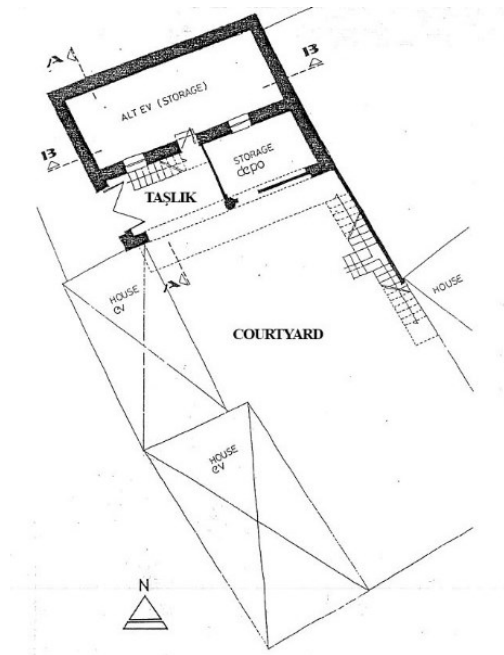
Figure 20. Lot organization in Tarsus

In Anatolia, the building is between two neighboring houses. The courtyard is at the back. The *taşlık* is reached from the street, through the courtyard and then to the *hayat* by timber stairs in the *taşlık*. There are storages on the ground floor, rooms are on the first floor, service elements such as kitchen, and toilet are on the mezzanine floor (Onat 1990) (Figure 20).

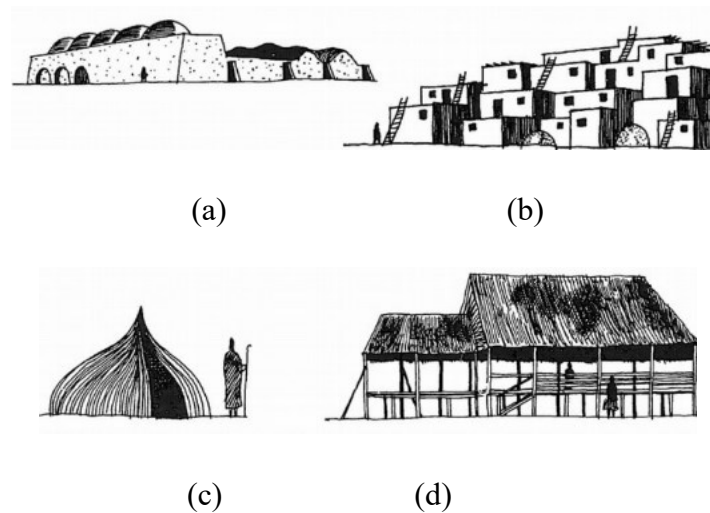
Due to the geographic, climatic, and cultural differences, even if the same material is used, it is used in different ways. The construction techniques make the designs authentic. In Arabia, stone and mud, which demand heavy walls structurally, are used. In Africa, palm logs and mud are used in huts. The structure of the hut is a wooden skeleton frame that carries a roof of wing, on top of which is a roof of beaten mud for the purpose of climatic control. (Figure 21) (Rapoport 1969).

Figure 21: Houses made of mud: (a) Iran and (b) United States , and wood: (c) Africa and (d) Amazon (Source: Revised from (Rapoport 1969))

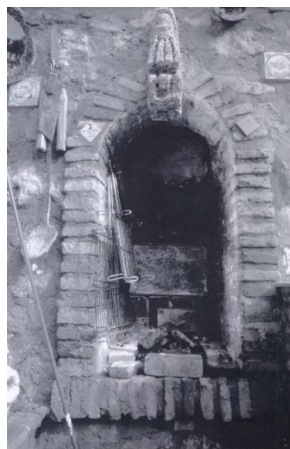
Figure 22. A fireplace in Spain (Reynolds 2001)

In Spain, fireplaces, fountains, plants, and furniture such as tables and chairs are the elements of the courtyards. Fireplaces radiate heat to the courtyard and heat it in winter, illuminate the courtyard with the light from the fire, and are used for cooking (Figure 22). They are in the wall and at the center of the courtyard. Fountains provide cooling in hot summer, and they add an aesthetic value. The courtyards are used as a kitchen, especially in hot summers. Some courtyards are used permanently as kitchens and there are sinks, fireplaces, and sideboards. Flowerpots and candlelights are on the wall (Reynolds 2001).

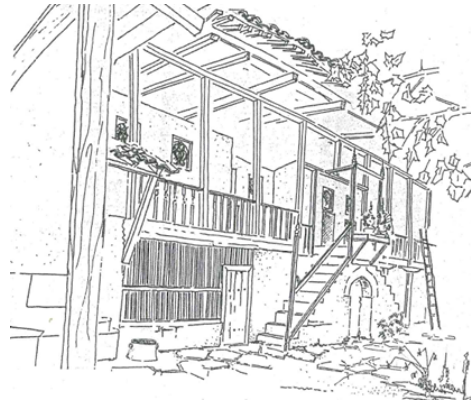
Figure 23. An Anatolian *hayat* house (Kuban 1995)

In Anatolian houses, according to daily activities such as eating, washing and drying laundry, washing and drying dishes, cooking, drying foods and meeting with neighbors, elements are added to the courtyards. Fountains, fireplaces, timber stairs, furnitures are the elements of the courtyards. Ceramic pots to store olive oil and foods are used on the ground floor (Erdoğan 1996). Generally, fountains, first steps of stairs, and fireplaces made of stone or brick are elements of the courtyards. Fireplaces are on the wall of the courtyards and the location of the fountains are dependent on the courtyard. The stairs could be outside the gallery or under its roof (Figure 23). The timber stair is provided access from the *taşlık* to the upper floors (Kuban 1995).

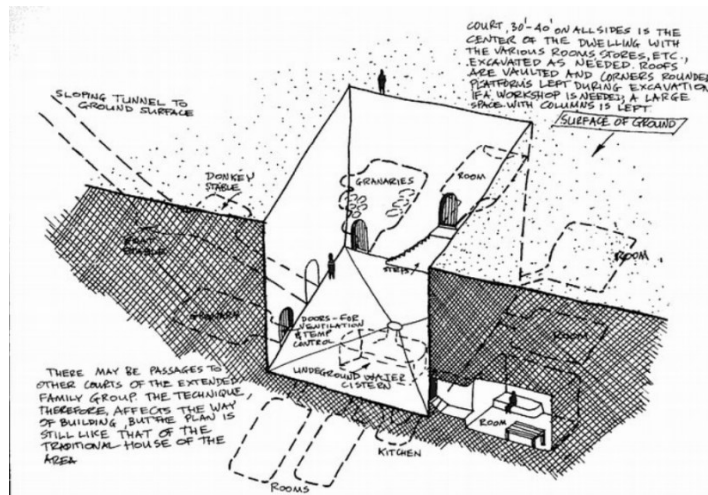
Figure 24. Cooling effects with water element (Rapoport 1969)

The use of plants and water in the courtyard has soothing and cooling effects in a hot and dry environment and helps provide an outdoor living space. In Southern Arabia, houses were built underground, so that rooms and courtyards are under a layer of earth. The courtyard acts as a cooling ground and alters the microclimate by lowering ground temperatures and radiation and evaporating water. There is cross ventilation between rooms and outside the courtyard because the high courtyard walls act as a chimney (Rapoport 1969) (Figure 24).

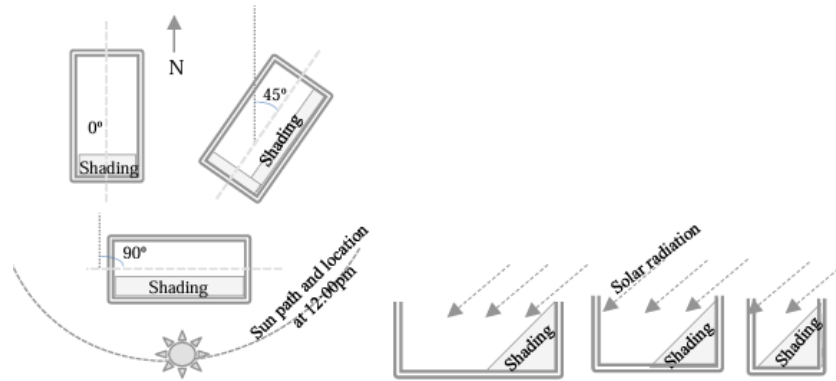
Figure 25. The illumination and shading area (Al-Hafith et. al. 2017)

The natural illumination can be maximized by increasing the width to the length ratio of the courtyard and when the long axis is along the North-South direction (Al-Hafith et. al. 2017) (Figure 25).

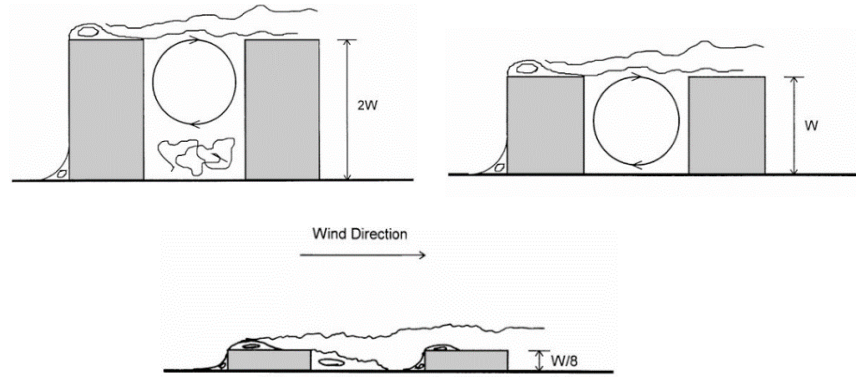
Figure 26. Wind effects to the courtyards (Hall et. al. 1998)

The ratio of the height of the courtyard wall to the width of the courtyard (H/W) should be between 0.3 and 1 to ensure normal natural ventilation. It has been determined that in examples where the wall height is the same or greater than the width of the courtyard, recirculation currents occur in the courtyard and the air flows are fast (Hall et. al. 1998) (Figure 26). For short courtyards, and isolated standing flow is formed, while for more elongated courtyards the flow submerges at one end and surfaces at the other end (Moonen et. al. 2011) (Figure 27).

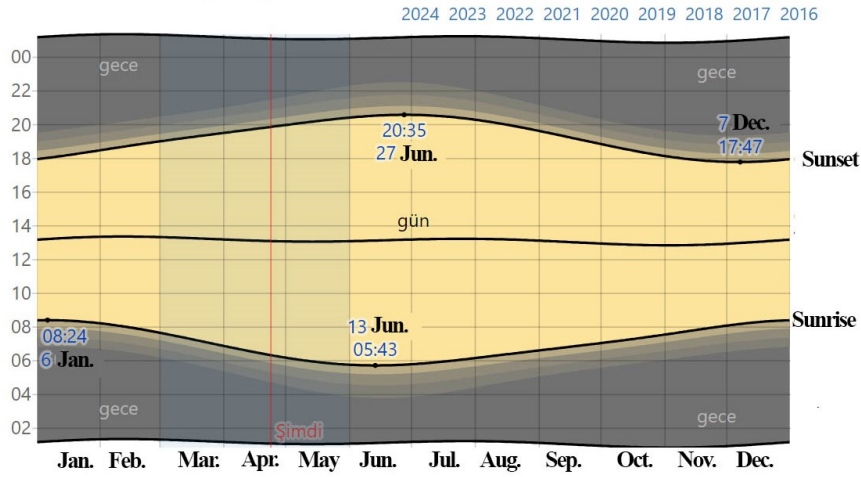
Figure 29. Day length throughout the year in Birgi

The shortest day in Birgi is on December 21<sup>st</sup> with 9 hours and 30 minutes of daylight, while the longest day is on June 21<sup>st</sup> with 14 hours and 50 minutes of daylight (Figure 29).

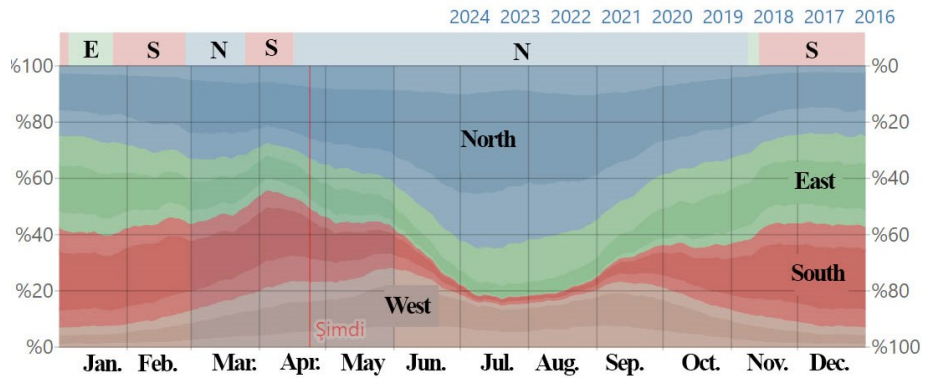
Figure 30. Wind direction in Birgi (Source: Revised from (Weatherspark 2024))

In Birgi, the wind blows from the north most of the time of the year. The wind generally blows from the east for 2.9 weeks: from January 5<sup>th</sup> to January 25<sup>th</sup> and from November 8<sup>th</sup> to November 13<sup>th</sup>, with the highest rate of 34% on January 9<sup>th</sup>. The wind generally blows from the south for 1.1 months: from January 25<sup>th</sup> to February 27<sup>th</sup>, from March 25<sup>th</sup> to April 16<sup>th</sup> for 3.1 weeks, and from November 13<sup>th</sup> to January 5<sup>th</sup> for 1.7 months, with the highest rate of 35% on February 19<sup>th</sup>. The wind generally blows from the north for 3.9 weeks from February 27<sup>th</sup> to March 25<sup>th</sup> and for 6.7 months from April 16<sup>th</sup> to November 8<sup>th</sup>, with the highest rate of 35% on July 16<sup>th</sup> (Weatherspark 2024). Especially the north wind is the prevailing wind in summer and the south wind is the prevailing wind in winter (Figure 30).

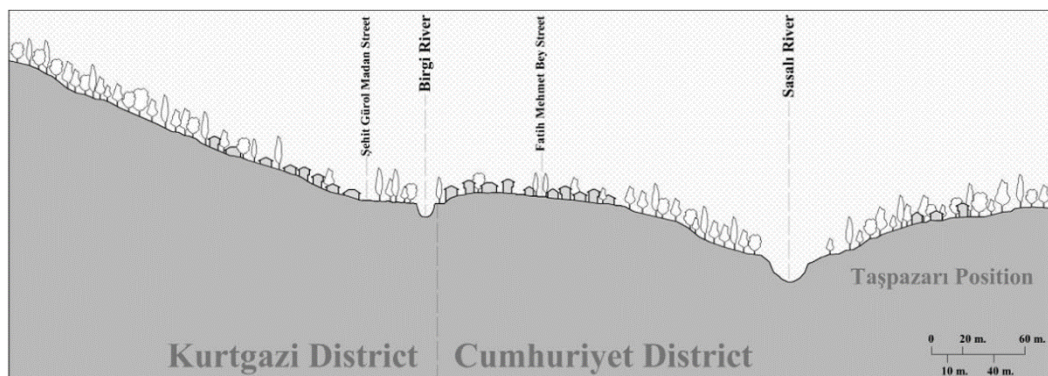
Figure 31. Section of the Birgi Settlement (Diri 2010)

Birgi settlement is limited by slopes of up to 50% at its Northwest- Southeast ends. There are two types of urban texture in Birgi: organic and grid-iron. Kurtgazi district has organic urban texture. The streets in Kurtgazi are narrow and sloping. The land slope in the *Kurtgazi* district varies between 4 to 33% at the Northwest–Southeast direction (Google Earth 2024) (Figure 31).

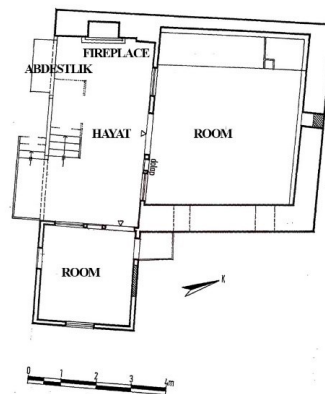
Figure 35. First floor plan in a Birgi house (Source: Revised from (İşeri 1998))

walls are stone masonry, which is made with rubble stone, slate stone, river stone, brick and tile pieces. First floor walls are in timber frame system, and they have semi-open space, which is called *hayat*. The *hayat* is open to the courtyard. It was designed with *abdestlik* and fireplace (İşeri 1998). It is used as a kitchen and *abdestlik* is used as a cupboard and sink of the kitchen. *Abdestlik* is made of wood, and it has a shelf. It is located on the balustrade and in the courtyard direction of the *hayat*. Dishes are washed and water flows directly to the courtyard (Figure 35) (Diri 2010).

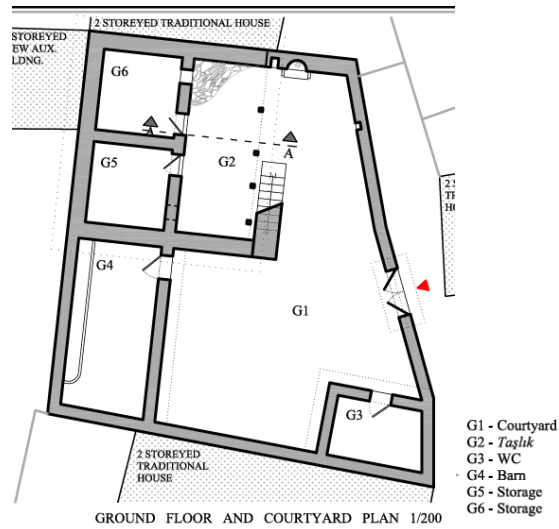
Figure 36. Ground floor plan in a Birgi house (Source: Revised from (Diri 2010))

The connection between the ground floor and the first floor was ensured with timber stairs in the *hayat*. The connections between the courtyard and the house ensure with *taşlık*. It calls *taşlık* because its ground is covered with stone. The *taşlıks* are another semi-open space on the ground floor. The ground covering of the *taşlık*, and the ground floor spaces are slate stone, which is indigenous material in Birgi (İşeri 1998). The *taşlıks* designed also as service spaces connected with kitchens, courtyards, toilets, barns, storage, and animal sheds, and it connected by timber stairs to the main floors. It has fountains, pools, wells and fireplaces (Kuban 1995) (Ekinci 2005). Olive oil, water and grain are stored in clay pots in the storage (Keleş 2022). The functions of the *taşlık* are eating and resting (Uzel and Türkoğlu 1991). The courtyard is open spaces of Birgi houses. The ground covering of the courtyard is earth or slate stone. The courtyard is designed isolated from the street and neighbors. The elements of the courtyards such as fireplaces, fountains, animal sheds and toilets are along the sides (Figure 36) (Figure 37) (Diri 2010).

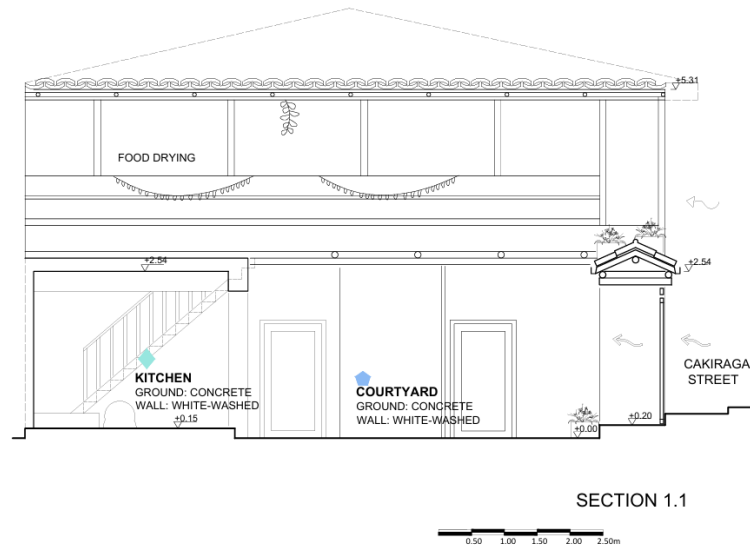
Figure 40. Section of the case 1 in the current state  
(Source: Prepared by Author 2022)

The courtyard is directly accessed from the Çakırağa street and the entrance of the courtyard is from the north (Figure 40). The circulation system is from the street to the courtyard through a gate, then to the *taşlık* and finally to the closed spaces.

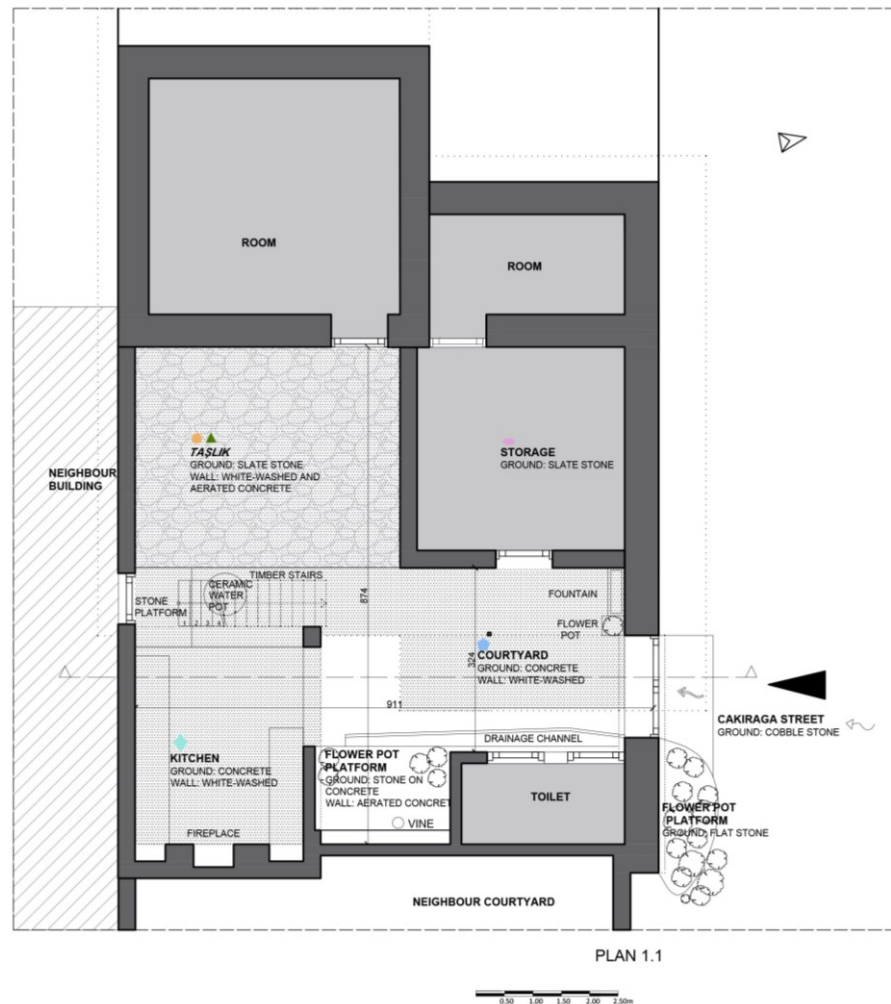
Figure 41. Ground Floor Plan of the case 1 in the current state  
(Source: Prepared by Author 2022)

at the interior. A timber roof with tile finishing crowns the wooden gate (Figure 41). The gate is kept open for increasing the air flow throughout the day in summers. There is a flowerpot, which is made with slate and rubble stones as well, next to the gate.

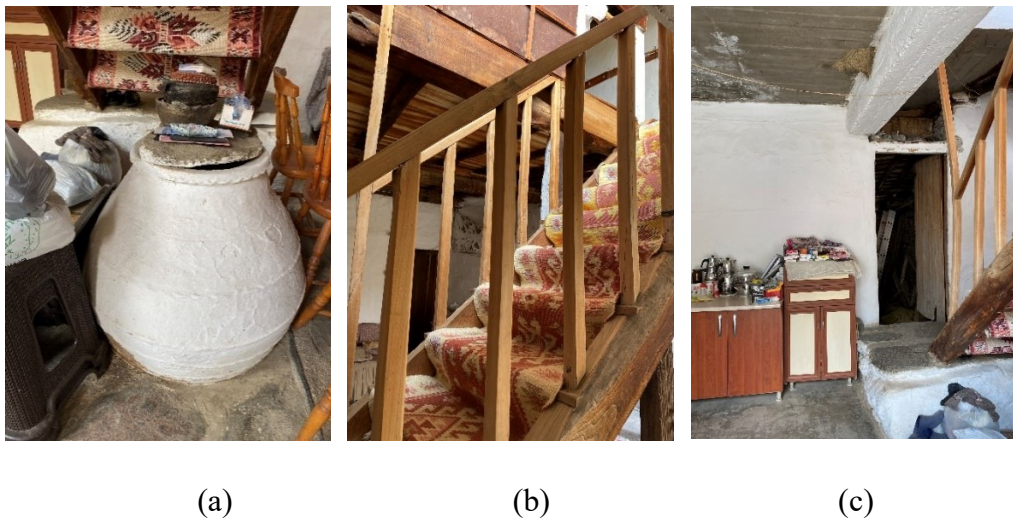
Figure 42: (a) Authentic pot, (b) authentic timber stairs and (c) authentic stone steps  
(Photos taken by Author 2022)

There are authentic elements such as a ceramic pot (which is used to store olive oil, water and grain, it is used as a decorative element at present), timber stairs, and stone steps (Figure 42). Contemporary furniture like couches, a table, chairs, stools and cupboards are also present in the *taşlık*. Resting and eating are the functions of *taşlık*.

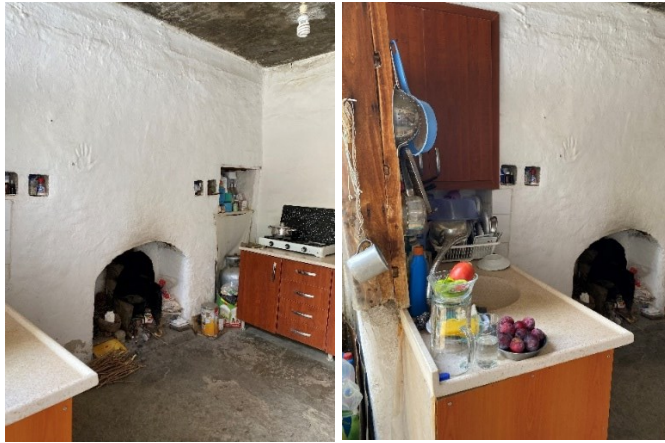
Figure 43. The contemporary a fireplace (left) a sink (right)  
 (Photos taken by Author 2022)

There is a kitchen (11 m<sup>2</sup>) at the south of the courtyard. The area of the courtyard decreased after the kitchen was added. The ground covering of the kitchen is concrete. The walls of the kitchen are plastered and white-washed. There are contemporary elements such as a fireplace, a sink and cupboards in the kitchen (Figure 43). Washing and drying dishes, and cooking are the functions realized in the kitchen (Figure 44) (Figure 45).

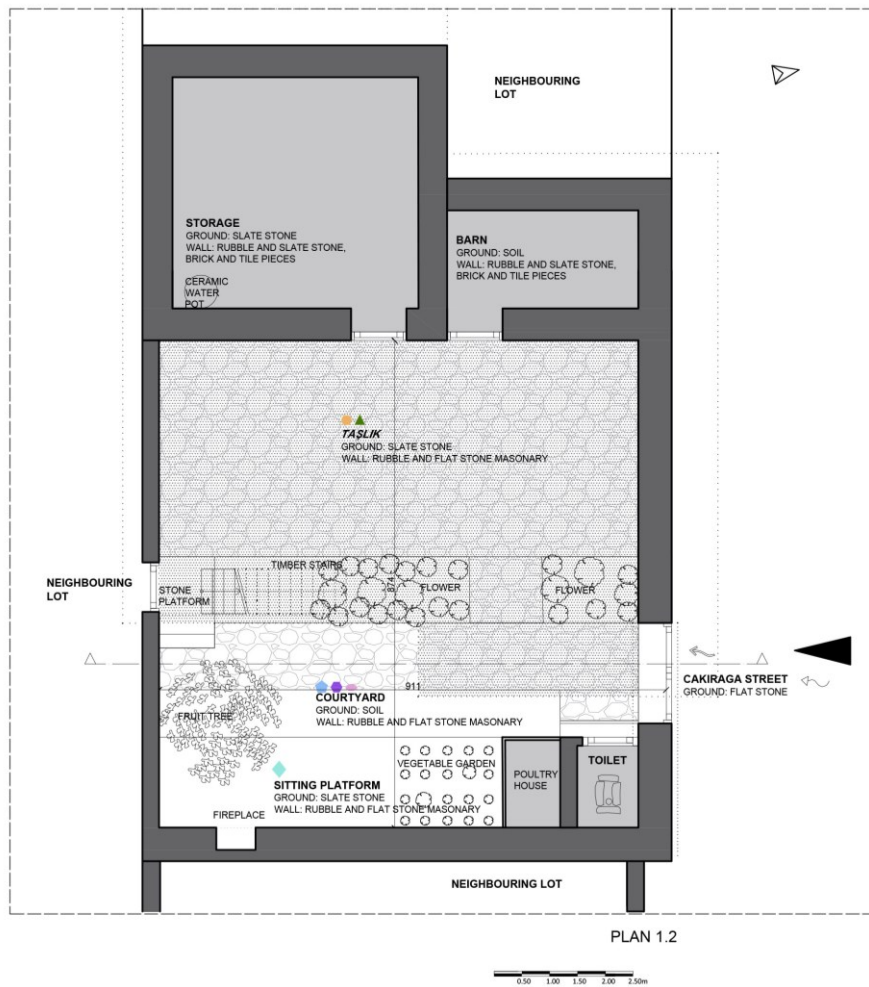
Figure 44. Ground floor plan of the case 1 in the authentic state  
 (Source: Prepared by Author 2022)

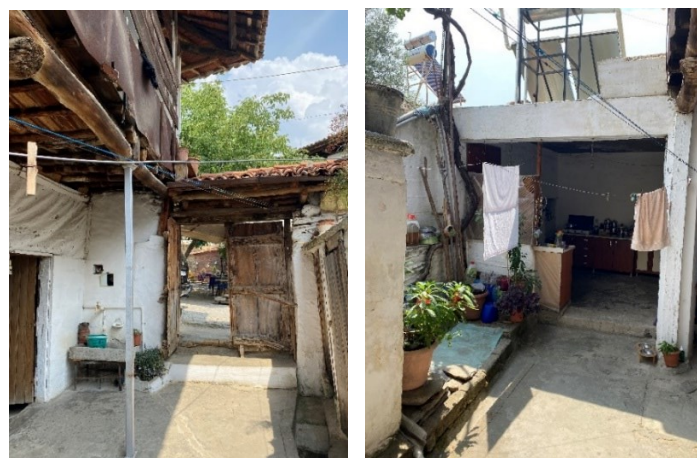
Figure 46. The courtyard of the case 1 (Photos taken by Author 2022)

There is a toilet at the east of the courtyard. There is a drainage channel in front of the toilet. It collects rainwater or water after the toilet and the courtyard are washed. The wall of the toilet is plastered and white-washed (Figure 46).

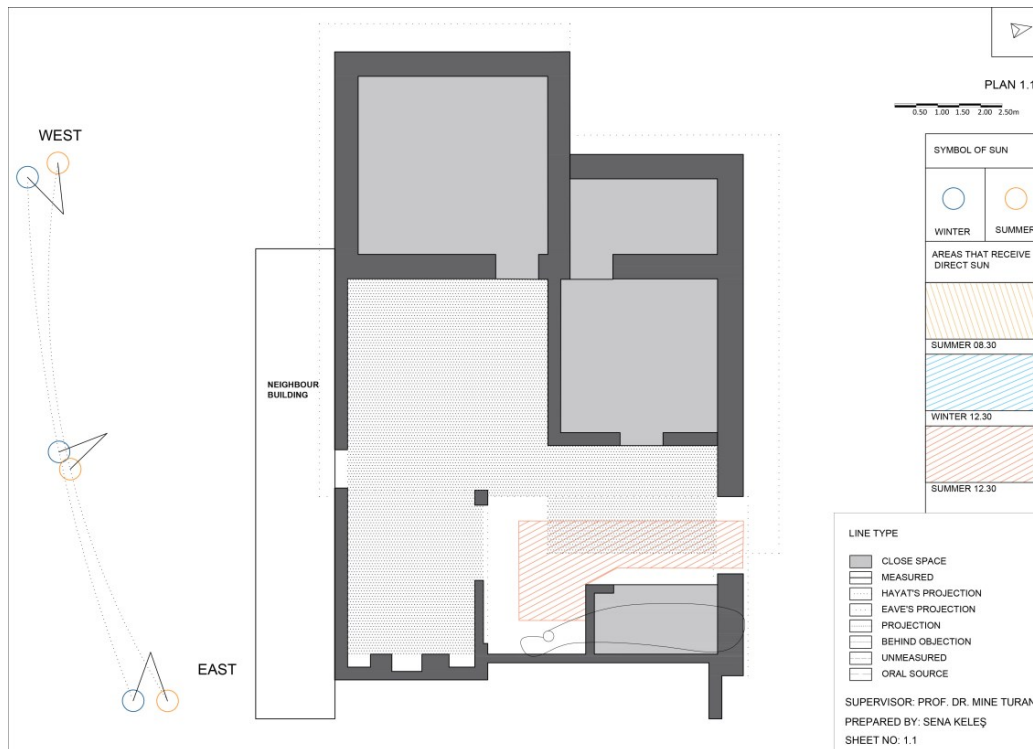
Figure 47. The amount of sunlight in the section and the plan for the current state in the case 1 (Source: Prepared by Author 2024)

The amount of the courtyard ground directly exposed to the sunlight today is 7.5 m<sup>2</sup> in the summer noons but it is not directly exposed to the sunlight in the winter noons and summer mornings because there is mass additions in the courtyard. The amount of the courtyard and *taşlık* grounds directly exposed to the sunlight was 17 m<sup>2</sup> in the summer noons and 9 m<sup>2</sup> in the winter noons before the mass additions (Figure 47). The amount of the courtyard and *taşlık* grounds directly exposed to the sunlight was 29 m<sup>2</sup> in the summer mornings before the mass additions. The courtyard ground was not exposed to the sunlight in the winter mornings today even before the mass additions because the length of the shadow of the courtyard wall is long in the winter (Figure 48) (Figure 49).

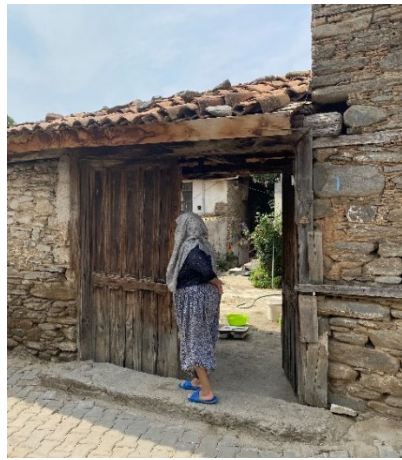
Figure 51. The entrance of the case 2 (Photo taken by Author 2022)

The courtyard wall is masonry out of rubble stone, slate stone, brick, tile pieces, and mortar plastered and painted from the inside of the courtyard. This gate has a wooden roof with tile finishing (Figure 51). There is a contemporary fireplace within the northeastern courtyard wall.

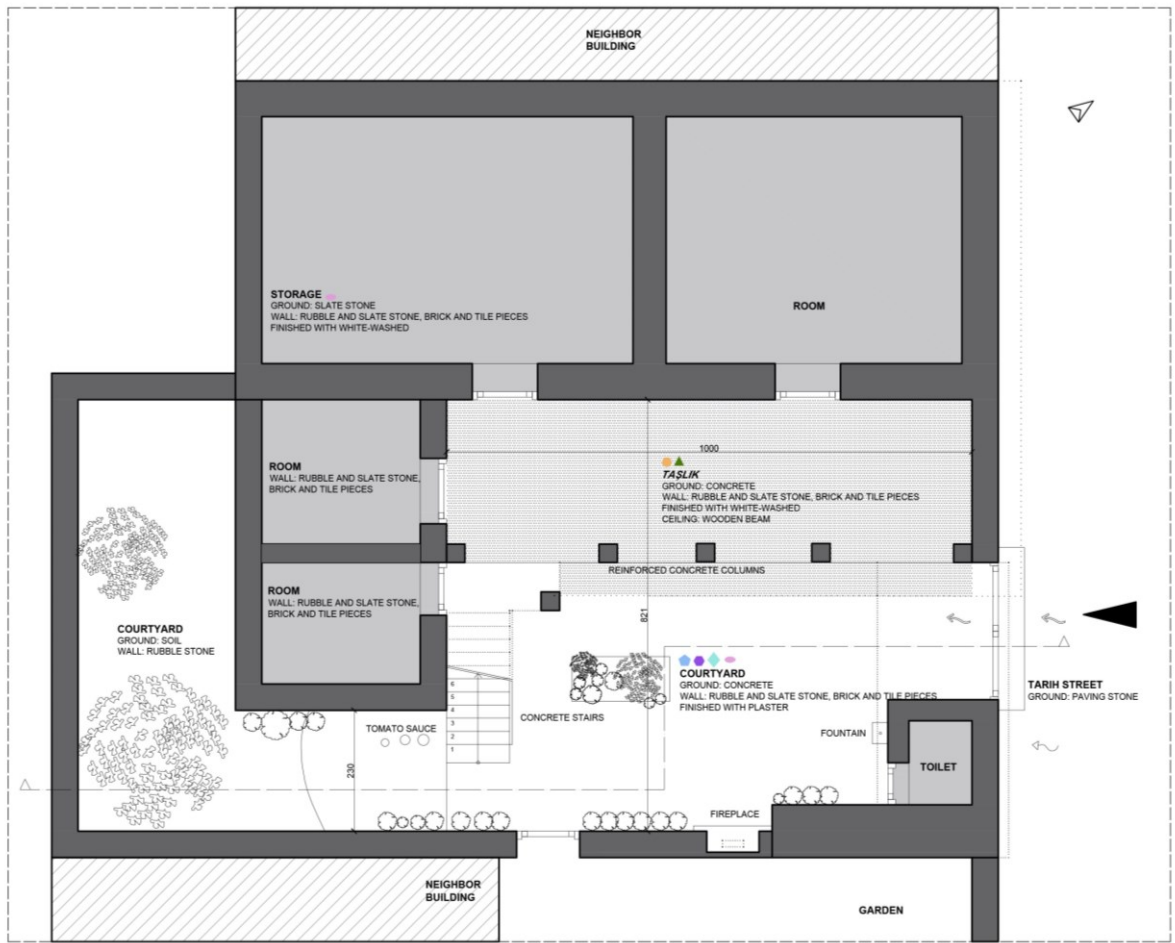
PLAN 2.1

Figure 52. Ground floor plan of the case 2 in the current state  
(Source: Prepared by Author 2022)

The semi-open *taşlık* (26m<sup>2</sup>) was preserved at the northwest of the courtyard. It has a rectangle plan. The ground finishing of the *taşlık* was renewed with concrete. The walls of the *taşlık* are building walls and mass addition's walls. Building walls and mass addition's walls at the sides of the *taşlık* are white-washed. The reinforced concrete columns between the *taşlık* and the courtyard are plastered and painted. There are a contemporary dinner table and chairs. Resting and eating are the basic activities realized in the *taşlık* (Figure 52) (Figure 53).

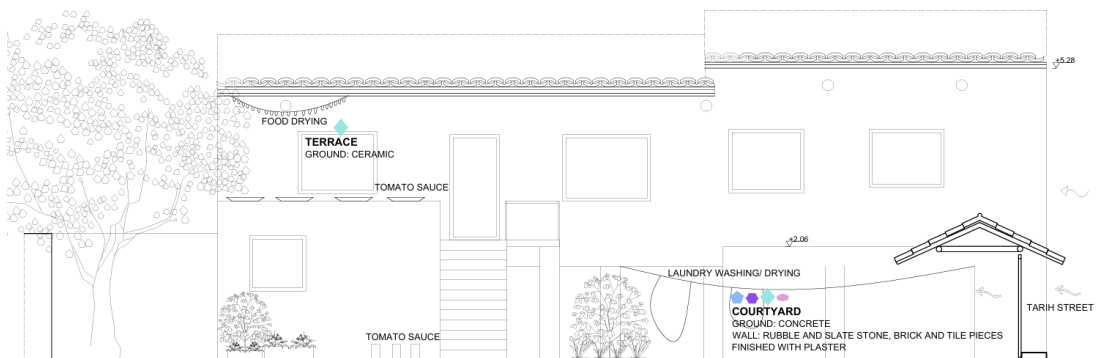
SECTION 2.1

Figure 53. Section of the case 2 in the current state (Source: Prepared by Author 2022)

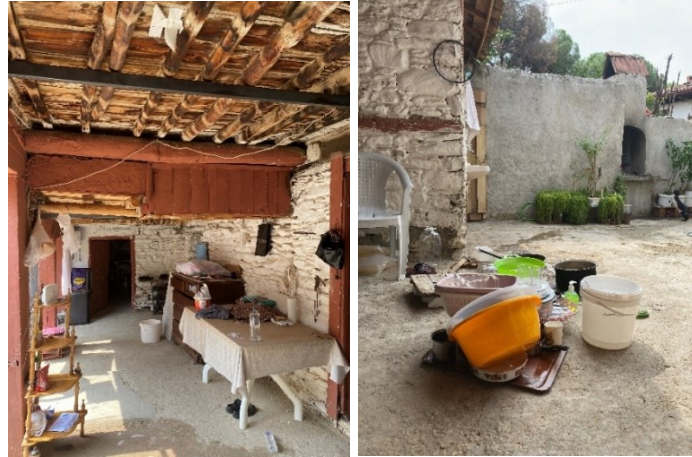
Figure 54. The *taşlık* (left) and the courtyard (right) (Photos taken by Author 2022)

The mass addition (35m<sup>2</sup>) has masonry walls out of rubble stone, slate stone, brick, tile pieces and mortar. The wall portion facing the *taşlık*, is plastered and painted. The reinforced concrete stairs juxtaposing the mass addition at its northeast leads to the first floor (Figure 54).

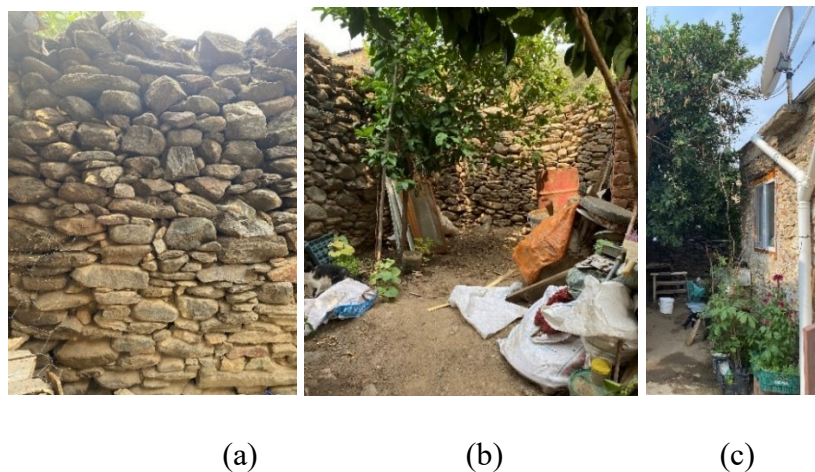
Figure 55. (a) The wall of the courtyard, (b) the courtyard, (c) the mass addition (Photos taken by Author 2022)

The southwest of the courtyard has a lemon and magnolia tree. The ground is soil and courtyard walls are dry masonry out of slate and rubble stones (Figure 55). Gardening of tomatoes, flowers is the activity realized here.

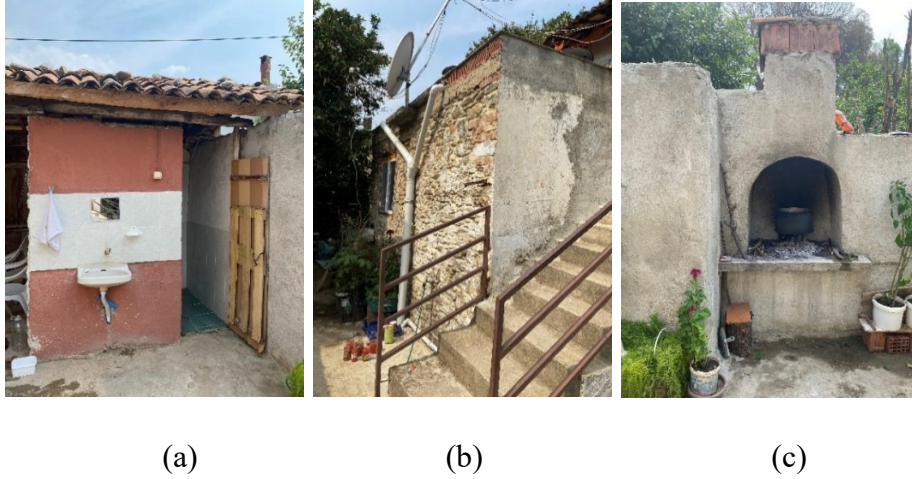
Figure 56: (a) The toilet, (b) the mass addition and (c) the fireplace  
(Photos taken by Author 2022)

There is a toilet at the eastern corner of the courtyard. The toilet was constructed together with the courtyard wall and they are plastered and painted (Figure 56). There is a contemporary sink next to the toilet wall.

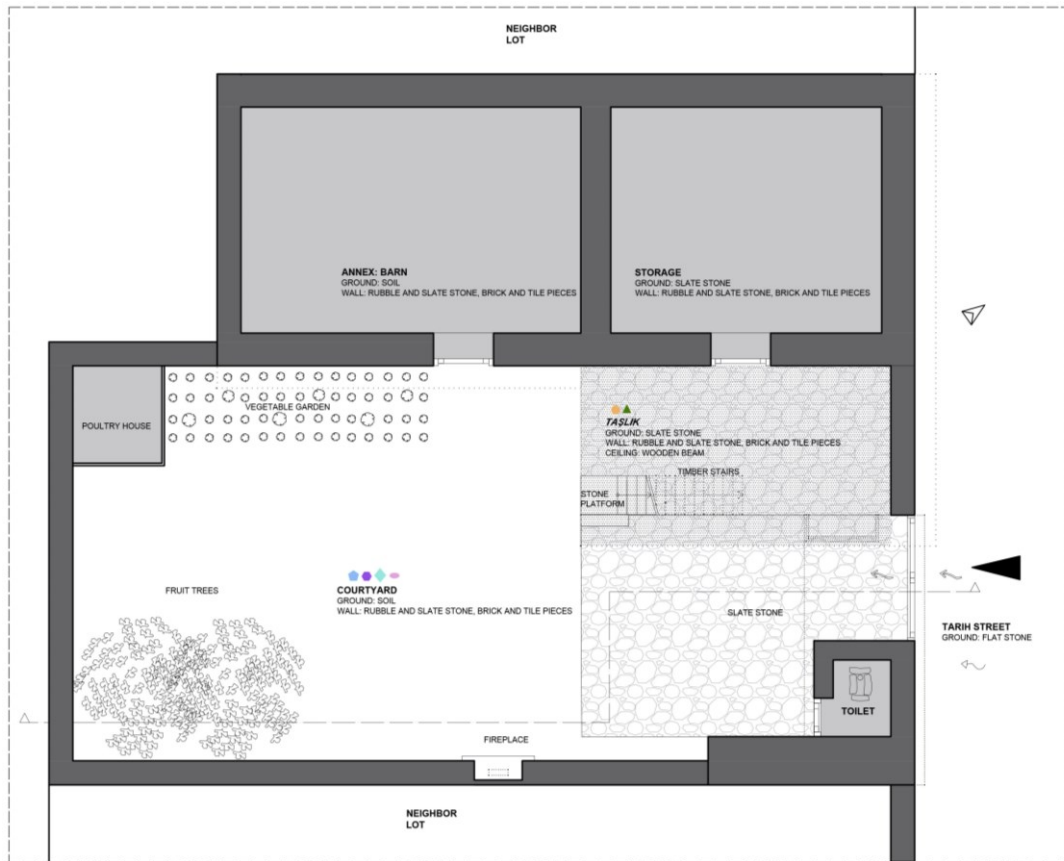
PLAN 2.2

Figure 57. Ground floor plan of the case 2 in the authentic state  
(Source: Prepared by Author 2022)

The ground covering, which was compacted earth, is screed at present (Keleş 2022). The amount of reflection of sunlight increased after changing the covering material of the courtyard's ground. The courtyard walls are plastered only at the portions, close to the *taşlık* and the toilet. Washing and drying laundry, and washing and drying dishes are the activities realized in the courtyard (Figure 57) (Figure 58).

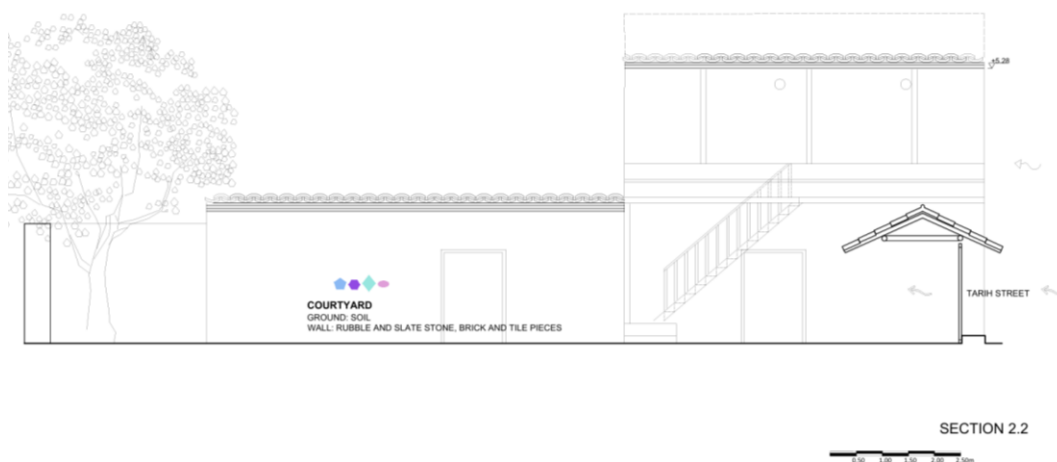
SECTION 2.2

Figure 58. Longitudinal section of the case 2 in the authentic state  
(Source: Prepared by Author 2022)

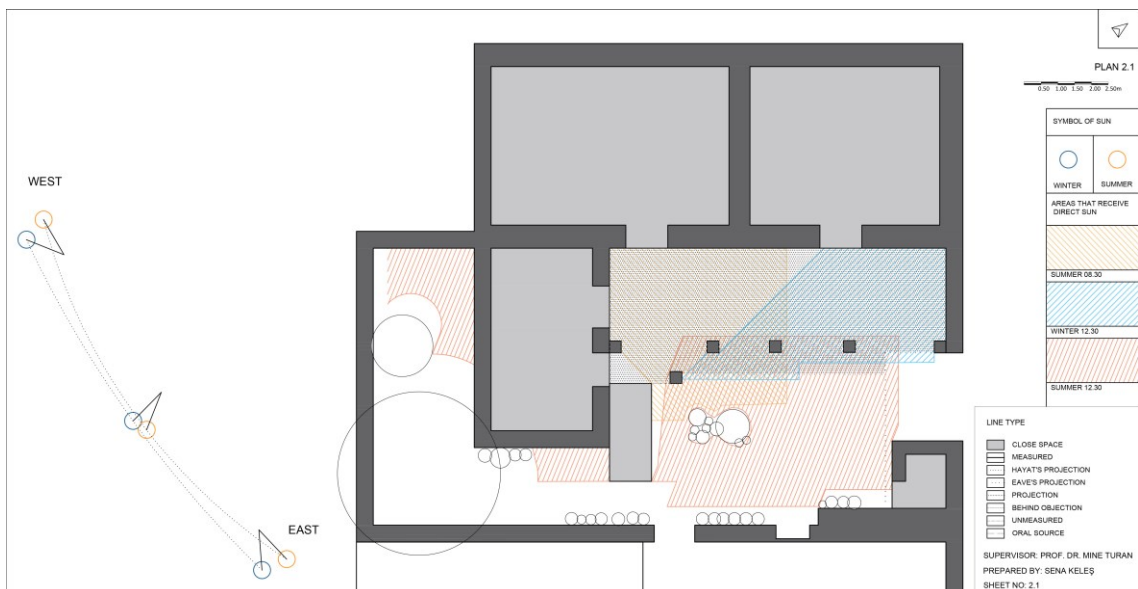
Figure 60. The amount of illumination in the plan for the current state in the case 2 (Source: Prepared by Author 2024)

The amount of the courtyard and *taşlık* grounds directly exposed to sunlight today is 40 m<sup>2</sup> at noon in the summers and 19.5 m<sup>2</sup> at noon in the winters. It was 87 m<sup>2</sup> at noon in the summers and 44.5 m<sup>2</sup> at noon in the winters before the mass addition. *Taşlık* receives less direct sunlight at summer noons. Eave length blocks summer sun to enter completely the *taşlık* in noons. The amount of the courtyard and *taşlık* grounds directly exposed to the sunlight today is 23 m<sup>2</sup> in the summer mornings (Figure 59). In the winter mornings, no sunlight reaches the courtyard ground since the courtyard wall blocks it (Figure 60) (Figure 61).

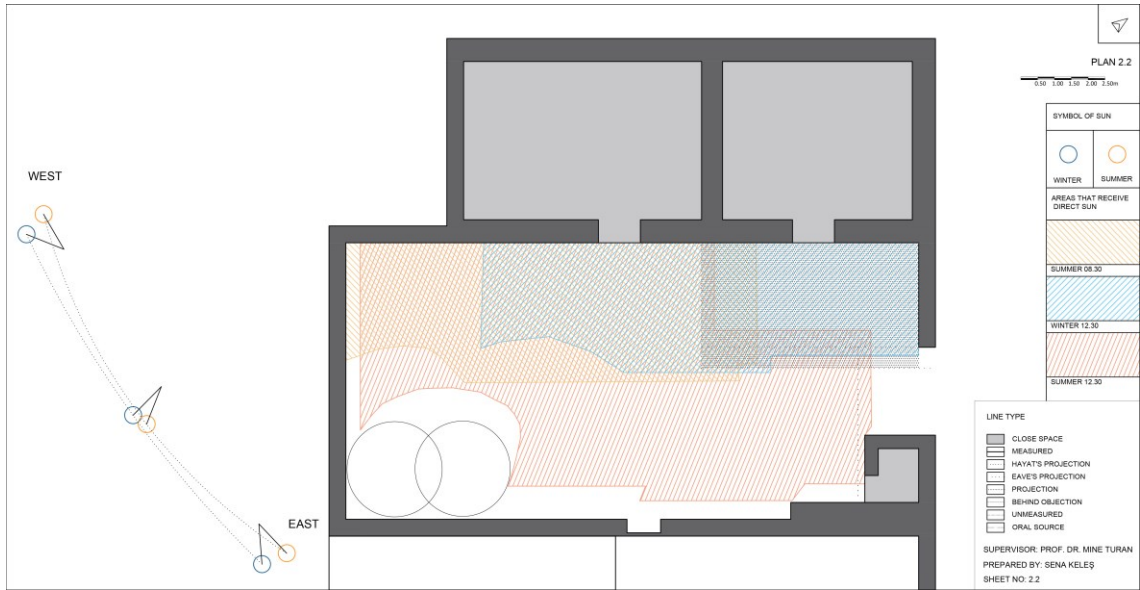
Figure 61. The amount of illumination in the plan for the authentic state in the case 2  
 (Source: Prepared by Author 2024)
