# **CHARACTERISTICS OF COURTYARDS OF TRADITIONAL HOUSES IN KURTGAZI, BİRGİ**

**A Thesis Submitted to  
the Graduate School of  
İzmir Institute of Technology  
in Partial Fulfillment of the Requirements for the Degree of**

**in Architectural Restoration**

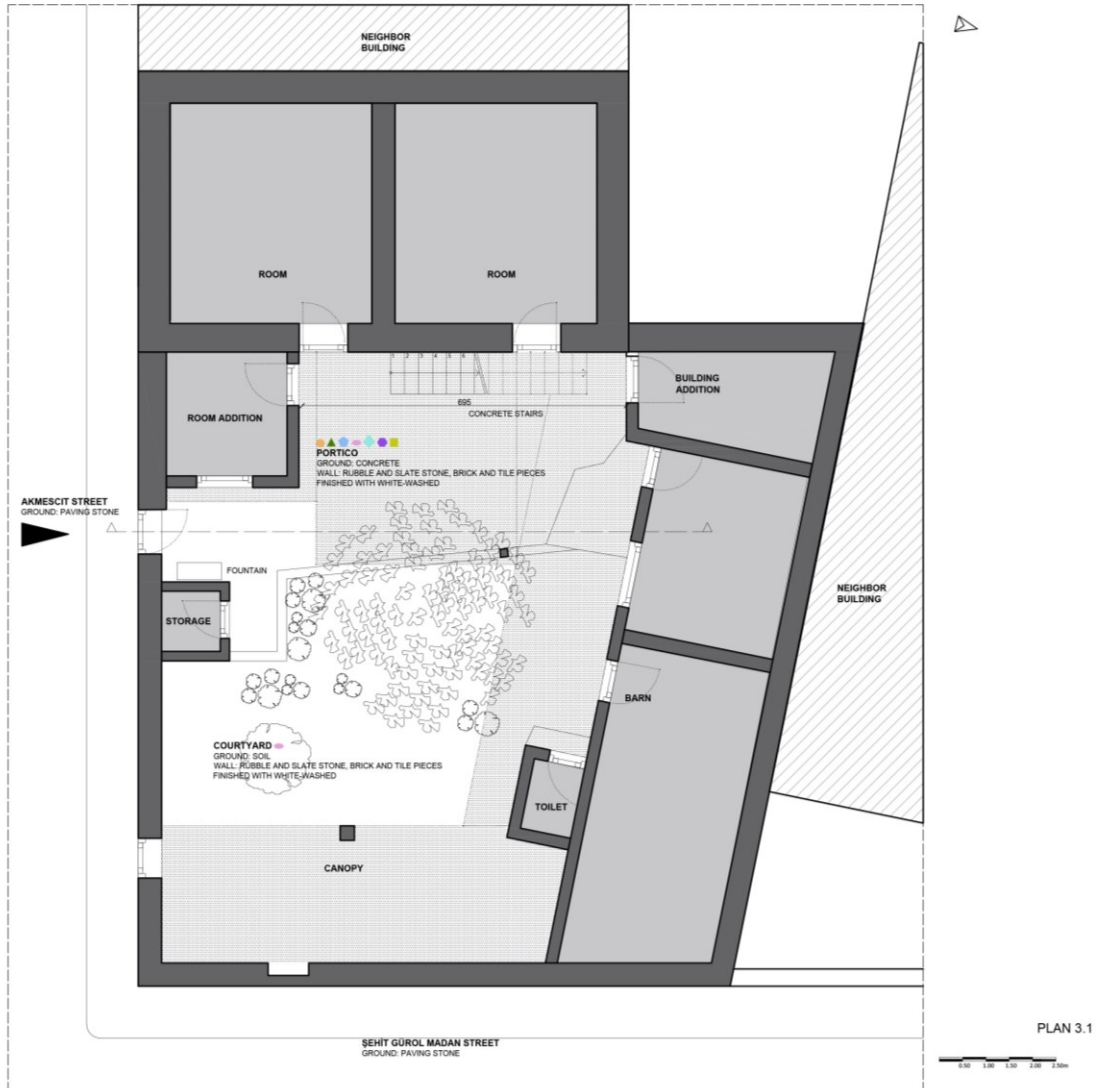
Figure 63. Ground floor plan of the case 3 in the current state  
(Source: Prepared by Author 2022)

The lot comprehends a main building, a courtyard, an additional mass (barn), an additional mass (room), an additional mass (building addition), an additional portico, and an additional canopy. The main building is at the west of the lot, the room addition at the east of the main building, the portico at the east of the main building, the courtyard is at the south, the building addition at the northwest, the barn at the north, the canopy at the southeast. The main building is two storey high, the room addition is one storey high, the building addition is two storey high, the barn is one storey high and there is one storey on the barn. The courtyard is directly accessed from Akmescit street at the south. The form of the courtyard is trapezoid (because the building addition wall has a trapezoidal shape that follow the border of the lot). The circulation system is from the street to the courtyard through the gate, then to the semi-open space (portico) and finally to the closed spaces (Figure 63) (Figure 64) (Figure 65).

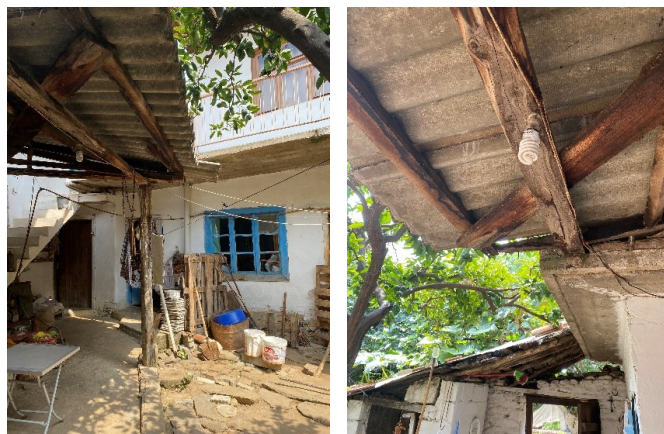
Figure 64. The portico (Photos taken by Author 2022)

There is a portico in the entrance of the main building. Its walls are plastered and white-washed. The finishing of its ground is screed. There is reinforced concrete stairs at the west. Access to the upper floor of the building at the west is provided with these stairs. There is a table and chairs in the portico. Resting and eating are the activities of the space.

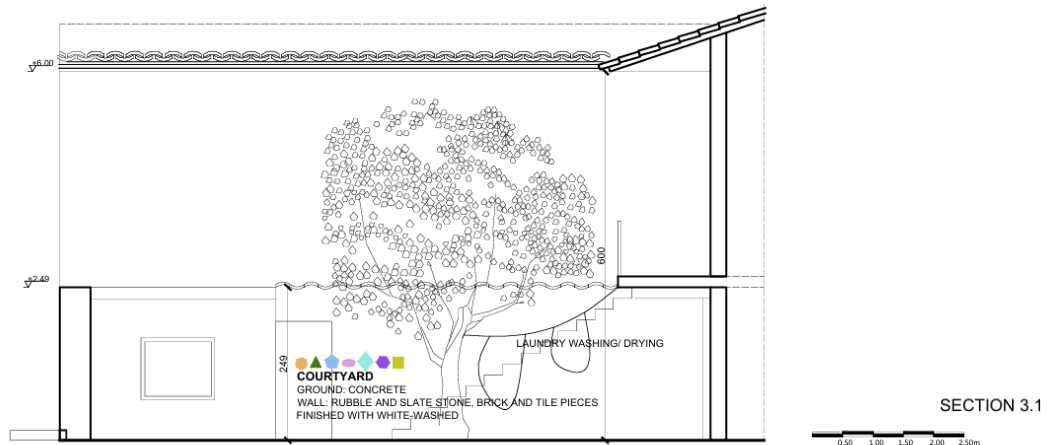
Figure 65. Cross section of the case 3 in the current state  
(Source: Prepared by Author 2022)

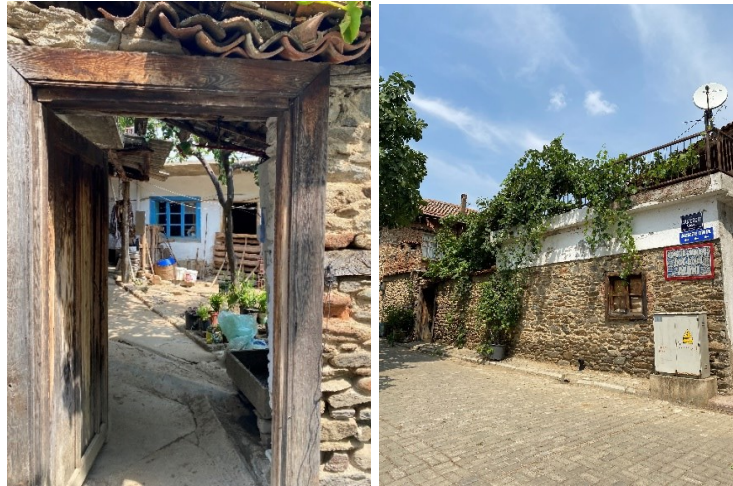
Figure 66. The entrance of the case 3 and its street façade  
(Photos taken by Author 2022)

The gate of the courtyard is single-leaf and wooden. It has an over and under tile roof. There is a contemporary fountain and a storage on the right of the gate.

The walls of the courtyard have preserved their authenticity slate stone, brick, and tile pieces, put together with mortar and reinforced with wooden beams. The height of the wall was increased with the construction of the additional structures. This additional wall portion is white-washed from the inside of the courtyard (Figure 66).

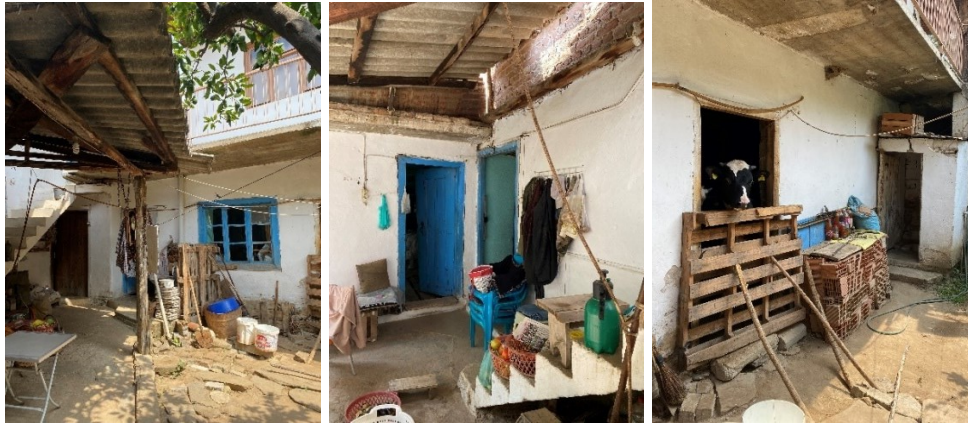
Figure 67. (a) The building addition, (b) the concrete stairs and (c) the barn

Location of the barn at the north. The total height of the barn and the upper floor of the barn is almost the same as the width of the courtyard. Natural ventilation has decreased after the barn and the upper floor of the barn was added (Figure 67).

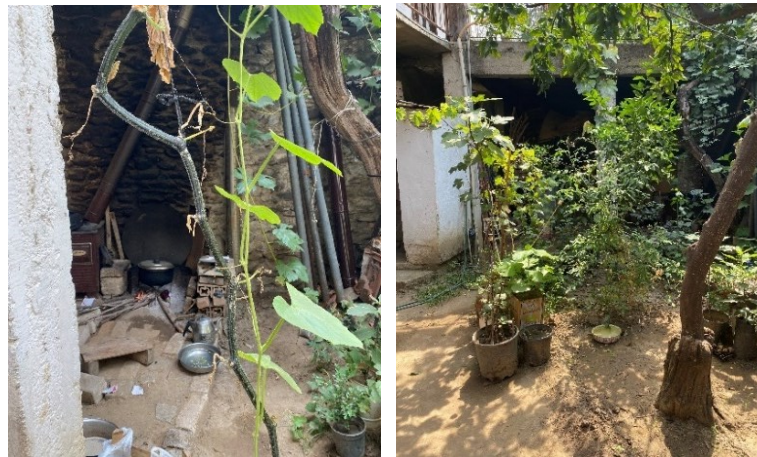
Figure 68. The fireplace (left) and the courtyard (right) (Photos taken by Author 2022)

There is a canopy at the east of the courtyard. There is a fireplace in this semi-open place (canopy). Cooking and storing are the activities of the canopy (Figure 68).

The ground covering is compacted earth in the courtyard. There are fruit trees, ivy, flowers, and vegetables in the courtyard. Gardening, washing and drying laundry, washing and drying dishes and drying foods are the activities of this area (Figure 68) (Figure 69) (Figure 70).

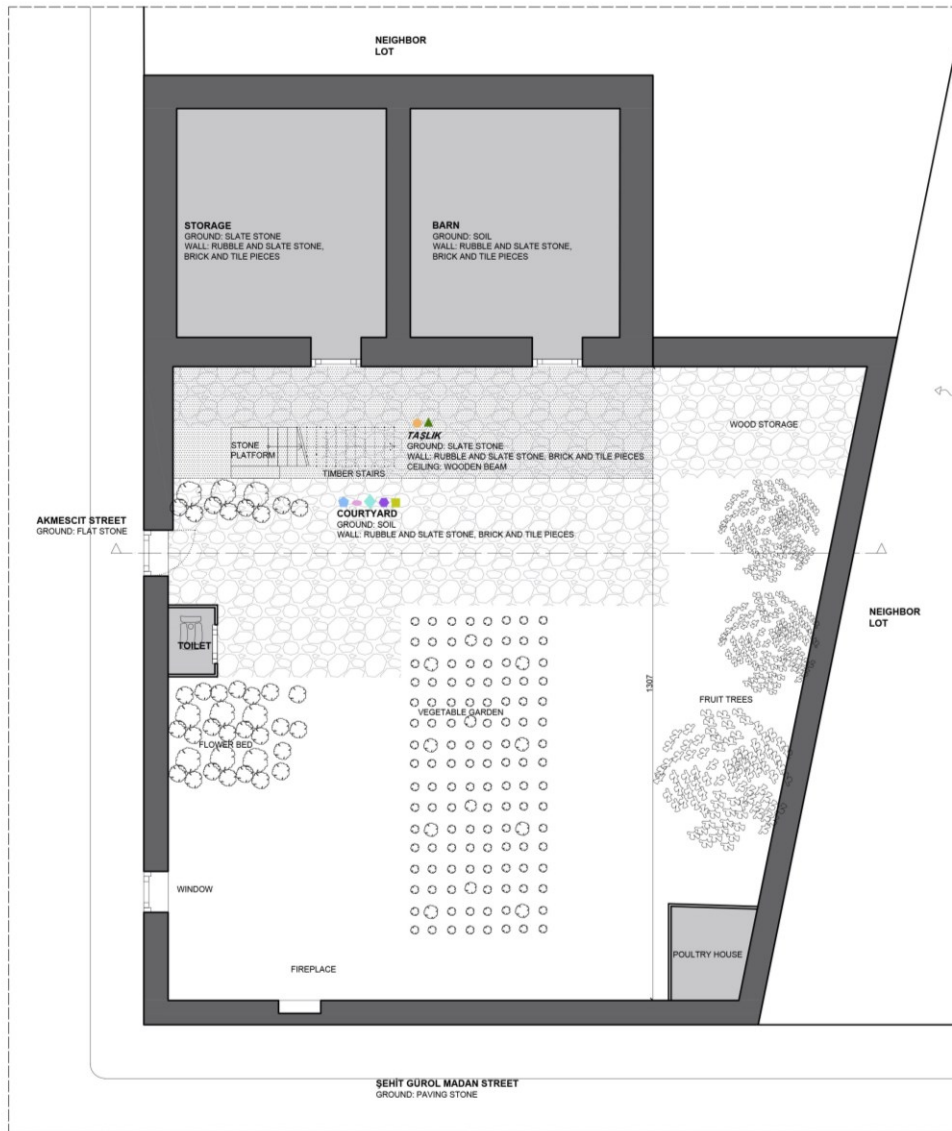
PLAN 3.2  
0.00 1.00 1.50 2.00 2.50m

Figure 69. Ground floor plan of the case 3 in the authentic state  
(Source: Prepared by Author 2022)

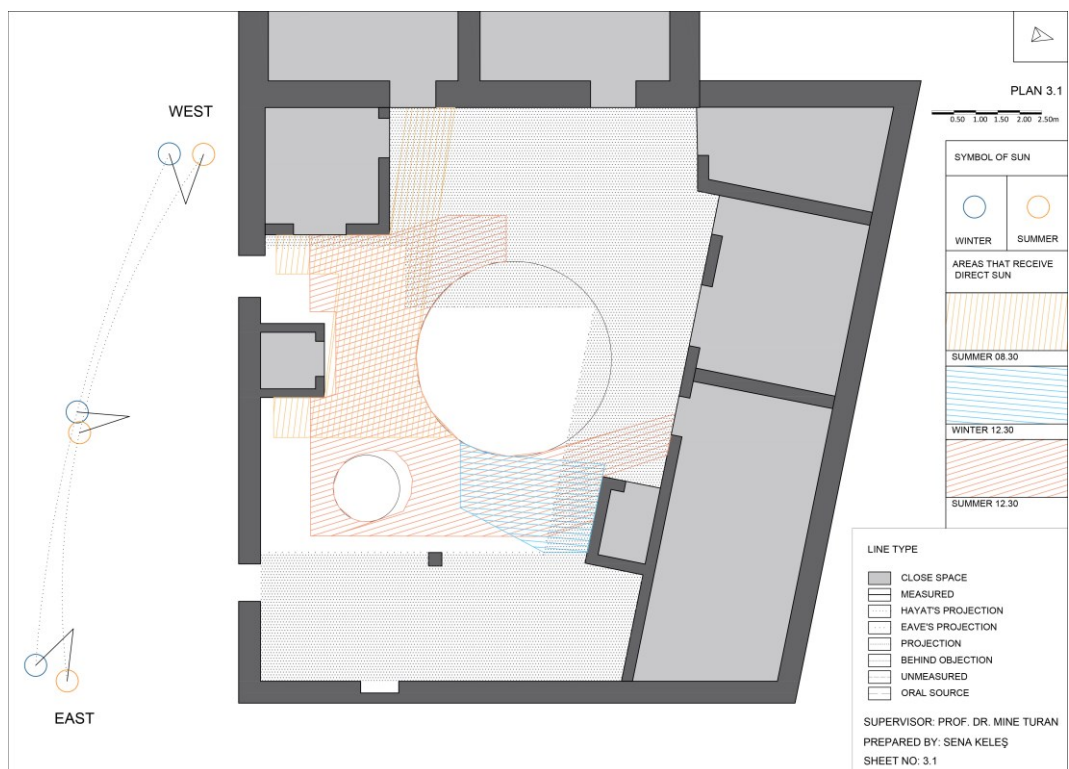
Figure 72. The amount of illumination in the plan for the current state in the case 3  
(Source: Prepared by Author 2024)

The northern air flows are blocked by additions at the north in summers. The south wind comes from the upper of the courtyard walls to the courtyard in winters. Hot air rises up the courtyard as the plants here are watered and the courtyard is washed in the summers. The airflow was from the north to the courtyard, then to the *hayat* and to the elevated roof. The airflow decreased because of the building was added to the north of the courtyard. The closing of *hayat* and the elevated roof with walls also restricted the natural ventilation. Airflow from south decreased because the additional structure added on the courtyard wall (Figure 72) (Figure 73).

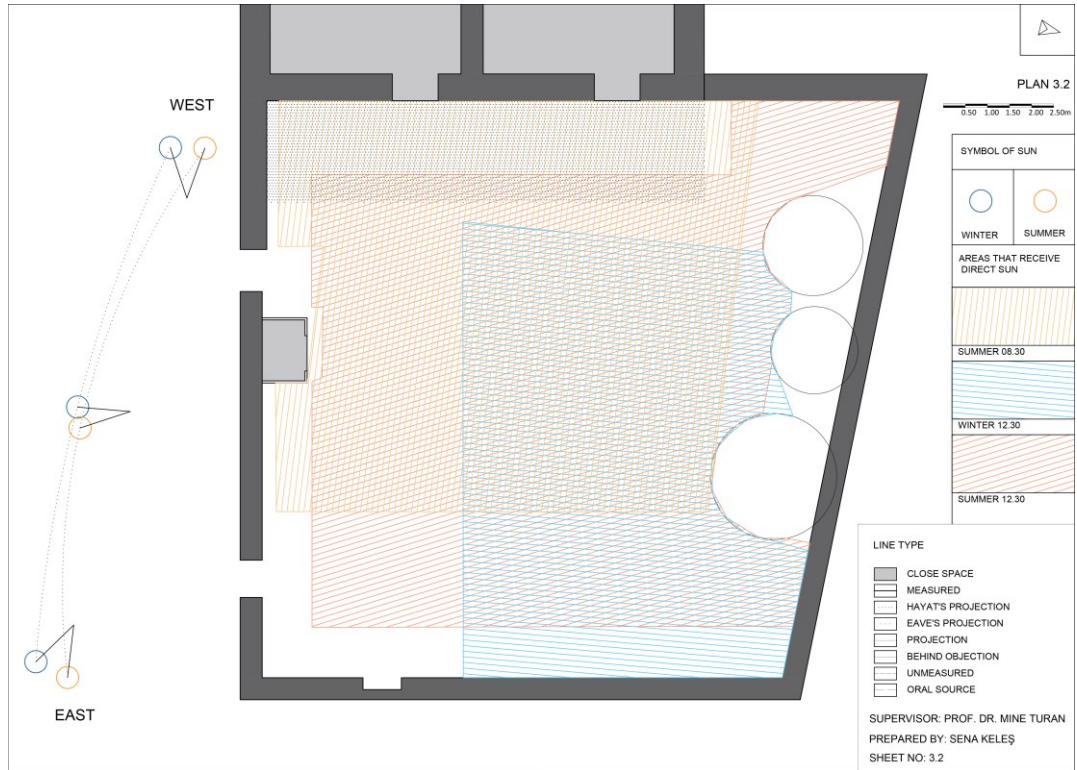
Figure 73. The amount of illumination in the plan for the authentic state in the case 3  
(Source: Prepared by Author 2024)

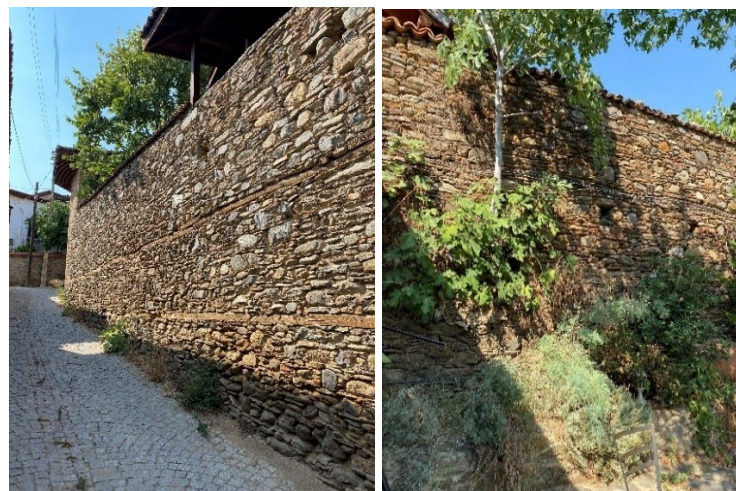
Figure 76. Courtyard walls in the case 4 (Photos taken by Author 2022)

The courtyard walls have preserved their authenticity slate stone, brick, and tile pieces, put together with mortar, reinforced with wooden beams and crowned with tiles (Figure 76). The wall between the two courtyards and flower pots were built with rubble stone and mortar (Figure 77) (Figure 78).

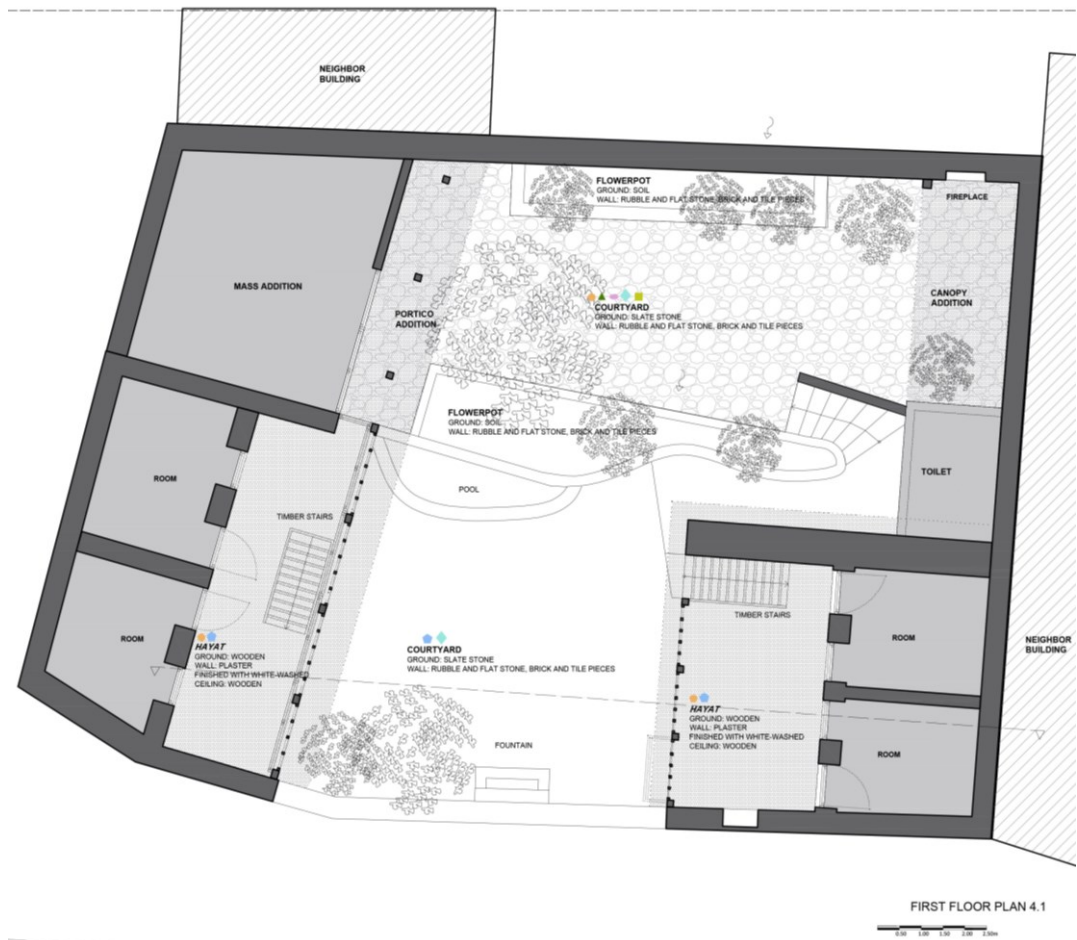
Figure 77. The upper portion plan of the courtyard in the case 4 in the current state  
(Source: Prepared by Author 2024)

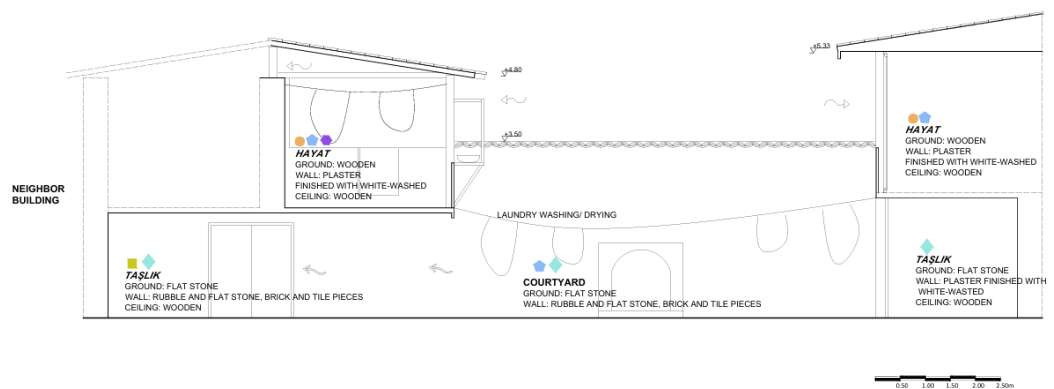
Figure 78. Section of the case 4 in the current state (Source: Prepared by Author 2024)

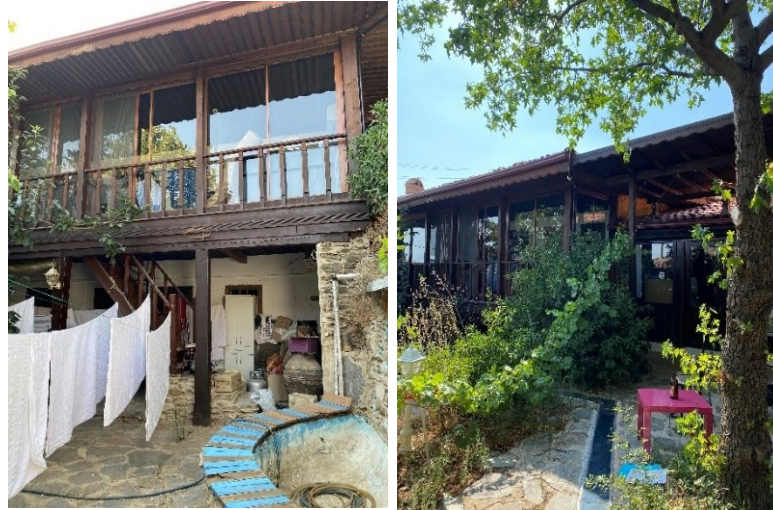
Figure 79. The ground level courtyard (left) and the upper level courtyard (right)  
(Photos taken by Author 2022)

Washing and drying laundry are the activities of the courtyard at the bottom portion. There is a swing, a table and chairs at the upper portion. Resting and eating are the activities realized here (Figure 79).

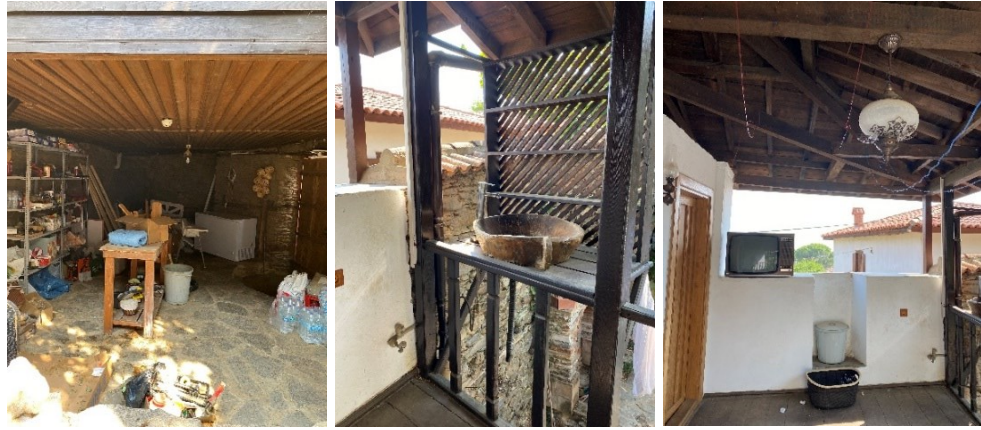
Figure 80. (a) The *taşlık* of the annex and (b) (c) the *hayat* of the annex

The *taşlık* of the main building and the *taşlık* of the annex are preserved. There are stone steps and timber stairs between the *taşlıks* and the *hayat*'s at their upper levels. The *hayat* of the main building is closed with glass panels. The *hayat* of the annex is preserved and this *hayat* has *abdestlik*. The wall of the *taşlık* in the main building is plastered and white-washed. There is a ceramic pot and wardrobe in the *taşlık* of the main building. Storing is the basic activity realized in the *taşlık*. The wall of the *taşlık* in the annex has preserved its authenticity slate stone, brick, and tile pieces put together with mortar exposed without plaster and paint. The *taşlık* of the annex is used as an entrance space (Figure 80). At the same time, cutting and storing wood, and doing hobbies are realized (Figure 81) (Figure 82) (Figure 83).

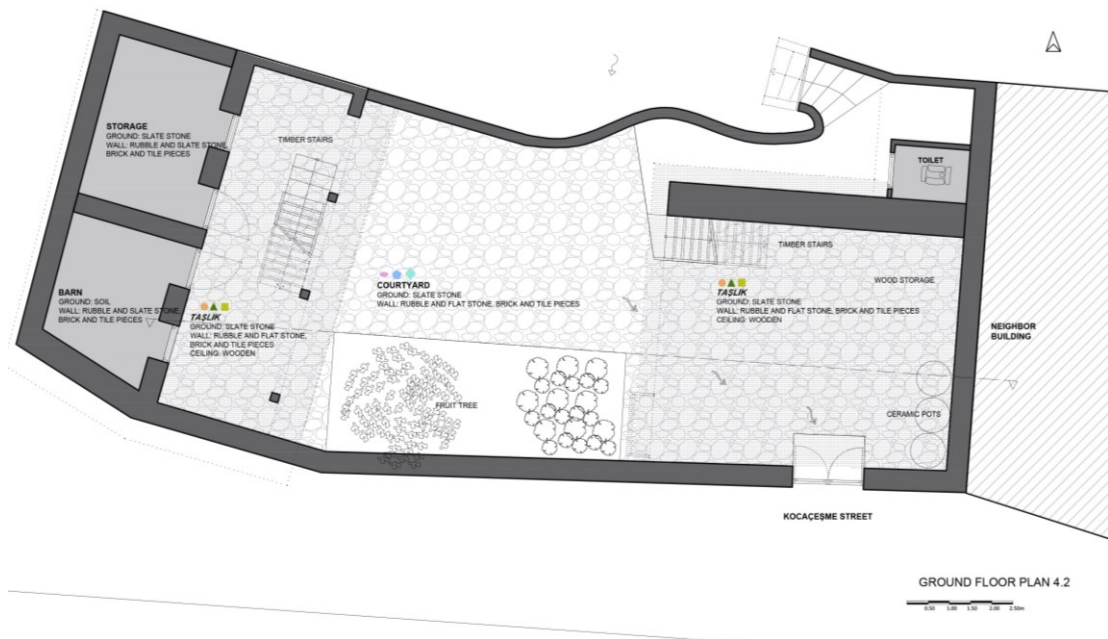
Figure 81. The bottom portion plan of the courtyard in the case 4 in the authentic state

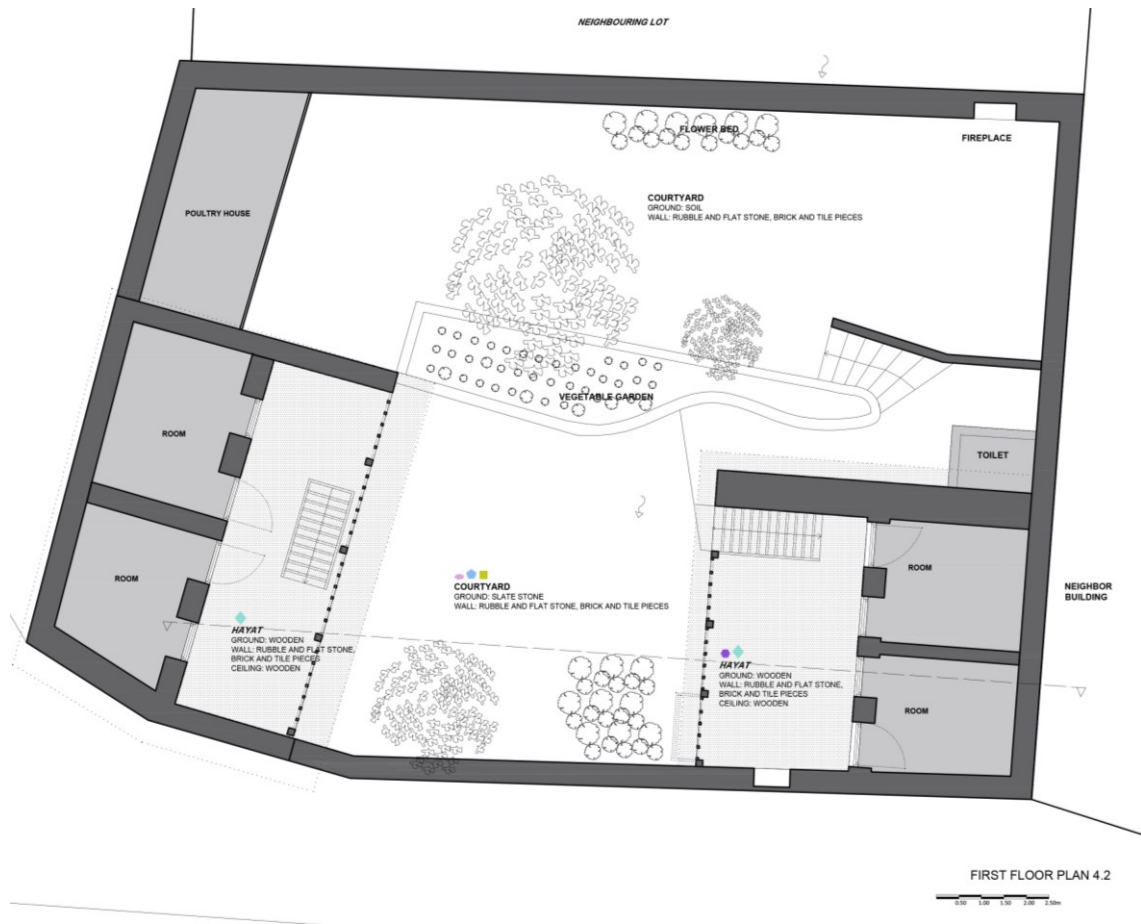
Figure 82. The upper portion plan of the courtyard in the case 4 in the authentic state  
(Source: Prepared by Author 2023)

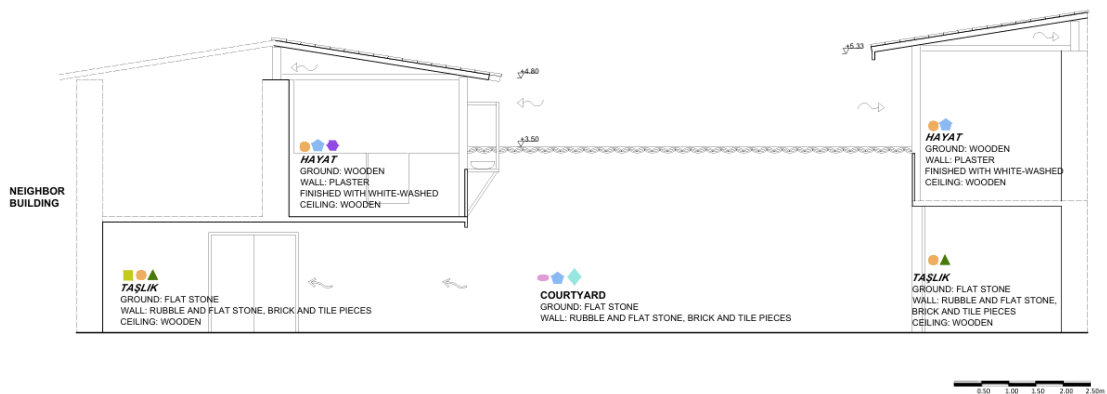
Figure 83. Section of the case 4 in the authentic state  
(Source: Prepared by Author 2023)

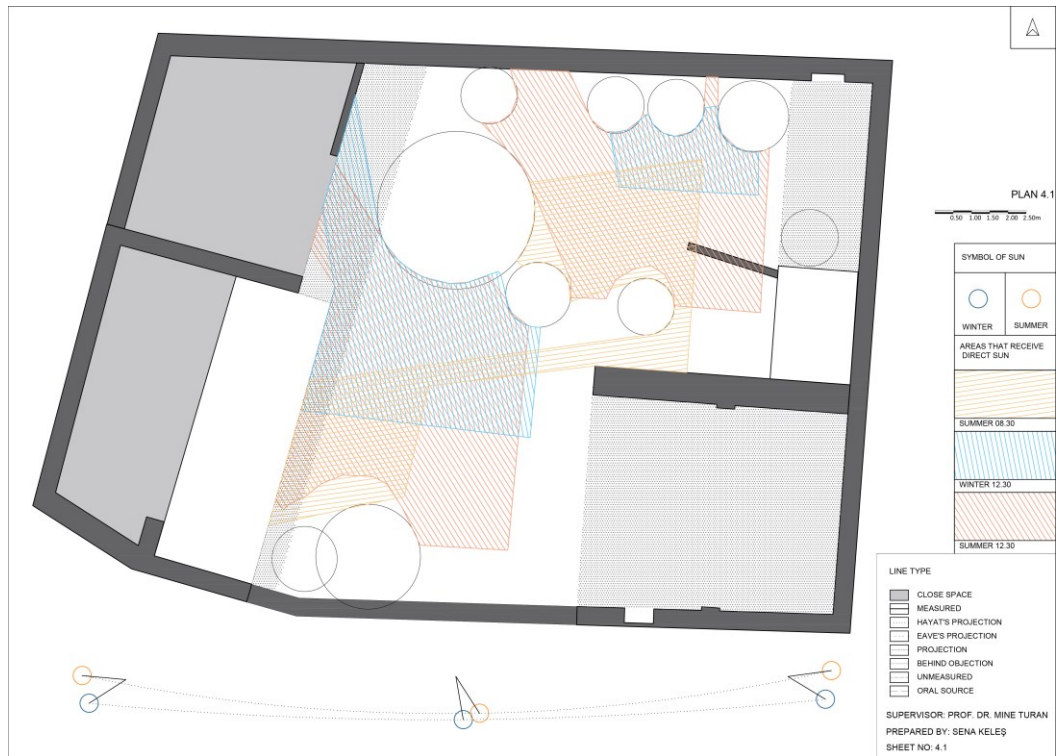
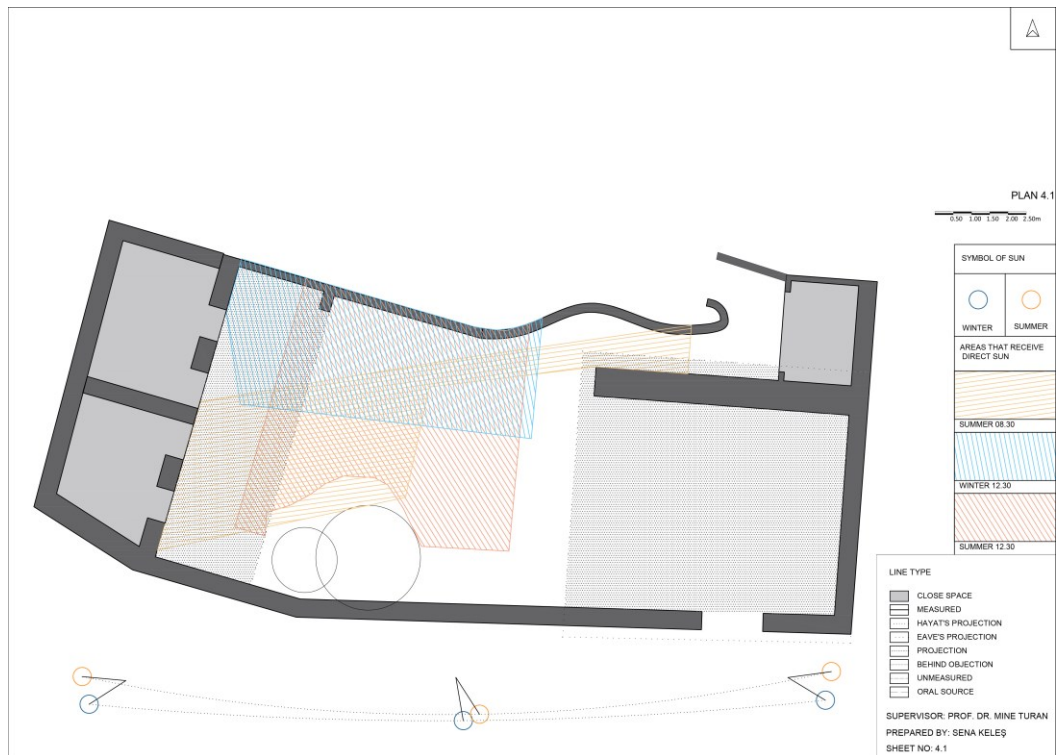
The area of the bottom portion ground and the upper portion courtyard directly exposed to the sunlight today is 78 m<sup>2</sup> in the summer noons. The area of the bottom

portion courtyard and the upper portion courtyard ground directly exposed to sunlight today is 39.5 m<sup>2</sup> in the winter noons. The area of the bottom portion courtyard and the upper portion courtyard ground directly exposed to sunlight today is 46 m<sup>2</sup> in the summer mornings. The courtyard ground is not directly exposed to sunlight today in the winter mornings since the courtyard wall blocks it (Figure 84).

Figure 85. The amount of illumination in the plan for the current state in the case 4  
 (Source: Prepared by Author 2024)

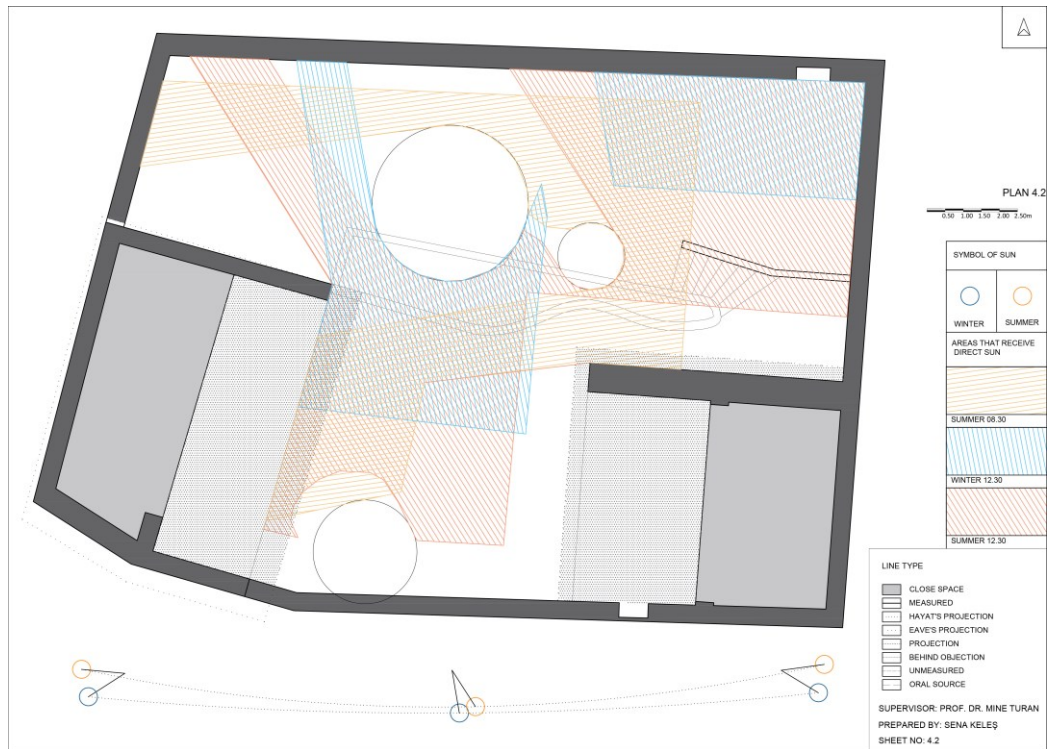
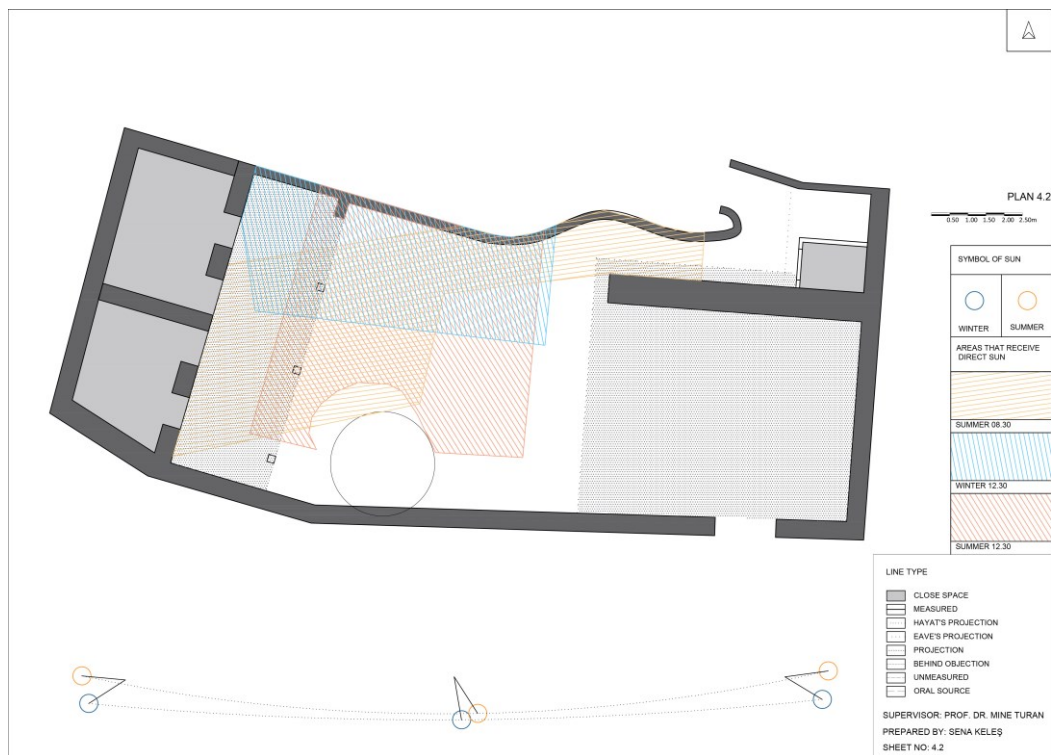
In the authentic state, the amount of sunlight was 108 m<sup>2</sup> in the summer noons and 61.5 m<sup>2</sup> in the winter noons, since there were no service masses. The area of the bottom portion courtyard and the upper portion courtyard ground directly exposed to sunlight was 80.5 m<sup>2</sup> in the summer mornings (Figure 85) (Figure 86).

Figure 86. The amount of illumination in the plan for the authentic state in the case 4  
(Source: Prepared by Author 2024)

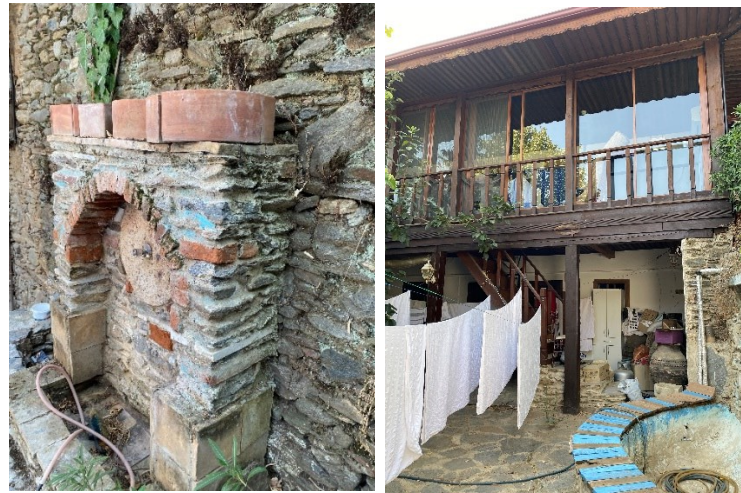
from the upper of the courtyard wall to the courtyard, through to the *taşlık* of the annex then to the gate. The southern wind comes from the upper of the courtyard wall to the courtyard or the southern wind comes from the gate to the *taşlık* and to the courtyard. Evaporation of water the fountain basin, the pool and the watered garden during summer days decrease the temperature on the courtyard surfaces, and creates an airflow between the courtyard, the *taşlık* and the *hayat*.

In the authentic state, the northern wind came to the courtyard, through the *hayat* of the annex and the main building, then it moved to the elevated roof of the annex and the main building. Watering of the courtyard was a tradition that helped cooling of the spaces in the summers (Figure 87).

Figure 87. The contemporary fountain (left) and pool (right) in the case 4  
(Photos are taken by Author 2022)

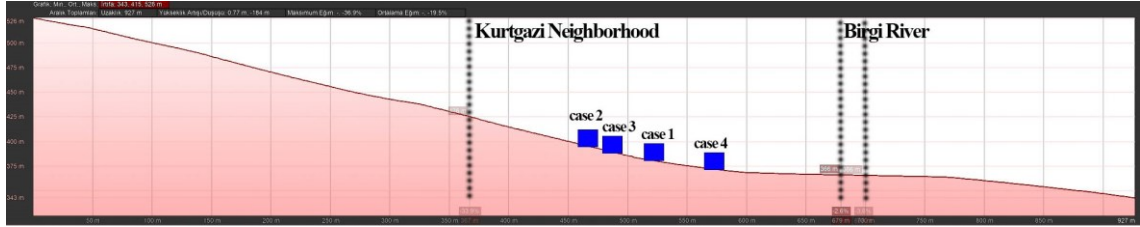
The land slope in the *Kurtgazi* neighborhood varies between 4 and 33% at the Northwest–Southeast direction. The studied cases are between *Birgi* river and the crest of

the *Boz* Mountains, and the studied cases are close to the *Birgi* river. The land slopes of the cases are 21% (case 1), 18% (case 2), 12% (case 3), and, 11% (case 4). The altitude of the cases is between 368 meters and 395 meters (Figure 89).

Figure 89. The slope of the case studies (Source: Revised from Google Earth Pro 2024)

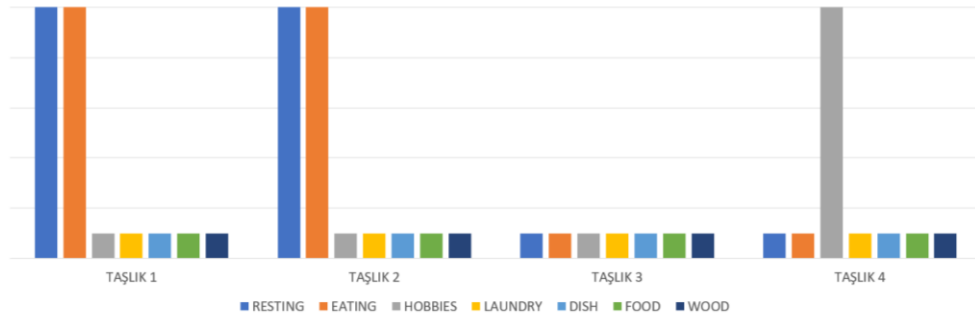
Figure 92. The existence of daily and seasonal activities in *taşlıks* in the current state  
(Source: Prepared by Author 2024)

At the current state, three buildings out of four buildings have *taşlıks* (case 1, case 2 and case 4). Other case closed their *taşlıks* by building wall (case 3). Resting and eating are outstanding activities in the *taşlıks* (2 out of 3). The function of the *taşlık* was changed by the new owner of the case 4 as hobby space (repairing of objects) (Figure 92).

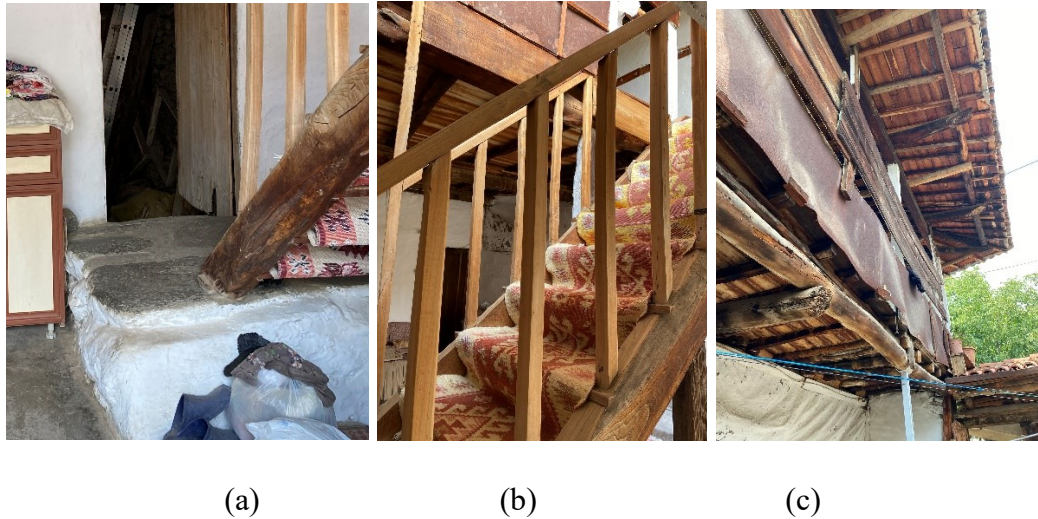
In the current state; timber stairs, stepping stones and ceramic water pots are represented in 2 out of 4 cases: case 1 and case 4 (Figure 93). In these cases, the location of ceramic water pots was changed and the usage of water pots was changed after the establishment of the fresh water infrastructure. Ceramic water pot are used for decorative purpose instead of storing water. In other cases, timber stairs were converted into concrete ones (2 out of 4, cases: case 2, and case 3). In the half of the cases (cases 2, and case 3),

Figure 93. (a) Stepping stone, (b) timber stair and (c) *hayat* in the case 1  
(Photos taken by Author 2022)

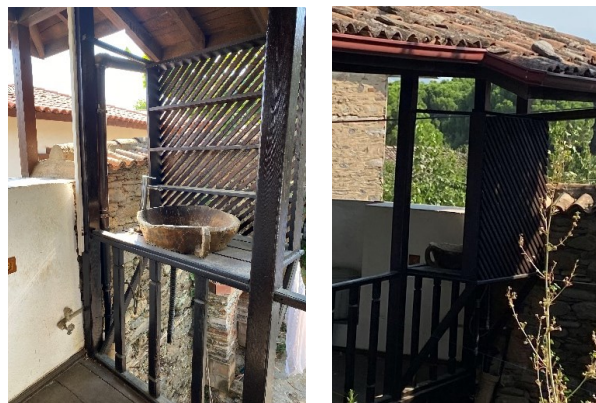
*hayat* and *abdestlik* are not represented. *Abdestlik* is represented in only one case: case 4 (Figure 94). Although *Hayat* is sustained *abdestlik* is not in case 1.

Figure 94. *Abdestlik* in the case 4 (Photos taken by Author 2022)

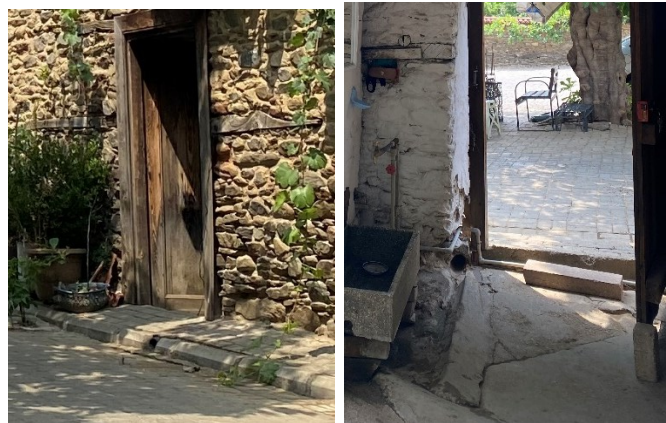
There are new fireplaces and fountains in all of the courtyards. There are often drainage channels in the courtyards: the cases 1, case 3 and case 4 (3 out of 4). Surface water flows out to the street through a pipe inserted into the courtyard wall: case 3 (Figure 96). In the other cases, water does not drain to the street. There are stone channels on the street. Fireplace, fountain, concrete stairs, pool, concrete flower pot, benches, tables and hoses are contemporary elements of the courtyards.

Figure 96. Drainage in the case 3 (Photos taken by Author 2022)

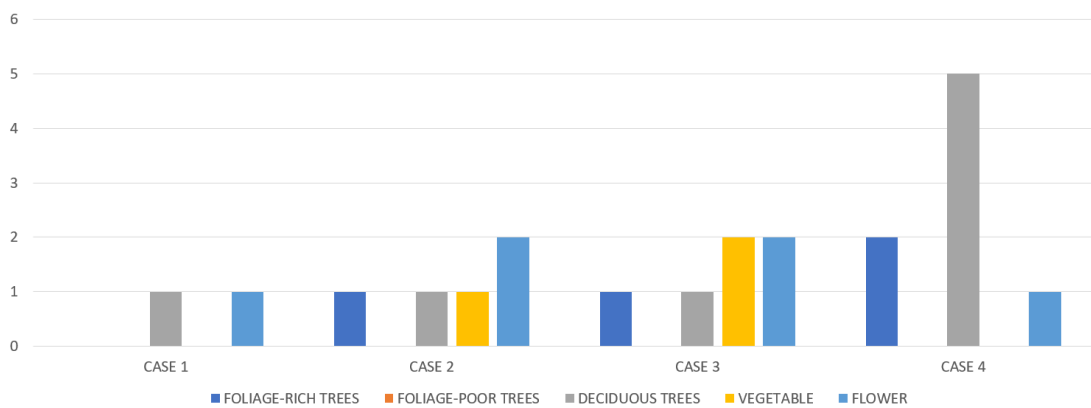
The number of deciduous trees in case 4 are more than in other cases. There are deciduous trees in the south part of the courtyard of the case 4, and deciduous ivies (grape vine) in the south part of the courtyards (cases 1 and case 3). There are evergreen trees in the south part of the courtyards (case 2) and in the central part of the courtyards (case 3, and case 4). The number of foliage-rich trees in case 4 is more than in other cases.

Figure 99. Green elements in the courtyards (Source: Prepared by Author 2024)  
(X: Cases Y: Amount of the green elements)

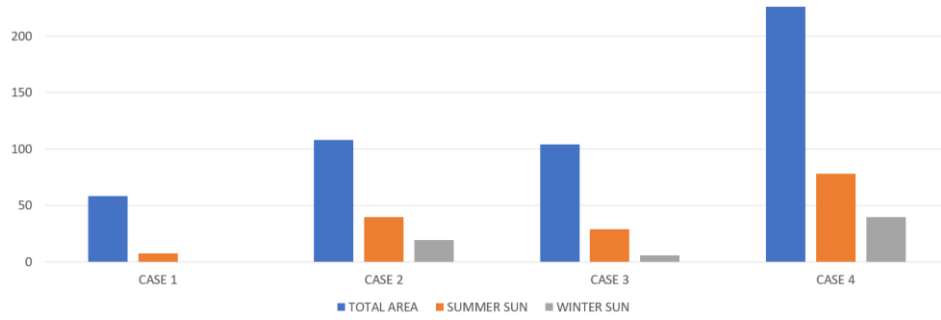
All of the open and semi-open spaces receive more sunlight during summers. The courtyard and the *taşlık* of case 4 have the maximum area among the studied cases and it is exposed to direct sunlight at a maximum amount both in winters (39.5 m<sup>2</sup>) and in summers (78 m<sup>2</sup>). This is followed by the case 2 (19.5 m<sup>2</sup>), case 3 (6 m<sup>2</sup>), and the courtyard of the case 1 does not receive direct sunlight in the winters; and case 2 (40 m<sup>2</sup>), case 3 (29 m<sup>2</sup>), and case 1 (7.5 m<sup>2</sup>) in the summers. The case 2 has the best ratio of the depth to the height of courtyard wall at south. When the ratios of the area exposed to direct sunlight to the whole of the courtyard area are compared, the case 2 is the best in terms of receiving direct sunlight in winters (18 %) and in summers (37 %). This is followed by the case 4 (17 %) and case 3 (5 %), in the winters; case 4 (34 %), case 3 (27 %) and case 1 (12 %) in the summers (Figure 101).

Figure 101. Amount of the area exposed to direct sunlight in the current state (X: Cases Y: Meter square) (Source: Prepared by Author 2024)

All of the courtyards receive maximum sunlight in summers because sunlight coming to the courtyards with a larger angle compared to the winters can escape through the long eaves and courtyard walls. The Sun culminates at  $27.77^\circ$  altitude in winters (21<sup>st</sup> December) and  $72.96^\circ$  altitude in summers (21<sup>st</sup> June) at noons (12.30). Winter sun reaches to the *taşlıks* according to the orientation of the sun.

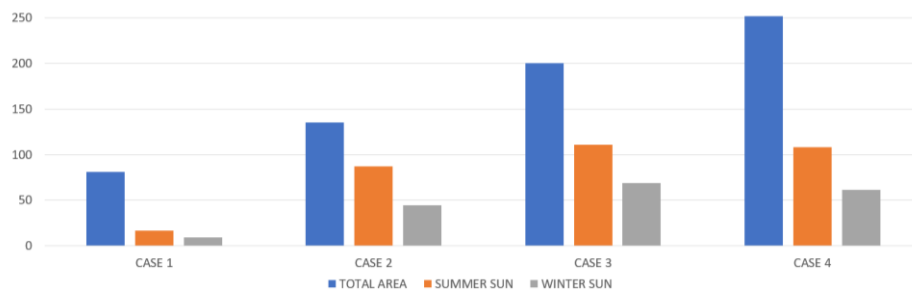
In the authentic state, the courtyard of case 3 (111 m<sup>2</sup>) was exposed to direct sunlight at maximum amount in summers. This was followed by case 4 (108 m<sup>2</sup>), case 2 (87 m<sup>2</sup>), and case 1 (17 m<sup>2</sup>). The courtyard of case 3 (69 m<sup>2</sup>) was exposed to direct sunlight at maximum amount in winter. This was followed by case 4 (61.5 m<sup>2</sup>), case 2 (44.5 m<sup>2</sup>), and case 1 (9 m<sup>2</sup>). When the ratios of the area exposed to direct sunlight to the whole of the courtyard area; the case 2 (64 %), case 3 (55 %), case 4 (42 %), and case 1 (20 %) in summers. The courtyard of case 3 was the best in terms of receiving direct sunlight in winters (34 %). This was followed by case 2 (32 %), case 4 (24 %) and case 1 (11 %) (Figure 102).

Figure 102. Amount of the area exposed to direct sunlight in the authentic state (X: Cases Y: Meter square) (Source: Prepared by Author 2024)
