DYNAMIC BEHAVIOR OF REINFORCED CONCRETE FRAMES WITH INFILL WALLS

**A Thesis Submitted to
the Graduate School of Engineering and Sciences of
İzmir Institute of Technology
in Partial Fulfillment of the Requirements for the Degree of**

MASTER OF SCIENCE

in Structural Mechanics

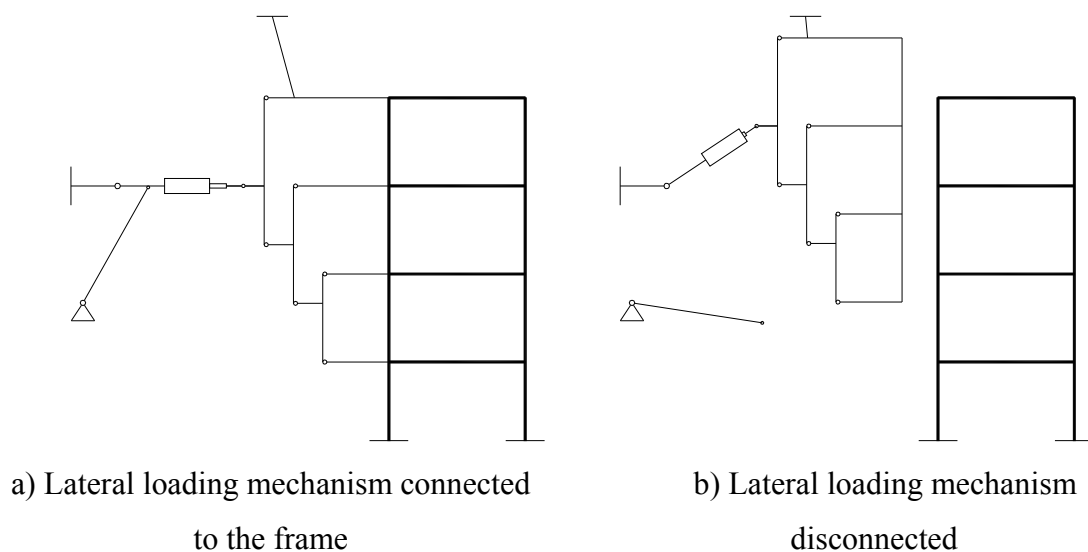
Dynamic testing of the frames necessitated detachment of the pseudo-static loading system at every loading cycle of the frames, Figure 2.11. For this purpose the hydraulic jack was designed to connect with two hinges at both ends. During the static tests jack was stabilized by a support plate, Figure 2.12. When it was needed to perform dynamic test, connections of the load distribution mechanism to the frame and the support struts of the jack was disconnected.

Figure 2.11. Positions of the static loading system for static and dynamic tests

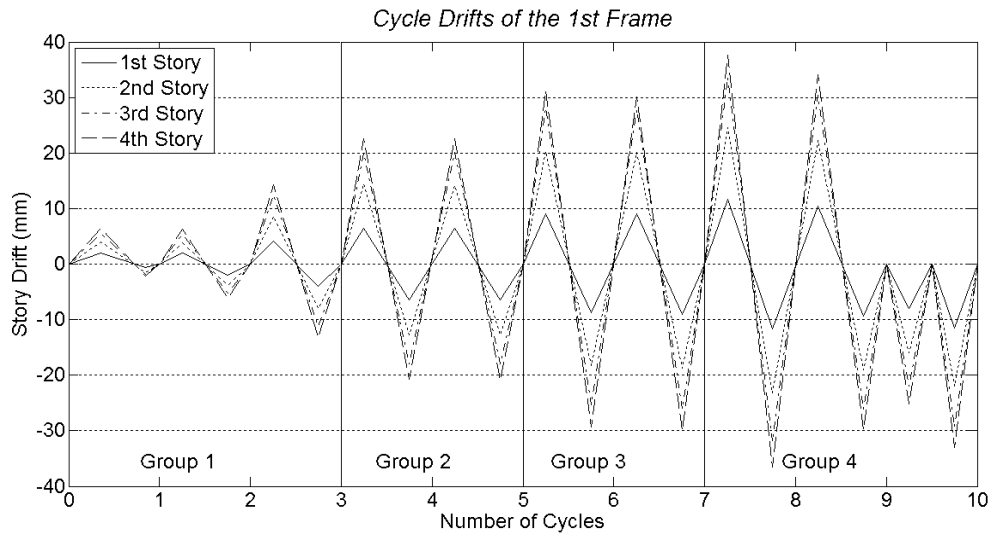
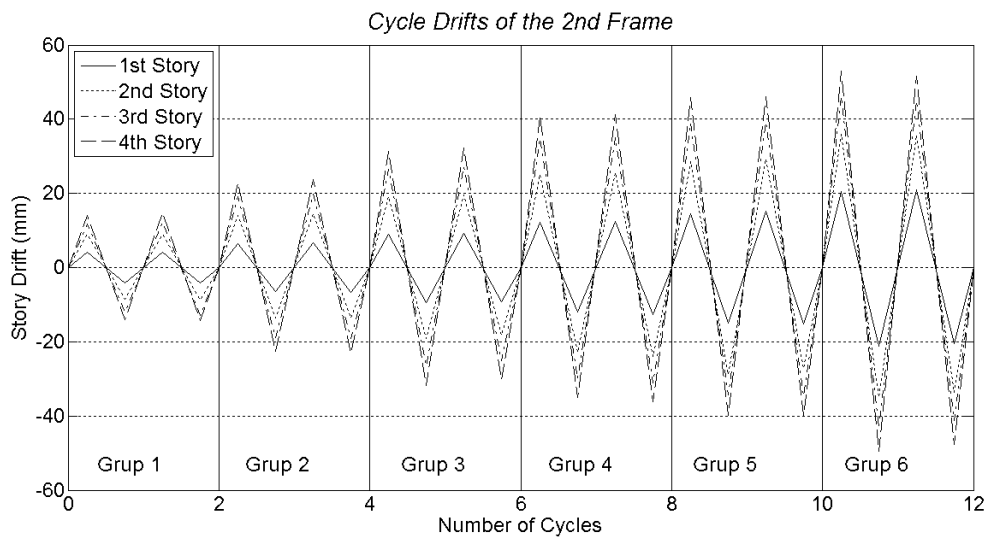
Figure 3.1. Absolute story drifts of the first and second frames

Loading history of all frames was organized to apply target drift demands twice. Each repetition subset is considered as cycle groups. The displacement loading histories of all the frames were independent of the time and presentation will be done with consideration of the peak values only. The planned loading scheme could not be applied as planned in the first frame due to the testing difficulties and calibration need of the test setup. As it can be observed in Figure 3.1, first and the last cycle groups contain more than two complete cycles. The presented drift values in Figure 3.1 and Figure 3.2 are the absolute displacements of each story relatively to ground. The displacement loading history of the second, third and fourth frames consisted of six cycle groups and for the first stories they have reached to maximum of $\pm 20\text{mm}$, $\pm 10.5\text{mm}$ and $\pm 11.5\text{mm}$ displacement values, respectively.

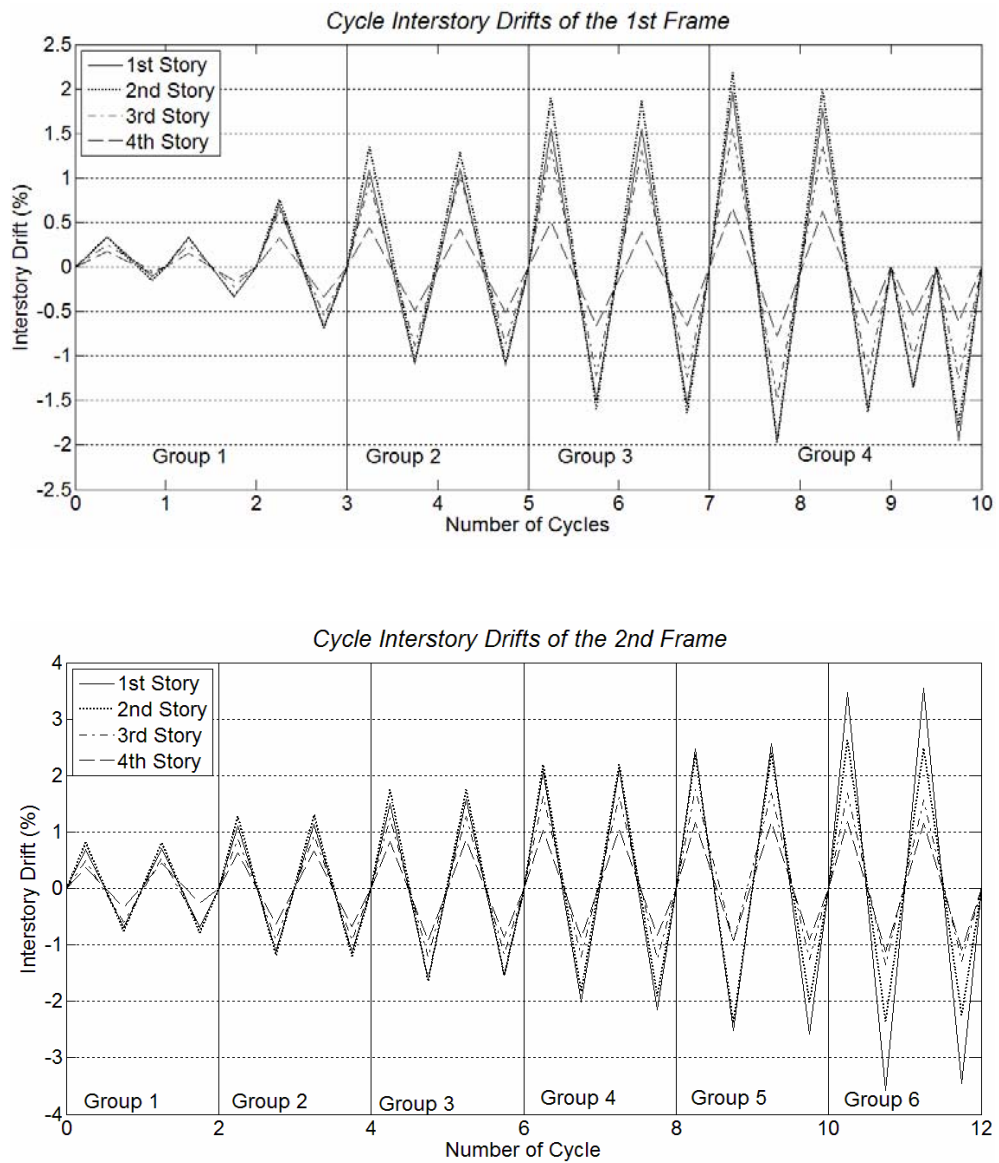
Inter-story drift ratios were chosen to be in incremental fashion. These were 0.7%, 1.1%, 1.5%, 1.9% and 0.7%, 1.1%, 1.5%, 2%, 2.5%, 3.4% on the first stories of first and second frames respectively, Figure 3.3 Initial inter-story drift ratios were chosen to initiate the cracks on columns. Following drift levels were selected to have

Figure 3.3. Inter-story drift ratios of the first and second frames

In order to show the demand for each story, inter-story drift ratios are calculated and presented in Figure 3.3 and Figure 3.4. It should be noted that rotations in the beam-column joints of the frames are not measured. Therefore, except the first story values inter-story drifts reported in the figure are not the exact values. On the other side, it is obvious that exact values are greater than or equal to the reported values.

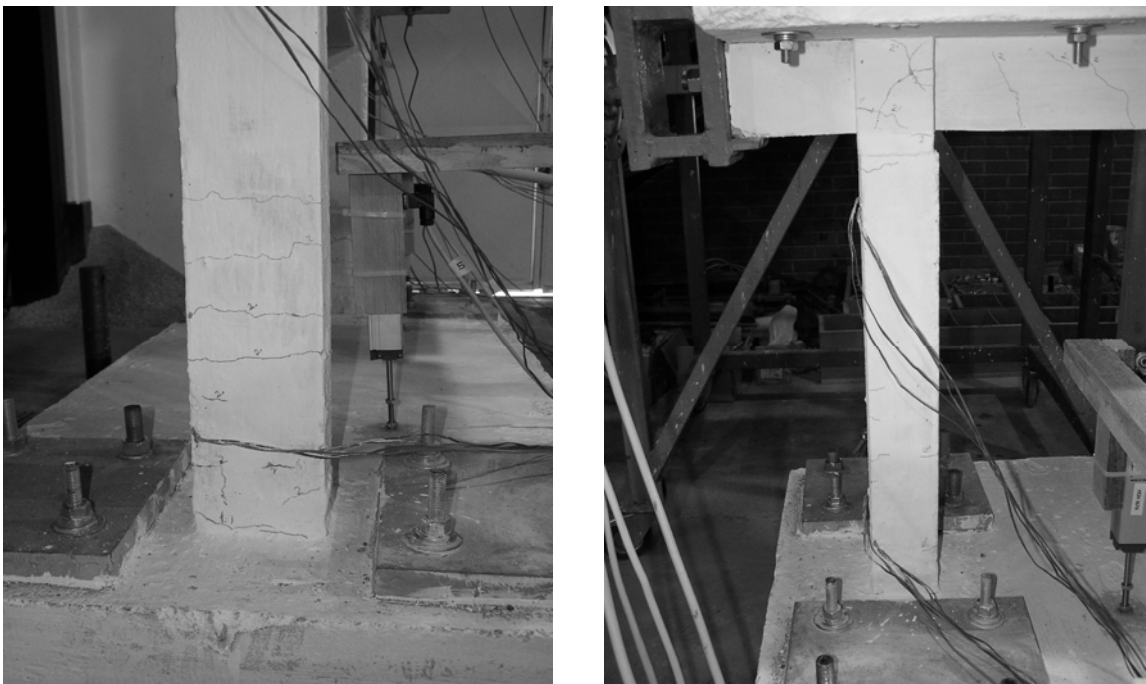
In the second loading group, inter-story drift of the first story reached a maximum of $\pm 6.5\text{mm}$ (1.1%) with 1450 kgf total lateral loading. At this stage of loading, hysteresis curves could still be accepted linear. Flexural cracks of first story columns were expanded to the span of columns. On the beam-column joint zones, shear cracks were appeared along the faces that are parallel to loading direction, Figure 3.10. Moreover flexure and flexure-shear cracks appeared on beams. Drift value at the fourth floor reached a maximum of 22.6mm.

Figure 3.10. Flexural cracks at the east face (left) and shear cracks at the north face (right) of the first story east column at the end of the second loading group

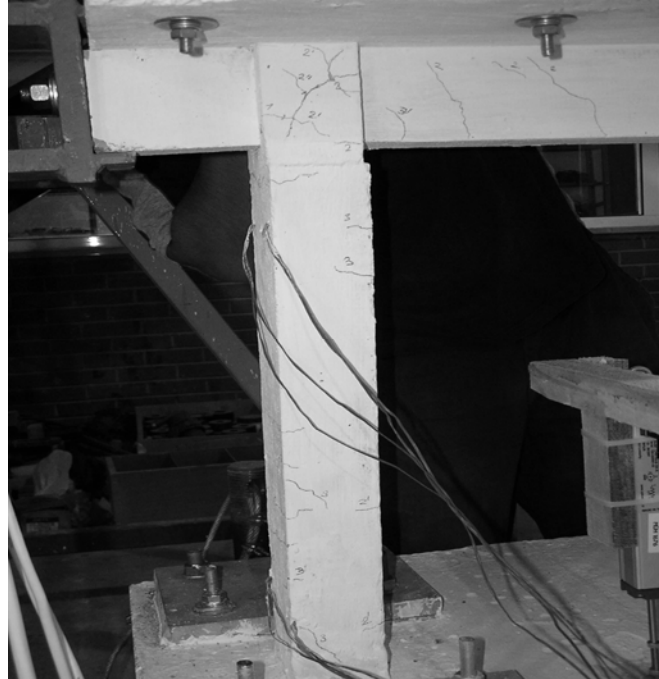
Figure 3.11. Cracks at the north face of the first story east column, at the end of the third loading group

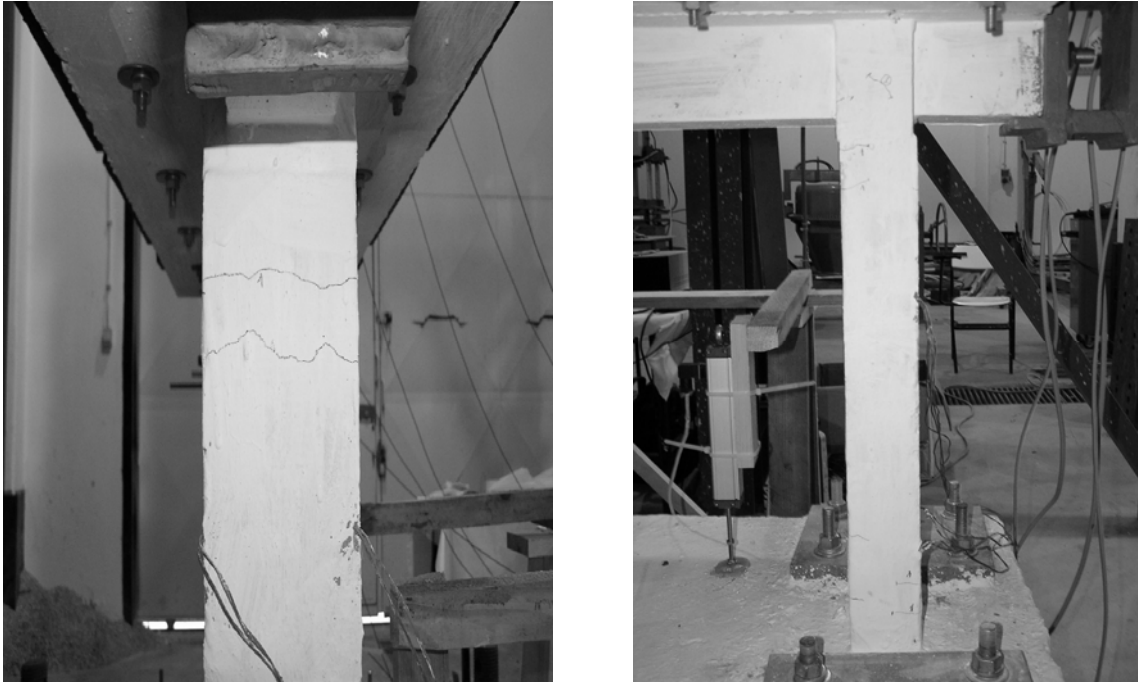
In the first loading group, inter-story drift of the first story reached a maximum of $\pm 4\text{mm}$ (0.7%) with 1120 kgf total lateral loading. Similar to the first frame even though the column section exceeded its flexural cracking capacity and had cracks, hysteresis curves can be accepted as linear lines, Figure 3.13. In addition to the flexural cracks, a shear crack initiation was also observed in the joint zone at the north face of first story east column, Figure 3.13. At this stage of loading, absolute drift of the fourth floor reached a maximum of 14mm.

Figure 3.13. Flexural cracks at the east face (left) and shear crack initiation at the south face (right) of the first story east column, at the end of the first loading group

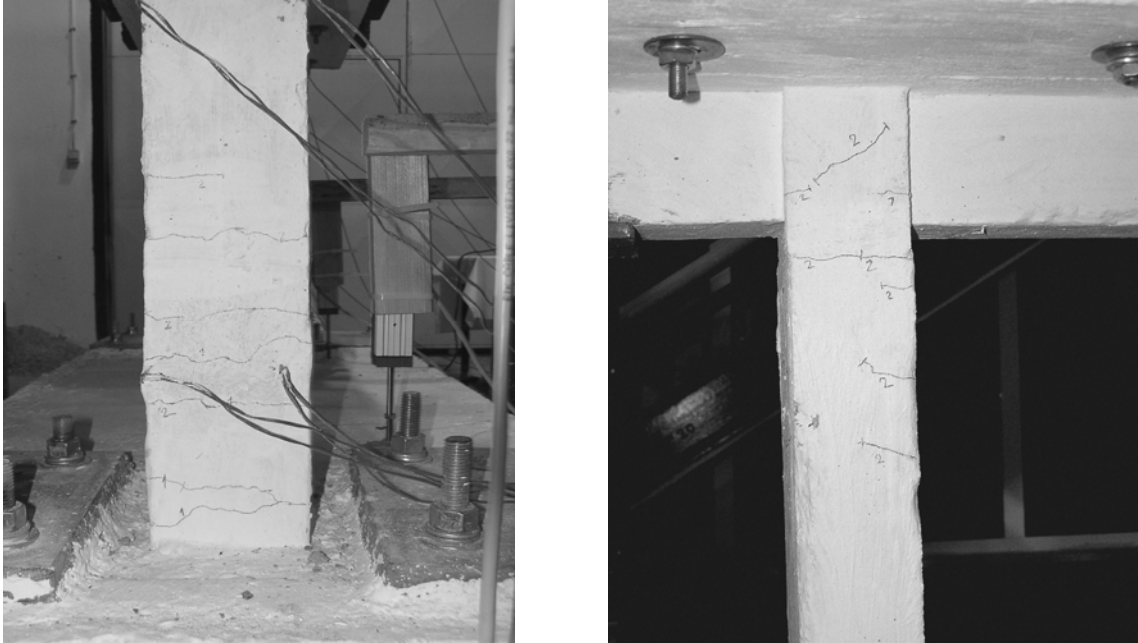
Figure 3.14. Spreading of flexural cracks at the east face of the first story east column (left) and new shear crack in the joint zone of second story north face east column (right) at the end of the second loading group

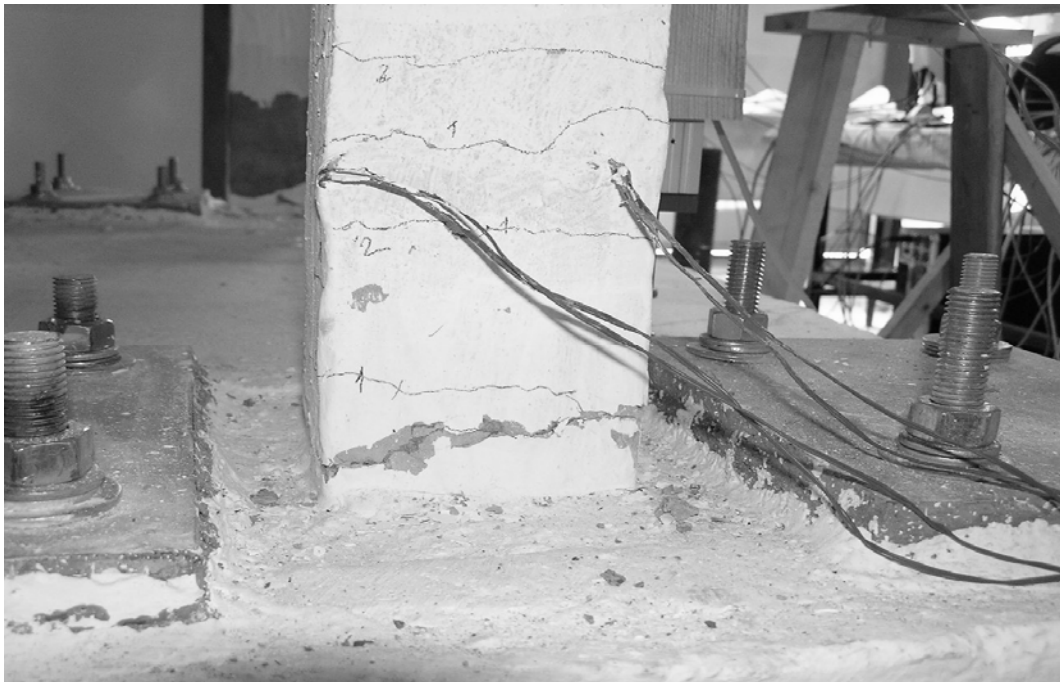
Figure 3.16. Crushing of concrete on the first story, east face of east column, end of the fourth loading group

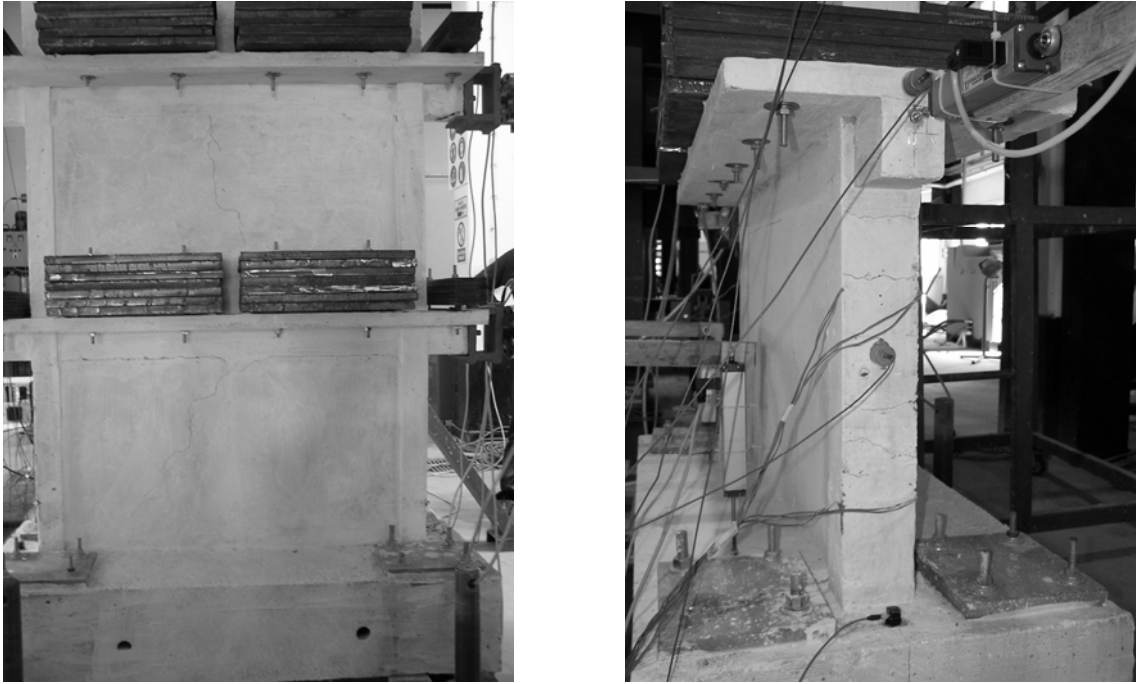
Unlike the first loading groups of first and second frames, the target inter-story drift of the first story is chosen to be $\pm 0.7\text{mm}$ (0.1%) for having an opportunity to observe the behavior of partition walls. Even at this low drift levels cracks occurred in the system. In the first and second story partition walls, diagonal cracks were observed, Figure 3.19. Separations occurred in the interfaces of partition walls and frame elements of first and second stories. Moreover, flexural cracks were also appeared in the first story west column, Figure 3.19. In this loading group a maximum of 2800 kgf total lateral load was reached on the first story. Finally the drift of the fourth story reached a maximum of 3.9mm.

Figure 3.19. Diagonal cracks in the first and second story partition walls (left) and flexural cracks of the first story west column (right), at the end of first loading group

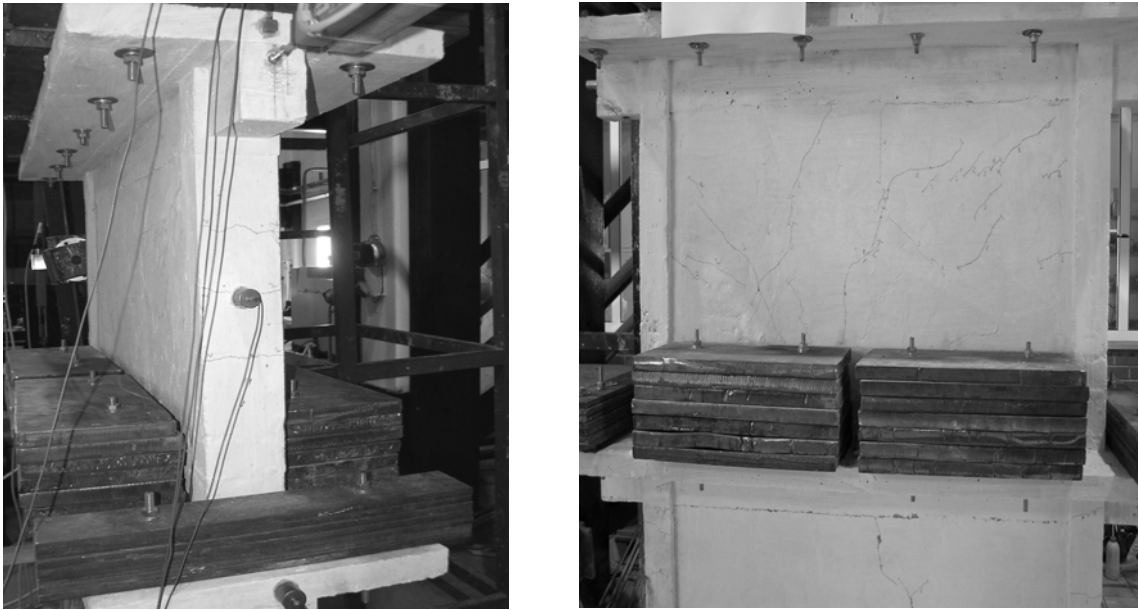
Figure 3.20. Spreading of flexural cracks in the west column (left) and shear cracks in the partition wall (right) of the second story, at the end of second loading group

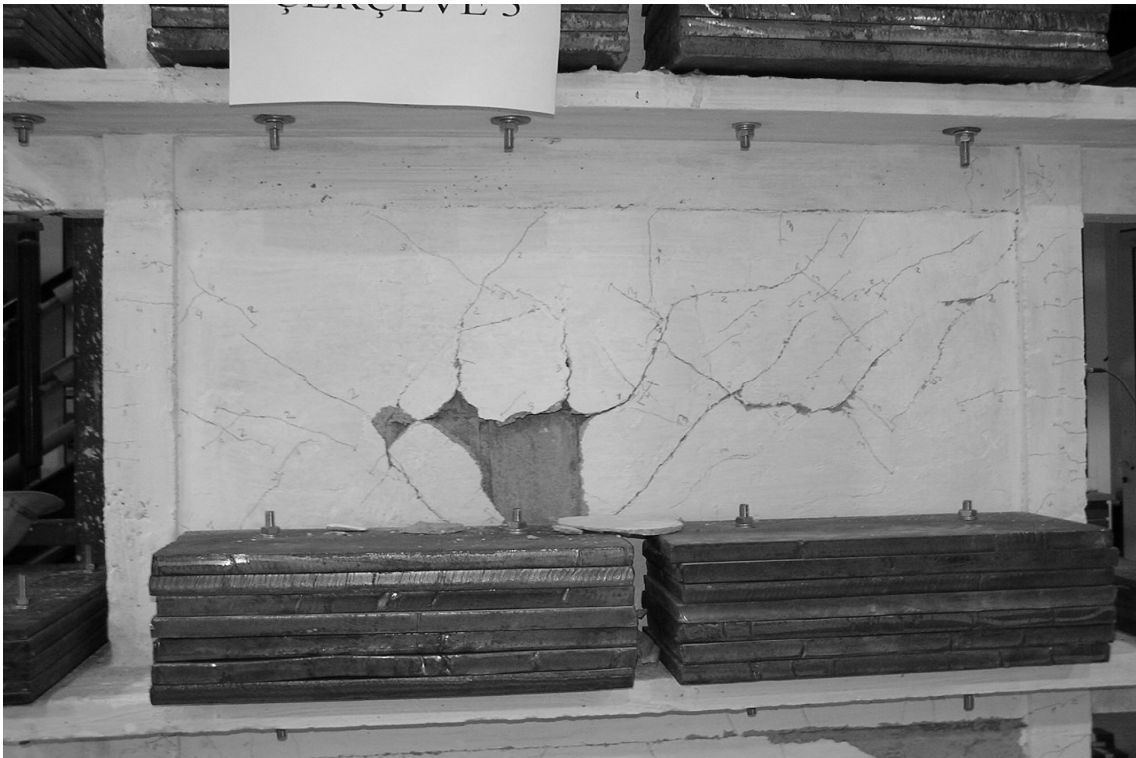
Figure 3.22. Spalling of the partition wall plaster in the second story north face

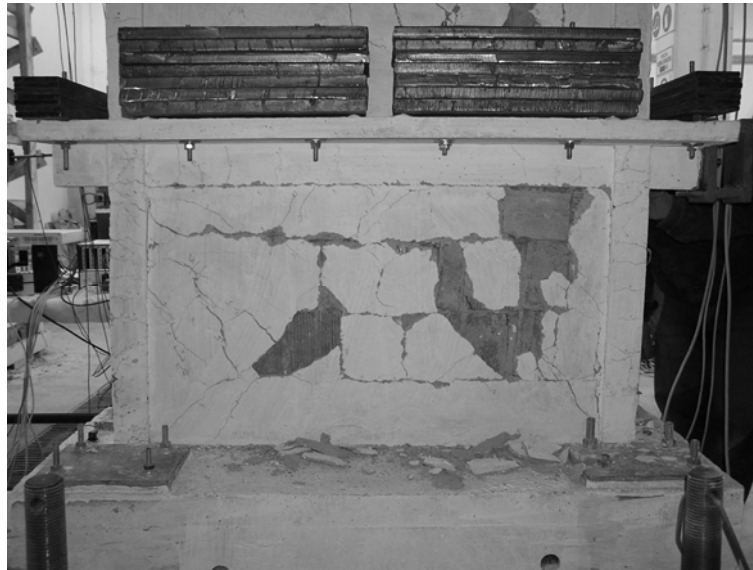
Figure 3.23. Residual deformation of the first story columns and the partition wall

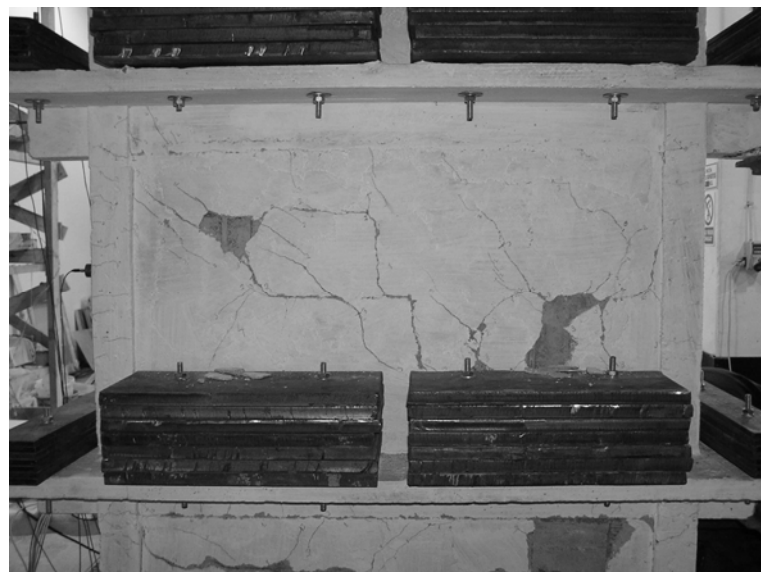
Figure 3.24. Residual deformation of the second story columns and the partition wall

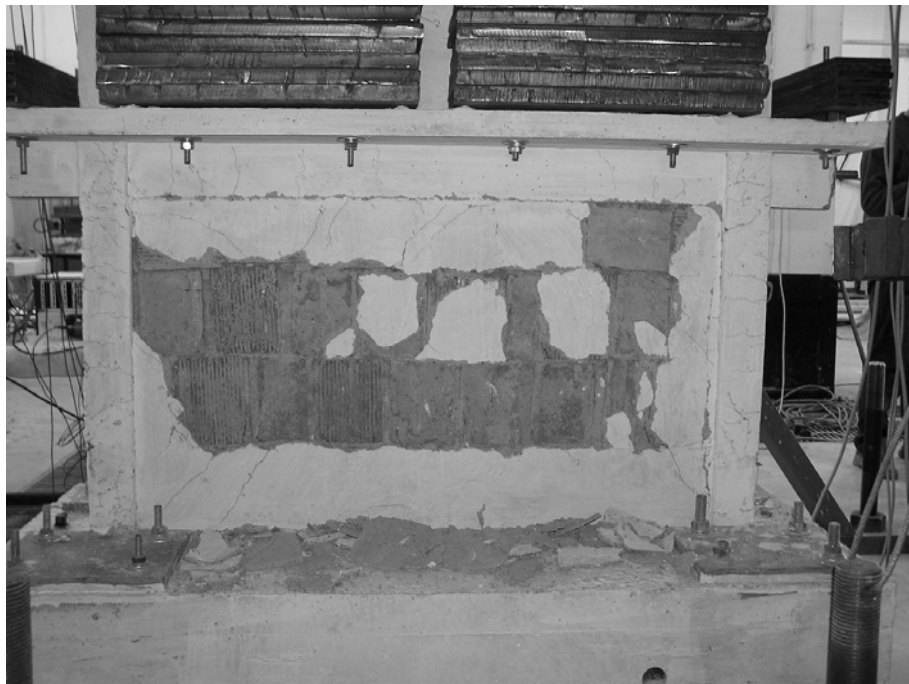
Figure 3.25. Damage of the first story at the end of the sixth loading group south face

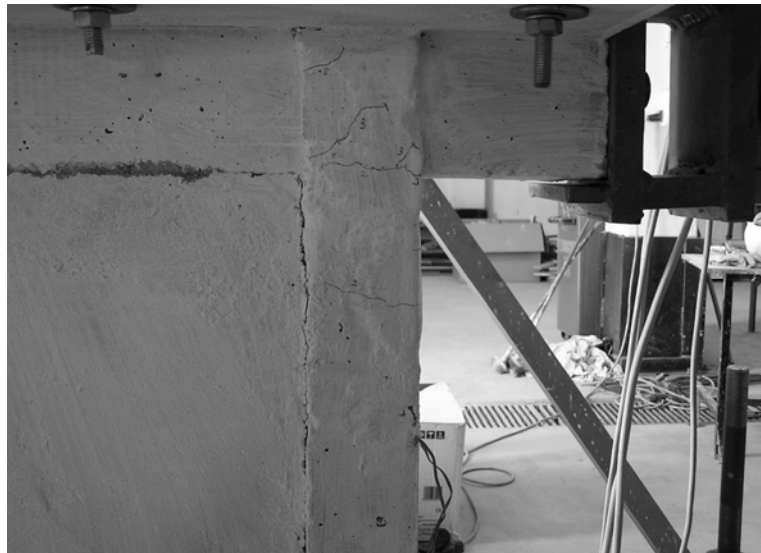
Figure 3.28. Damage in the joint zone of the first story at the end of third loading group, east column

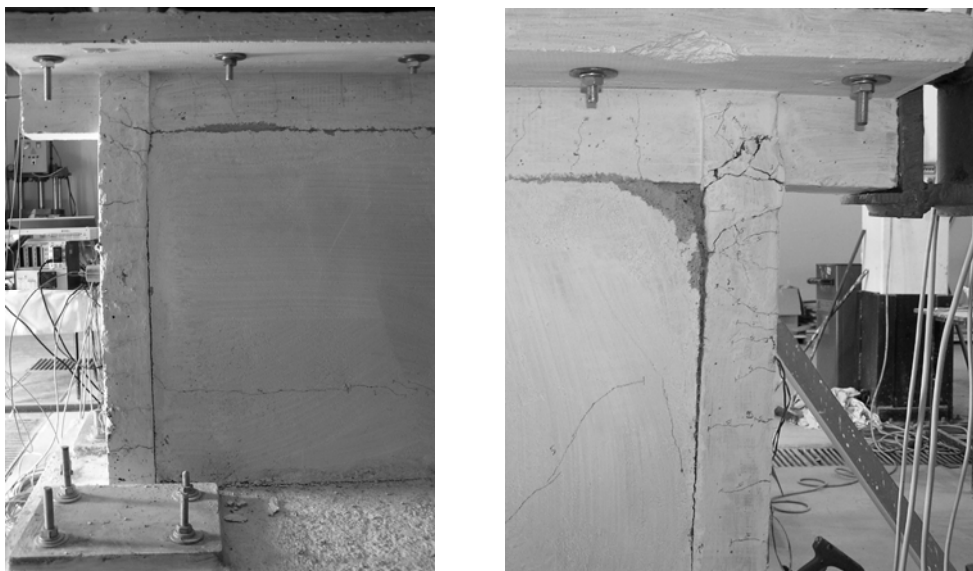
Figure 3.29. Damage in first story west column (left) and east column (right) at the end of the fifth loading group, south face

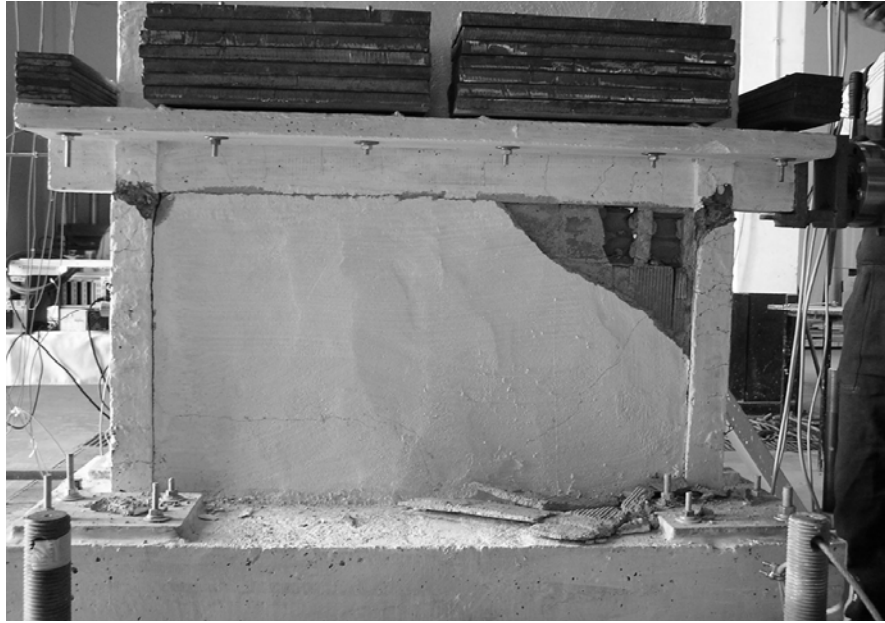
Figure 3.30. Damage of the first story at the end of the sixth loading group, south face
