**CONSERVATION PROBLEMS OF HISTORIC  
WALL PAINTINGS OF TAXIARHIS CHURCH  
IN CUNDA, AYVALIK**

**A Thesis Submitted to  
the Graduate School of Engineering and Sciences of  
İzmir Institute of Technology  
in Partial Fulfillment of the Requirements for the Degree of**

**In Architectural Restoration**

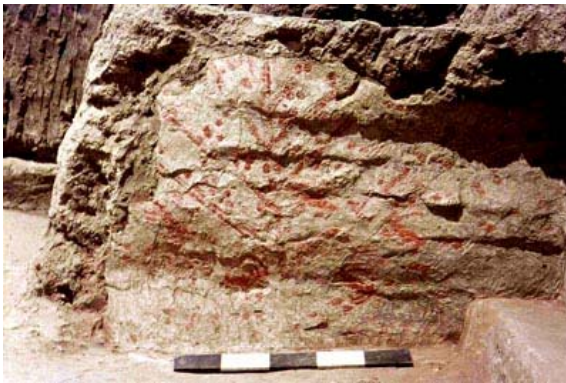
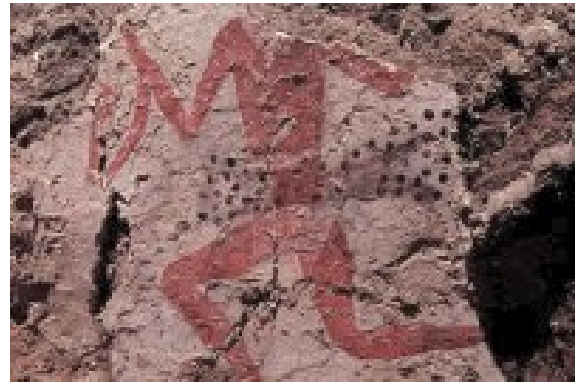
Figure 2.3. Wall painting from Çatalhöyük (Source: WEB\_3 (2005))

Figure 2.4. Wall painting from Çatalhöyük (Source: WEB\_4 (2005))

In Çatalhöyük wall paintings that dated back to the beginning of Neolithic period (6.000 B.C.) were applied on a clay based plaster (Figure 2.3, Figure 2.4). It can not be identified if any binding media is used in these paintings (Mora et al.1984).

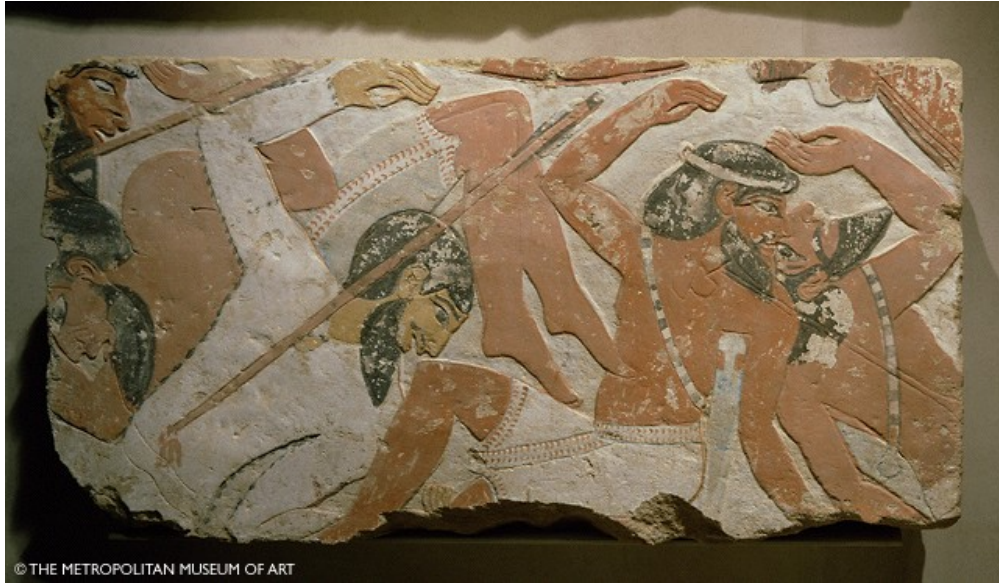
Figure 2.5. Wall painting from Egypt Thebes, Asasif (1400-1390 B.C.)  
(Source: WEB\_5 (2005))

In Egypt, wall paintings were applied on a one or two layered plaster according to the smoothness of the wall (Figure 2.5). Generally first layer of this plaster was composed of silk and the second layer was composed of gypsum that contains calcium sulphate and calcium carbonate (Mora et al.1984). Arabic gum, gelatine, egg white and beeswax are the defined binding medias used in Egypt (Boxall 1978).

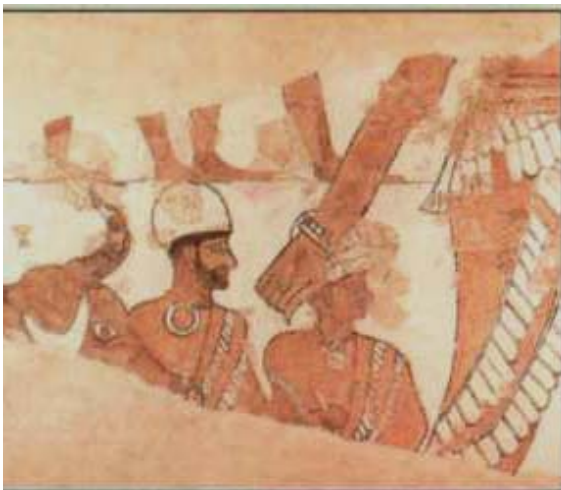
Figure 2.6. Wall painting from Zimri-Lim Palace, Mari (Source: Atlaslı büyük uygarlıklar ansiklopedisi)

Wall paintings of Zimri-Lim Palace (Figure 2.6) at Mari are dated to the beginning of the second millennium B.C. These paintings had been executed directly on a mud wall surface or mud plaster with straw covered with thin whitewash of plaster. The technique used in these paintings was most probably tempera. (Parrot 1958, Mora et al.1984). Wall paintings of Yarim-Lim palace (Figure 2.7) at Atchana which are roughly contemporary to Zimri-Lim Palace were applied on a two layered lime rendering. First layer (4-8 mm) was applied directly on brick wall surface or primary rendering of clay and finishing layer on this plaster was 1 mm. thick pure lime (Mora et al. 1984). The main contours of the painting were incised in the fresh plaster and the painting was executed a *fresco* with highlights a *secco* (Wooley 1955, Mora et al. 1984). According to this, paintings of Atchana can be evaluated as first known *frescoes* (Wooley 1955, Mora et al. 1984).

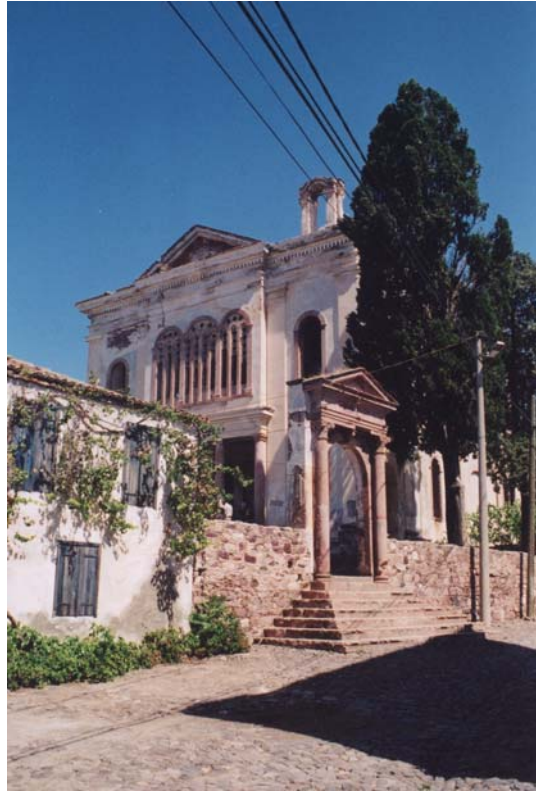
Figure 3.2. West Elevation of the Church

Taxiarchis Church was situated on Namık Kemal Street, No: 1657 in Cunda (Alibey) Island in Ayvalık. It is located in a high and wide courtyard which is in the middle of a historical district (Figure 3.1). The courtyard was bordered with streets on east, west and south directions and on the north side it is limited with historical houses. Entrance of the courtyard was raised by seven steps and emphasized with a fronton (Figure 3.2). There is a fountain on the west of the fronton.

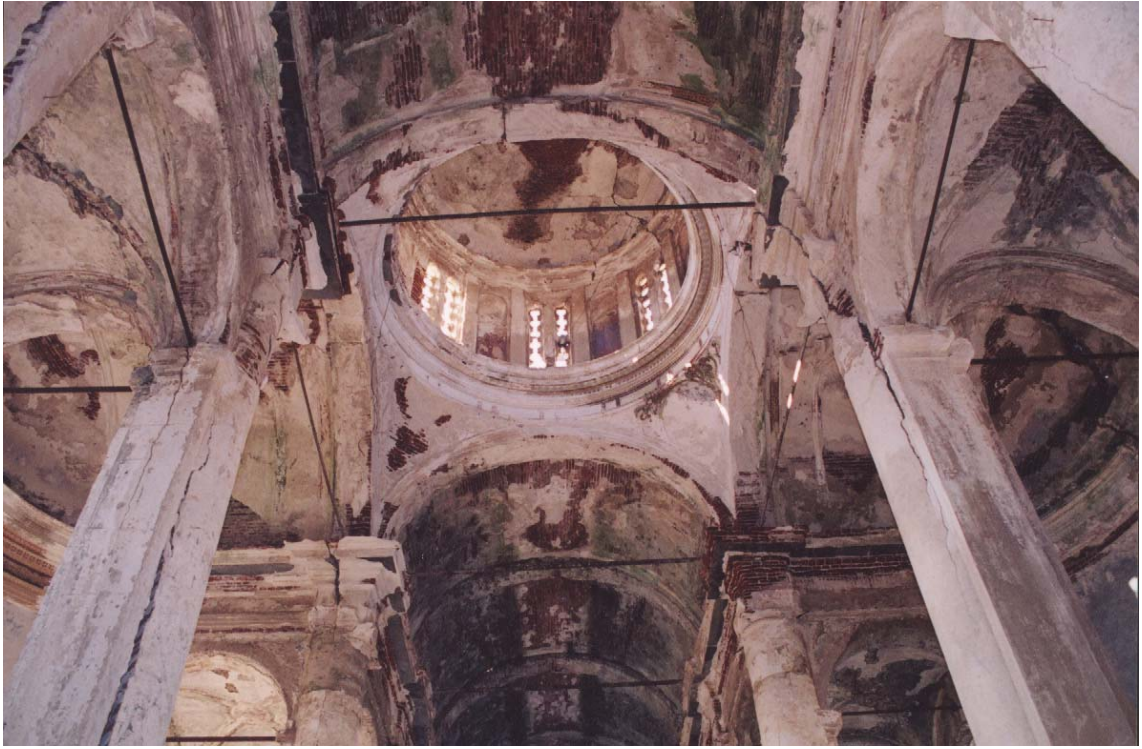
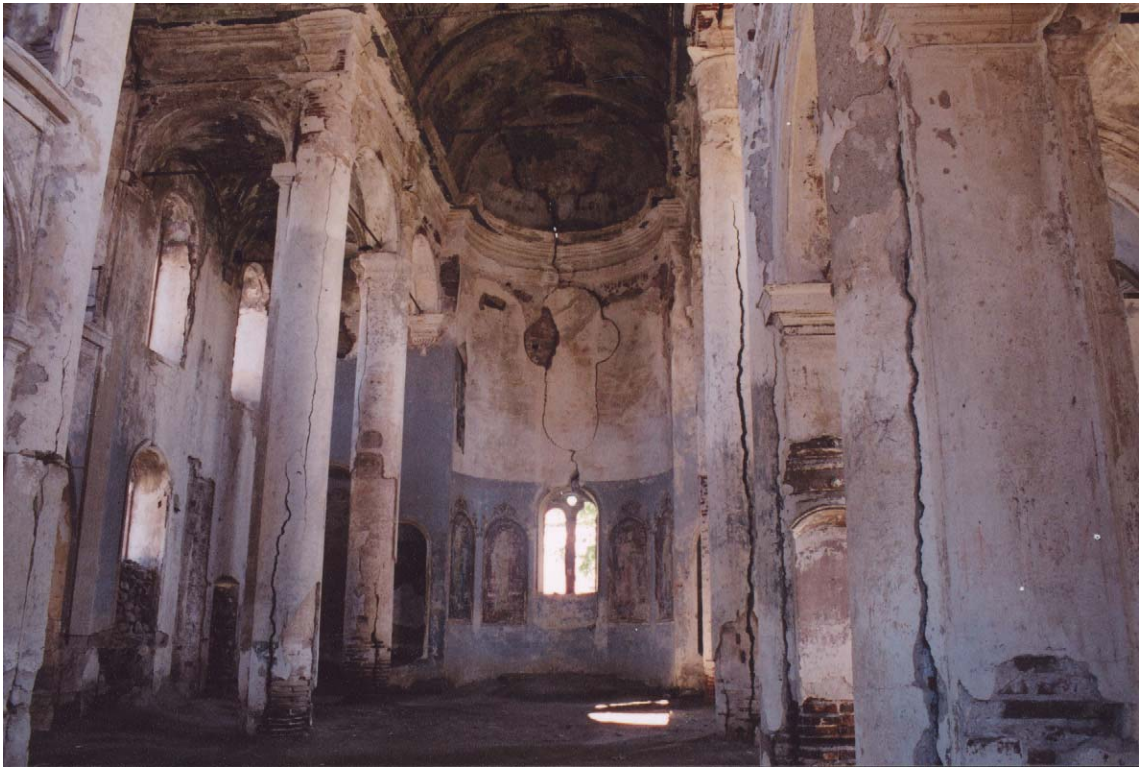
Figure 3.4. Interior views of the Church

observed (Figure 3.4). All of these structural problems and demolition of windows make the building open to rain water and caused dampness in the building.

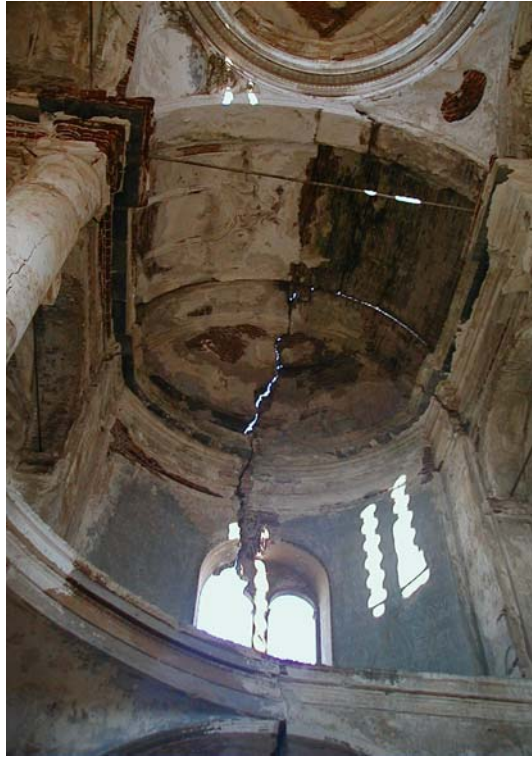
Figure 3.5. Interior view of the Church

Important structural failures appear in Taxiarchis Church. It is thought that structural failures became after the earthquake in 1944. And because of no intervention, these problems gradually increased. Severe vertical cracks in the columns of naos, and cracks (north-south direction) in semi domes of the arms of the cross were determined (Figure 3.5). Beside these, detachments in the barrel vault covering the naos were

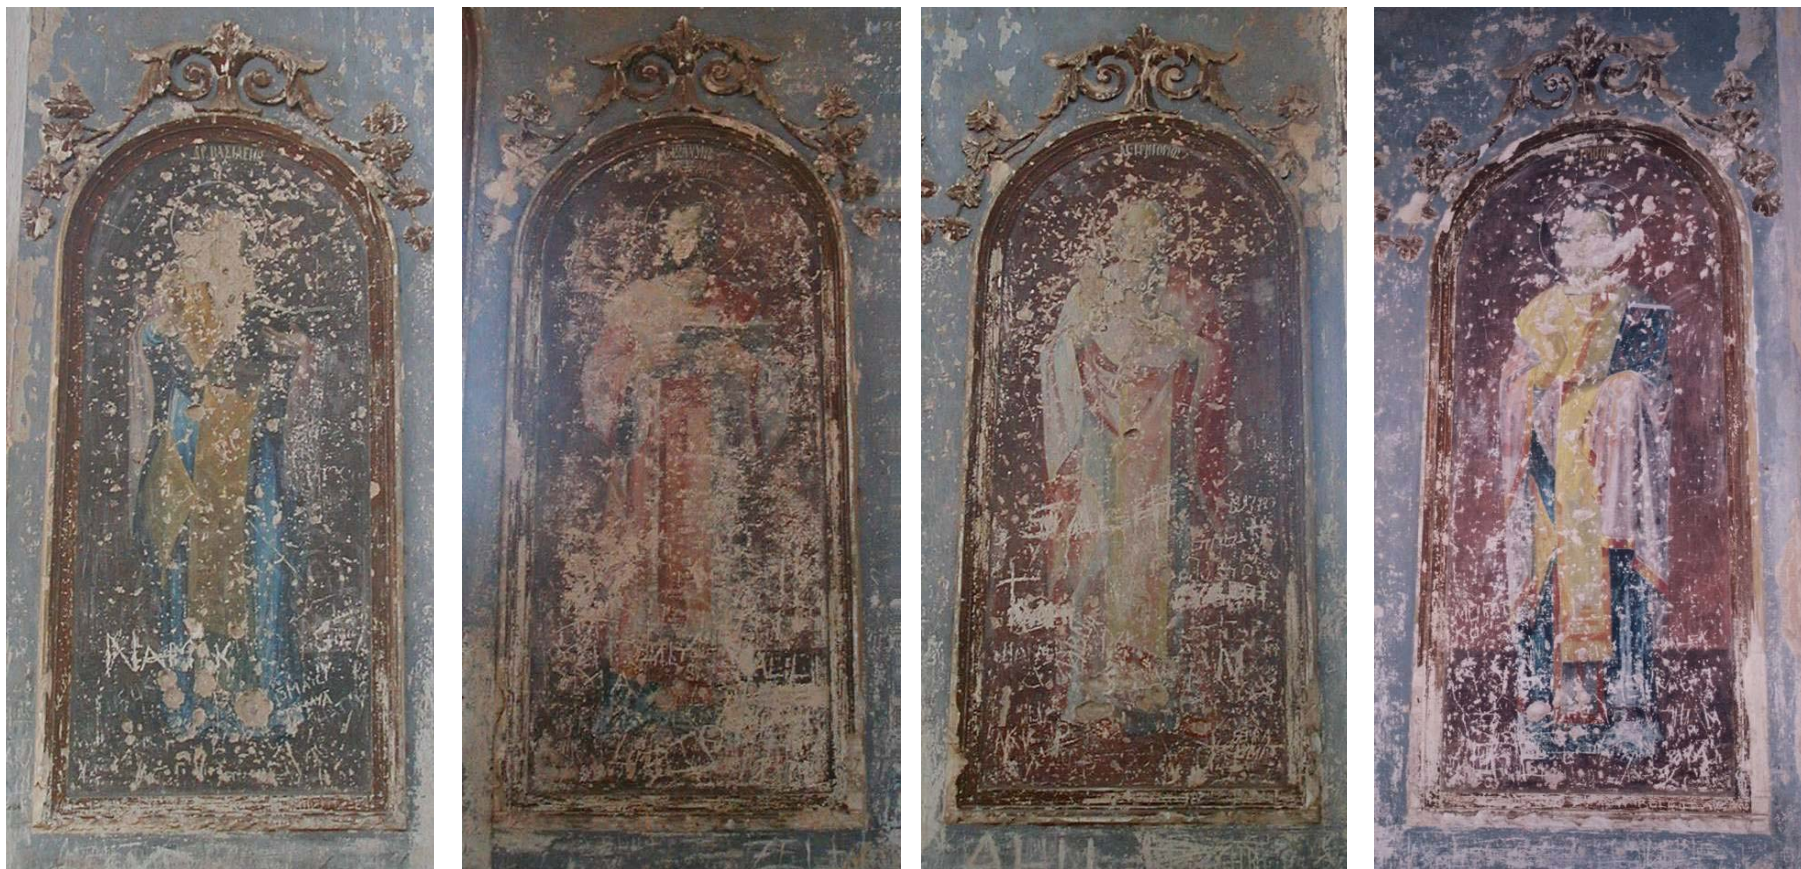
Figure 3.6. Paintings of four apostles on the wall of the main apse

In apse, paintings belong to four apostles are present. The one on the north is Petrus and the one on the south is Paulos (Figure 3.6). Other two apostles can not be identified. These paintings are surrounded by stuccos made of gypsum.

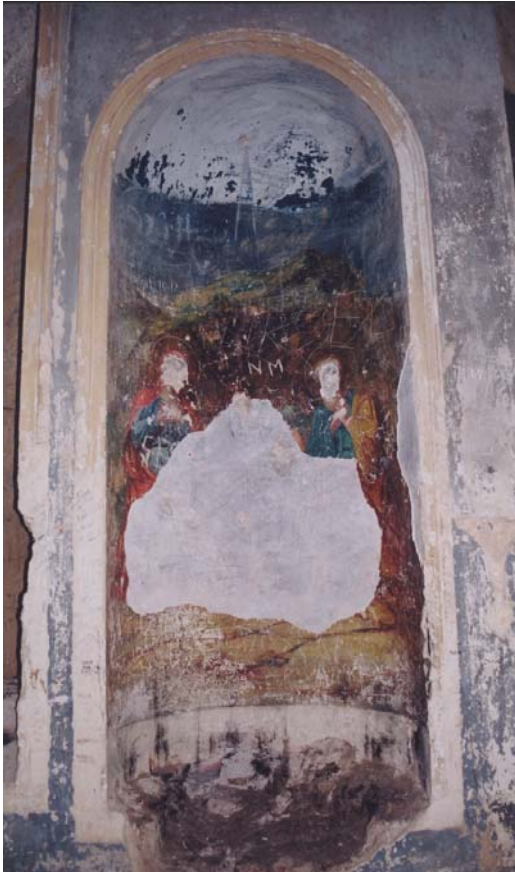
Figure 3.7. Painting on the niche on the north of the main apse

In the niche on the north of the main apse, the birth of Christ (Figure 3.7) and in the niche on the south of the main apse the baptism of Christ was painted (Figure 3.8). These two paintings show different characteristics from the other paintings on the point of their themes and deteriorations.

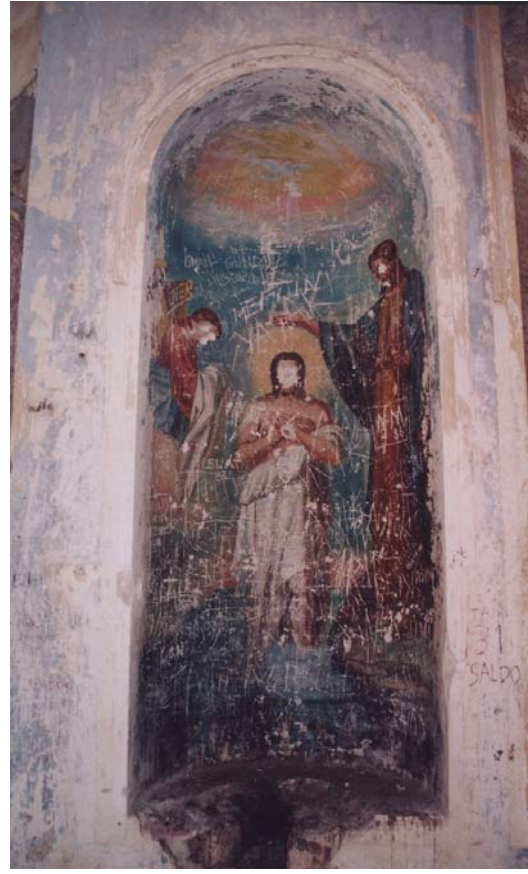
Figure 3.8. Painting on the niche on the south of the main apse

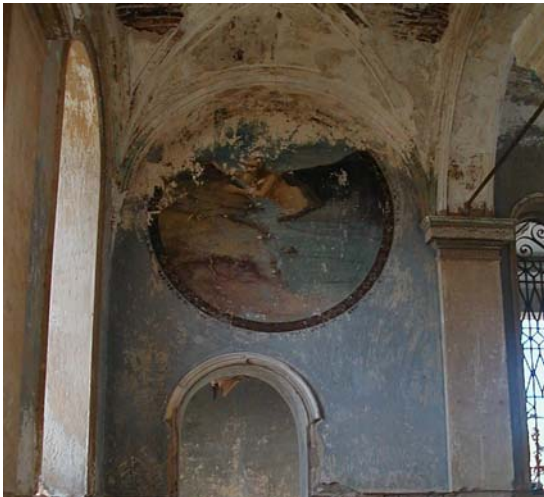
Figure 3.9. Painting over the doorway on the South of the narthex

On the doorway near two sides of the narthex two circular wall paintings exist, over the south door, landing of Prophet Jonah from the mouth of a fish (Figure 3.9) was painted. The painting over the north door is completely lost (Figure 3.10).

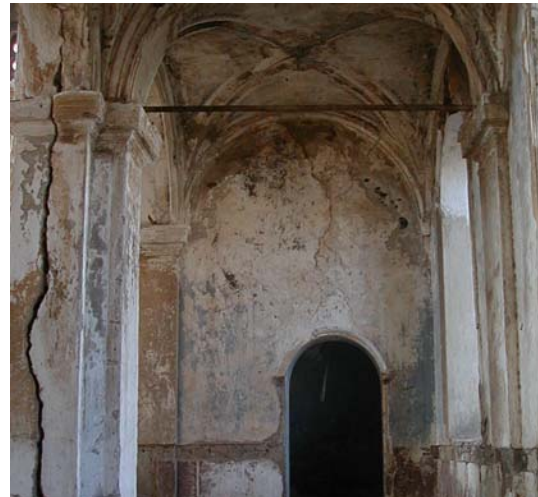
Figure 3.10. Traces of the painting over the doorway on the north of the narthex

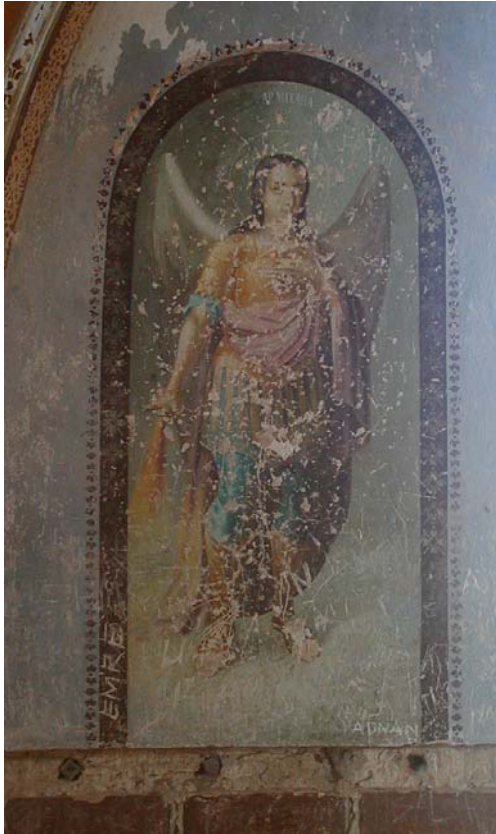
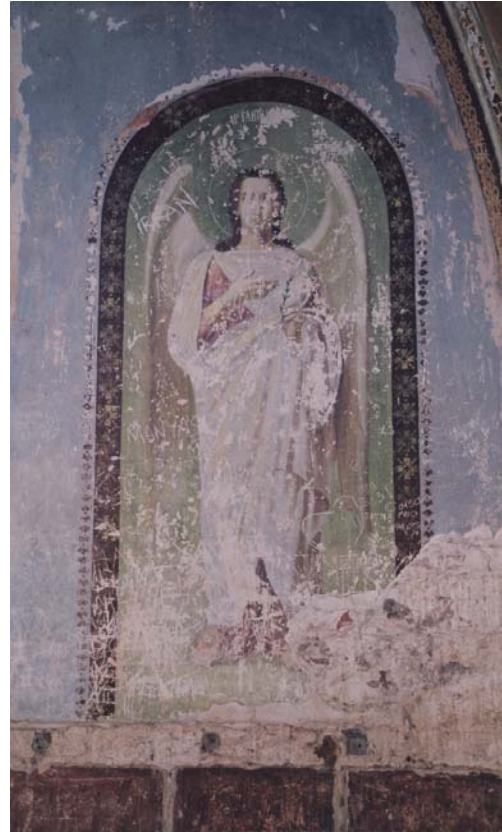
Figure 3.11. Paintings of the angels (Mikael on the left and Gabriel on the right) on the north arm of the cross

On the north arm of the cross, on the east of the window the figure of Gabriel, and on the west of the window the figure of Mikael was painted (Figure 3.11). On the south arm of the cross Emperor Constantine and Empress Helena were painted (Figure 3.12).

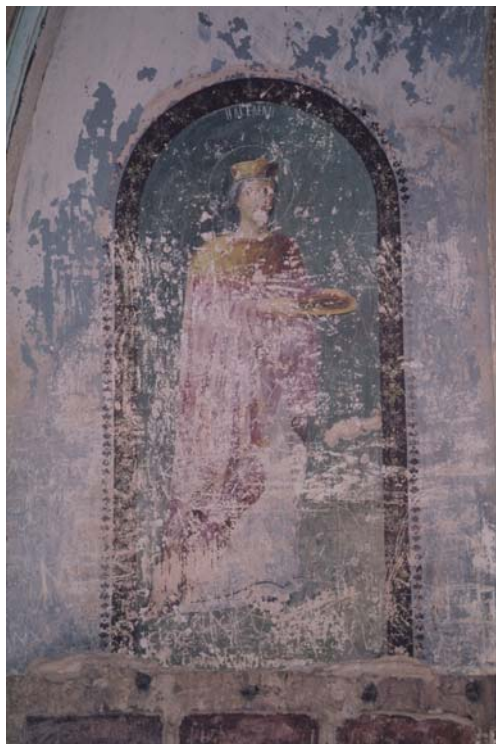
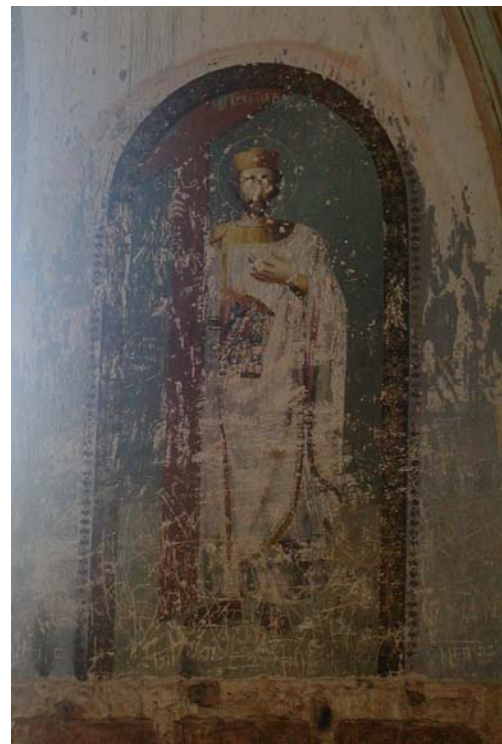
Figure 3.12. Paintings of the Empress Helena and Emperor Constantine on the south arm of the cross

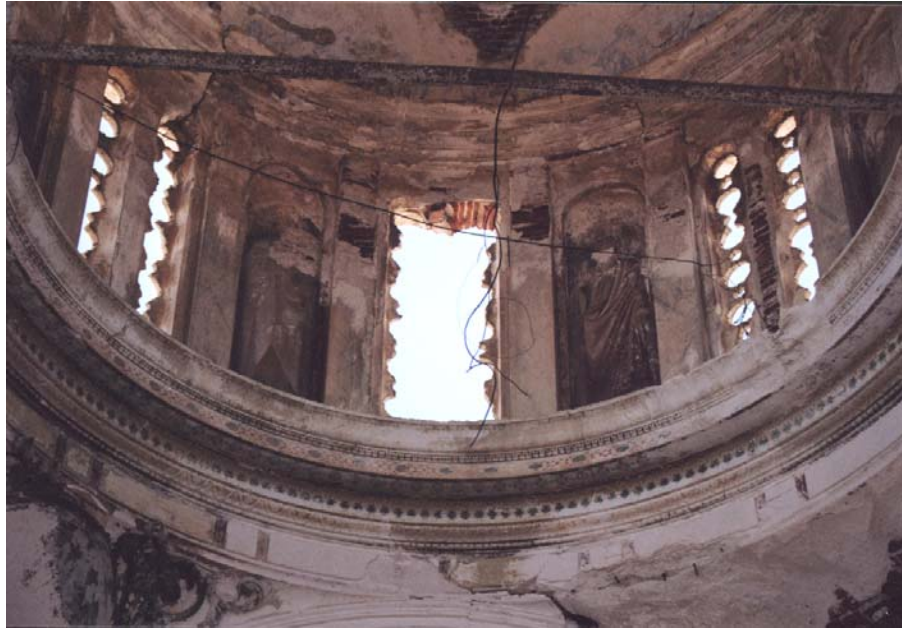
Figure 3.13. Wall paintings on the drum of the dome

Drum of the dome on the center of the cross was decorated with the paintings of apostles (Figure 3.13). Over the paintings on the main apse, remains of a painting on canvas exists. But it is demolished today and only a small part of it is present.

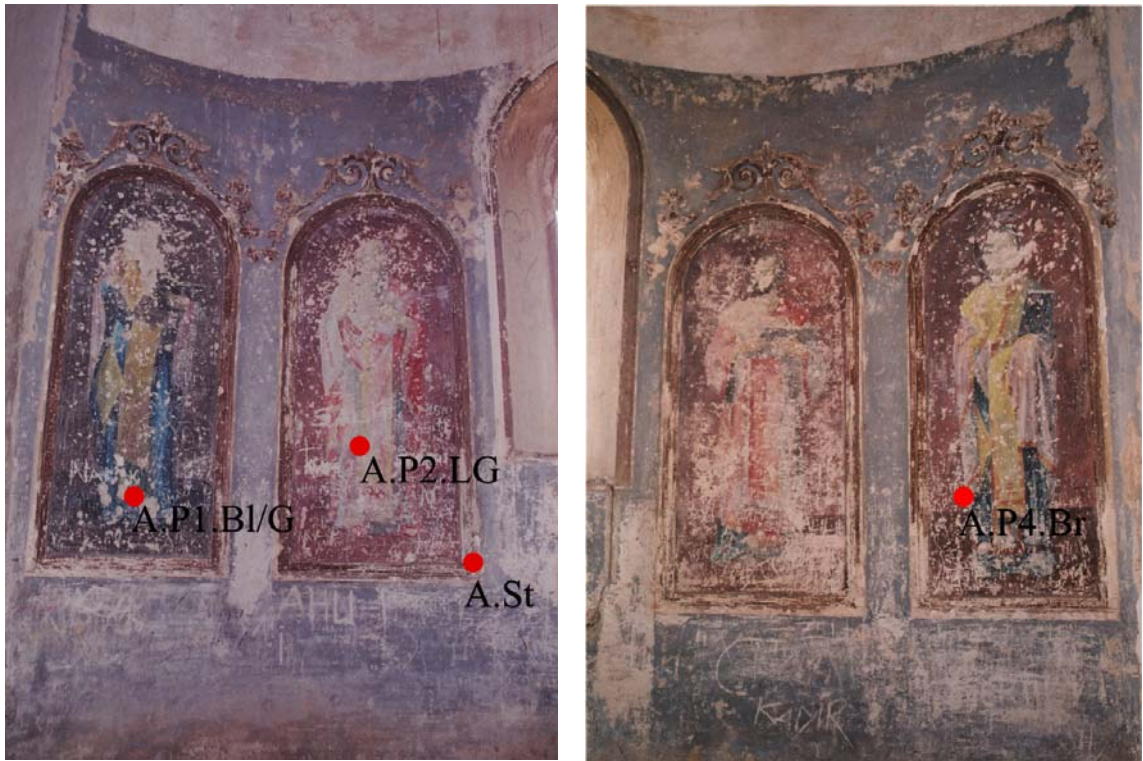
Figure 4.3. Painted plaster samples taken from the main Apse

Rough (arriccio) and fine (intonaco) plaster layers were collected from the apse and arms of cross, from sections near by the paintings, in order to determine their physical properties (Figure 4.2). Intonaco samples of the first periods paintings were collected from the main apse (Figures 4.2 and 4.3). Intonaco samples of the second periods paintings were collected from the niche on the north (Figures 4.2 and 4.4). Plaster layers lying under this layer are thought to be same with those belonging to the first period.

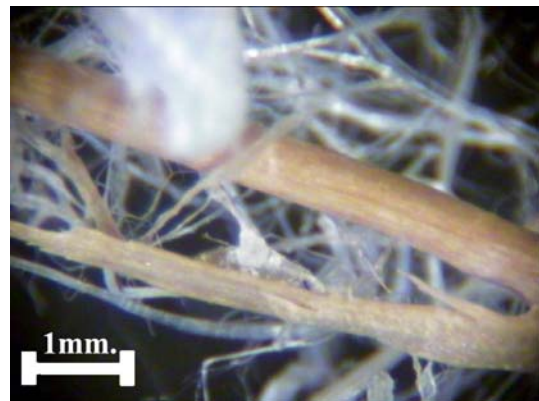
Straw from fine plaster sample C.Fp

Figure 5.2. Stereo microscope images of oakum and straw used in plaster samples

Bottom plaster layers used in Taxiarchis Church contain little quantities of oakum and straw pieces beside lime and aggregate (Figure 5.2). Lime/Aggregate ratios of bottom plaster layers are between 1/4 and 1/3 by weight (Figure 5.3). Upper plaster layers are basically composed of lime, oakum and straw pieces. Oakum and straw could be used in order to avoid cracks formation during drying and carbonation of the lime (Mora et al. 1984).

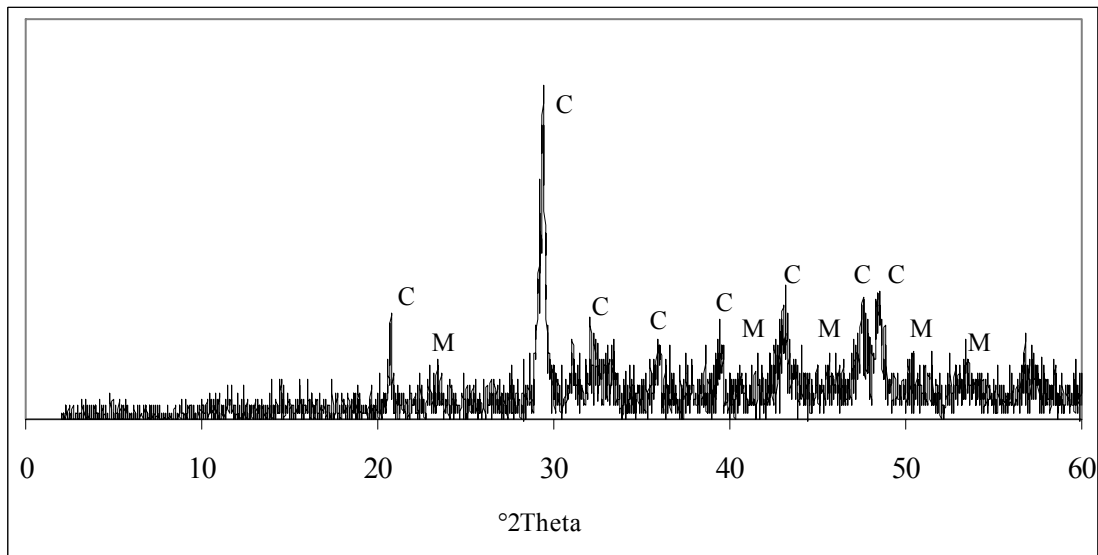
Mineralogical compositions of the fine plasters on which paintings were applied in two different periods were similar. Their XRD patterns show that they were mainly composed of calcium carbonate ( $\text{CaCO}_3$ ) and magnesium carbonate ( $\text{MgCO}_3$ ) (Figure 5.7).

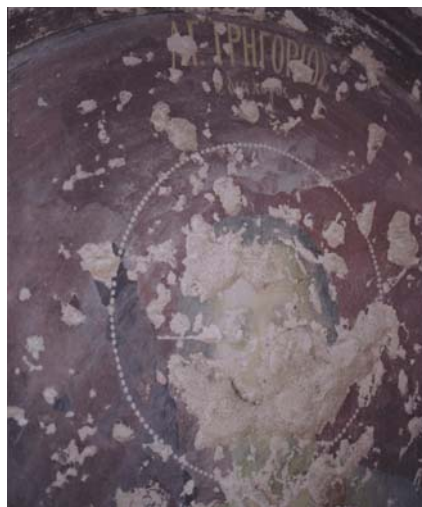
Figure 5.38. Loss of plaster and painting layer due to dampness in the painting no:4 on the main apse of the church

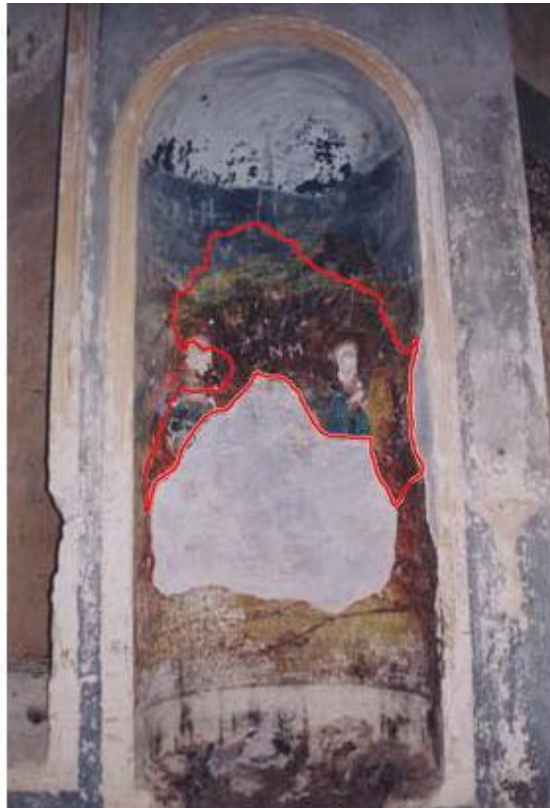
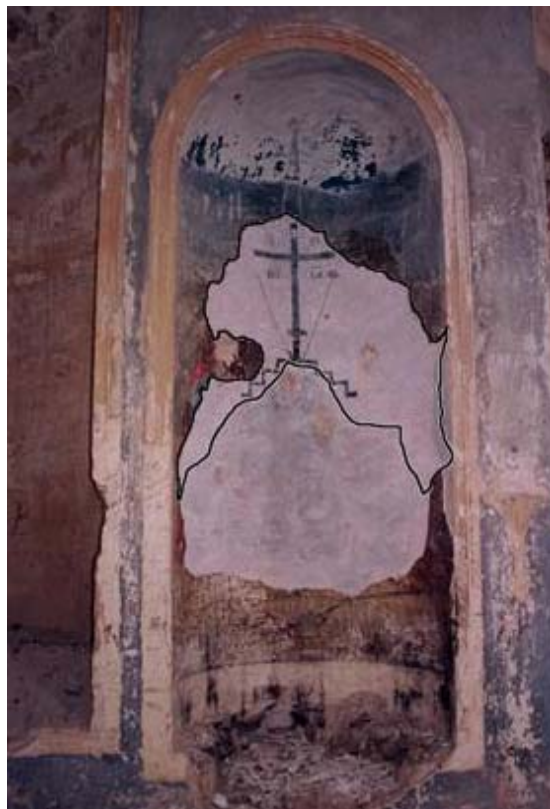
Figure 5.39. Loss of the paints due to the vandalism. Region bordered with red color was destroyed by human beings between 2003-2004 in order to discover the underlying cross figure

Vandalism is also one of the main problems that destroy the integrity of the paintings (Figure 5.39).

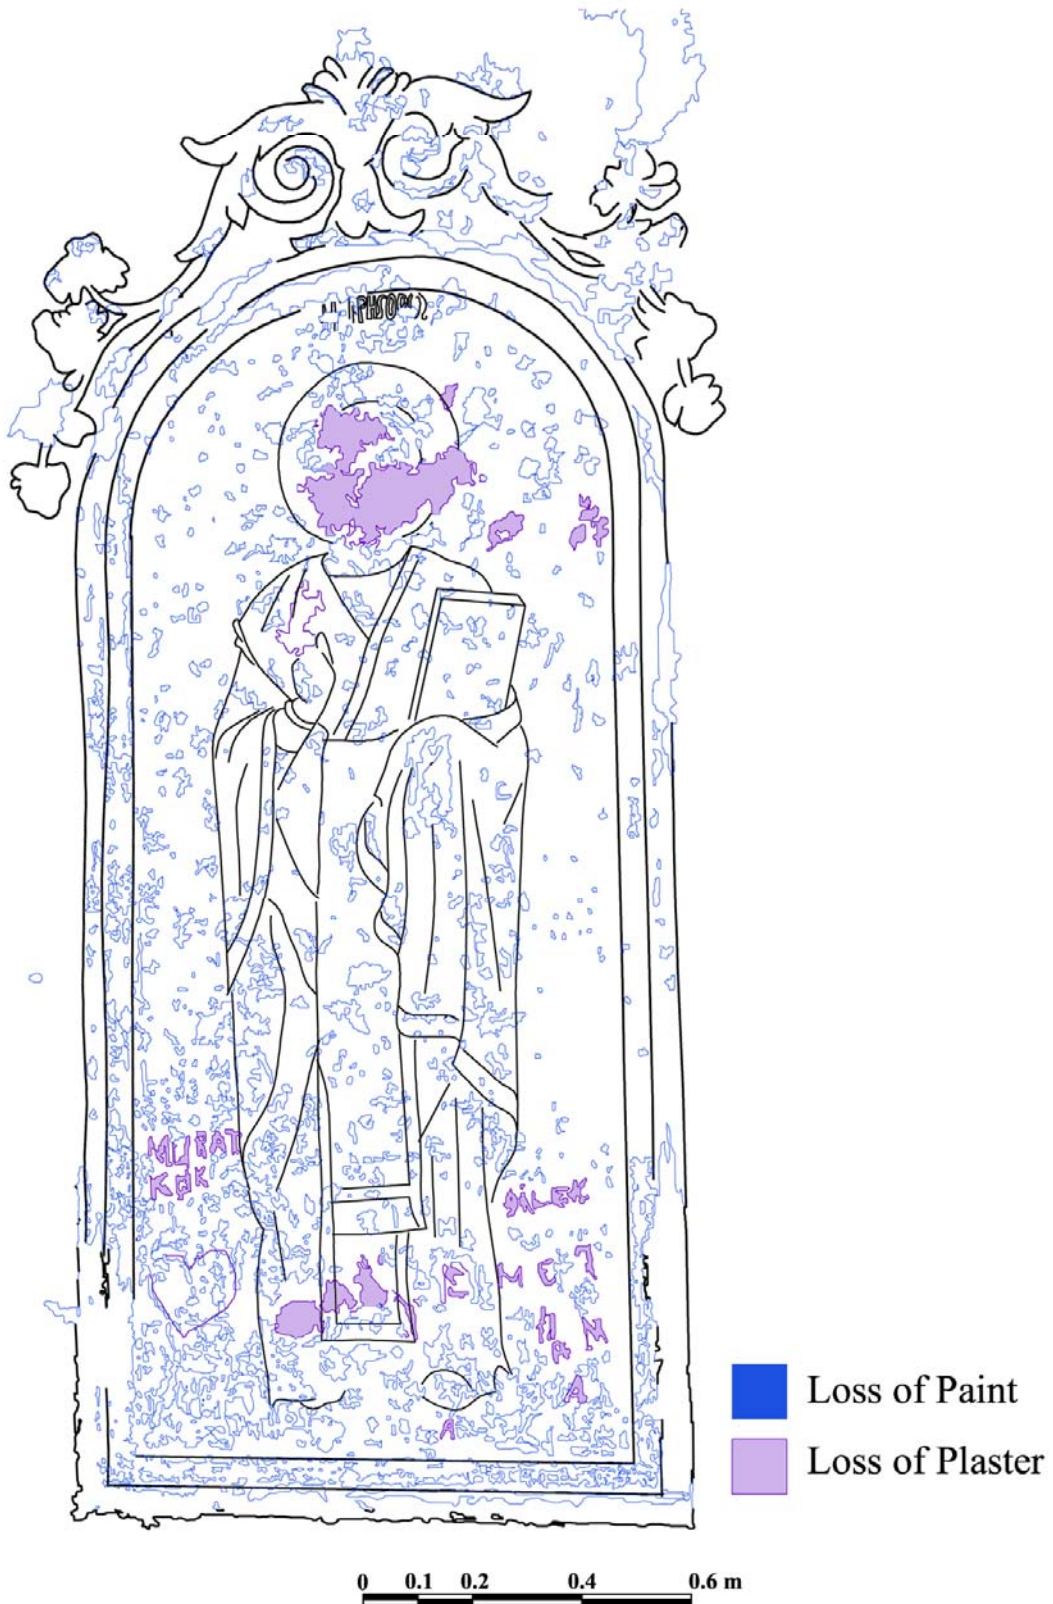
Figure 5.43. Measured drawing of the Apostle (no:4) painting on the main apse
