**MATERIAL CHARACTERISTICS AND
DETERIORATION PROBLEMS OF ROMAN
MOSAICS IN ANTANDROS ANCIENT CITY**

**MASTER OF SCIENCE
in Architectural Restoration**

**by
Ziřan KARAYAZILI**

**July 2013
İZMİR**

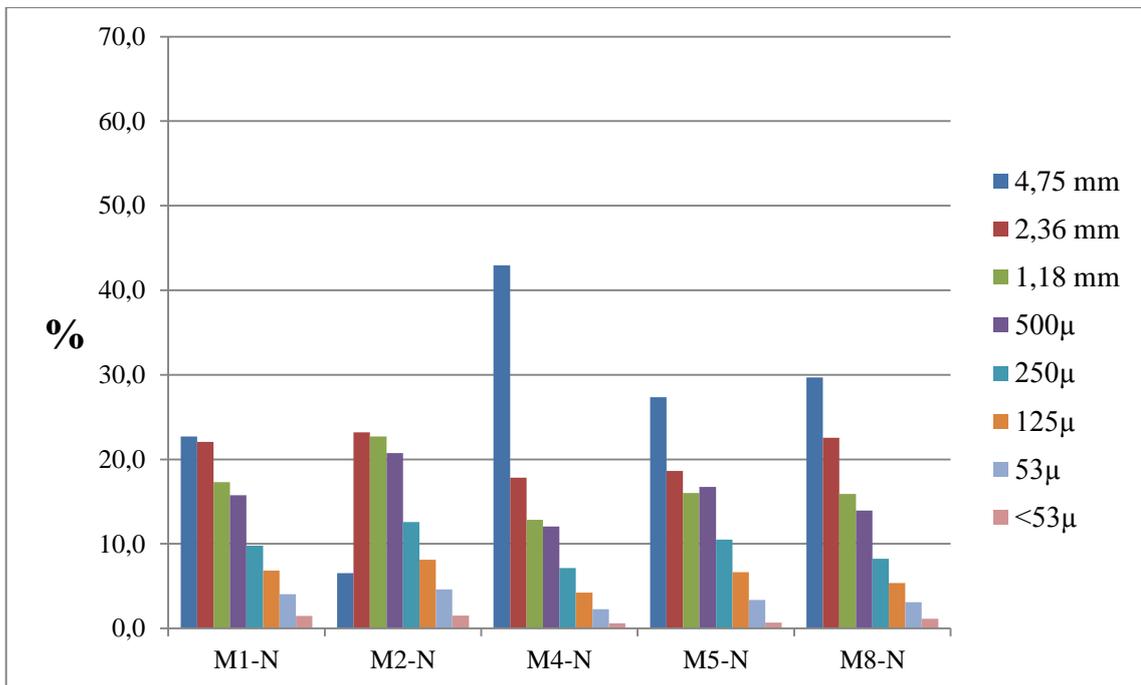
Figure 4. 6. Particle size distributions of aggregates of nucleus mortar layers

These results showed that although rudus and nucleus layer mortars were composed of nearly same aggregate/lime ratios, the manufacturing of mortars were not same when considering the particle size distribution of the brick aggregates in the mortars.

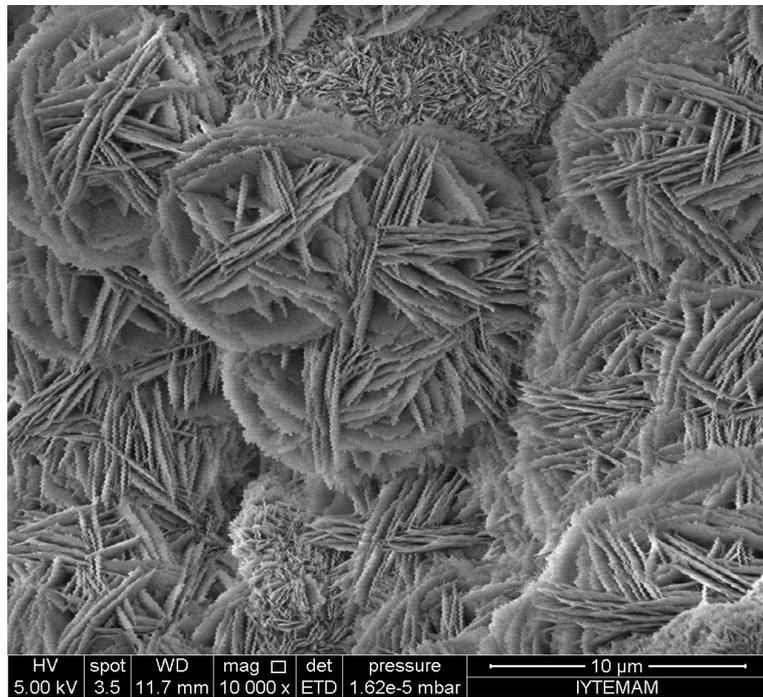
Figure 4. 21. SEM images of small size of tridymite crystals (10000x) in yellow stone tesserae

The microstructural analysis of white and grey limestone indicates that they were composed of mainly fine-grained calcite crystals (Figure 4. 18, Figure 4. 19). Different from the white and grey limestone samples, yellow and beige dolomite contain high amounts of tridymite crystals composed of a high-temperature polymorph of quartz minerals (Figure 4. 20, Figure 4. 21).
