**EVALUATION OF ARCHITECTURAL HERITAGE  
CHARACTERISTICS OF BEKİRBEYLER HOUSE  
IN KULA, MANİSA**

**A Thesis Submitted to  
the Graduate School of Engineering and Sciences of  
İzmir Institute of Technology  
in Partial Fulfillment of the Requirements for the Degree of  
MASTER OF SCIENCE  
in Architectural Restoration**

**October 2013  
İZMİR**

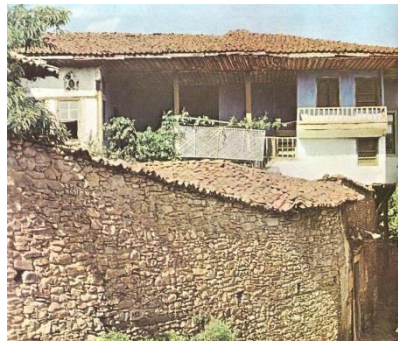
Figure 3. A view of an exterior hall from street in Kula  
(Source: Mutlu 1975)

The instinct to get intertwined with nature show itself with exterior hall. A room should be closed as it is a living unit, but the hall to which the room opens can be considered as an outdoor space although it is sheltered towards strong winds (Günay 1999).

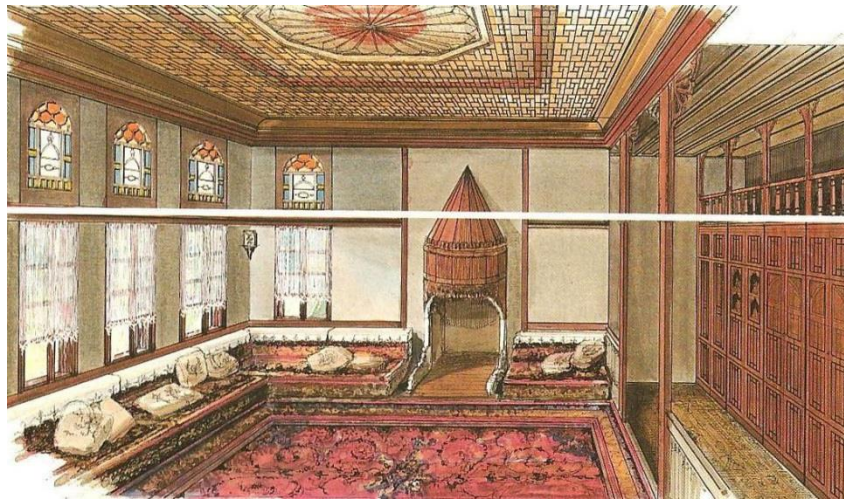
Figure 5. A traditional room scheme  
(Source: Küçükerman et al. 1995)

The room and the hall (*hayat*) was the essence of the traditional Ottoman dwelling concept with its spatial and functional organization. It expresses the deepest sanctity of the family and reflects an original aesthetics for the shaping of the immediate surroundings. The room's repetitive principal elements, its form and general dimensions defined a clear dwelling style. A room was an undifferentiated space in most of the housing traditions. It was for living, gathering, reception, eating and sleeping purposes. In each household, there are functional priorities attached to each space. There is no morphological and functional specificity among the rooms. The room is covered with rugs. One sits on a quilt, whether on the *sedir* or on the floor. For eating, a small stol (*sofra iskemlesi*) is used, on which a very large tray (*sini, tepsi*) in copper and everyone can sit on the floor around the tray and eat their meal (Eldem 1968, Kuban 1995, Günay 1999, Küçükerman 2007).

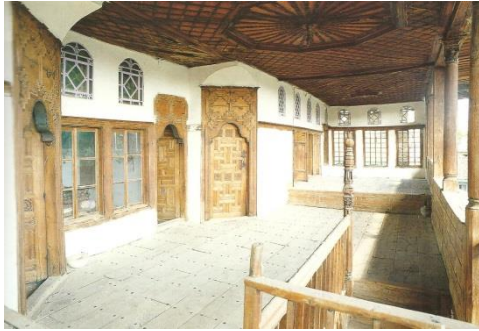
Figure 11. A view from hall of Beyler House, Kula  
(Source: Günay 1999)

A large shaded gallery was an extremely convenient space to be used for agricultural aims. It is connected with both the first and ground floors, and with the vertical circulation of the house. The *hayat* was the only living facade of the houses in the early period. The hall developed its own secondary spaces for more specified

functions in an extended area. In addition to the main *eyvan* one side of the hall can also be elevated and used as a sitting area closer to the courtyard and with a better vista. These parts were separated from the hall either in the form of a recess (*eyvan*) in between the row of rooms or in the form of a projection (*köşk*, kiosk) added to the front of the hall. The open *kiosk* was transformed into a room facing the garden (Eldem 1968, Kuban 1995).

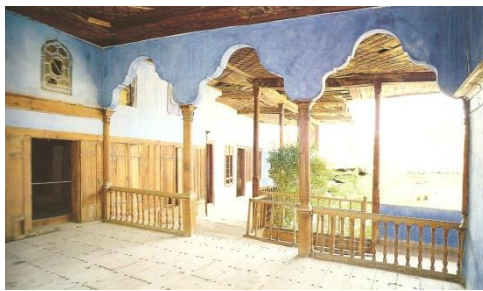
Figure 14. A view *eyvan* in Kestaneciler House, Kula  
(Source: Günay 1999)

In addition to its function of circulation, the hall served similar functions like the room. The secluded parts of the hall, which were free from circulation, were used for sitting. The hall was also used for sitting, working, entertaining guests, sleeping in summers. Some of these houses have fireplaces on halls, so they were used as open kitchen areas. Many halls have a small wash basin, combined with the balustrades, served for ablution. The hall was also a common practice to dry fruits on its floor. The ideal form of *hayat* cannot be thought without the *eyvan*. The hall was like an extension of the room or other spaces. Considering the reverse, the *hayat* is the extension of this rectangular recess or the *eyvan* can be interpreted as a spatial extension of the semi-open gallery towards the house interior. The *eyvan*, as the most isolated part of the *hayat*, was the natural area for sitting. Functional differentiation by typology was not a strict rule in these houses (Eldem 1968, Kuban 1995).

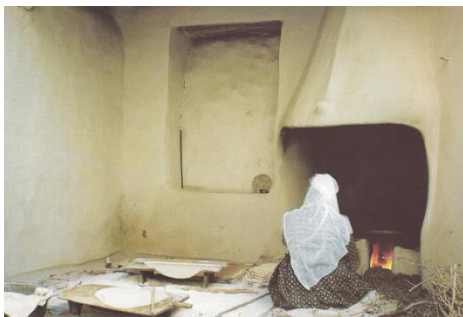
Figure 16. A view of kitchen in a house  
Balaban, Malatya  
(Source: Kuban 1995)

The kitchen (*mutfak*, *matbah*); was usually a working place of a woman's daily household activities consonant with the nature in the open air. Frequently the kitchen took the form of a masonry building in the courtyard, detached from the house as a precaution against the risk of fire. Generally a kitchen is a large, longitudinal, unadorned room with a rough stone pavement (*taşlık*) and a large fireplace which has one or many *ateşlik* (hearth). Their connection to the house is through the open courtyard. In the large houses the *mutfak* was integrated into the ground floor, opening through a separate door on to a secluded section in the garden, because the *mutfak* was a private domain belonging to the women (Kuban 1995, Berk 1995, Altiner and Budak 1997).

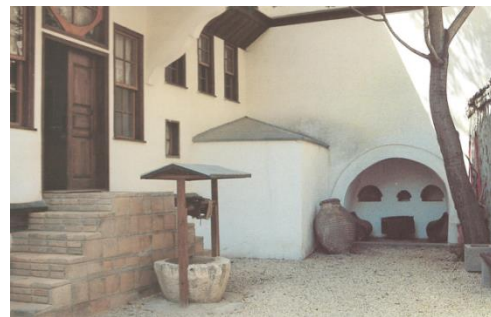
Figure 17. A view of kitchen of  
Hezarenler House, Amasya  
(Source: Kuban 1995)

It may have a long working table and large earthenware jars often connected with storerooms, granaries, pantries and other service rooms. The meals were cooked in the *mutfak* but never eaten there. So its windows do not have glass but can simply have wooden grills. In a traditional house, the multifunctional room was generally also the dining room. There are summer and winter kitchens in large mansions. The summer kitchens were simply working areas in the shade without walls. In houses with vineyards, a special room as large as a kitchen was assigned for squeezing the grapes to

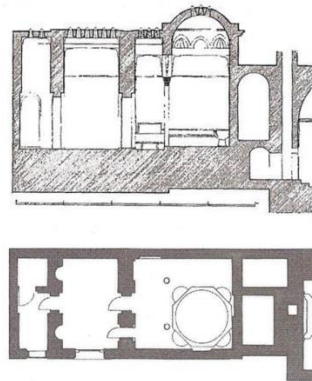
Figure 20. The bath plan and section of Zarif Paşa Yalısı, İstanbul  
(Source: Kuban 1995, Altıner and Budak 1997)

The standard lavatories (toilet) of the houses were composed of two rooms, one the lavatory proper, the other for a wash basin. They had practically standardized marble elements for the lavatory and for the basin. In wealthy houses, the wash basin had an elaborate fountain head as a decorated large panel. The lavatory walls also had a high marble dado around the marble stone of the latrine. To use the lavatories it was customary to wear high heeled sabots. In Anatolian houses the bath, the kitchen and the '*firin*' (for baking bread) may be composed as a single, independent building in the courtyard (Kuban 1995, Altıner and Budak 1997).

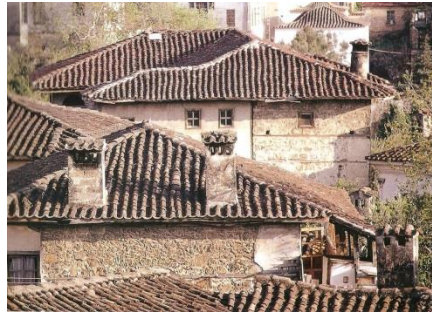
Figure 21. A view of traditional house units  
(Source: Günay 1999)

Stone, wooden and mud-brick were the primary materials of construction in all regions during the evolution of these houses. Local building traditions and climatic variations brought differences in the techniques of wall construction, infills and form of roofing. The use of rubble stone for ground floor walls was general feature. The stone masonry ground floor provided the security of the house and protected the wooden from humidity. Wood was used as horizontal beams embedded in walls. The main structural system in the houses was a wooden framing used essentially over the masonry walls of the ground floor. This system responds well under the stress of earthquakes (Kuban 1995, Günay 1999, Ahunbay 2007).

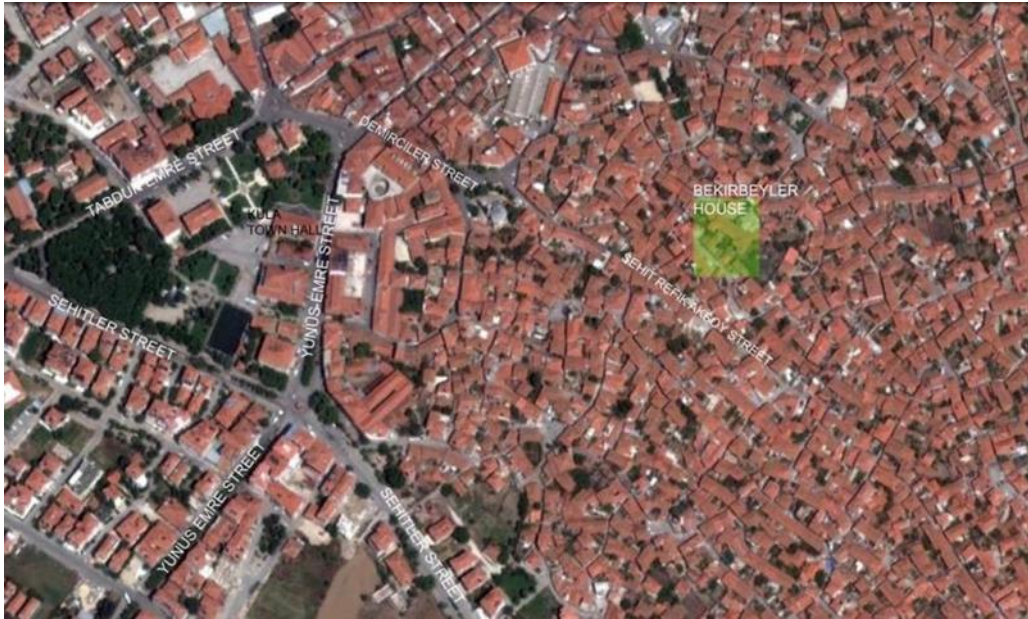
Figure 1. The house and close by surrounding  
(Source: Google Earth 2013)

In this thesis, the Bekirbeyler House in Kula has been taken as the case study. Bekirbeyler House is located in Cami-i Cedit (Mehamid) District which is one of the old districts of Kula. It is near the commercial quarter and a 15<sup>th</sup> century mosque (Kurşunlu Mosque-1497) at the center of Kula (Figure 1). There is also an 18<sup>th</sup> century mosque (Hacı Recep Mosque, 1770) in the southeastern of the building. Unlike the majority of the houses at the historic center of Kula, Bekirbeyler House stands out with its large scale. In this chapter, spatial and structural characteristics of Bekirbeyler House are to be introduced in detail.

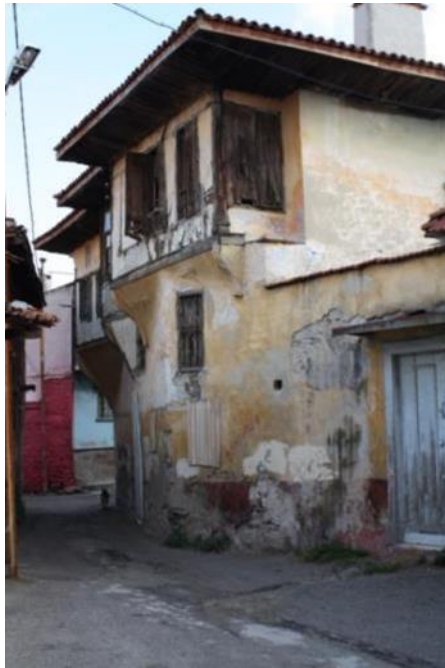
Figure 2. A view of the Bekirbeyler House from the 168 street

At present, it is located on 168 Street, no: 32, 33, 34 in Kula, Manisa, Turkey (Figure 2). It is on a corner plot group that is located on 114<sup>th</sup> city block, bordered with three streets in the northwest (168 Street), north (154 Street) and southwest (157 Street) (Figure 3). Plot-1 has been granted to Kula Municipality and plot-29 was expropriated

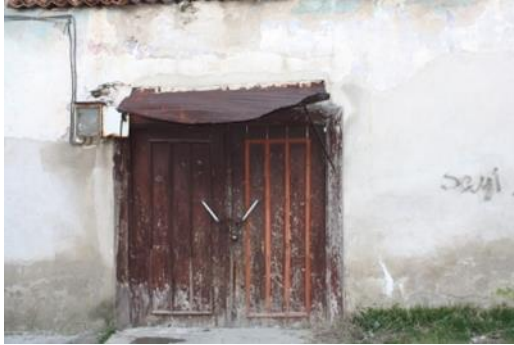
Figure 16. A view of courtyard entrance door of unit- 2

are on the 157 street in the southwest for the units which are on plot-2 and plot-29 (Figure 16, 17). The entrances of the annexes are from courtyard and the annex which is on the plot 29 is from the 157 street.

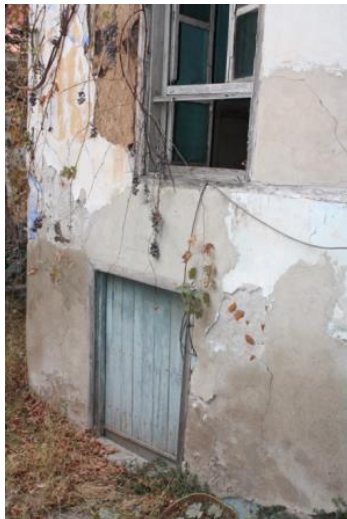
Figure 18. A view of the entrance of B01 (kitchen) from courtyard

The service space that is referred by B01 was used as a kitchen as understood from the kitchen counter in the space. It is located on the western corner of the main building and pentagonal (3.00x 2.10x 2.24x 2.81x 4.02 m., 13.3 m<sup>2</sup>) in plan. The space is on the same level with the courtyard which makes it possible to access to space directly and it is entered through a single leafed door (1.00 by 1.50m., D2). It also opens to 168<sup>th</sup> street with small windows (W3) that have been closed with wooden plank. It is a gloomy-dark space because of the small openings that were closed. The other architectural elements in the space are an interior door that opens to additional division space and a window to provide connection with the division space, an additional kitchen counter. Ceiling (1.73 m.) is wooden covering without decoration (CC3), while floor is additional concrete covering (SG3). The walls are thick (70 cm.) with small openings on and they are plastered and colour washed. The material of the counter and division walls is not original. The window openings were closed at present with wooden plank and also have additional iron grills and altered iron frames.

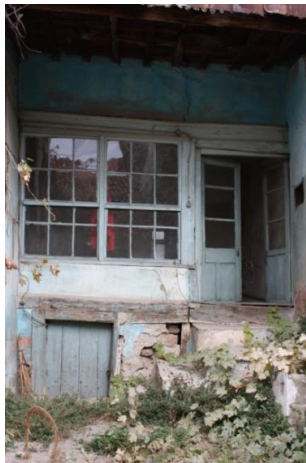
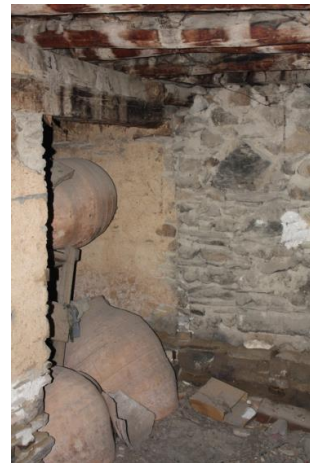
Figure 22. The courtyard entrance of B02 (hall)

Figure 23. A view of B02 (hall) and the door opening of B03 (storage)

The circulation space, referred by B02, is a hall and it is located on the western side of the main building, quadrangle (6.32x 3.05x 5.50x 3.08 m., 17.8 m<sup>2</sup>) in plan. The space level (-0.83 m.) can be accessed to space with two steps descending. It opens to courtyard with a door, 168<sup>th</sup> street with another door (D1). It is a gloomy-dark space, because there is no opening in the space except doors. The architectural elements in the space are an additional staircase (SC4) which is reached from inside the house, a door and a window opening. Ceiling (1.83 m.) is exposed without covering (CC4), while floor is additional concrete covering (SG3), slate stone covering (SG1). On some parts slate stone covering disappeared and earth covering is observed under it. The stone masonry walls are thick (70 cm.), some parts are exposed without covering while some parts are plastered with mud reinforced with straw or plastered and painted. There is an additional wall to divide the space. There are two additional wooden posts in the space to support the upper floor. The originality of the entrance door that opens to street also can be discussed, because to reach the main building from the street is not usual for this type of house. This space has an entrance door on the street wall to access the main

building directly and a new staircase to access ground floor level (G01- hall). Also this space allows access to B03 (storage). The wall that divides the space is an addition as understood from its material. The wall of courtyard facade is damaged.

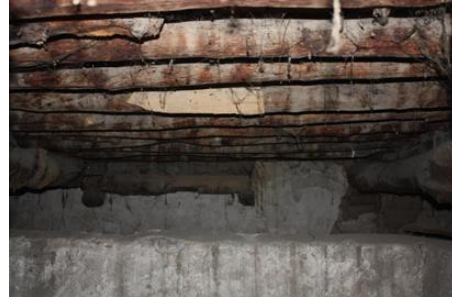
Figure 25. A view of the B03- storage from its window opening

The service space that is referred by B03 is storage. It is located on northern corner of the main building and quadrangle (5.39x 4.40x 4.21x 4.23 m.; 20.3 m<sup>2</sup>) in plan. The space is on the same level with the B02 (hall). It opens to B02 (hall) with a door opening and a window opening. It is a gloomy-dark space. The architectural elements in the space are a door opening and a window opening only. Ceiling (1.83 m.) covering is exposed without covering (CC1), while floor is slate stone covering (SG1). The walls are exposed without covering. There is a low division wall and debris in the space. Because of debris can not be entered to the space.

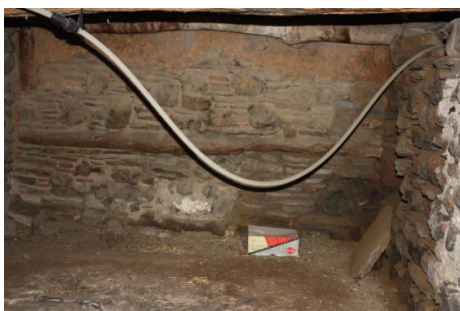
Figure 26. A view of B04 (stable)

The service space that is referred B04 is stable. It is located on the southwestern side of the main building and rectangle (3.03x 2.45 m.; 7.4 m<sup>2</sup>) in plan. The space floor level is under the level of courtyard. It opens directly to courtyard with a door. It is a gloomy-dark space because there is no opening except the entrance door. Ceiling (1.73 m.) is exposed without covering (CC4), while floor is earth covering (SG4). The walls are stone masonry that exposed without covering.

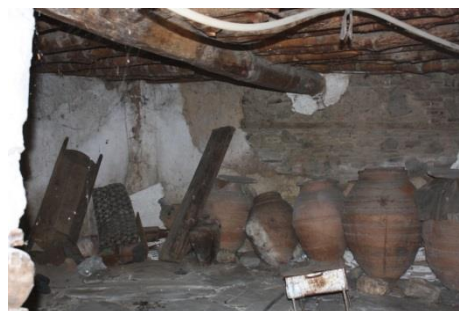
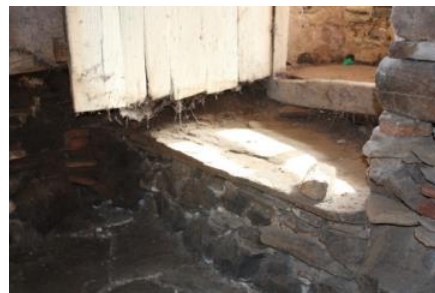
Figure 27. A view of B06 (storage)

Figure 29. A view of the entrance steps of B06- storage

The service space which is referred by B06 is storage. It is located on the northeastern side of the main building and rectangle (4.60x 4.02 m.; 18.5 m<sup>2</sup>) in plan. The floor level of the space is -0.96 m. and from B05 (hall) it can be accessed directly. It opens to B05 (hall) with a door so it is a gloomy-dark space because there is no other opening in this space. The architectural elements in the space are an entrance door (D2) and ceramic jars. Ceiling (1.73 m.) is exposed without covering (CC4), while floor is slate stone covering (SG1). The walls are stone masonry and exposed without finishing.

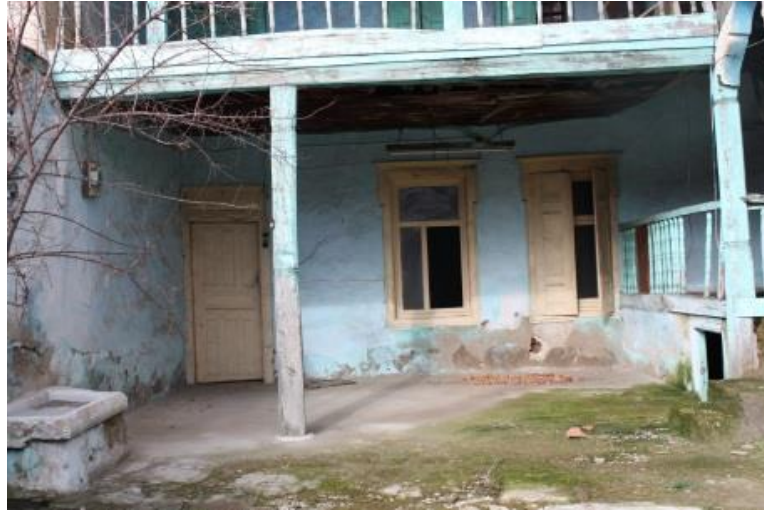
Figure 30. A view of B07- hall

The circulation space that is referred by B07 is hall (*hayat*) and it is a semi-open space. It is located on the southwestern side of the main building and rectangle (4.95x 3.57 m.; 17.7 m<sup>2</sup>) in plan. The space level is the same with courtyard. It is a luminous space. The architectural elements in the space are an exterior door, a window series and a post with its stone base. Ceiling (2.77 m.) is wooden covering without decoration (CC3), while floor is concrete covering (SG3). The walls are plastered with mud reinforced with straw and colour washed.

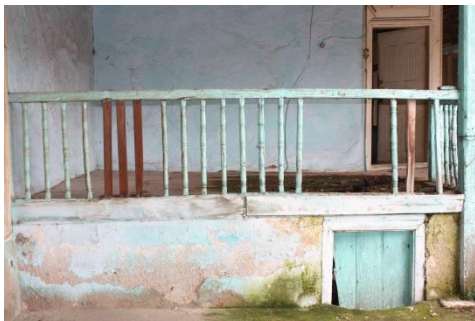
Figure 34. A view of the entrance door of stable (B10)

There is a service space functioning as a stable referred by B10 in the southeastern of the main building. It is rectangle (1.32x 3.12 m., 4.1 m<sup>2</sup>) in plan. The space opens to the hall (B07) with a door (D2) and it is a gloomy space. Ceiling (1.29 m.) is exposed without covering (CC4) and floor is earth covering (SG4). The walls are stone masonry that are exposed without covering on three sides and the wall that is on the hall (B07) side is wooden post and beam framing.

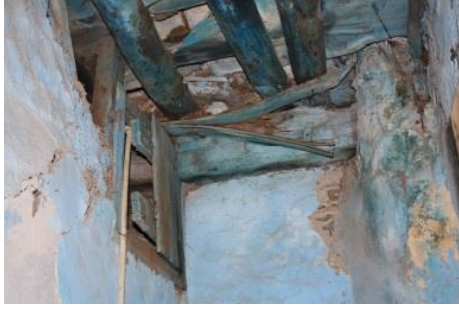
Figure 36. A view of the shutter in the toilet (B11)

There is a service space referred by B11 is wet space functioning as a toilet on the eastern corner of the main building. It is rectangle in plan (2.21x 1.14 m., 2.5 m<sup>2</sup>). It is a gloomy space. The space opens to garden directly with a door and it is related to the furnace (*külhan*) that probably heats the bath (G10). The furnace can only be observed as its shutter is the same level with the toilet's ceiling. Besides, there is a toilet pan, a door with grill on it. Ceiling (2.53 m.) is exposed without covering (CC4) and floor is concrete covering (SG3). The walls are plastered and colour washed.

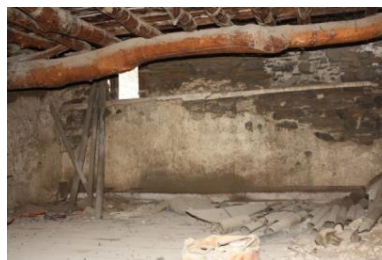
Figure 39. A view of the windows of the storage (B12)

The service space that is referred by B12 is storage in the southeastern side of the main building. It is rectangle in plan (8.14x 4.19 m.; 34.2 m<sup>2</sup>). The level of the space is -0.82 and it can be reached by two steps descending. It is a gloomy space. There is a door opening (D2) with its frame, the entrance door has been removed. Besides, there are two small windows (W2), one of them is closed. Moreover, there are division wooden panes inside. Ceiling (1.79 m. and 2.21 m.) is exposed without covering (CC4), while floor is wooden covering (SG2) with under compacted earth covering. On the some parts, the walls are plastered mud reinforced with straw or plastered lime reinforced with straw. The rest face of walls is exposed without covering. The walls are stone masonry walls except the wall between the space and the hall (B13). The wall is wooden post and beam framing.

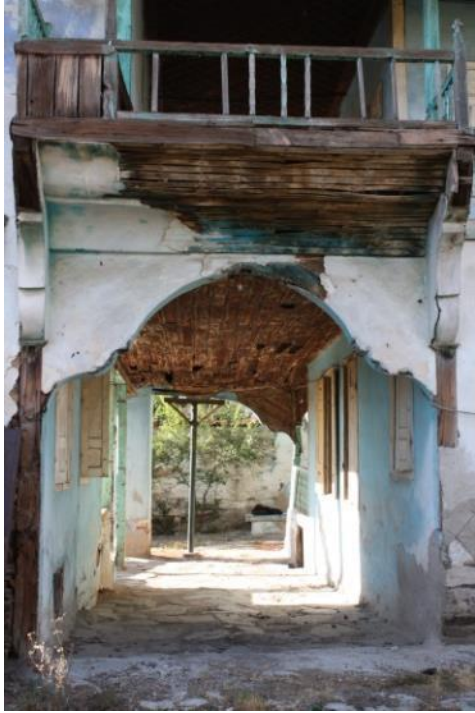
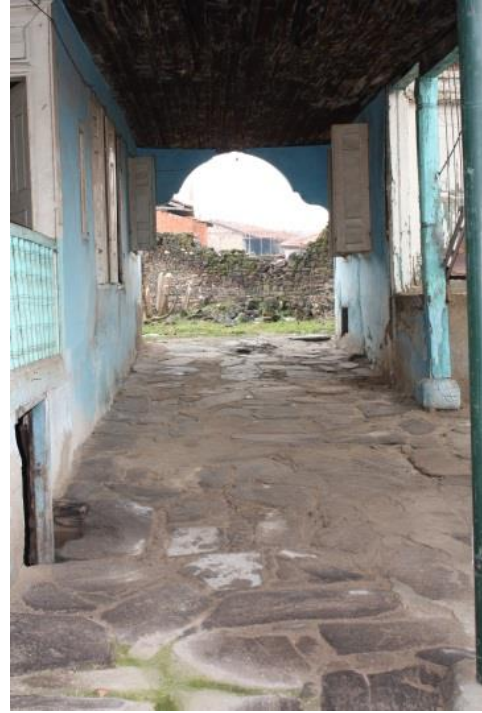
(an iron post and a brick masonry pier). Ceiling (2.30 m.) is wooden covering without decoration (CC3), while floor is slate stone covering (SG1). The walls are plastered mud reinforced with straw and colour washed.

Figure 41. A view of the hall (B13) from the garden

Figure 42. A view of the hall (B13) from the courtyard

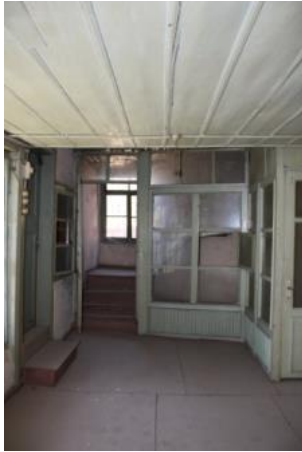
Figure 43. A view of the hall (G01)

The circulation space that is referred by G01 is a hall. It is located on the northwest of the main building and quadrangle (11.62x 3.50x 10.66x 3.58 m., 39.18 m<sup>2</sup>) in plan. The level of floor is above the level of courtyard (+0.82 m.). Originally it is a semi-open space, but at present it has been closed. It is a luminous space. There are

doors, windows and two staircases (SC1, SC2). The space has been divided into two with an additional wall. Ceiling (2.52, 2.13 and 2.04 m.) is wooden covering without decoration (CC3), while floor is wooden plank covering (FC2). The walls are plastered and colour washed.

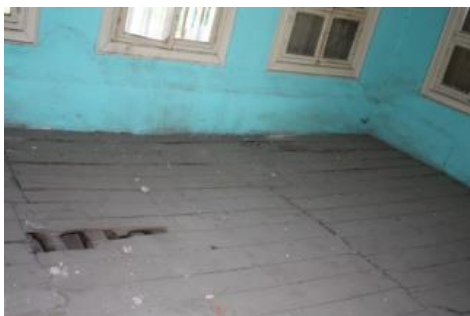
Figure 45. A view of floor of G02-room

The main-living space which is referred by G02 is a room. It is located on the western side of the ground floor. The room is pentagonal in plan (4.13x 3.62x 2.02x 2.18x 3.30 m., 15.5 m<sup>2</sup>) and it is entered through a double leafed door from the hall (G01). The room opens to the courtyard and street with windows on the northwestern and the southeastern sides (W3). It is a luminous space due to the windows on both sides. There are shelves, a closet system (CS+G), window series (WS6), a fireplace and a cupboard in this room. The ceiling (2.22 m.) is covered with wooden covering without decoration (CC2), while the floor is covered with wooden plank (FC1). The walls are plastered and colour washed.

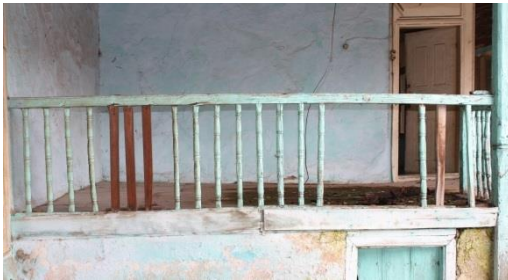
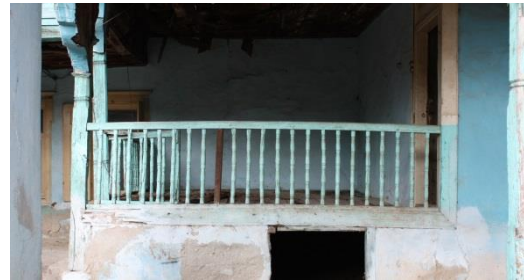
Figure 47. A view of the hall (G07) and the entrance of stable (B10)

Figure 48. A view of the hall (G07) and the entrance of storage (B12)

The circulation and service space which is referred by G07 is a hall (*hayat*) and it is a semi-open space, located in southeastern side of the main building. It is an entrance hall to reach the room (G08), at the same time the space is for daily activities and to work. It is rectangle in plan (4.64x 3.38 m., 15.7 m<sup>2</sup>). The space level is higher than courtyard (+0.80 m.). It is luminous space. It opens to courtyard and to halls (B07, B13). The architectural elements in the space are posts, balustrades and a pseudo arch (*Bursa kemeri*). Ceiling (2.55 m.) is wooden covering without decoration (CC3), floor is wooden covering (FC1). The walls are plastered mud reinforced with straw and colour washed.

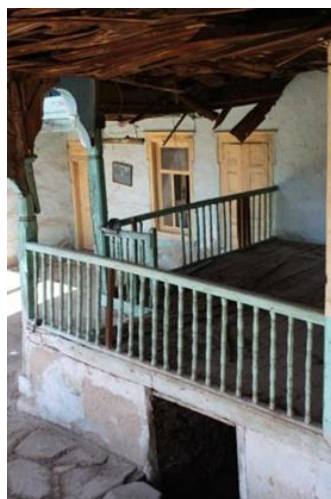
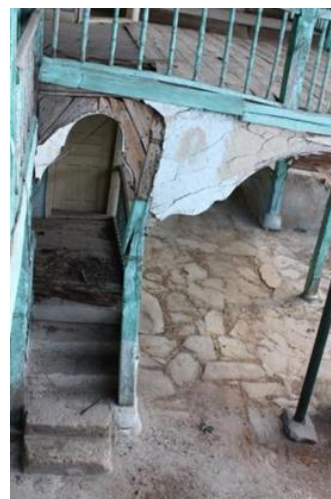
Figure 49. A view of the hall (G07) and the entrance of storage (B12)

Figure 50. A view of entrance of the hall (G07) and entrance of room (G08)

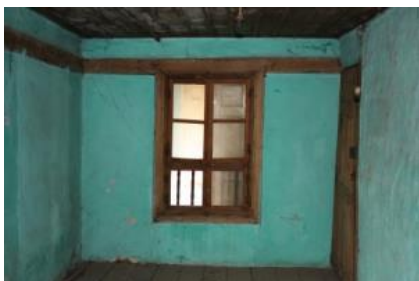
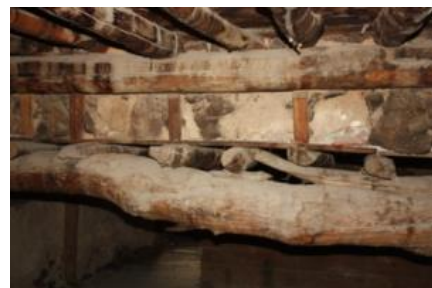
The circulation space which is on the southwestern side of the ground floor, G09, is a hall. The hall is a transition space between bath (G10) and room (G08). The room is rectangle in plan (4.50x 2.24 m.; 10 m<sup>2</sup>) and it is entered through a single leafed door (80 by 210 m.) and two steps from the room (G08). The level of the hall (+1.32 m) is higher than the room (G08). The hall opens to the hall (B13) and garden with windows (W1). It is a luminous space due to the windows on two sides. There are windows (W1) in this hall, these are original but two of them were closed, as understood from the wooden frame on them. The ceiling (2.00 m.) is wooden covering without decoration (CC3) and the floor is wooden covering (FC2). The walls are plastered and colour washed.

Figure 51. A view of the hall (G09)

Figure 52. A view of floor system of the hall (G09)

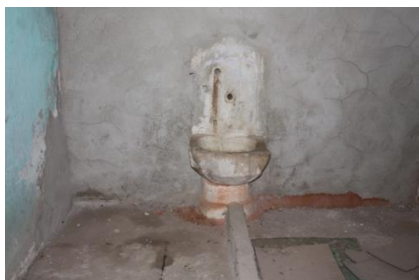
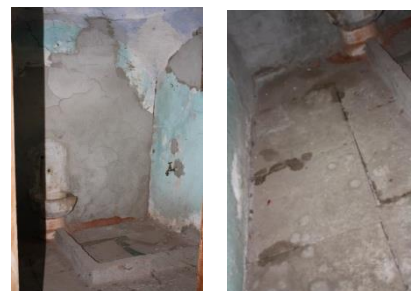
Figure 53. A view of the floor and the wash basin in bath- G10

Figure 54. The views of the floor and the pendentive of flattened dome

The service space which is on the southeastern side of the ground floor, G10, is a bath. The bath is rectangle in plan (2.30x 2.05 m.; 4.7 m<sup>2</sup>) and it is entered through a single leafed door (80 by 210 m.) from the hall (G09). The bath opens to the garden with a small window (W3). It is a gloomy space. There is a wash basin (*kurna*) in this room. The ceiling is flattened dome. It is plastered and colour washed (CC1, 2.19 m. at the center). The floor of the bath is marble covering (FC3). The walls are plastered and colour washed. The space which is next to the bath, is regarded to be in relation with bath. The level of the space seems to be the same with bath. There is only one opening to reach the space in the toilet (B11). The opening is a shutter. The space is approximately 1.9 m<sup>2</sup>.

Domed or cascaded ceiling types are examined in the spaces. The G10 (bath) has flattened dome ceiling. The construction technique of the ceiling can not be observed, it can be constituted like the dome in F08 (room). The ceiling is plastered and white washed (lime plaster reinforced with straw underlayer, lime plaster finishing layer).

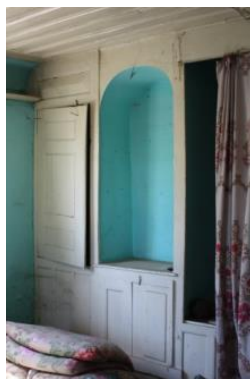
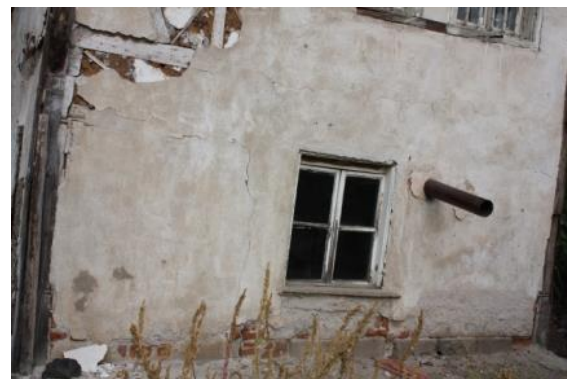
Figure 57. A view of the room- G11

Figure 58. A view of the renewed wall of the room- G11

The main-living space which is on the southern corner of the ground floor, G11, is a room. The room is rectangle in plan (4.27x 3.55 m., 15.2 m<sup>2</sup>) and it is entered through a single leafed door (90 by 220 m.) from the courtyard. The room opens to the hall (B13) with window series (WS4), to garden two windows. It is a luminous space. There are shelves, a window series (WS4), two windows (W3), a closet system (CS+G)

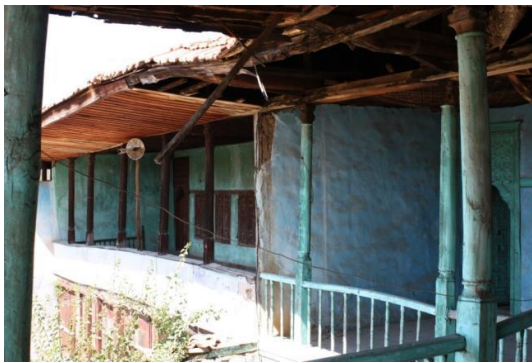
Figure 59. The addition walls that divide the hall into three parts

There are two staircases, both of which are on the hall and they are semi-open. The other staircase is open and attached to the hall. The architectural elements are balustrade, platforms to sit and cupboards. Its ceiling is wooden decorated covering with 'çitakari' technique (FC2), and its decoration differs along the hall. Floor is wooden covering. The walls are plastered and colour washed. The space is divided into three parts with addition walls.

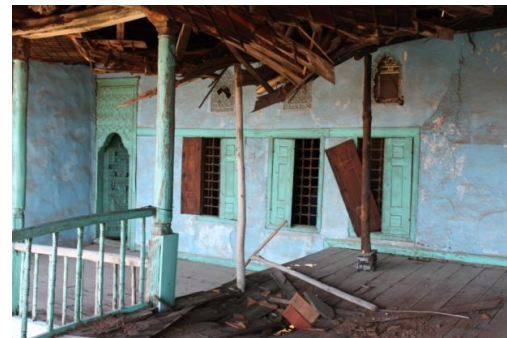
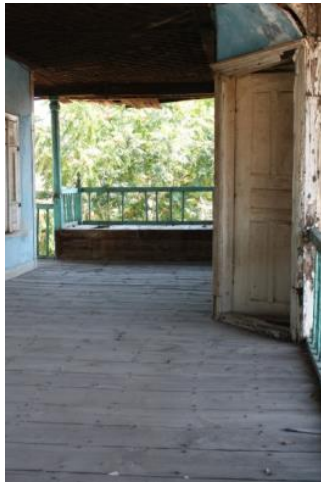
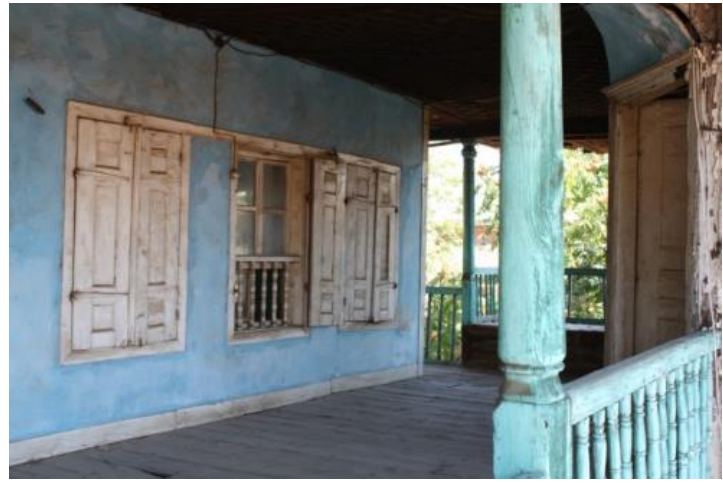
Figure 60. A view of the hall (F01) and openings of the room (F06)

F01- Hall is the largest and the most emphasized space of the main building (138.85 m<sup>2</sup>). It is a circulation and a living space. It is a semi-open space on the southwestern side of the main building and continues along the main building turning between the spaces to reach all of them. The outer hall has a complicated plan which can be defined as combination of two L forms. The outer hall can also said to be a combination of a long part (I), and a U-shaped part.

Along the I-formed long branch (3.6x 26.9 m.) there are five rooms (F02- F06) opening to the hall (F01). On the second branch, there are two rooms (F08, F11) which open to the space with diagonal doors. At the end of the hall there are wet spaces (F09, F10). The levels are different along the hall. The levels and heights are respectively +3.41 m. - 2.60 m. on the entrance of the F02; +2.98 m. - 3.03 m. on the entrances of F03- F06; +3.44 m. - 2.57 m. in the entrance of F08; +3.65 m. - 2.39 m. in the entrance

of F11 and wet spaces. It opens to courtyard, seems like an arcade, and it has extensions to street, to garden and to courtyard. It is a semi-open, luminous space.

Figure 61. A view of the hall- F01, the platform to sit

Figure 62. A view of the hall- F01, the window system of F08 and the entrance door of F11

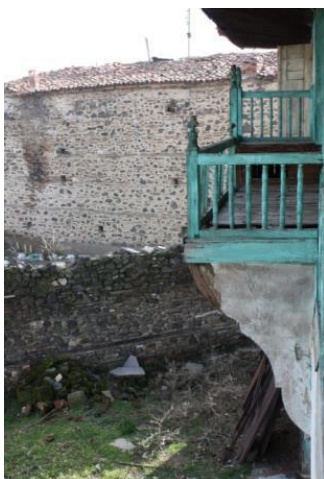
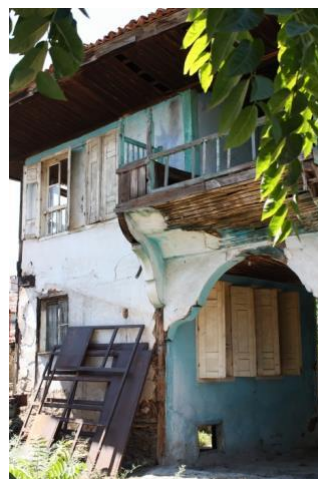
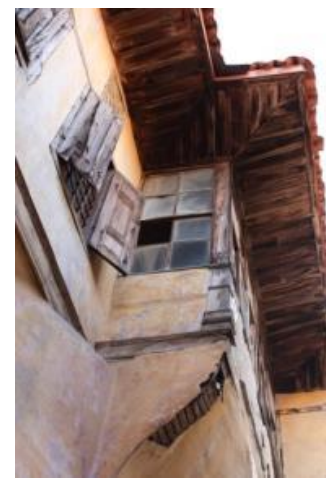
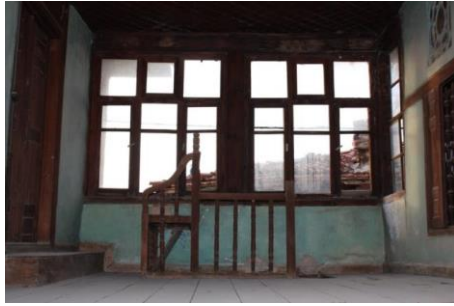
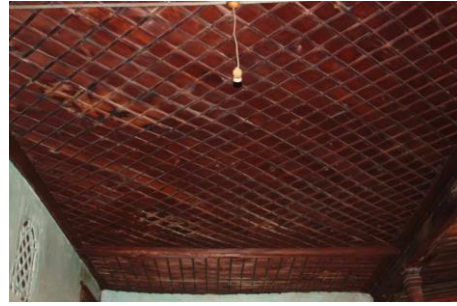
Figure 63. A view of the platform

Figure 64. A view of the pseudo-arch

Figure 65. A view of the projection of F01

Figure 66. The first staircase in front of the entrance of F02- room

Figure 67. A view of the ceiling of F01- hall

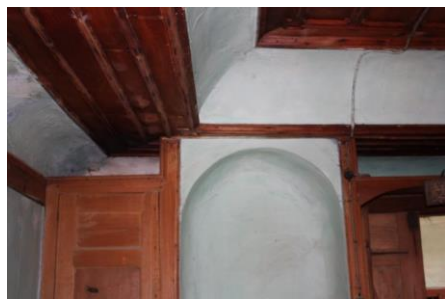
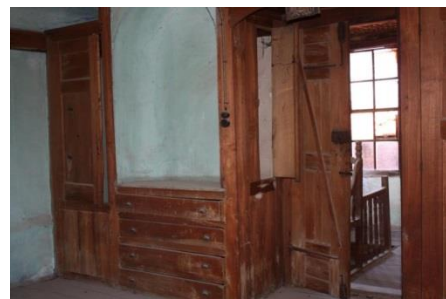
The main-living space which is referred by F02 is a room. It is on the western corner of the first floor. The room is quadrangle (4.31x 4.45x 4.31x 4.54 m., 19.4 m<sup>2</sup>) in plan and it is entered through a double leafed door (135 by 220 cm.) from the hall (F01). The room opens to courtyard and to street with window series on three sides (WS1), making it a luminous space. There are shelves, a closet system (CS+G) and a fireplace (F3) in the room. The ceiling (2.31 m. at the edges, 2.75 m. on the middle) is decorated and cascaded (CC1). The center of the ceiling is square. The plastered wooden laths on edges of ceiling provide curvilinear transition among the walls and ceiling. There is a wooden covering without decoration. The covering surrounds the room on four sides 100 cm. in width. After the covering, there is a second plastered wooden lath transition. This part provides connection among the center and the edges. The floor is wooden covering (2x18x various cm., FC1). The walls are plastered and colour washed. Two windows are closed as understood from their frame which can be seen on the facades.

Figure 68. A view of F02- room, its ceiling and closet system

Figure 69. A view of F02- room, its floor and entrance

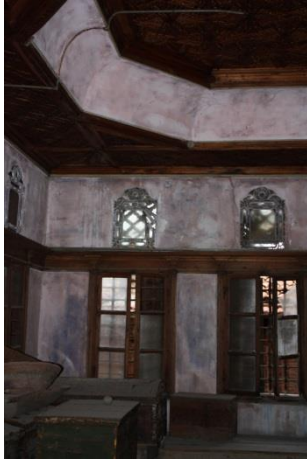
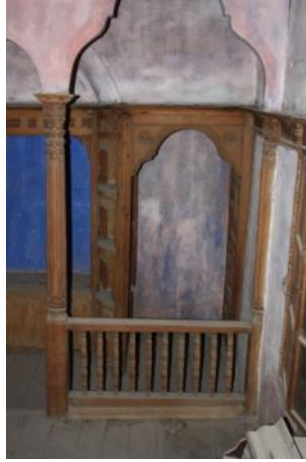
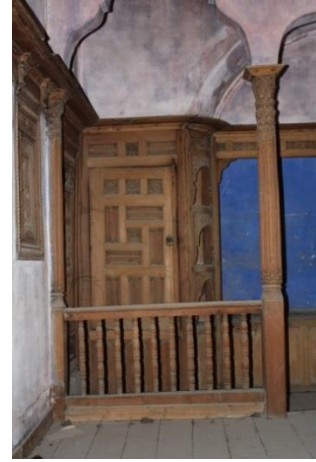
The main-living space which is referred by F03 is a room. It is located on the northern corner of the first floor and rectangle (4.50X 6.30 m., 28.4 m<sup>2</sup>) in plan. It is entered through a single leafed door from the hall (F01). The room has two levels on the floor; the entrance level (*sekialtı*) is on the same level with hall-F01, while the living-

sitting level (*sekiüstü*) is raised 16 cm. from the entrance level. There is an arched arcade (*direklik*) between two spaces. The arcade is considered as a part of closet system.

Figure 70. A view of the room- F03

Figure 71. A view of the arcade and entrance

Figure 72. A view of the shutter of the *gusulhane*

It opens to the courtyard with an opening system (OS), to street with a window system (WS2). It is a luminous space, due to the number of the windows. There is a closet system (CS+G), a cupboard (CB1) and a top window over it on entrance level. There is a fireplace (F1), a *seki* on the living-sitting level. There are also shelves which surround the room 2 m.higher from the *sekiüstü* level.

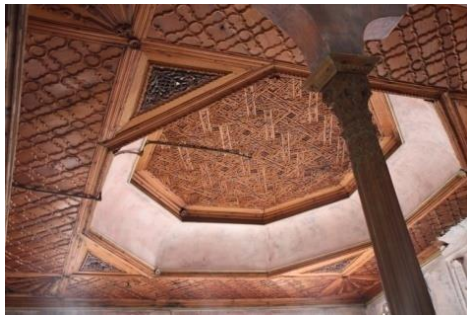
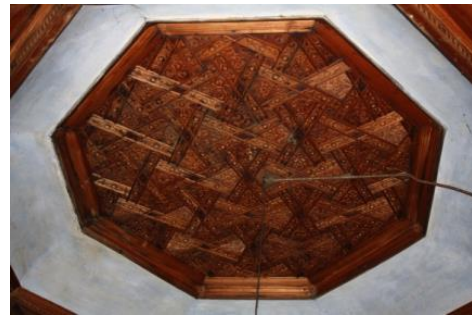
The ceiling is cascaded wooden covering (*sekialtı* 3.15 m., *sekiüstü* 2.83 m., at the center of *sekiüstü* 3.32 m., CC1). The ceiling is wooden decorated covering in *sekialtı*, while there are different techniques and levels of coverings in *sekiüstü*.

In *sekiüstü*, the edges are wooden decorated covering 100 cm. in width. The center of the *sekiüstü* is almost a square in plan. Its corners have a triangle wooden

decoration which are painted with madder and also have a metal element under the wood. The technique of the triangle elements is called 'ajur'. At the center, there is an octagonal wooden decorated covering and its level is different from the corners and edges. The transition to the octagonal center from the edges is plastered wooden laths. The floor is wooden covering (FC1). The walls are plastered and colour washed.

Figure 76. A view of the *sekiüstü* ceiling

Figure 77. The octagonal center

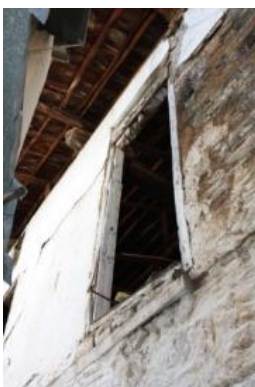
Figure 78. The door of F07

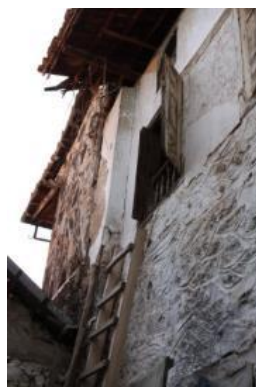
Figure 79. The window of F07

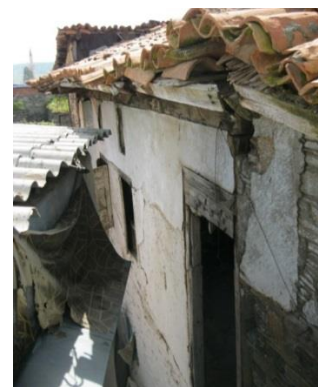
Figure 80. The opening system of F07- room

The space which is referred by F07 is on the northeast of the first floor. It can not be entered, observed only. Because the space has a door on the first floor level, but

there is any way to reach. According to observation it is regarded as main-living space, room. There is an opening system which opens to neighbour garden behind the main building. There is not a trace how could be reached in the past. Interior of the space could not be observed in detail. The ceiling is exposed without covering (CC4), while floor is wooden covering (FC1). The opening system seems to be the same size except a difference. It has two windows and top windows.

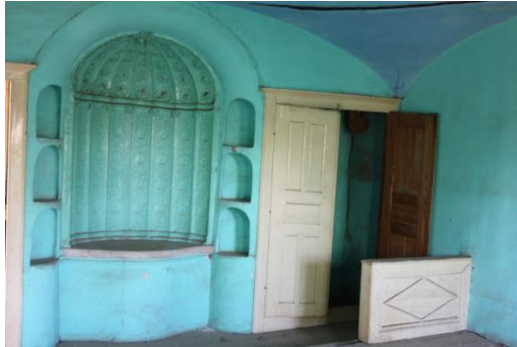
Figure 81. A view of the entrance level (*sekialtı*) and the closet system in F08- room

The main-living space which is referred by F08 is a domed room. It is located on the southeast of the first floor and rectangle (4.50 by 6.35 m., 28.3 m<sup>2</sup>) in plan. It is entered through a single leafed diagonal door (90 by 220 cm.) from the hall (F01). The room has two levels on the floor; the entrance level (*sekialtı*) is on the same level with hall-F01, while the living-sitting level (*sekiüstü*) is raised 17 cm. from the entrance level. It opens to the hall with window series (WS3) on two sides, so it is a luminous space. There is a closet system (CS) on entrance level, a fireplace (F1) and a shutter (80 by 160 cm.) on the living-sitting level.

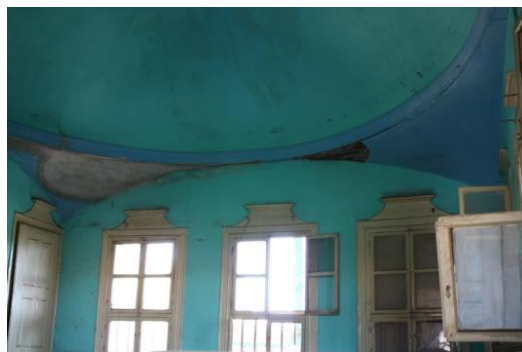
Figure 83. A view of the domed space and its windows series, F08- room

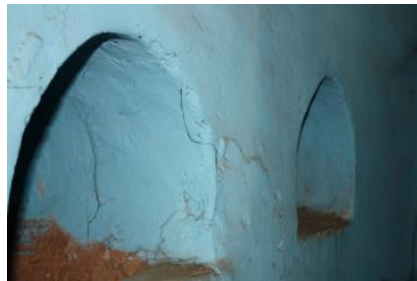
Figure 86. A view of the niches in the *gusulhane*

The ceiling (1.88 m.) is wooden covering without decoration (CC3), while floor is marble covering (FC3). The walls are plastered and colour washed. The heating system of the *gusulhane* is supposed to be related with the fireplace. There is a duct extending from the fireplace to the empty space under the *gusulhane*, like warm air duct.

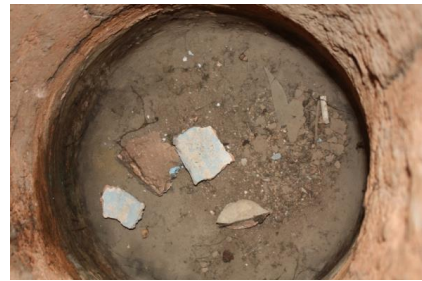
Figure 87. A view of the place to put a bucket that is on the niches in *gusulhane*

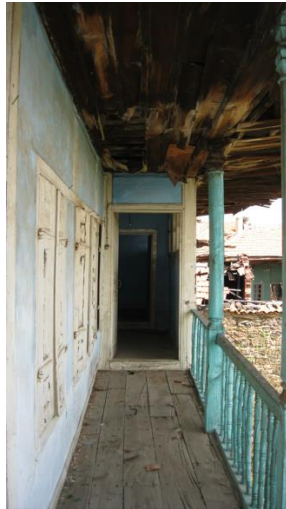
Figure 91. The door of F10- *abdestlik* and F09

*Abdestlik*- F10 is polygonal (0.88x 1.62x 1.27x 1.68x 2.15x 3.45 m., 5.04 m<sup>2</sup>) in plan. It is entered through with a door (D3, 80 by 220 cm.). The space opens to garden with a window.series (WS6) on southeastern side, so it is a luminous space. The ‘*gusulhane*’ of the room (F08) opens to the *abdestlik* with a small window (W2). There is an additional or renewed counter as understood from its material. The ceiling (2.34 m.) is wooden covering without decoration (CC3), while floor is additional concrete covering (FC4). The walls are plastered and colour washed.

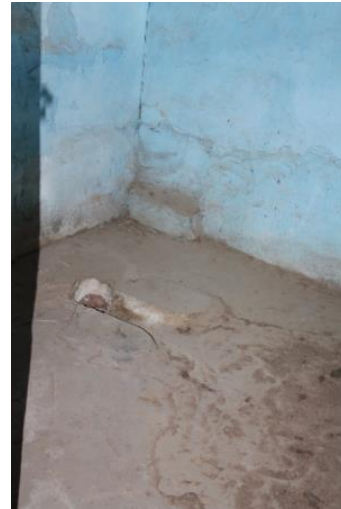
Figure 92. A view of F09- toilet

F09-toilet is rectangle (1.86 by 2.15 m., 4 m<sup>2</sup>) in plan. The toilet opens to garden with a small window (W2). It is a gloomy space, because there is only a small window to provide light. It also opens to *abdestlik* with a door (D3, 80 by 2.20 cm.), the door enables access to the space at the same time. Its ceiling (2.19 m.) is wooden covering without decoration (CC3), while floor is additional concrete covering (FC4). Under the existing floor covering; marble covering (FC2) can be seen from the B11-toilet. The walls are plastered and colour washed.

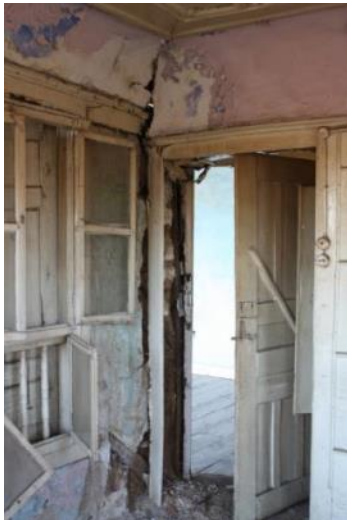
Figure 93. A view of the entrance of F11

The main-living space which is referred by F11 is a room. It is on the southern corner of the first floor. The room is almost square in plan (4.27 by 4.20 m. and diagonal entrance side 0.9 m., 17.74 m<sup>2</sup>) and it is entered through a single leafed diagonal door (90 by 220 cm.) from the hall (F01) like other spaces on the first floor.

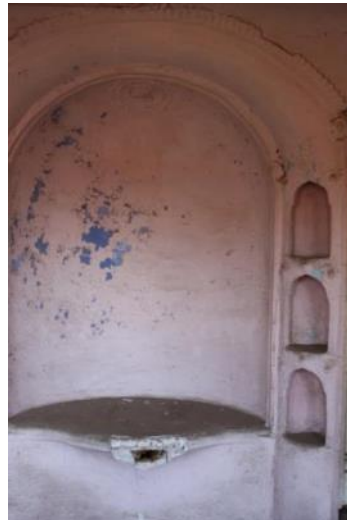
Figure 94. A view of the arced niche on closet system in F11

The room opens to the courtyard and garden with window series on northwestern, southwestern and southeastern sides (WS4). It is a luminous space due to the window series on three sides. There is also a closet system (CS+G). The ceiling (CC1, 2.44 m.) is wooden decorated covering except the edges. The plastered wooden laths on edges of ceiling provide curvilinear transition between walls and ceiling. The walls are plastered and colour washed. The floor is wooden covering (FC1). The room is spacious space with its height and window series on three sides. Also, the space has not a fireplace like most of the other rooms, so it can be considered as a summer room. Shutters of some windows were removed. These alterations and damages have caused to accelerate the damages of architectural elements. The northwestern wall of the room has been damaged. This problem is structural, so a rapid solution is needed.

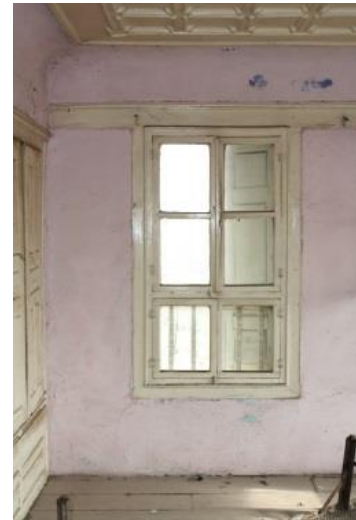
Figure 95. A view of the window, floor and ceiling of F11

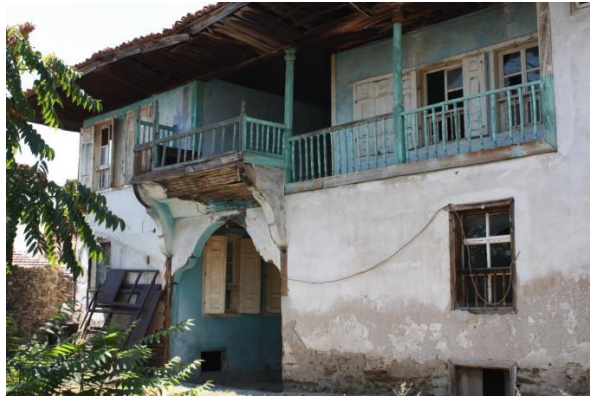
The southeastern (garden) facade of the house, which is 17.01 m. in width, has 6.54 m. eaves height. It is plastered and painted in white colour. The facade of the house is completed with eaves 150 cm and a hipped roof covered with over and under roof

tiles. On the facade, two window series and windows, a space entrance (B09- toilet) and a passage that opens to courtyard with its pseudo-arch above a projection are observed generally. The pseudo-arch and projection, which is nearly at the center, is the most dominant element of this facade. It is emphasized with its balustrade and curvilinear bracket finishings.

Figure 96. A view of the southeastern (garden) facade

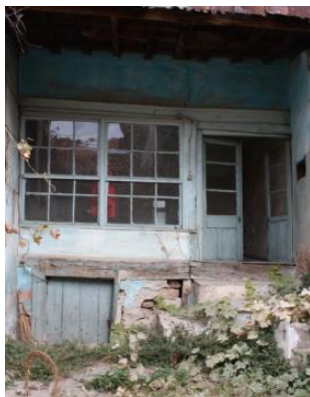
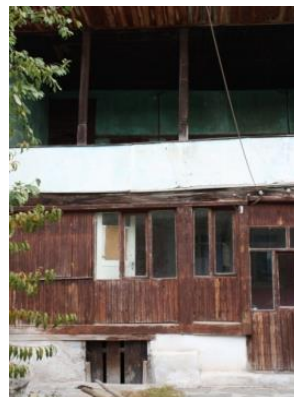
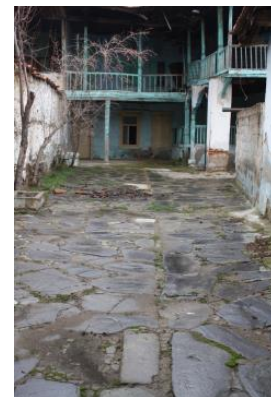
Figure 97. Three views of southwestern (courtyard) facade; a) unit-1, b) unit-2, c) unit-3

Southwestern (courtyard) facade is characteristic that related to traditional Ottoman house, with its hall, semi-open spaces, rhythmic opening order of the room row. On two ends of the mass, there are extensions towards the courtyard. The extensions create two new side facades. There is a huge courtyard on this facade which is bordered with extensions of main mass. The division units in the house can be seen clearly.

For the first floor can be said that the characteristic of the house continues. But on the ground floor, the closed spaces which are semi-open in original probably are not characteristic feature of this house.

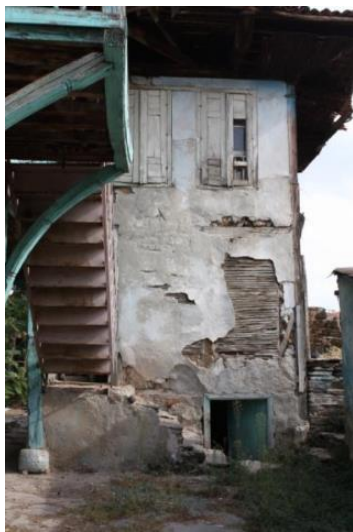
Figure 98. A view of courtyard facade

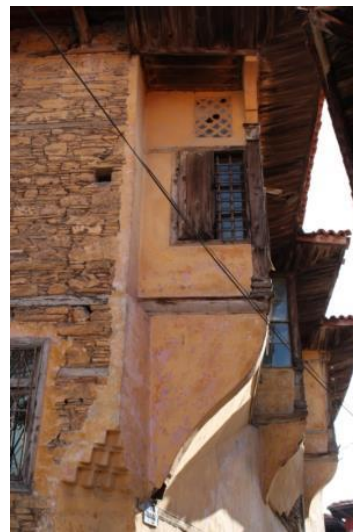
Figure 99. A view of street facade

On the northwestern (street) facade, the house could not be perceived as whole. But it is the only facade that can be perceived entirely. The influence of the facade, the house is a two storied modest example of traditional Ottoman House. There are three projection, two of them projection of main space (room), the one is of hall that the most emphasized spatial element of the house. Brackets that support the projections were closed with wooden laths and finishing elements on. There are two window systems open to the street on this facade. The window system is similar as looking their position, but one of them without top windows. This facade is impressive with its projection, rhythmic window series, wide eaves, beveled corner to facilitate the turning on narrow streets. But at the same time, openings that closed with wooden or plastic plank, deterioration on the first floor level, damages because of the passing cars cause to reduce the impact of authenticity.

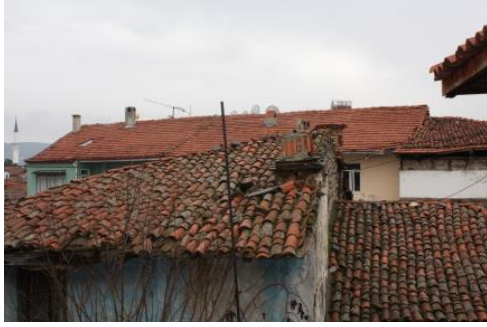
Figure 108. A view of the roofs of annex-1 and annex-2

Annex-1 is adjacent to annex-2. The roofs are hipped roof that are covered with over and under roof tile.

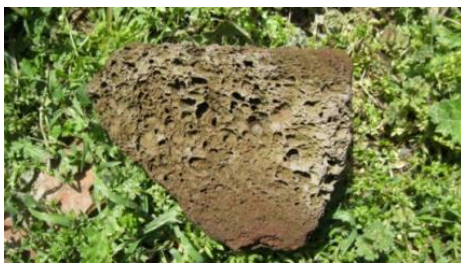
Figure 120. The *köfeke* stone used as a filling material

Kula was settled on a volcanic area, so can be seen widespread use of the volcanic origin stones as construction material on the walls and grounds of the houses. In Bekirbeyler House the courtyard and some spaces as storage are covered with slate stone covering. Slate stones can be seen also on the masonry walls as beams. The local building materials are observed in Bekirbeyler House. The slate stone are type of schist and have dark gray colour. These stones are mined around the *Kara-Divlit*. Another local building material observed in the house is '*karataş*'. It is a black in colour, volcanic origin and hard stone. The stone is used on the main walls and foundations of the buildings. The '*köfeke*' is a stone that is used on the wooden framing walls as infill element, and bond of the chimneys. It is a volcanic origin, brunette colour and soft stone that can be easily carved. While '*köfeke*' is low density porous and lightweight stone, '*karataş*' is heavier and with more intensity.
