**EVALUATION OF ARCHITECTURAL HERITAGE  
CHARACTERISTICS OF BEKİRBEYLER HOUSE  
IN KULA, MANİSA**

**A Thesis Submitted to  
the Graduate School of Engineering and Sciences of  
İzmir Institute of Technology  
in Partial Fulfillment of the Requirements for the Degree of  
MASTER OF SCIENCE  
in Architectural Restoration**

**October 2013  
İZMİR**

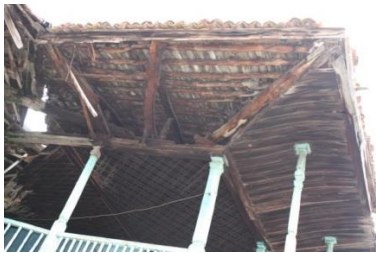
The roof characteristic of the building is its simplicity. Due to the geometry of the building, the roof is a complication of gable (*beşik*) and hipped (*kırma*) roof. Large eaves are used to increase the stability of roof, also to protect the walls. They also provide a more protected semi-open space, hall. The roof is in wood plank and beam roof system with wide eaves (80-150 cm.). The roof system is simply supported by the walls and posts. The wooden elements have larger section and were roughly shaped (25x25 cm.). The main horizontal joists were placed parallel to the shorter side of the house spaced at 2- 2.50 m. intervals. The primary large horizontal joists carried the uprights. The wide inclined eaves were obtained by extending the horizontal ceiling joists. The width of eave is 150 cm. on street, courtyard and garden facades and 50 cm. on the rear facade.

Figure 122. A view of roof and eaves

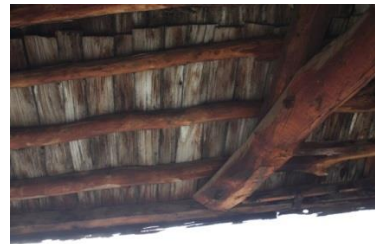
Figure 123. A view of eaves

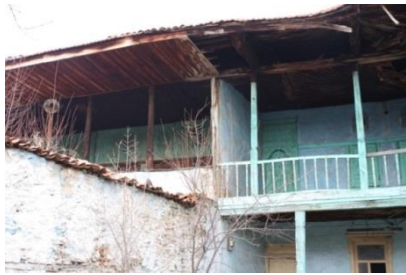
Figure 137. A view of the additional walls on the first floor and courtyard

Courtyard and main building are divided into three independent units with the walls. The division walls are stone masonry on courtyard and ground floor, while wooden post and beam framing on the first floor.

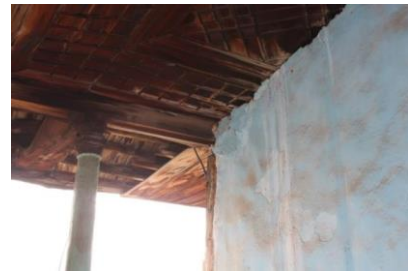
Figure 138. A view of the additional walls on the first floor

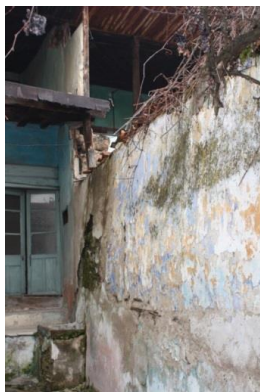
Figure 139. A view of the additional walls on the first floor and courtyard

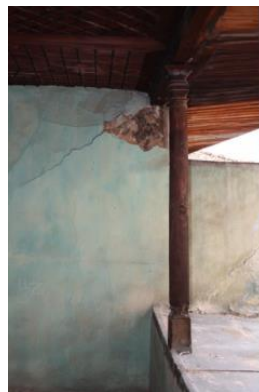
Figure 140. A view of the additional walls on the first floor

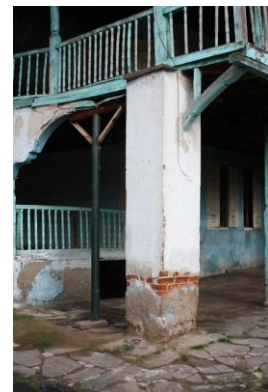
Figure 141. A view of the additional pier on courtyard facade

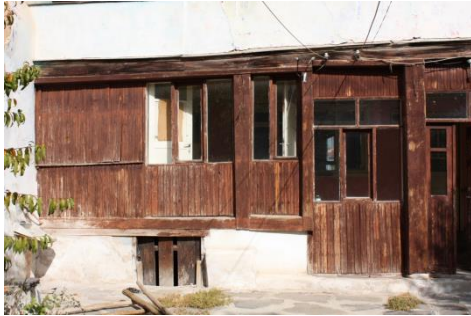
On ground floor, the wooden panes are also additional, the panes closed semi-open spaces. The elements influences the courtyard elevation, are causing loss of authenticity. The bulwarks are also additional elements, because balustrades are used in the building in general. The elements are added to the building as partial walls. The metal porch is an other additional element. It is constituted with a wooden structure and metal covering.

Figure 142. A view of the additional panes on ground floor

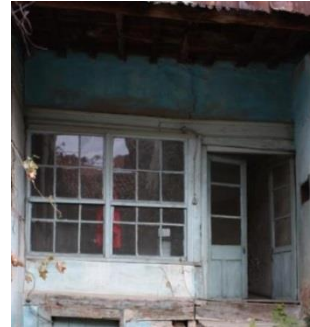
Figure 143. A view of the additional panes on ground floor

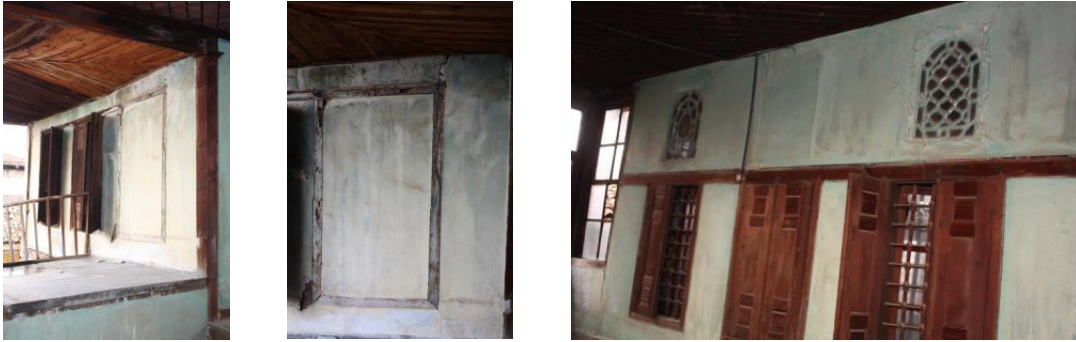
Missing elements are partial or whole building elements were lost by natural or human affect. Their traces can be seen in the house. For instance, the shutters of the F11 has been removed but the hinges of them are still in place. Some windows of F02 (room) was closed but their frames can be observed on the facades.

Figure 147. Missing elements, closed windows in the main building a) F02 (room)  
b) frame of the window c) closed top window in F01 (hall)

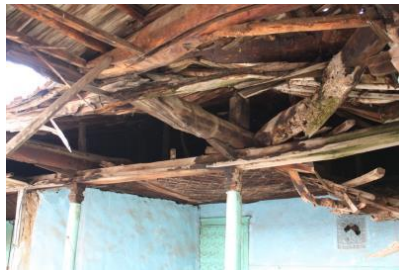
Figure 149. The collapse of roof and ceiling

The roof of Bekirbeyler House has been repaired as an emergency conservation measure. At the same time, researches have been continued to restore the building. This study will be a guide in the succeeding restoration design.

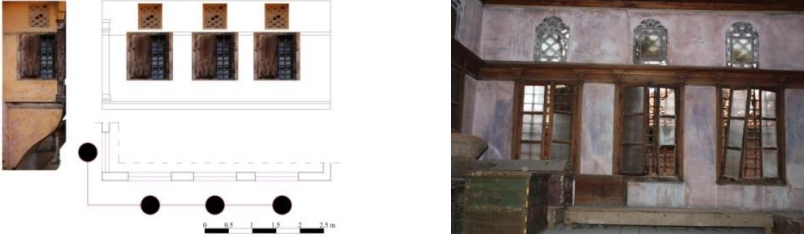
3	Window System-2 (WS2)	<p><b>Location:</b> F03</p> <p>Windows on two sides of a projection; three bottom and three top windows on one side and one bottom and one top window on the other, providing light to room from open space. Wooden grills on the windows.</p>

<p style="text-align: center;">Window system-2 (WS2) <span style="margin-left: 200px;">Interior view of window system-2</span></p>
4	Window System-3 (WS3)	<p><b>Location:</b> F08-room</p> <p>Windows on two sides the room; three bottom windows on two sides (95x160 cm), providing light to room from hall. Half wooden grills on the windows. Their height from the sekiüstü 50 cm.</p>

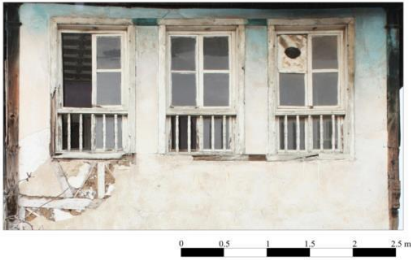
5	Window System-4 (WS4)	<p><b>Location:</b> F11, G11</p> <p>Windows in form of 2 or 3 bottom window series, extending the room to the courtyard, garden or hall; no top windows, half wooden grills on the windows, shutters of some are removed. The height from floor is 45 cm, proportion : 1 / 1.7.</p>

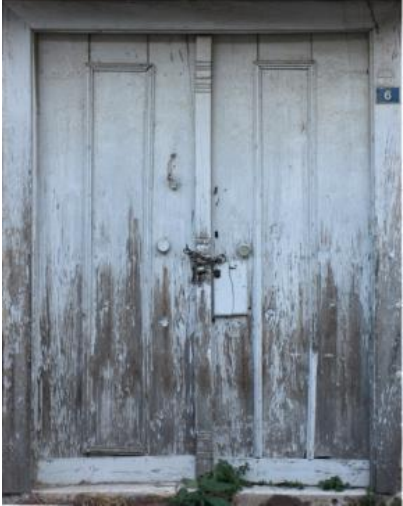
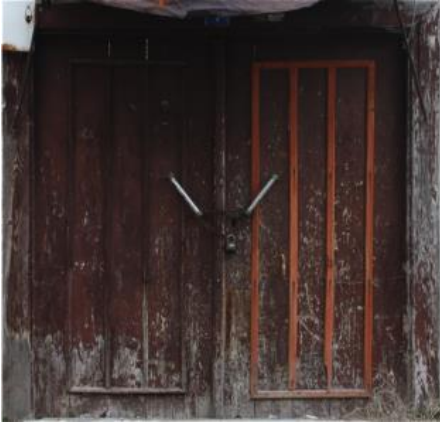
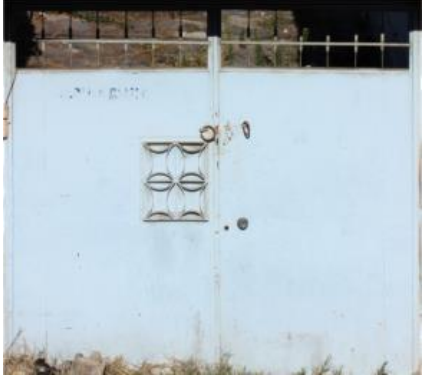
ID	Name	Location and Morphologic Characteristics
10	Courtyard Entrance Doors (D1)	<p data-bbox="470 293 678 320"><b>Location:</b> Courtyard</p> <p data-bbox="470 331 1394 398">Gateways providing entrance to the courtyard, double leaves out of wood whose of one is renewed with iron.</p> <div data-bbox="730 454 1134 958" style="text-align: center;">

</div> <p data-bbox="735 987 1129 1014">Entrance Door of unit-1, Plot-1, wooden</p> <div data-bbox="711 1043 1153 1462" style="text-align: center;">

</div> <p data-bbox="735 1491 1129 1518">Entrance Door of unit-2, Plot-2, wooden</p> <div data-bbox="719 1547 1142 1921" style="text-align: center;">

</div> <p data-bbox="746 1951 1118 1977">Entrance Door of unit-3, Plot-29, iron</p>

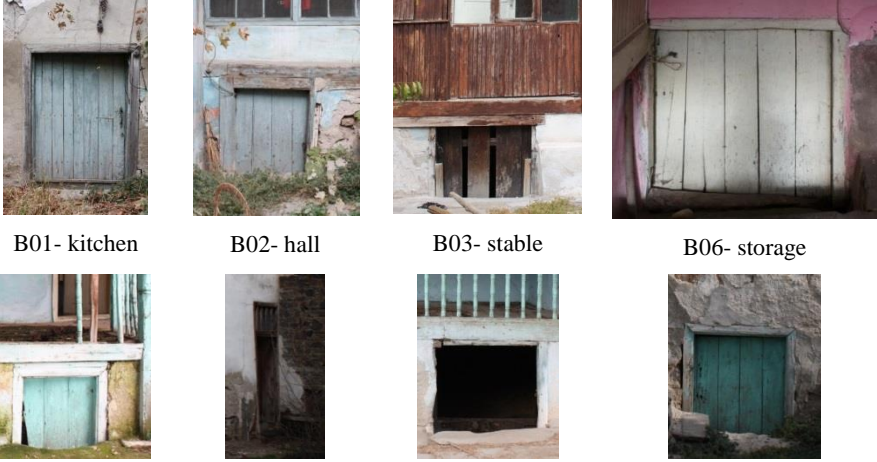
ID	Name	Location and Morphologic Characteristics
11	Basement Space Doors (D2)	<p>Single leaf doors out of wood providing entrance to basement level service spaces which opens to courtyard directly, wooden plank are put together with wooden metal studs.</p>

<p>B01- kitchen      B02- hall      B03- stable      B06- storage</p> <p>B10- stable      B11- toilet      B12- storage      B14- stable</p>
12	Original/ Renewed Interior Doors (D3)	<p>Single leaf doors out of wood providing entrance to main living spaces on ground and basement floor</p>

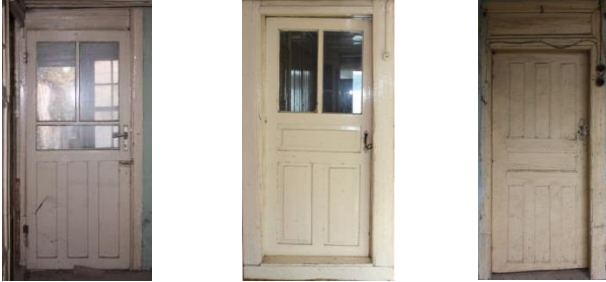
<p>G03- room      G06- room      B08- room</p> <p>Single leaf doors out of wood providing entrance to wet spaces on first floor</p>

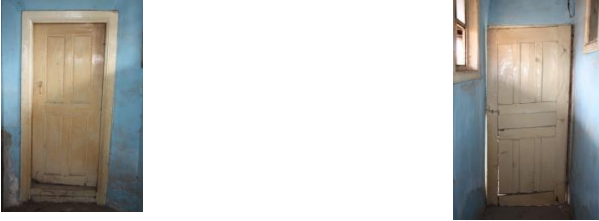
<p>F09-toilet      F10-abdestlik</p>
13	Additional Doors (D4)

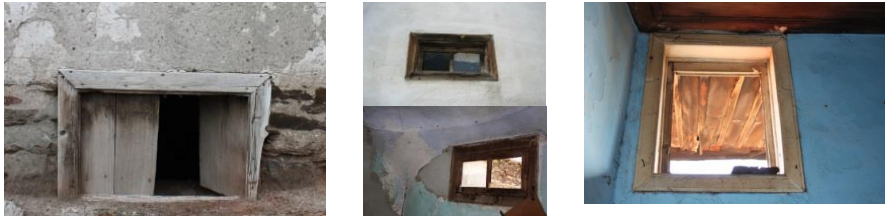
<p>G01                      G02                      G03</p> <p>G03                      G11</p>
15	Service Space Windows (W2)	<p><b>Location:</b> Gusulhane (F08), toilet (F09), B01, B08, B11, B12, B14</p>

<p>B12                      G10                      F09</p>
16	Additional Windows (W3)

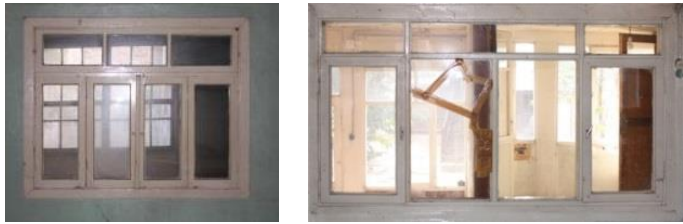
<p>G03                      G04</p>

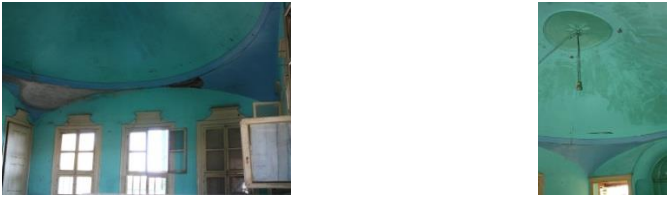
20	Domed or Cascaded Ceiling (CCI)-4	<p><b>Location:</b> F08- room</p> <p>Domed ceiling, wooden laths, lime plaster reinforced with straw, lime plaster and colour washed. Herbal figures exist under the paint.</p>

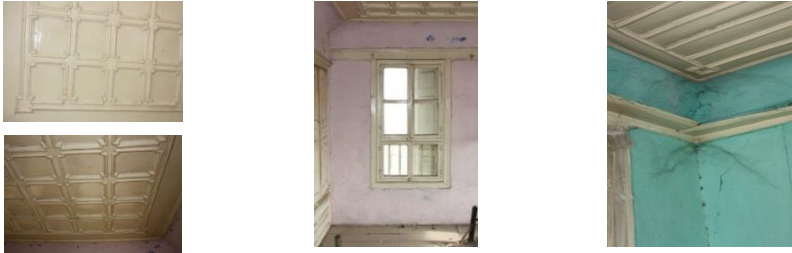
21	Domed or Cascaded Ceiling (CCI)-5	<p><b>Location:</b> F11 (room), G11 (room)</p> <p>Wooden decorated ceiling, curvilinear transition from ceiling to walls.</p>

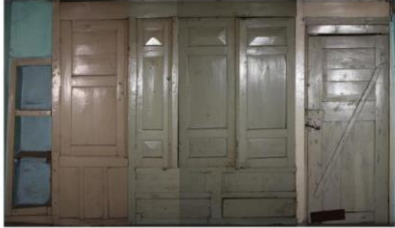
34	Closet System with Gusulhane (G02)	<p>Two leveled closet system; entrance door at one side, central cupboards with shutters suitable for storing mats and blankets, a side cupboard in form of a niche for small utensils and a bathing unit with shutter added to the other side.</p>

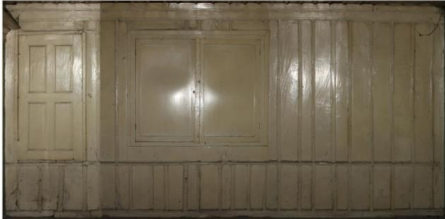
35	Closet System with Gusulhane (G03-1)	<p>Two leveled closet system; entrance door, central cupboards with shutters suitable for storing mats and blankets, bathing unit with shutter added to one end.</p>

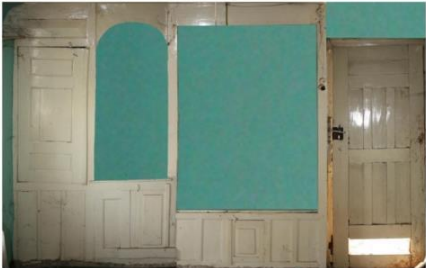
36	Closet System with Gusulhane G11	<p>Two leveled closet system without shutters. Top level: central cupboards suitable for storing mats and blankets, bathing unit with shutter and entrance door added to two end. Bottom level: only shutters.</p>

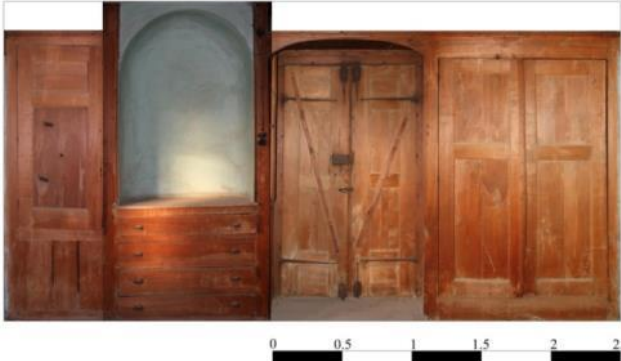
38	Closet System withGusulhane (F03-F06)	<p>Location: F03, F06</p> <p>Two leveled closet system with shutters and three arched element, <i>direklik</i>. Central cupboards suitable for storing mats and blankets without shutter, narrow cupboards with shelves flanking the two sides of the central unit, entrance door at one corner, bathing unit with shutter added to the other corner. Bottom level: only a shutter.</p>

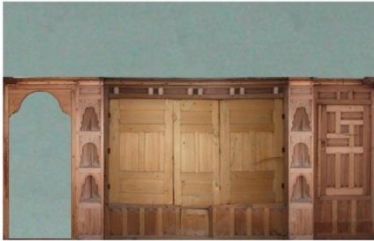
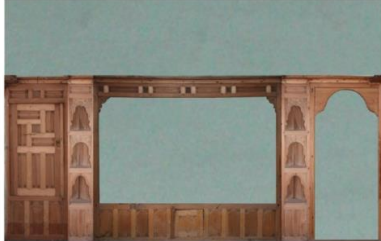
ID	Name	Location and Morphologic Characteristics
39	Closet System with Gusulhane (F04-F05)	<p>Two leveled closet system with shutters. Central cupboards suitable for storing mats and blankets with shutter, narrow cupboards with shelves flanking the two sides of the central unit, entrance door at one corner, bathing unit with shutter added to the other corner. Bottom level: only a shutter.</p> <div style="display: flex; justify-content: space-around; align-items: center;">

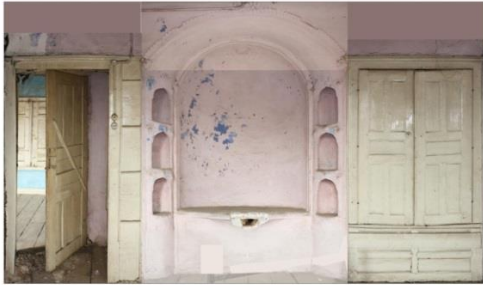
40	Closet System with Gusulhane (F11)	<p>Central arched niche for presentation of objects or placement of mirror with three small niches on both sides of the central niche and a cupboard in entrance space, bathing unit with shutter added to one end. Reliefs on niche unclear because of additional plaster and paint. The corner entrance crowned with a squinch and cornice, single leaf door out of wood, providing entrance to the main space room (F11).</p> <div style="text-align: center;">

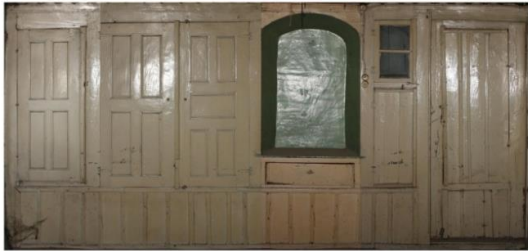
</div>
41	Closet System without Gusulhane (G03-2)	<p>Two leveled closet system with shutters. Top level: central cupboards suitable for storing mats and blankets, side cupboards with shelves and sometimes also with shutters for small utensils, arched niche for presentation of objects or placement of mirror. Bottom level: only shutters.</p> <div style="text-align: center;">

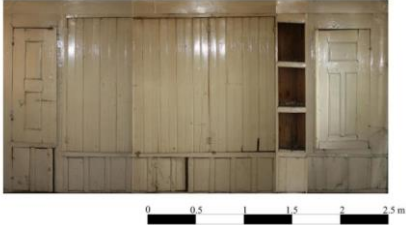
ID	Name	Location and Morphologic Characteristics
42	Closet System without Gusulhane (G04)	<p>Two leveled closet system with shutters. Top level: central cupboards suitable for storing mats and blankets, side cupboards with shelves and sometimes also with shutters for small utensils, bathing unit with shutter added to one end. Bottom level: only shutters.</p>

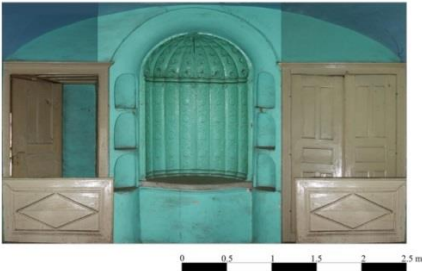
<p style="text-align: center;">Closet system of F08- room</p>

45	Closet System without Gusulhane (F08)	<p>Central arched niche for presentation of objects or placement of mirror with three small niches on its both sides and a cupboard in entrance space, closet with shutters and entrance door. Elevated space (<i>sekiüstü</i>) dividing elements (h:60 cm from <i>sekiüstü</i>). The niche was oil painted. The corner entrance crowned with a squinch and cornice, single leaf door out of wood, providing entrance to the main space room (F08).</p>

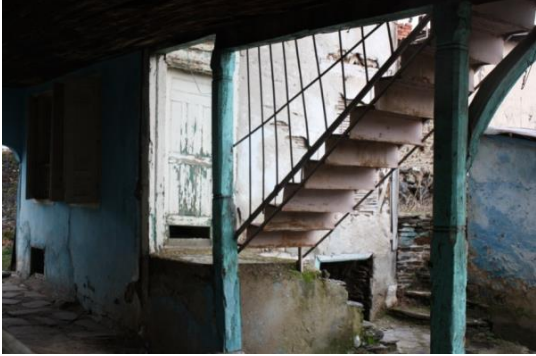
ID	Name	Location and Morphologic Characteristics
50	Staircase3 (SC3)	<p><b>Location:</b> G13, courtyard reaches to F01 (renewed with new material)</p>

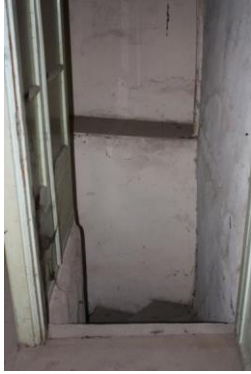
51	Staircase4 (SC4)	<p><b>Location:</b> B02, reaches to G01 (new material, converted or additional element)</p>

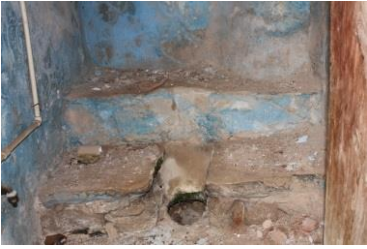
65	Toilet Pan	<p><b>Location:</b> B11-Toilet</p> <p>Original toilet pan out of marble.</p>

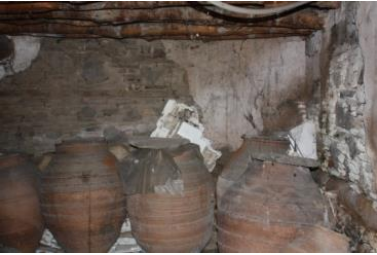
66	Ceramic Jars	<p><b>Location:</b> B03, B06 (Storages)</p> <p>Original ceramic jars for storing raisins, figs, olives, olive oil, etc.</p>
