THREE DIMENSIONAL MODELING VIA PHOTOGRAPHS FOR DOCUMENTATION OF A VILLAGE BATH

H. B. Balta^a, M. Hamamcioglu-Turan^{a*}, O. Ocali^b

^a Izmir Institute of Technology, Department of Architectural Restoration, IYTE, 35430, Urla, Izmir, Turkey – (hamitbalta, mineturan@iyte.edu.tr)

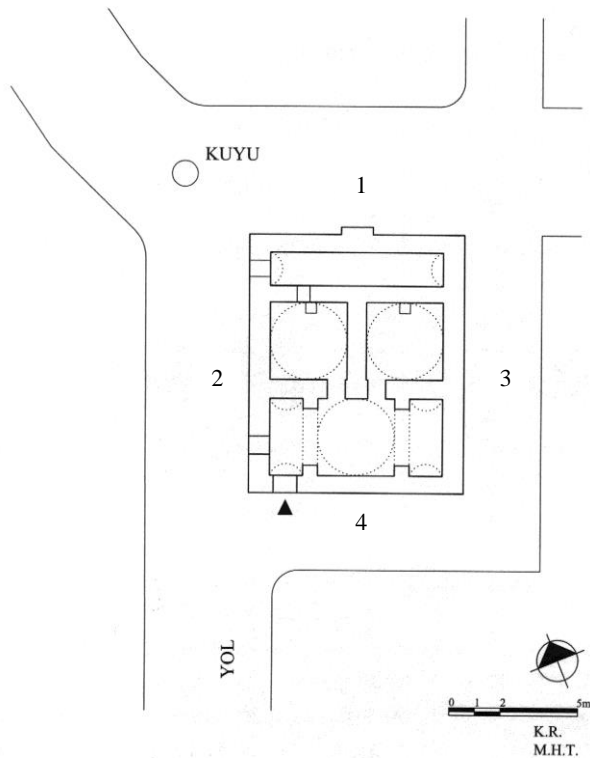
Figure 2 Plan of studied building (Hamamcioglu – Turan, Reyhan, 2005)

The building (8.30 x 10.65 x 3.00) entered from a door at its north side and an irregular opening at its west side is composed of an *iliklik-sicaklik* (tepidarium-caldarium); two *halvets* (hot rooms) and a water tank at present (Figure 2).

As revealed from the characteristic of the entrance door, the ruins of the *soyunmalik* (apodyterium) juxtaposing the *iliklik-sicaklik* should be underneath the street at the 4. The trace of the fireplace underneath the water tank and the well at the 1 of the building indicate that there might be ruins of a woodshed juxtaposing the water tank, and a courtyard at the 2 and 3 of the bath. The rectangular *iliklik-sicaklik* (2.50 x 5.60), running in east direction, is domed at its center and barrel vaulted on its two sides. The *halvets*, juxtaposing the *iliklik-sicaklik* at its south and north, are domed as well. This plan organization can be evaluated among one of the types in Eyice's classification of Turkish bath plans (1960) elongated rectangular *sicaklik* with domed central unit and two *halvets*. The oculi at the domes and vaults elements are the sources of illumination together with the two entrance openings mentioned in the above. In turn, the illumination level is low at the interior. Rubble stone, brick timber and mortar is used in the construction of the walls and brick and mortar is used in the construction of the domes, vaults, pendentives and the drum of the central dome at the *iliklik-sicaklik*. The surfaces of these elements are exposed without plastering at their exterior at present, while they are

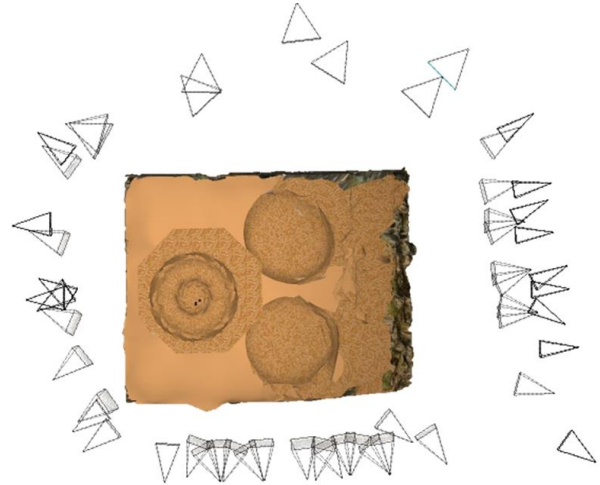
Figure 7. Placement of cameras for the exterior surfaces of the walls

Since the shooting distances for southern and western façades are limited (max. 1.5 m and 2 m, respectively) because of the neighboring houses, smaller focal lengths (wide angles) were

preferred and the numbers of photographs were increased. For northern and eastern façades, the focal length was relatively larger (Figure 7).

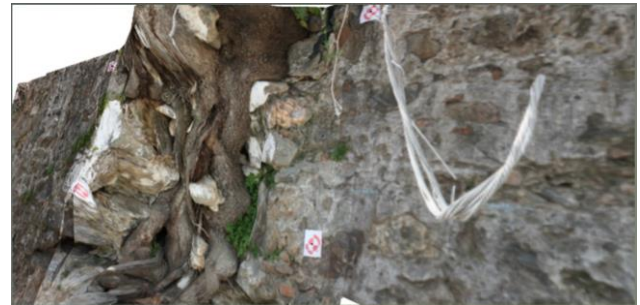
Figure 10. Presentation of photorealistic details of historical morphologies.

historical building. The end result model based on experiments with targets presents photorealistic details of the studied Ottoman bath. The accuracy is measurable with the error data provided by the software. The exterior surfaces including those of the walls and the vaults of the *iliklik-sicaklik*, the drum of the major dome, and bottom zones of all domes were modeled successfully (Figure 10). These positive results were achieved in the presence of the conditions mentioned in the below:

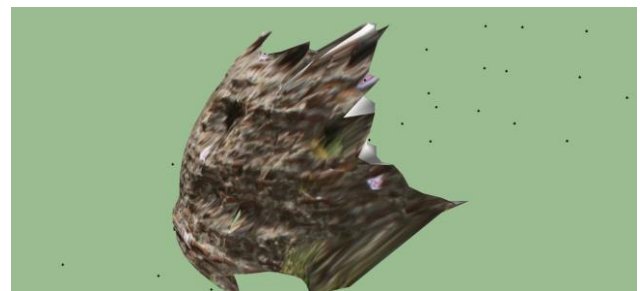
Figure 11. Distortion of surface material

Despite these positive results, there were some problems observed in the model gained with the targets. These may be listed as distortion, blurring and incompleteness. Distortion could be seen in the edges of building elements stemming from unrealistic mesh formation and photo projection. E.g. the edge between the vault of the water tank and the wall of the *halvets*, the edges of the domes that is in relation with the sky. Distortion parts were erased by tool and unrealistic shapes were cleaned (Figure 11).
