## Consolidation of a Bath Ruin in an Archaeological Site

The study has focused on consolidation of a historical bath ruin in an archaeological site. Cevher Paşa Bath, which is located in Tabae archaeological site in Denizli, Turkey and dated to the 15th century, presents structural problems. The aim of the study is to propose a framework for planning consolidation of the ruins of Cevher Paşa Bath so that conservation work regarding similar masonry ruins in archaeological sites can be guided. Thus, methods of architectural restoration and civil engineering are combined in an interdisciplinary scope. Provision of temporary shoring as an emergency intervention, consolidation and presentation of the ruin within the scope of an interdisciplinary restoration project, and monitoring of the asset within the frame of a monument management plan are suggested, respectively. Structural analysis considering stress and overturning moment checks are performed. Consolidation work includes only supporting of arch remains. Some walls of the ruin are weaker than other parts. These parts need further detailed analysis, and if necessary, further consolidation and strengthening are to be carried out.

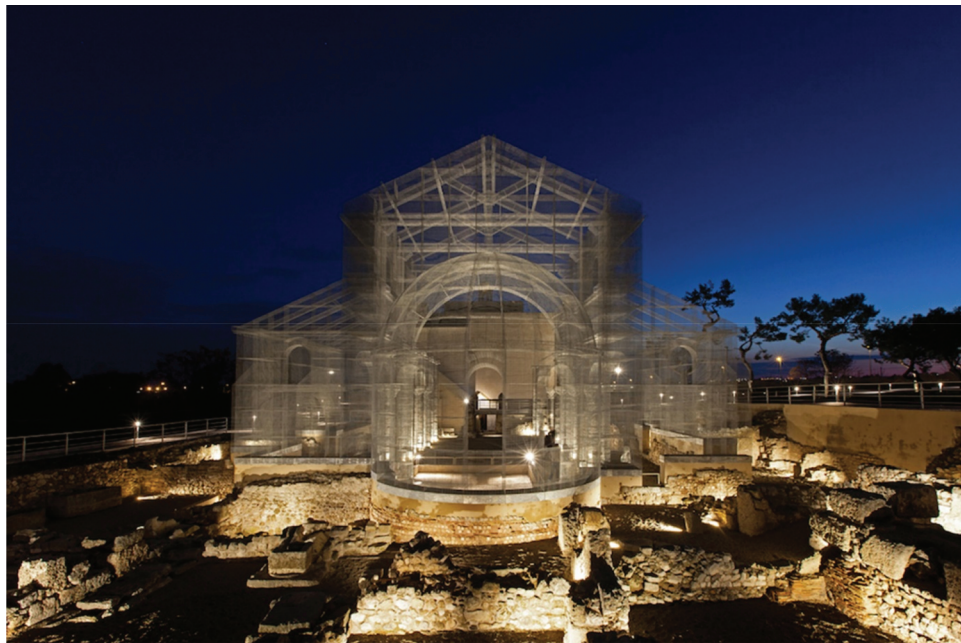
**Figure 1.** Basilica di Siponto, after 2016 restoration (Il Post 2016).

On the other hand, long-range approaches focus on comprehensive conservation and presentation necessities as revealed in the four similar cases analysed. The cases are an early Christian church ruin (Figure 1) in an archaeological park of Siponto (Basilica di Siponto), Doria Castle ruin in Dolceacqua (Figure 2) in Portovenere, which stands on a rocky plateau with steep walls; and a monastery ruin (Figure 3) located in Santa Cataline Botanic Garden (Santa Cataline de Badaya). The ruin of Basilica di Siponto was reintegrated with contemporary building material. New and old are clearly distinguishable, but compatibility of steel in a long-time span should be monitored. The original volumetric effect of the monument is perceived, but the integrity of the archeologic site is ruined since it is the only ruin integrated to its full height. The ruin of Doria Castle and the monastery ruin in Santa Cataline were conserved as they were. The elements added for consolidation and presentation are out of contemporary material and technique. So, they are distinguishable. Timber as a compatible material is preferred, whenever there is direct contact with the ruin. However, steel elements in Doria Castle may corrode in the long term. Integrity of the archaeological/natural sites is sustained. Accessibility and consistency of interventions are achieved in all examples, while re-treatability is only possible in the conservation only and re-integration examples. In terms of presentation tools such as balustrades for safety, walking paths and information panels for the visitors; Basilica di Siponto, Doria Castle ruin

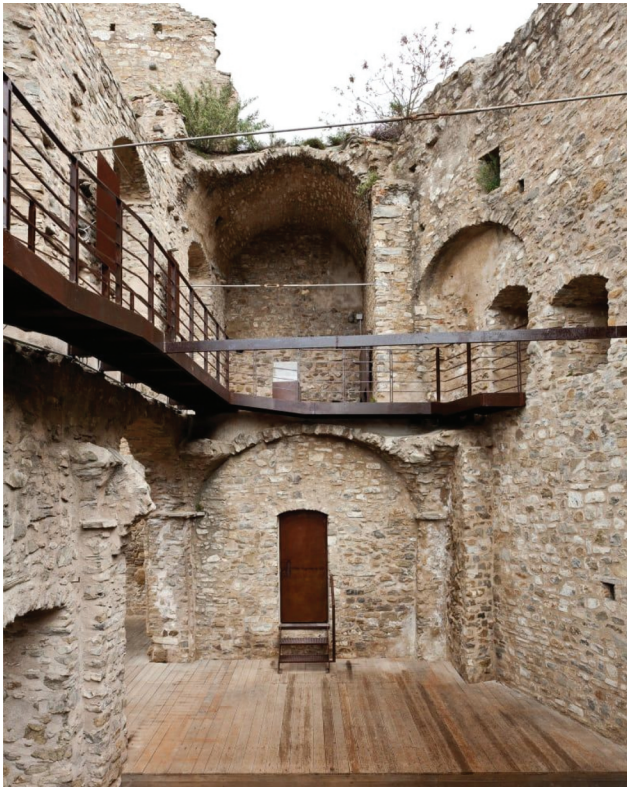
**Figure 2.** Restoration of Doria Castle in Dolceacqua (Divisare 2018).

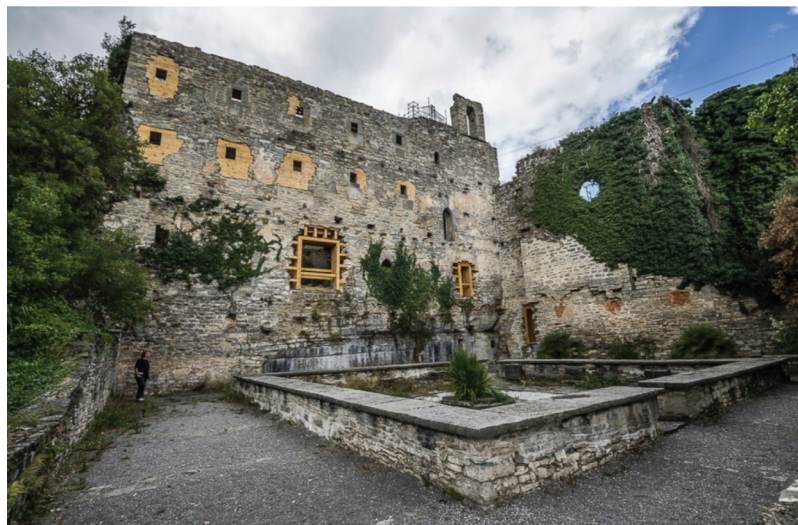
**Figure 3.** Restoration of Santa Catalina di Badaya (Revistaad 2018).

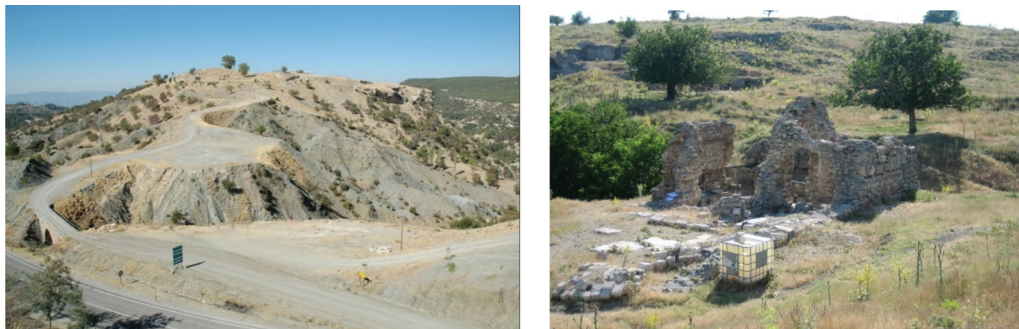
**Figure 8.** (a) Kale settlement, (b) Cevher Paşa Bath as viewed from west.

a highly seismic region. The studied bath ruin is located at the northern part of the butte, on inclined ground and the inclination reaches approximately 60% at the east (Figure 8).

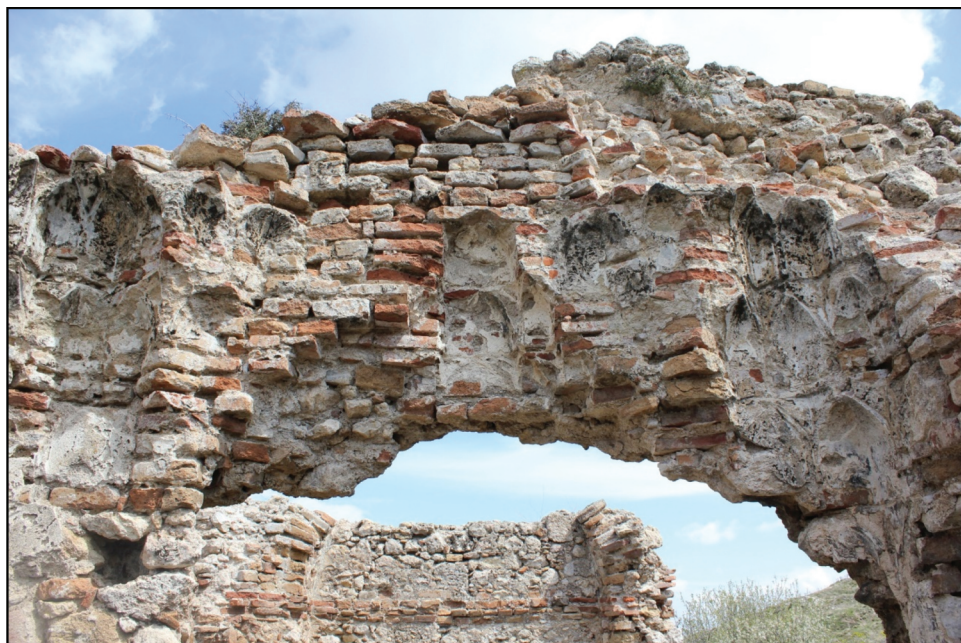
Figure 10. Dome remain as viewed from south.

The arch remain (thickness: 89 cm, spanning distance: 3.7 m) and dome remain (thickness: 100 cm, spanning distance: 3.46 and 4.27 m at east-west and north-south axis, respectively) are composed of brick (5 x 17 cm) at their both surfaces, rubble stone and lime mortar in between. The squinches are at the four corners of the dome remain in space 4. Squinches were detected as bricks and lime mortar. The original load-bearing walls are three-leaved: rough-cut stone and lime mortar at the outer leaves and rubble stone and lime

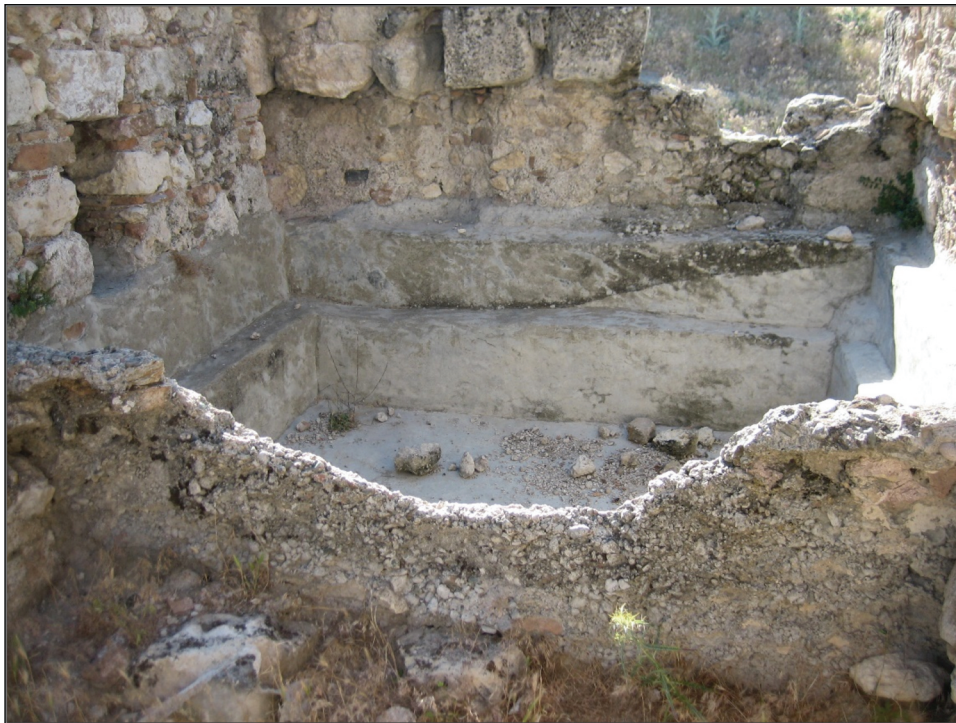
**Figure 12.** Load-bearing walls: rough-cut stone at both surfaces, rubble stone and lime mortar in between (left), rough-cut stone with cement mortar.

mortar at the interior (**Figure 12**). Rough cut stone with cement mortar is only seen at the lower portions of north-eastern wall, which was intervened just after the excavation. There are low and non-load bearing walls surrounding the concrete pools formed during the leather workshop period. At present, the floor is mainly covered with debris and partially screed, which also belongs to the leather workshop period. The remains of the original floor covering are marble blocks with different sizes (e.g., 0.9 m x 1.25 m, 0.63 m x 0.61 m).
