A quantitative approach for evaluating intervention-value relations: historic mosques of Manisa, Turkey

Purpose – This study aims to propose a systematic way of evaluating the impact of historic and current interventions on cultural asset values of monuments that have preserved their authentic functions so that future interventions can be better guided.

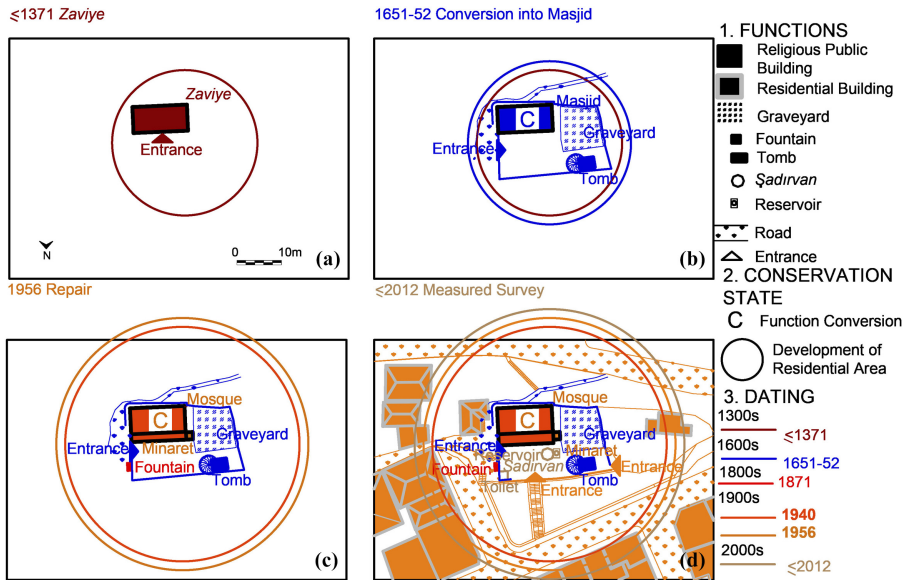
Figure 3.
Site evolution, Haki
Baba Mosque

Haki Baba Mosque was built firstly as a *zaviye*; a house for secluded religious members, in 1371 (Figure 3a). The *zaviye* was converted into a *masjid*; a small praying space in which Friday prayer is not carried out, in 1650–51 (Gökçen, 1950) (Figure 3b). After the addition of a minaret, a concrete minbar and a *mihrab* niche in 1956, it was regarded as a mosque (Figure 3c; Figure 3d). Its restoration was completed in 2014 (Plate 1).

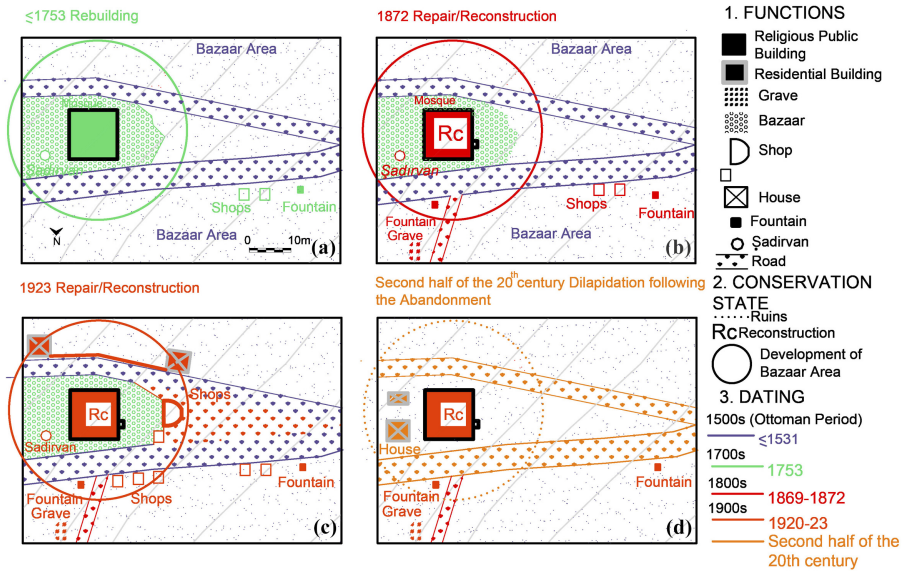
Figure 6.
Site evolution,
Pazaryeri Mosque

before 1753 (Figure 6a). After the landslide risk in 1940, the government relocated the inhabitants to a new place and the historic settlement was abandoned. Pazaryeri Mosque is the only building intervened in Gördes (Figure 6d). The restoration was completed in 2013 (Plate 4).

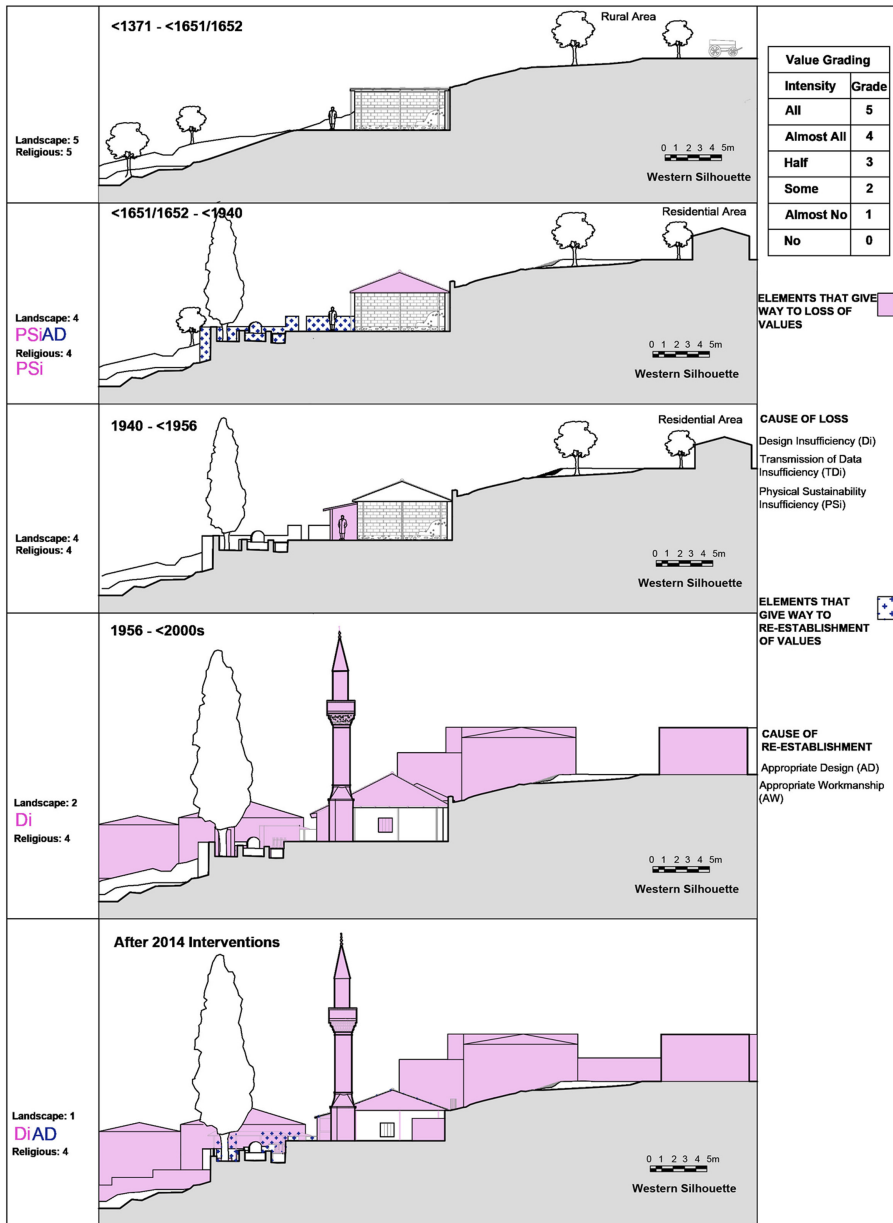
Figure 8. Site scale values, Haki Baba Mosque

The values defined for each period are graded in order to assess the variation in their intensities (Table 1). Presence of all qualities listed in the definition of a value is graded with full points (5). Reduction in value diminishes the related grade. If there is re-establishment of a value with interventions, then this increases the related grade (Figure 8, Figure 9).

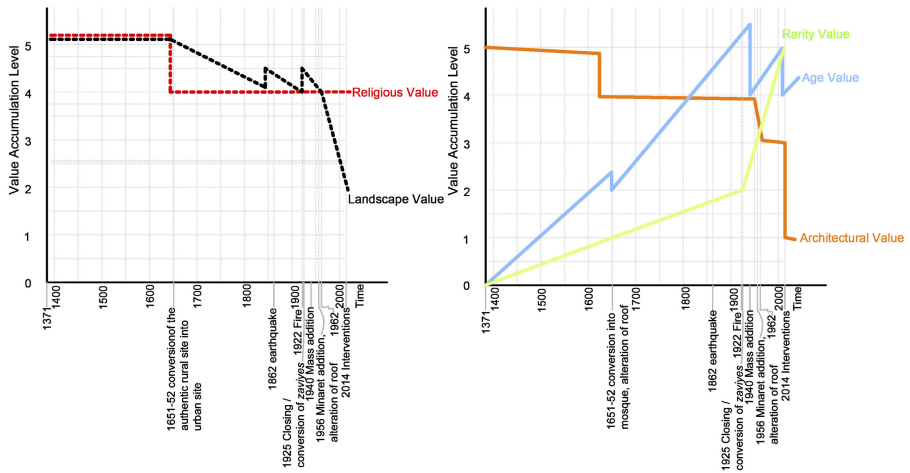
Figure 10. Variation in site (left) and building (right) scale values, Haki Baba Mosque

Afterward, grades for each value type and dates of interventions and disasters regarding the monument are plotted on line graphs (Figure 10).

Disasters have caused partial collapse of mosques (4 of 5, excluding Haki Baba). These were reintegrated as in Kabasakal, Çarşı and Pazaryeri, but they lost their authentic superstructure, plan or façade organization. The reintegration of Göktaşlı in 1906 was qualified. In this context, Haki Baba sustained its rarity value (Figure 10).

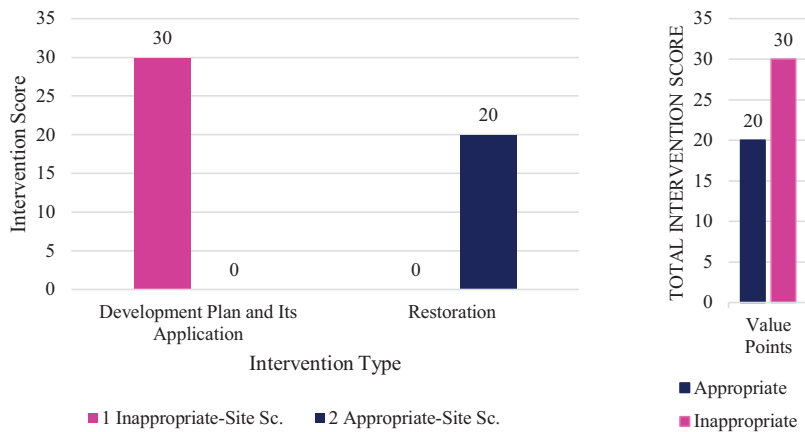
Figure 11.
Intervention scores,
neighborhood of Haki
Baba Mosque

formula: Scale of intervention X Vulnerability of the element intervened X Appropriateness of intervention = Intervention Score. The intervention scores for each case study are summarized on tables (Figure 11, Figure 12).

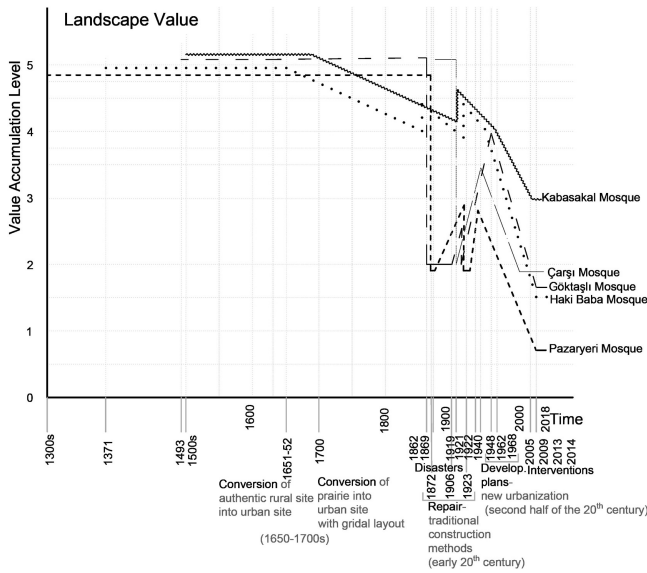
Figure 13.
Landscape values

The case studies sustained their landscape values until the modernization period (excluding Kabasakal and Haki Baba). In between 1650 and 1700s, rural sites were gradually converted into traditional neighborhoods (Kabasakal and Haki Baba). In the second half of the 19th century, new urbanization was seen in connection with the change in transportation patterns. Nevertheless, traditional construction methods were sustained until the mid-20th century. Thus, if monuments fell into ruin as a result of fires, earthquakes and landslides, they were re-integrated or re-built within the traditional urban landscape in later years (Göktaşlı, Pazaryeri and Çarşı). So, they had maintained their picturesqueness with minor losses until this time interval (Figure 13).

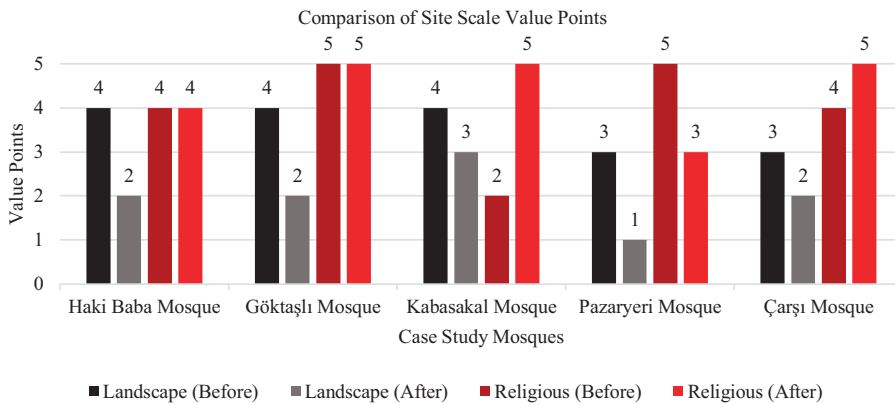
Figure 14.
Site scale value points
in the second half of the
20th century (before)
and today (after)

However, development plans of the mid-20th century yielded radical and irreversible changes in the sites (Figure 14). Gördes had gained the qualities of an archaeological site since the residents had moved the building material of their houses to their new settlements. All these interventions affected the landscape values, while the religious values were sustained, unless there was a radical functional transformation threatening the holy atmosphere; e.g. the addition of a huge dining hall to the courtyard of Kabasakal mosque (Figure 15), the abandonment of Pazaryeri mosque together with its neighborhood and addition of service spaces to the courtyard of Çarşı (Figure 14).

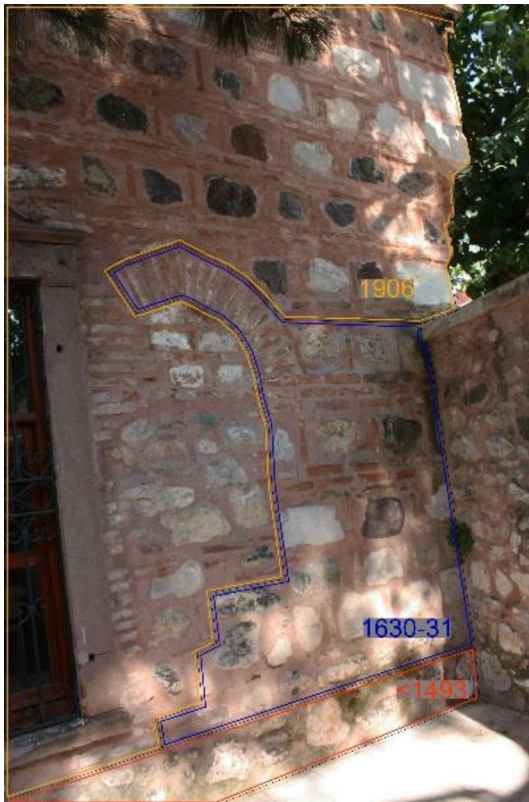
Plate 7.
Western wall, Göktaşlı
Mosque

In building scale, reconstructions on their previous bases with the style of their times; as in 1631 repair of Göktaşlı 1872 repair of Pazaryeri and ≤1968 repair of Kabasakal; re-established architectural values. 1906 re-integration of Göktaşlı (Plate 7) and 1872 re-integration of Pazaryeri are also evaluated as qualified interventions with positive impact on authenticity. Mass additions made in the 20th century, in order to fulfill the necessities of the growing populations, are generally inconsiderate (4 of 5, excluding Pazaryeri) and reduce the authenticity (Figure 10). Current restorations either sustained these unqualified additions

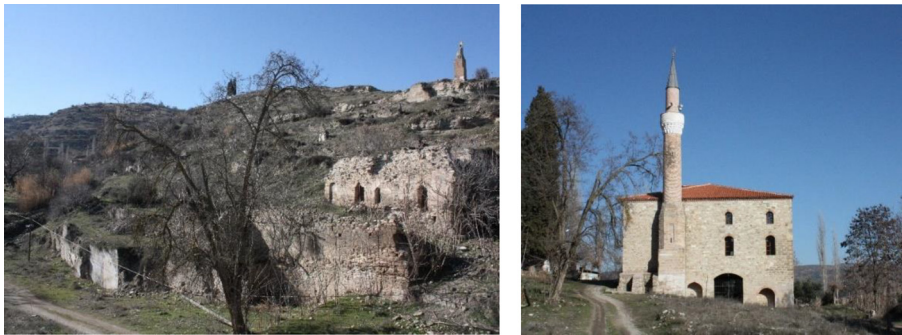
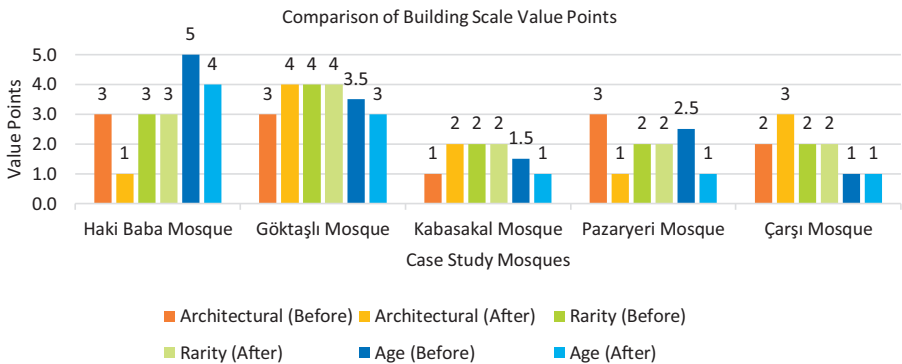
Figure 17.
Building scale value points before and after the current interventions

When current interventions are considered, it is seen that the same restoration approach is applied in all mosque restorations: consolidation and reintegration of the mosque and improvement of comfort conditions to fulfill contemporary standards. This may be acceptable for the examples in dense urban sites to some extent, but for a site that was totally abandoned (Pazaryeri in Gördes) (Plate 8), it is discussable (Figure 17).

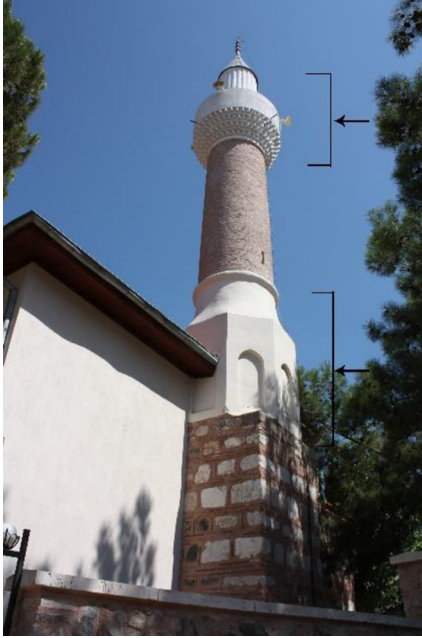
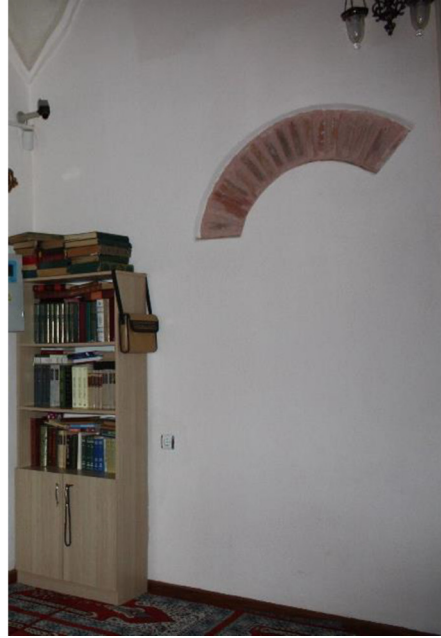
Plate 9.
Minaret (left), remain of
a window arch (right),
Göktaşlı Mosque

In terms of sustaining historic construction techniques, there are problems stemming from incorrect interpretation of what the original is; e.g. mudbrick masonry walls of Haki Baba were reinforced with timber posts (Figure 12). Insufficiency in terms of sustaining the physical integrity decreased the architectural value. Inconsistency within the same application may be seen; e.g. renewal of unqualified plaster additions to the minaret, while exhibiting the window arches of the first construction period in Göktaşlı (Plate 9).
