**CHARACTERISTICS OF BYZANTINE PERIOD  
BUILDING BRICKS USED IN ST. JEAN BASILICA  
(AYASULUK HILL) AND ANAIA CHURCH  
(KADIKALESİ)**

**A Thesis Submitted to  
the Graduate School of Engineering and Science of  
İzmir Institute of Technology  
in Partial Fulfilment of the Requirements for the Degree of**

**in Architectural Restoration**

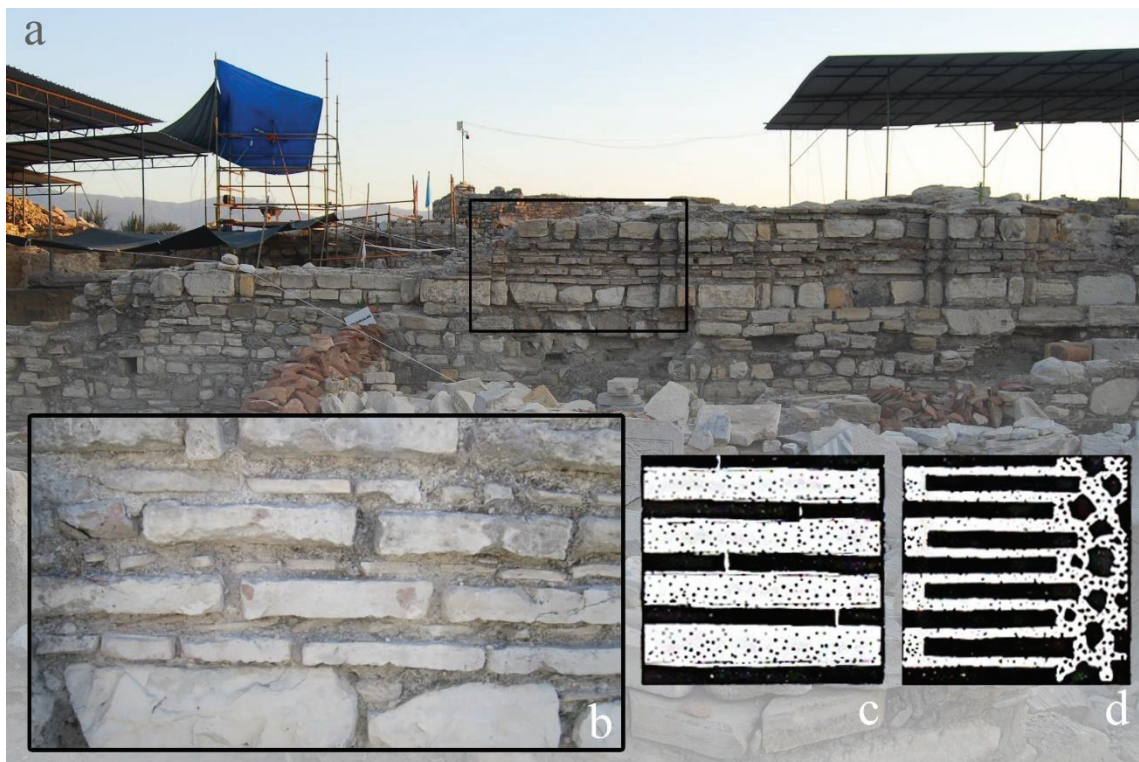
Figure 2.2. Recessed brick technique, a: Northern façade of Anaia Church (Photo: E. Çam, 2020), b: Detail of squared area shows recessed bricks (Source: Kanmaz 2015), c: Elevation sketch of the technique (Source: Ousterhout 1999, 174), d: Section sketch of the technique (Source: Ousterhout 1999, 174)

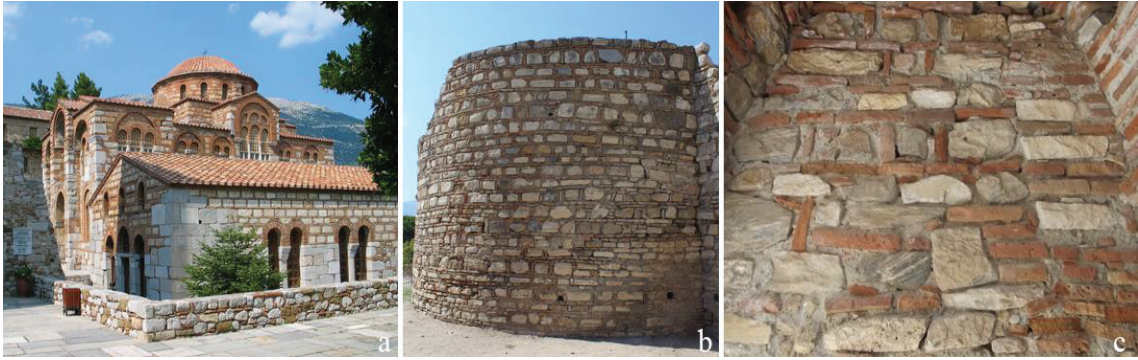
Figure 2.3. Examples of cloisonne technique, a: Monasteries of Daphni, Greece (Source: “Monasteries of Daphni, Hosios Loukas and Nea Moni of Chios - Gallery - UNESCO World Heritage Centre” n.d.) b: A bastion of Kadıkalesi (Photo: E. Çam, 2021), c: Fortification wall of Ayasuluk Hill (Photo: E. Çam, 2020)

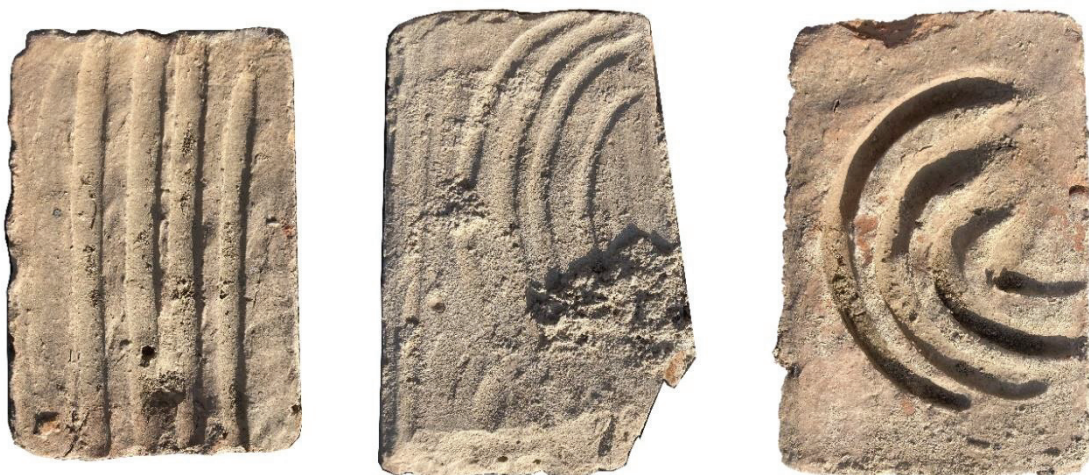
Figure 2.5. In-situ bricks from Anaia Church, Kadikalesi with scratches on the surfaces

The shaping was achieved by the four-sided wooden or metal moulds (Ousterhout 1999). Clay mixture was placed into moulds, and trimmed to remove the excess material (Davey 1961; Adam 2005; Wright 2005; Fernandes, Lourenço, and Castro 2010; Malacrino 2010) (Figure 2.4). Producers sometimes made scratches on the surfaces of fresh bricks by hand to increase the surface area and thus to provide a better bond between brick and mortar (Figure 2.5).

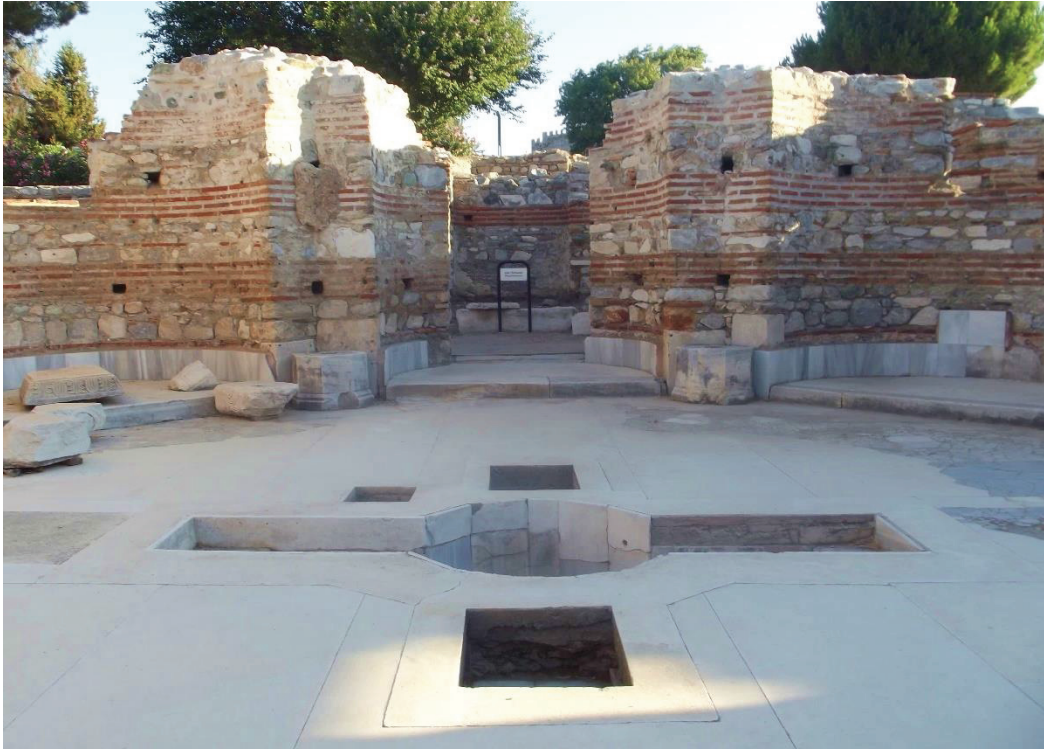
Figure 3.6. Baptistery pool and wall structures from 1<sup>st</sup> period

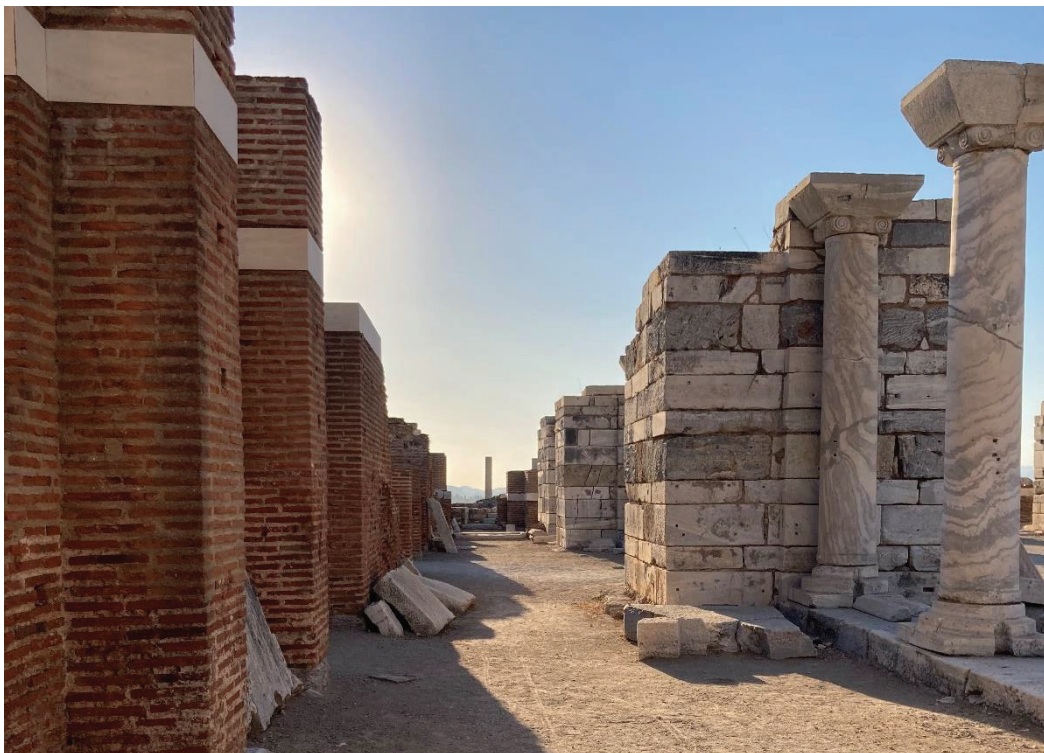
Figure 3.7. Photo of southern nave with outer brick wall on the left and stone columns and pillars on the right

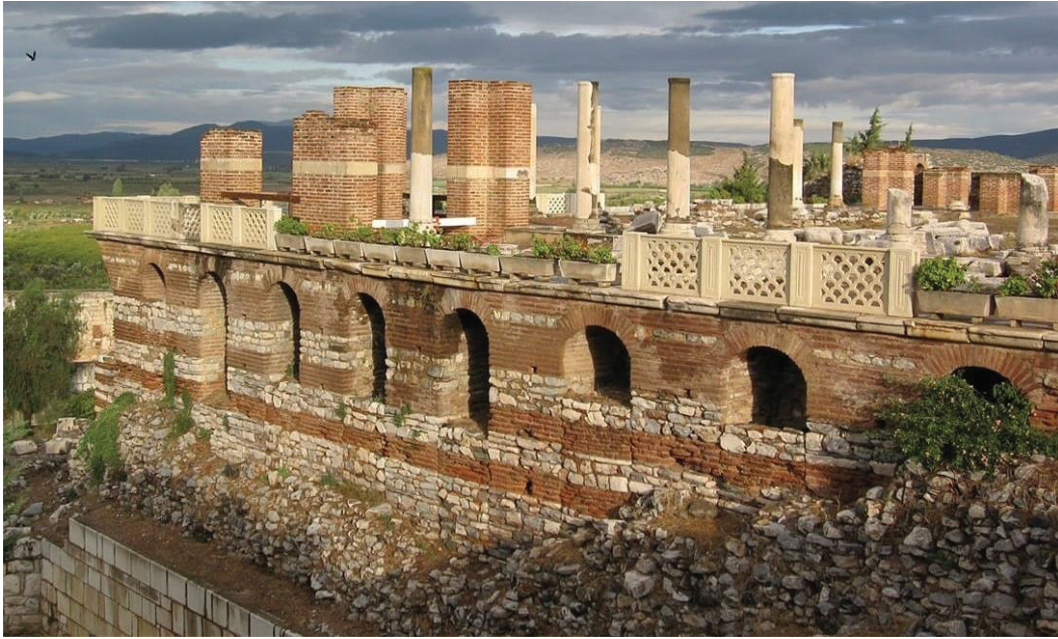
Figure 3.8. Photo of the exterior walls of substructure and the atrium built on top of it  
(Source: Büyükkolancı 2018, 24–25)

The grave of St. Jean, to whom Ayasuluk Hill and the basilica were dedicated, is on the southern slope of the hill. The first church was built in the 5<sup>th</sup> century AD with a wooden roof covering the grave, a baptistery and a treasure room (or Skeuophylakion) on the north side (Hörmann, Keil, and Sotiriou 1951) (Figure 3.5, 3.6). The church was demolished by the earthquakes occurred in 467-468 AD (Büyükkolancı 2001), and only outer walls of transepts, treasure room and baptistery survived from the first construction period (Figure 3.5). The damaged church was rebuilt by order of Emperor Justinian and designed as a cross-shaped and domed structure (Büyükkolancı 2001; Ladstaetter et al. 2015; Karydis 2016). It was thought that the building was tried to be adapted in an axial plan type with the complex that involved the baptistery and treasure room. In the second construction period, two transepts in the north-south direction, an apse and bema were constructed in the 520s (Karydis 2016) (Figure 3.5). The third construction period, dated to around 550 AD, was a continuation of the second phase. The west aisle, a narthex, an atrium, and a substructure were added to the church in the third phase. The final church reached the dimensions of 110x130 meters and gained a monumental character (Ladstaetter et al. 2015). The structure was covered with six domes that were carried by pillars. Three naves on the west aisle were separated by arched colonnades (Büyükkolancı 1991; Ladstaetter et al. 2015) (Figure 3.7). The entrance to the Church was provided from narthex with three porticos (Büyükkolancı 2001). There was an atrium with a courtyard surrounded by arcades supported by columns in front of the church (Figure 3.5). The atrium was thought to be constructed through the substructure that was built to raise the ground level to the church level (Ladstaetter et al. 2015) (Figure 3.8).

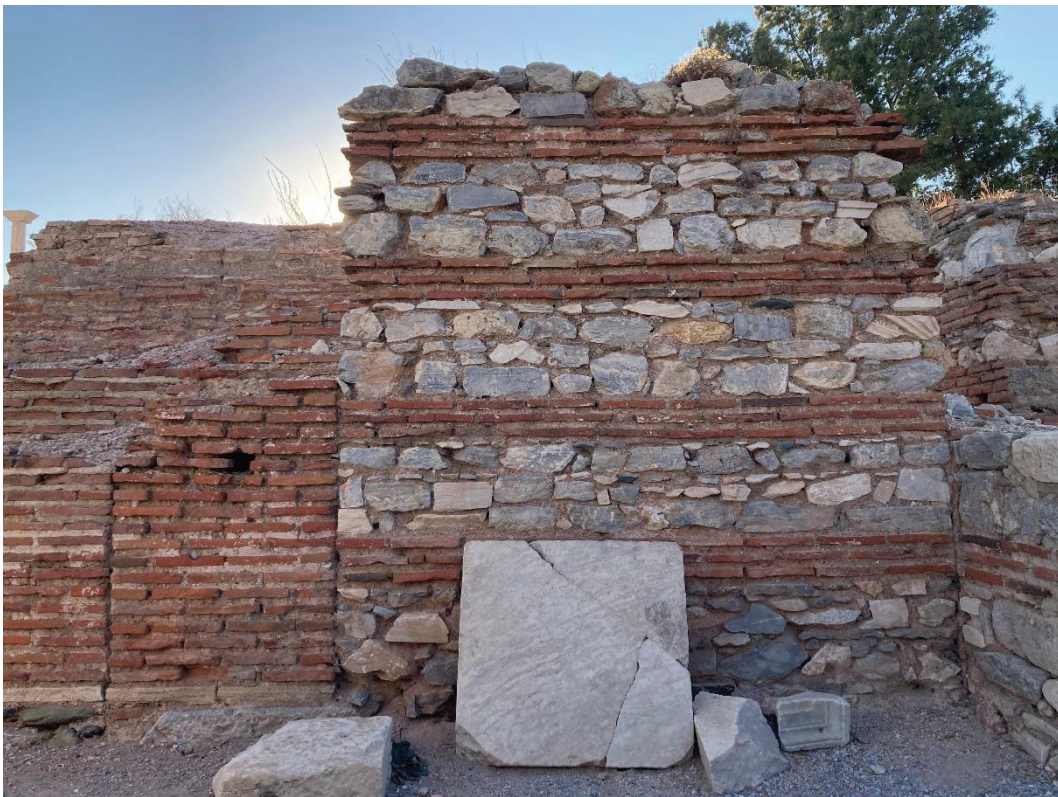
Figure 3.9. Different wall bonding types from the northern transept (Right side of the wall was a part of 1<sup>st</sup> phase, and the left side was built in later periods)

Besides, there were differences between the bonding types of structural elements regarding construction periods. The walls of the treasure room, baptistry, and some parts of transepts that belonged to the first phase were constructed with brick and stone alternating bonds (Figure 3.6). The brick was used alone in the walls of the second and third construction periods, such as the external walls of naves, transepts, narthex, and apse walls (Figure 3.9). Also, the bond type of pillars differed between bema and naos, dated to the second and third construction periods, respectively, as mentioned in the study of Karydis (2016).

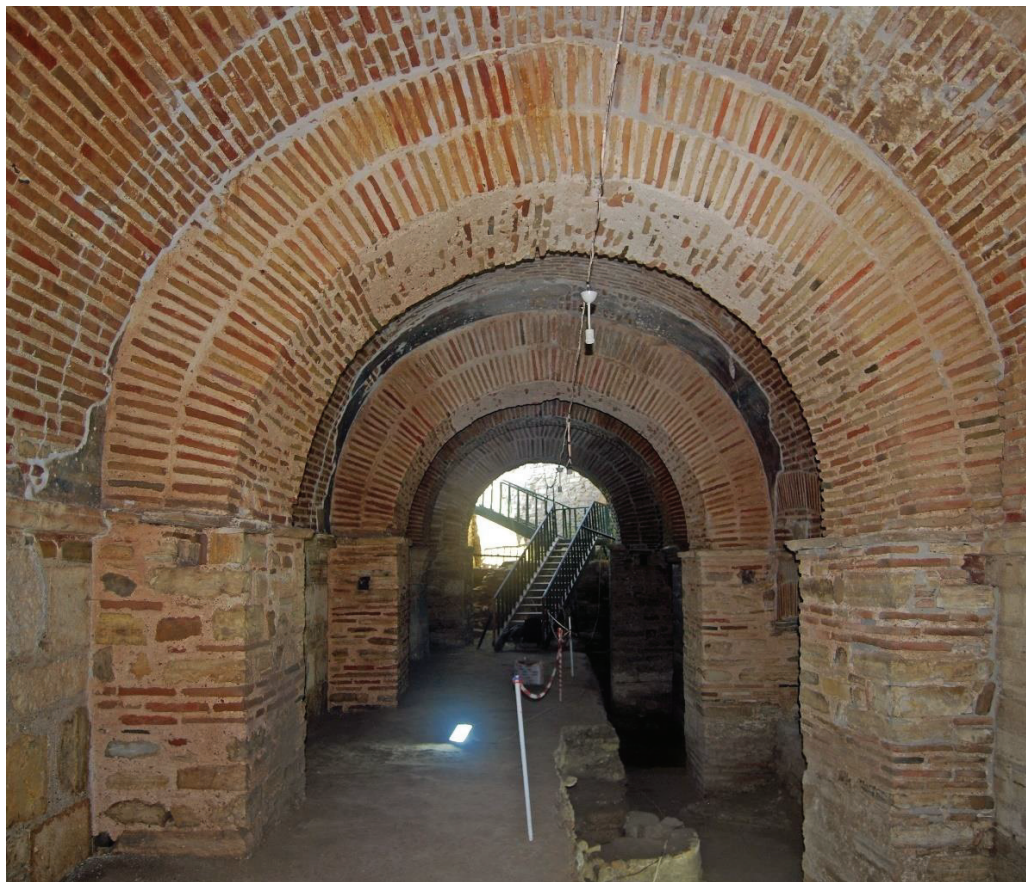
Figure 3.13. Substructure from 1<sup>st</sup> phase with brick vault and arches

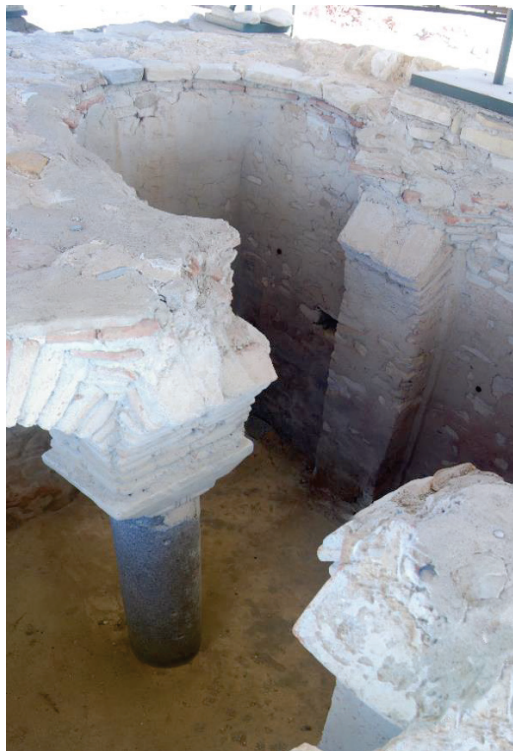
Figure 3.17. Photo of the cistern in the west corner showing the remains of arches and domes

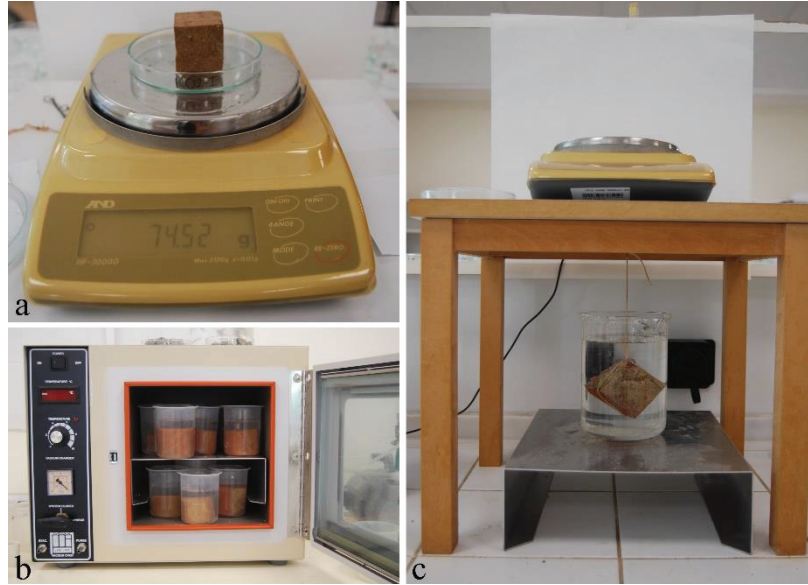
Figure 4.4. a: Weight measurements, b: Samples in vacuum oven, c: Measurements of Archimedes weight

Standard test methods were used for the determination of the basic physical properties of brick samples (RILEM 1980). For this purpose, two parallel cubic samples of each brick, with sizes ranging between 3 and 6.5 cm due to the thickness of the bricks, were prepared. Samples were dried in an oven at 40°C for at least 24 hours, and their dried weights ( $M_{dry}$ ) were measured (Figure 4.4). The samples were kept in distilled water for 24 hours at atmospheric pressure in room condition and also under low pressure in a vacuum oven (3608-6CE Vacuum Oven, Lab-Line) (Figure 4.4). The saturated weights of samples at atmospheric pressure ( $M_{atm}$ ) and low pressure ( $M_{sat}$ ) were measured. Afterwards, the Archimedes weights ( $M_{arch}$ ) were measured when samples were totally immersed in distilled water (Figure 4.4). The weight measurements were carried out by a precision balance with the sensitivity of 0.01 g (HF-3000G, A&D). Porosity (P), apparent density (D), saturation coefficient (S) and pore interconnectivity ( $A_x$ ) were calculated by using weights.

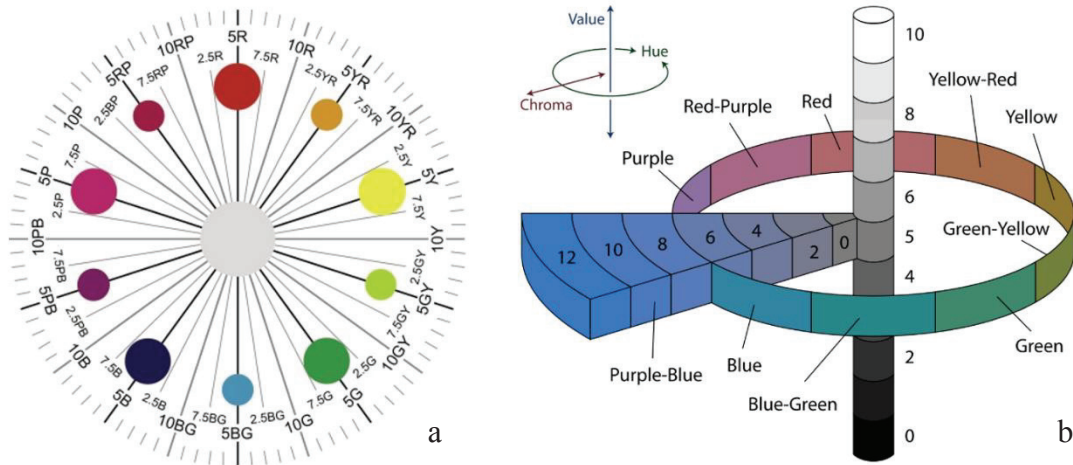
Figure 4.6. a: Munsell Hue scale (Source: Setchell 2012, 103), b: Munsell colour system (Source: Cochrane 2014, 29)

The colour of brick materials depends on the mineralogical composition of raw material and firing temperature. Consequently, the determination of the colour is significant for the classification of bricks. Colour of brick samples was examined by using Munsell Soil Colour Chart (Munsell Colour (Firm) 2000). In Munsell colour system, colours are defined with three variables: hue, value, and chroma. The Hue, that represents the colour, consists of five principal hues, which are red (R), yellow (Y), green (G), blue (B), purple (P), and five intermediate hues (YR, GY, BG, PB, RP). The degree of overlapping of colours expresses with four values that 2.5, 5, 7.5, 10 (Figure 4.6). In the system, the value indicates the lightness of the colour. It changes in the range of 0 to 10, in other words, dark to light. The saturation of colour is represented by the chroma in the Munsell colour system. The zero point of the chroma in all hues is the colour grey, and the saturation increases in higher values (Gerharz, Lantermann, and Spennemann 1988) (Figure 4.6).

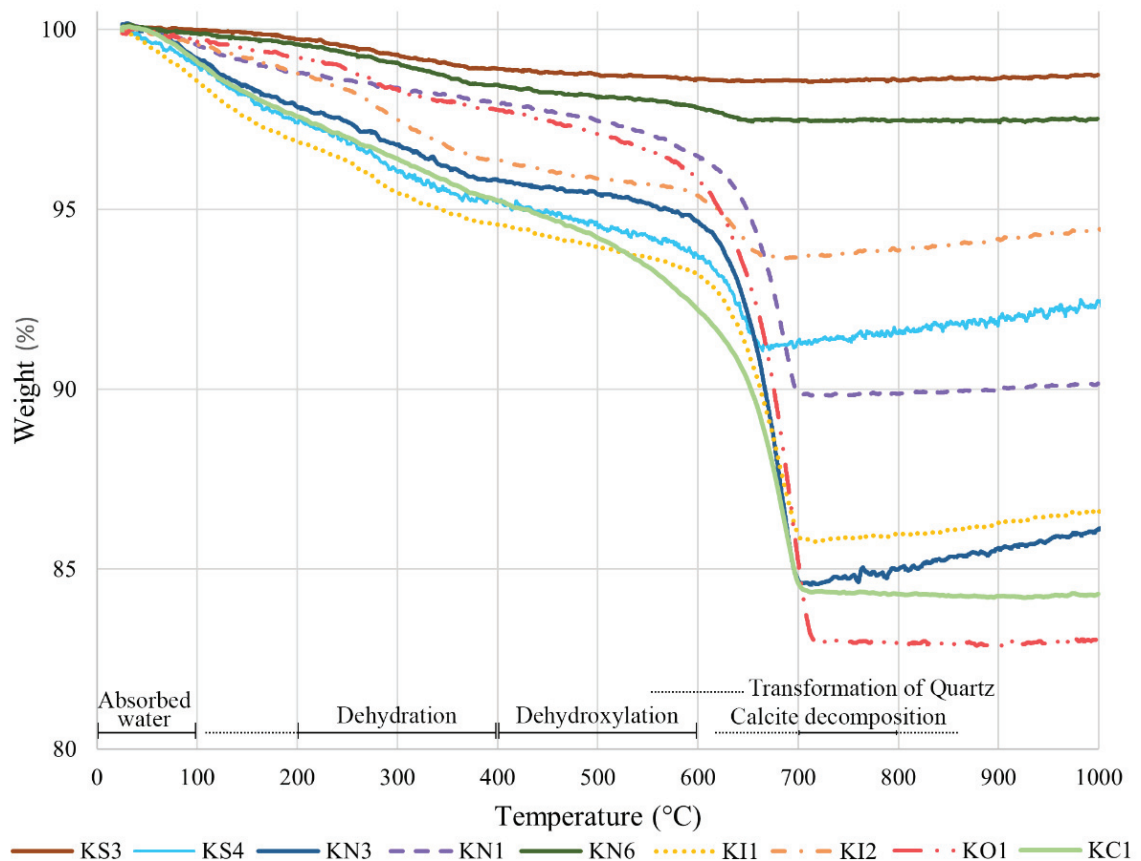
Figure 5.16. TGA graphs of Anaia Church bricks

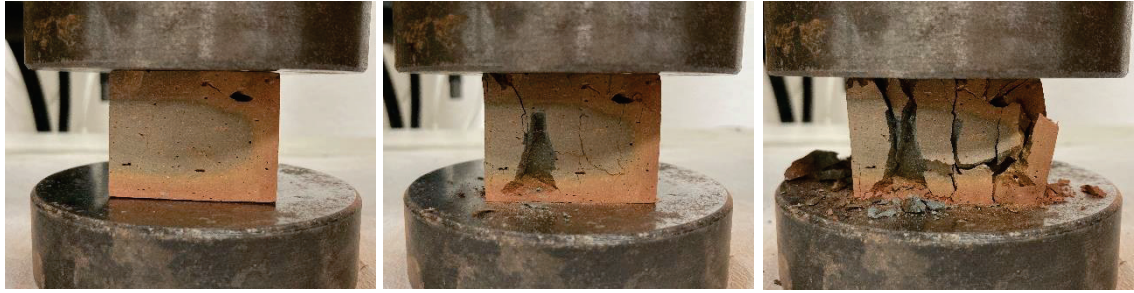
Figure 5.22. The behaviour of AN during the mechanical test

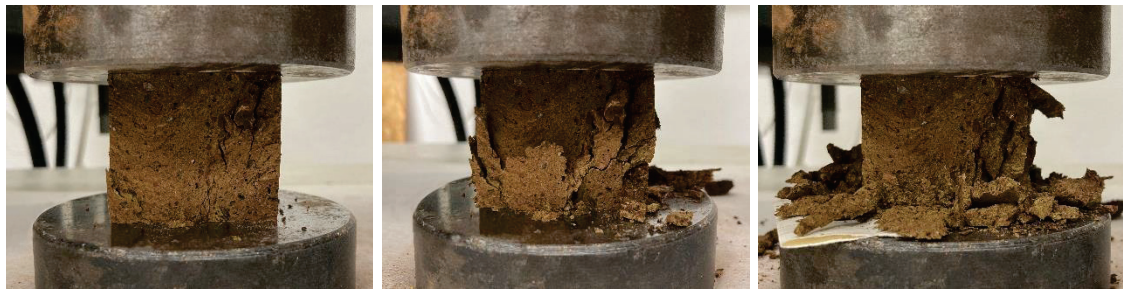
Figure 5.23. The behaviour of KN5 during the mechanical test
