**ASSESSMENT OF CONSERVATION
INTERVENTIONS AT BOULEUTERIA
IN ANATOLIA**

**A Thesis Submitted to
the Graduate School of Engineering and Science of
İzmir Institute of Technology
in Partial Fulfillment of the Requirements for the Degree of**

In Architectural Restoration

**by
Tuğçe TEKİN**

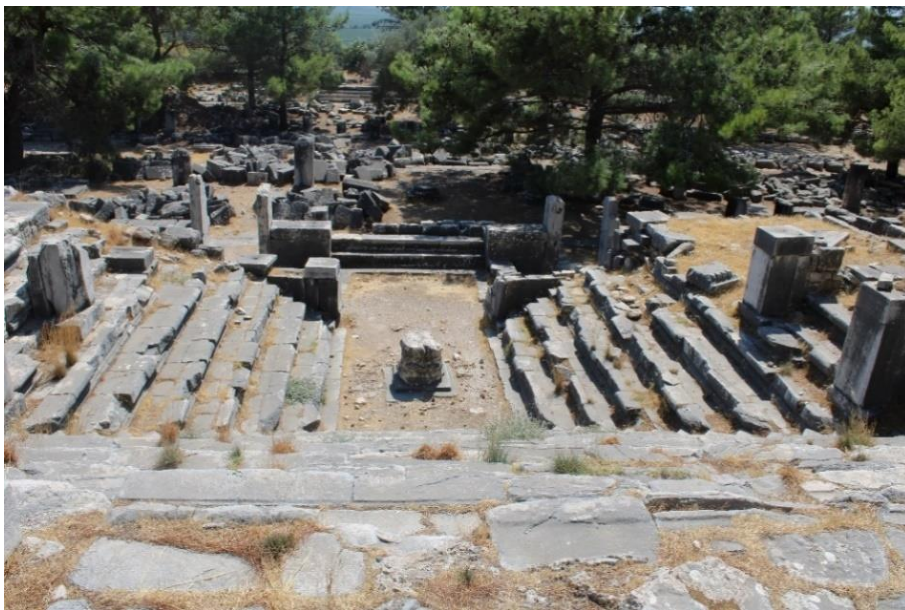
Figure 2.8. Priene Bouleuterion with seating arranged parallel to the exterior walls in a square exterior wall form (Photograph: T. Tekin, 06.09.2021).

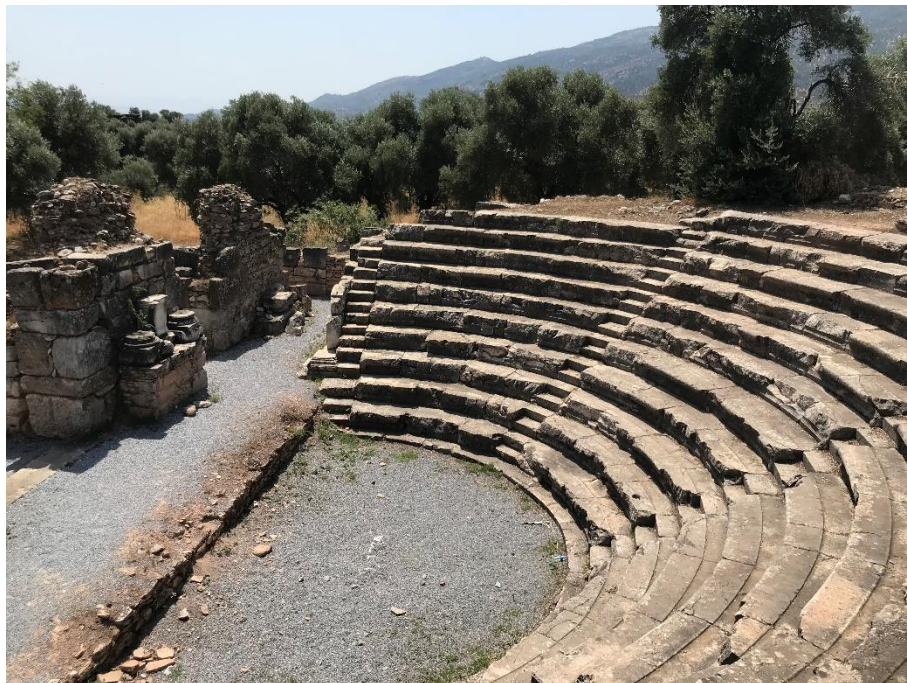
Figure 2.10. Nysa Bouleuterion/Gerontikon which has a curvilinear seating arrangement
(Photograph: T. Tekin, 26.06.2021).

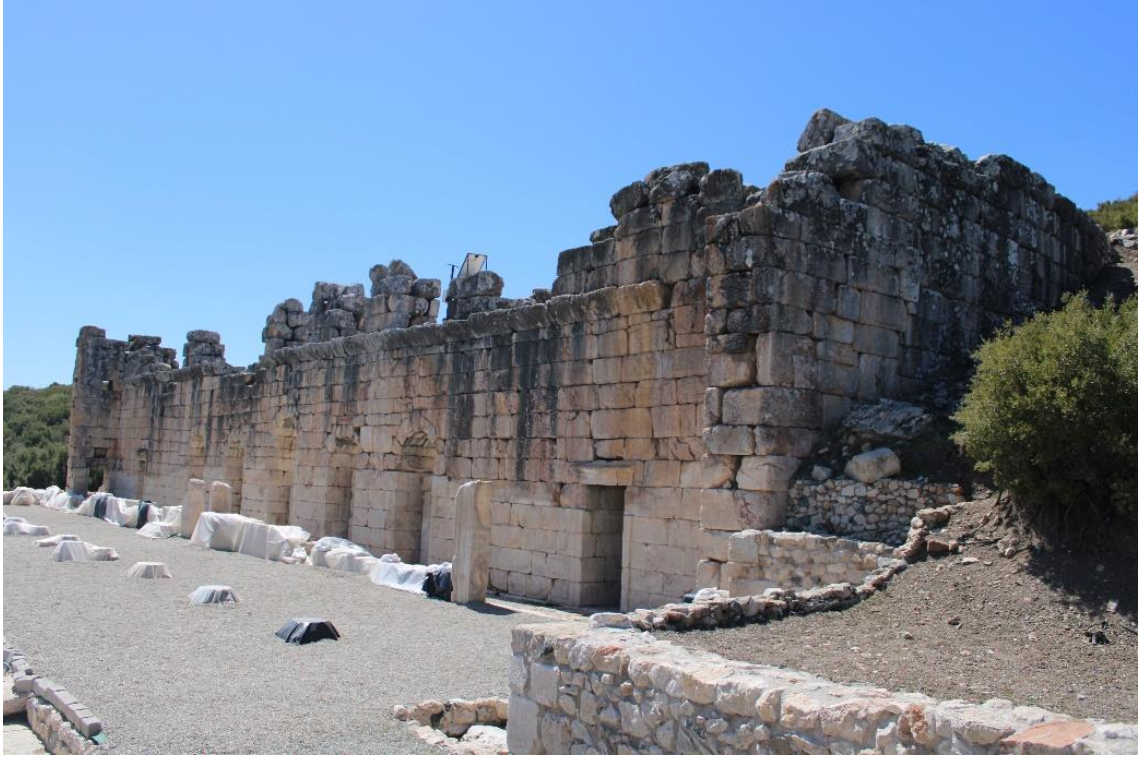
Figure 2.13. View of the Kibyra Bouleuterion from the northeast direction (Photograph: T. Tekin, 09.04.2022).

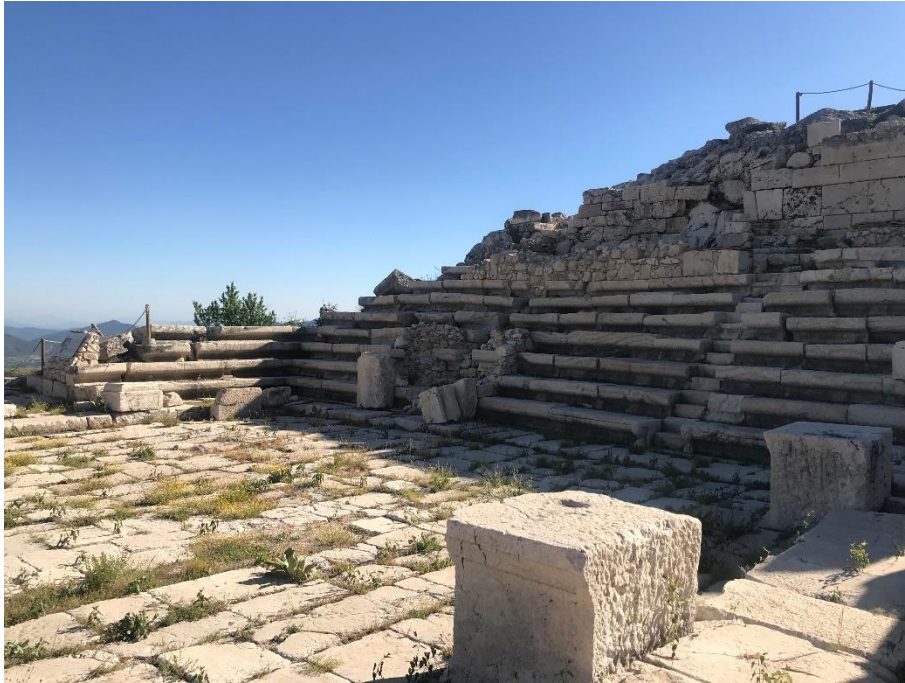
be arranged by covering them with marble. The Bouleuteria of Miletus and Sagalassos are cited as examples of bouleuteria where flat stone blocks were arranged side by side to form flooring (Figure 2.14). Flooring can also be formed with the technique called opus sectile by bringing coloured marble pieces side by side in a geometric order. The Bouleuteria of Nysa and Iasos can be cited as examples of structures with this type of flooring (Öz 2006).

Figure 2.14. A part of the cavea and flooring of the Sagalassos Bouleuterion (Photograph: T. Tekin, 20.05.2021)

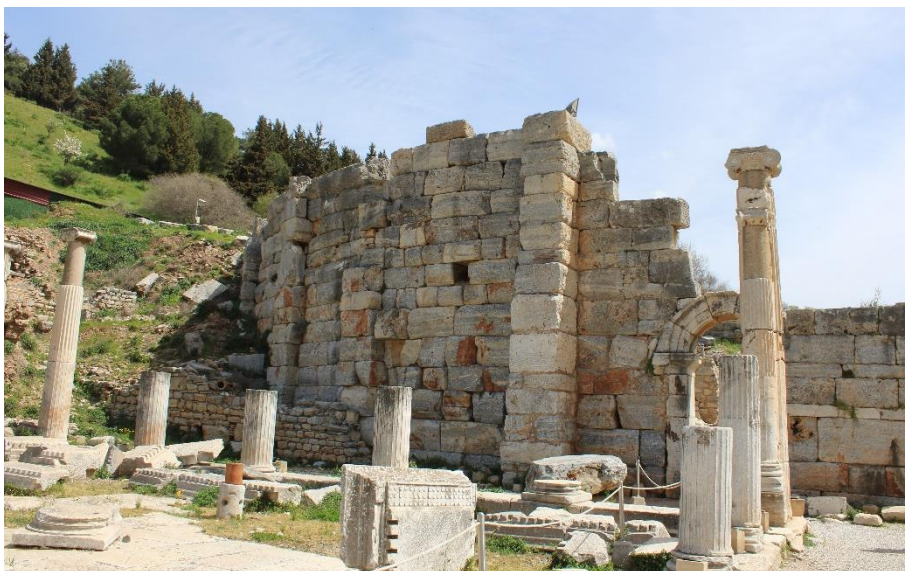
It is observed that there are buttresses built with cut stones supporting the circular outer wall surrounding the cavea of the Ephesus Bouleterion/Odeion and its linear exterior wall in the west direction from the outside (Figure 2.15). In Priene Bouleterion remains, there are rectangular internal support elements which support the roof (Figure 2.16).

Figure 2.15. Remains of the curvilinear exterior wall and some of the buttresses on the west side of the Ephesus Bouleterion/Odeion (Photograph: T. Tekin, 03.04.2022).

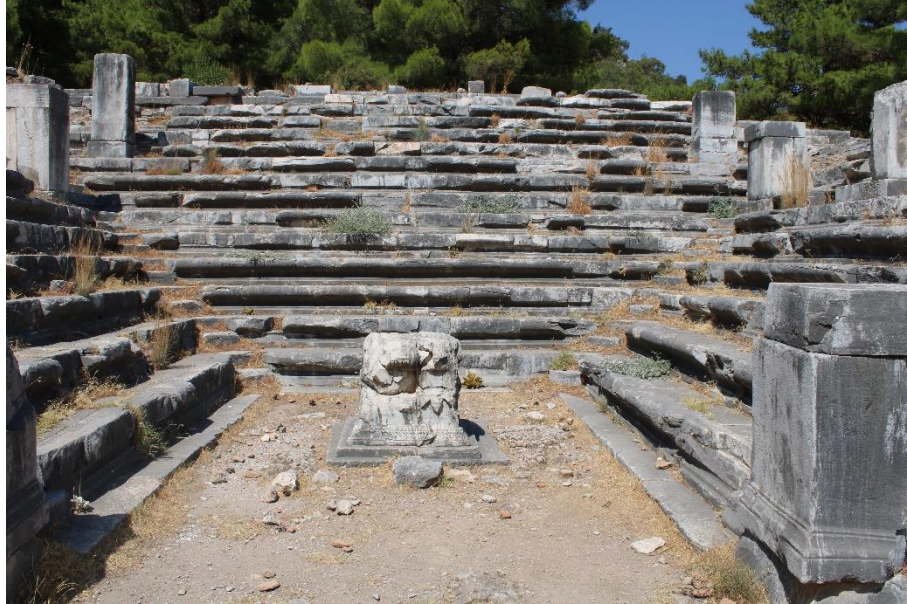
Figure 2.16. Internal support elements in Priene Bouleuterion/Odeion (Photograph: T. Tekin, 06.09.2021).

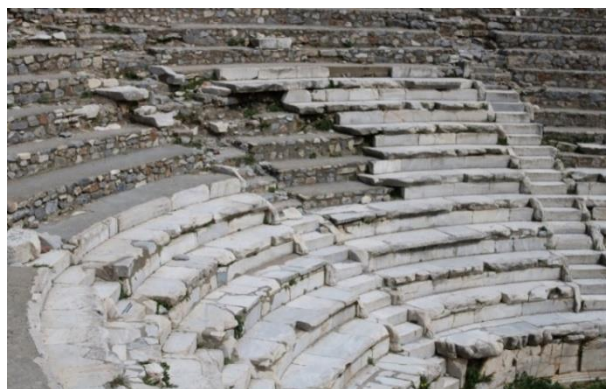
Figure 2.17. Ima cavea section of the Ephesus Bouleuterion/Odeion built of stone blocks and the reconstructed rubble filling under the seating rows (Photograph: T. Tekin, 03.04.2022).

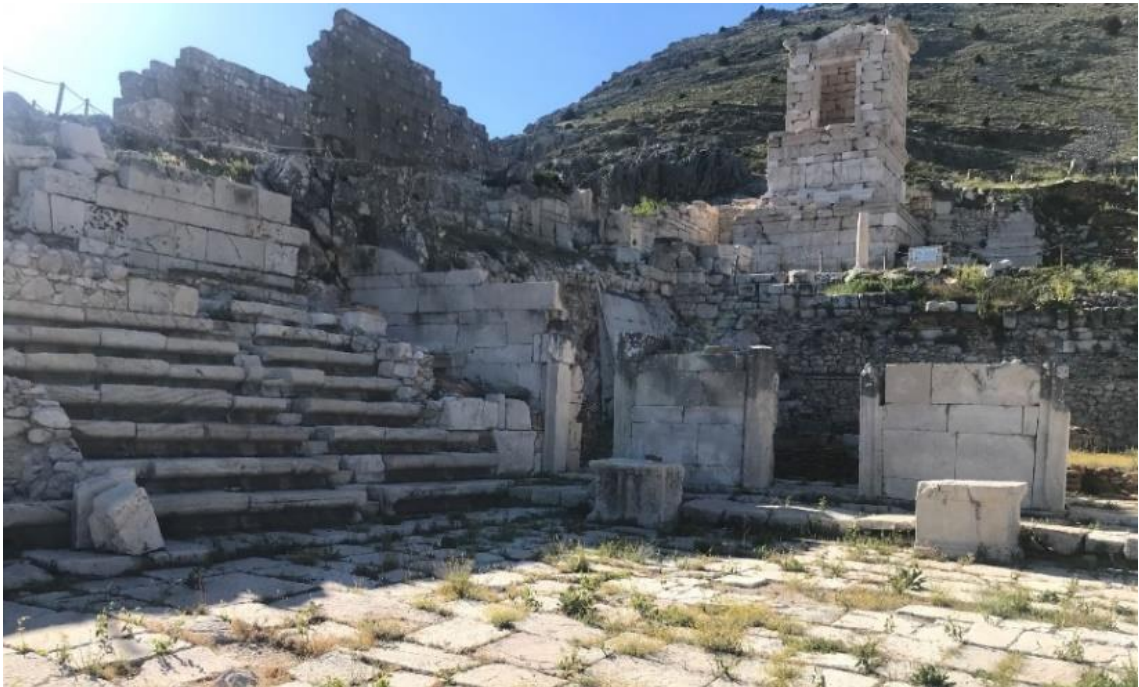
It is seen that the curvilinearly planned cavea of the Aigai Bouleuterion consists of 12 seating rows with a height of approximately 34 cm and 23 stair steps with a height of 15 cm. It is reported that the seating rows at the top level on the natural slope decreasing from west to east were formed by using monoblock (block stone) and the others by using andesite stone slabs. It is reported that ornamented support stones were placed between the andesite slabs forming the riser and carrying the covering blocks (Kaplan 2009). According to Gürbüzler (2015), the height of the seating rows of the Aigai Bouleuterion is 35 cm. The support blocks reported to have the figure of a lion's foot have a height of 20 cm and a depth of 35 cm (Gürbüzler 2015). It is seen that stone blocks were used in the construction of the cavea in Sagalassos Bouleuterion (Figure 2.18).

Figure 2.18. The profiled seating rows of the Sagalassos Bouleuterion, built of stone blocks (Photograph: T. Tekin, 20.05.2021).

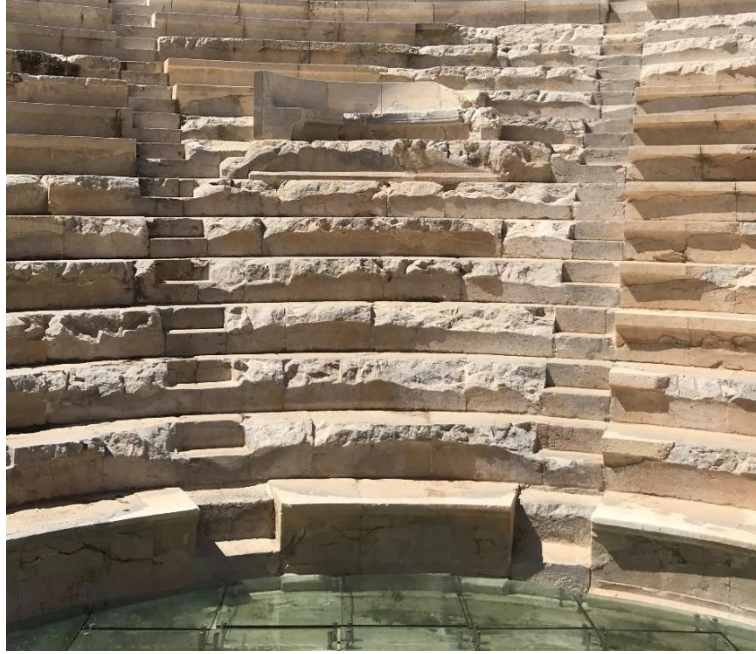
There is a curvilinear throne remain approximately in the central part of the cavea section of Patara Bouleuterion/Odeion. It is seen that the throne was built from limestone blocks like the seating rows and stairs in the cavea (Figure 2.19). As it can be understood from this remain, it can be thought that special sections were separated between the rows of seats according to the status of the council members.

Figure 2.19. Remains of profiled seating rows and throne of Patara Bouleuterion/Odeion (Photograph: T. Tekin, 08.04.2021).

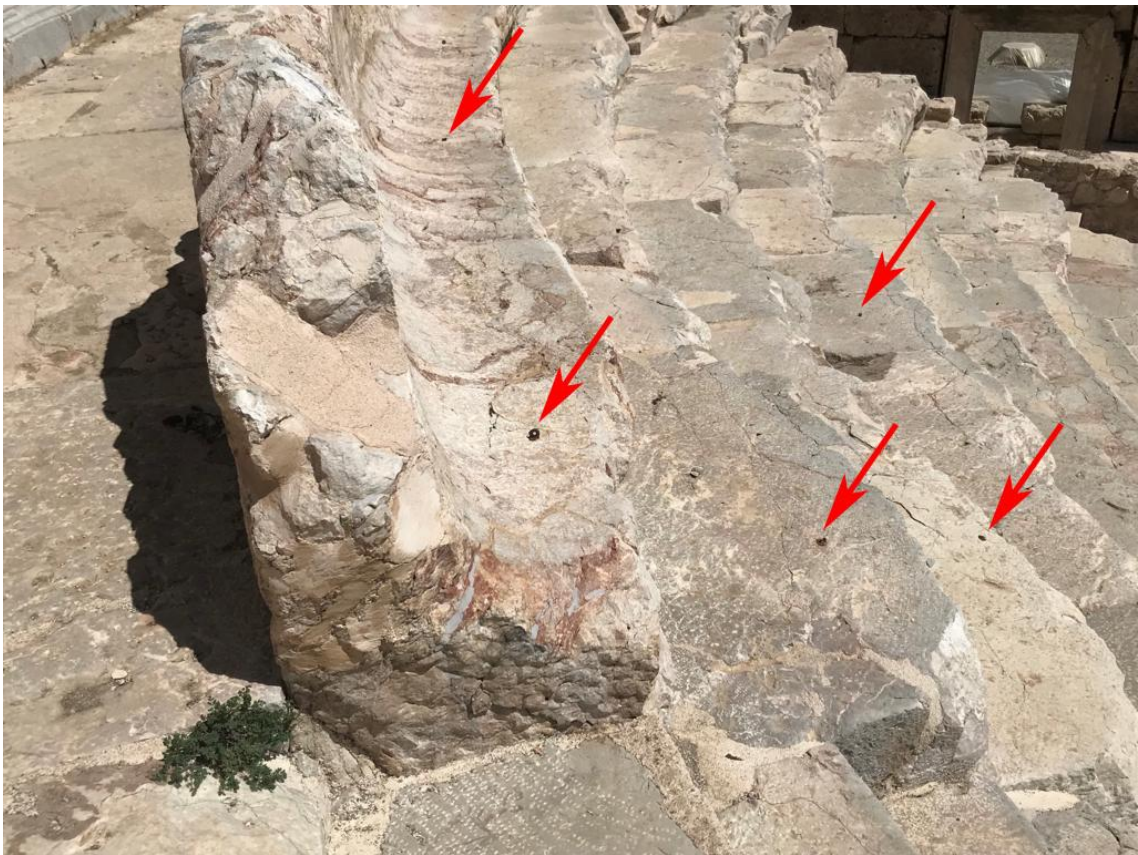
It is thought that the remnants of rings, hooks, and nails on one of the seating rows in the ima cavea section of the cavea of the Kibyra Bouleuterion/Odeion, and the remnants of rings found in other rows belong to the fasteners organised to connect the boards of the wooden coverings that were placed on the seating sections (Figure 2.20) (Özüdoğru, Tarkan and Öztürker 2010).

Figure 2.20. Fastener ruins on the seating rows of Kibyra Bouleuterion (Photograph: T. Tekin, 09.04.2022).

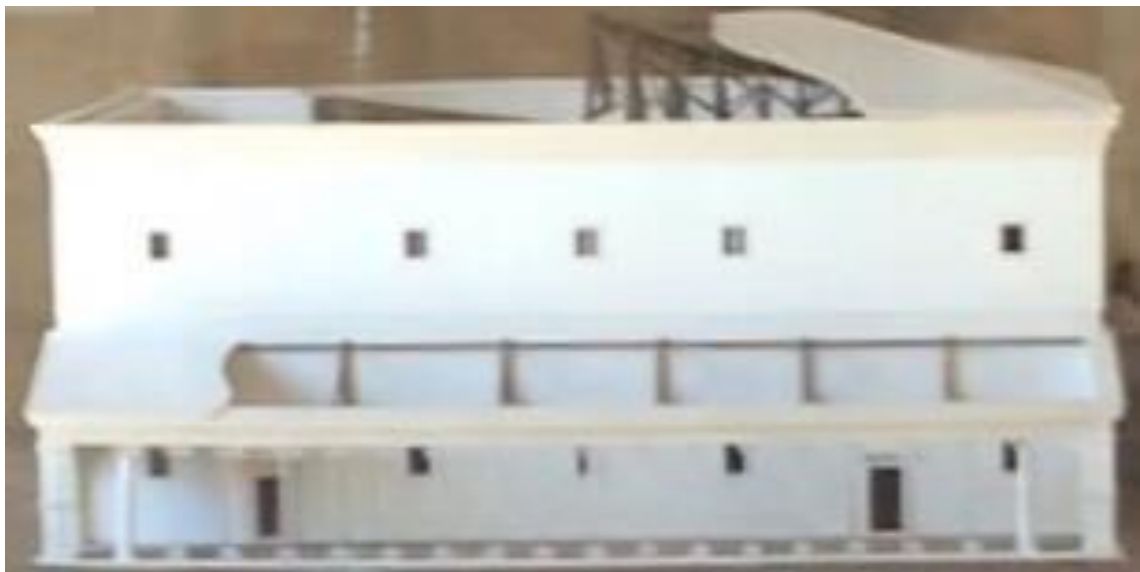
During the excavations carried out in 2009 in the ancient city of Patara, it has been reported that the remains of tiles which are thought to belong to the roof of the bouleuterion were found (Figure 2.21) (Keskin 2011).

Figure 2.21. Restitution model of Patara bouleuterion which is in the bouleuterion's south room and shows the roof construction (Photograph: T. Tekin, 08.04.2021).

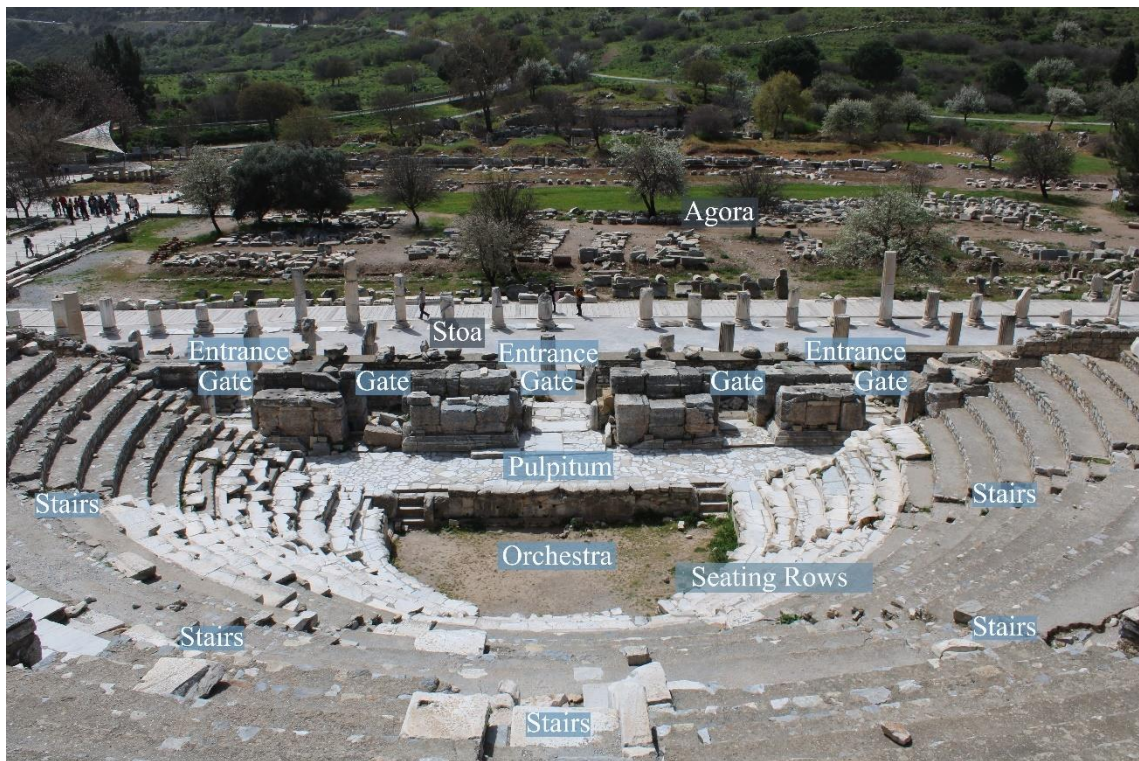
It is seen that the cavea section of the structure with a circular plan is divided into ima cavea and summa cavea by means of a diazoma. The ima cavea is divided into five kerkides with a total of six staircases, two adjacent to the analemma wall and four in between (Figure 4.8). The present-day ruins of the bouleuterion show the summa cavea divided into eight kerkides by seven stairs. The seating sections on the east and west sides of the summa cavea are narrower than the other sections. It is understood from the original remains of the seating rows that they were built with marble blocks and there are stone support blocks bearing lion's foot figures at the junction with the stairs. The remains of the original seating rows of the building are mostly found in the ima cavea. At the junction point of the cavea with the orchestra, there is a diazoma that is narrower than the other diazomas (Figure 4.9). The orchestra is four steps lower than the level of this narrow passage. Between the orchestra and the stage section, there is a pulpitum rising from the east and west directions towards the centre with a slight slope.

Figure 4.8. Parts of the Ephesus Bouleuterion/Odeion seen when looking from the north direction to the south direction (Photograph: T. Tekin, 03.04.2022).

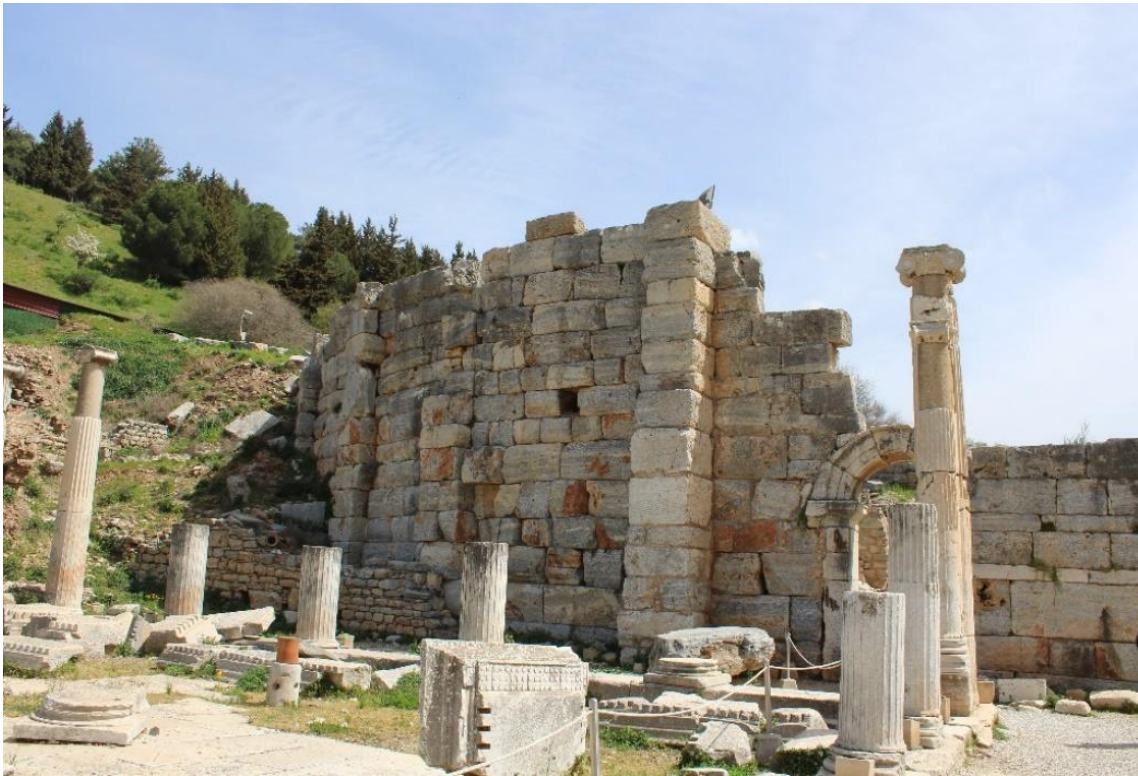
There is an exterior wall with a thickness of 1.10 m that surrounds the cavea of the structure with a semi-circular form from the north, east and west directions and supported by buttresses from the outward directions. The analemma walls with a thickness of 62 cm, bounding the cavea in the southeast and southwest directions were built with cut stone blocks. The walls of the vomitoria were built by using rubble stone

Figure 4.10. View of the curvilinear exterior wall on the west side of the Ephesus Bouleuterion/Odeion, the buttresses supporting the wall, and the arched gateway (Photograph: T. Tekin, 03.04.2022).

It has been reported that there are vaults supporting the cavea above the *parados*, which were not present at the time of the first construction but were added in the subsequent periods (Aurenhammer, Quatember and Thür 2011). The vaults have not survived to the present day. It can be seen that the curvilinear exterior walls are supported by buttresses on the north, east and west directions.

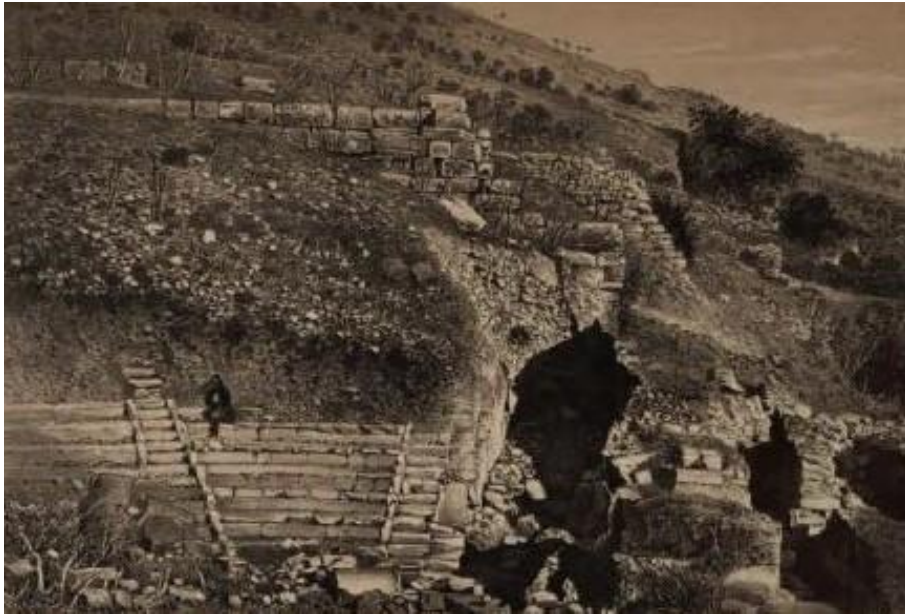
It has been reported that the remains of the stage, orchestra, seating platforms/seats and the steps of the stairs were well preserved since they were covered by rubble and soil fill. At the same time, the remains of the exterior wall on the south side of the stage section with a height of about 228 cm (7 feet 6 inches) are reported (Figure 4.13) (Wood 1877).

Figure 4.13. View from west to east of the structure before the excavation and conservation works (Source: Wood 1877).

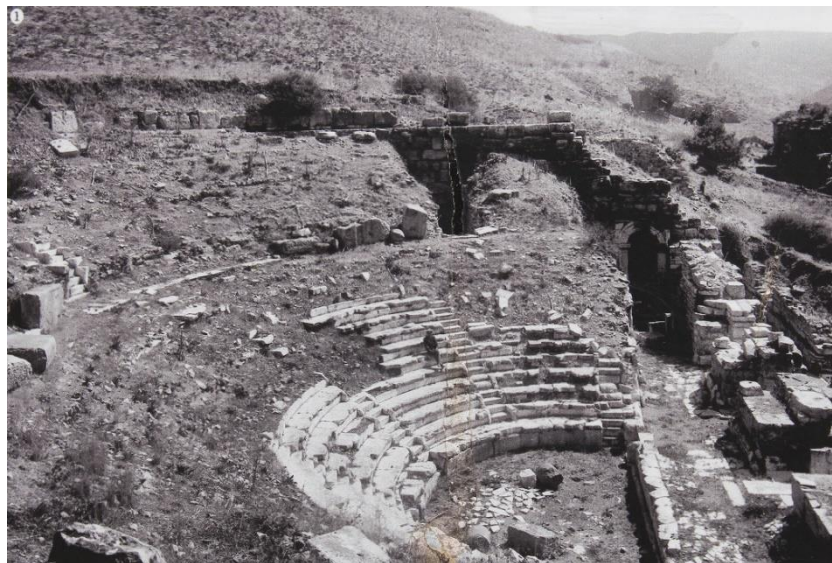
The photograph dated 1908 on the information board in the Ancient City of Ephesus shows that the remains of the bouleuterion/odeion have been uncovered (Figure 4.14). Remains of the lower seating rows in the centre and east of the cavea, the gap of the vomitorium in the east, the remains of marble flooring on the floor of the orchestra and pulpitum, and the remains of the walls of the stage section approximately at the level of the seating rows can be seen from this photograph.

Figure 4.14. Photograph from the information board showing the remains of the original seating rows, space for the vomitorium, pulpitum flooring and stage section, 1908.

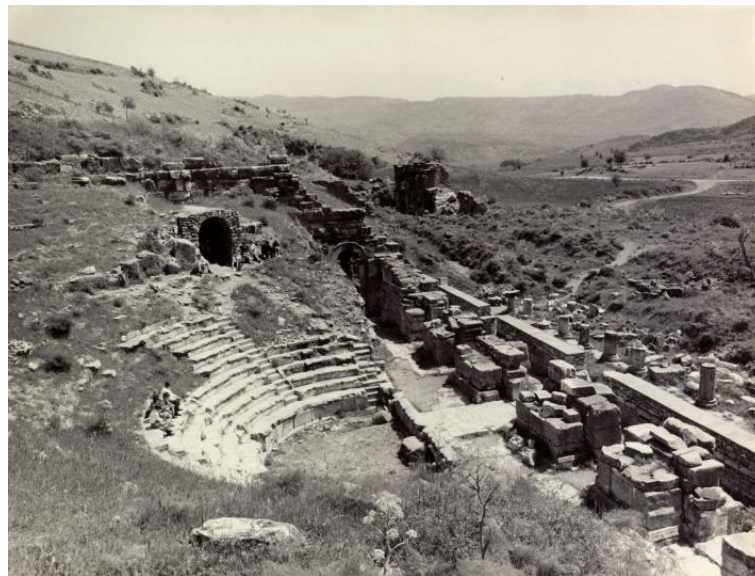
Figure 4.15. Reconstruction of the vomitorium, completion of the pulpitum and capping on the masonry on the south direction, 1964 (Source: Salt Research, 2022, Photograph: Laroche 1964).

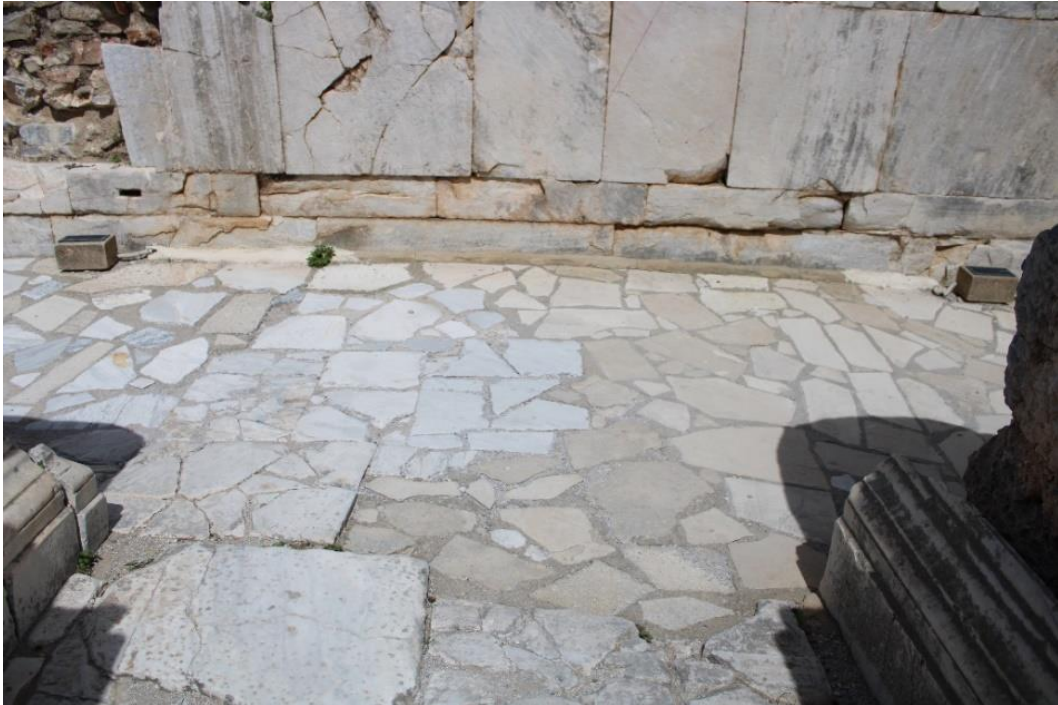
Figure 4.21. Irregularly shaped stone slabs on the east side of the pulpitum flooring (Photograph: T. Tekin, 03.04.2022).

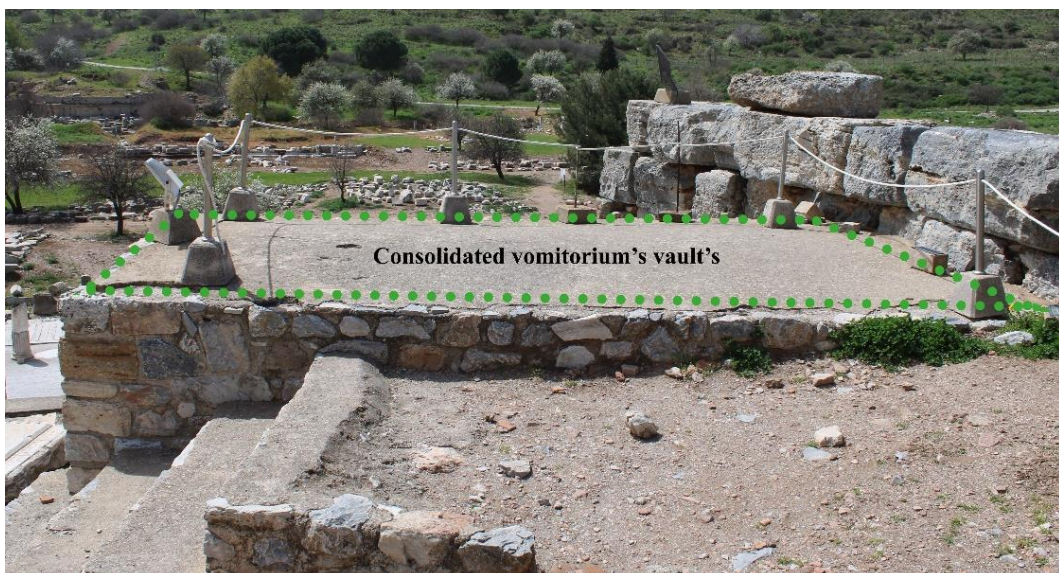
Figure 4.22. Concrete implementation on the western vomitorium vault (Photograph: T. Tekin, 03.04.2022).

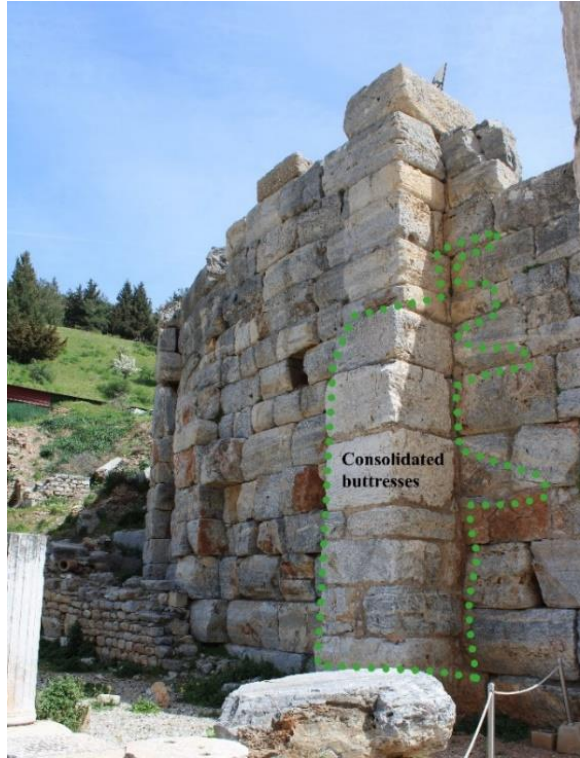
A joint filling, which is assumed to be cement mortar, was applied between the joints of the stone blocks of the western buttresses which support the curvilinear exterior wall of the structure (Figure 24). The eastern jamb of the gate on the eastern direction of the southern exterior wall was filled with cement mortar in places between it and the wall to its east (Figure 25).

Figure 4.24. Consolidated buttress at the west side of the bouleuterion (Photograph: T. Tekin, 03.04.2022).

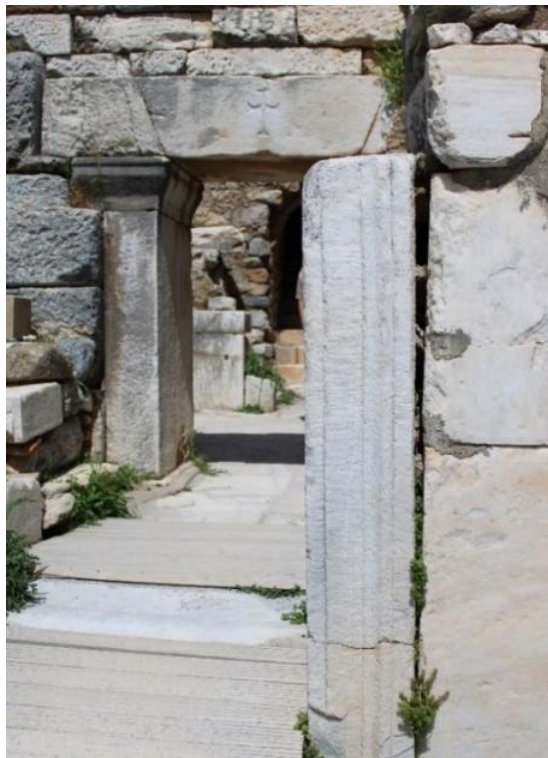
Figure 4.25. Cement infill between the entrance door block and cut stone (south) façade (Photograph: T. Tekin, 03.04.2022).

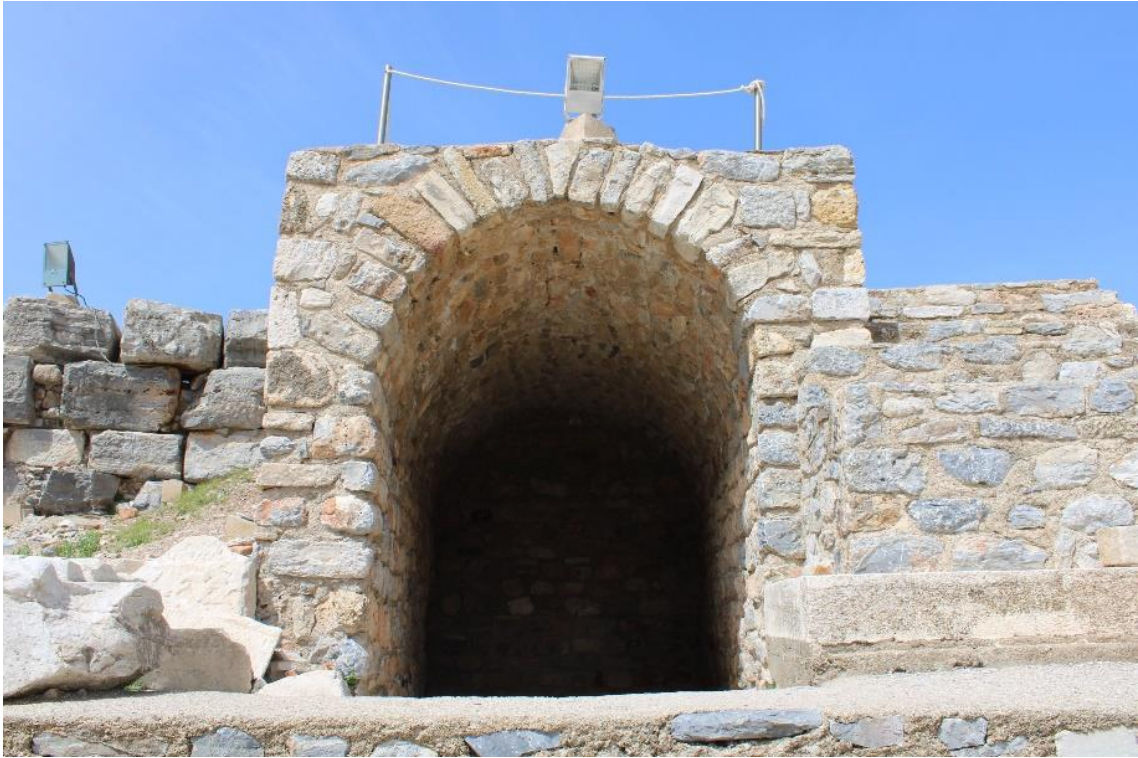
Figure 4.29. Reconstructed and completed vault of the western vomitorium (Photograph: T. Tekin, 03.04.2022).

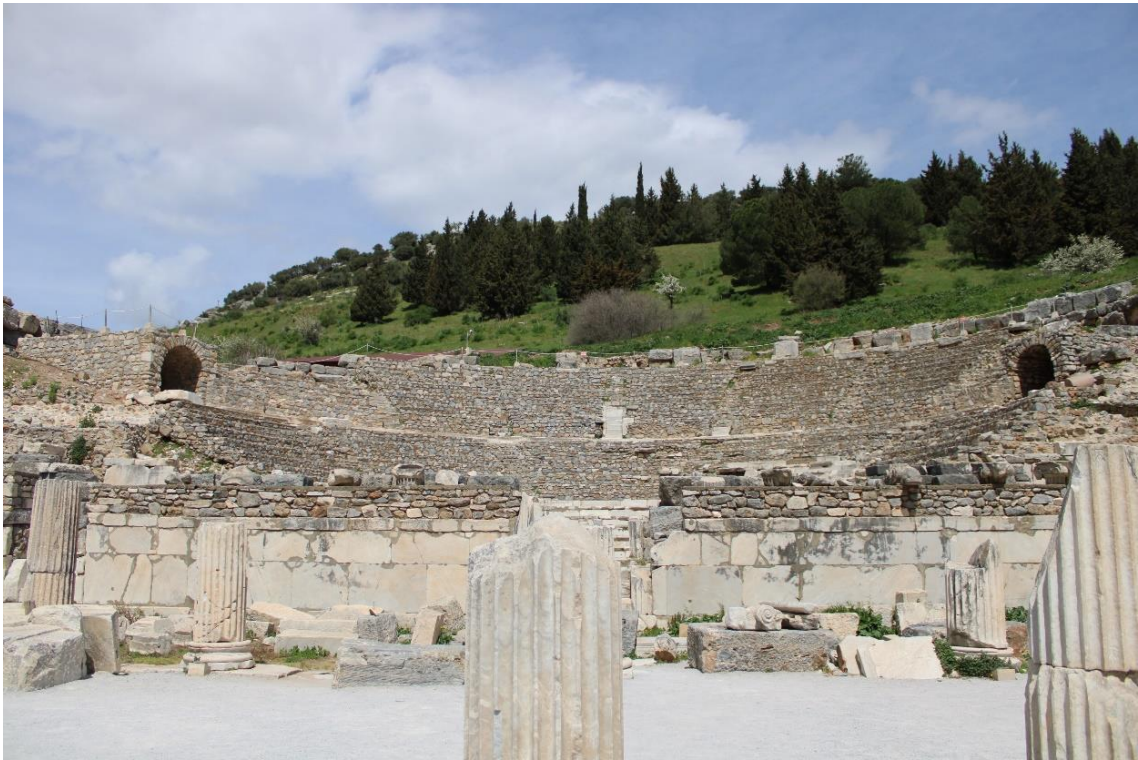
Filling the cracked or missing parts of the remains of the mouldings on the pedestal bases with cement mortar and joining the broken parts with cement mortar enabled the remains to be successfully brought together, the visual integrity however could not be achieved due to the different material properties. Furthermore, the partially chamfered cement mortar applied at the junction of the analemma walls with the pulpitum floor, at the junction of the walls of the vomitorium with the stair edges, and at the

junction of the diazoma and the summa cavea have been considered to negatively affect the visual integrity (Figure 30).

Figure 4.30. View of the Ephesus Bouleuterion from Stoa
(Photograph: T. Tekin, 03.04.2022).

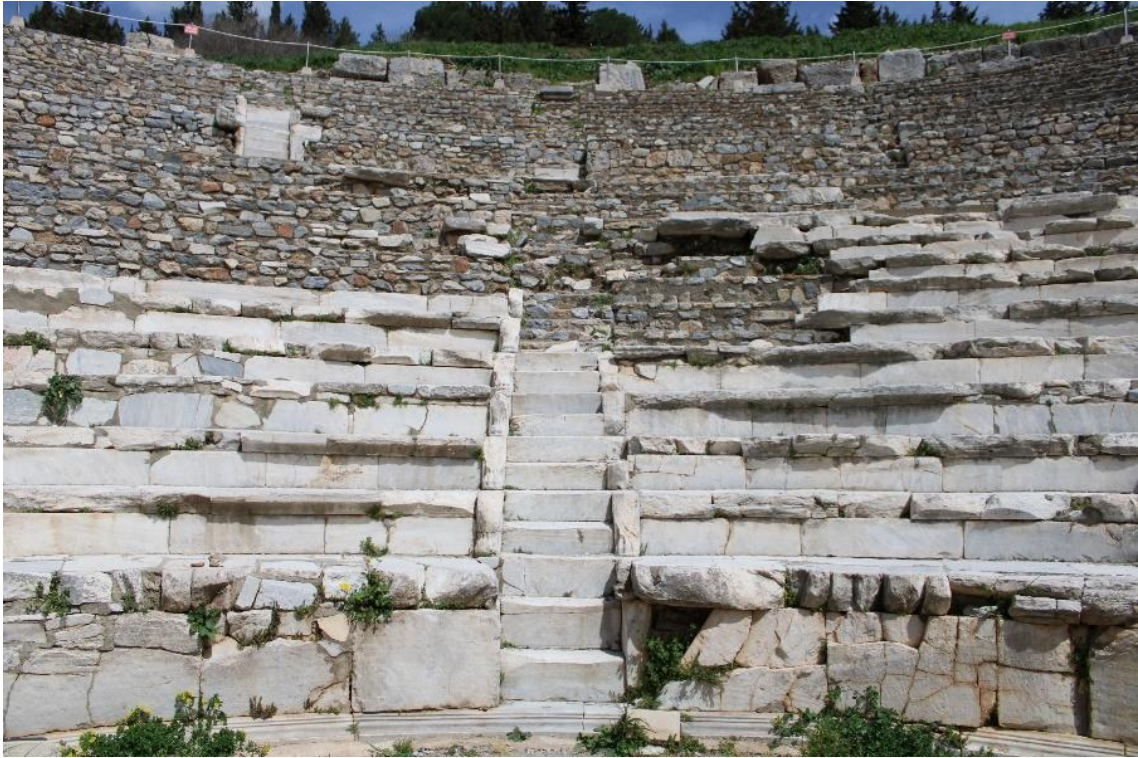
Figure 4.31. Completed and reconstructed cavea of the Ephesus Bouleuterion (Photograph: T. Tekin, 03.04.2022).

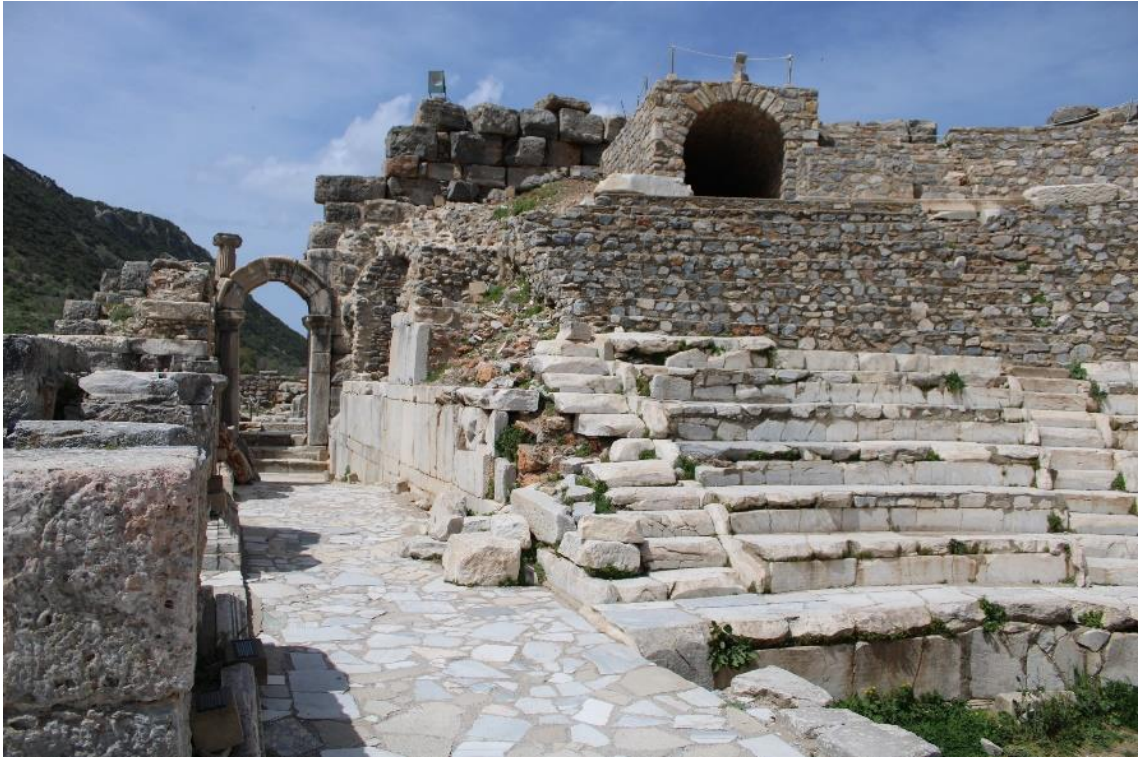
Figure 4.32. View of the southwest of the Ephesus Bouleuterion from east side of the pulpitum (Photograph: T. Tekin, 03.04.2022).

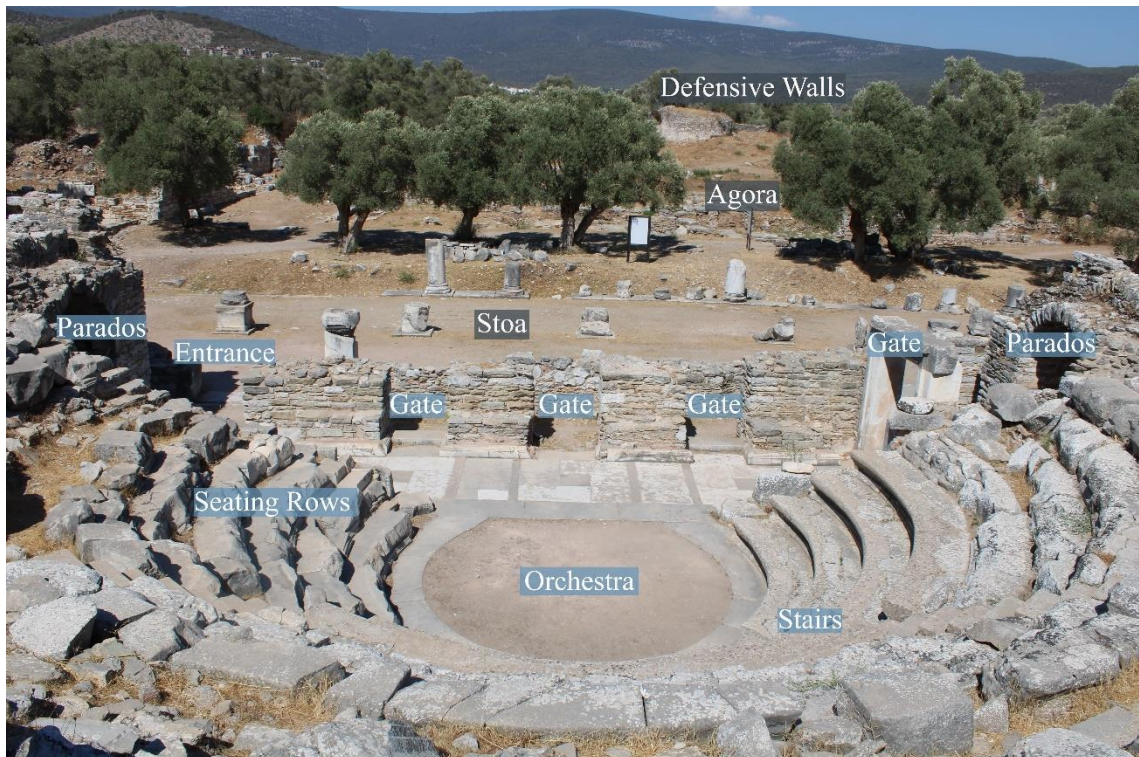
It is understood that the structure is accessed through a portico from the south stoa of the agora. Access to the corridor behind the stage is provided by a gate located near the east and west ends of the exterior wall on the north side. There are three gate openings in the stage wall. The remains of the stage wall, the parados, the horseshoe-shaped orchestra, the cavea, the diazoma, the vaulted corridors on the east and west sides of the cavea, and the passage space beneath the diazoma are the parts of the structure that can be observed by visitors today (Figure 4.41).

Figure 4.41. The parts of the Bouleuterion that can be seen when looking from the north to the south (Photograph: T. Tekin, 05.09.2021).

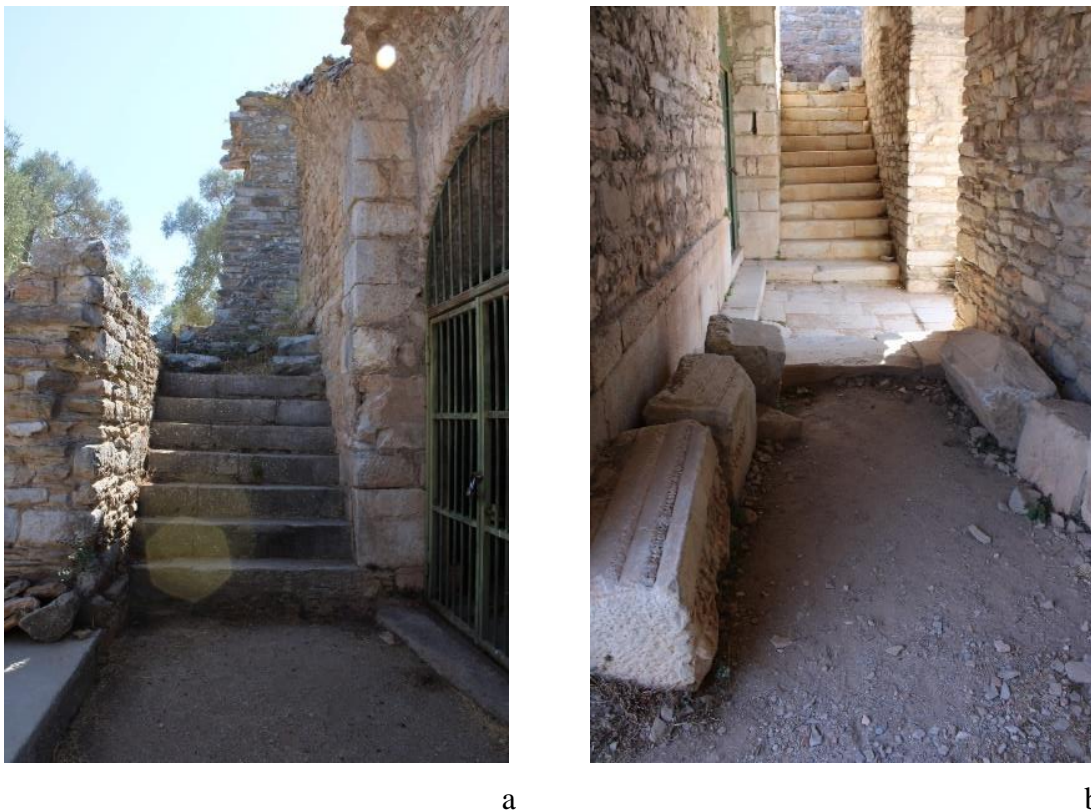
Most of the vault of the western corridor has survived to the present day, while in the eastern corridor there are only traces of the beginning (springing) of the vault in the direction of the parados. In the southwest of the corridor in the east and in the southeast of the corridor in the west, it can be observed that there are gate openings leading to the circular underpass, and these openings are now closed with iron gates (Figure 4.42). Besides, it is also understood that this area is being used as a storage room today.

There are window openings on the exterior wall of the corridor in the west direction. It is observed that the floor of this space is partly made of compacted soil, while the front of the gate opening to the outside is paved with cut stone and is one step lower in terms of level. There are no windows on the exterior walls of the corridor in the eastern direction as far as it is understood from the remains. Moreover, the floor is made of compacted soil.

Figure 4.42. West corridor(a) and east corridor(b) of the Iasos Bouleuterion (Photograph: T. Tekin, 05.09.2021).

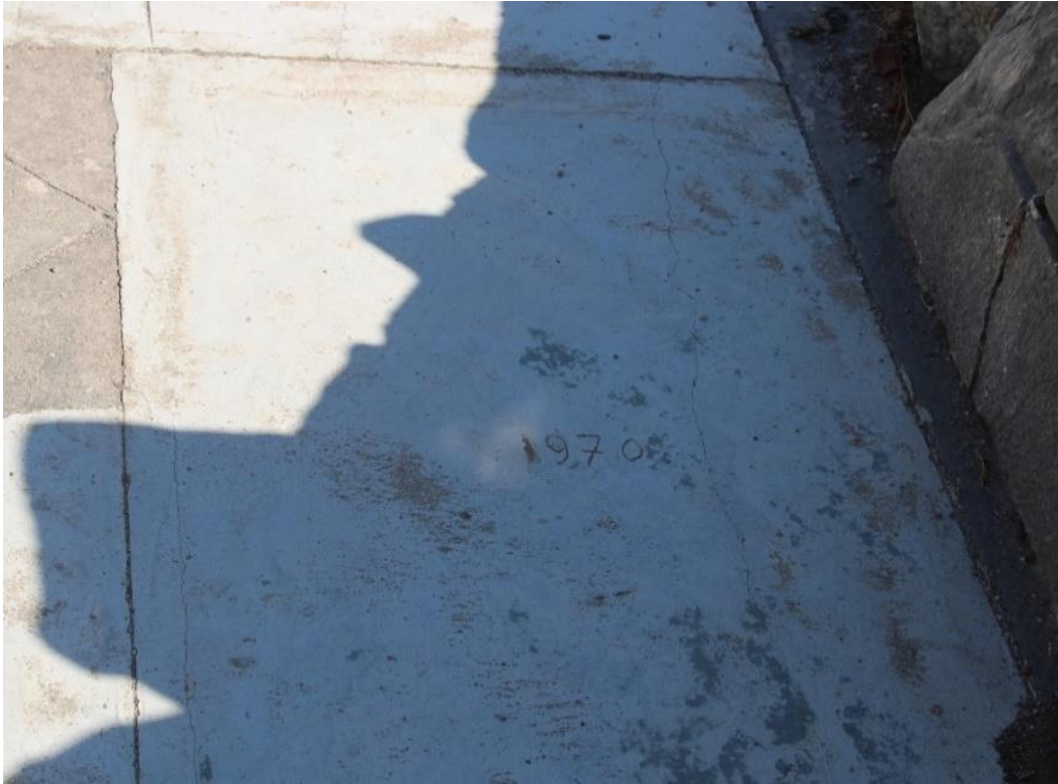
It is understood that the first conservation interventions in the bouleuterion were made in the 1970s (Berti 1999). It is highly likely that there are sections of the pulpitum flooring and the steps of the cavea that had concrete completions and reconstructions made in the 1970s. On a section of the parados flooring close to the west, a concrete section, which has the appearance of stone, was marked "1970" (Figure 4.43 and Figure 4.44).

Figure 4.43. 1970 inscription on the pulpitum floor, which is thought to reflect the date of completion of the pulpitum flooring (Photograph: T. Tekin 05.09.2021)

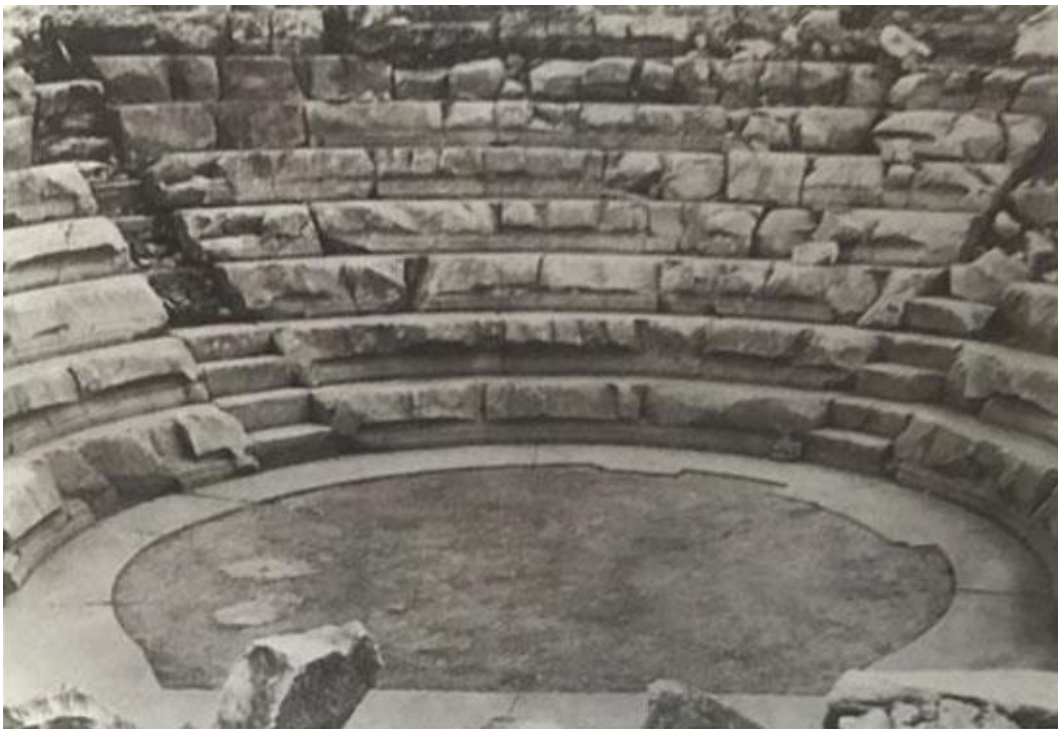
Figure 4.44. View from the stage to the cavea, original seating rows and staircase steps (Source: Levi 1986).
