**ASSESSMENT OF CONSERVATION
INTERVENTIONS AT BOULEUTERIA
IN ANATOLIA**

**A Thesis Submitted to
the Graduate School of Engineering and Science of
İzmir Institute of Technology
in Partial Fulfillment of the Requirements for the Degree of**

In Architectural Restoration

**by
Tuğçe TEKİN**

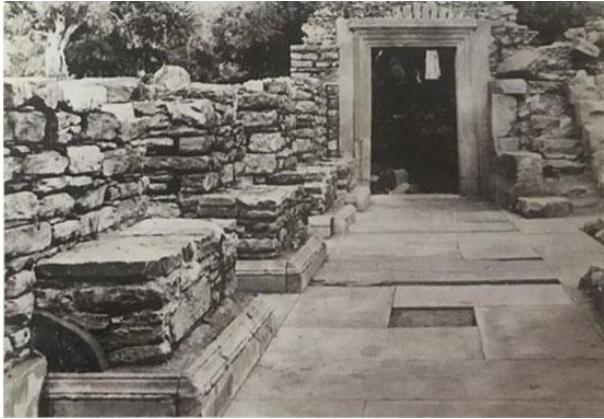
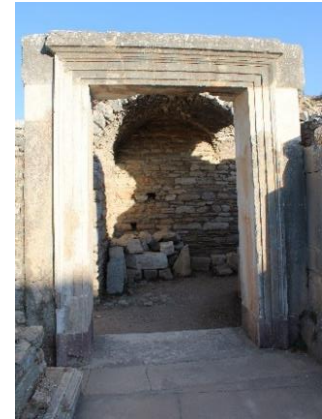
It has been reported that dismantling, cleaning, consolidation, and reassembly works were carried out on the two gates of the bouleuterion, and that the completion of the gate on the eastern side of the parados, which was made of concrete in the 1970s, was replaced with a material, the nature of which has not been specified, but which has been reported to be a more suitable material (Figure 4.48). The dislocated parts of the seating rows in the cavea section have also been cleaned, reinforced, and reinstalled (Berti 1999)

Figure 4.48. Completed door opening with using materials which are different from the original stone block material. After implementation(a) and today's state(b) (Source of a: Levi 1986, Figure 37, 1986; Photograph of b: T. Tekin, 05.09.2021).

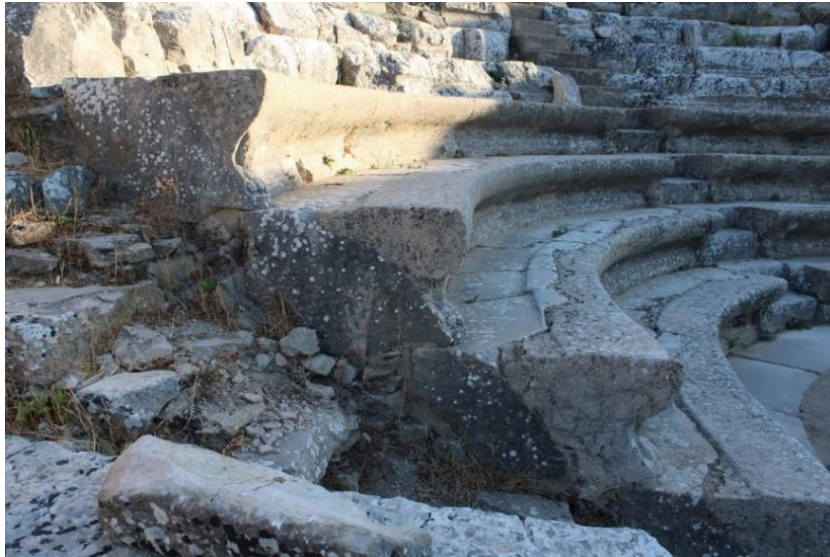
Figure 4.50. Completed seating rows by using concrete (Photograph: T. Tekin, 05.09.2021).

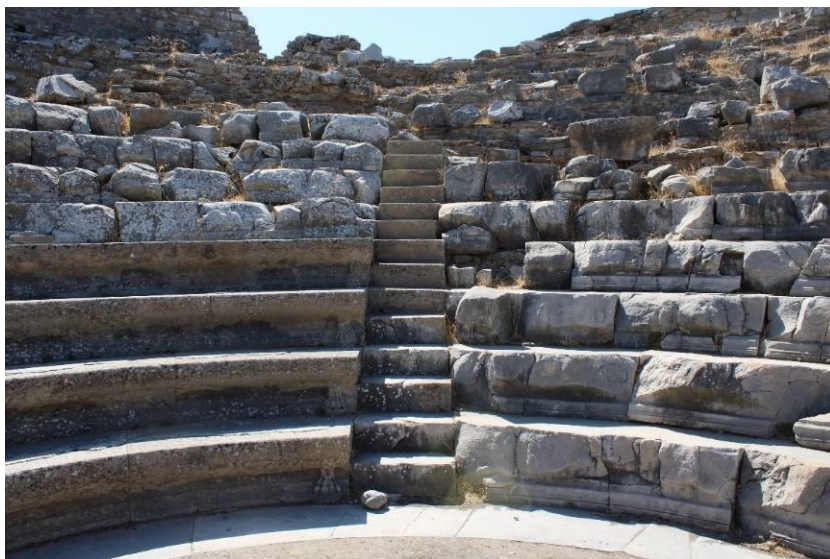
The completion process implemented by using concrete on the remains of the gate in the north of the analemma wall in the eastern direction has enabled the gate parts to be combined, but since the original form is not compatible with the marble gate, it has resulted in the structural integrity not being maintained. It has been observed that the remains of the original stone blocks in the first four rows of the seating rows have been completed with concrete material and the concrete material is different from the original stone blocks in terms of character, colour, and texture. In addition, joints have been made to obtain the appearance of cut stone (Figure 4.50 and Figure 4.51).

Figure 4.51. Completed seating rows and completed and reconstructed stairs by using concrete (Photograph: T. Tekin, 05.09.2021).

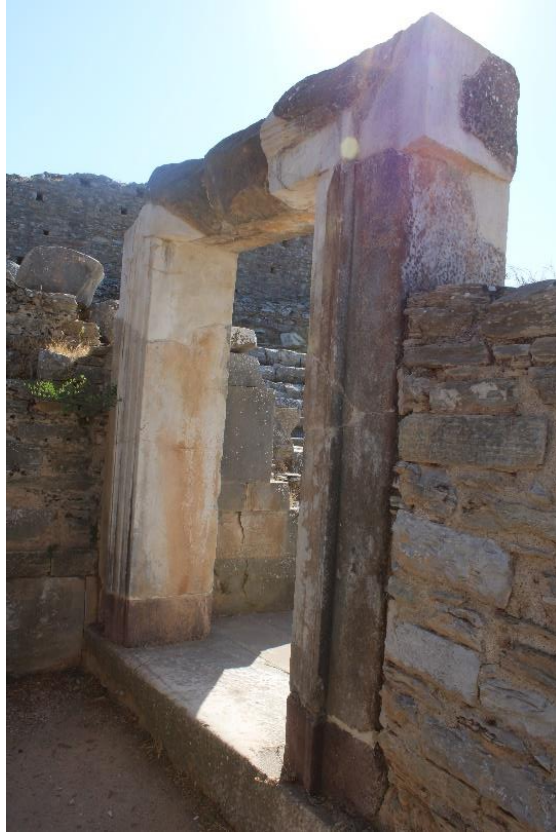
Figure 4.52. Completed and consolidated gate opening
(Photograph: T. Tekin, 05.09.2021).

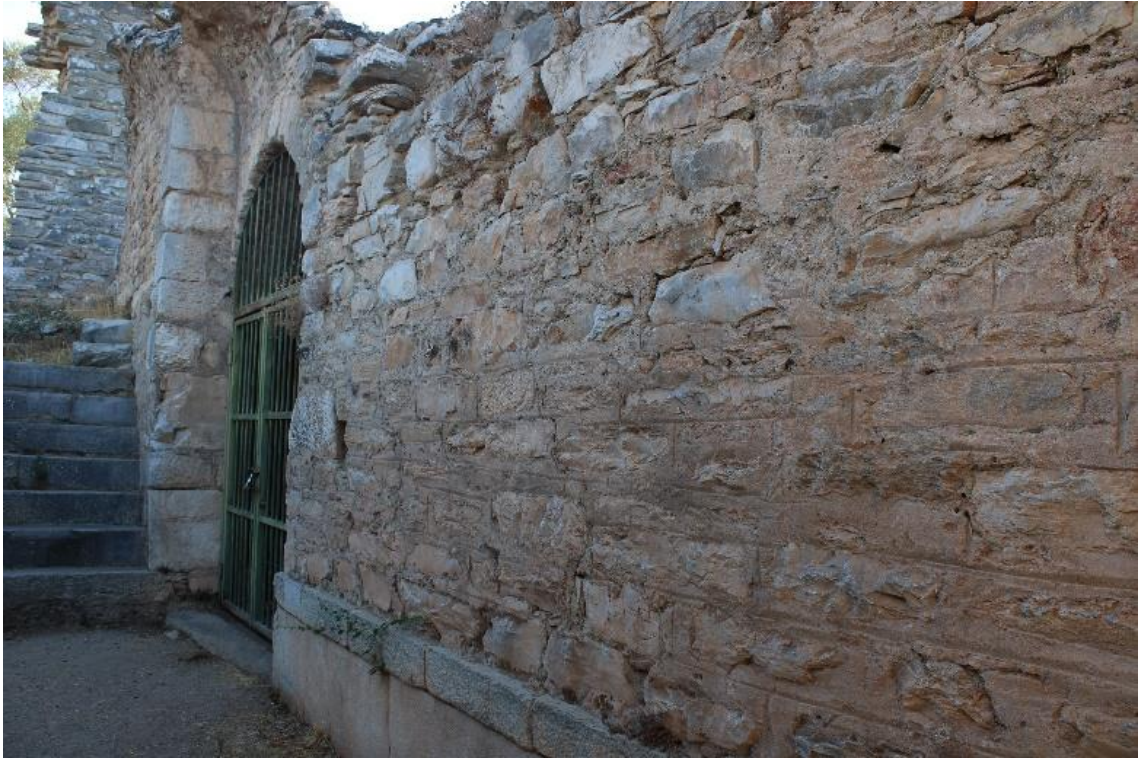
The mortar used in the consolidation of the walls, the window jambs in the west corridor, the niches in the north exterior wall and the parados vaults are different from the original material, which can be understood through their colour and texture. It also takes attention that the mortars used differ from each other in terms of colour and texture (Figure 4.53). It can also be perceived that the concrete used in the completion and reconstruction of the cavea is different from the original stone blocks. In addition to these, it can be recognised that the concrete material used during the completion of the gate adjacent to the north side of the analemma wall on the east side is different from the original marble block. The cement-based materials and iron gates used during the implementations are not compatible with the original state.

Figure 4.53. Consolidated east inner wall of the west corridor
(Photograph: T. Tekin, 05.09.2021).

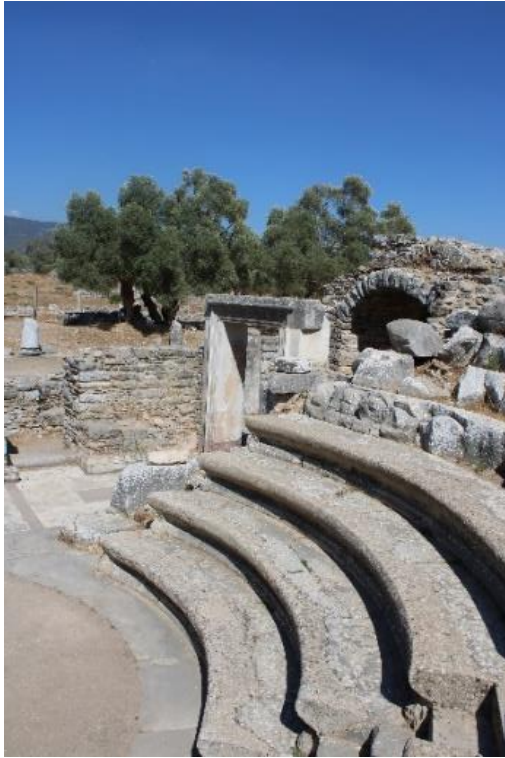
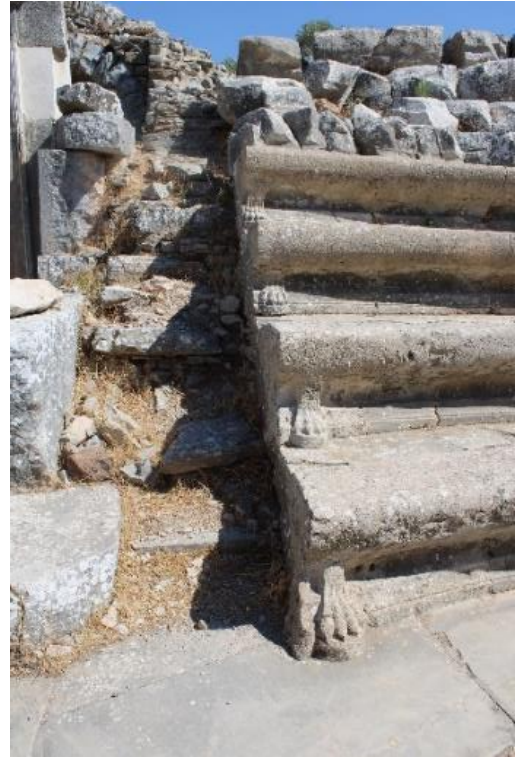
Since the cement-based mortar and concrete material used in the implementations are integrated with the original cut stone blocks or rubble stones, it is difficult to re-intervene. Similarly, the concrete used in the cavea section and the stair steps in the eastern direction is integrated with the original cut stones and thus does not allow for re-intervention. During the intervention of the concrete blocks, it is highly likely that the original stone blocks will be damaged and disintegrated and the original material will be lost (Figure 4.54). It can be argued that the original stones were damaged during the installation of the green-painted metal gates added from both sides to the circular underpass under the cavea. During the re-intervention, new damage to these stone blocks is likely to occur.

Figure 4.54. The integration of the concrete used into the original seating row remains (a and b) (Photograph: T. Tekin, 05.09.2021).

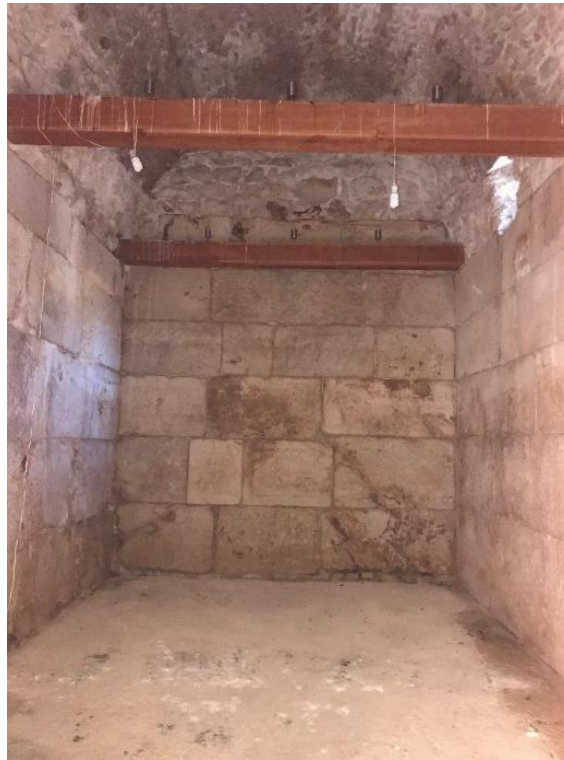
Figure 4.66. Wooden tensioners added to ensure the structural integrity of the walls made of cut stone blocks in the vaulted room on the northern direction (Photograph: T. Tekin, 08.04.2021).

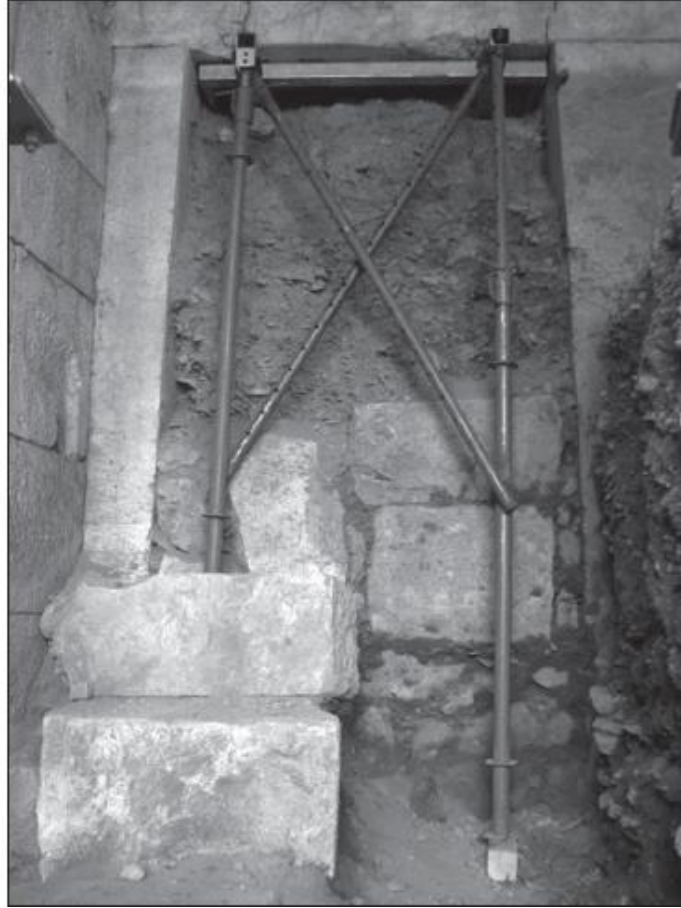
Figure 4.67. Static strengthening work at the north gate
(Source: İşkan Işık 2011, p.21 Figure:25).

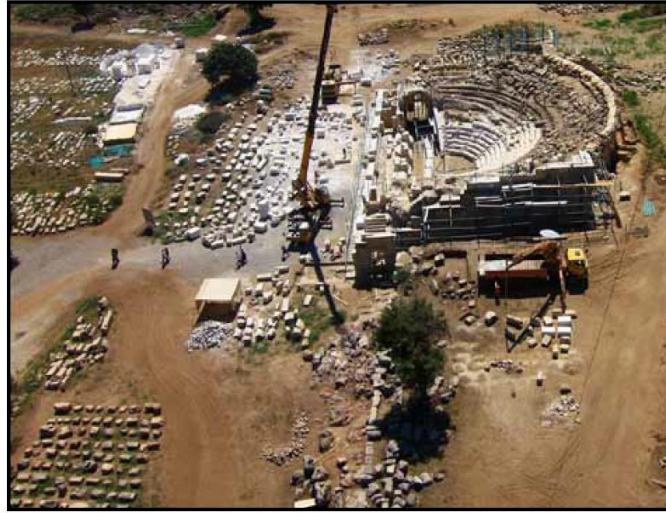
Figure 4.68. Aerial photograph taken in 2010 during the excavations in the ancient city of Patara, showing the works in the bouleuterion (Source: İřkan Iřık 2012, p.36 Figure:9).

In 2010, the northern and southern walls of the structure, the northern parados and the upper cover of the southern vaulted room were underpinned within the scope of the static project. It has been stated that all façades of the council building have been plumbed and levelled and dismantling works were carried out on the north, south and east walls where slippage was observed (Figure 6.68). Furthermore, partial dismantling was carried out in the interior parts of the structure (the side walls of the north and south entrances, the south wall, the south parados, the sides of the gates in front of the south staircase, the

south vaulted room) and the dismantled stone blocks were consolidated and then placed back in their places (Akıncı 2012).

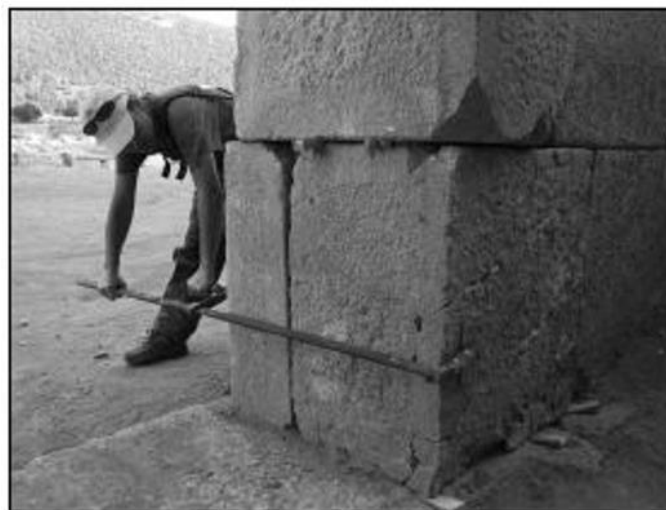
Figure 4.69. Reinforcement implementation in the cut stone blocks (Source: 28. Kazı Raporu, 1. Cilt, p.28 Figure:13, 2005)

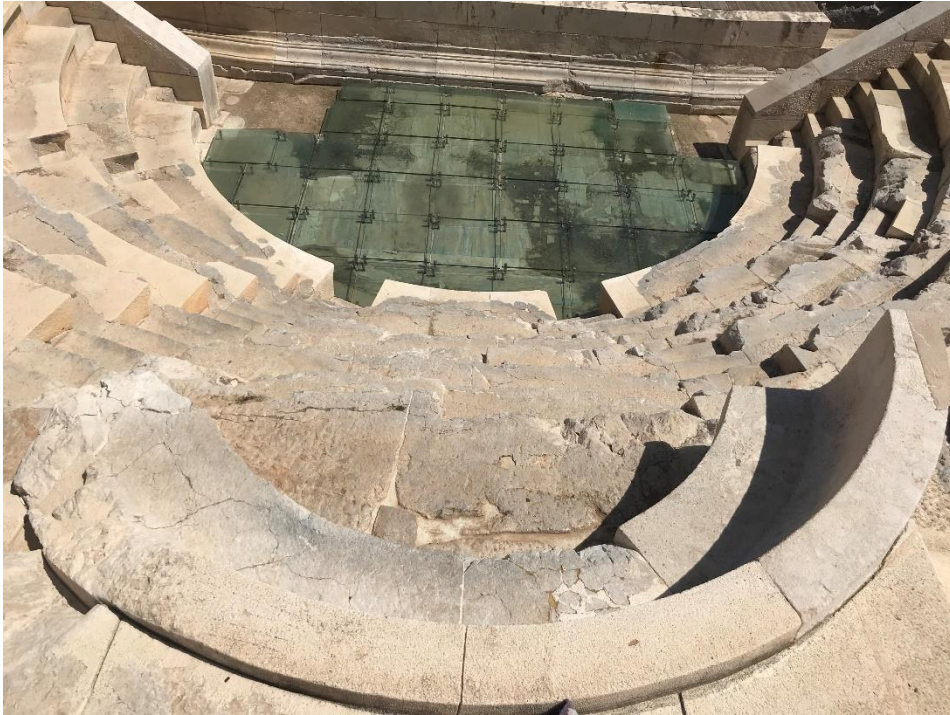
Figure 4.75. View of the upper cavea, orchestra, and scene from the upper seating rows (Photograph: T. Tekin, 08.04.2021).

glass platform, which is thought to have been added in order to protect the original stone flooring of the orchestra, not only damages the original material because it is connected to the flooring, but also disrupts the perception and visual integrity of the orchestra because it is not in the original state of the structure (Figure 4.75).

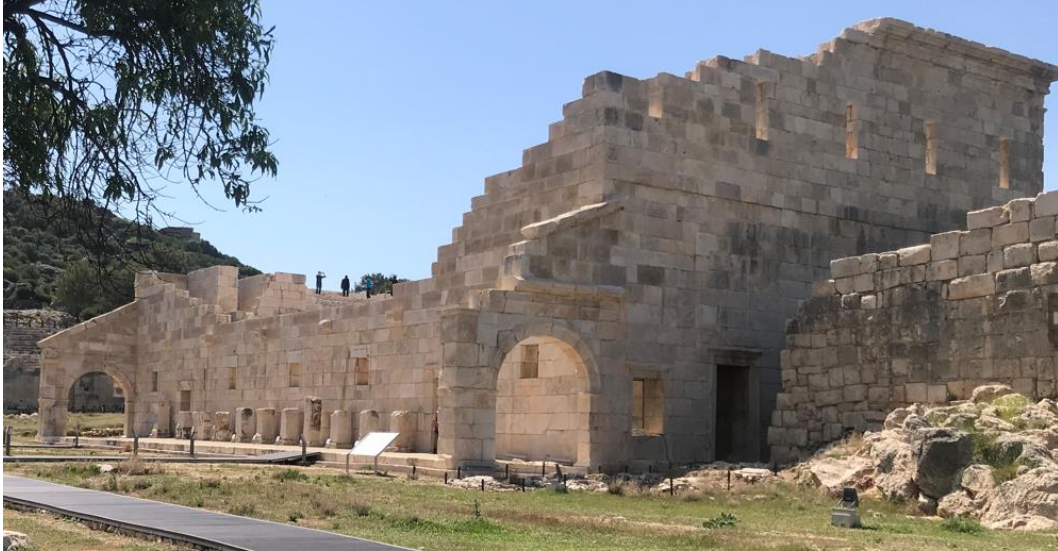
Figure 4.76. View of the Patara Bouleuterion from the northeast side of the structure (Photograph: T. Tekin, 08.04.2021).

When the structure is viewed from the exterior façade, the new stone blocks used to complete the walls between the old stone blocks are perceived as prominent, but they have a harmonious appearance with the old stone blocks. On the other hand, the use of new stone blocks is more frequent than the use of old stone blocks. The cavea and analemma walls were intensively completed with new stone blocks. Since these stones are similar to the original material, at first glance, it may be thought that they are physically and structurally compatible, however, these new stones stand out among the old stones and attract the attention of visitors (Figure 4.76).

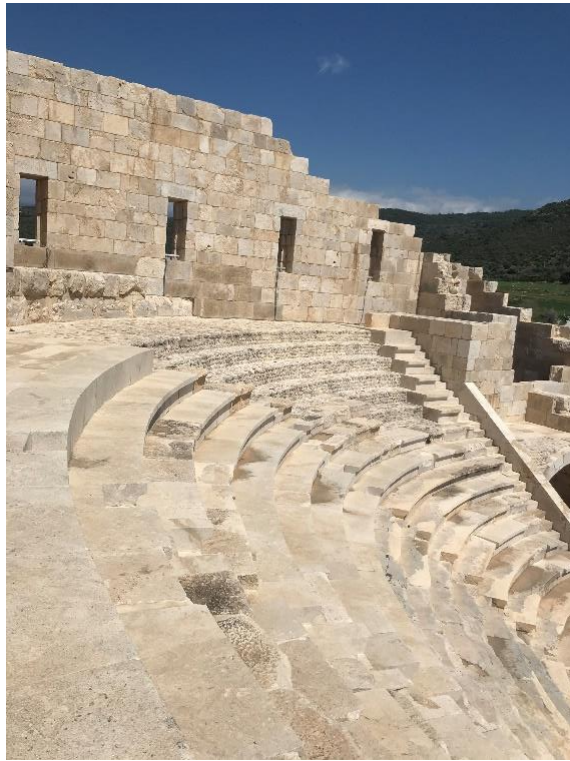
Figure 4.77. View of the cavea's north and northeast side from the middle of the upper seating rows (Photograph: T. Tekin, 08.04.2021).

Reintervention to the mortar material used between the stone blocks and between the paving stones in the masonry during the implementations may only be possible by dismantling the stone blocks, which may damage the original construction material (Figure 4.77). The glass platform added on the orchestra flooring can be removed, but there is a risk of damaging the original material during the reintervention since the glass sheets have been applied to the flooring by metal fasteners (Figure 4.78). It is possible to reintervene the reproduced wooden pulpitum flooring and the door joinery on the interior and exterior walls in case of ageing. The glass attached to the door opening on the exterior

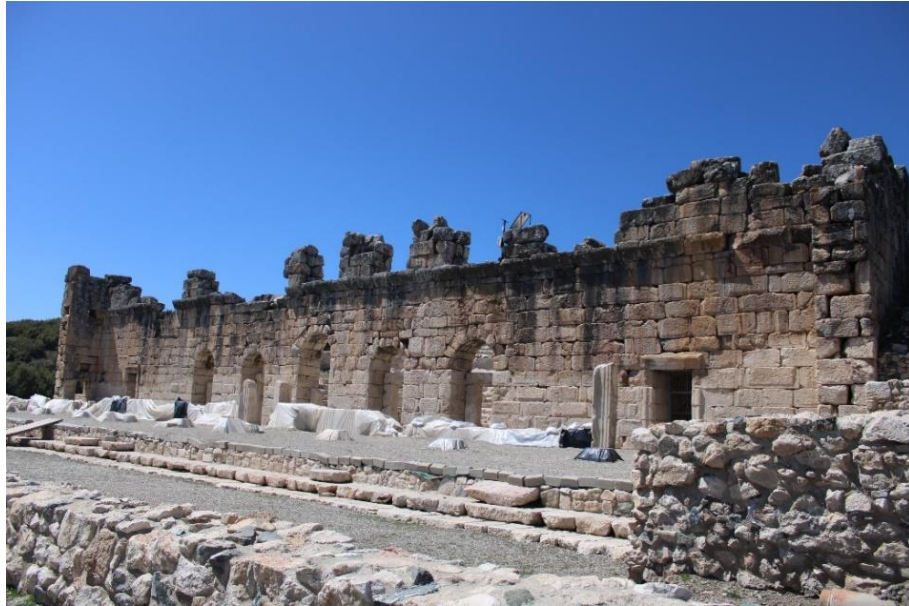
Figure 4.83. The west facade of the Kibyra Bouleuterion/Odeion (Photograph: T. Tekin, 09.04.2022).

The exterior wall at the level of the remains on the eastern side also forms the back wall of the stoa. Between the exterior wall and the stage wall, a longitudinal corridor was planned in the north-south direction and the upper cover of the corridor has not survived to the present day (Figure 4.83). On the stage wall, there are rectangular door openings opening to the parados on the north and south sides and rectangular gates designed in five arched openings opening to the pulpitum located between these gates. The middle one of the arched openings is designed to be higher than the others. On the ante wall east of the south wall of the structure, a rectangular door opening to the corridor provides access to the corridor (Figure 4.84).

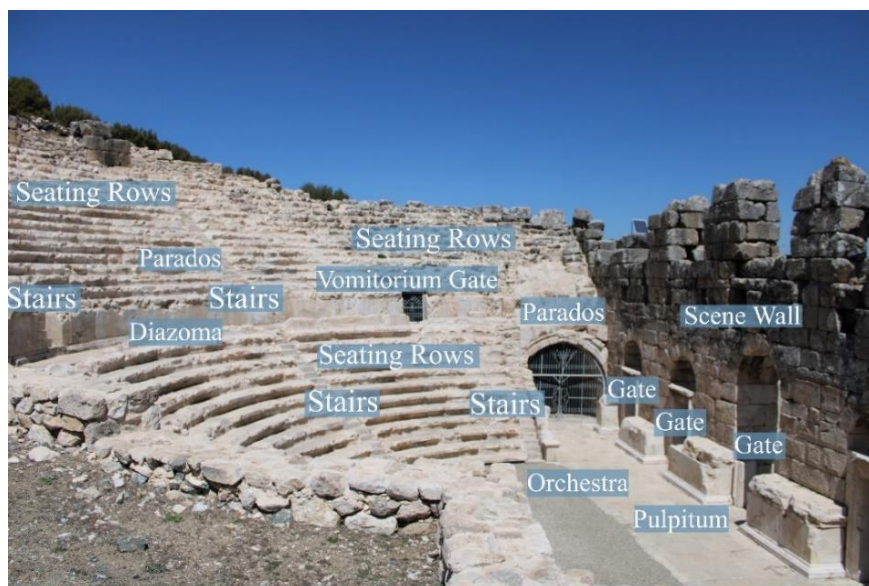
Figure 4.86. The view of some parts of the Kibyra Bouleuterion/Odeion from south (Photograph: T. Tekin, 09.04.2022).

The pulpitum which is west of the stage wall has parados vaults on the northern and southern sides. It has been observed that the upper cover of the parados vaults in the north direction is preserved, while only the arch pattern is preserved in the south direction (Figure 4.85, Figure 4.86, and Figure 4.87).

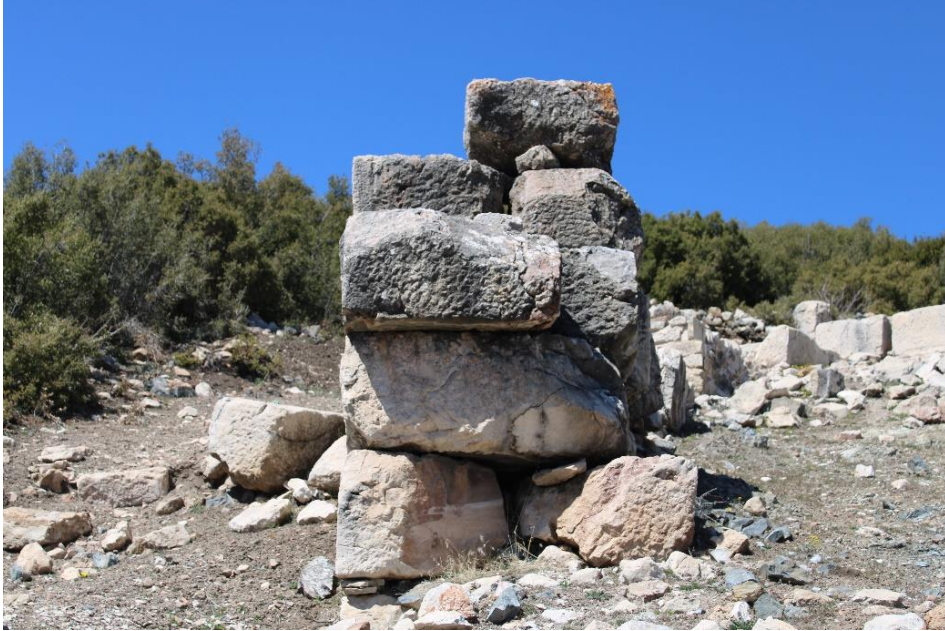
Figure 4.88. Retaining wall masonry in the southwest section of the bouleterion which is surrounding the cavea with curvilinear form (Photograph: T. Tekin, 09.04.2022).

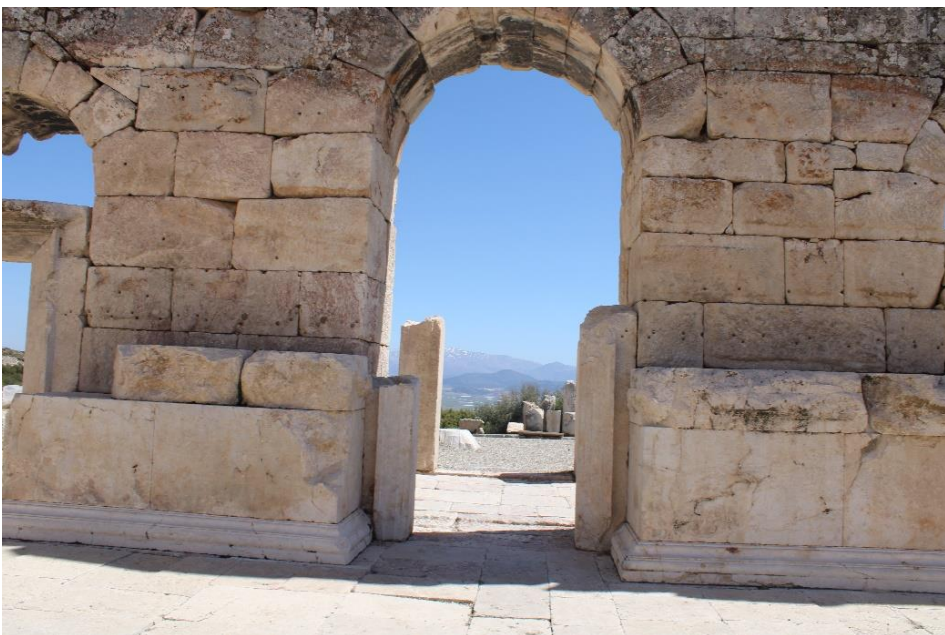
Figure 4.89. Traces of fastener remains on the west side of the scene wall (Photograph: T. Tekin, 09.04.2022).

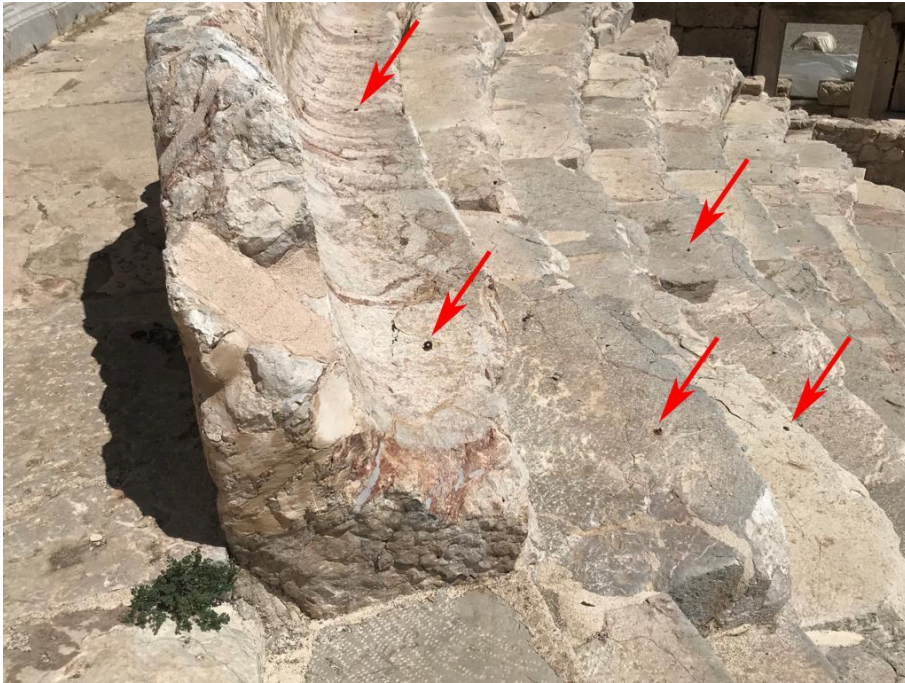
Figure 4.90. Fastener remains on the seating rows
(Photograph: T. Tekin, 09.04.2022).

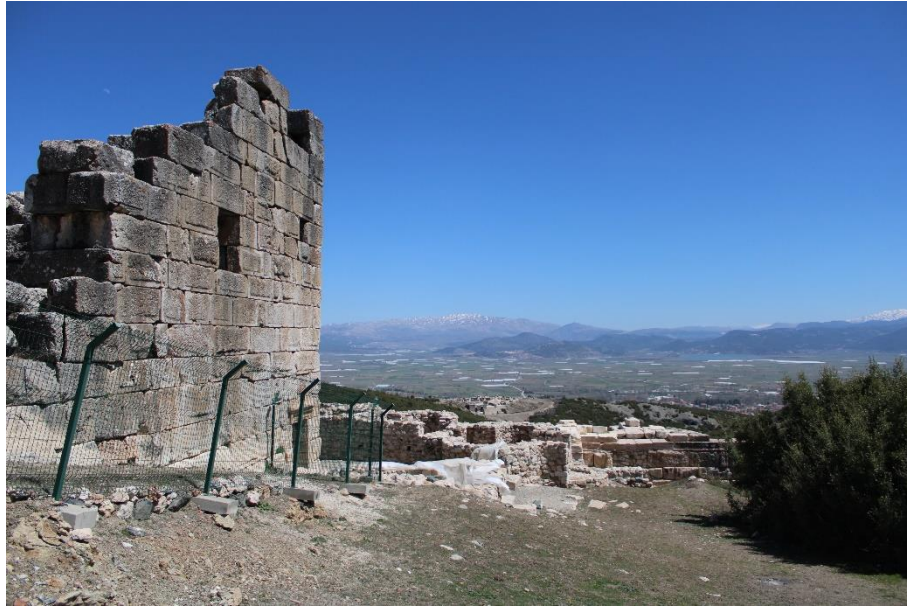
Figure 4.91. Window openings in the southeast section of the building
(Photograph: T. Tekin, 09.04.2022).

It has been stated that the lighting of the structure is provided by a total of 14 windows in the curvilinear shaped perimeter wall and the stage section (Figure 4.91). It has been suggested that the floor of the window openings was built with rubble stones and there are lintels and jambs built with large stone blocks on both sides of the openings, and that the central part of these piers in the west direction is also related to the load-bearing elements of the roof (Tarkan 2021).

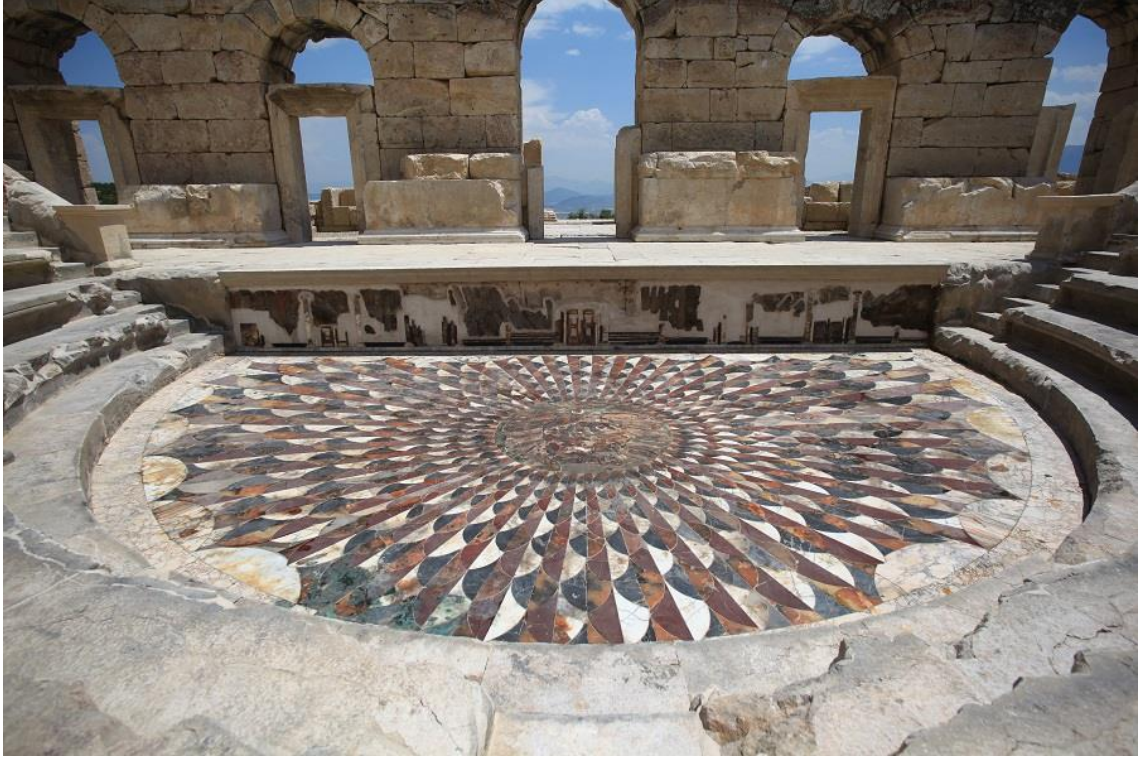
Figure 4.96. Orchestra floor after implementations
(Source: Kültür ve Turizm Bakanlığı 2022).

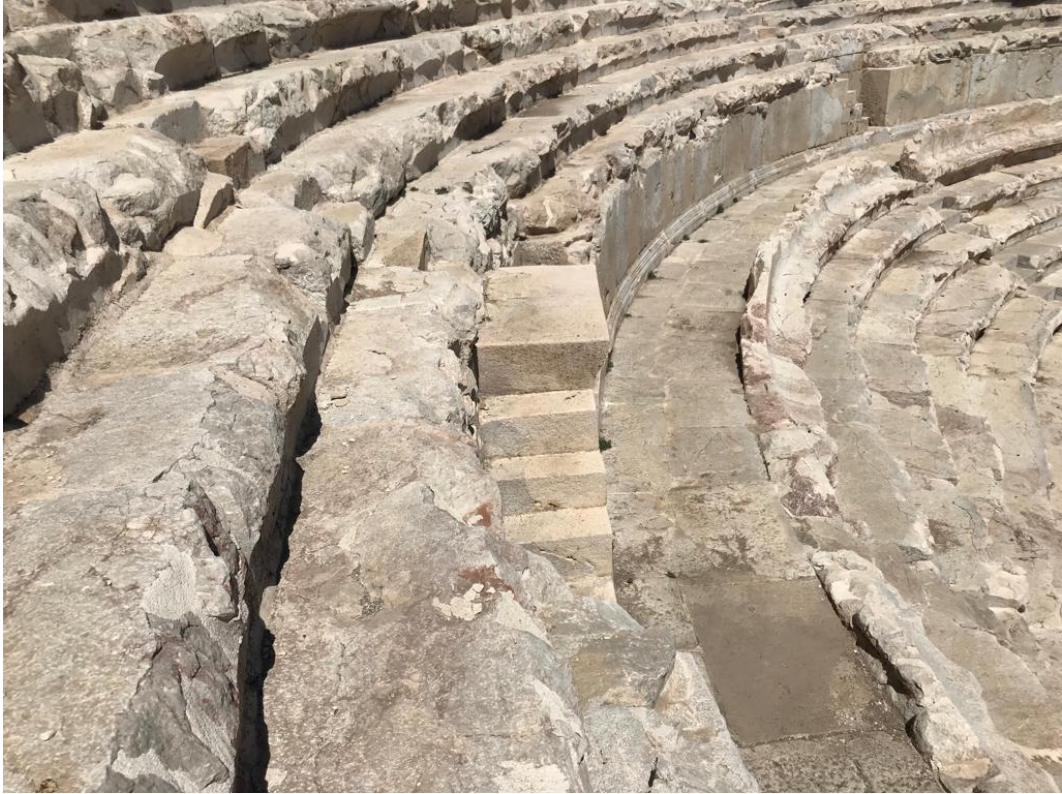
Figure 4.97. Completed and partially reconstructed stairs and seating rows
(Photograph: T. Tekin, 09.04.2022).

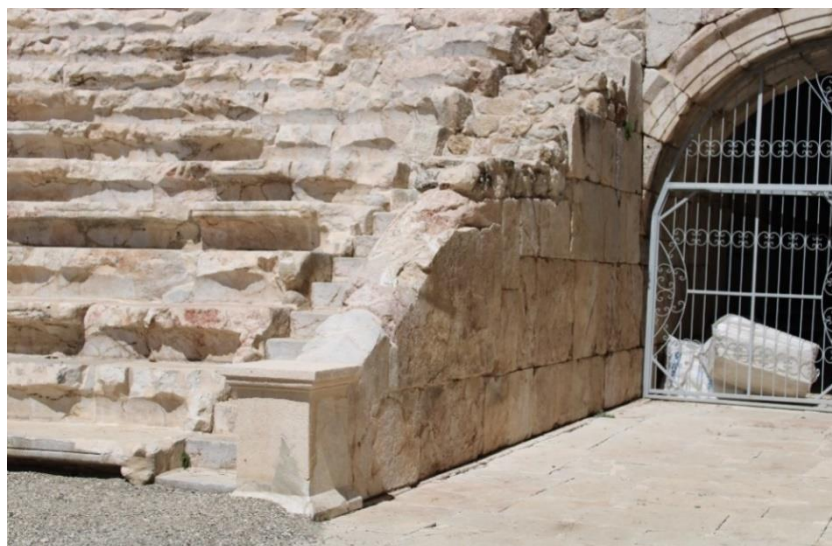
Figure 4.100. Reconstructed part at the beginning of the north analemma wall (Photograph: T. Tekin, 09.04.2022).

In the southern part of the summa cavea, a partial reconstruction was performed by using rubble stones and mortar on the wall section in front of the seating rows that have not survived to the present day. The masonry under the window openings in the curvilinear exterior wall was also subjected to reconstruction using rubble stone and mortar. It has been understood that the partial reconstruction was carried out by using concrete at the lowest elevation of the analemma walls above the pulpitum flooring (Figure 4.100 and Figure 4.101).

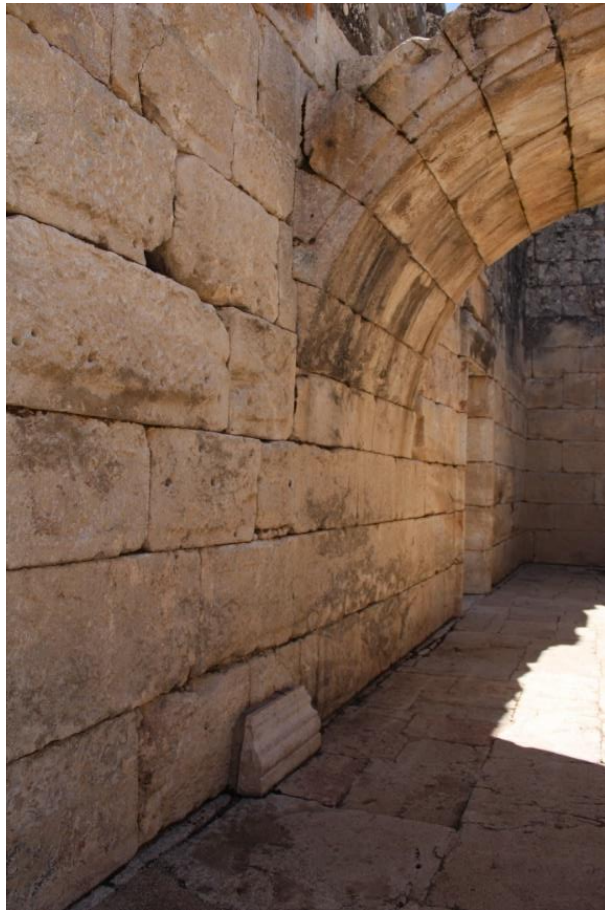
Figure 4.103. Fixing plinth-like remain to the south section of the scene wall with mortar (Photograph: T. Tekin, 09.04.2022).

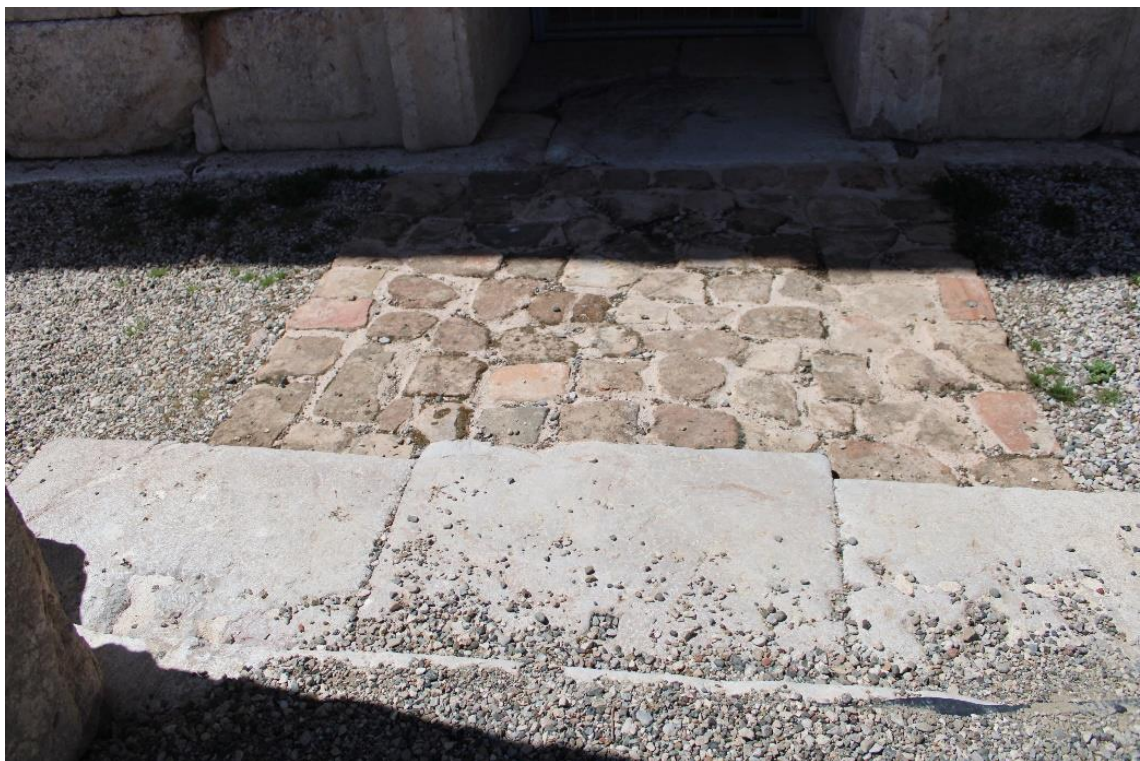
Figure 4.105. Reconstructed part using rubble stone and mortar between the scene wall and stoa (Photograph: T. Tekin, 09.04.2022).

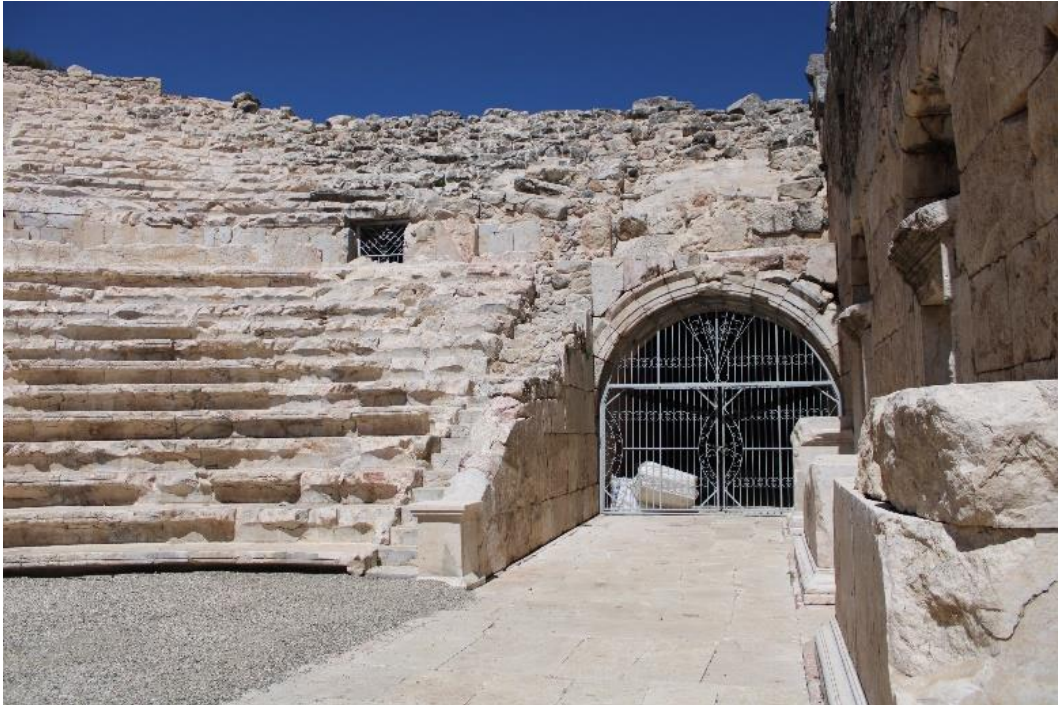
Figure 4.106. Completed seating rows with mortar in north side, partially reconstructed part at the beginning of the north analemma wall and completed pulpitum flooring with mortar (Photograph: T. Tekin, 09.04.2022).

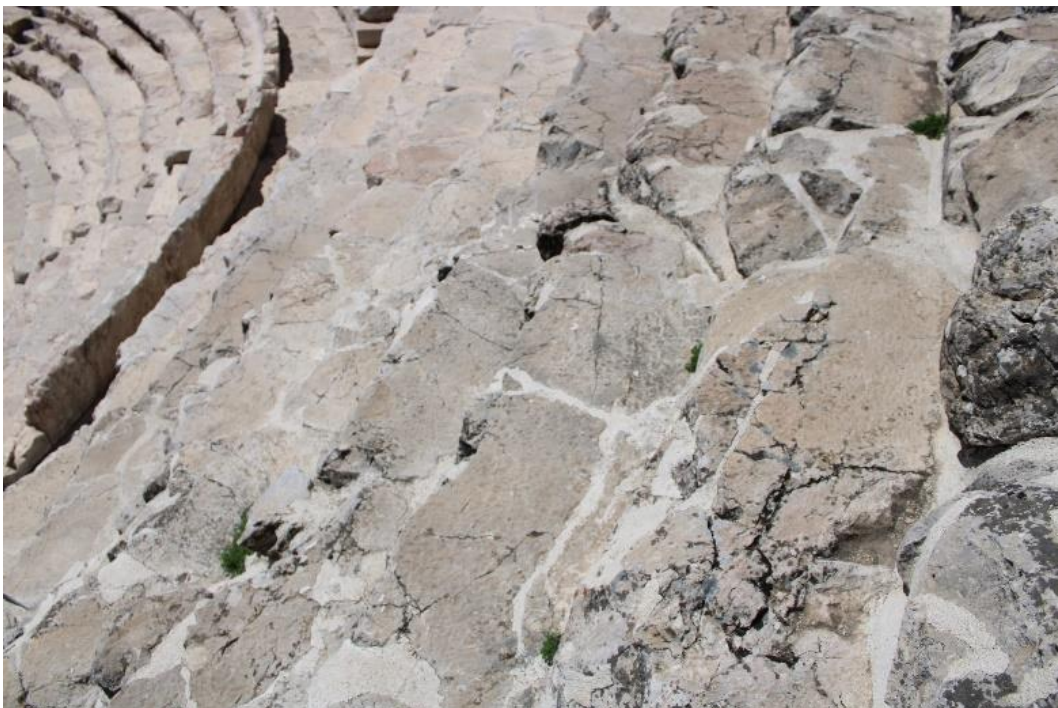
Figure 4.107. Completed seating rows in the north upper side of the cavea with mortar and original seating row remains (Photograph: T. Tekin, 09.04.2022).

Although the completion and consolidation of the seating rows of the cavea and the completion, consolidation, and partial reconstruction of the staircase steps provided structural integrity, the use of chemical cleaning materials, new mortar, and concrete during the implementations have resulted in the failure to maintain the use of original materials and construction technique (Figure 4.106 and Figure 4.106). The partial reconstruction of the wall on the south side of the summa cavea has stabilised the filling of the cavea seating rows, however, the use of rubble stone and mortar is not compatible with the original materials and construction technique. The rubble stone and mortar completions in the lower parts of the window openings of the curvilinear exterior wall have provided structural integrity in the curvilinear exterior masonry.

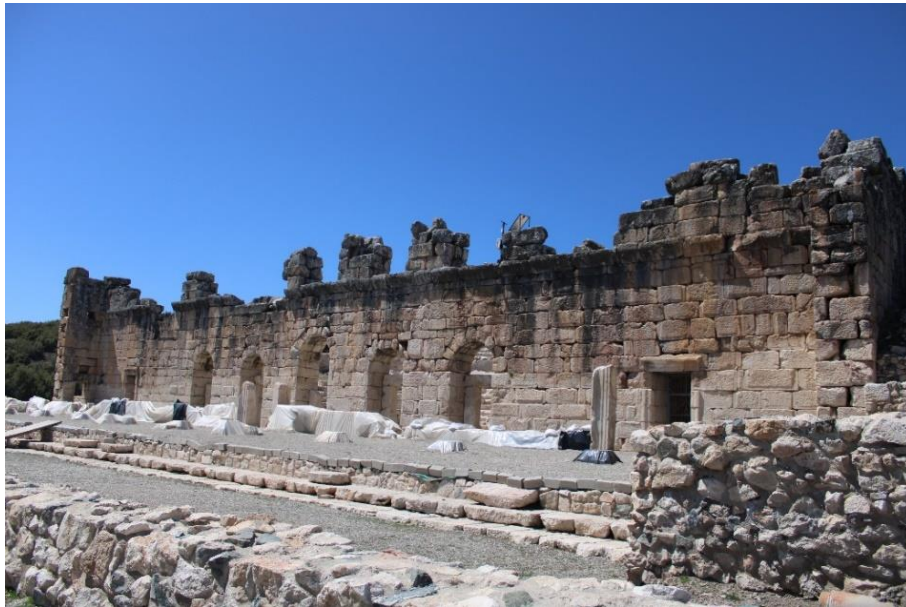
Figure 4.108. The east side of the scene wall of the Kibyra Bouleuterion (Photograph: T. Tekin, 09.04.2022).

Since the remains of the Kibyra Bouleuterion/Odeion are mostly conserved to the present day, the form, material and construction technique, capacity, and architectural characteristics of the structure can be understood. Therefore, the structure maintains both its mass effect in the area and its visual integrity with the other remains (Figure 4.108).

Although the fixation of the plinth-like remains on the parados flooring in the southern direction to the wall has ensured the integration of the original remains, the cement mortar used during the integration has failed to maintain both the original material use and construction technique and the visual integrity since it attracts attention when observed closely. The filling of the joints between the stone blocks in the pulpitum flooring by using mortar at some points has not only failed to maintain the original material use and construction technique but also has adversely affected the visual integrity.

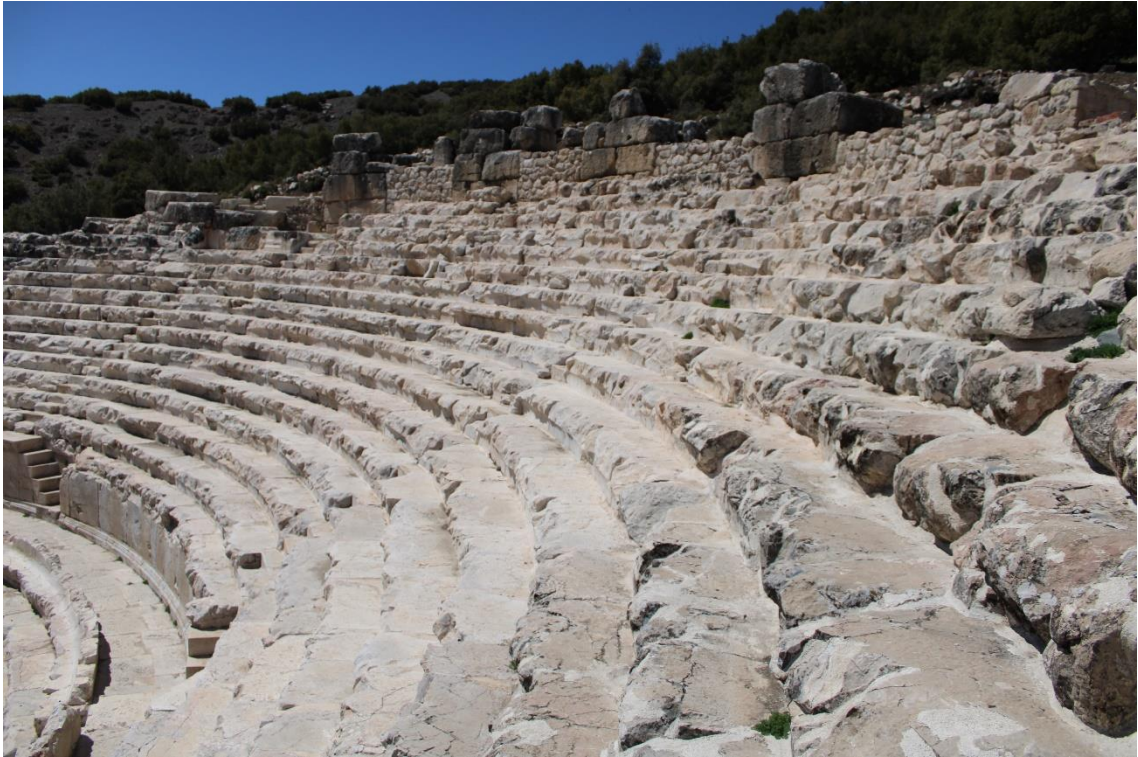
Figure 4.109. The east side of the upper cavea of the Kibyra Bouleuterion (Photograph: T. Tekin, 09.04.2022).

The reliability of the implementation has failed to be determined since it is not clear whether the stone block fragments used during the completion of the remains of the seating rows and stair steps in the ima and summa cavea section of the structure belong to the original rows or steps. Furthermore, the mortar material used to stabilise the seating rows and stair steps and to subject the remains to anastylosis, and the concrete completion of the stone block remains on the stair steps providing access to the summa cavea and the door opening of the south ante wall are not reliable as they are not compatible with the original material use and construction technique. The mortar used to join the stone block

joints in the diazoma flooring, the pulpitum flooring, and the remains of the plinths at the junction of the diazoma with the summa cavea is not reliable as it does not maintain the original materials and construction technique. The added iron gates are also unreliable as they are not original.

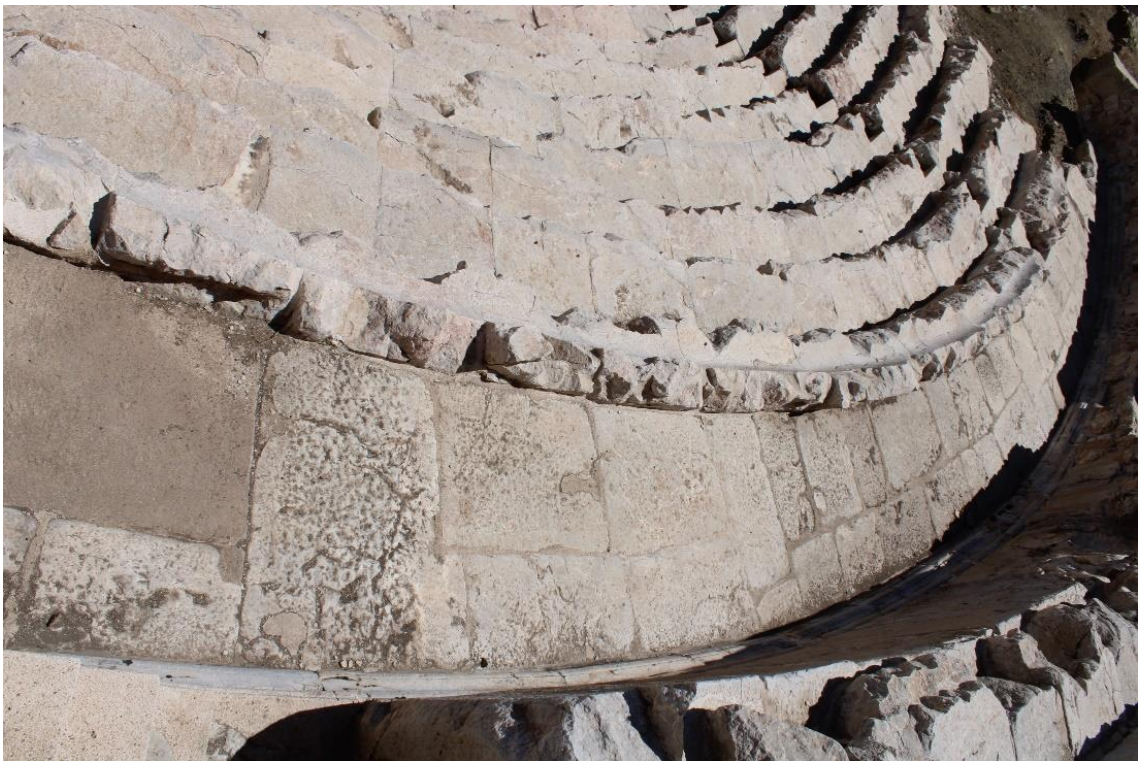
Figure 4.110. The completion of the stone gaps at the diazoma with mortar and partial reconstruction with concrete (Photograph: T. Tekin, 09.04.2022).
