# Characterization of materials used in the execution of historic oil paintings by XRD, SEM-EDS, TGA and LIBS analysis

In this study, the material used in the execution of wall paintings of Taxiarchis Church and the present state of the paintings were determined to decide the appropriate intervention methods and materials to be used in the conservation of the paintings.

Taxiarchis Church was built in the neoclassical style by Architect Emanuel Kounas as the main Church of Cunda/Ayvalık in 1873. It had the basic properties of Byzantine church architecture

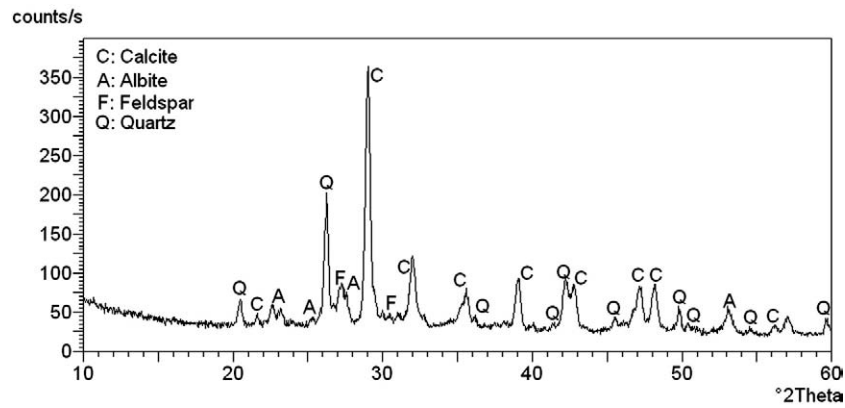
Fig. 3 – XRD pattern of rough plaster layer.

The bottom layer is mainly composed of binder and natural aggregates with small amounts of oakum and straw pieces. Its density and porosity values are approximately 1.7 g/cm<sup>3</sup> and 33% by volume respectively. It is mainly composed of calcite, quartz, albite and feldspar minerals (Fig. 3). Calcite originates from the lime binder and the others from aggregates. The lime/aggregate ratio of the bottom plaster layer is nearly 1/3 by weight. The aggregate sizes that ranged from 1180–500 µm comprise the largest fraction of the total aggregates, and varied in the range of 61–73%. Aggregates larger than 1180 µm and smaller than 125 µm made up the smallest fraction of the total aggregate. This shows that mostly fine and very fine aggregates were used in the preparation of the rough plaster.

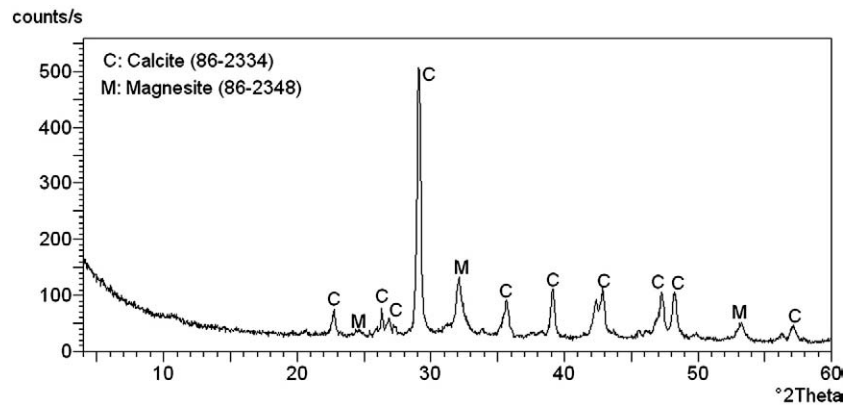
Fig. 4 – XRD pattern of fine plaster layer.

The fine plaster layer is mainly composed of carbonated lime and the fine size of acid soluble aggregates (marble or limestone powder) with oakum and straw pieces. Oakum and straw pieces could be used in order to avoid crack formation during drying and carbonation of the lime [1]. Density and porosity values of the fine layers were about 1.4 g/cm<sup>3</sup> and 41% by volume respectively. XRD patterns of the fine plaster indicated that it was mainly composed of calcium carbonate (CaCO<sub>3</sub>) and magnesium carbonate (MgCO<sub>3</sub>) (Fig. 4). Considering the results, it could be claimed that the binder used in the preparation of plaster was lime containing magnesium hydroxide.

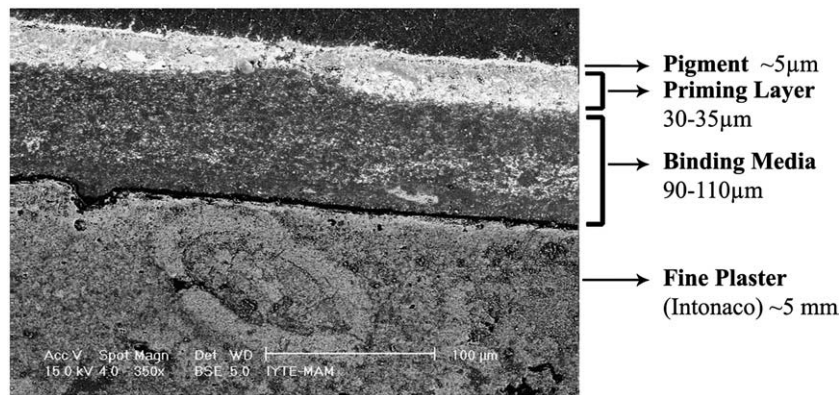
Fig. 5–BSE image of the painting layers.

SEM analysis indicated that the paintings were composed of binding and priming layers with pigments. Binding media has about 90–110 µm thickness over the fine plaster and priming layer has about 12 µm thickness over the binding layer. The thickness of the pigment layers was approximately 5 µm on the priming layer (Fig. 5).

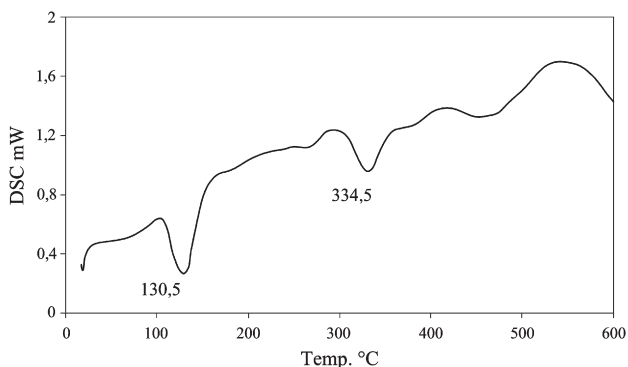
Fig. 6–DSC graph of binding media of paintings.

In the DSC spectrum of the binding medium, phase changes were observed at about 130 °C and 335 °C due to melting and

decomposition temperatures of the materials (Fig. 6). This result may indicate the presence of organic polymeric substances in the composition of the binding layer. In previous work, similar results have also been noted in the analyses of binding media that have been prepared by vegetable oil [8]. TGA analyses also support this result. In TGA graphs, weight losses are observed in the range of 30–200 °C, 200–600 °C and 600–900 °C, which are mainly due to absorbed water, decomposition of organic matter and carbon dioxide, respectively. The weight loss of the sample within a temperature range from 30 °C to 200 °C is 3.01%. The weight losses within a range from 200 °C to 600 °C and 600–900 °C are 27.05% and 2.11%, respectively (Fig. 7). The observation of

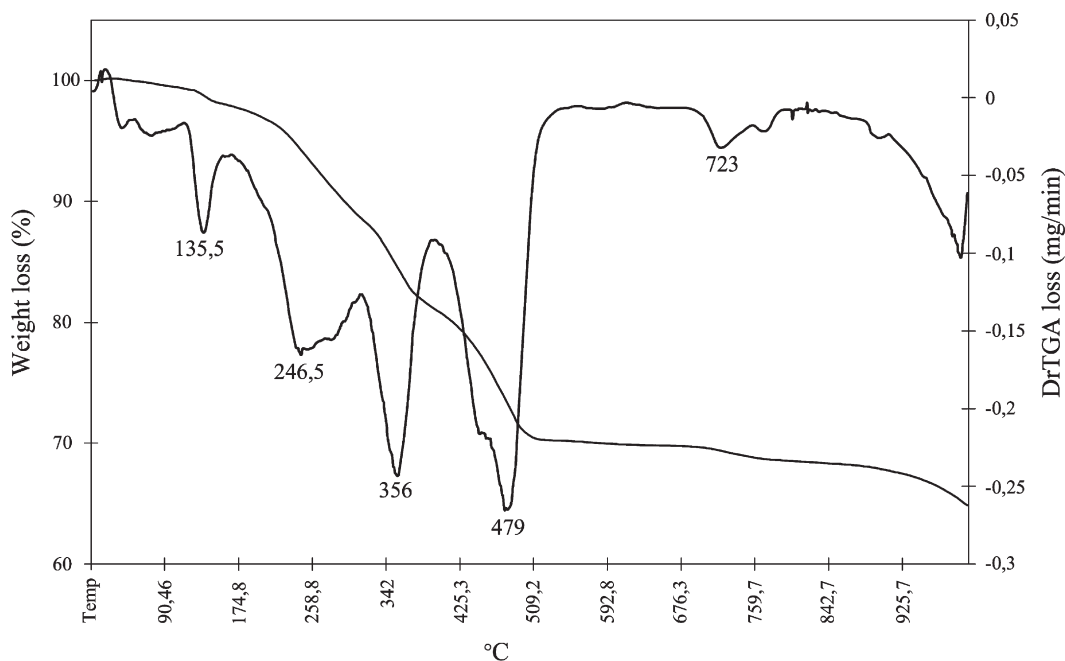
Fig. 7 – TGA graph of binding media of paintings.

high percentage loss at 200–600 °C shows the presence of high amount of organic matter in the binder. Weight losses at temperatures between 600 and 900 °C were due to carbon dioxide released during the decomposition of calcium carbonate, which was found as impurities in the binding layers.

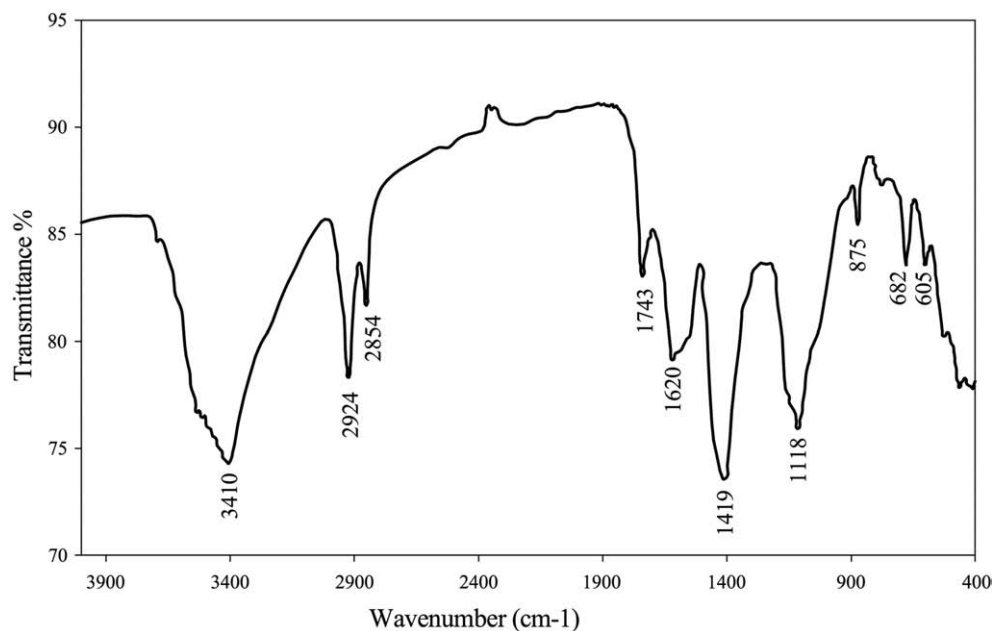
Fig. 8 – FTIR spectrum of binding media of paintings.

The compositions of the binder were determined by FT-IR analyses. In the FT-IR spectrum, the main hydroxyl band (OH) at 3410  $\text{cm}^{-1}$ , fatty acids ( $\text{CH}_2$ ) at 2924 and 2854  $\text{cm}^{-1}$ , esters ( $\text{C}=\text{O}$ ) 1743  $\text{cm}^{-1}$ , oxalate ( $\text{C}_2\text{O}_4^{2-}$ ) at 1620  $\text{cm}^{-1}$ , carbonate ( $\text{CO}_3^{2-}$ ) at 1419 and 875  $\text{cm}^{-1}$  and sulphate ( $\text{SO}_4^{2-}$ ) at 1118  $\text{cm}^{-1}$  were observed (Fig. 8). Fatty acids, esters and oxalate bands have already been identified in the FT-IR spectrum of dried

vegetable oils [16]. Sulphate and carbonate bands could originate from materials used in the preparation of priming layers and the binders of fine plasters.

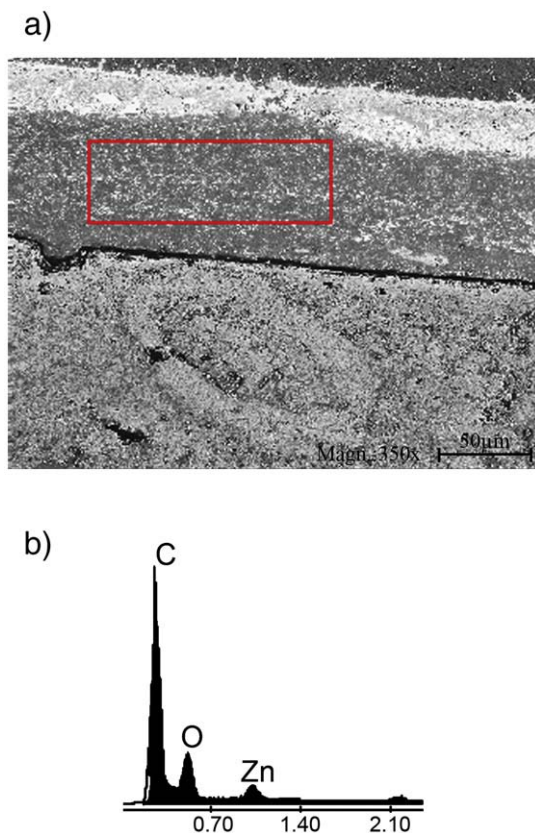
**Fig. 9**–SEM image (a) and EDX spectrum (b) of the binding layer of the paintings.

Chemical compositions of the binder were determined by SEM-EDS analysis. SEM-EDS analyses of the binder indicated that it contains high amounts of carbon (C) and low amounts of zinc (Zn) (Fig. 9). The high amounts of carbon in its composition show that the binder was produced from organic compounds. The presence of zinc may be explained by the addition of zinc oxide as a catalyst for the polymerization reaction of binder that was mainly composed of vegetable oil [17].

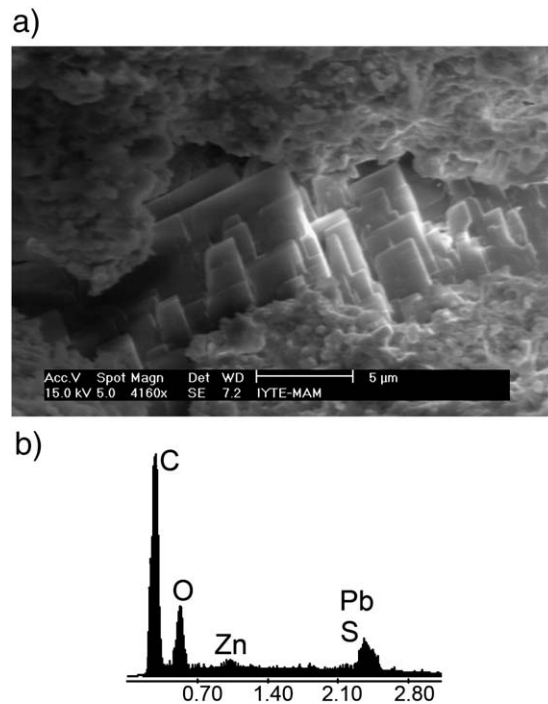
**Fig. 11**–SE image (a) and EDX spectrum (b) of anglesite crystals observed in the compositions of priming layer.

X-ray Diffraction analyses of the powdered painting layers showed that they were mainly composed of anglesite mineral ( $\text{PbSO}_4$ ) (Fig. 10). In the SEM-EDS analysis, crystals composed of lead and sulphur were found (Fig. 11). These two results show the use of anglesite minerals in the preparation of the priming layers. In some early studies, a similar usage has already been noted [2,18].

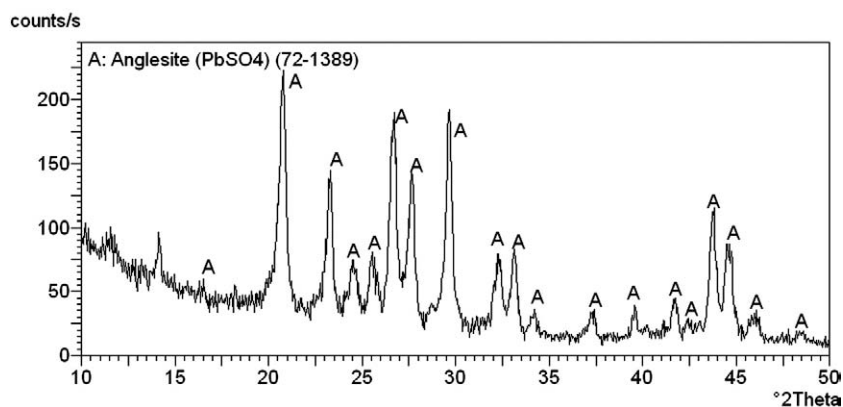
**Fig. 10**–XRD Pattern of priming layers of paintings.

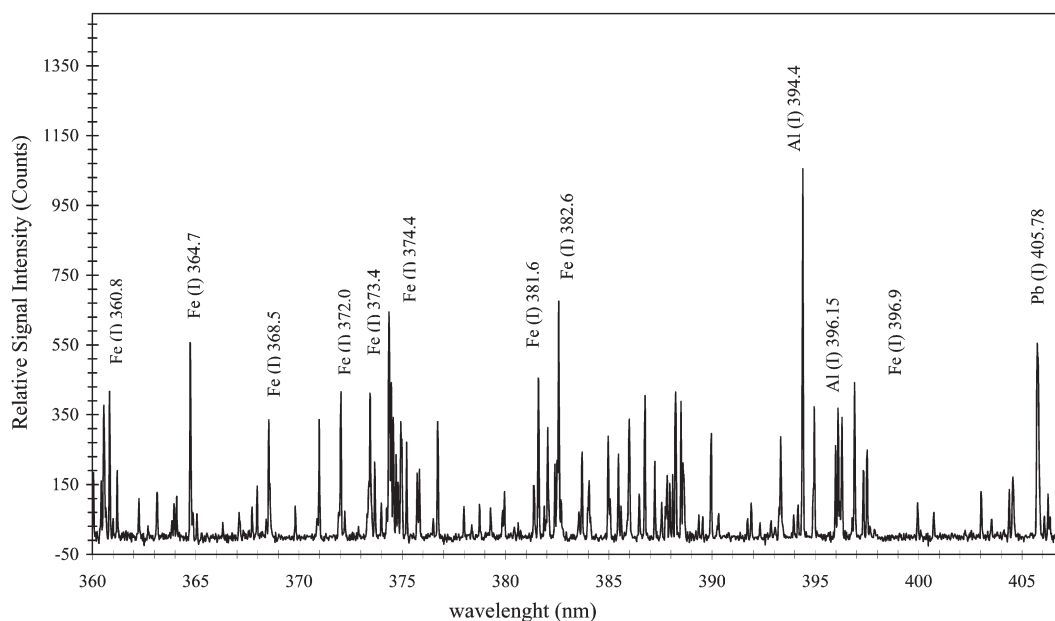
Fig. 12 – LIBS spectrum of brown painting.

surfaces indicated the presence of iron (Fe), and lead (Pb) (Fig. 12). Specific emission lines of the elements observed in LIBS spectrum were labeled in units of nanometers, nm. The presence of iron may show the use of iron containing pigments such as iron oxide [17,18]. The observation of unexpected lead signal can be explained due to impurities originating from the priming layer which was mainly composed of anglesite ( $\text{PbSO}_4$ ).

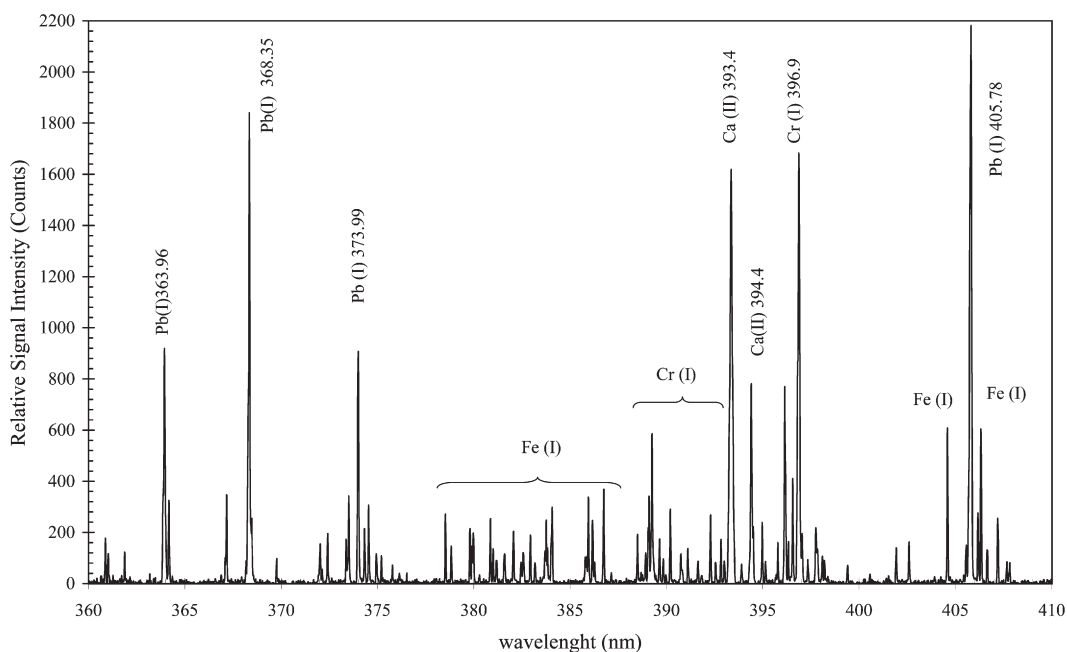
Fig. 13 – LIBS spectrum of red painting.

In the LIBS analyses of the red colored painting surfaces, a strong signal of lead and chromium was detected (Fig. 13). This may show the use of chrome red ( $\text{PbCrO}_4 \cdot \text{PbO}$ ) as pigment [19].

The observation of Fe and Ca signals in the analysis can be explained by the lime and brown pigment impurities found on the red painting.

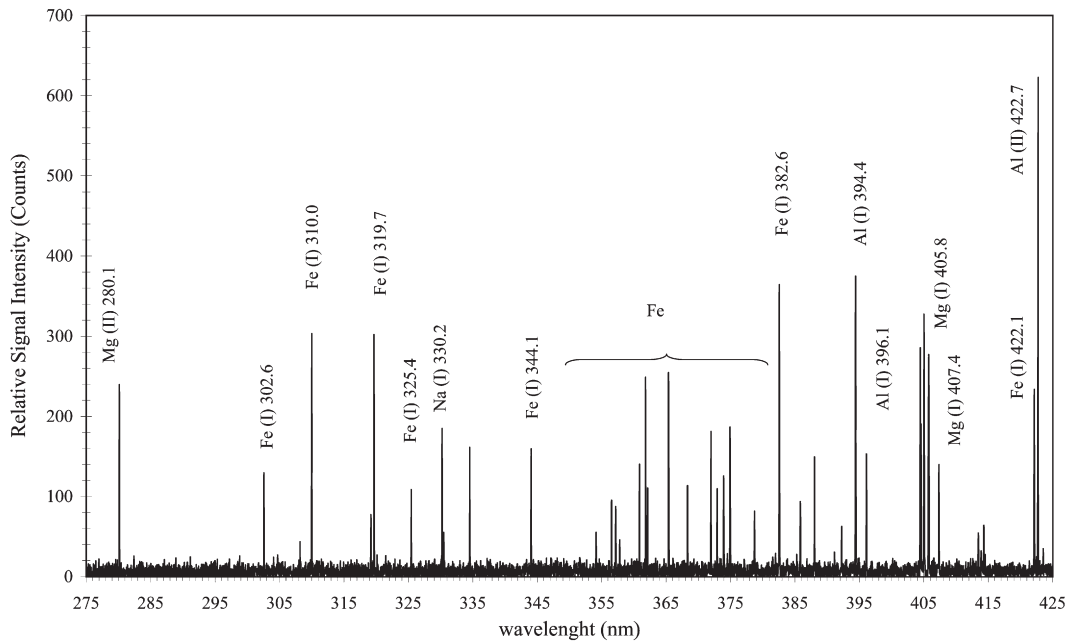
Fig. 14–LIBS spectrum of green painting.

LIBS analysis of green painting surfaces showed the presence of Na, Mg, Al and Fe (Fig. 14). In previous studies, the use of celadonite and glauconite called “green earth” having the same elements has been noted as pigments [17,18,20]. The observation of similar elements found in the composition of green painting surface may indicate the use of “green earth” as pigment in the painting.

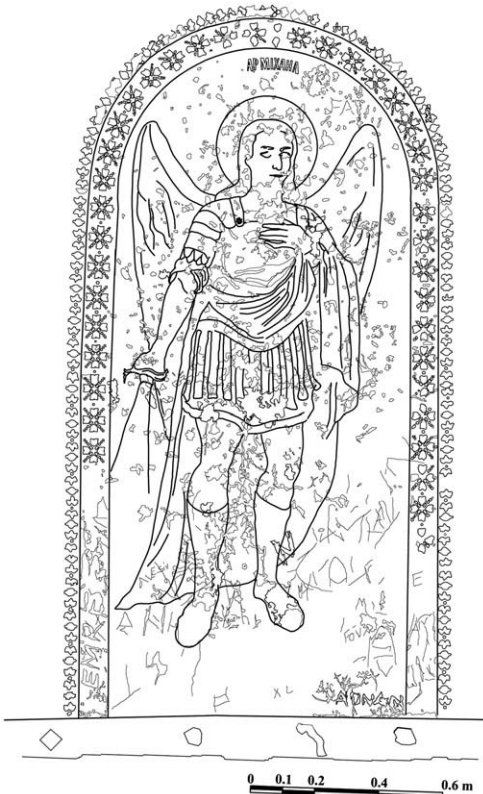
Fig. 15–Measured drawing of the Michael painting.

The main deterioration phenomena observed on the wall paintings were disintegration of plaster layers, blistering and peeling of painted surfaces (Fig. 15). SEM analysis indicated that the adhesion between the binding and priming layers of

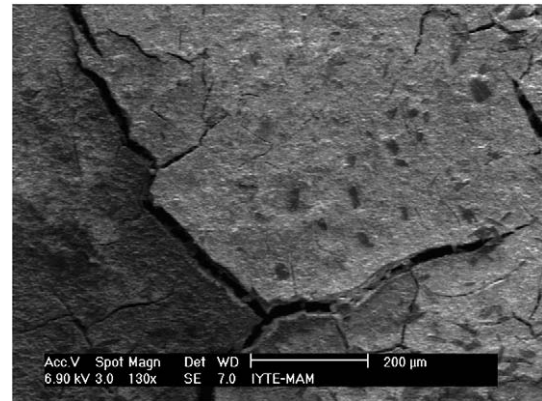
Fig. 16–SE image of micro crack formation on painting surface.

paintings was diffuse and strong. However, the common problems were the formation of micro-cracks on the surface, blistering of priming layers (Figs. 16, 17) and the detachment of

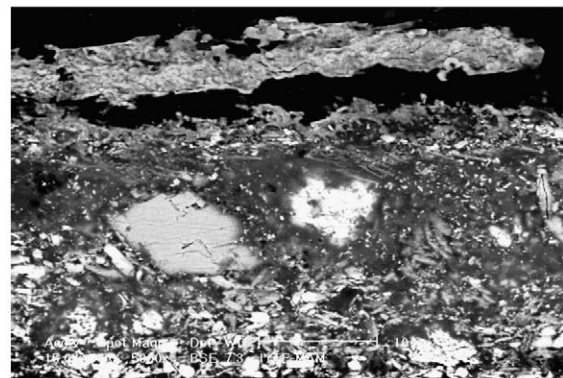
Fig. 17–BSE image of blistering on painting surface.

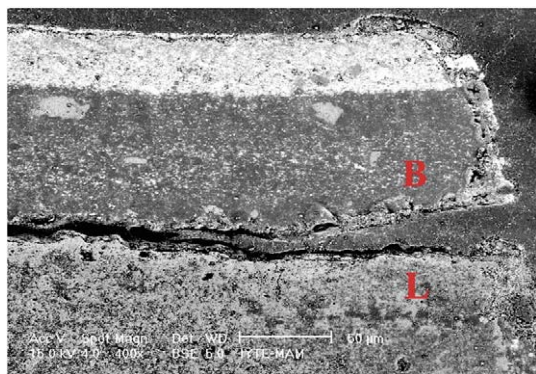
**Fig. 18** – BSE image of the detachment of painting layers from the lime plaster (B: binding layer, L: lime plaster).

the binding layer from the fine plasters (Fig. 18). Repeated wetting and drying cycles of the surfaces due to the rain penetration through the cracks or holes in the walls can be causes of the observed deteriorations on the paintings.
