Structural Analyses and Assessment of Historical Kamanlı Mosque in Izmir, Turkey

Abstract: Historical structures are one of the most precious pieces of cultural accumulation. In this study, an interdisciplinary work was conducted to assess the structural condition of a historical masonry structure, Urla Kamanlı Mosque in İzmir, Turkey. The structure is a member of group of structures, Yahşi Bey Complex, which includes a Turkish bath, a tomb, two fountains, and a primary school. The structure dates back to early 14th century to mid-15th century. History investigation, measurement survey, long-term settlement, and moisture observations were conducted. Nondestructive and destructive material tests were performed on stone, brick, and mortar. 3D finite-element model of the structure was used to investigate the critical locations of the structure under its self-weight, seismic load, and settlement load. Linear elastic and nonlinear settlement analyses were conducted to investigate the reason for massive cracks challenging the structural integrity.

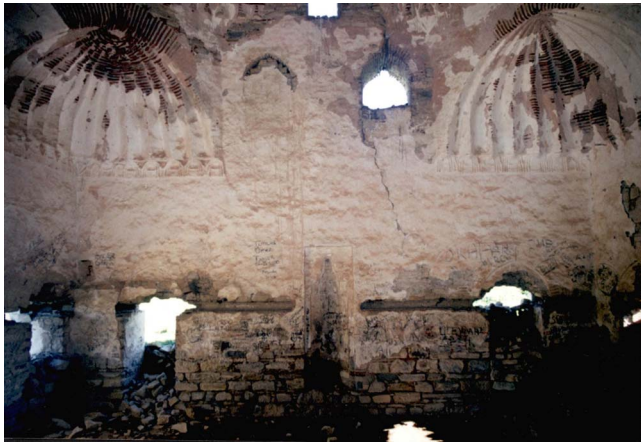
Fig. 1. East section view of the structure

The structure has a square plan of 10 m × 10 m with a wall thickness of 110 cm and the height of the structure is 12.66 m. The walls of the structure are stone masonry with limestone and thick mortar joints. The window arches and the dome are brick masonry with thick mortar joints. The transition from walls to dome on the corners is achieved by use of squinches which are also brick masonry as seen in Fig. 1.

On the east and west walls, extensive cracks follow the pathway of the windows and joins at the key stone of the dome (Fig. 1). In this study, the causes of these cracks have been investigated using 3D finite-element model of the structure.

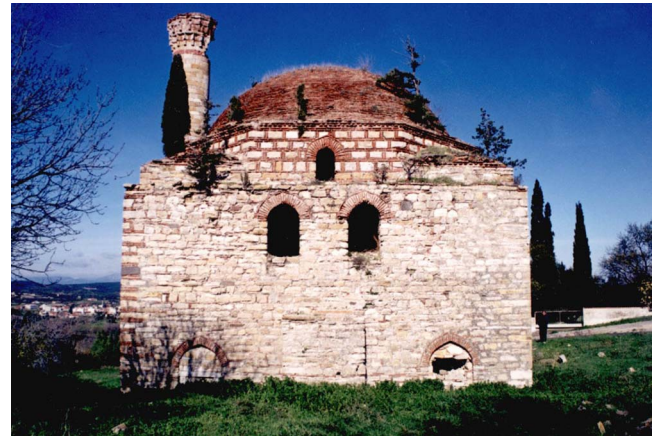
Fig. 2. South elevation view of the structure

The part of the minaret above the balcony collapsed during a storm according to the locals (Fig. 2). Plant formations on the structure challenge the structure's integrity as well; a tree growing on the wall near the drum has a height of 3 m, which is a clear sign that the structure has not been used for a long time. The drum and the west wall of the structure have a more qualified weave than the other walls (Fig. 2). According to Erim (1995), because of the primary school on the west side of the mosque, that part is a social zone, therefore has a more qualified weave than the other walls.

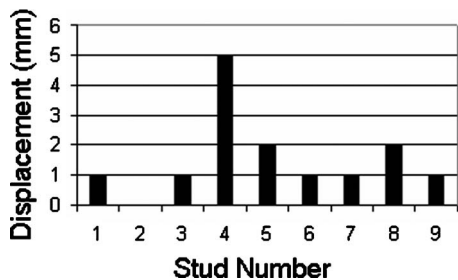
Fig. 3. Settlement measurements

The massive cracks on the east and west walls might be due to differential settlements. Settlement measurements were conducted by attaching studs on the corners of the structure. Studs 1, 2, and 3 are on the east wall corners; Studs 4 and 5 are on the north wall corners; 6 and 7 are on the west wall corners; Studs 8 and 9 are on the south wall corners. The heights of the studs were measured with respect to a local observation point using geodetics techniques with a 3-month period for 1 year.

There are decreases in heights, especially for the Studs 4 and 5 at the north elevation, which means that there is a settlement toward north direction, as seen in Fig. 3.

Visual inspection showed that there are extensive cracks on the east and west walls, uniting at the key stone of the dome. The wooden lintels which should surround the structure at two levels did not exist. The empty places of the lintels decrease the wall cross sections. Long-term settlement observations revealed that there was a settlement toward north direction of the structure.

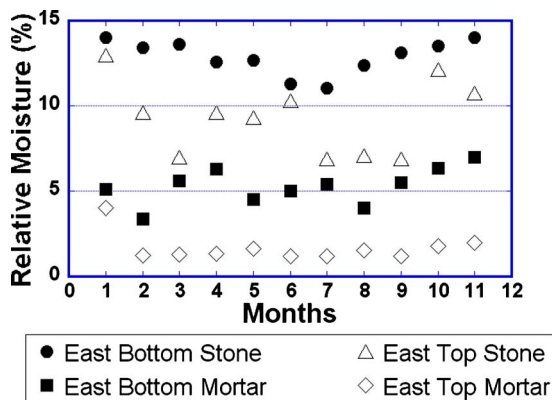
Fig. 4. Relative moisture measurements

The relative moisture of the stones and mortars at each section and at bottom (1 m from ground) and top (2 m from ground) have been observed monthly. A nondestructive moisture meter of

James Instruments Inc. which uses electromagnetic methods for determining the relative moisture to a depth of 1 in. (25 mm) was used. In Fig. 4, the relative moisture readings of the east section are given. The moisture at the bottom for stone is higher than the moisture of the stone at the top, and the same relation is valid for the mortar. At lower levels, moisture oriented degradation of materials is observed.

Material degradation inside the structure, especially at the first 1 m from the ground, was observed. Long-term moisture measurements showed that the moisture at the first 1 m from ground was higher than the moisture at 2 m from ground which causes material degradation.

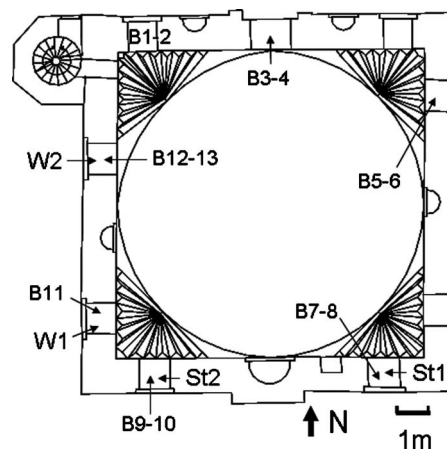
Fig. 5. Locations of stones (St1-2, W1-2) and bricks (B1-13) obtained from the structure

In order to characterize the materials of the structure, nondestructive and destructive tests were applied on stone, brick, and mortar samples obtained from the structure. Two stones from the south wall, two stones from the west wall, and 13 bricks were collected from locations in Fig. 5. The stone samples were obtained from bases of the first level window openings, and bricks were obtained from arches of the first level window openings. The tests' results on mortar were obtained from Architectural Restoration Department of Izmir Institute of Technology.

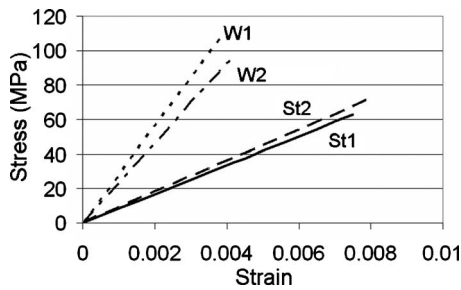
Fig. 6. Stress-strain graph obtained from uniaxial compression test for stone samples

Uniaxial compression test was applied to stone, brick, and mortar core samples according to International Society for Rock Mechanics (ISRM) (1981). The test was conducted using a mechanical testing machine which can read the stroke from the loading head. The modulus of elasticity was determined by using the stress-strain curves obtained from uniaxial compression tests. The tangent modulus at 50% of compressive strength is determined to be the modulus of elasticity. The averages of the uniaxial compressive strength and modulus of elasticity of the stone, brick, and mortar samples are presented in Table 1. The stress-strain curves obtained for stone and brick samples are presented in Figs. 6 and 7. Indirect tension test was applied to the stone, brick, and mortar core samples according to International Society for Rock Mechanics (ISRM) (1981). The average tensile strengths of samples are presented in Table 1. The chemical composition of the stones was determined to be CaCO_3 by use of Philips X-Pert X-Ray

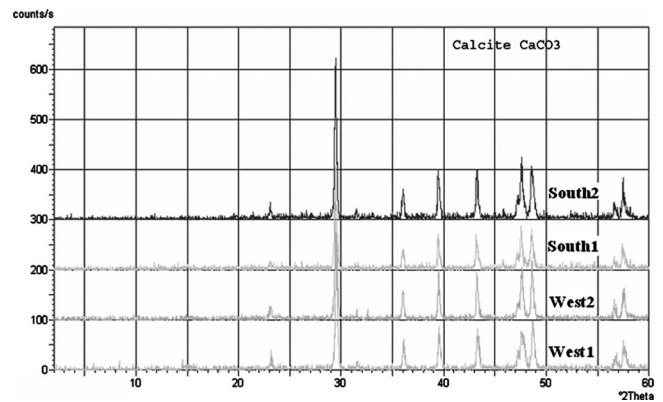
Fig. 8. XRD analyses of stone samples (x -axis: XRD angle; y -axis: counts/s)

diffraction (XRD) (PANalytical, Almelo, The Netherlands) as seen in Fig. 8.

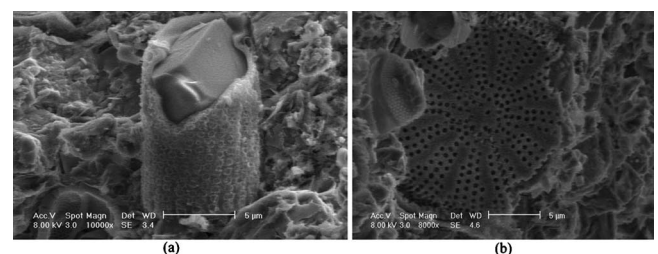
Fig. 9. SEM view of stone samples from south section: (a) fossil in stone sample south 1; (b) fossil in stone sample south 2

Microstructural analyses of stones were made by using Philips XL 30S-FEG scanning electron microscope (SEM). Fossils, 5–10 μm in outer diameter, were observed on the stone samples obtained from the south section as in Fig. 9. Fossils were not observed on the samples obtained from the west section. The Schmidt Hammer and pulse velocity values of the stones obtained from west section are higher than for the stones obtained from the south section.

Nondestructive and destructive tests were conducted on stone, brick, and mortar of the structure and mechanical properties were measured. The stones of the west wall have higher modulus of elasticity and compressive strength with respect to the stones of the south wall. The porosity of the stones obtained from west wall was lower than porosity of the stones obtained from the south wall. The high porosity of the south wall stone is due to the impurities such as fossils which were not observed in the stones obtained from the west wall.

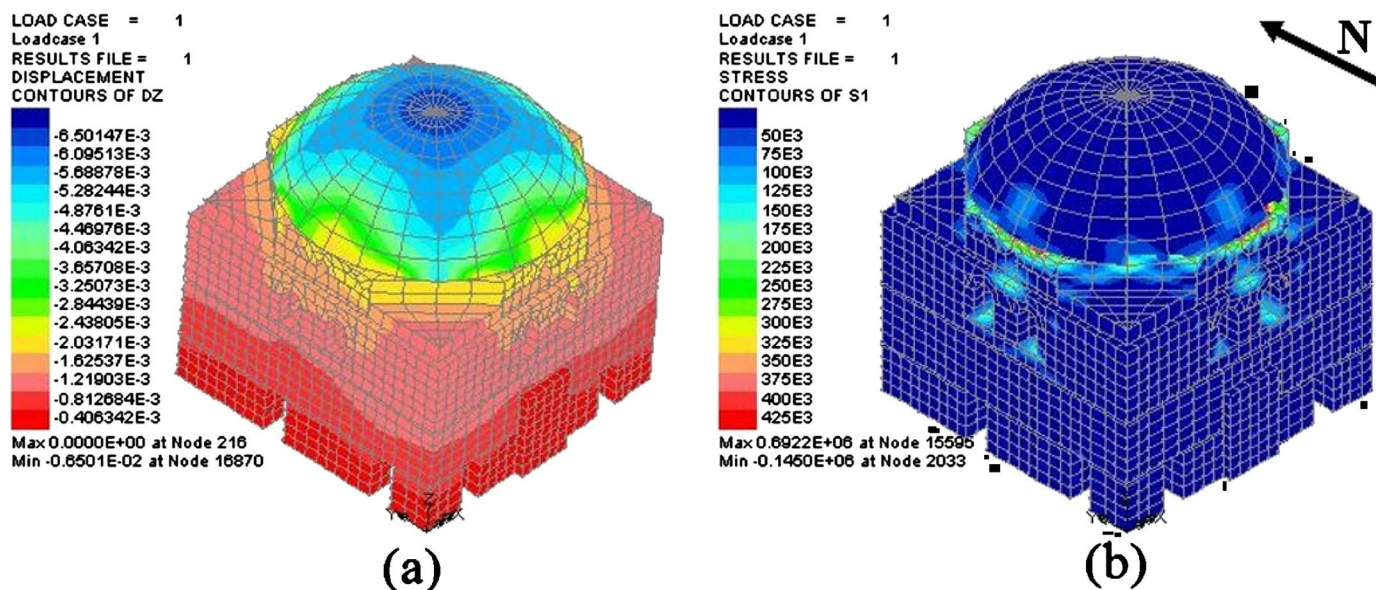
Fig. 10. Analysis results under self-weight: (a) vertical displacements [DZ (m)]; (b) first principal stresses [S1 (Pa)]

Linear elastic self-weight analysis of the structure was conducted in order to investigate the condition of the structure under its self-weight. Also, the relationship between stress state under self-weight and the existing cracks was investigated.

[Fig. 10(b)]. These stress concentrations coincide with the crack's route in east and west walls. The S1 stresses are lower than the tensile strength of brick masonry $f_{t,bm}=0.425$ MPa where brick masonry is used (dome, windows' arches, and squinches).

1. The critical locations of the structure under self-weight are drum-dome connections and second level windows which are on the existing cracks' route. The self-weight does not cause the cracks individually, but might support cracks' formation in combination with other loads.

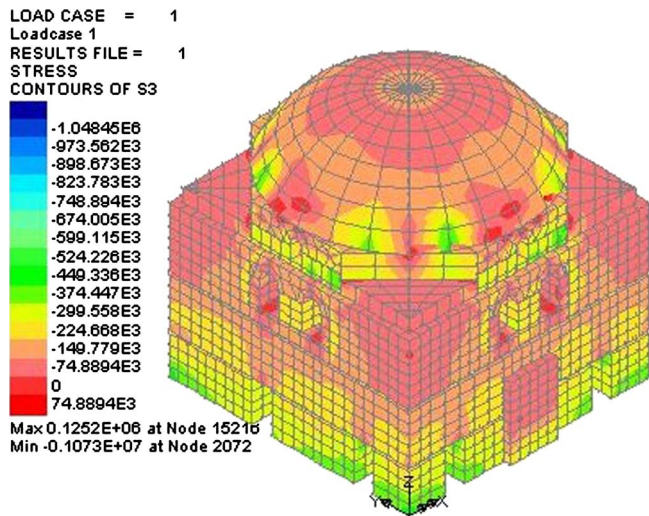
Fig. 11. Third principal stress results under self-weight [S3 (Pa)]

The minimum of the third principal stress ($S3=-1$ MPa) is not higher than the compressive strength of stone masonry ($f_{c,sm}=10.8$ MPa) and brick masonry ($f_{c,bm}=4.3$ MPa) (Fig. 11). It can be concluded that self-weight does not cause the cracks individually but might support their formation with other load conditions.

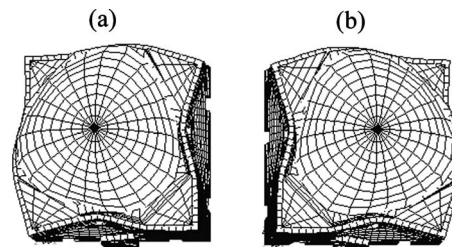
Fig. 12. (a) First mode shape; (b) second mode shape

Mode	Frequency (Hz)	Mass participation factor (%)		
		X	Y	Z
1	4.76	37.08	30.16	0.00
2	4.77	31.42	35.27	0.00
3	5.67	0.00	0.20	0.00
4	6.91	0.01	0.00	0.00
5	7.54	0.01	0.01	16.12
6	7.85	0.14	0.00	0.58
7	8.35	0.23	1.31	0.00
8	8.50	1.94	0.25	0.00
9	9.06	0.04	0.31	0.00
10	9.32	10.45	0.01	0.00

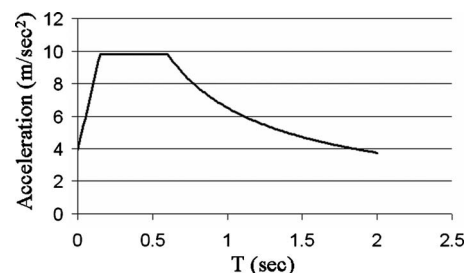
Fig. 13. Acceleration response spectrum

$$A(T) = A_o \times I \times S(T) \quad (4)$$

The A_o , I , and $S(T)$ =effective ground acceleration coefficient, building importance factor, and spectrum coefficient, respectively.

Effective ground acceleration coefficient was taken as $A_0=0.4$ as the structure is in the first-order seismic zone. The building importance factor was taken as $I=1$ (Ministry of Public Works and Settlement, Government of Republic of Turkey 1998). The acceleration response spectrum is defined using Eqs. (3), (4), and (5a)–(5c) and presented in Fig. 13. The response spectrum analyses were performed for the X and Y directions of the model.

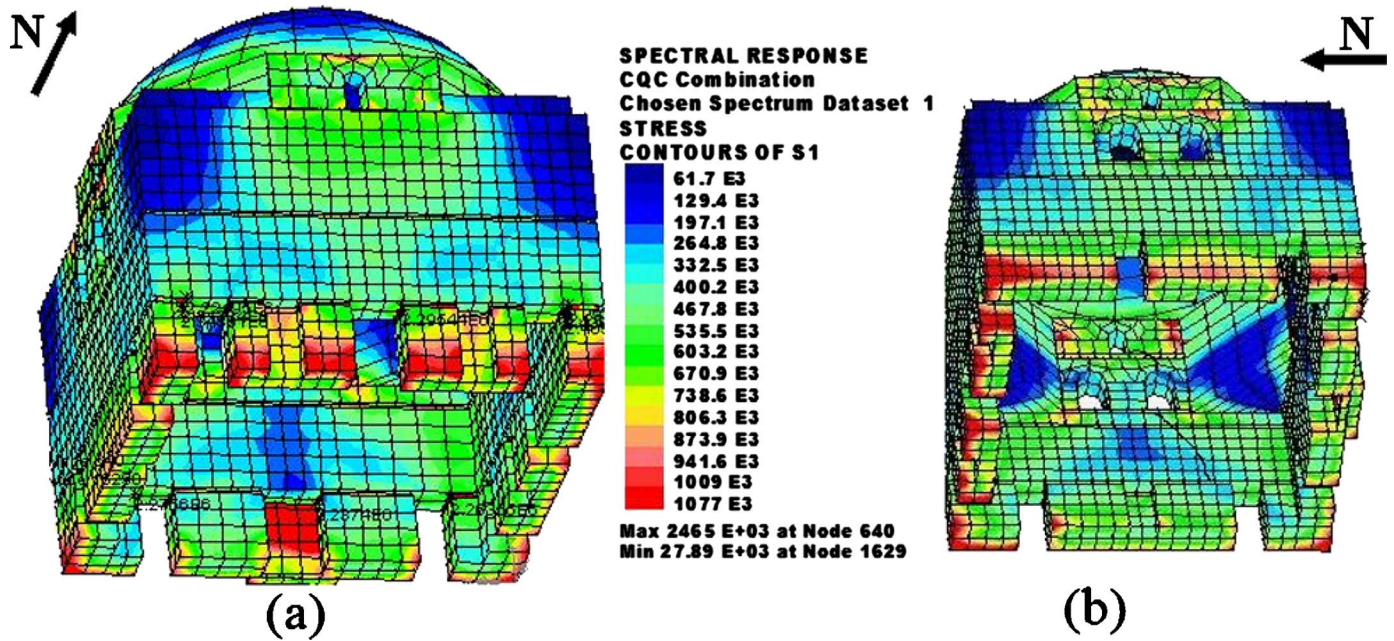
Fig. 14. S1 (Pa) contours due to spectral excitation in X (east) direction: (a) east and north elevations; (b) east section (the existing crack is plotted on the figure for comparison with stress contours)

For the excitation in the X (east) direction, the first principle stress ($S1=2.5$ MPa) exceeds the tensile strength of stone masonry ($f_{t,sm}=1.08$ MPa) at the lower level lintel at the north and south sections where the sections of the walls decrease considerably [Fig. 14(a)]. The tensile stresses are critical at the drum-dome connections and at the foundation, especially at the north where the tensile stresses exceed the tensile strength [Fig. 14(a)].

The S1 does not exceed tensile strength of brick masonry ($f_{t,bm} = 0.43$ MPa) at dome, squinches, and windows' arches which are brick masonry.

The S1 is lower than the tensile strength at crack locations [Fig. 14(b)]. The absolute value of the third principle stress (S3) is lower than the compressive strength for both stone masonry ($f_{c,sm} = 10.8$ MPa) and brick masonry ($f_{c,bm} = 4.3$ MPa).

3. Seismic analyses were done using response spectrum method. The lower level empty lintel places and drum-dome connections have high stress levels. The stresses are lower than the strength at the existing cracks' location.

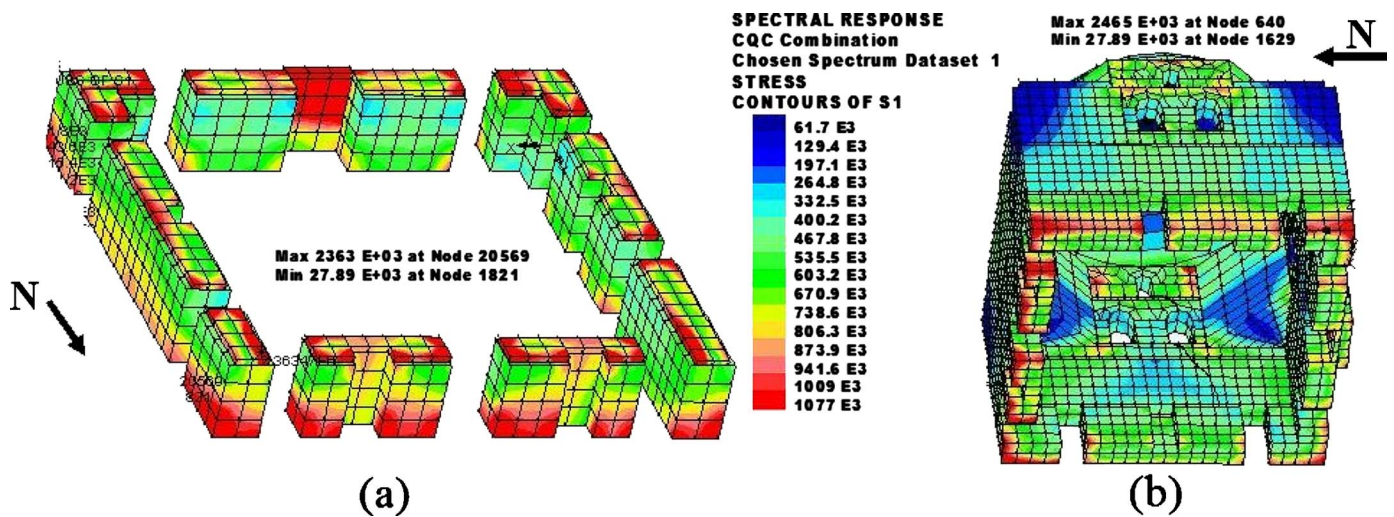
Fig. 15. S1 (Pa) contours due to spectral excitation in Y (north) direction: (a) east and north elevations; (b) east section (the existing crack is plotted on the figure for comparison with stress contours)

For the excitation in the Y (north) direction, the first principal stress (S1 = 2.4 MPa) exceeds the tensile strength of stone masonry ($f_{t,sm} = 1.08$ MPa) at the lower level lintel at the east section [Fig. 15(a)]. North and south lintel locations have high tensile stresses which are critical. The foundation has tensile stresses

larger than the strength especially at the north while the drum also has large tensile stresses [Fig. 15(b)]. In the east and west sections, the tensile stresses are lower than the strength at the crack locations [Fig. 15(b)]. The S1 does not exceed tensile strength of brick masonry ($f_{t,bm} = 0.43$ MPa) at dome, squinches, and windows' arches which are brick masonry.

The S1 is lower than the tensile strength at crack locations [Fig. 15(b)]. The minimum of the third principal stress (S3 = -0.32 MPa) is lower than the compressive strength for both stone masonry ($f_{c,sm} = 10.8$ MPa) and brick masonry ($f_{c,bm} = 4.3$ MPa) as seen in Fig. 16.

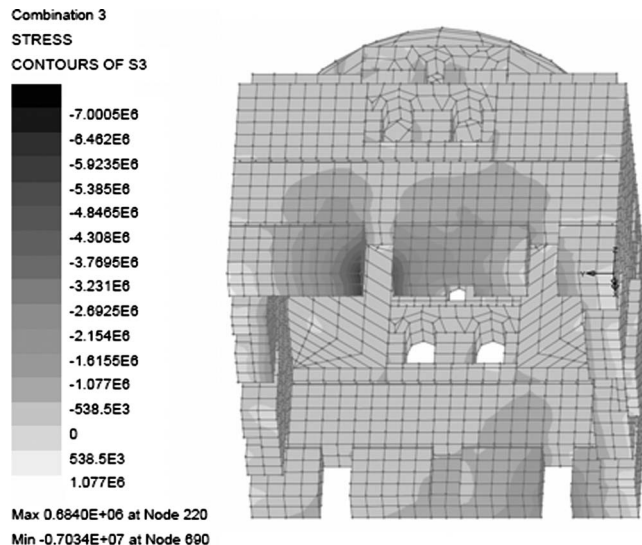
Fig. 18. S3 (Pa) contours for linear elastic settlement+self-weight

The minimum of $S3=-7$ MPa at the west foundation is smaller than compressive strength of stone masonry ($f_{c,sm}=10.8$ MPa) (Fig. 18). The $S3$ is smaller than compressive strength of brick masonry ($f_{c,bm}=4.3$ MPa) at dome, windows' arches, and squinches.

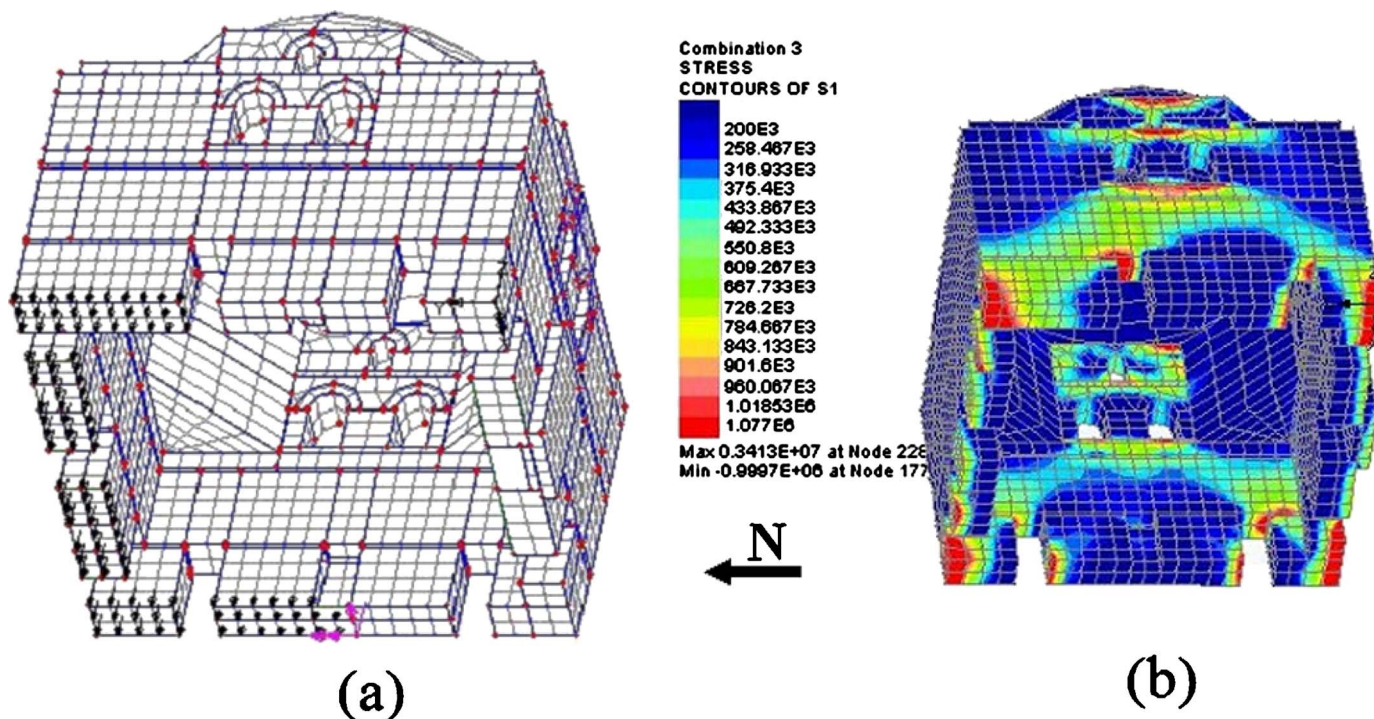
Fig. 17. (a) Settlement loading; (b) S1 (Pa) contours for linear elastic settlement+self-weight

the settlement was given by linear increase that starts with zero on the east and west walls' foundations and reaches maximum at the north foundation [Fig. 17(a)]. The results are given here for dead load plus settlement combination. The maximum $S1=3.4$ MPa is at the lintel places at the northwest corner. Tensile stresses are higher than tensile strength of stone masonry ($f_{t,sm}=1.08$ MPa) at northwest foundation, the drum-dome connections on the east and west. The $S1$ exceed tensile strength of brick masonry ($f_{t,bm}=0.43$ MPa) at first and second level windows' arches which are brick masonry. The high tensile stresses coincide with the cracks at the east and west walls of the structure [Fig. 17(b)].

The settlement load was applied starting with zero at east and west foundations, increasing toward the north foundation, as in Fig. 17(a). The nonlinear analysis was performed by acting the self-weight plus the settlement load.

4. The locations of the stress concentrations obtained from linear elastic and nonlinear settlement analyses match with the existing cracks' locations.

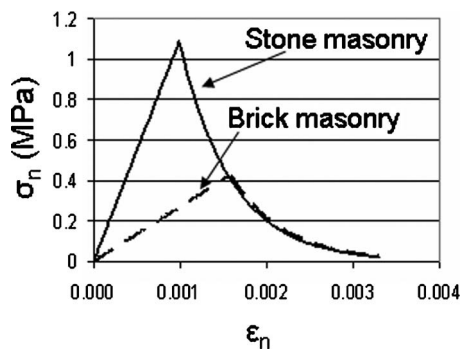
Fig. 19. Stress-strain curves normal to crack plane for stone and brick masonry (ϵ_n : strain normal to crack plane; σ_n : stress normal to crack plane) (FEA Ltd. 2002)

Three crack directions are active at any one time and are defined by the closest directions to the principal strain directions. Total principal strains are used to define the cracking directions rather than stresses because strains grow with the increasing fracture but stresses diminish to zero and do not provide a good measure of previous fracture directions (FEA Ltd. 2002). In tensile loading an exponential softening curve of stress-strain relationship is defined normal to crack plane for stone masonry and brick masonry (Fig. 19).

The strain at the end of softening curve is assumed to be 0.003, equal to the value for concrete. In order to check the sensitivity of the results to this assumption, the analyses were repeated for 0.002 and 0.004 and no significant change in results was observed.
