The Impact of Planimetric Configuration on Structurally Damaged Residential Buildings

To cite this article: Tuğçe Kazanasmaz Zehra (2009) The Impact of Planimetric Configuration on Structurally Damaged Residential Buildings, Architectural Science Review, 52:1, 54-70

Zehra Tuğçe Kazanasmaz

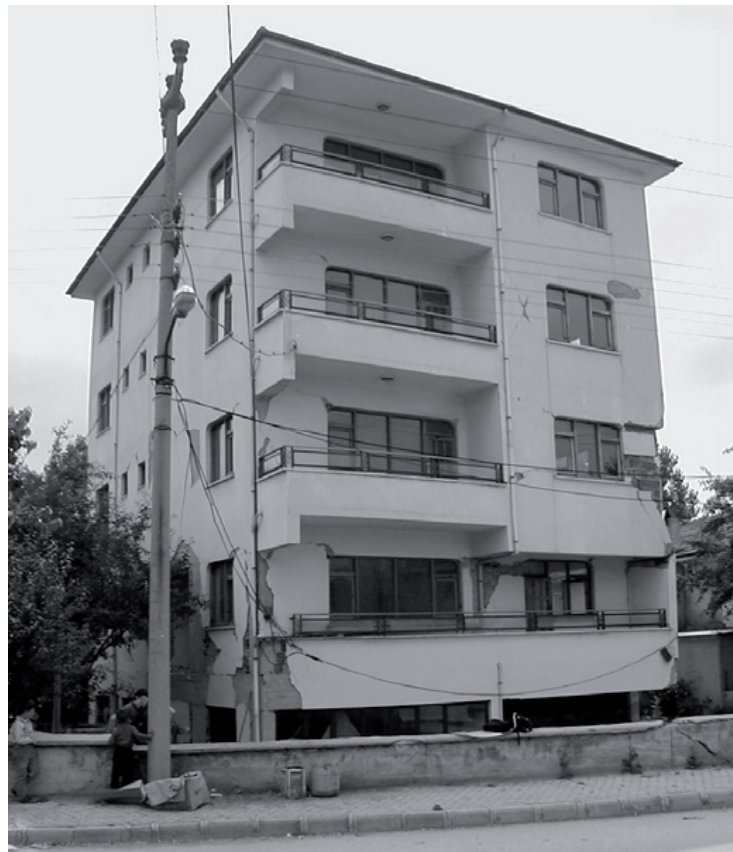
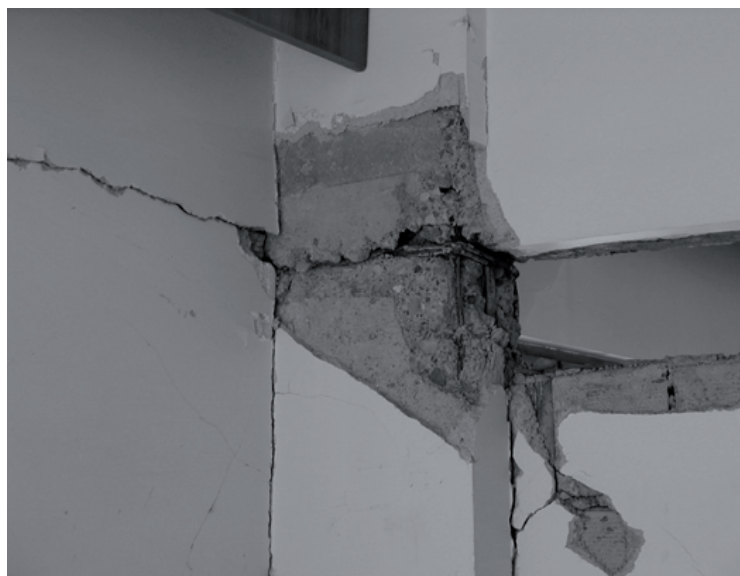
Figure 1: A five-storey hazardous building in Bolu (a) with a structural crack on the column and (b) beam connection inside.
(Source: Field teams from various universities. <http://www.anatolianquake.org>)

Figure 1 shows a detailed photo of a damaged building with a crack on its structural member. Another one is shown with damage to a brick infill wall in Figure 2.

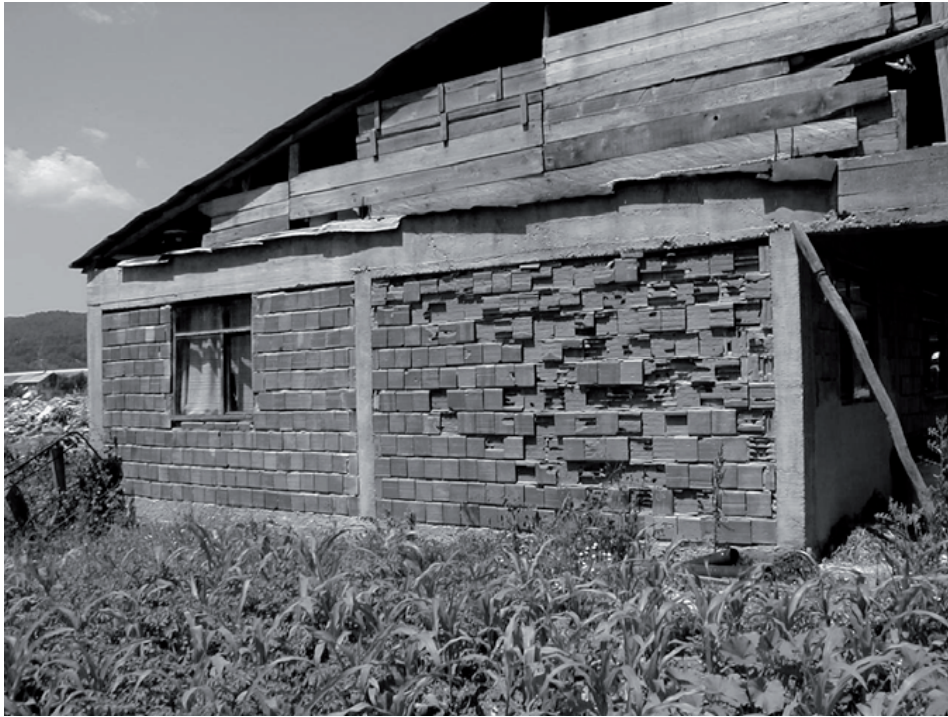
Figure 2: Damage occurred on the brick wall in a hazardous building in Kaynaşlı.
(Source: Field teams from various universities. <http://www.anatolianquake.org>)

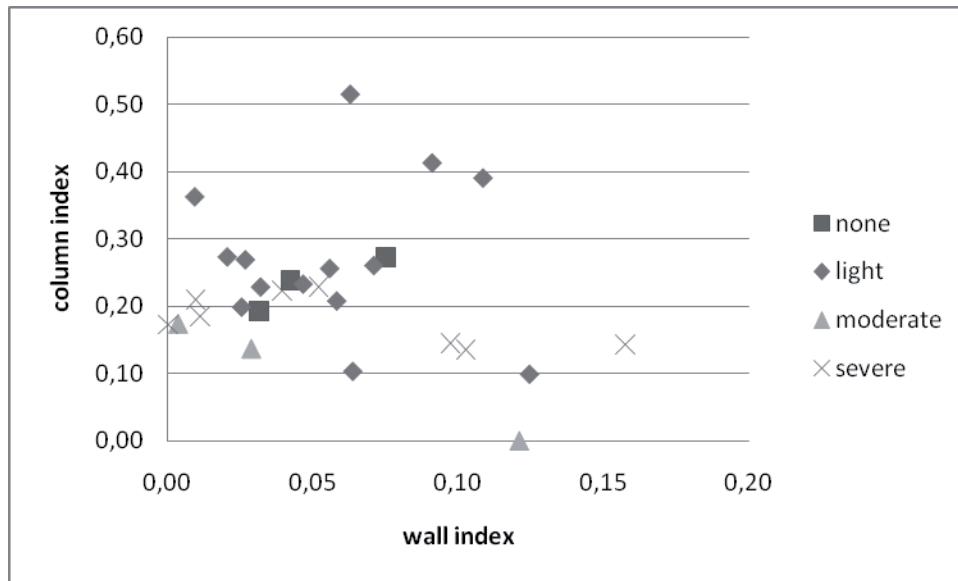
Figure 3: Scatter plot displaying wall and column index of sample buildings according to damage level.

The data, including these parameters and related photographs, consequently were available for this study. The priority index indicated the vulnerability of buildings against earthquake; and damage levels were classified by field teams as, ‘none’, ‘light’, ‘moderate’, and ‘severe’ according to the failures and cracks observed on structural members (Dönmez & Pujol, 2005; Hassan & Sözen, 1997; <http://www.anatolianquake.org>). A scatter chart summarises wall and column indices for the sample buildings, as shown in Figure 3.

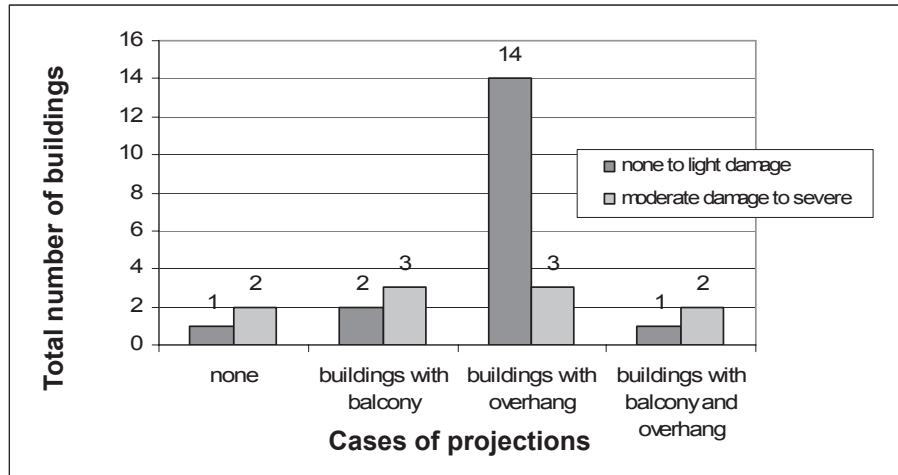
Figure 5: Distribution by cases of projections of damaged buildings according to damage levels.

overhangs of varying dimensions. Figure 5 shows the distribution of buildings according to the existence of overhangs and balconies. Among the buildings with overhang, only 18% of them had ‘moderate’ or ‘severe’ damage, while for buildings with balconies this was 60%. This meant that earthquakes caused more harmful effect on buildings with balconies than on buildings with overhangs. The literature explains that overhangs are extensions of the total mass, which results in an interrupted vertical structure. Therefore, the rotational inertia increases and stiffness changes. This situation causes undesirable stress concentrations and torsions (Dorwick, 1987). However, a balcony is a cantilever that supports its own weight and its structure creates its own vibration, leading one to conclude that earthquake forces may cause more harmful effect on overhangs. This conflict between the sample buildings and literature may stem from the infills in the balconies. Brick infills may increase the total weight and stiffness of the balconies. Figure 6 shows a building with an overhang and a balcony.

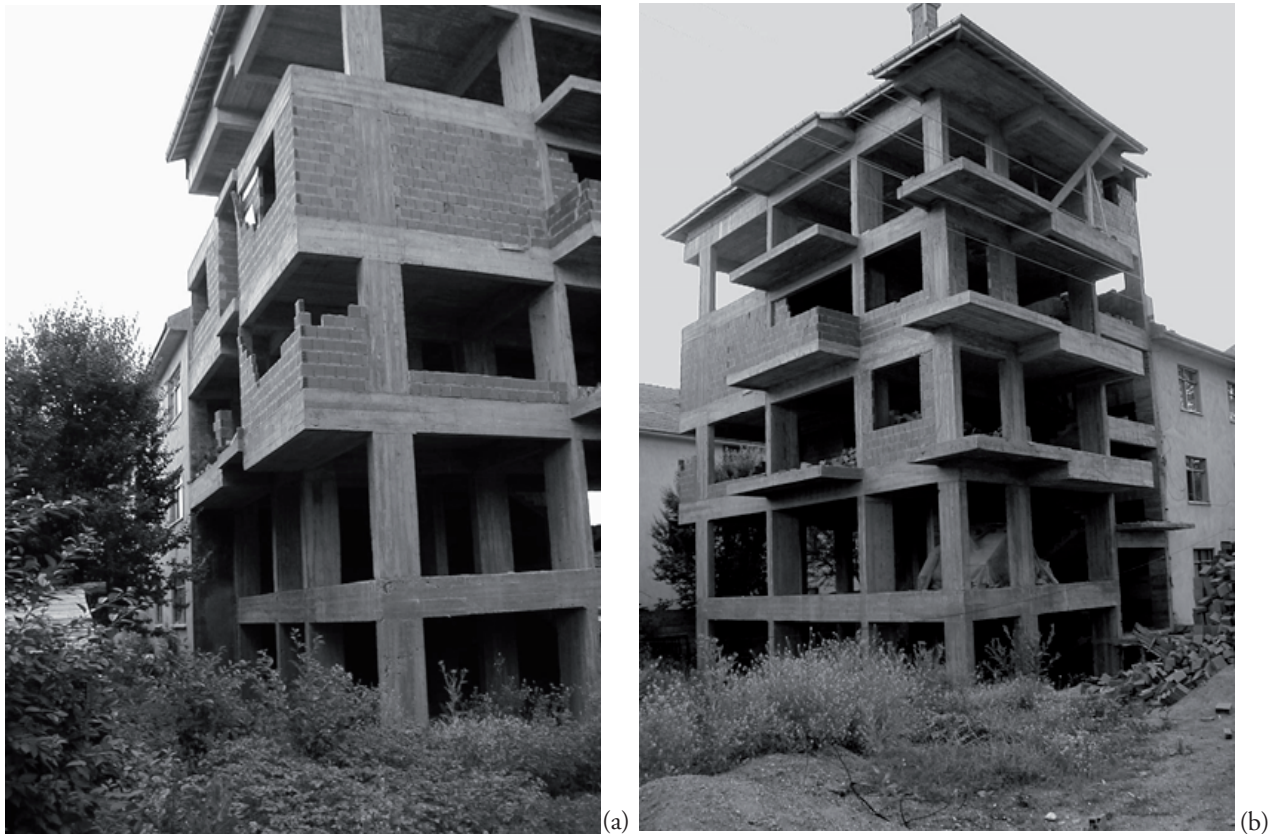
Figure 6: Views from a damaged residential building with (a) an overhang and (b) a balcony.
(Source: Field teams from various universities. <http://www.anatolianquake.org>)

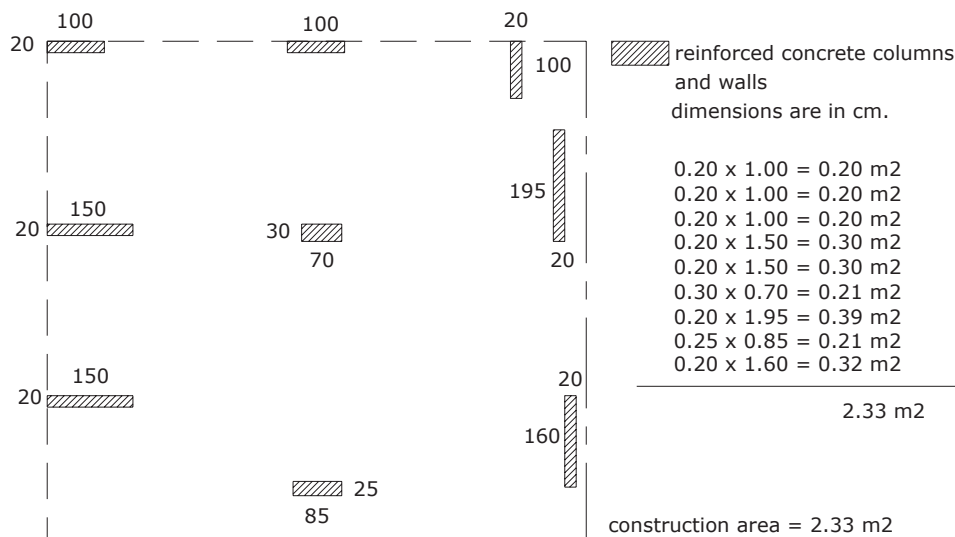
Figure 10: A sketch displaying the construction area.

Construction Area: This was the footprint area of all reinforced concrete columns, concrete walls and masonry walls given on the ground floor plan, as shown in Figure 10.

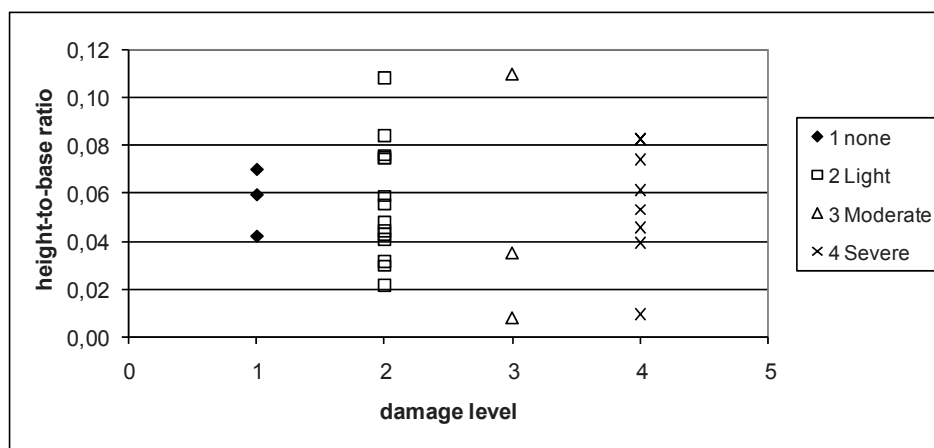
Figure 14: Scatter plots for height-to-base ratio and damage level.

The relation between the damage level and the height-to-base ratios of damaged sample buildings is shown in Figure 14. Plotting the values for the height-to-base ratios (y-axis) and damage level (x-axis) resulted in a fine scattering pattern. As

the height-to-base ratios ranged almost from 0.02 to 0.08 and all damage levels were within that range, no relation between these ratios and the damage level were noted as significant.

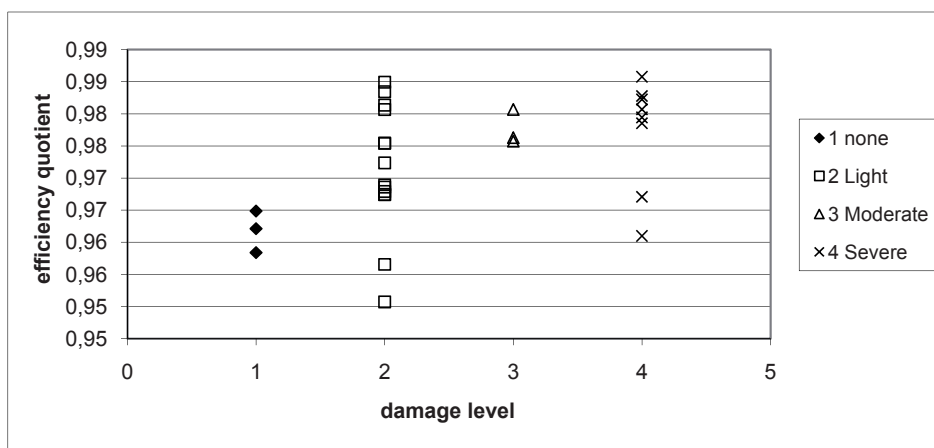
Figure 15: Scatter plots for efficiency quotient and damage level.

The relation between the damage level and the efficiency quotient of damaged sample buildings is shown in Figure 15. Plotting the values for efficiency quotient (y-axis) and damage level (x-axis) displayed similar dependency as the one found for damage level on construction efficiency quotient.

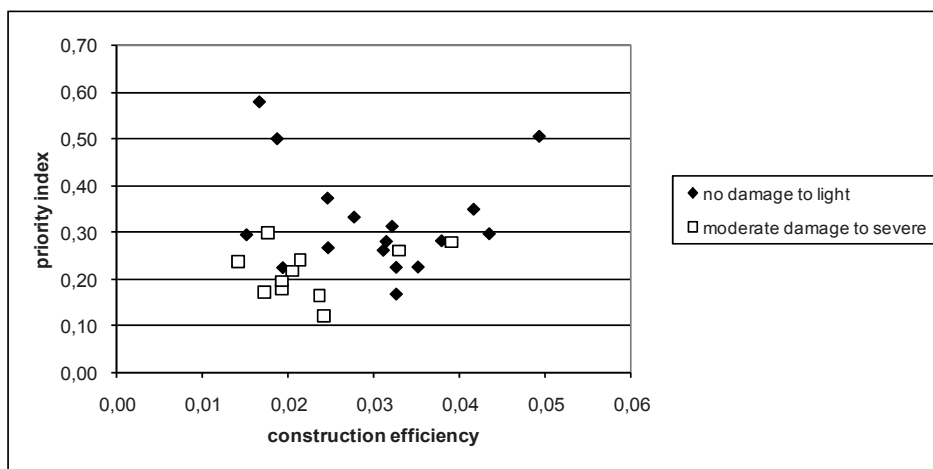
Figure 16: Scatter plots for priority index and construction efficiency quotients.

The relation between the priority index and the construction efficiency quotients of damaged sample buildings is shown in Figure 16. Plotting the values for the priority index (y-axis) and construction efficiency quotients (x-axis) resulted in a fine ranking procedure according to damage levels. This process is not meant to be a method to predict damage levels. It is simply an objective method to rank buildings with respect to their vulnerability and the density of vertical structural members, then, to define their relative relation for the sample

buildings. It was concluded that the damage level was high when construction efficiency had lower values, thus providing evidence of a reasonable relationship between priority index and construction efficiency.
