In this study, finite element analyses of historical masonry structures have been investigated. The study has been conducted on a case study structure, Urla Kamanli Mosque. In order to collect data for finite element analyses, history investigation and measurement survey of the structure were done. Long term observations of moisture, crack opening displacement and wall settlements were done periodically. Nondestructive and destructive material tests on stone, mortar and brick of the structure were applied. A 3D finite element model of the structure was generated on LUSAS, a commercial finite element software. Linear elastic and nonlinear analyses were conducted to determine the vulnerability and the reasons of the structural cracks. The nonlinear analyses were conducted by using appropriate constitutive criterion for masonry.

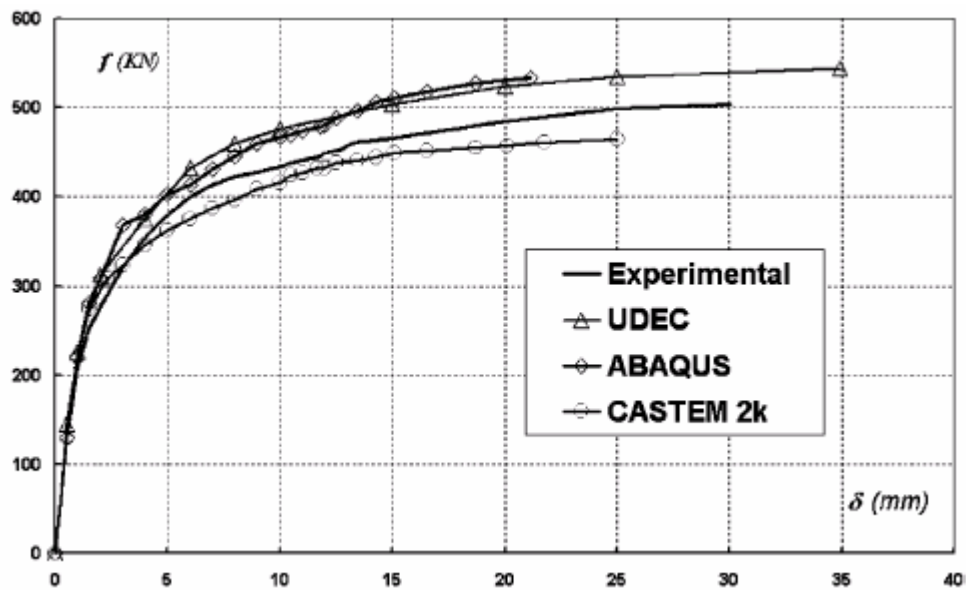
Discrete Element Method (DEM) was also used for modeling masonry. While modeling with DEM, it is assumed that the structure is an assembly of blocks which are rigid or deformable. The blocks interact by unilateral elasto-plastic contact elements which has Coulomb friction criterion. DEM can model large deformations therefore can simulate the failure of a system. During the analysis, new contacts are created due to the motion of the system. UDEC soft ware was used for modeling with DEM. DEM was used for modeling an experiment and the comparison of the experimental and numerical DEM results are given in Figure 3.4. The results of DEM follows the experimental results closely, see Figure 3.4 (Giordano et al. 2002, p. 1058).

Figure 3.4. Experimental versus numerical results (Giordano et al. 2002, p. 1068).

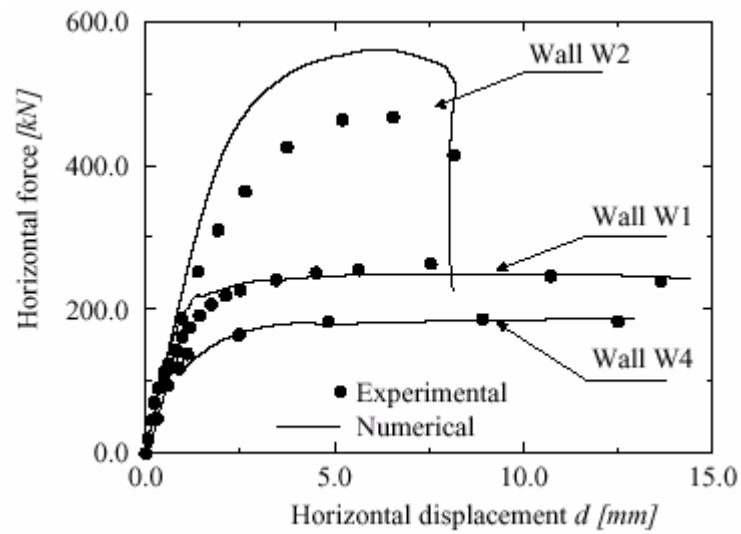
Figure 3.13 Load–displacement curves of experiments and numerical models (Lourenco 1996, p.163).

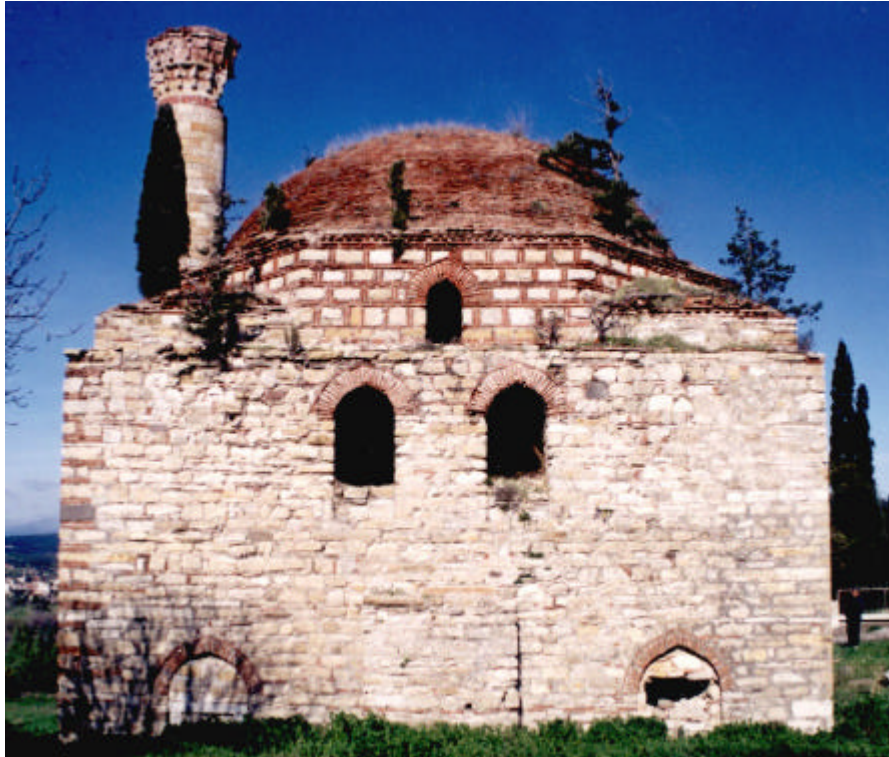
Figure 4.3. South Elevation.

The part of the minaret above the balcony collapsed during a storm, as locals commented, see Figure 4.3. Plant formations on the structure challenges the structure as well; a tree just in front of the minaret has a height of 3 m, which is a clear sign that the structure is not used for a long time. The drum and the west wall of the structure have a more qualified weave than the other walls, see Figure 4.4. According to a conversation with Ferhan Erim who is an arthistorian worked on the structure, because of the primary school on the west side of the mosque, that part is a social zone and so has a more qualified weave than the other walls.

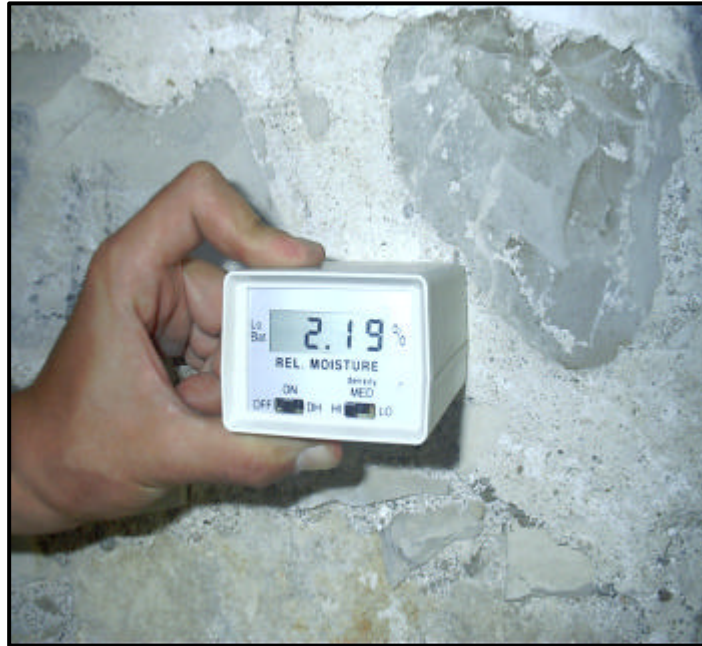
where R(%), W_w and W_T are relative moisture, weight of the water in the specimen and total weight of the specimen, respectively. In order to measure the moisture in a material, the circle at the back of the device is touched to the material paying attention not to leave air space between device and the material. The relative moisture of the material is read from the digital screen of the device, see Figure 4.7. The device can be used at three different density levels; HIGH for concrete, brick, stone, granite, sand, soil, rock; MEDIUM and LOW depends processing technique for wood, food, paper, textile materials etc.

Figure 4.7. Moisture meter application.

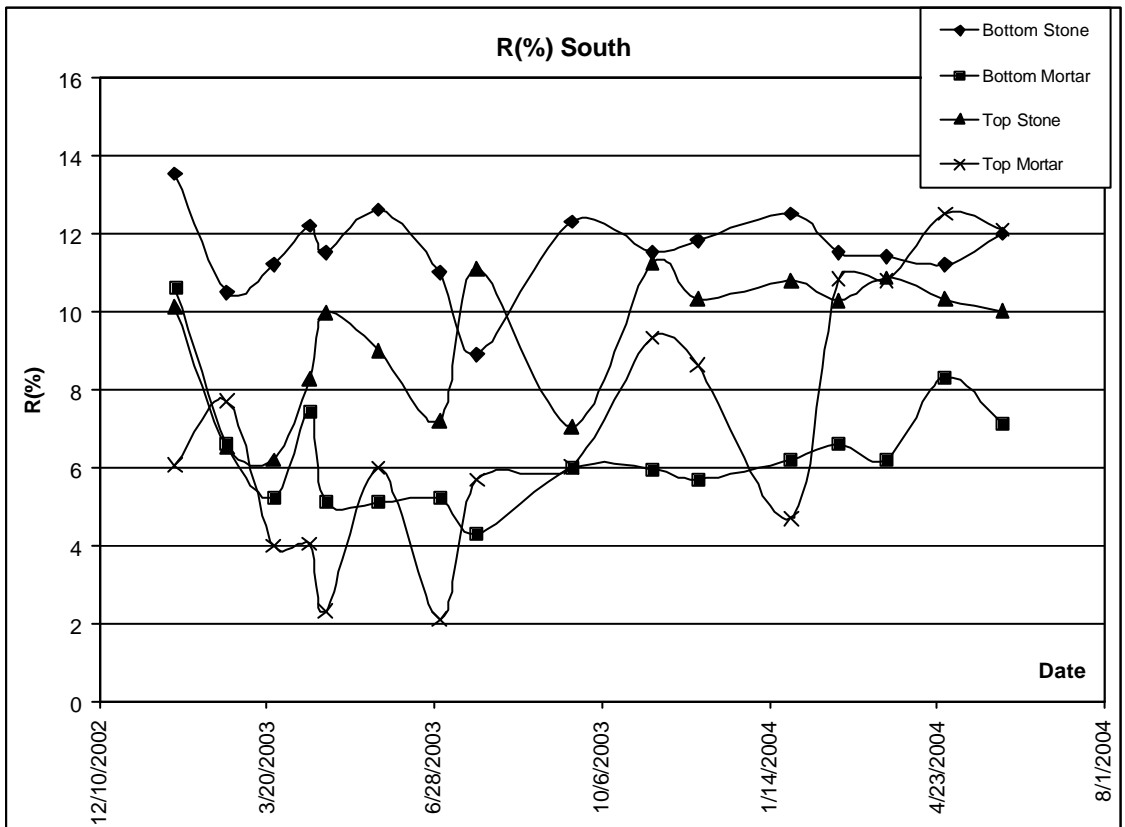
Figure 4.9. Relative moisture at south section

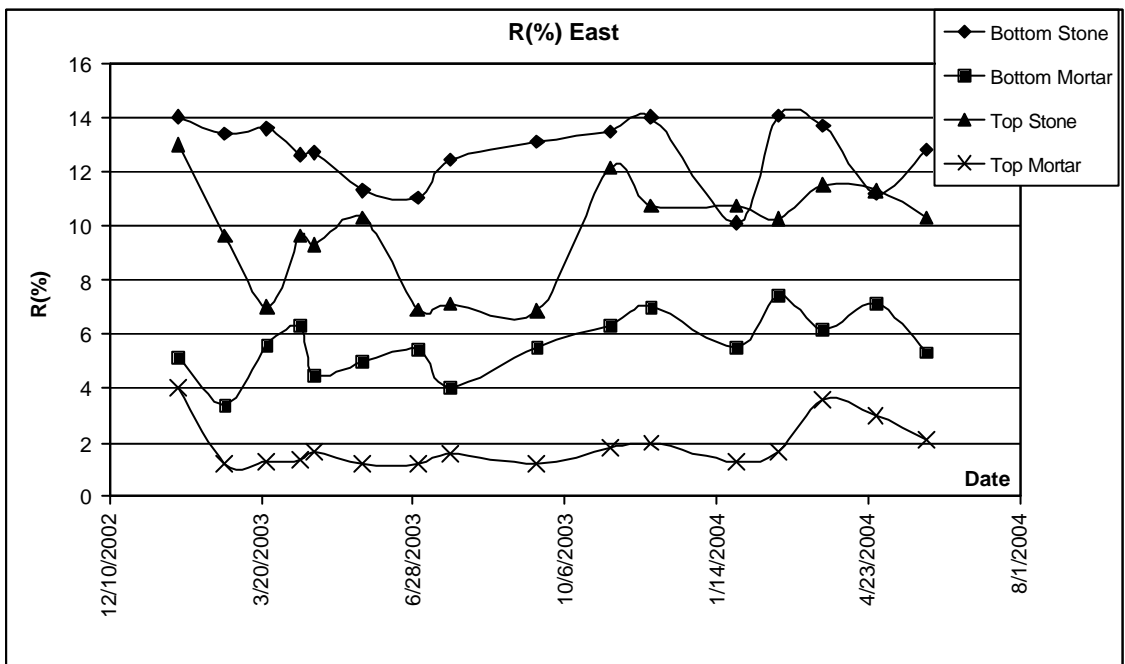
Figure 4.11 Relative moisture at east section

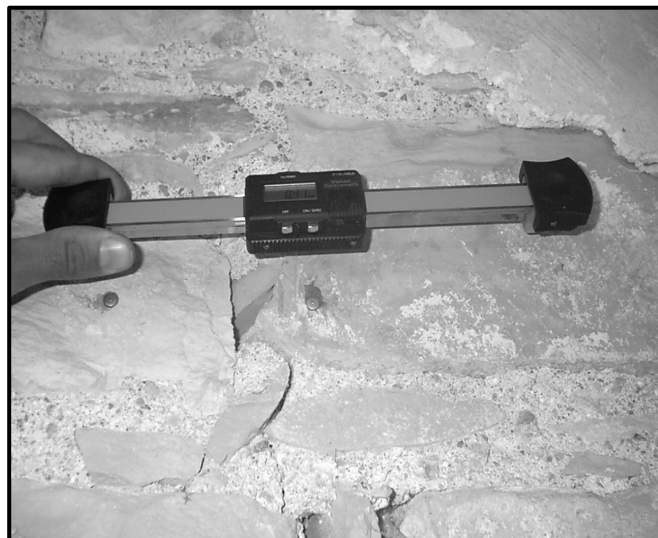
Figure 4.12. Crack measuring device

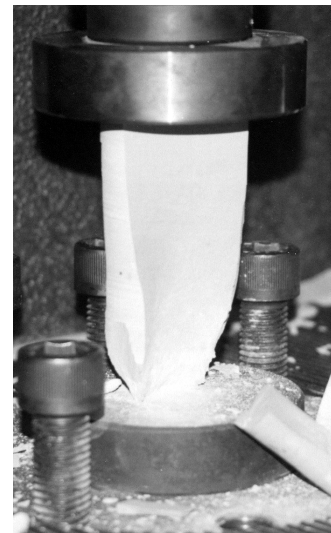
The testing procedure is presented in 2.5.4. The dimensions and relative moisture of each sample are measured. The diameter of each sample is $D=54\text{mm}$, while their lengths vary. The perfectly shaped cylinder core samples have a “y” while the ill shaped ones have a “n” on the “shape” column of Table. 4.7. The test was conducted by use of mechanical testing machine Shimadzu AG1 which has a capacity of 250kN. The machine reads the stroke from the head with respect to applied load and time. The loading rate was taken as 0.2mm/minute which satisfied the condition of failure time between 5 to 10 minutes. Generally all the samples were failed at 10 minute. The stone samples have a brittle type of fracture, see Figure 25 a-b.

a. Loaded sample

b. Failed sample

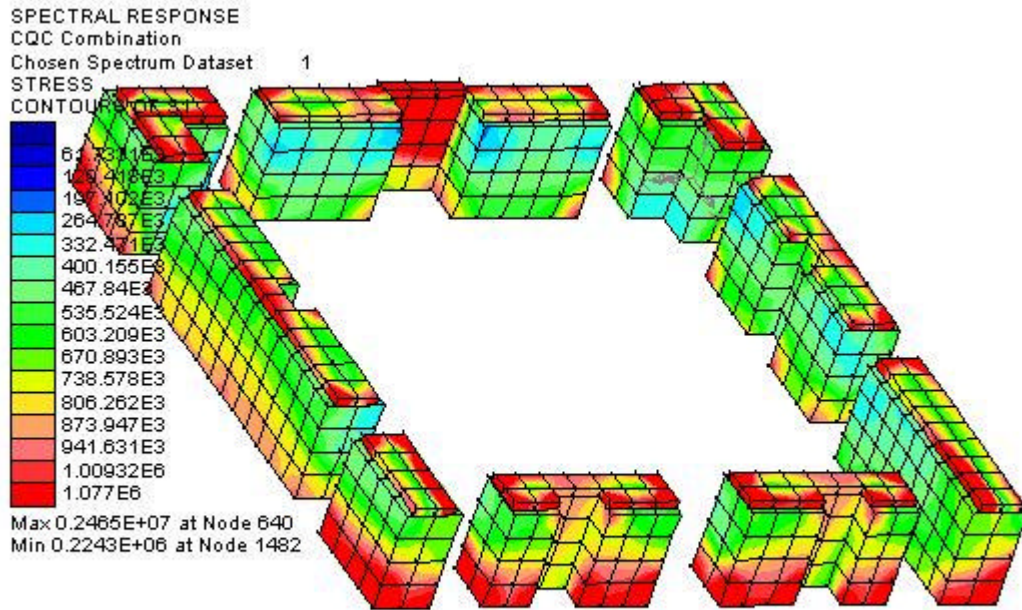
Figure 4.78. The S1 contours of the lintel places.

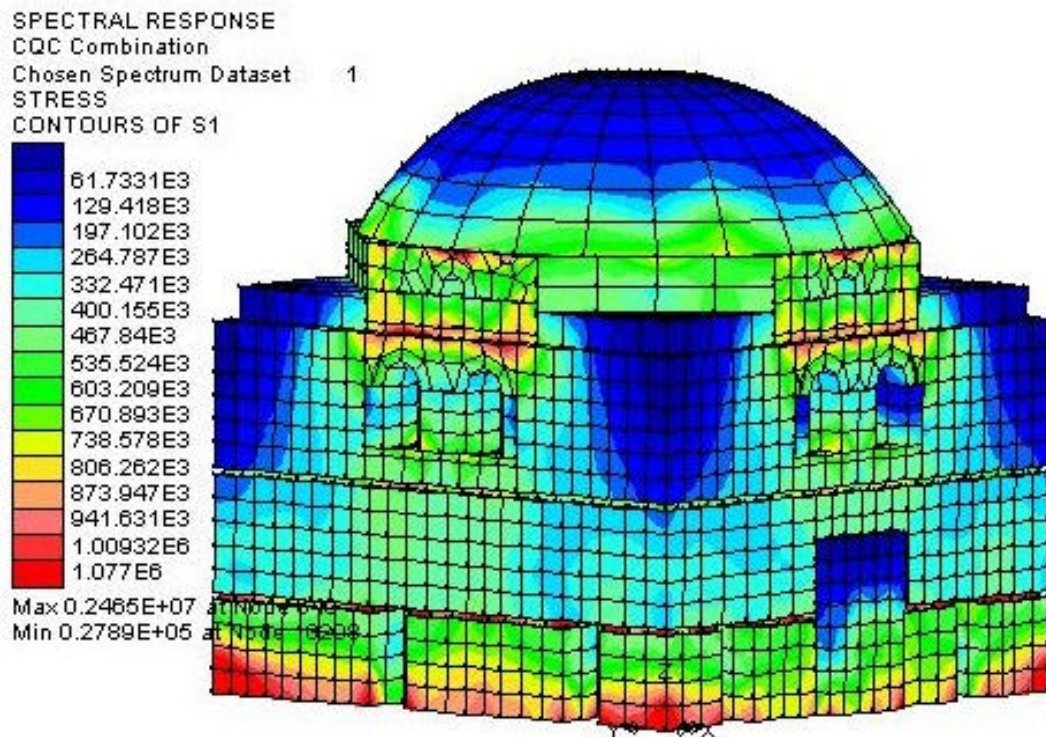
Figure 4.80. S1 of south and west elevations.

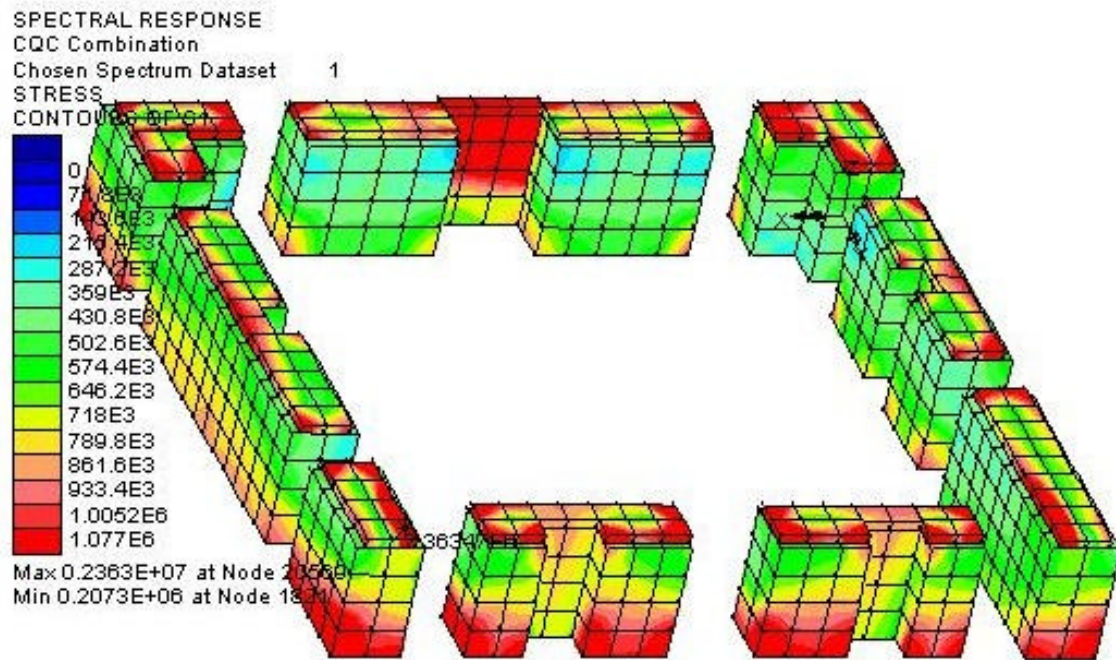
Figure 4.83 S1 contour plot of the lintels.
