**EFFECTS OF SHEAR REINFORCEMENT ON THE
IMPACT BEHAVIOR OF REINFORCED
CONCRETE SLABS**

**A Thesis Submitted to the
the Graduate School of Engineering and Sciences of
İzmir Institute of Technology
in Partial Fulfillment of the Requirements for the Degree of**

in Civil Engineering

**July 2014
İZMİR**

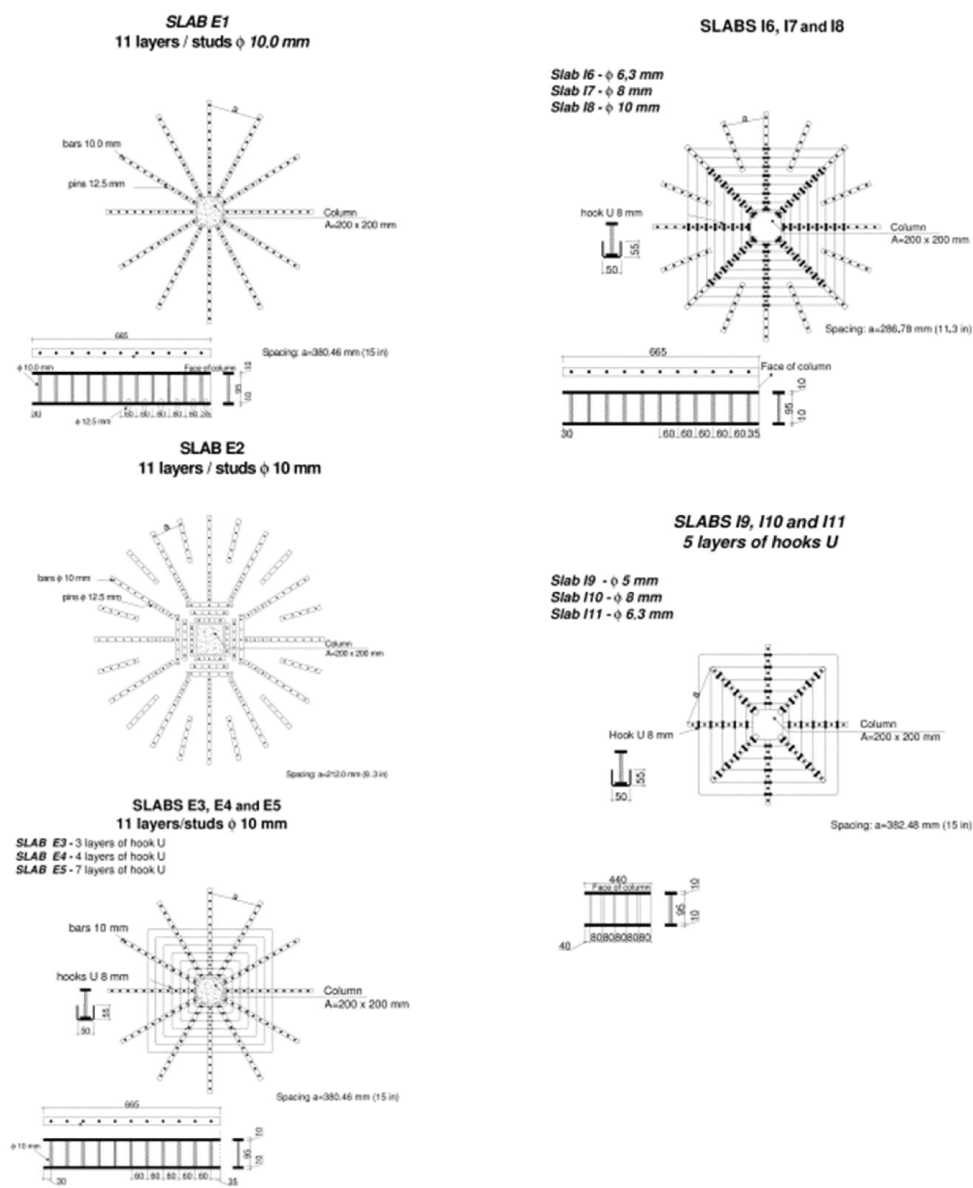
Figure 2.17. Shear reinforcement details for specimens of Trautwein et al (2011)

In studies involving shear studs, a number of different distributions of shear studs around the column were employed. Alongside that, control specimens and specimens with openings in front of the column were also tested to compare the results. Researchers have applied various loads and/or moments on the specimens in experiments. As for the results independent from the loading type, it was seen that applying shear studs increased the ductility of the connection. This change was proportional to rows of shear bolts used around the column. Also formation of shear cracks was prevented compared to control specimens.

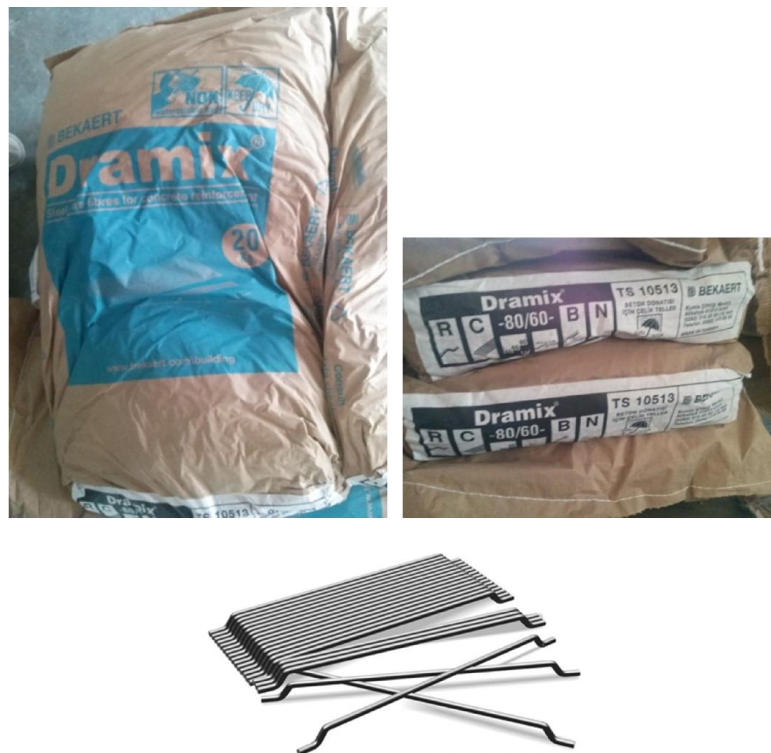
Figure 3.6. Steel fibers

Steel fibers had a length of 60 mm and diameter of 0.75 mm, with a length/diameter ratio of 80 (Figure 3.5). To reach 1 % volume fraction, 80 kg of steel fibers were mixed in concrete mixer for each cubic meters of fresh concrete. General view of steel fibers is in Figure 3.6. Tensile strength of fibers on the wire was minimum 1050 N/mm^2 and it conforms to EN 10016-2 – C9D, low carbon steel. Other characteristics of the fibers are in Appendix.

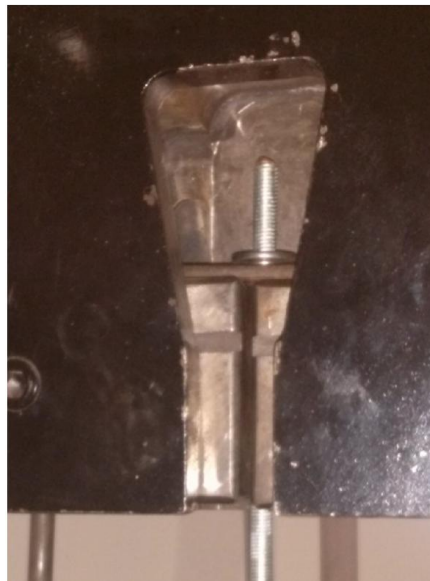
Figure 3.7. Testing shear studs

Reinforcement bars were 8 mm in diameter and they had a yield strength of 420 MPa which confirms with B420C standards. Steel rods used to make shear studs were made of cold-drawn steel and their average calculated yield strength was 586.6 MPa. Manufactured shear studs were also tested to confirm that the failure was due to the breaking of the rod, not the slippage of the nut at both ends. Tests confirmed this and studs failed under tension from the rods before the slippage of nuts (Figure 3.7).

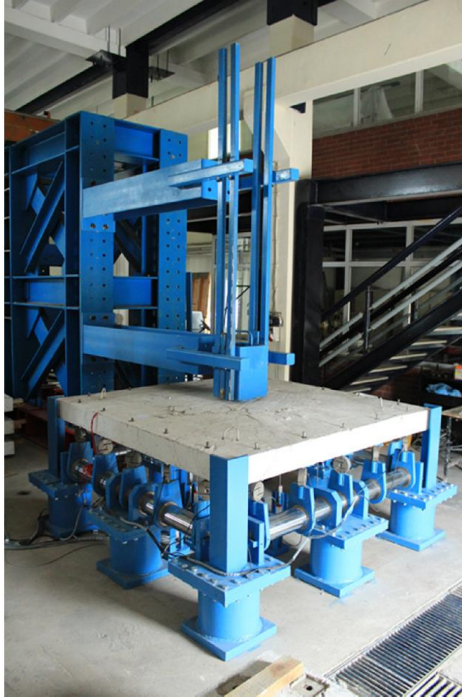
Figure 3.8. Test Setup

A test setup was manufactured at the İzmir Institute of Technology as a part of a previous work by Batarlar (2013). In this test setup, both static and impact tests can be done with few alterations. It consists of eight footings, four on corners and four at the mid of the edges, fixed to the strong floor (Figure 3.8). Each two corner footings and the one footing between them were connected to each other by a circular shaft. Load-cells were hinged on these circular shafts in a manner allowing free rotation of the edges. But vertical movement was prevented.

For impact testing, the hydraulic mechanism was removed from underneath the specimen. A drop tower established from four rails was mounted on the top of the test setup (Figure 3.8.). Specimens were impacted several times. Individual tests are referred as the drop number following the specimen name. Drop height was kept constant at 2.5 m for all impact tests except tests YA200fb-2, YA200fb-3 and YA200fb-4, which the drop height was 2.44 m. Sixteen accelerometers have been placed on slab and on the drop-weight. After every drop, the cracks underneath and the crack on top of the slab were marked and photographed. Major cracks were measured in millimeters and documented. Crack distributions were hand drawn using the photographs of the specimens.

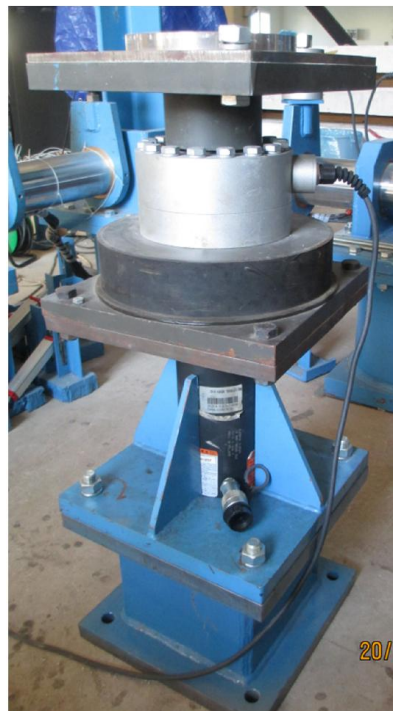
Figure 3.10. Hydraulic piston with 50 ton capacity load cell on top

Three kinds of load cells have been used. Eight load cells had 5000 kg capacity, type S model TB (Figure 3.9.b). Twelve load cells have 10000 kg capacity, type S model SC (Figure 3.9.a). One other load cell was placed on the top of the hydraulic jack and had a capacity of 50 tons (Figure 3.10). The manufacturer of all load cells was ESİT Electronics Production and Trade Co.

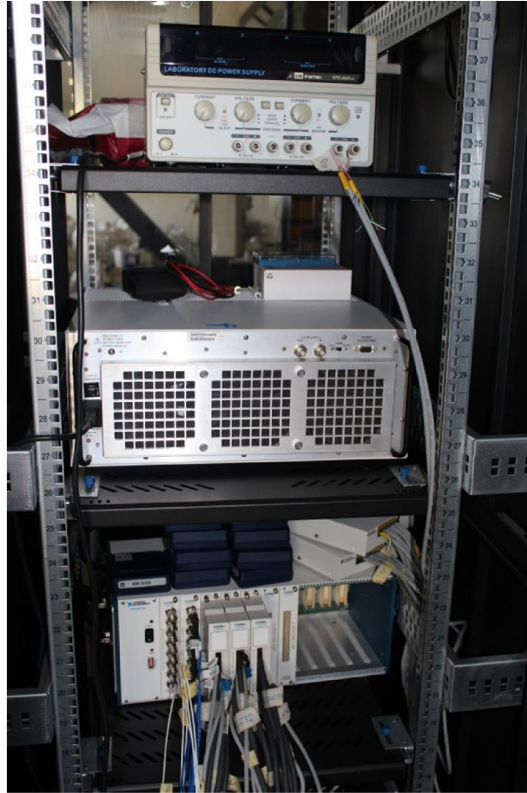
Figure 3.22. General view of DAQ

A high speed data acquisition system was employed (Figure 3.22.). National Instruments NI PXI-6143 S series multifunction data acquisition modules with 250 kS/s per channel sampling rate, NI SCXI-1520 8 channel universal strain gauge input modules, NI SCXI-1531 signal conditioning modules and NI SCB-68 shielded I/O connector blocks were used to record data from load cells, strain gauges, accelerometers and RLPT's. As software, Lab VIEW Academic Standard Suite program was used.

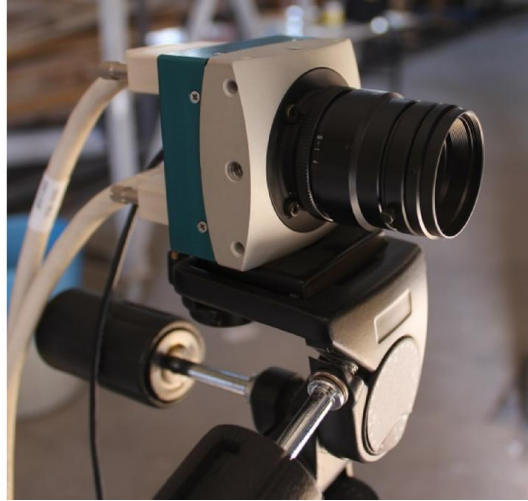
Figure 3.23. Mikroton EoSens high speed camera

A high speed camera was installed to monitor the free fall of the drop weight and to calculate the impact velocity. MotionBLITZ high speed camera system was used (Figure 3.23) manufactured by Mikrotron GmbH. The camera was used at frame rates from 800 fps to 1262 fps.

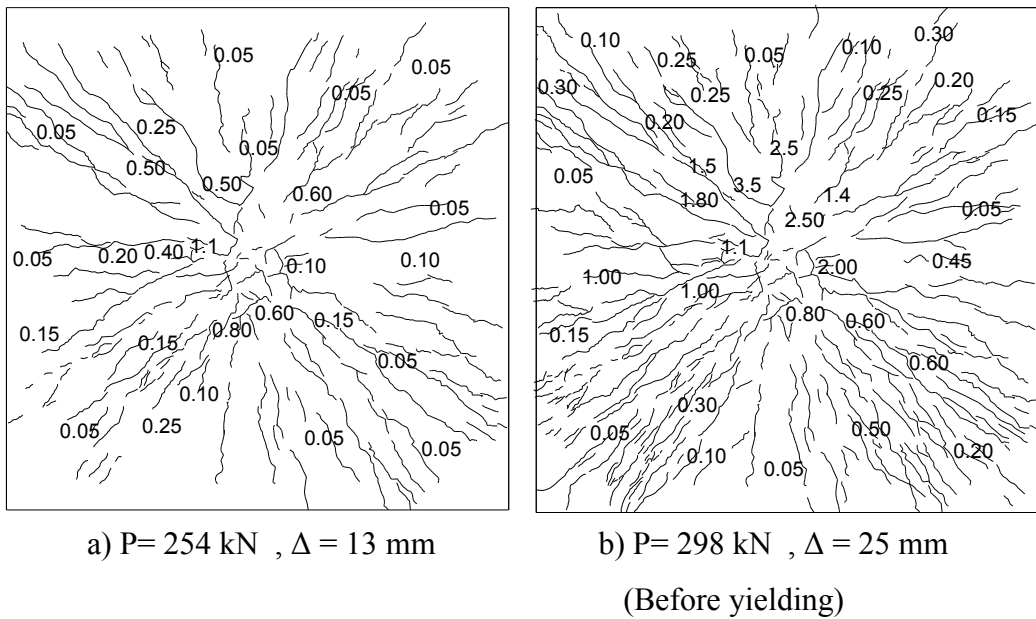
Figure 3.33. Crack profile of the front face of specimen YA200fa

c) $P = 125 \text{ kN}$, $\Delta = 68 \text{ mm}$ (After failure)
 (Numbers indicate crack widths in millimeters)

Specimen YA200fa reached 320 kN load carrying capacity and a midpoint displacement of 55 mm before failing. Crack distribution of the specimen is in Figure 3.32 and Figure 3.33.

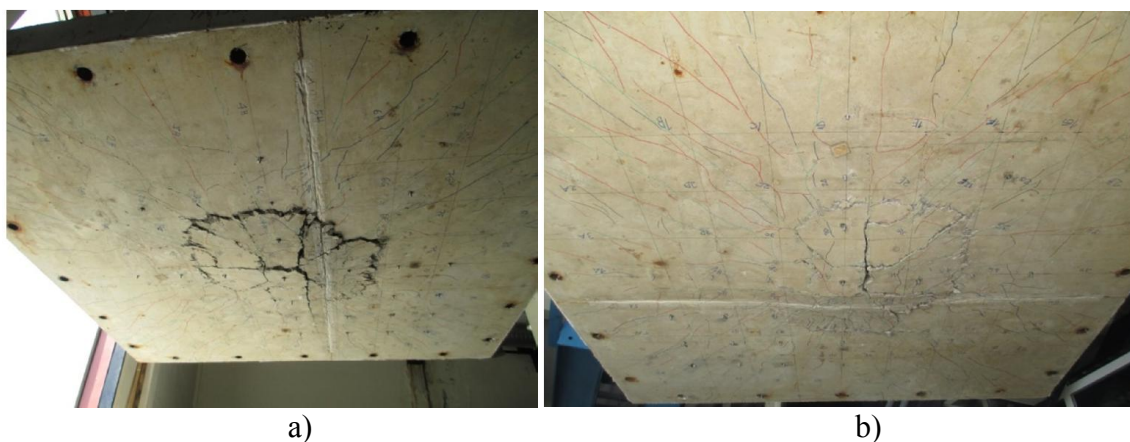
Figure 3.40. a) Formation of punching cone and b) General view of the back face of the specimen YA150fb after testing

Specimen YA150fb endured five impact loadings from 2.5 m with the 320 kg drop weight. Almost no scabbing occurred (Figure 3.40). No cracks formed on the impacted surface of the specimen (Figure 3.41). Crack distribution of specimen is in Figure 3.42.

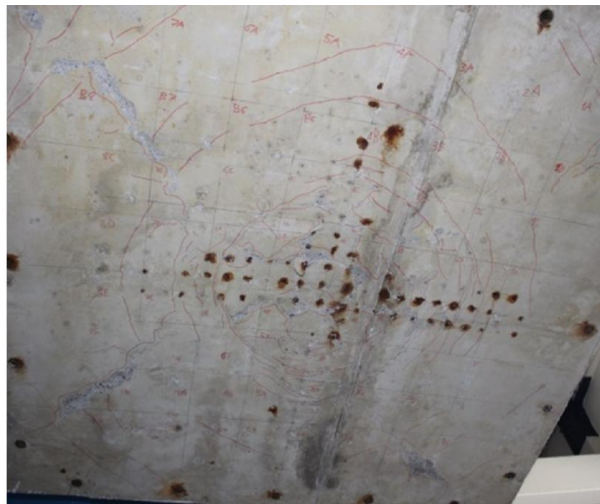
b) Loading face of the specimen YA150a, after testing

Due to the wide cracks on the diagonal axes, compression formed on the rear diagonals of the specimen. Compression of the concrete caused scabbing, as can be seen from Figure 4.2b. Additionally, circular cracks formed on the loading face, which exhibits ductile flexural behavior of the member.

Figure 4.2. Drawings and photographs of specimens with the same longitudinal reinforcement ratio, after testing

All three specimens have the same longitudinal reinforcement. BB150a is the control specimen and was tested by Batarlar (2013). Specimen YA150a has shear studs addition to longitudinal reinforcement and specimen YA150fa has SFRC instead of plain concrete. Crack profiles after the testing of all three specimens are presented in Figure 4.2.

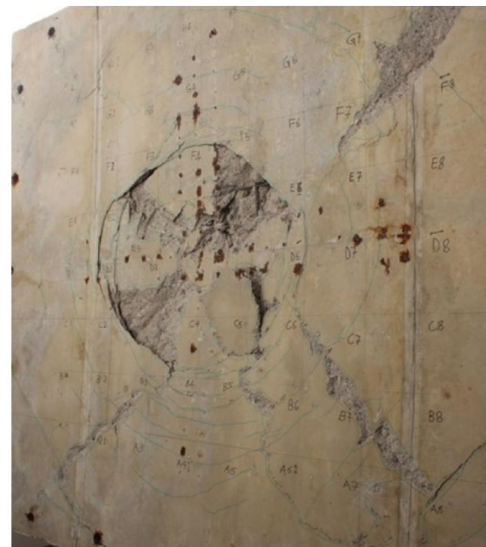
b) Loading face of the specimen YA200a, after testing

Figure 4.4. Drawings and photographs of specimens with the same longitudinal reinforcement ratio, after testing

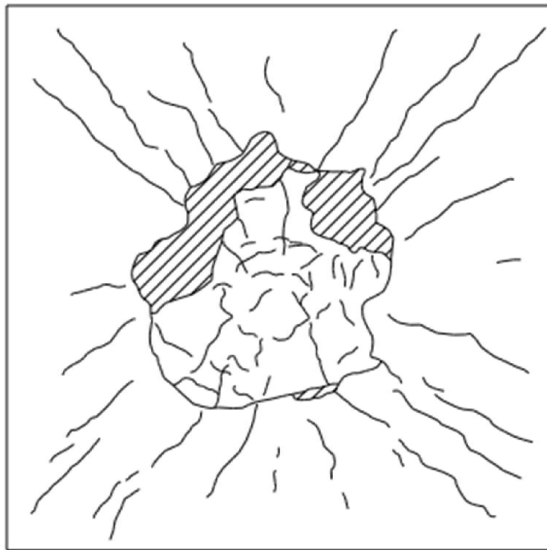
Figure 4.9. Crack profiles of the back face of BB150b
(Source: Batarlar,2013)

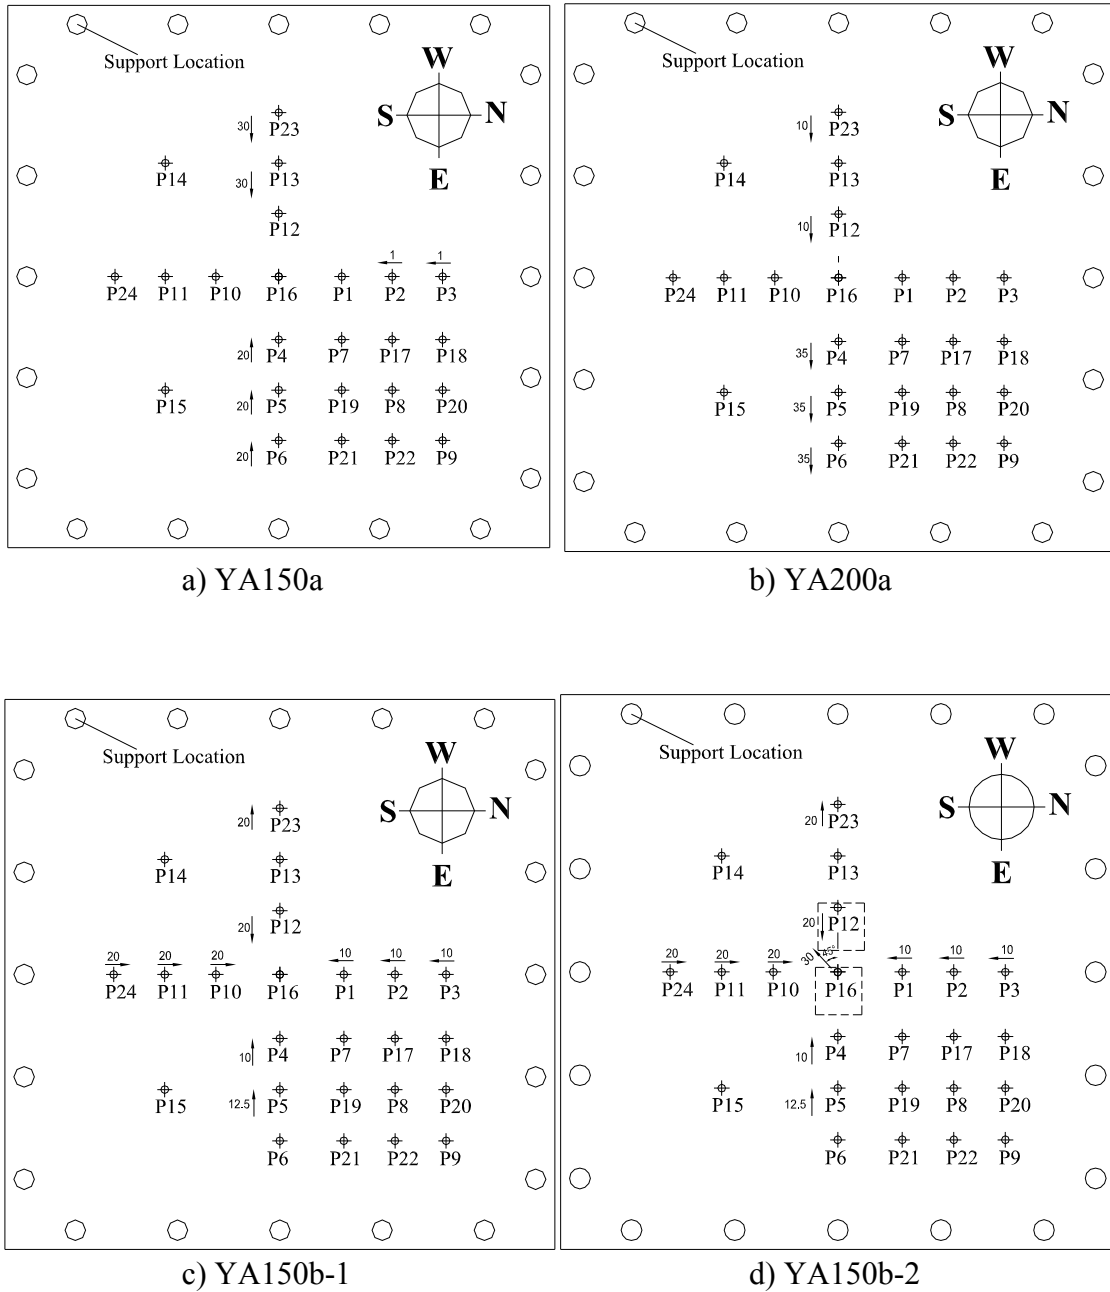
Figure 4.17. Modifications done to relocate RLPT's (Numbers indicate modifications in millimeters)
